**MATURE SUBALPINE TREE &
SHRUB TRANSPLANTING AT THE
CLIMAX MINE, CLIMAX, CO**

**Robin Bay & Ken Carlson – Habitat Management, Inc.
Aaron Hilshorst – Climax Molybdenum Company**

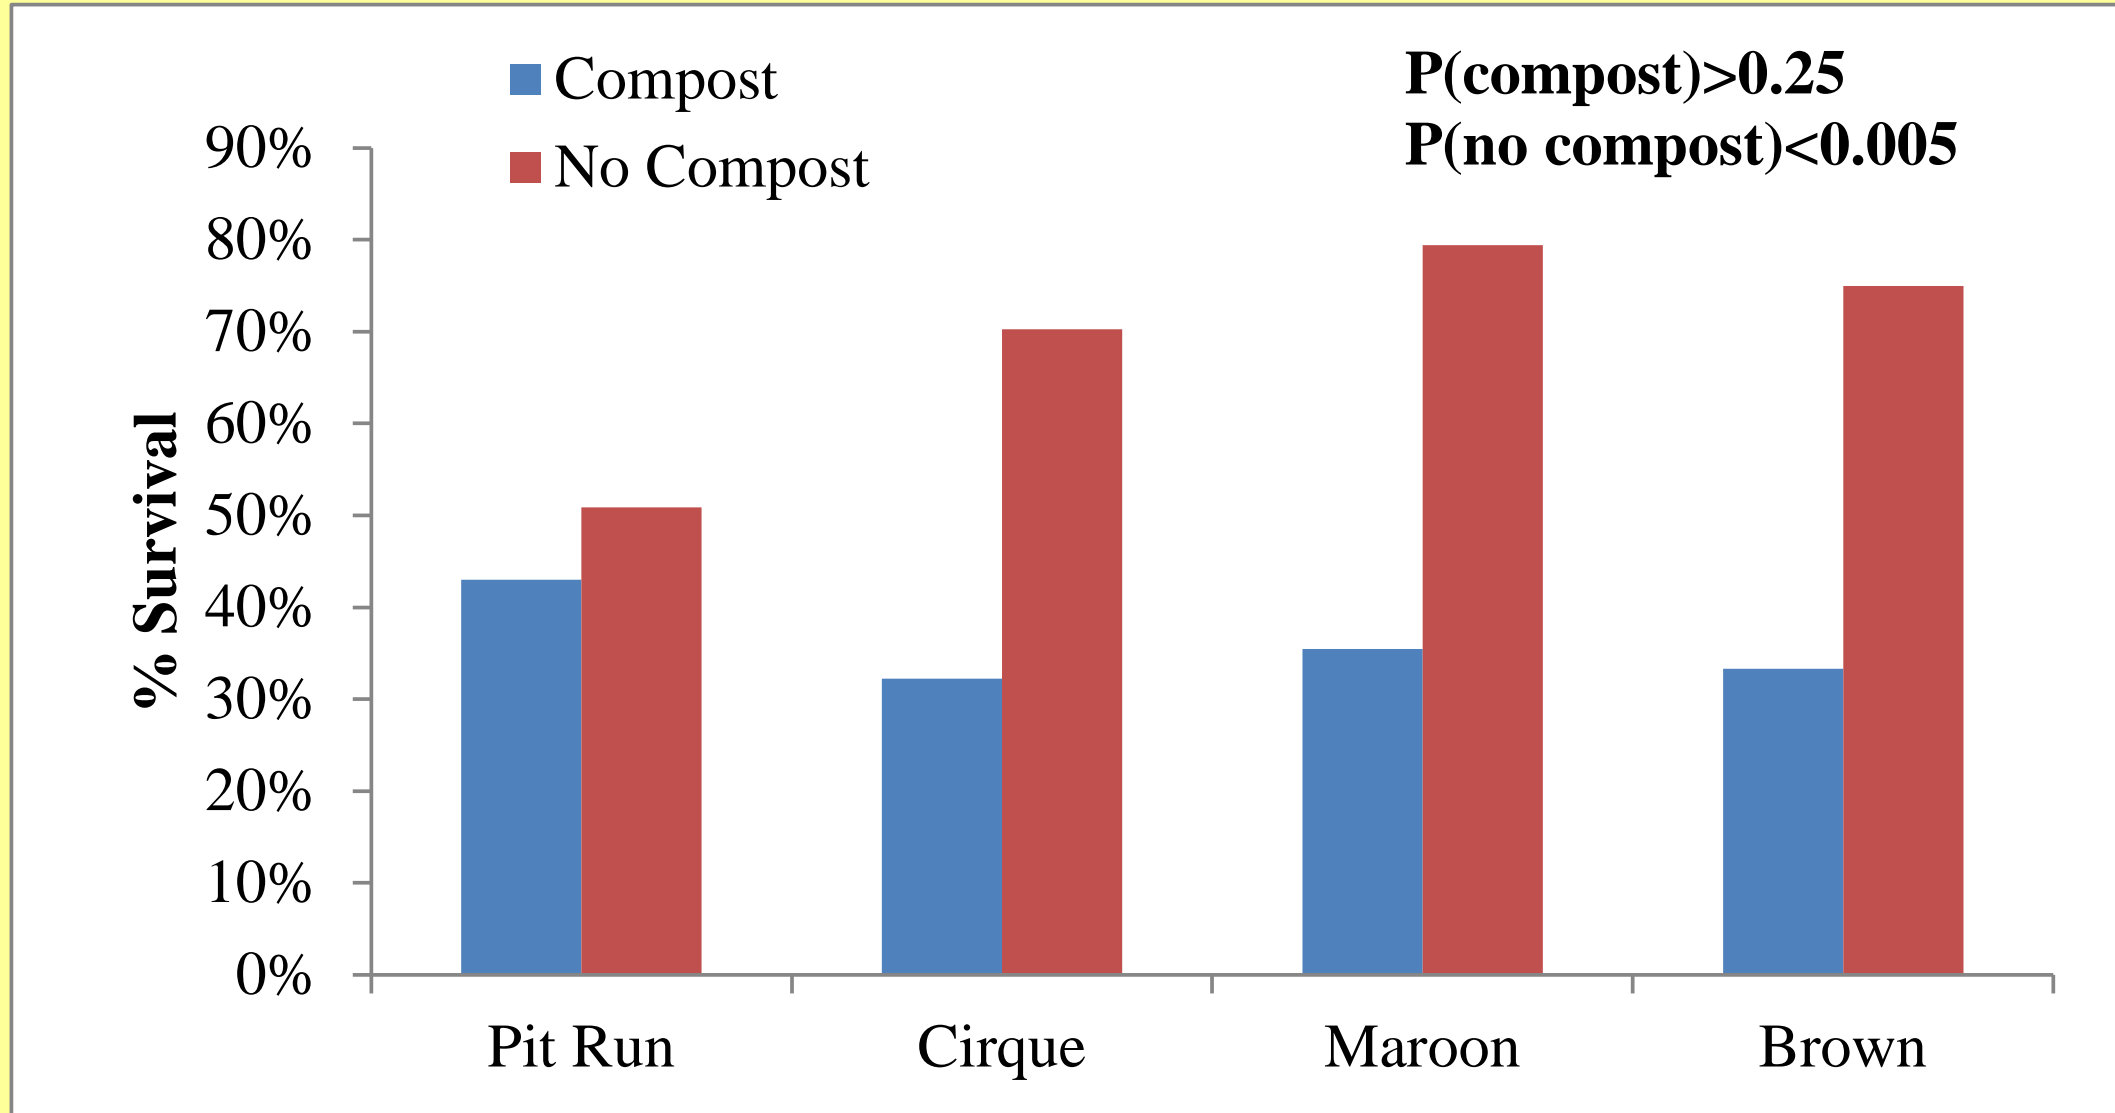
Results – Tree Transplants by Soil Type

Location	Soil Type	Spruce		Fir		Total	
		Alive	% Survival	Alive	% Survival	Alive	% Survival
E Dump	Pit Run	198	80%	6	100%	204	81%
Robinson TSF	Pit Run	154	46%			154	46%
	Cirque	39	49%	6	38%	46	47%
	Maroon	113	72%	14	64%	127	71%
	Brown	10	77%	5	42%	15	60%
	Dark Brown	5	71%			5	71%
	Dark Grey	1	100%	1	11%	2	20%
Billy Blvd	Dark Grey	28	85%			28	85%
Storke	Fill	184	69%	5	36%	189	68%
Native	Topsoil	1	33%			1	33%
Total		551	71%	37	47%	589	69%

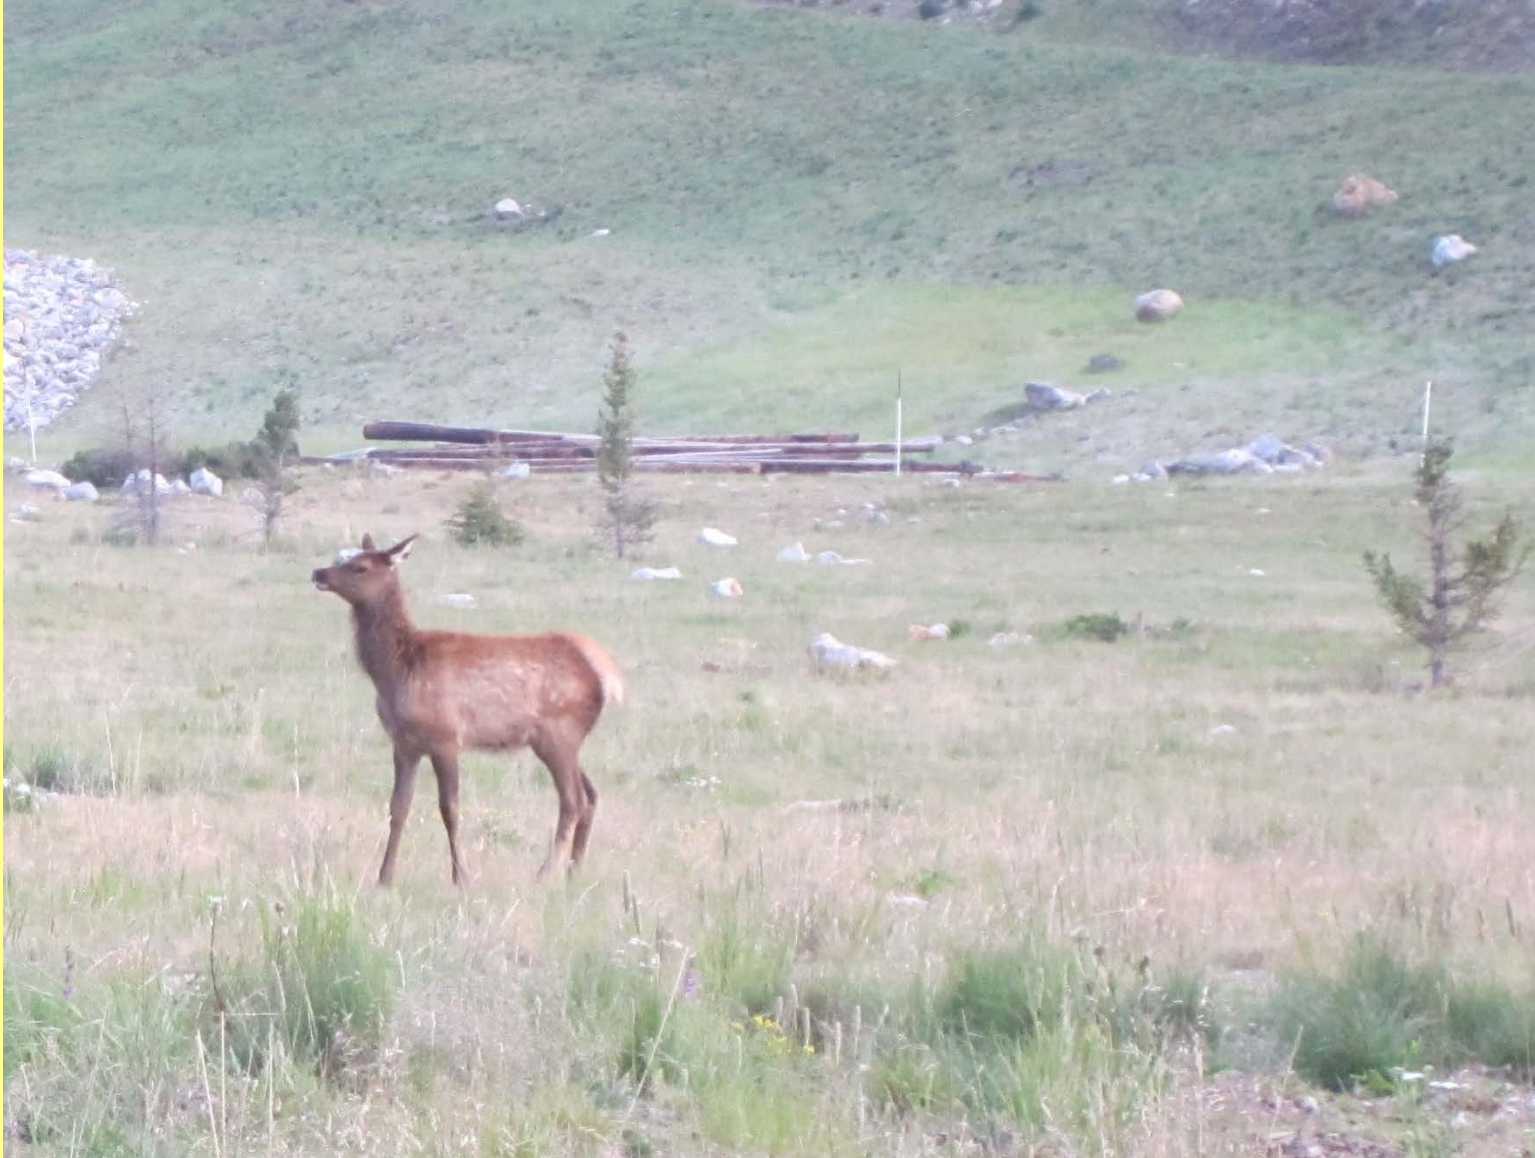
Results – Tree Transplants & Elk Damage

Location Planted	Trees Damaged By Elk	% of Planted Trees Damaged	Dead Elk Damaged Trees in 2012	% of Elk Damaged Trees Killed
Robinson TSF	220	33%	73	33%
E Dump	44	17%	0	0%
Storke	48	17%	7	15%
Total	312	25%	80	26%

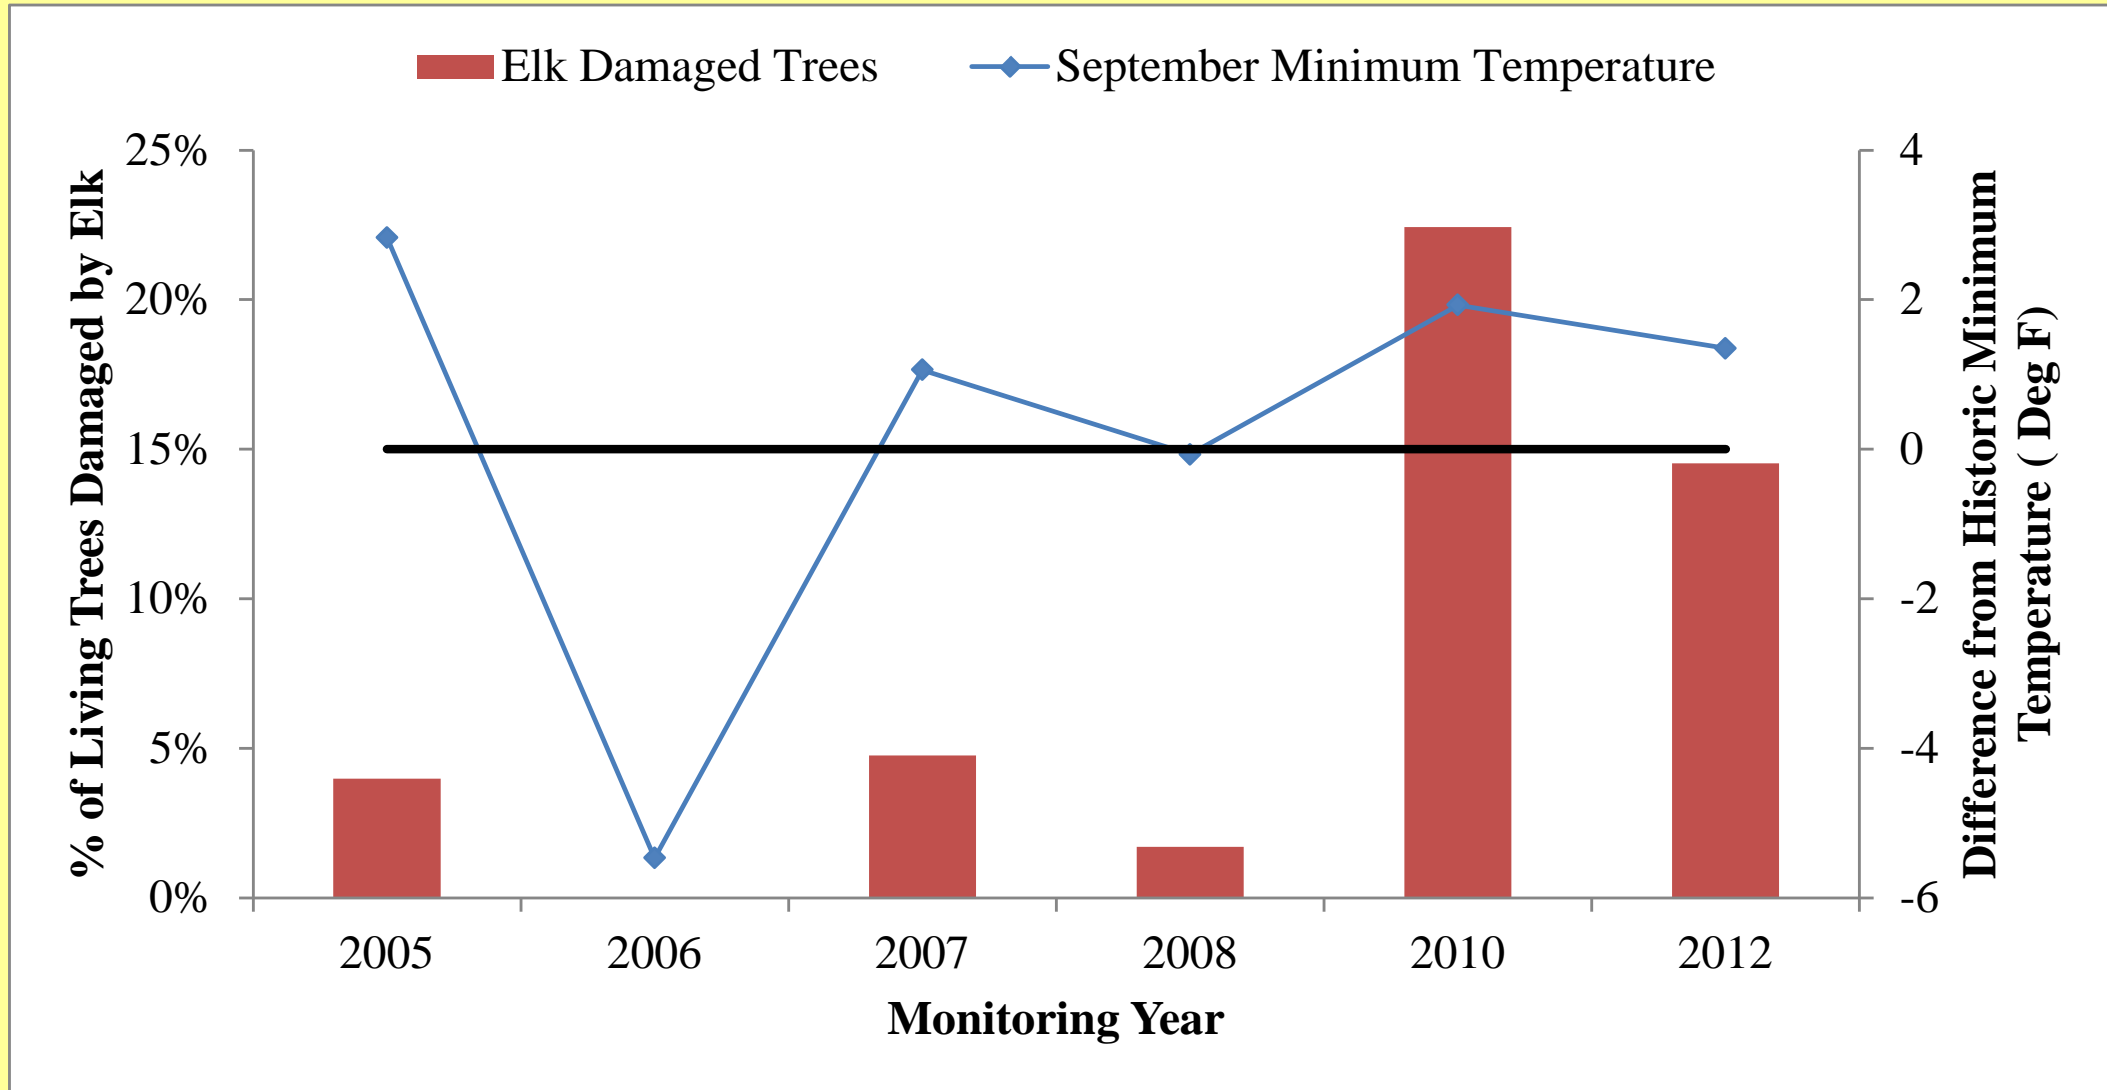
Results – Tree Transplants & Elk Damage

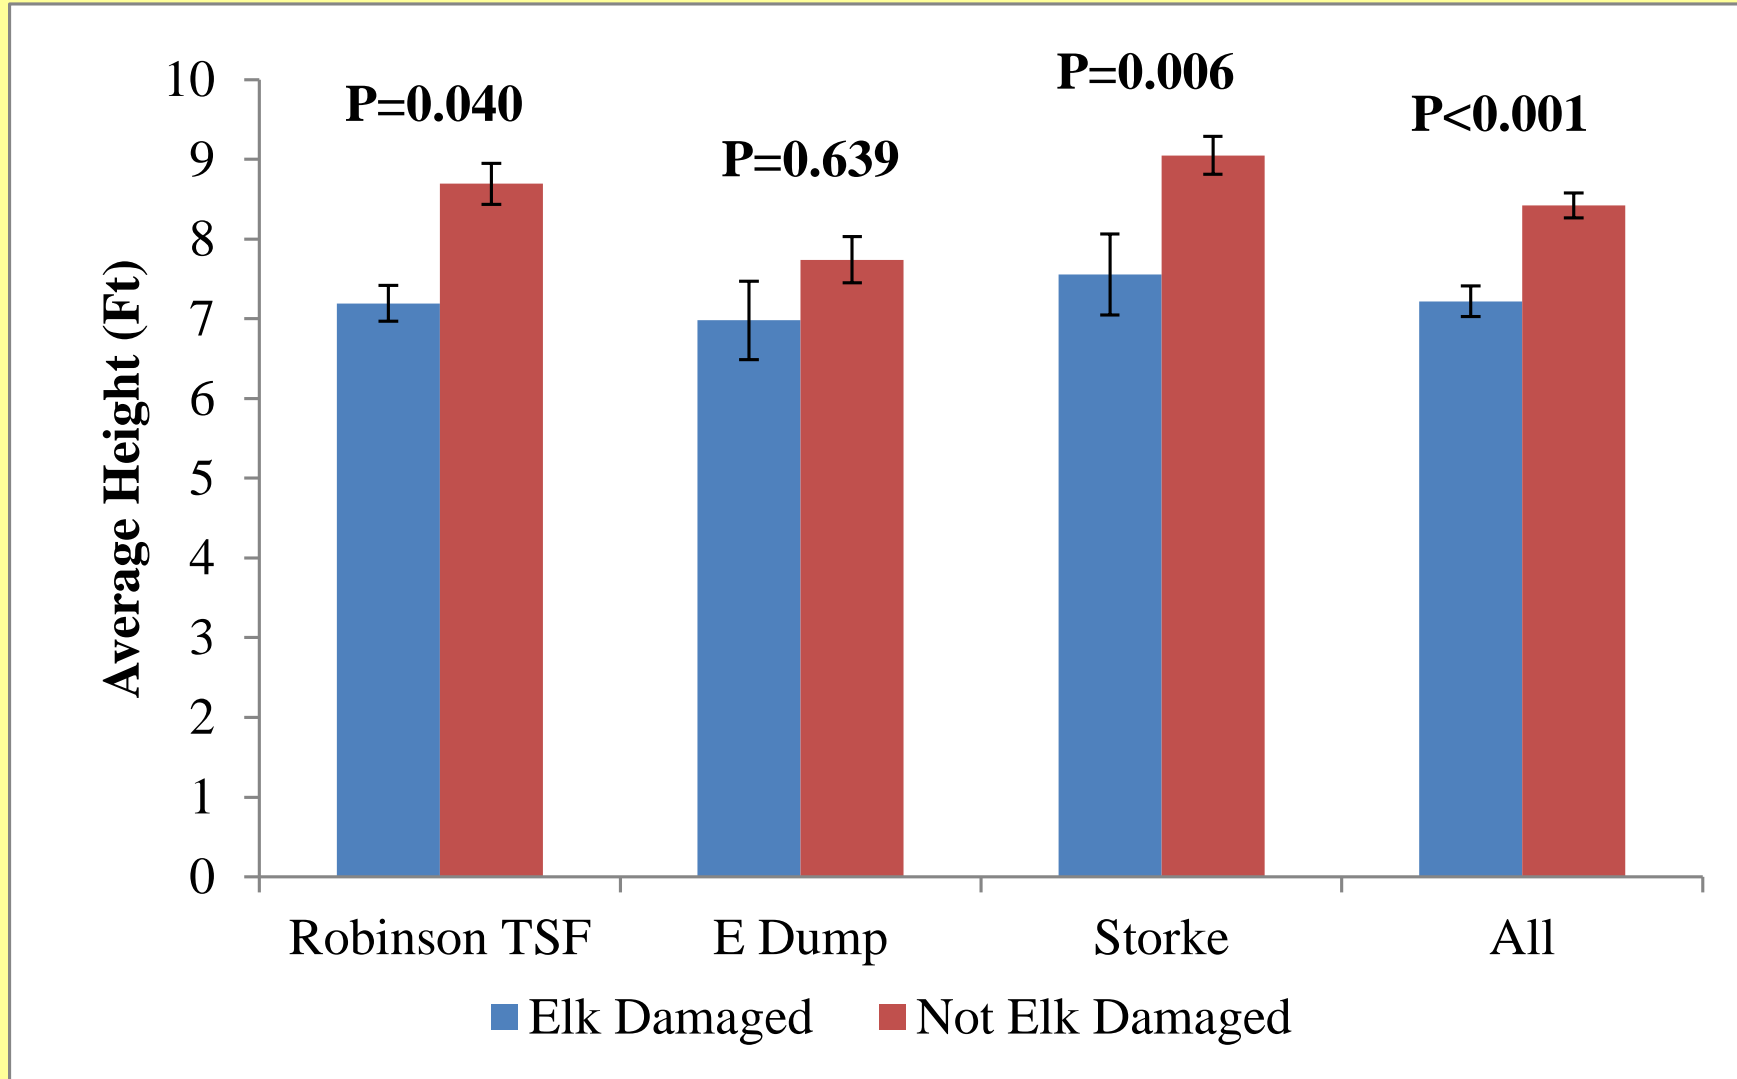
Results – Tree Transplants & Elk Damage
