Shullsburg Mine: A Case Study

the journey to a fully reclaimed wildlife habitat site;
secure, aesthetically compatible, ecologically
functional, and geomorphically resilient

Presentation to
American Society of Mining & Reclamation
June 16, 2014

Tom Hunt, PhD
Director of Science
Applied Eco
Brodhead, WI

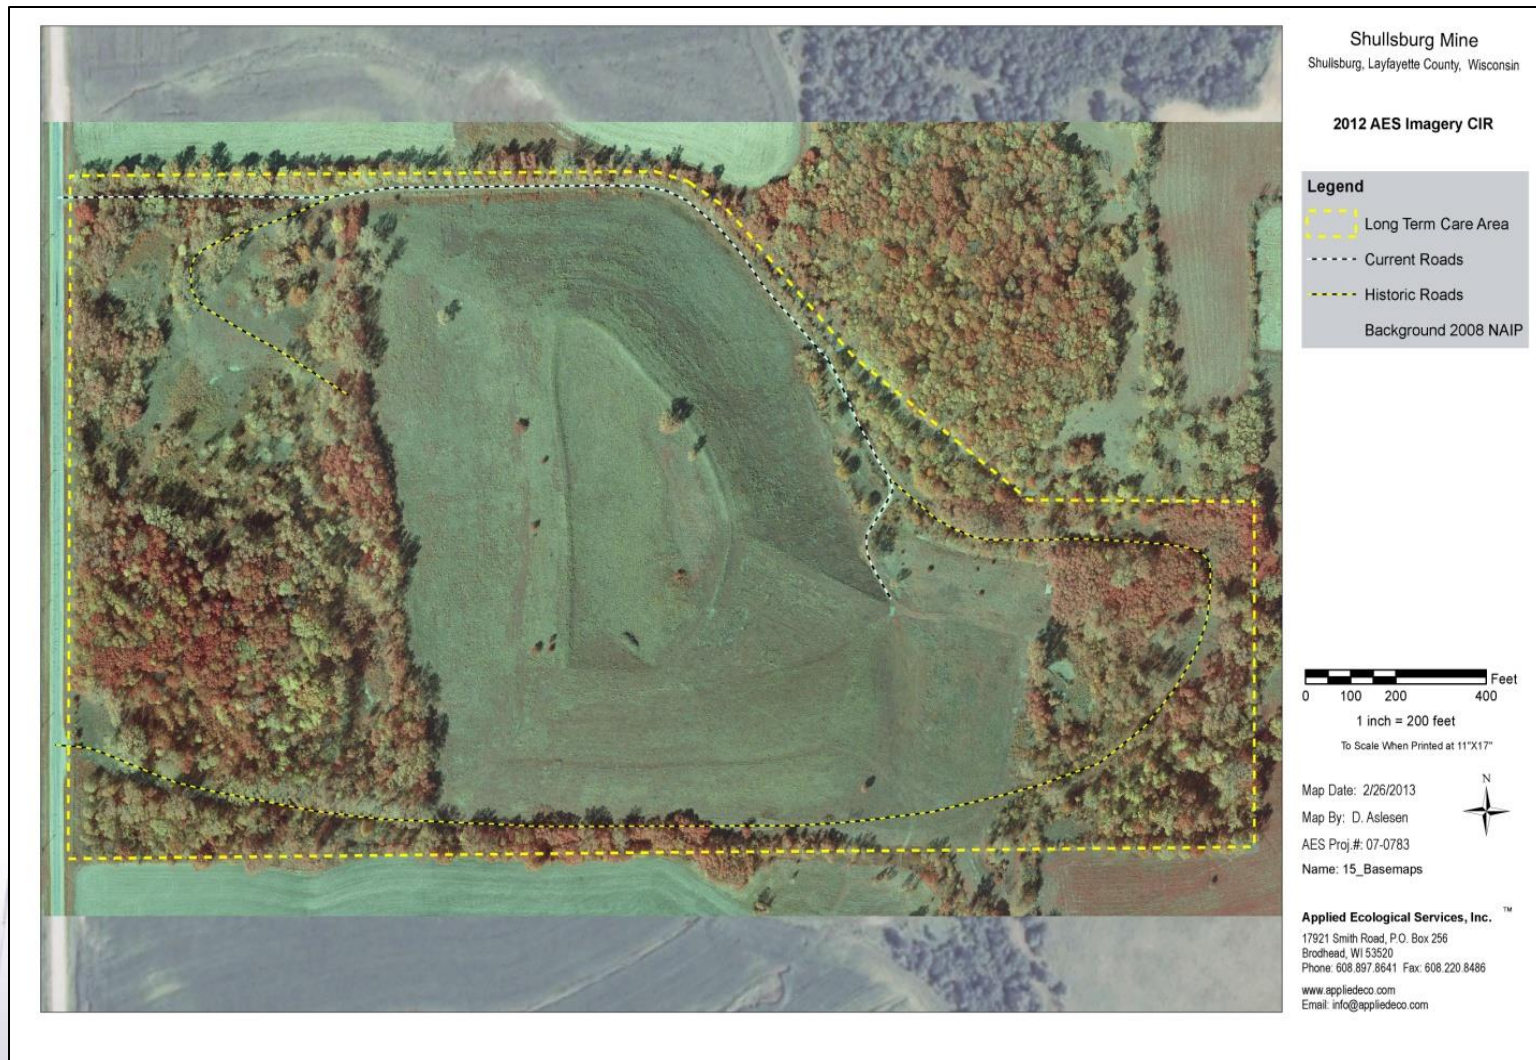
CIR aerial imagery of the Shullsburg Mine site. Surrounding land use predominately row crop agriculture with scattered oak woodlands in various states of degradation.

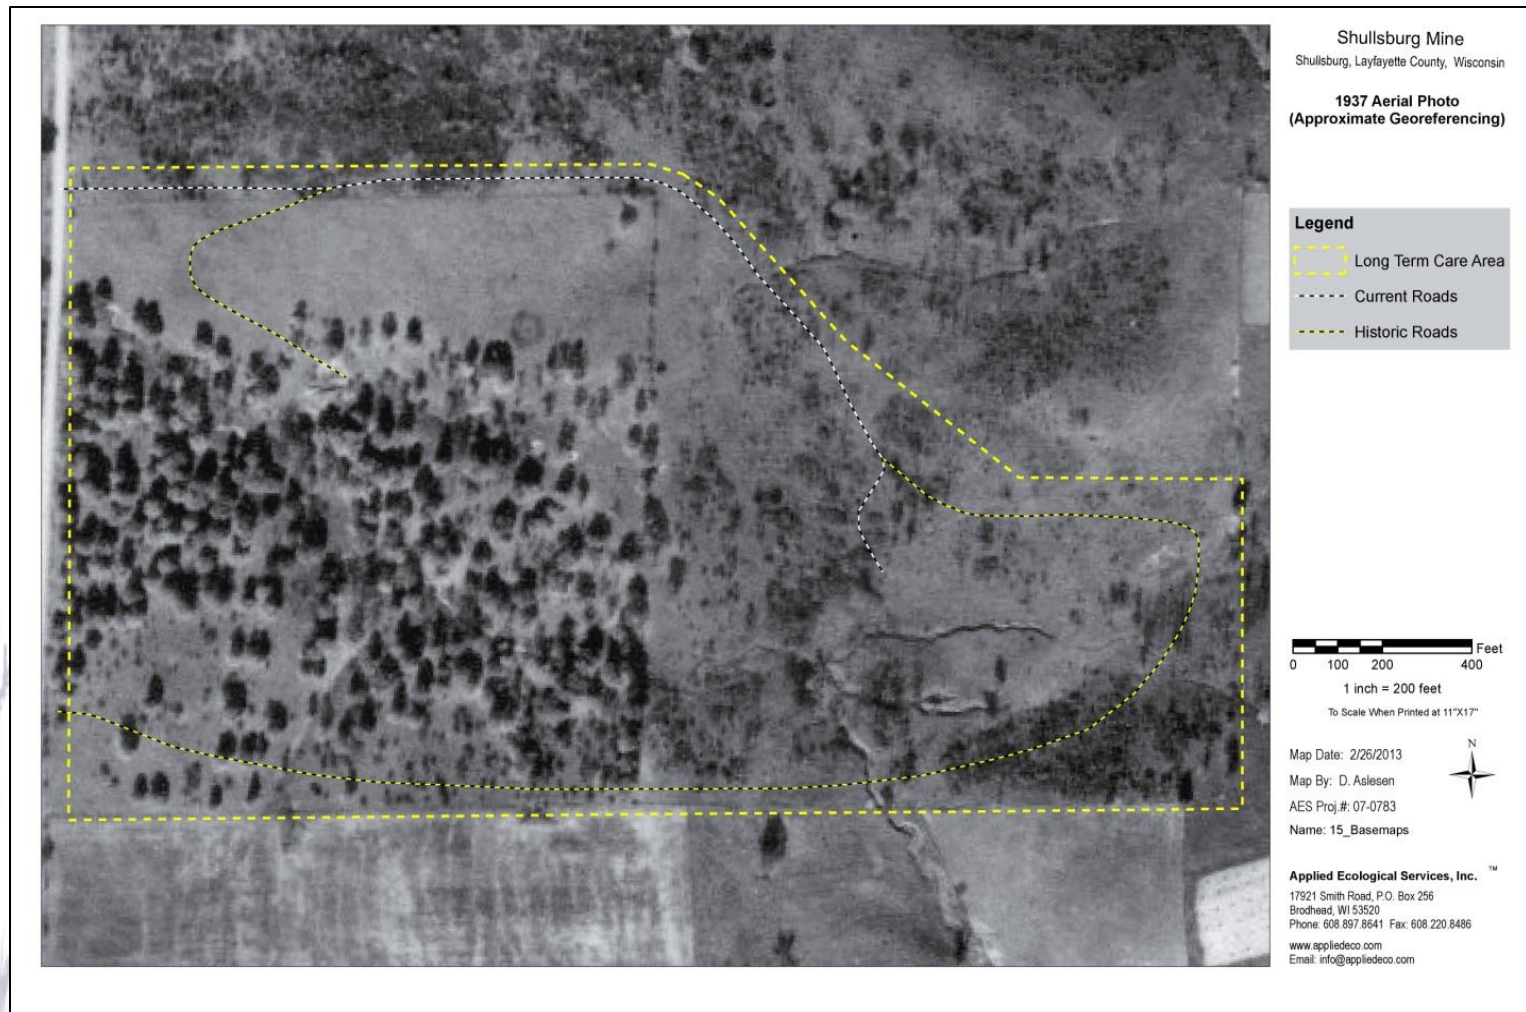
A 1937 aerial image depicting historic oak savanna conditions in the southwest section of the site. Note historic stream pathways also.

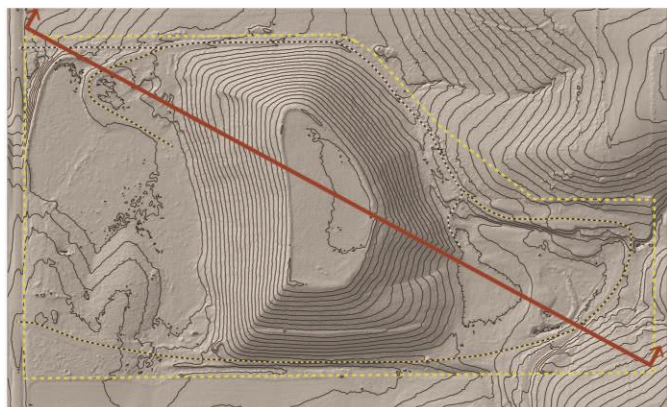
Typical Cross Section

Horizontal Scale: 1"=200' 0' 200' 400'
Vertical Scale: 1"=100' 0' 100' 200'

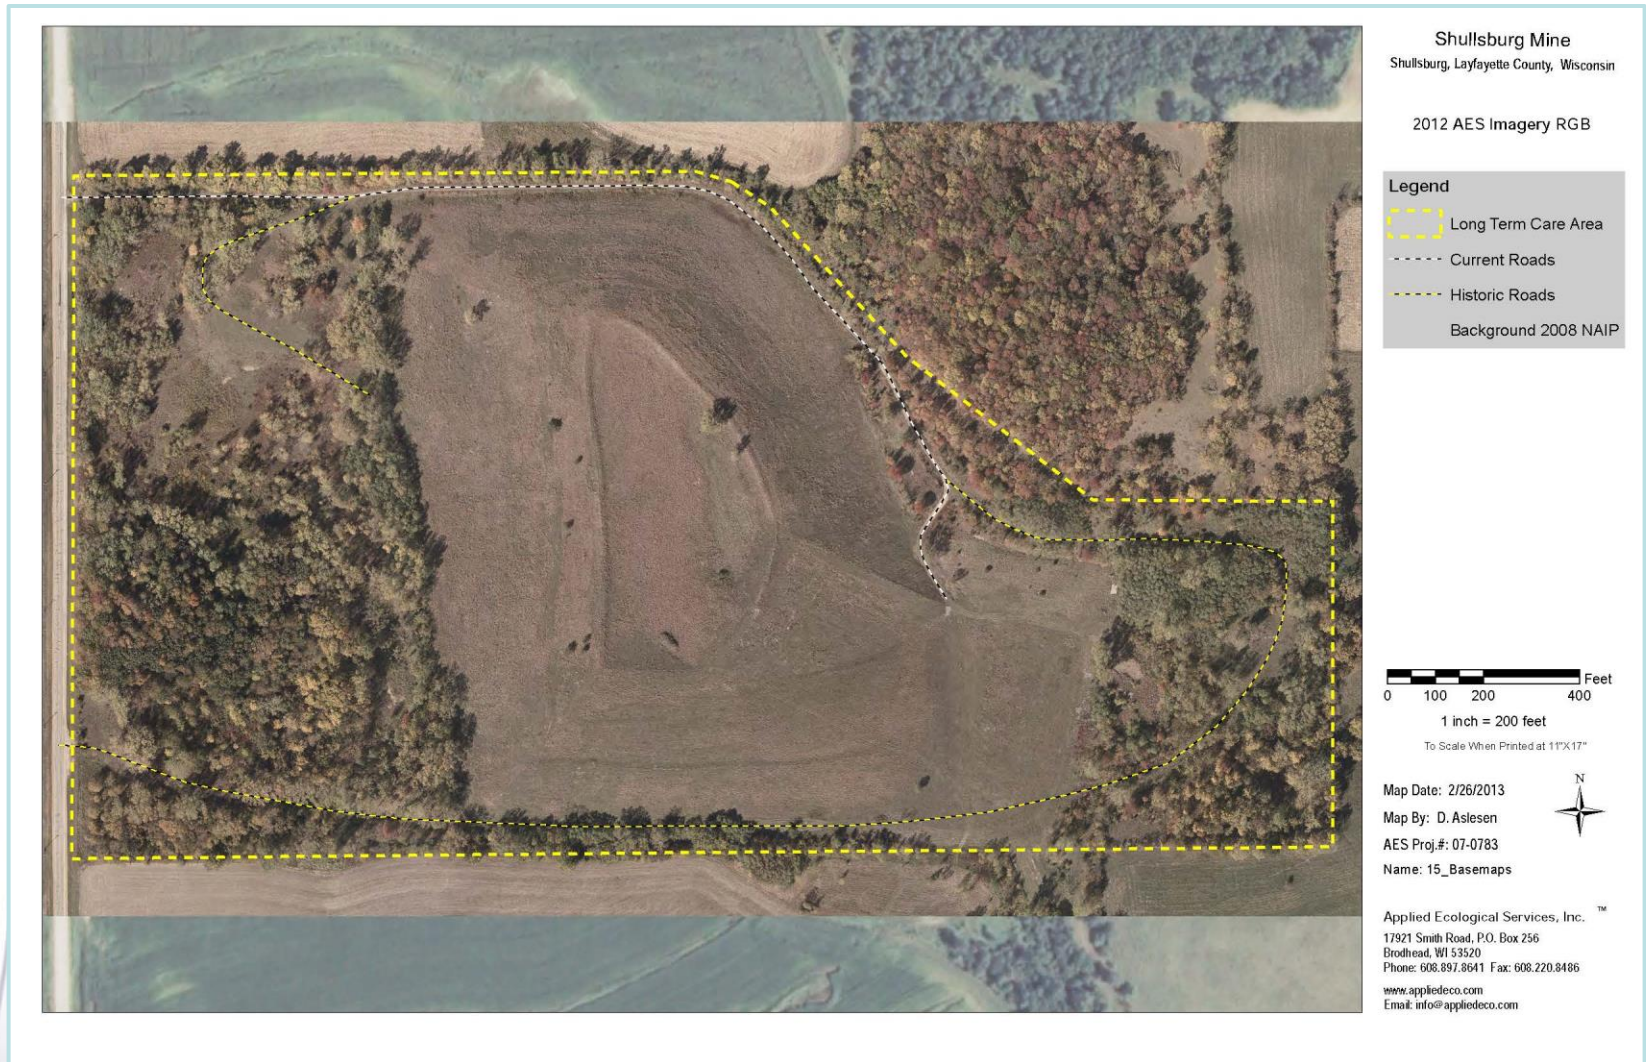
Site After Reclamation Complete (2012)
