Phytoremediation on Lead And Acid mine Drainage soils

Council for Geoscience
Leaders in Applied Geoscience Solutions

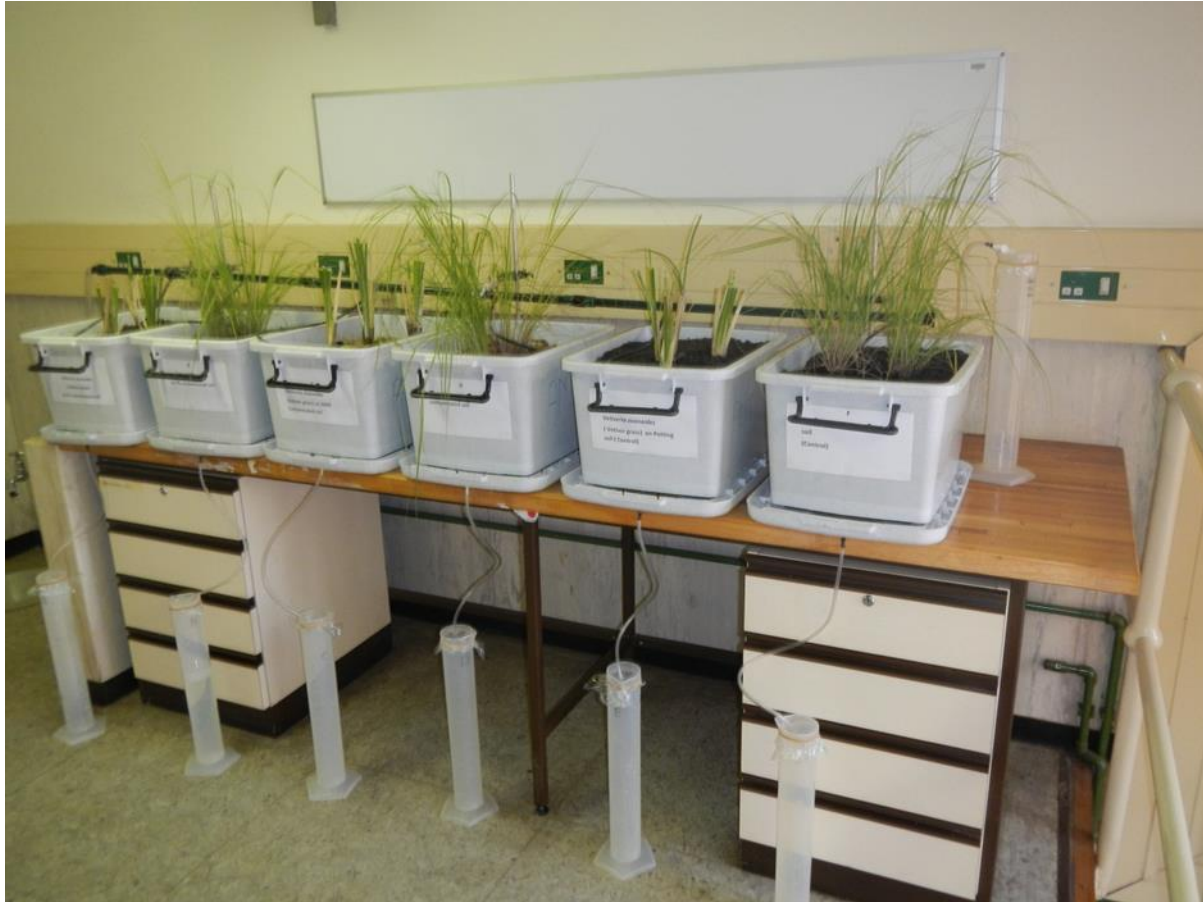
Experimental setup in the EGU lab

- Two different grass species (Vetiver and Eragrotis Curvula)
- Planted in Pb – Zn and acid mine drainage polluted soils
- Also in potty soil for control purposes
- EGU lab with dripping system connected to a tap - irrigation

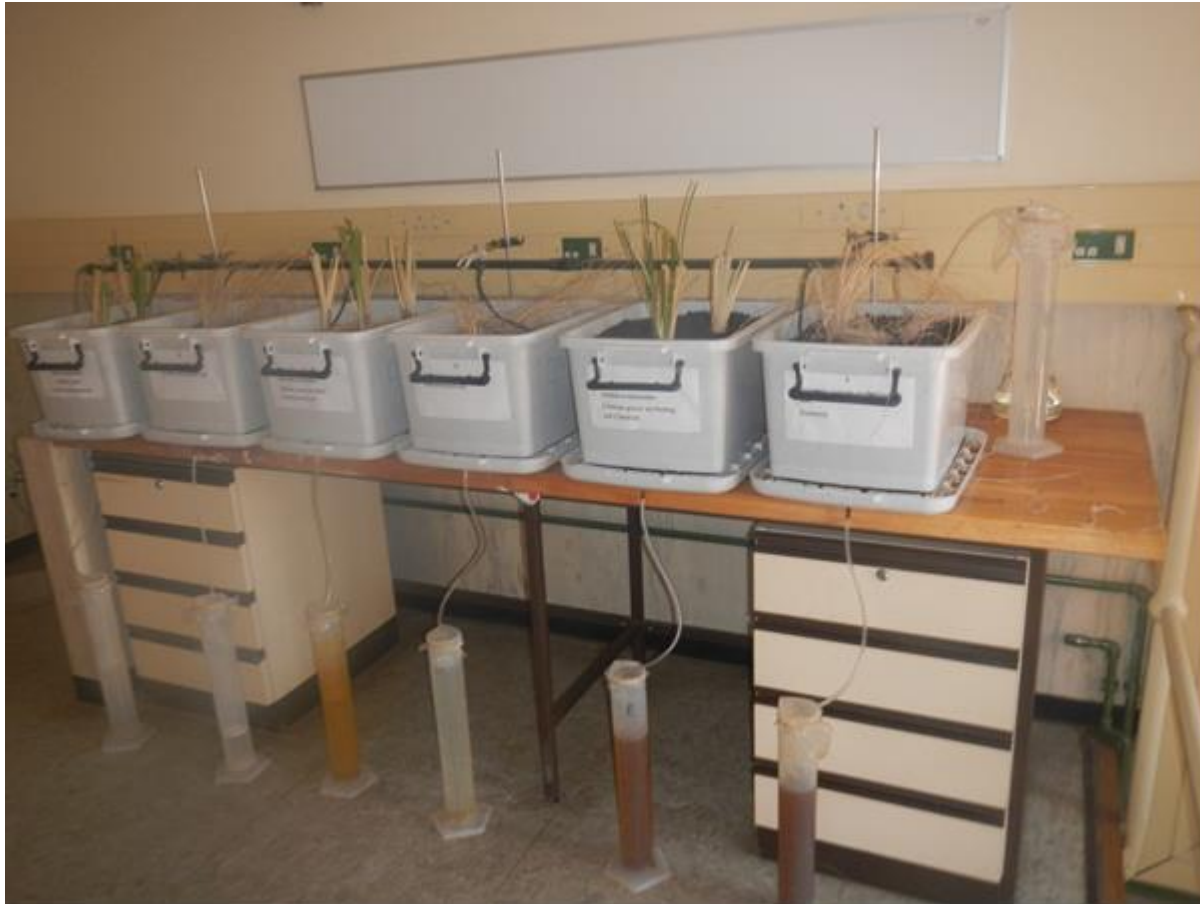
Appearance of the grasses after December Holidays

- Growth rates of the grasses recorded weekly
- The dripping system was stopped during December holidays to avoid spillage in the lab
- Vetiver grass showed signs of drying up in the AMD soil

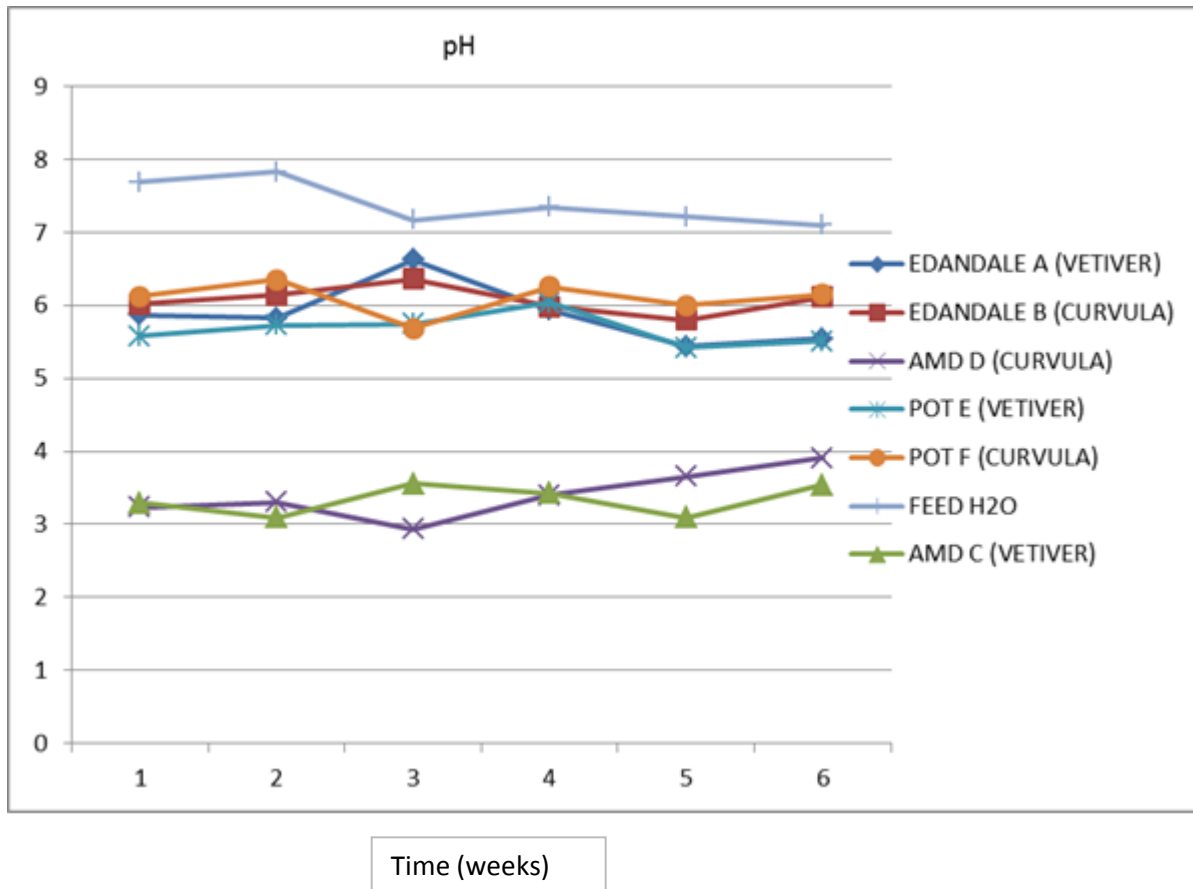
Leachate PH with time

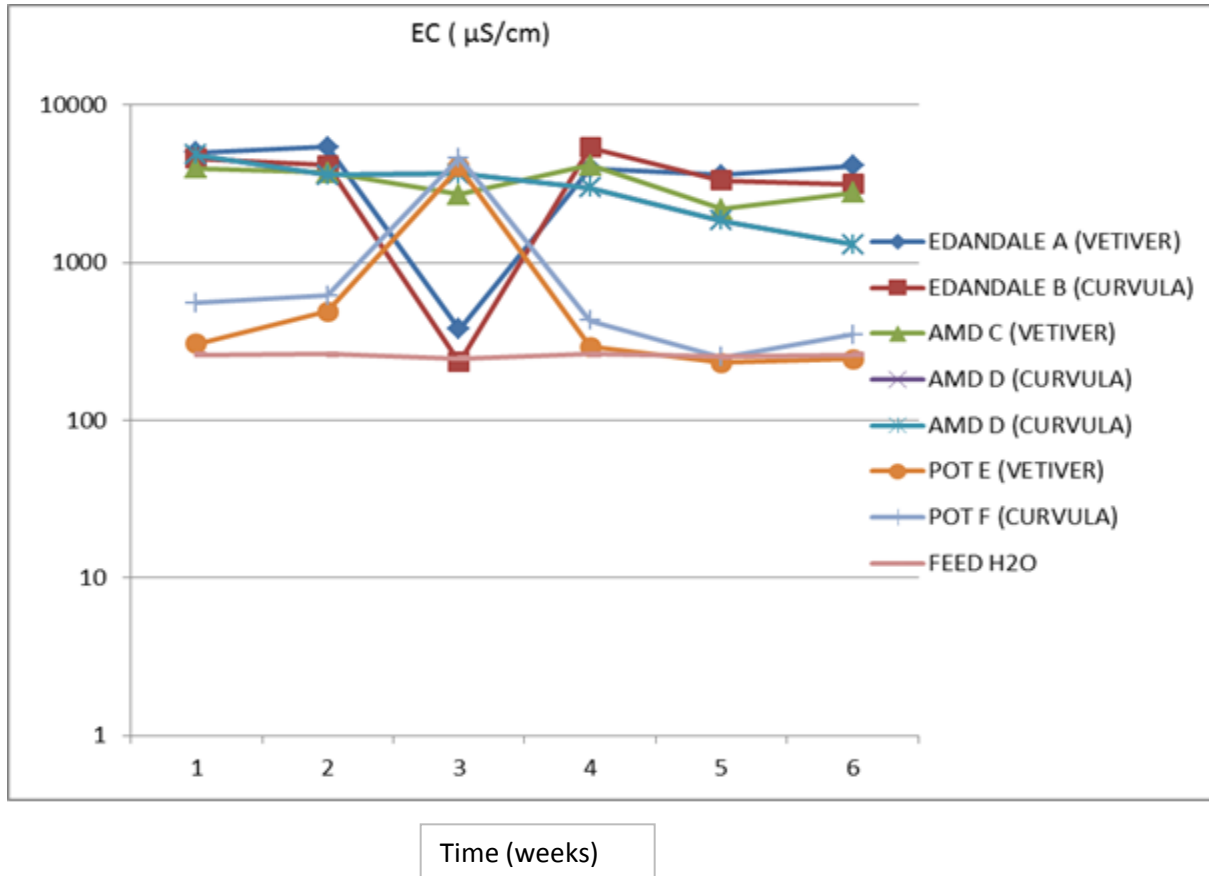
Leachate EC with time

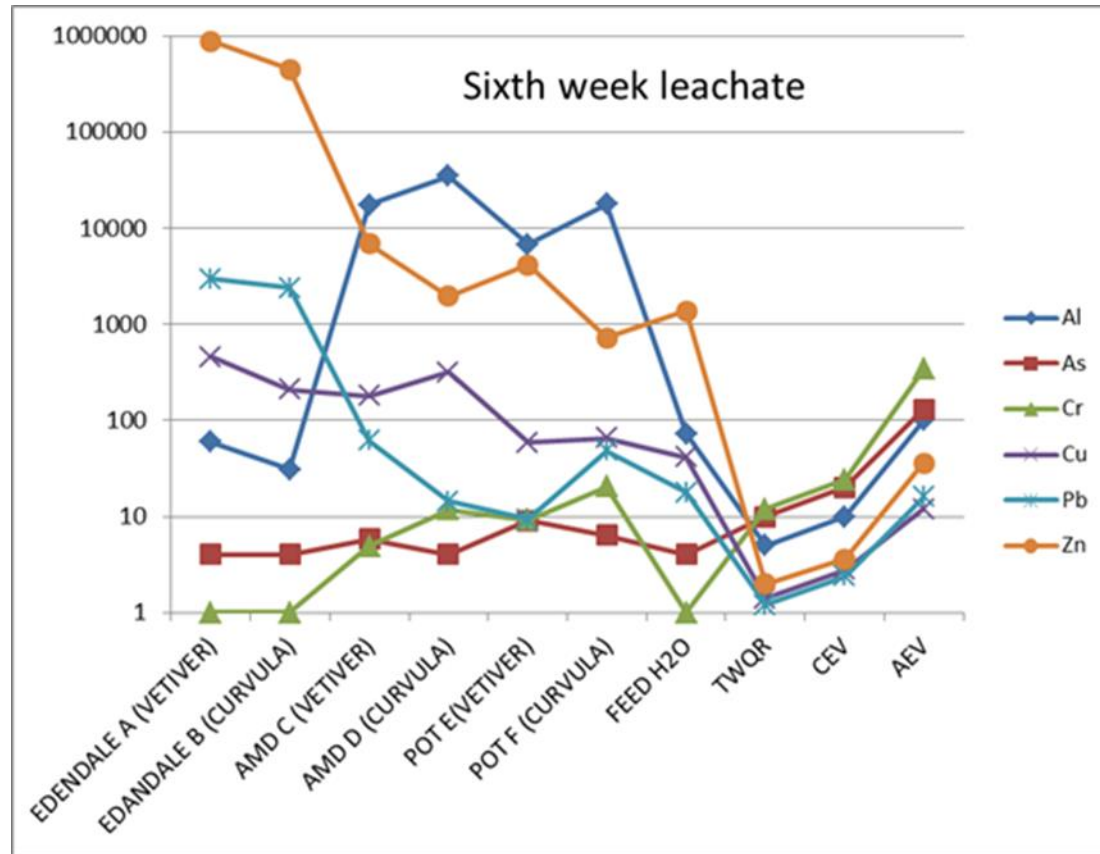
Summary of the sixth week leachate for different metals in each soil

- Summary of the sixth week leachate shows high pollution of aluminium, copper, lead and zinc
- Concentrations extremely higher than the TWQR for the aquatic ecosystem
- No indication of arsenic pollution

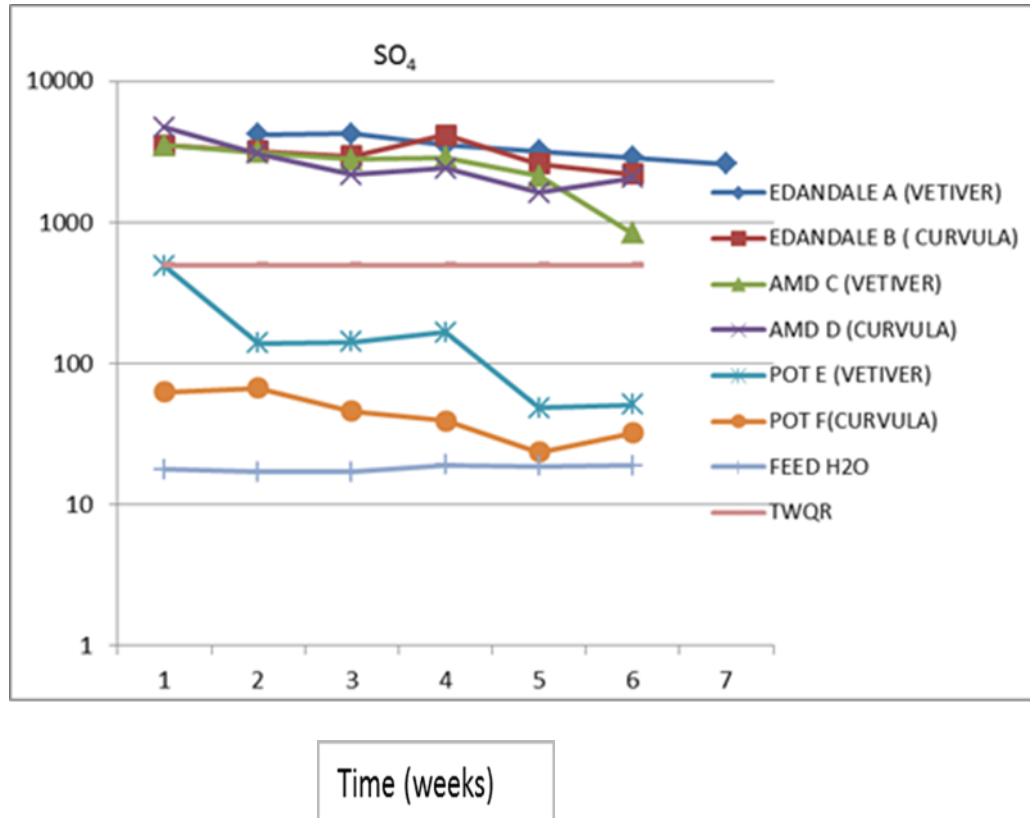
Leachate sulphate concentration

- Sulphate adopted to protect aquatic life = 500 mg/L
- WHO guideline
- More than 500 mg/L notify relevant authorities
- Edendale and AMD leachate samples exceeds 500 mg/L
- Sulphate in Edendale from dissolution of Anglesite (PbSO_4)
- High sulphate concentration typical for AMD
