RECOVERY OF NORTH POTATO CREEK, COPPER BASIN, TENNESSEE

Ben B. Faulkner, Scott Deal

Presented to
The American Society for Mining and Reclamation

June 9, 2015

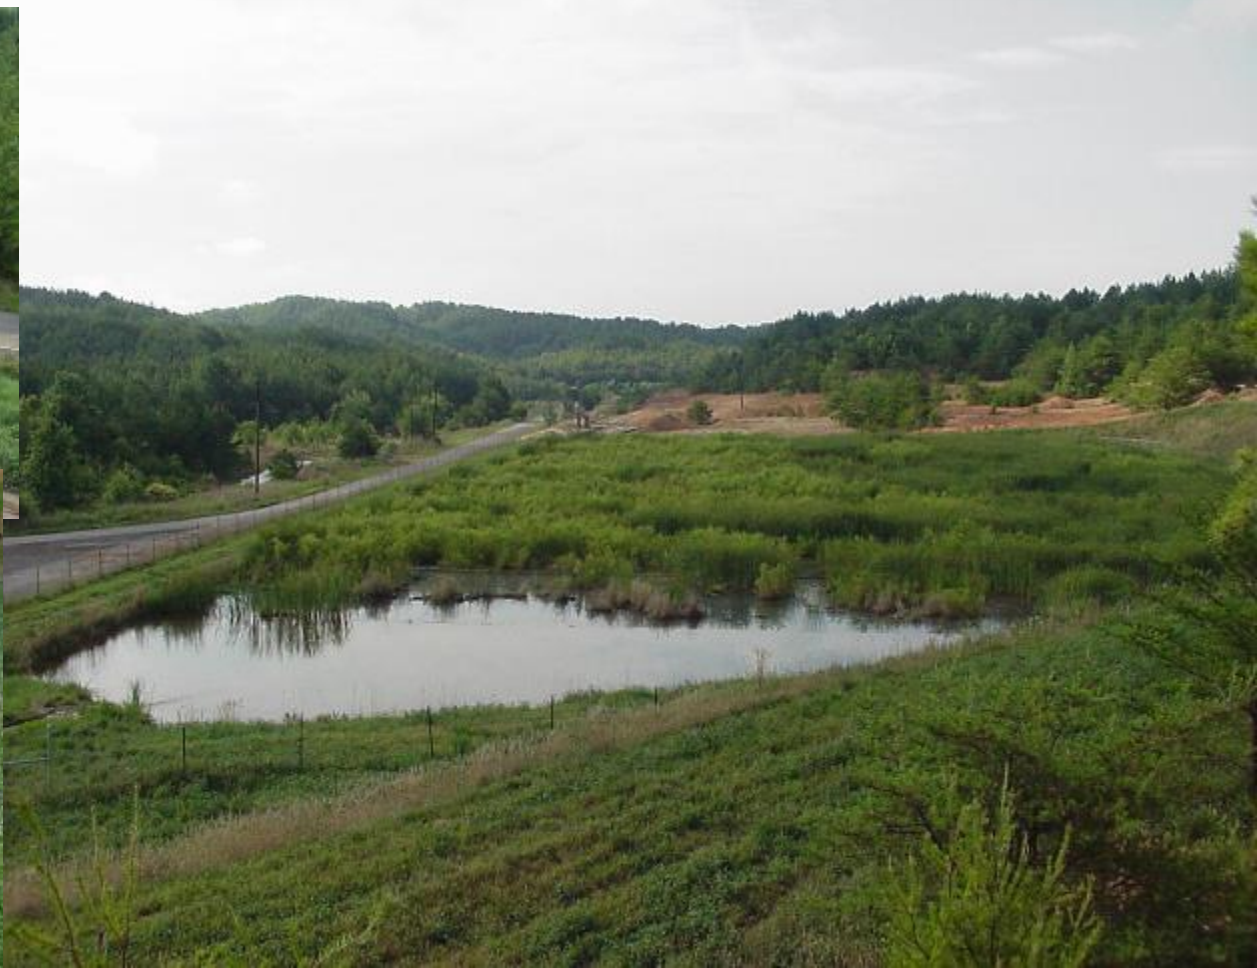
McPherson Branch Demonstration:
Reclamation
Passive System
Restored Stream Segment

Refuse Removal Area

Dam

Anaerobic unit

Aerobic unit

Rock filter

diversion

RSS

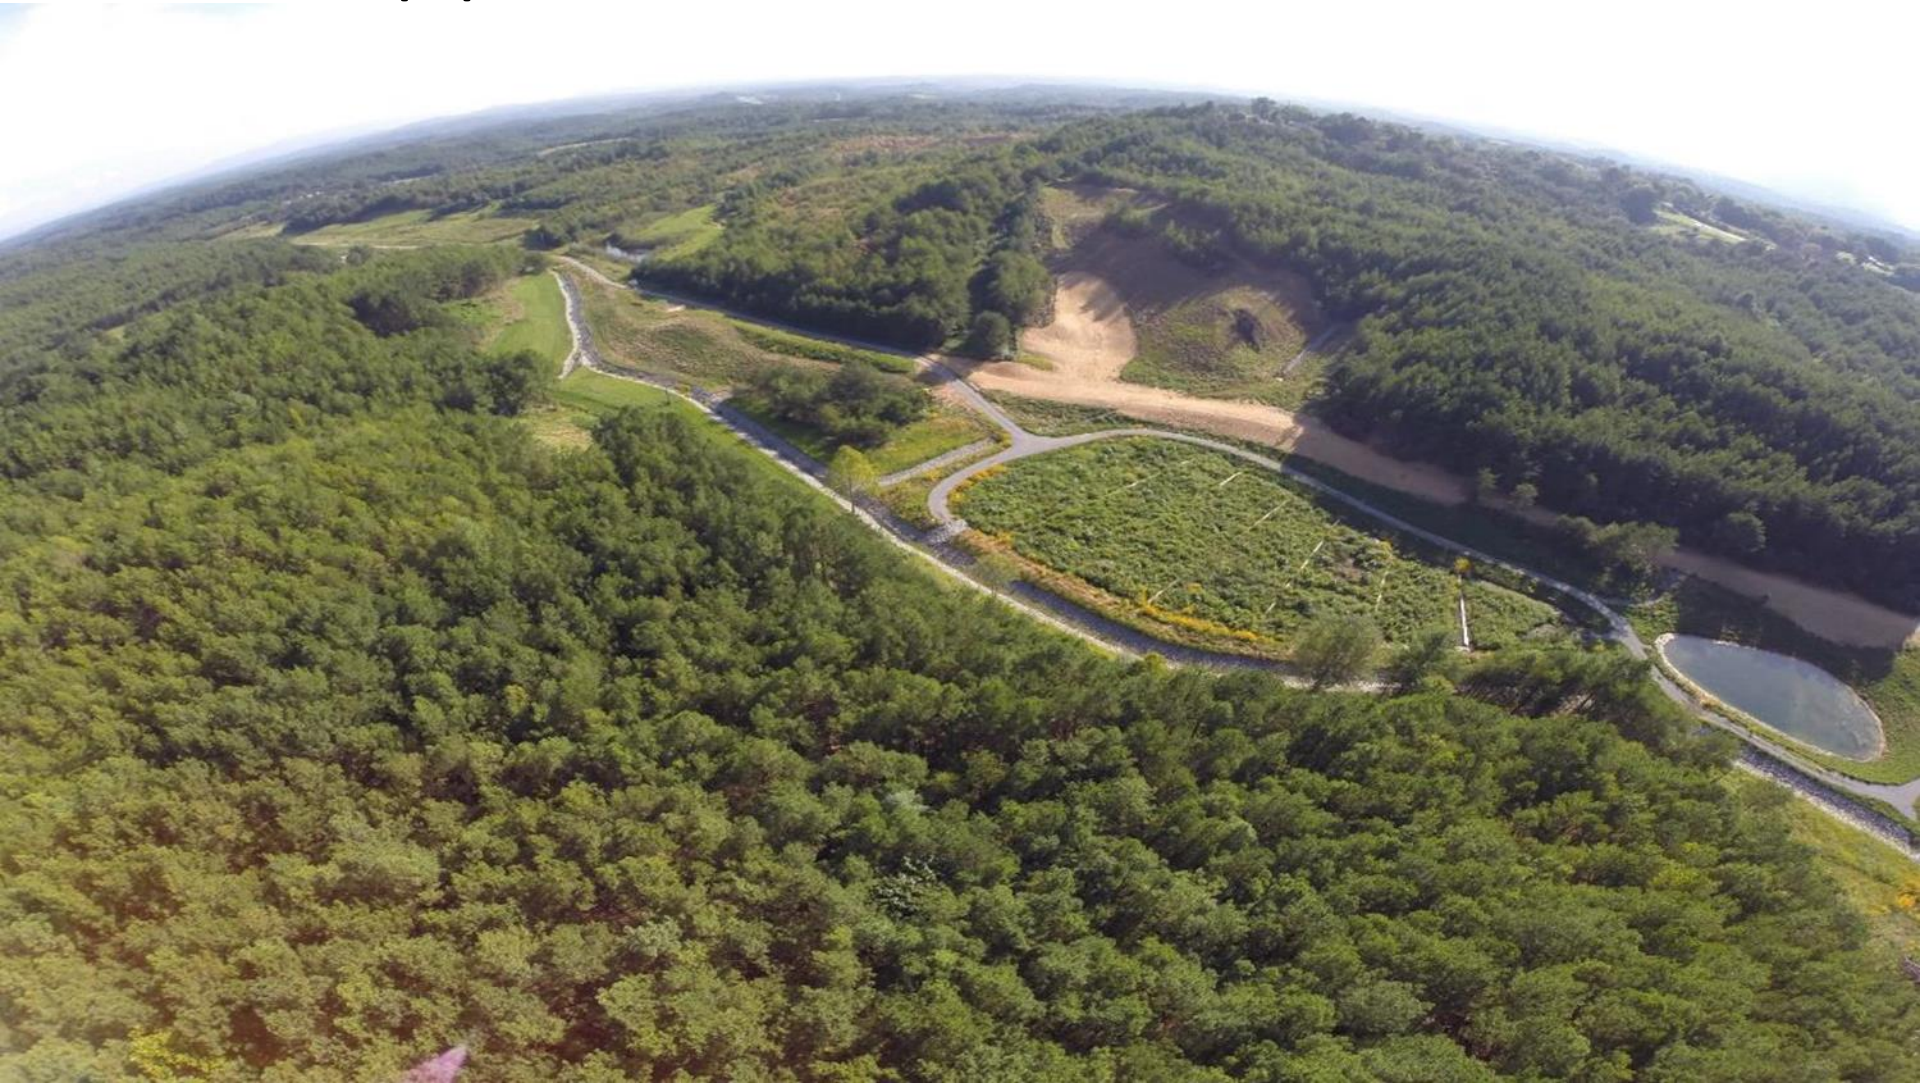
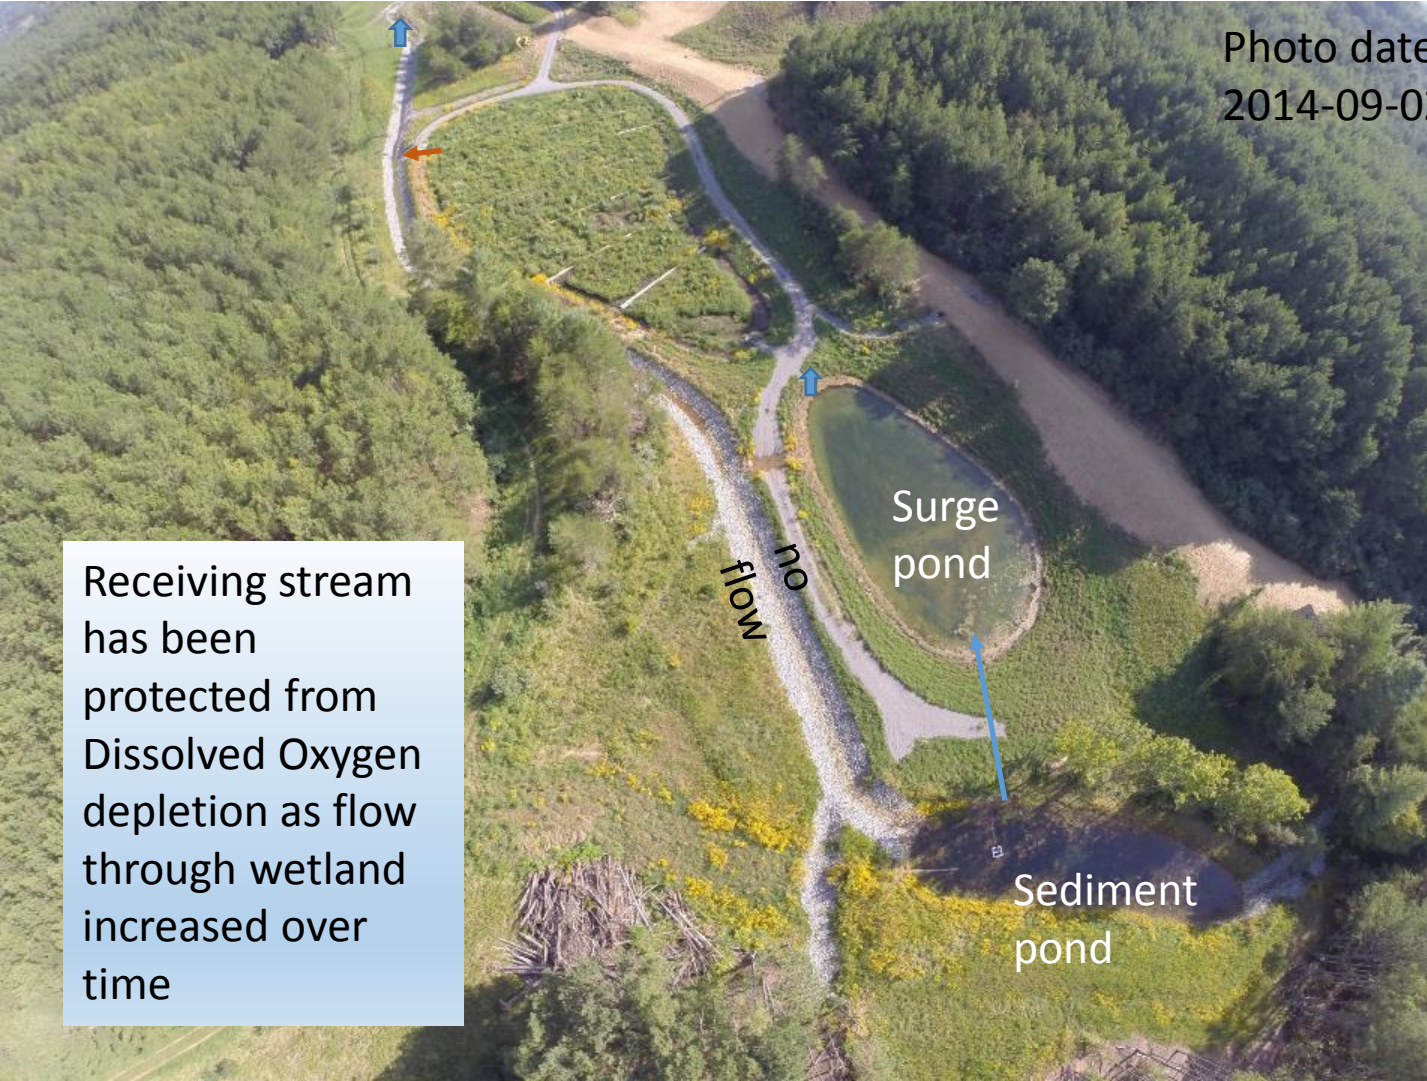
Upper McPherson Wetlands

Photo date
2014-09-02

Upper McP Wetlands
2014-02 flow
introduced

(pumped to Lower Wetlands to ameliorate BOD)

2014-04 discharge to
McP Br. (monitored DO in McP
Branch since)

2014-09 Herbicide
Treatment

2014-11 Resumed
discharge

2015-02 criteria met
(no BOD)

Receiving stream
has been
protected from
Dissolved Oxygen
depletion as flow
through wetland
increased over
time

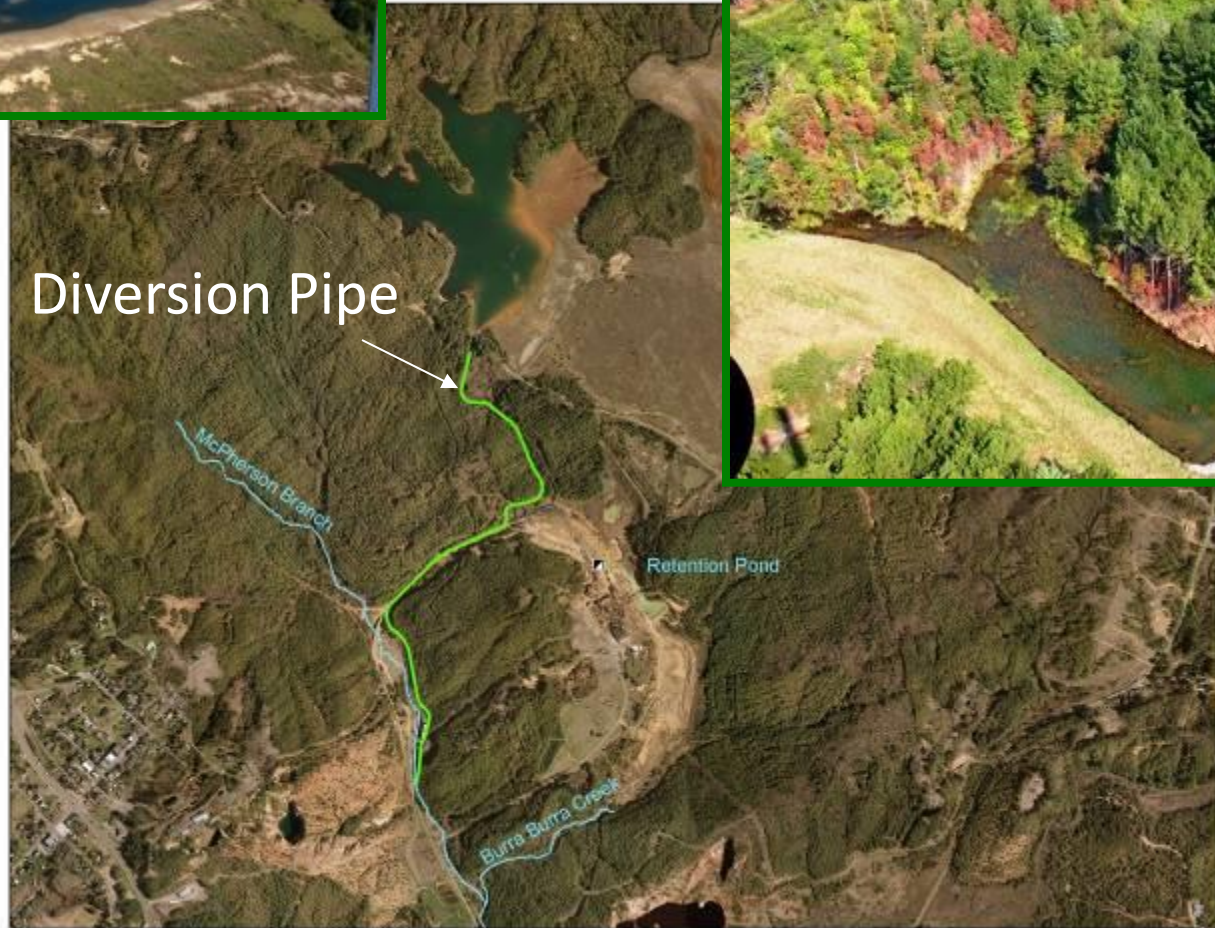
Diversion Pipe

Diversion of base flow and storm runoff,
up to and including the 10-yr/24-hr storm

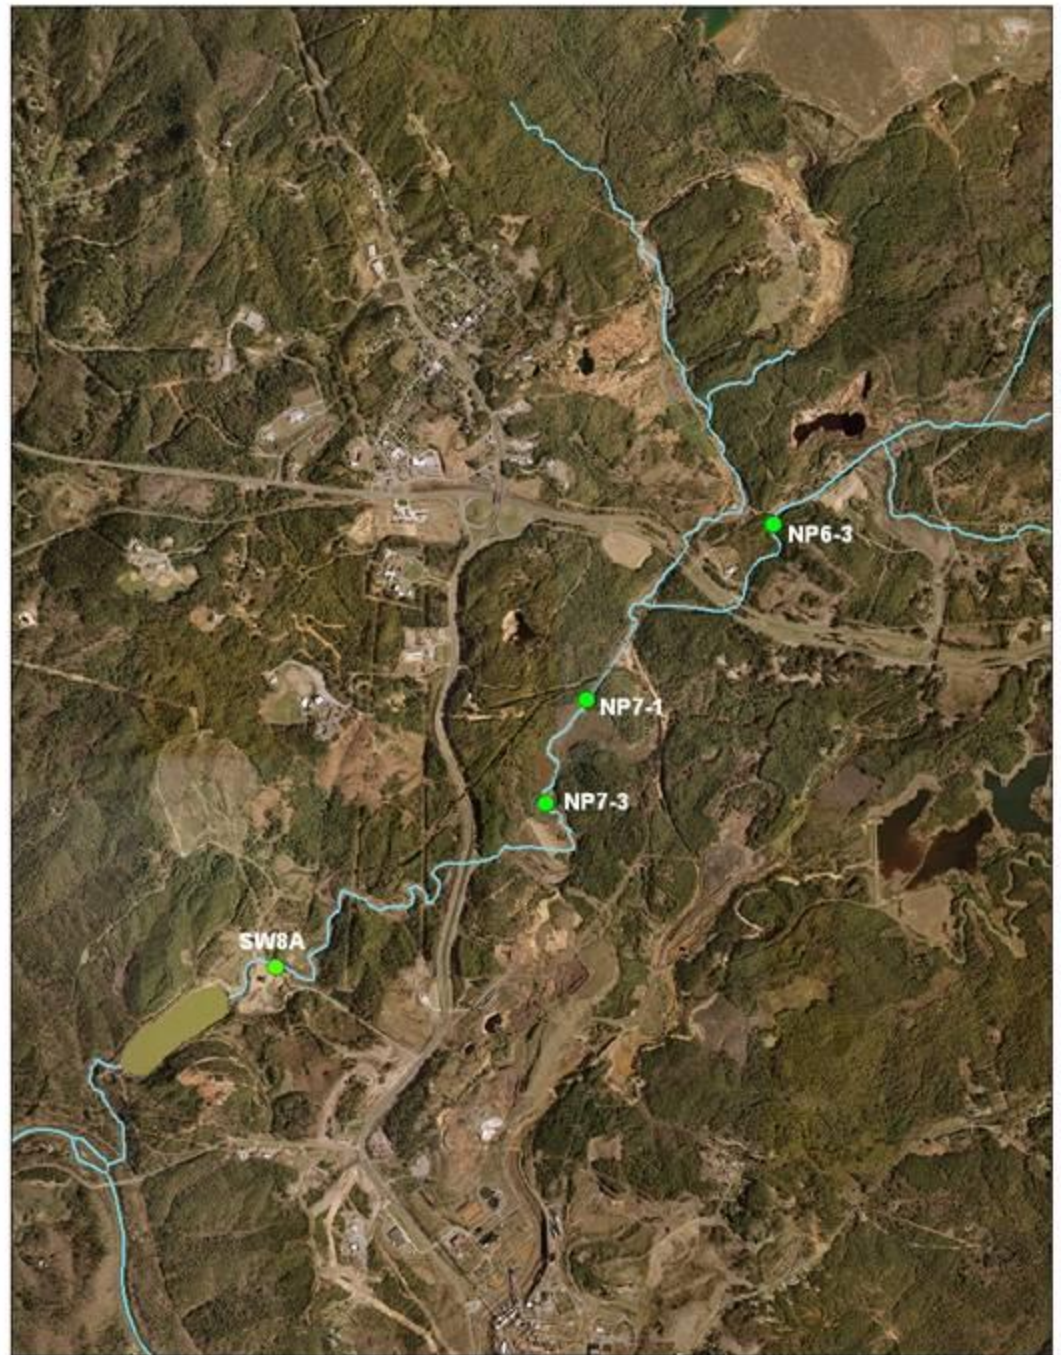
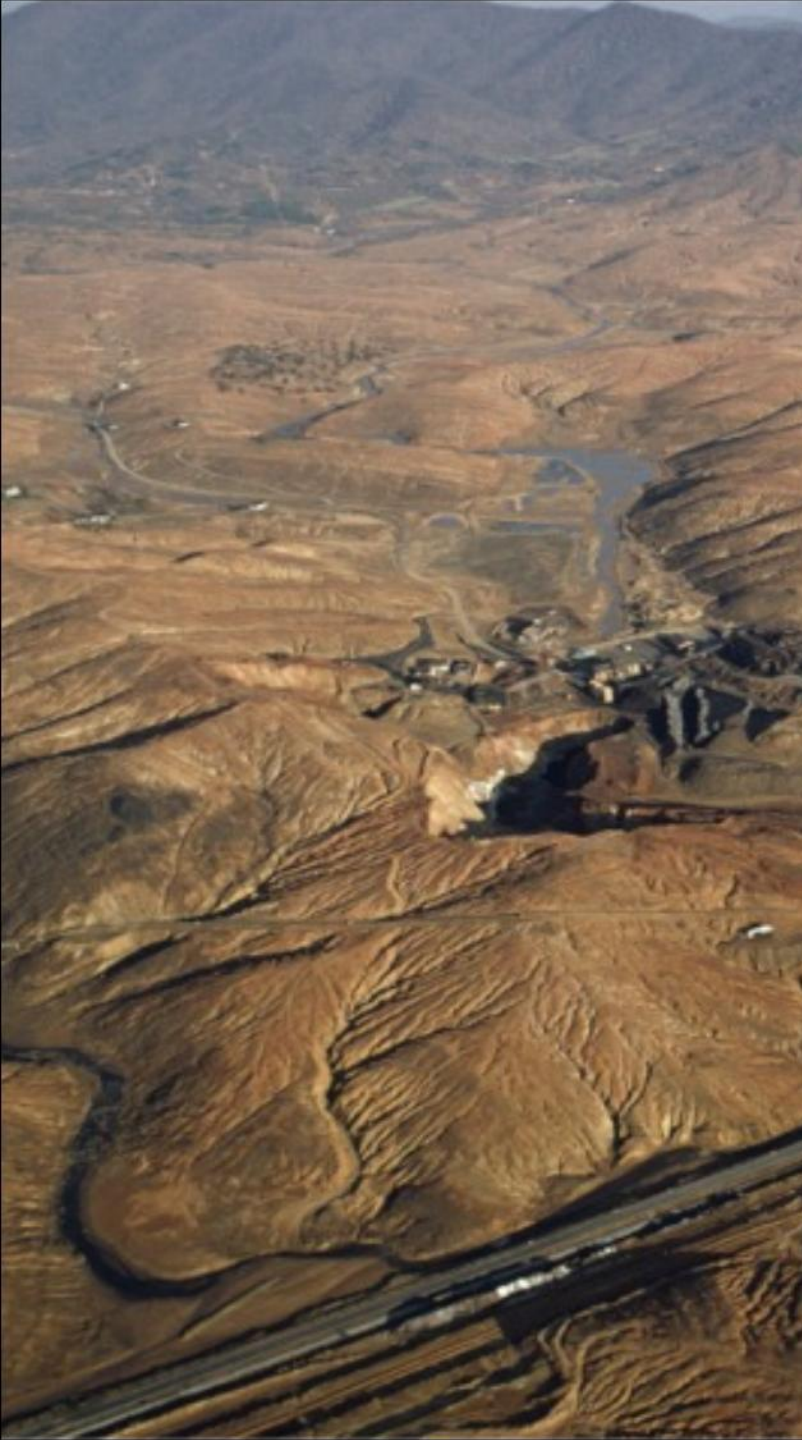
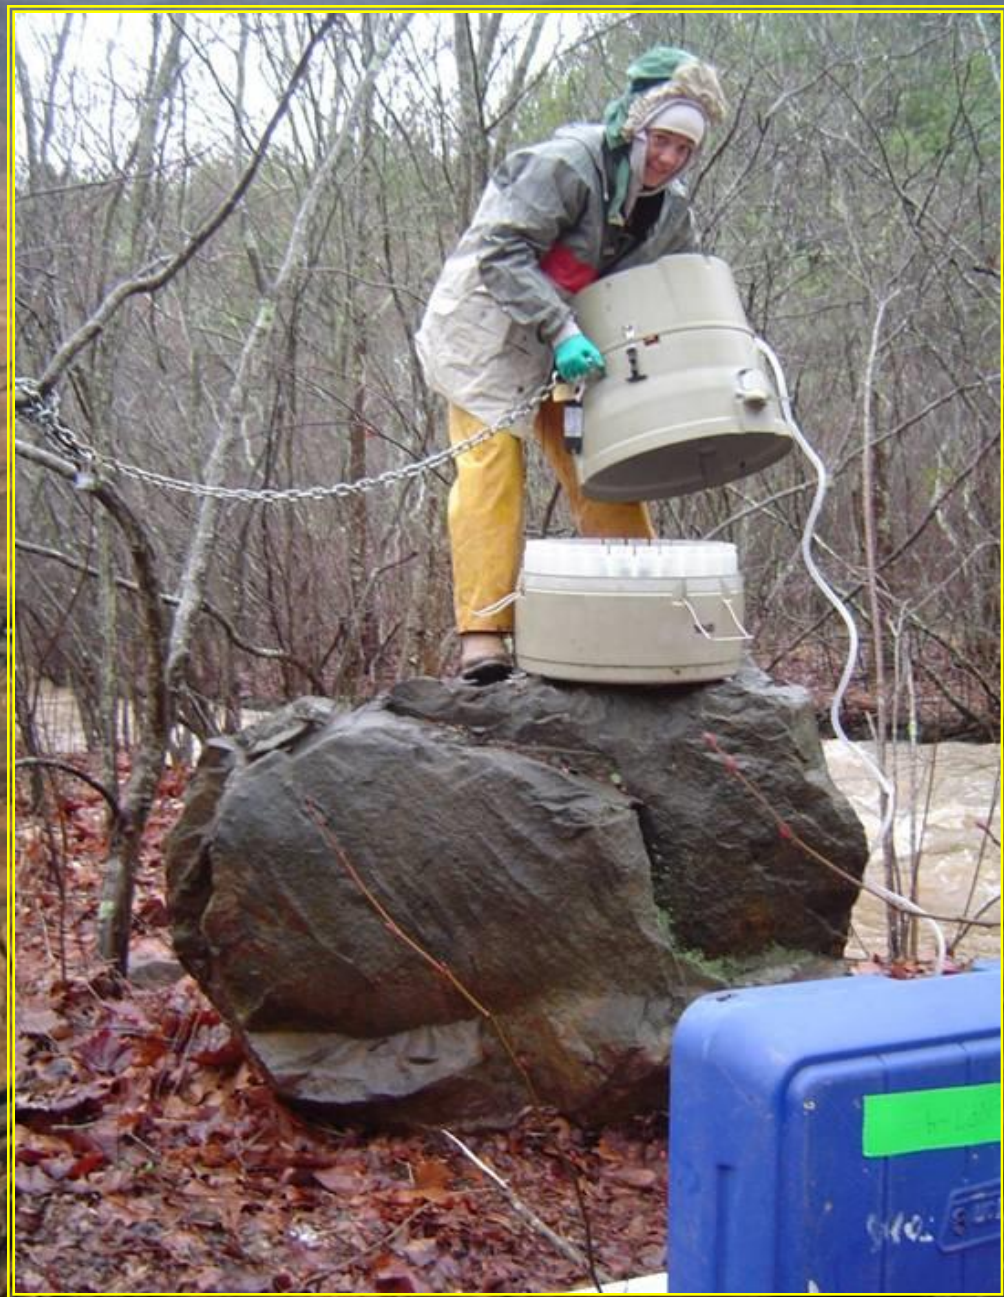
Comprehensive Surface-
Water Sample Locations

October 2008 Storm Event

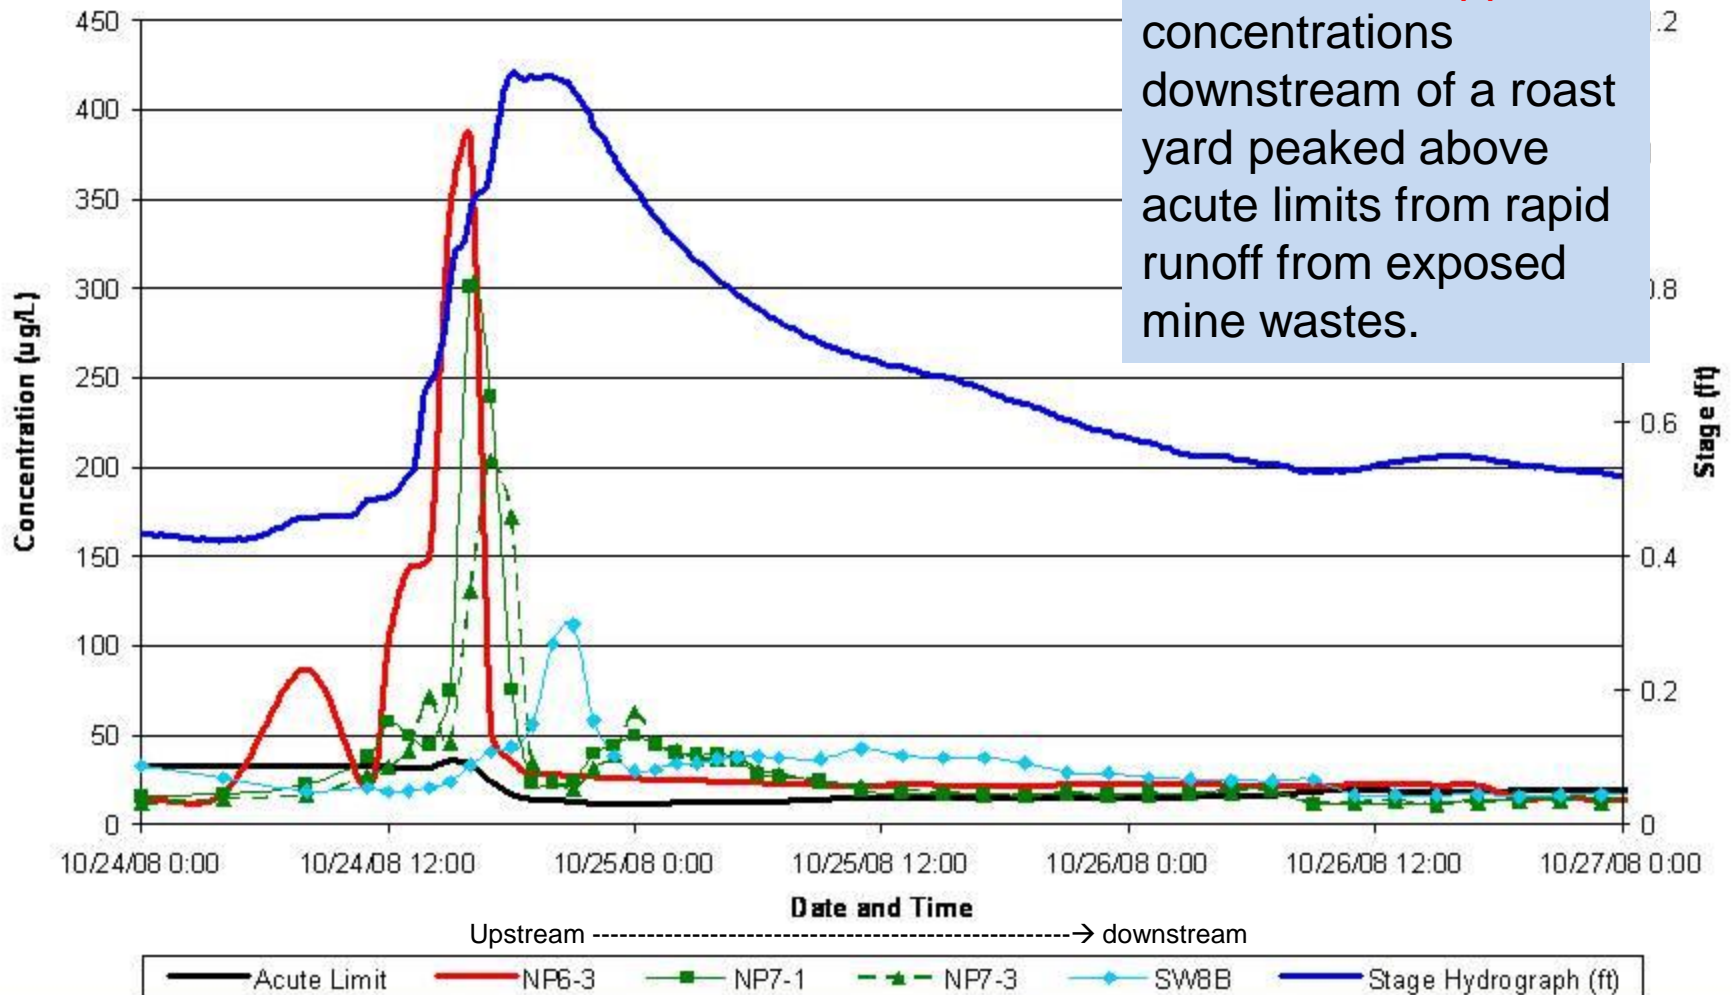
North Potato Creek
October 2008 Storm Event
Dissolved Copper

As flow increases rapidly during this 2008 storm, **copper** concentrations downstream of a roast yard peaked above acute limits from rapid runoff from exposed mine wastes.

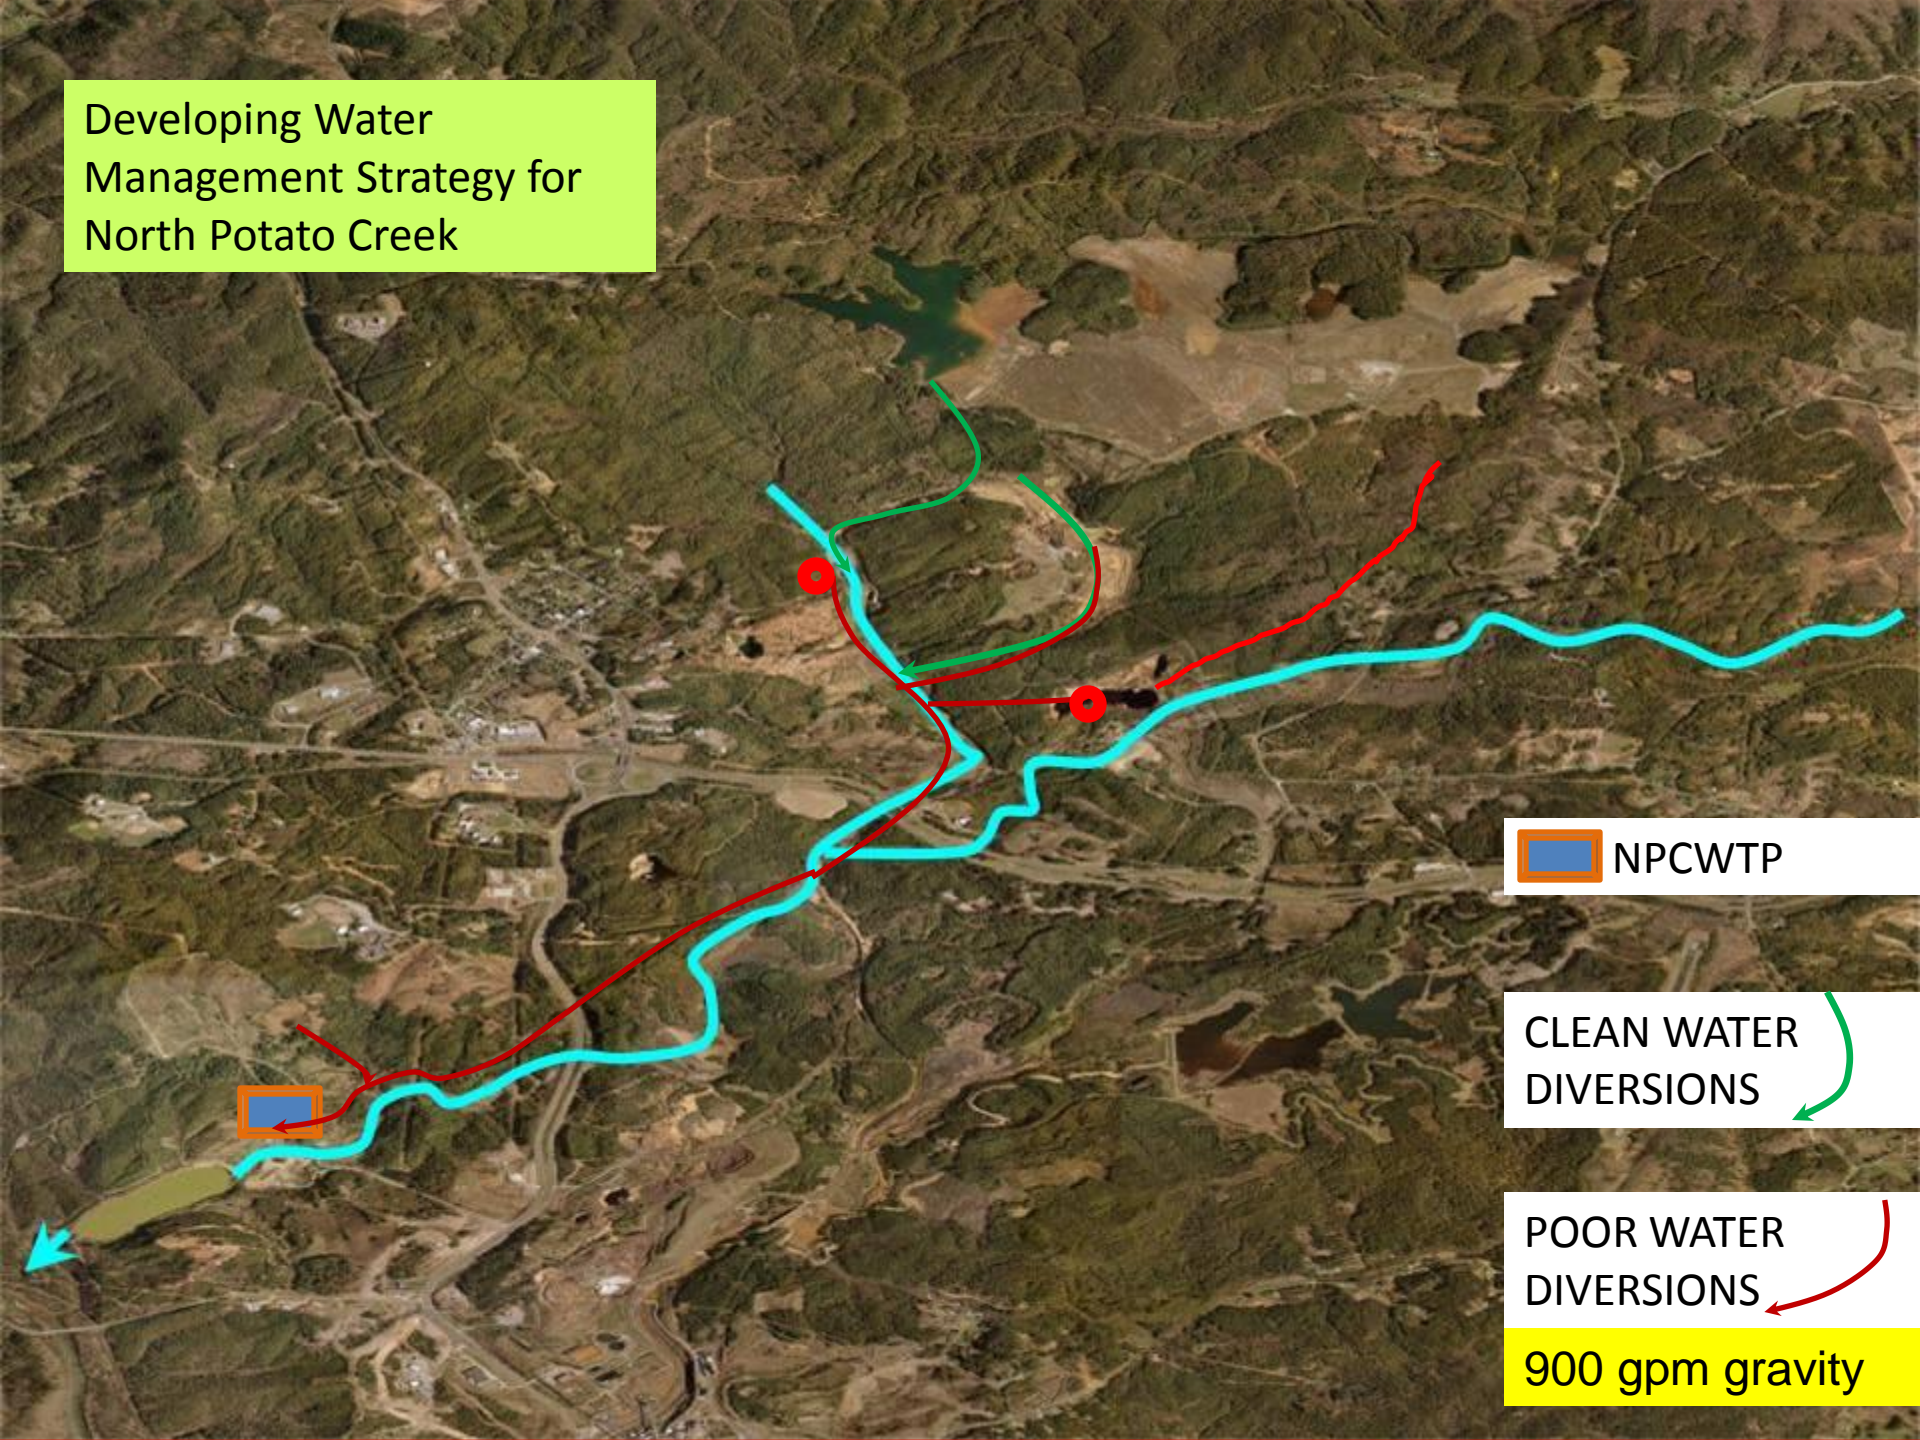
Developing Water Management Strategy for North Potato Creek

NPCWTP

CLEAN WATER
DIVERSIONS

POOR WATER
DIVERSIONS

900 gpm gravity

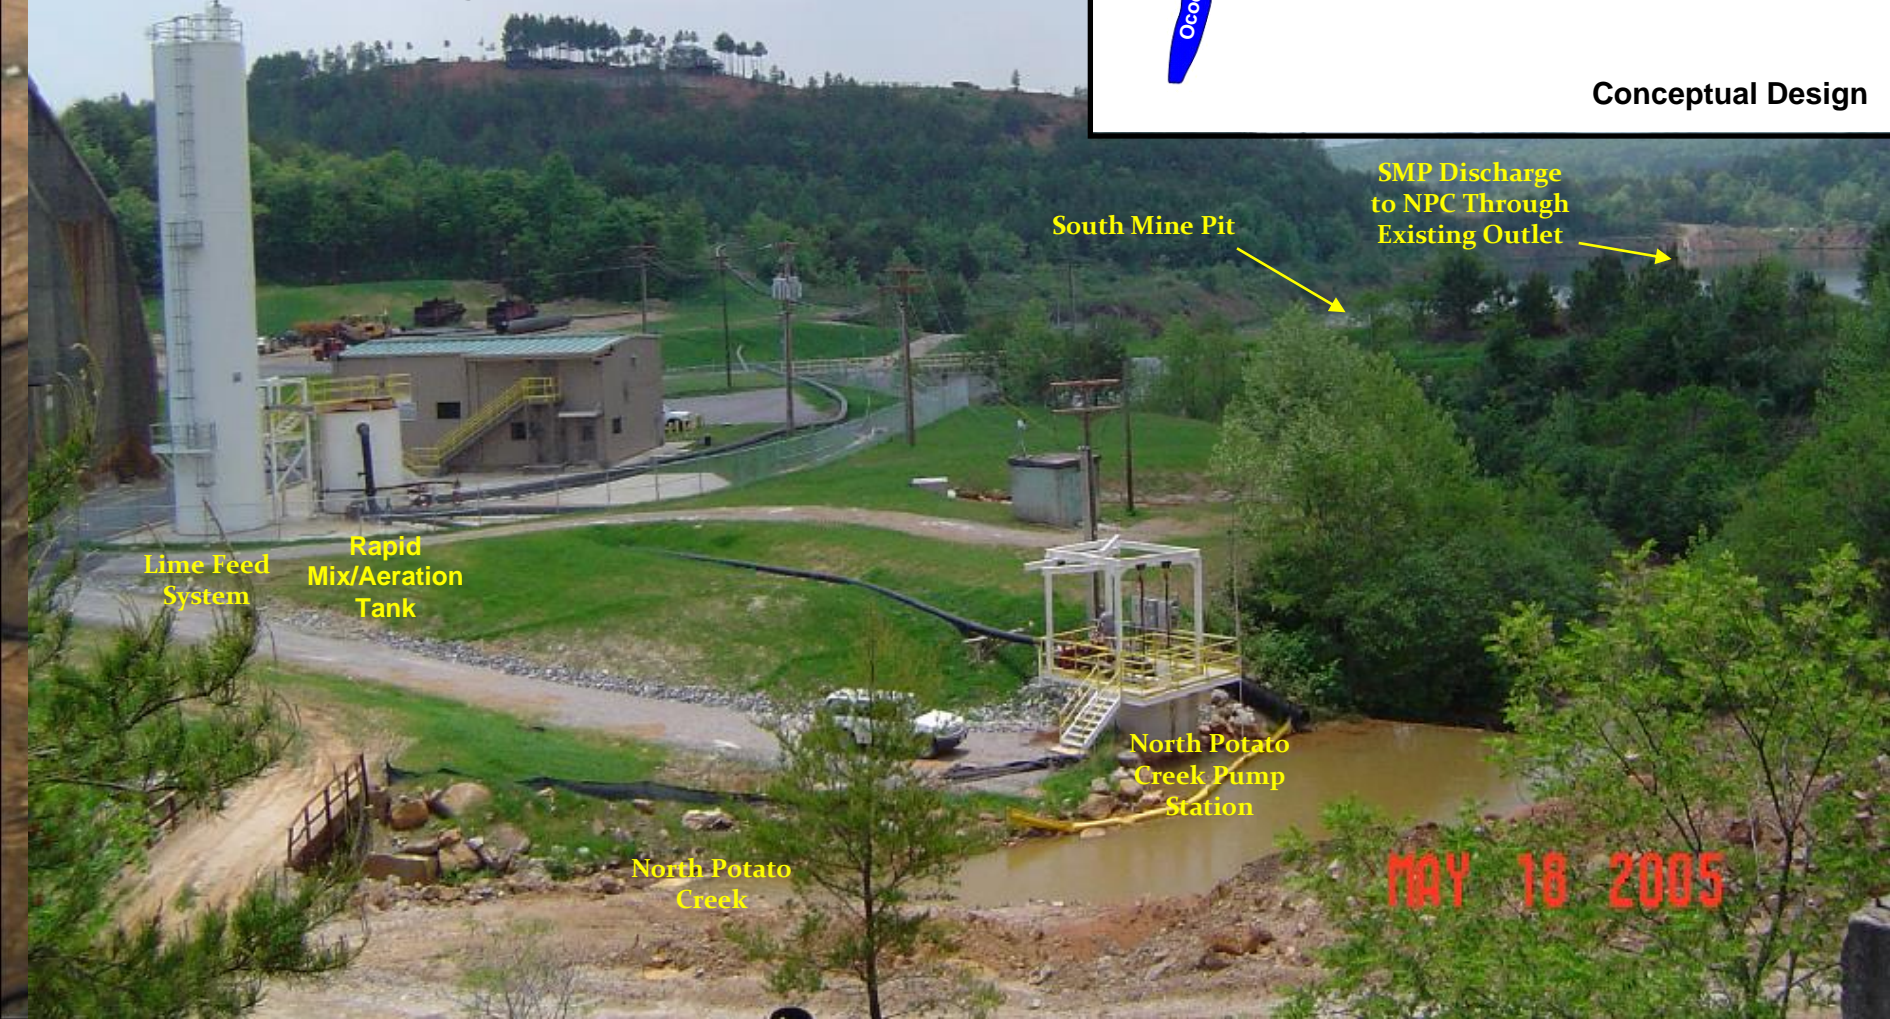
The North Potato Creek Water Treatment Plant began treating water on January 10, 2005, and is removing 681 lbs. per day of dissolved metals from North Potato Creek prior to discharge to the Ocoee River

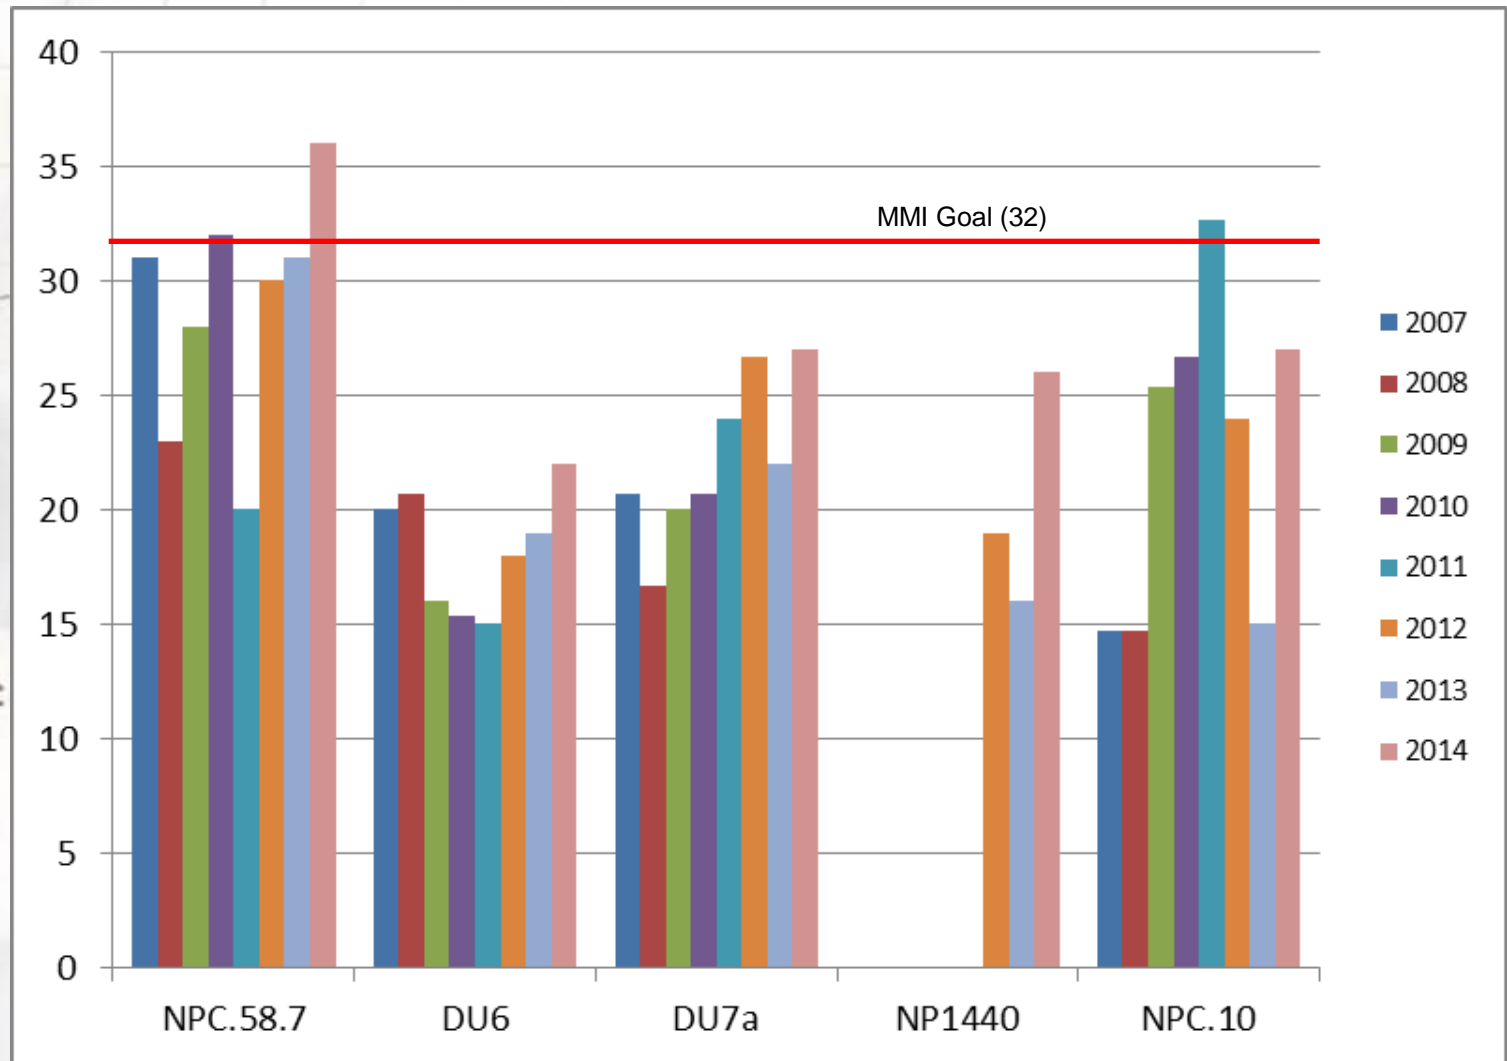
TDEC MMI: Lower North Potato Creek

Habitat:
Optimal 2014
No Iron Effects
