# Sediment Metal Concentrations in Selected Coves of Grand Lake O' the Cherokees

S. Zawrotny, J. Arango, L. Diede, A. McLeod,  
M. Salisbury, G. Rutelonis, J. LaBar, R. Knox,  
D. Townsend and R. Nairn

Center for Restoration of Ecosystems and Watersheds  
School of Civil Engineering and Environmental Science  
The University of Oklahoma, Norman, OK

# 2012 Capstone Project

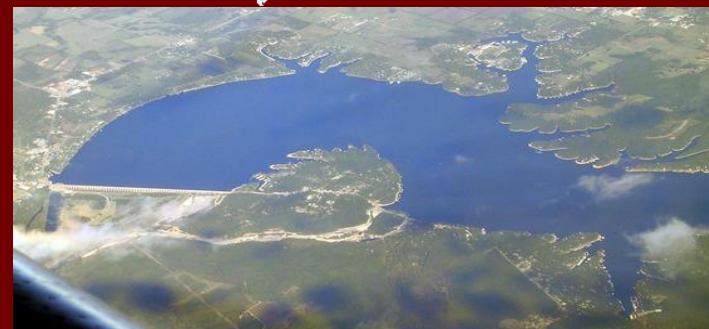
- Pensacola Dam (1940)
- Largest multiple arch dam

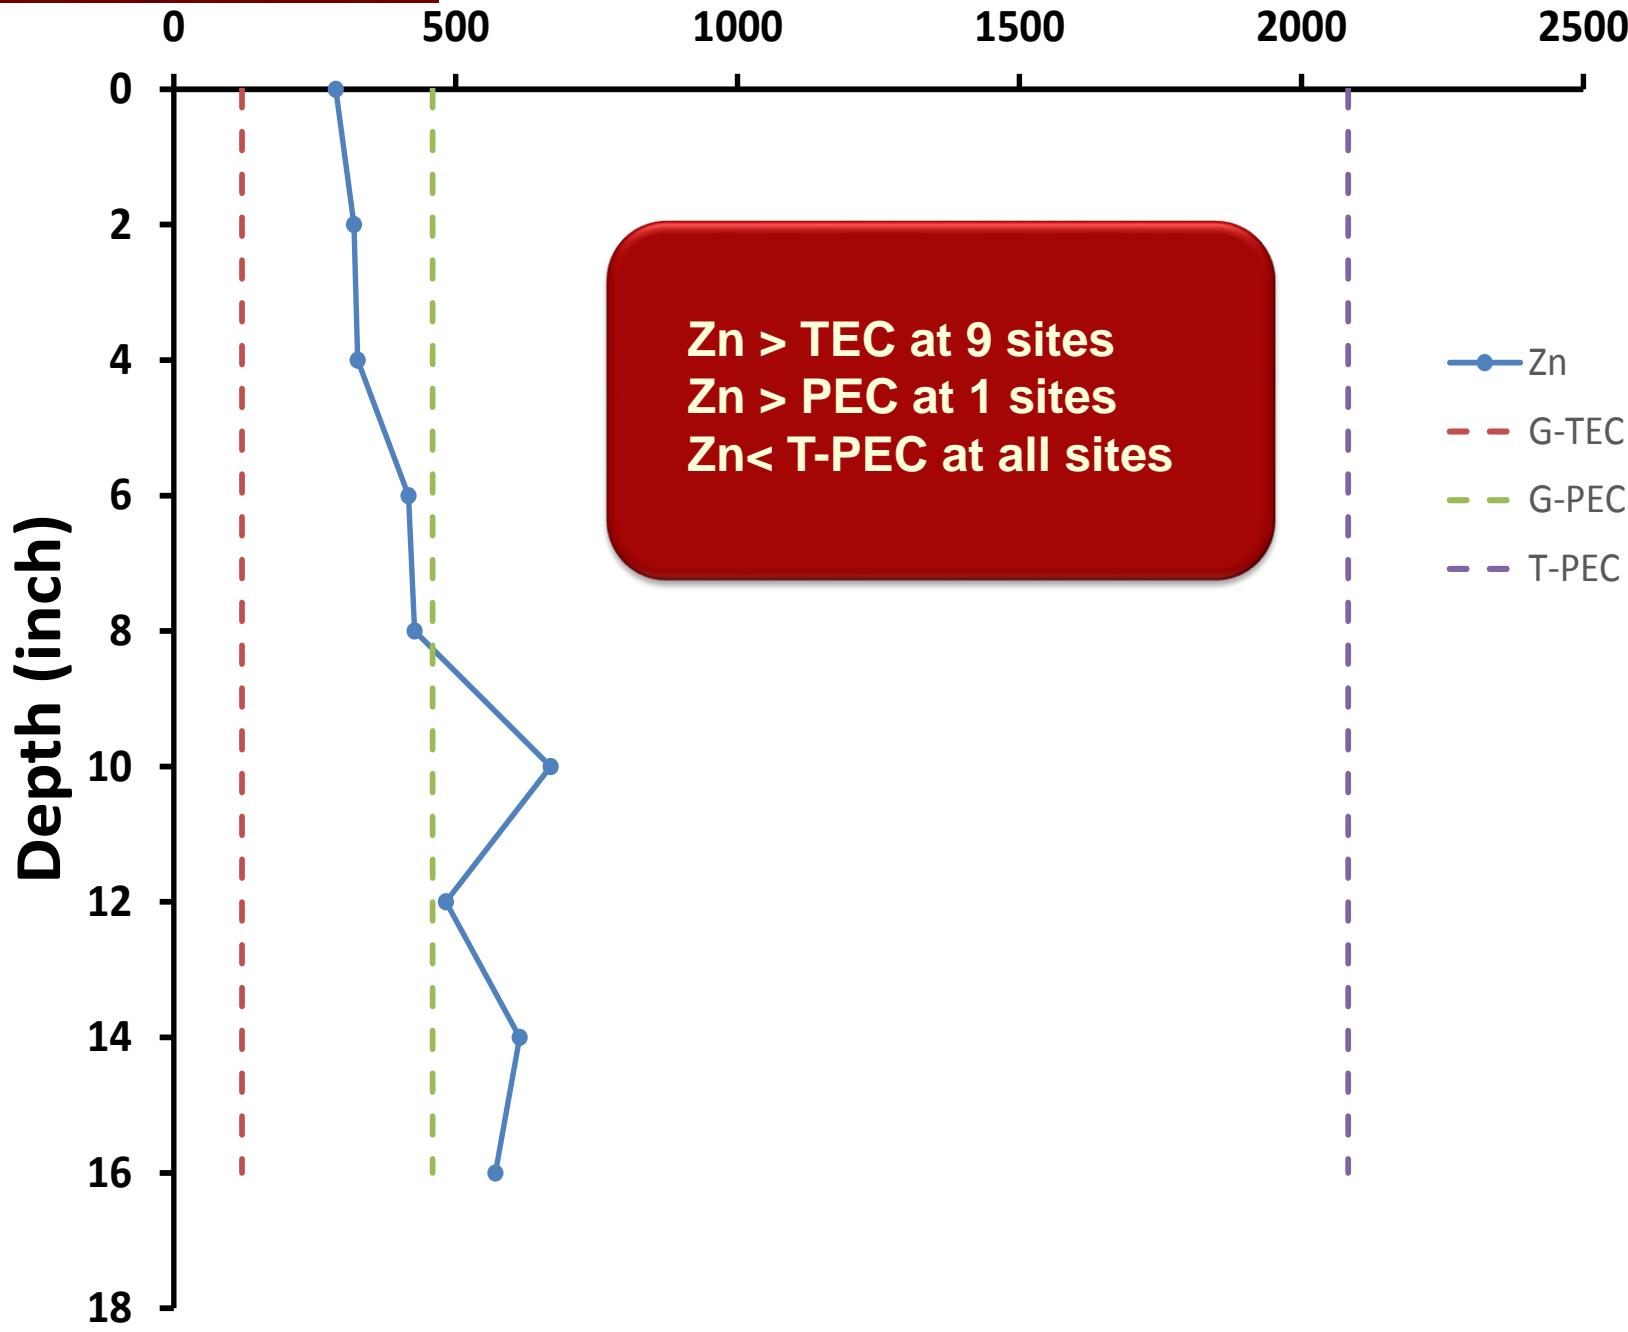
# DCK-4

## Zn Concentration (mg/kg)

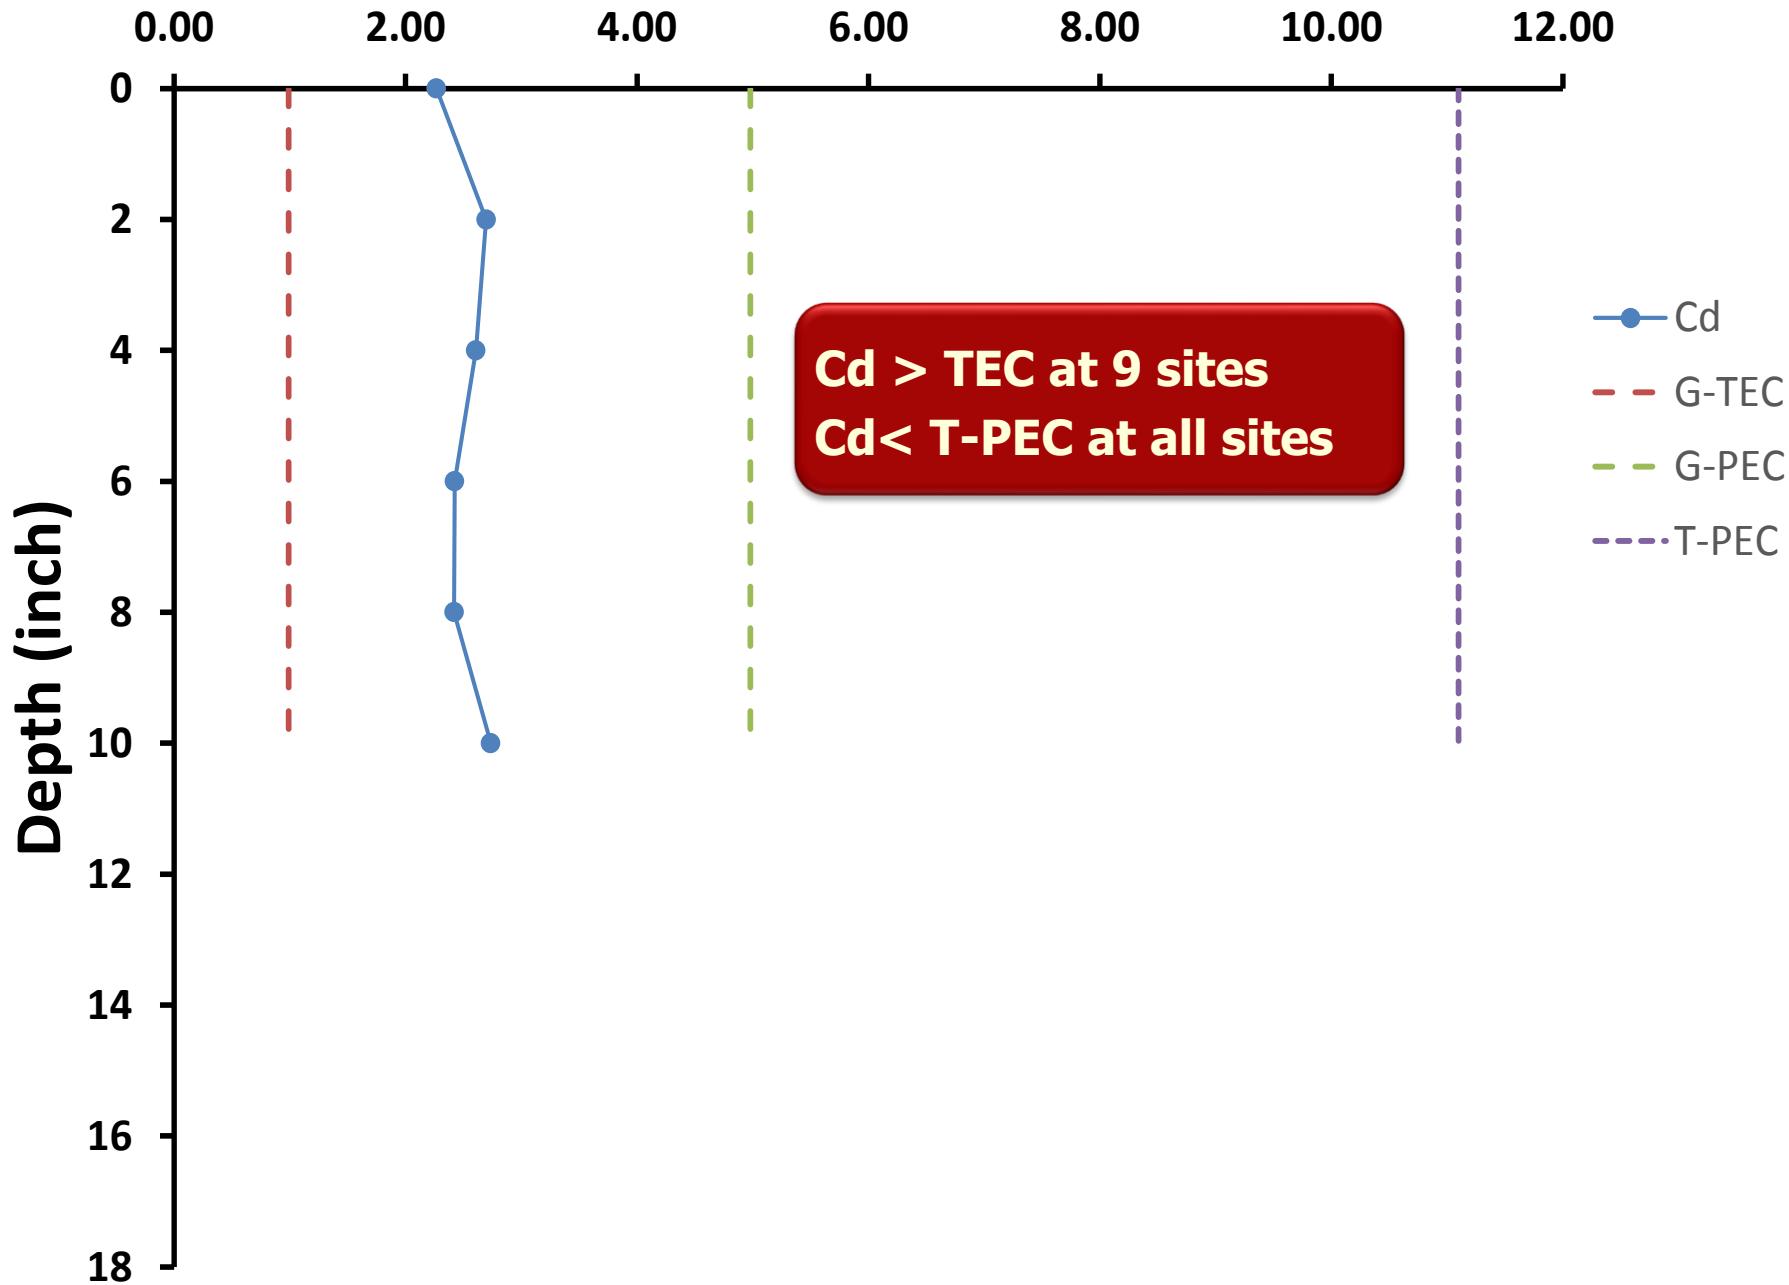
# DCK-1

## Cd Concentration (mg/kg)

- Phosphate > in-lake criteria in all samples
- Ammonia and nitrate < in-lake criteria
- Cd > chronic criteria at DCK-1

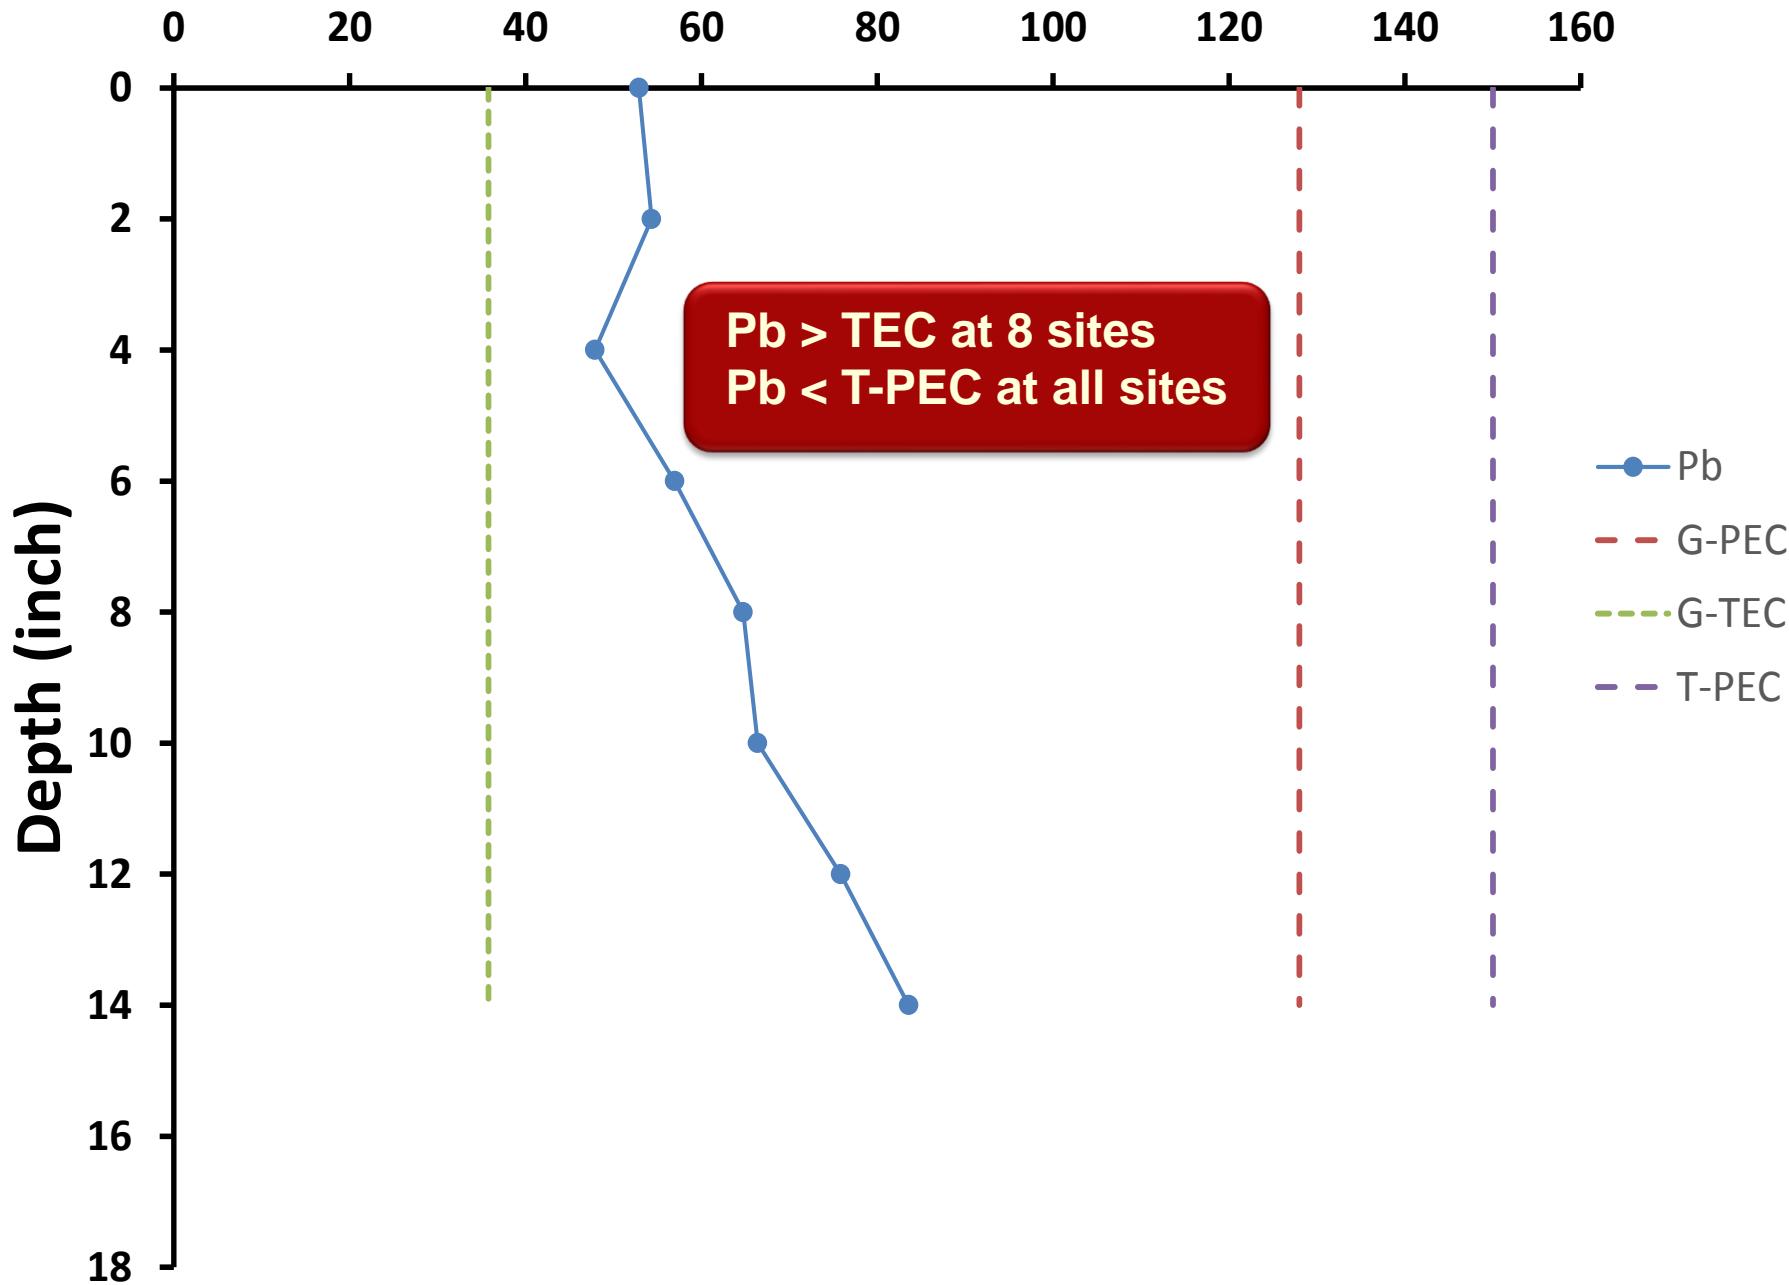
# DCK-6

## Pb Concentration (mg/kg)

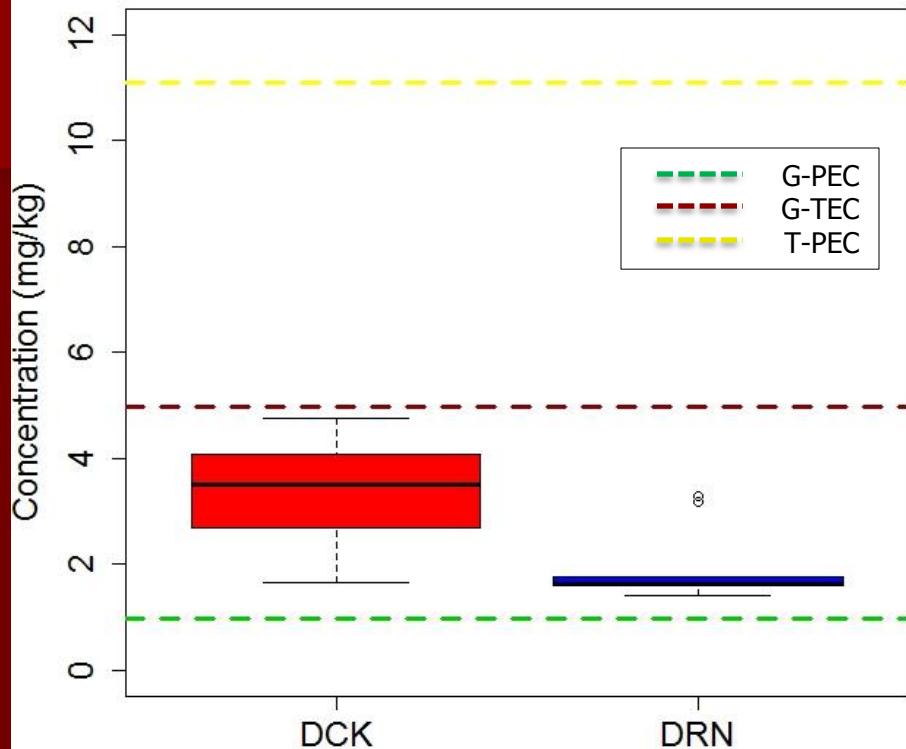
### Mean [Cd] (mg/kg)

| Parameter | p-value |
|---|---|
| Total Cd Concentration | 0.0001915 |

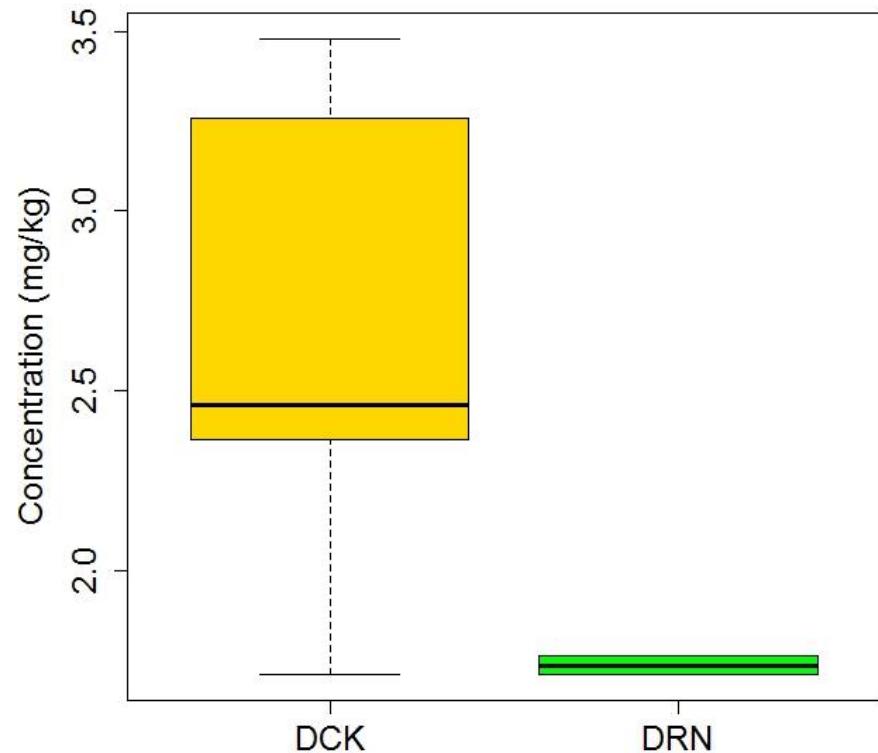
### 0-2 Inch Increment [Cd] (mg/kg)

| Parameter | p-value |
|---|---|
| 0-2 Inches increment Cd | 0.007787 |

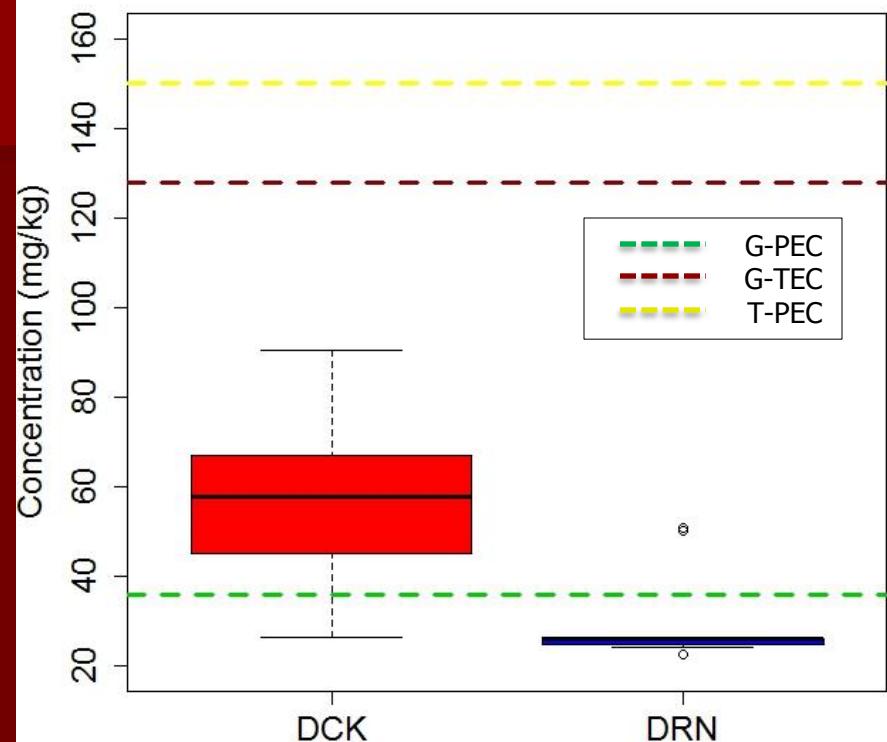
### Mean [Pb] (mg/kg)

| Parameter | P-value |
|---|---|
| Total Pb Concentration | 3.652e-0.5 |

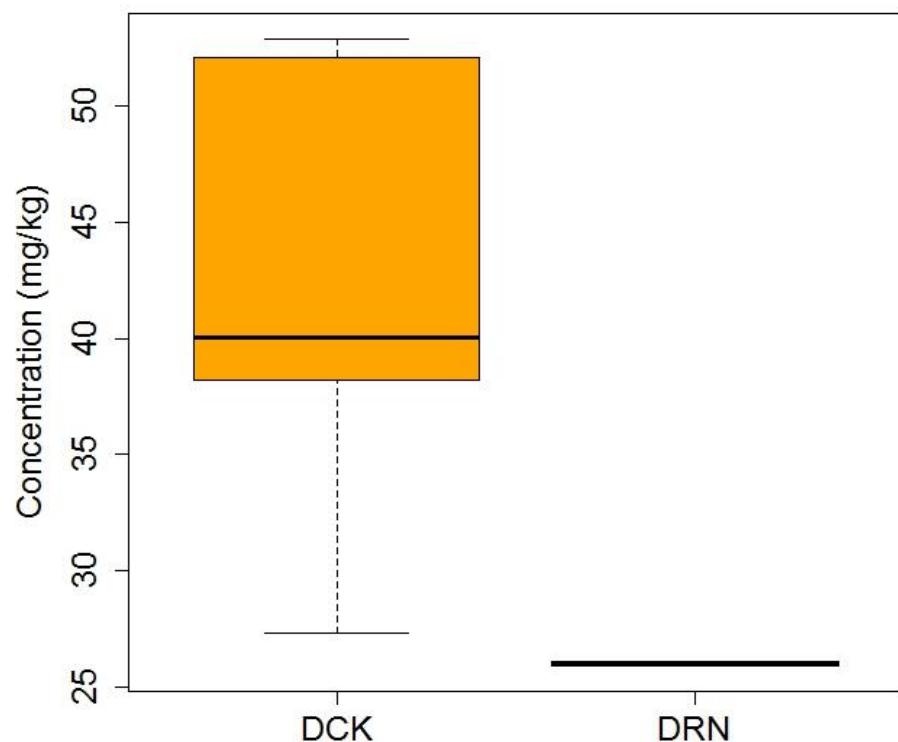
### 0-2 Inch Increment [Pb] (mg/kg)

| Parameter | P-value |
|---|---|
| 0-2 Inches Increment Pb | 0.003615 |

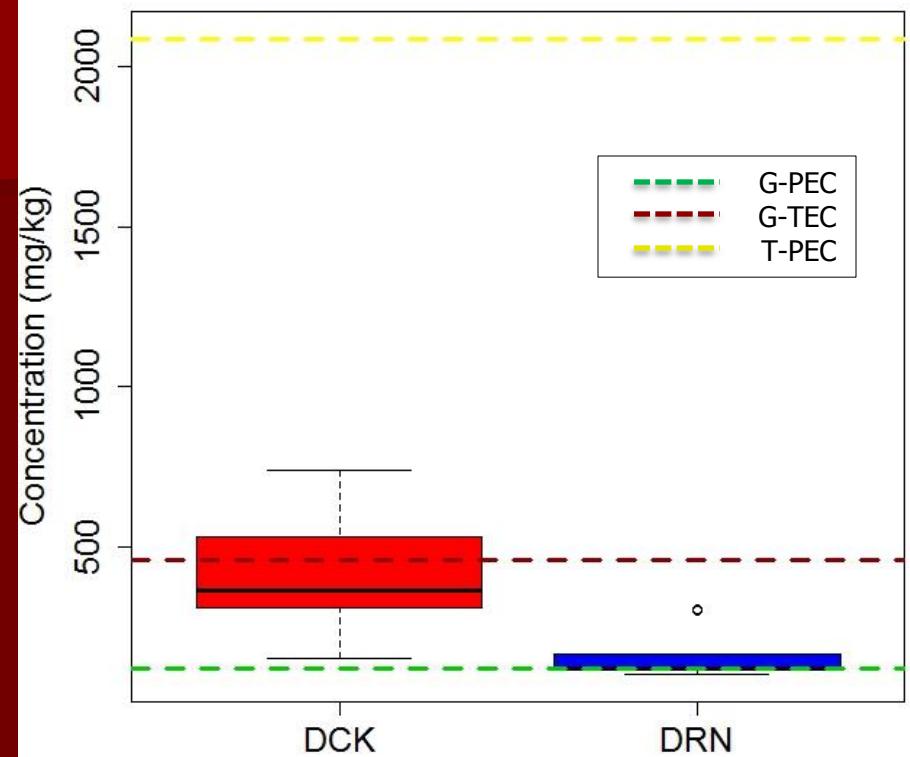
### Mean [Zn] (mg/kg)

| Parameter | p-value |
|---|---|
| Total Zn Concentration | 4.504e-07 |

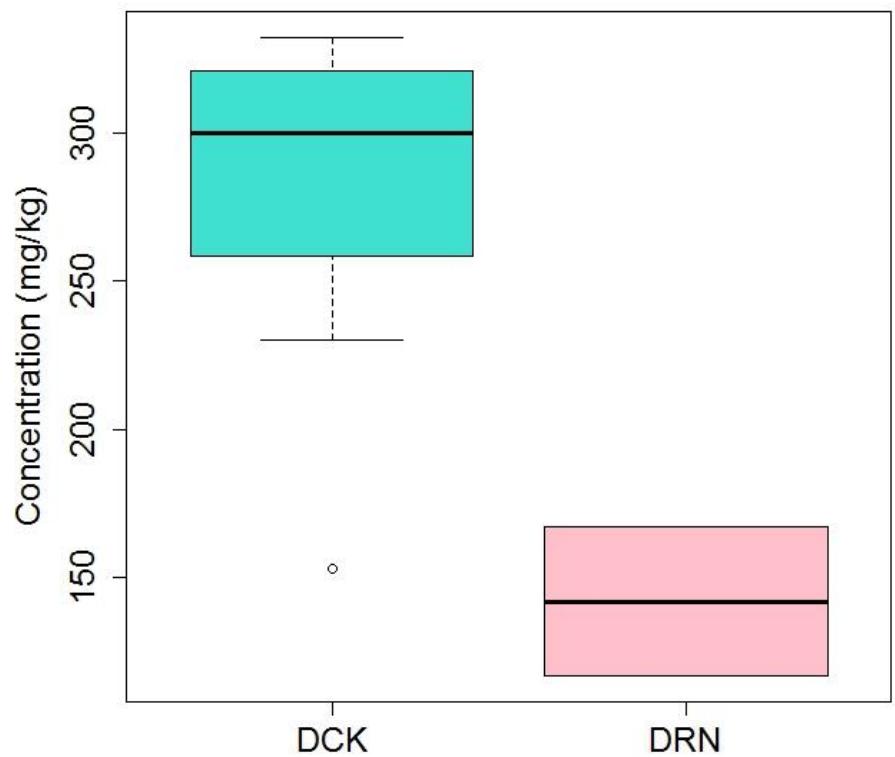
### 0-2 Inch Increment [Zn] (mg/kg)

| Parameter | p-value |
|---|---|
| 0-2 inches increment Zn | 0.02533 |
