Silvertip Pipeline Incident

Post Clean-up Revegetation

Len Ballek (Herrera) and Laura Alvey (MT DEQ)

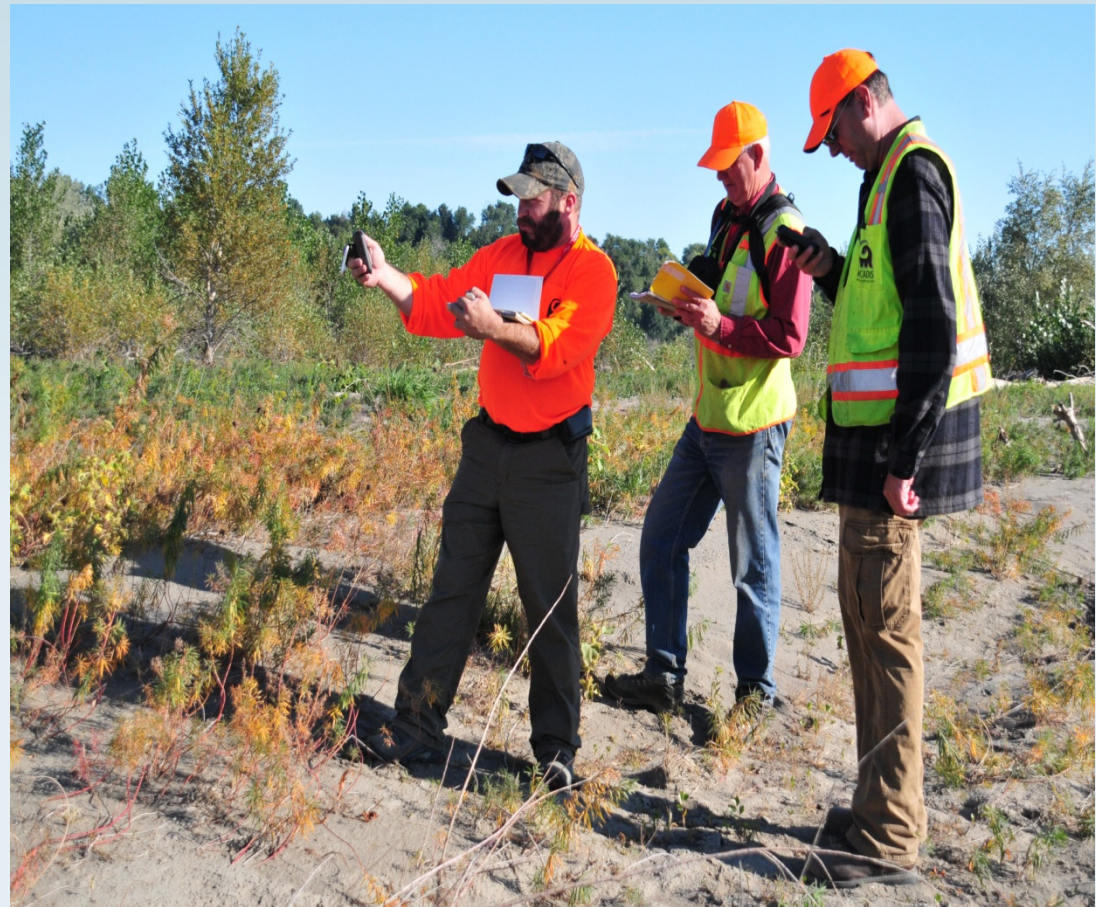
Sand or Gravel- Less than 25% Cover

- No Action

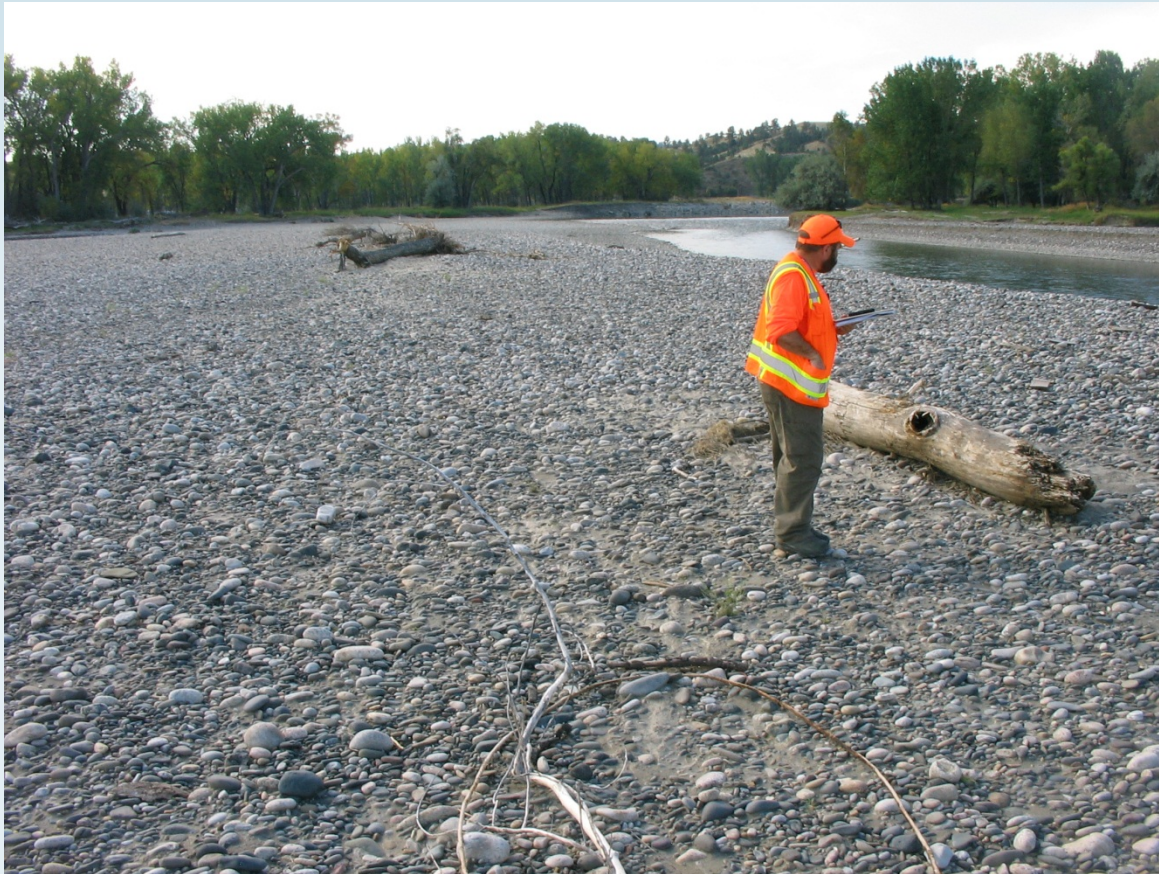
Weeds or Smooth Brome

- Seed Mix 1- Brome mix

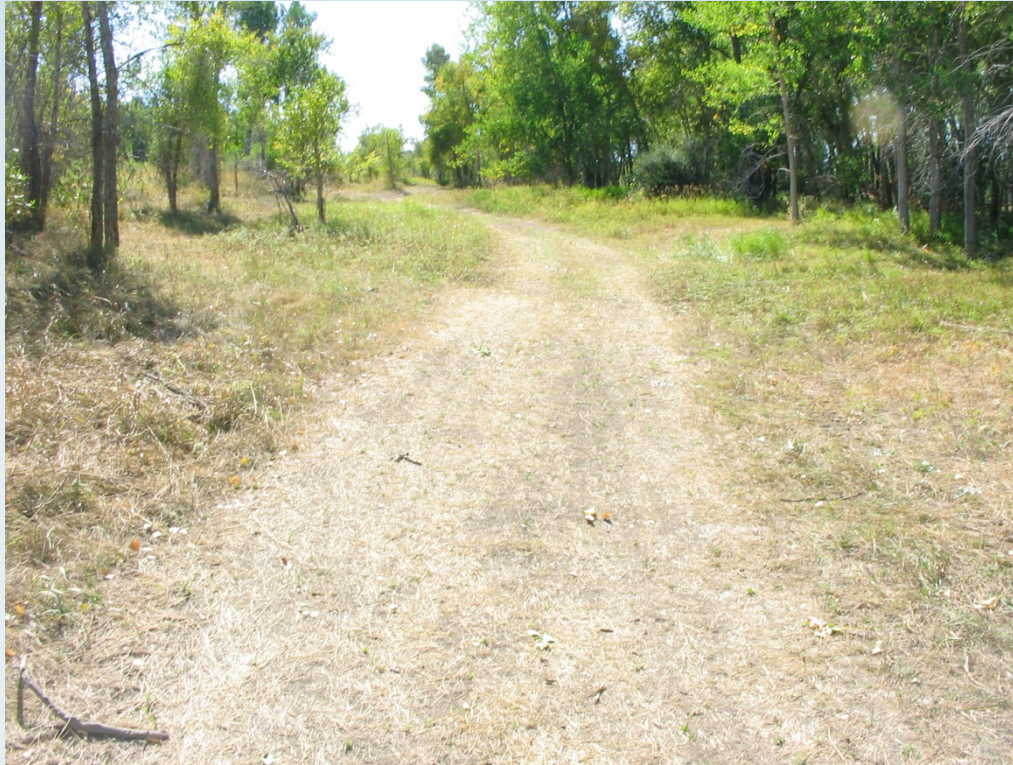
Less than 25% Tree, Shrub or Wetland Cover

- Seed Mix 2- Dry Meadow Mix

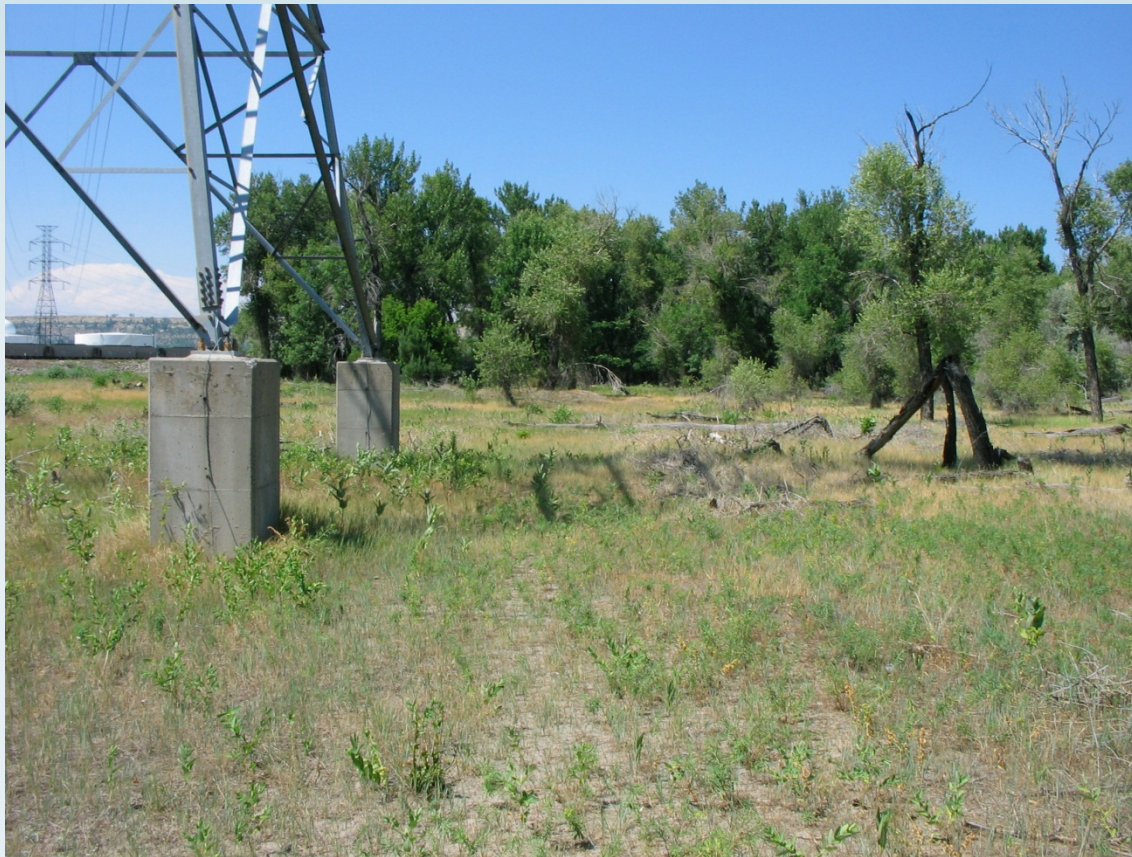
Less than 50% Cover of Wetland Herbaceous Species

- Seed Mix 3- Riparian Mix

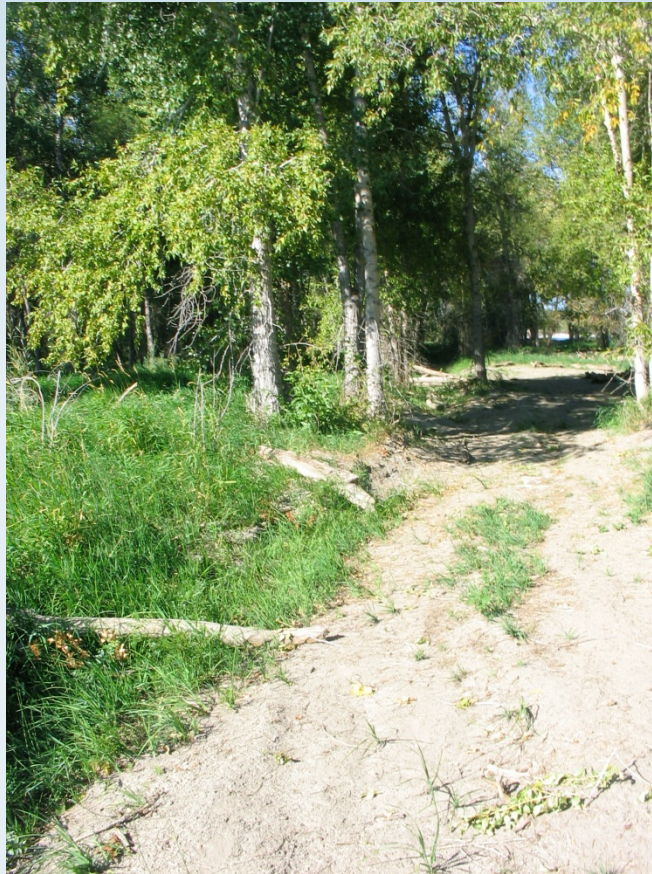
More than 50% Cover of Wetland Herbaceous Species

- Seed Mix 4- Wetland Mix

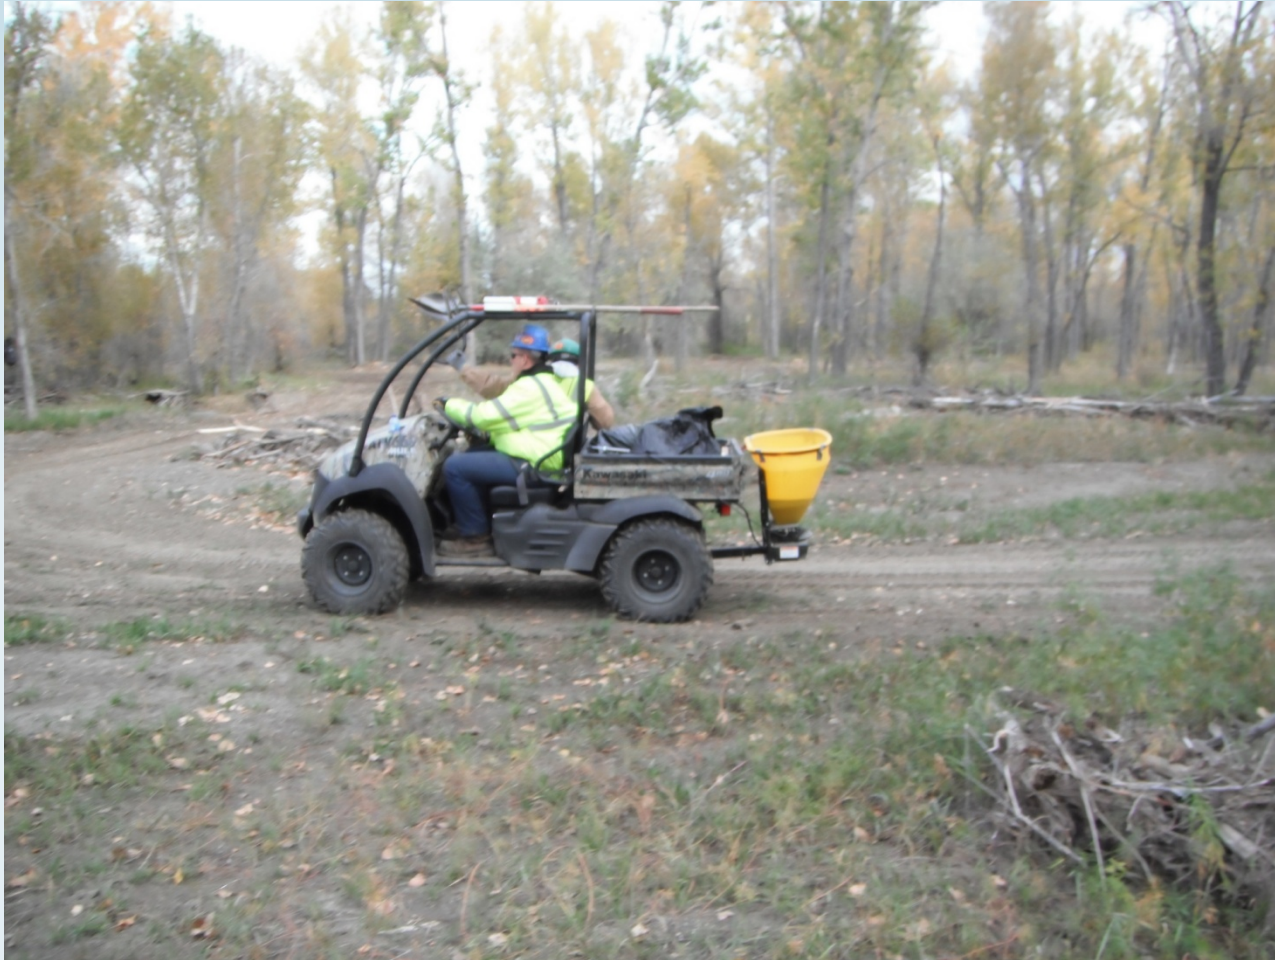
Harrowing and Rolling

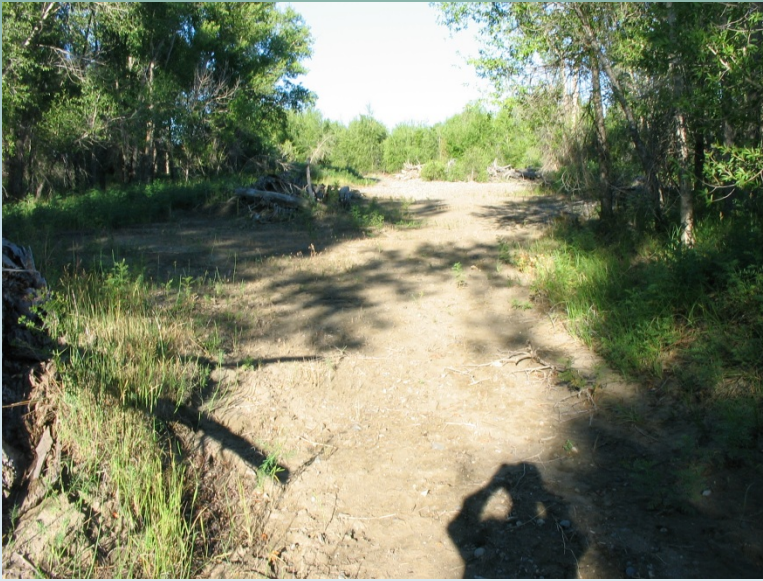
Unsuccessful revegetation

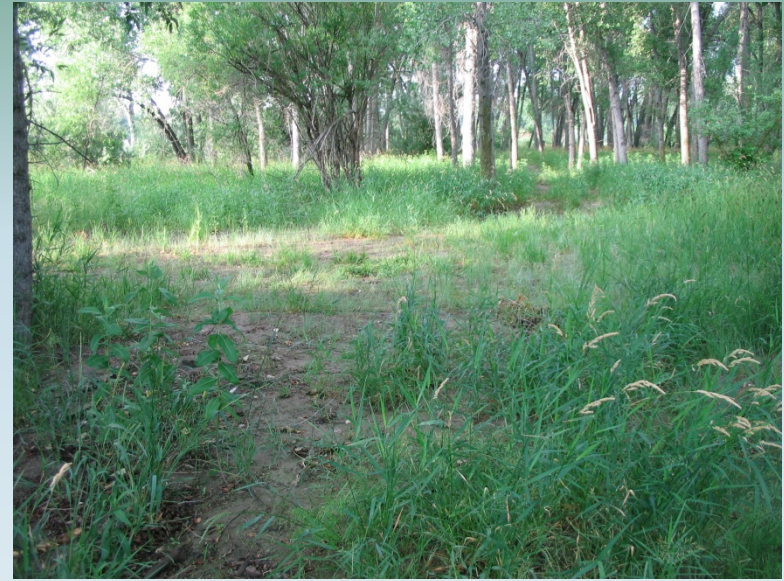
Successful natural regeneration

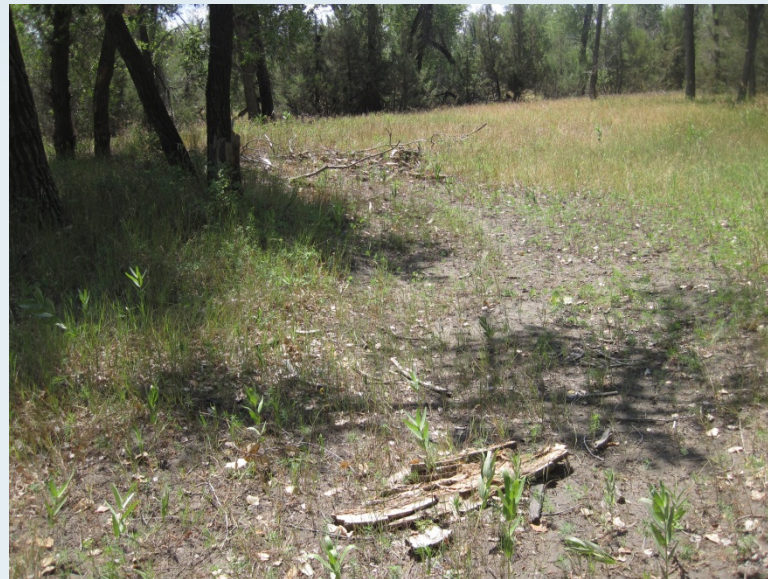
Successful seeding

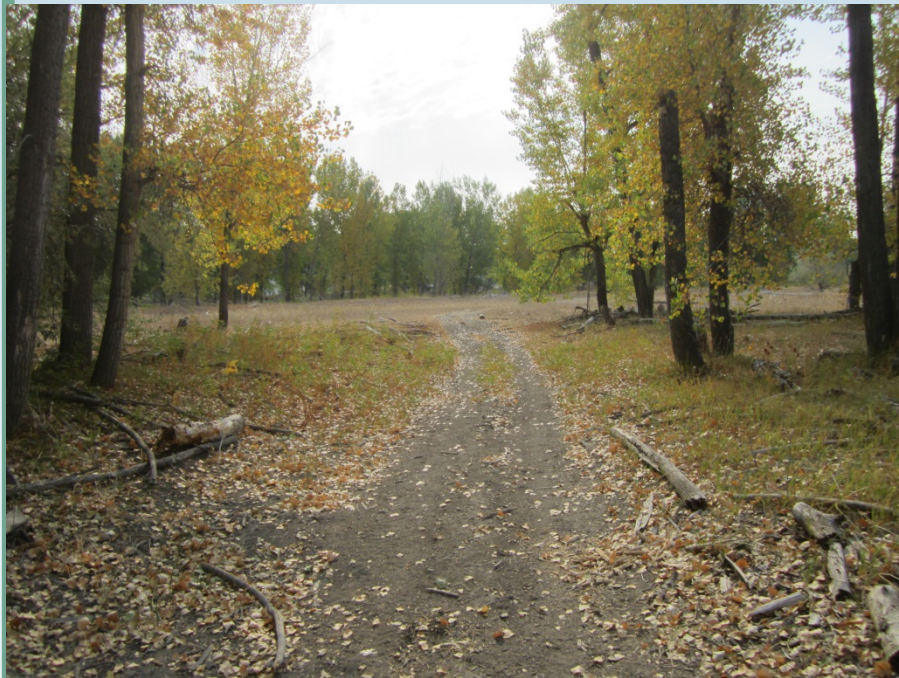
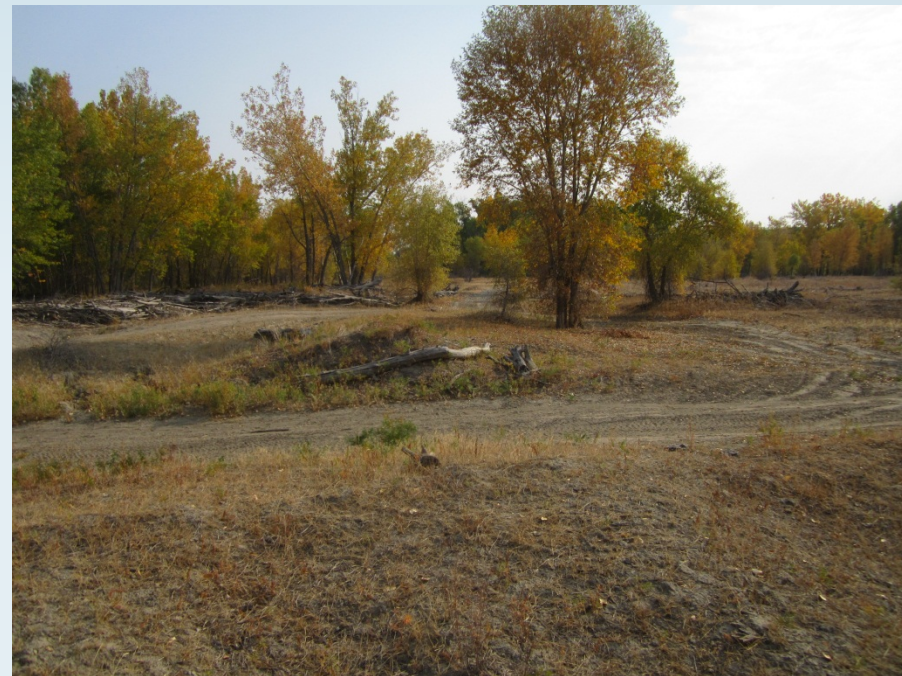
Continued disturbance by ATV's

- Worked with landowners to determine trails needed for management activities
- Unnecessary trails treated with barriers and/or debris placement
- Signs were placed to discourage ATV traffic

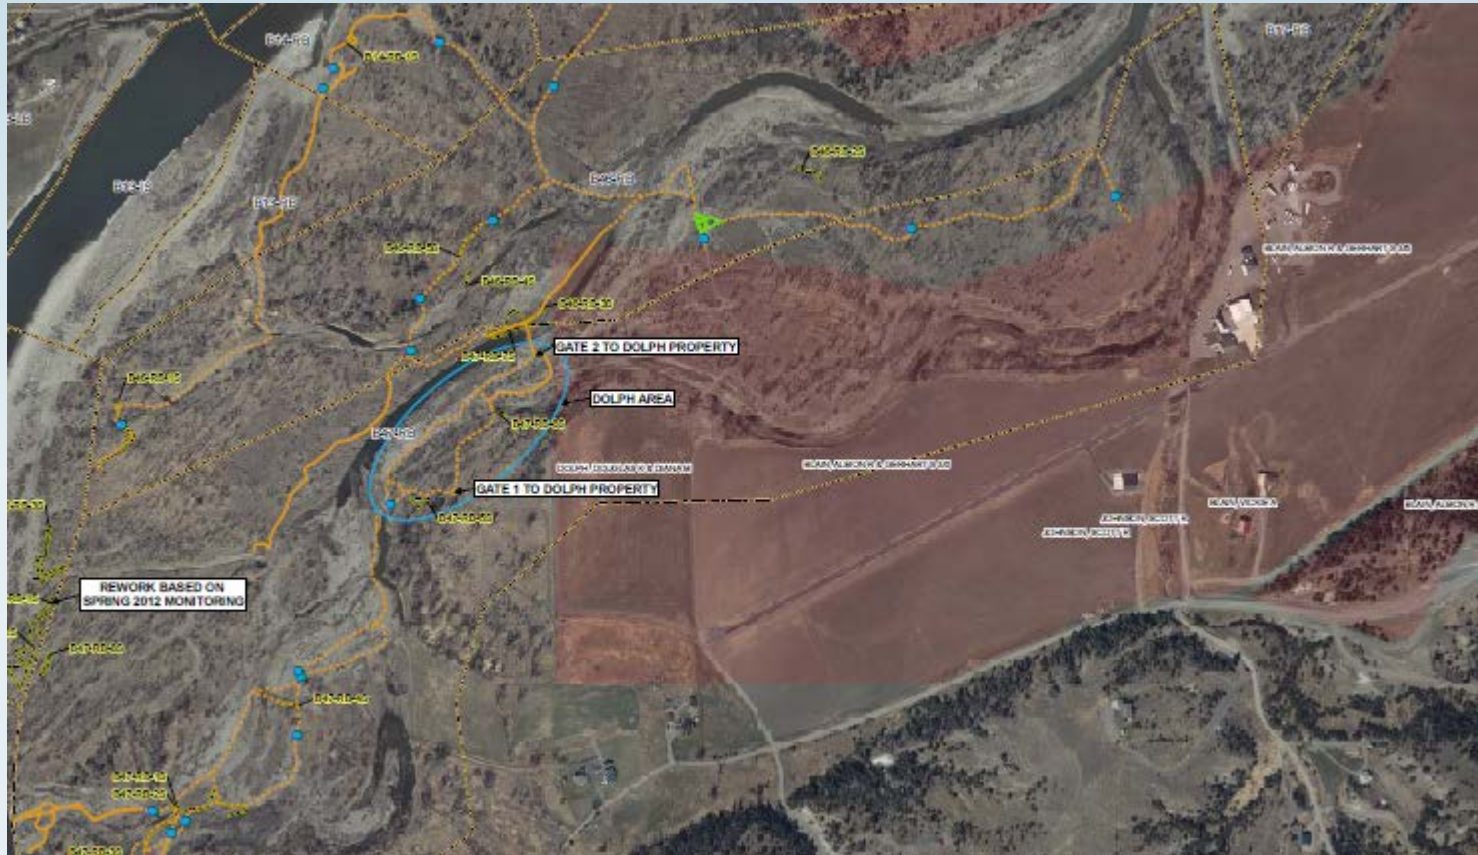
Posting Closure of Trails

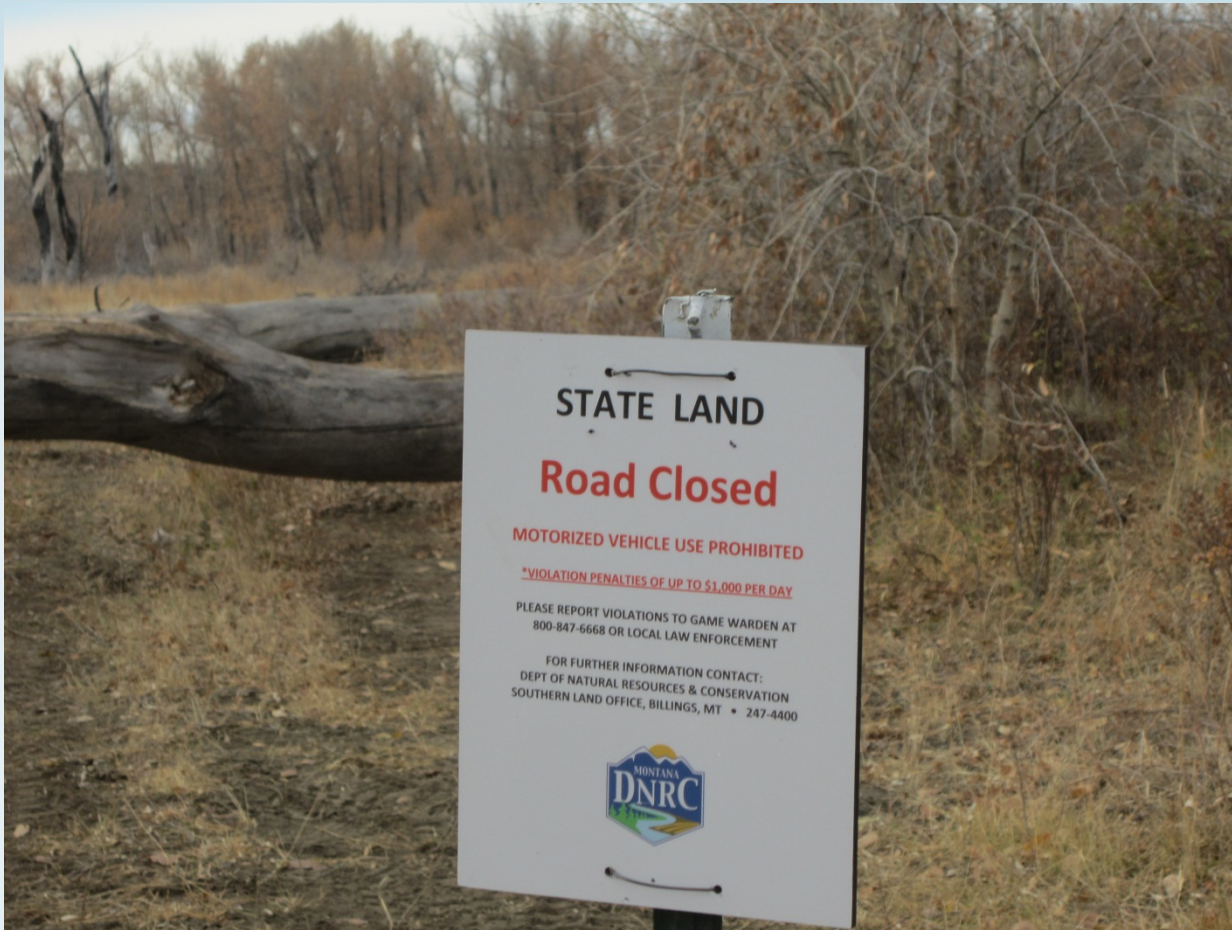
Fencing

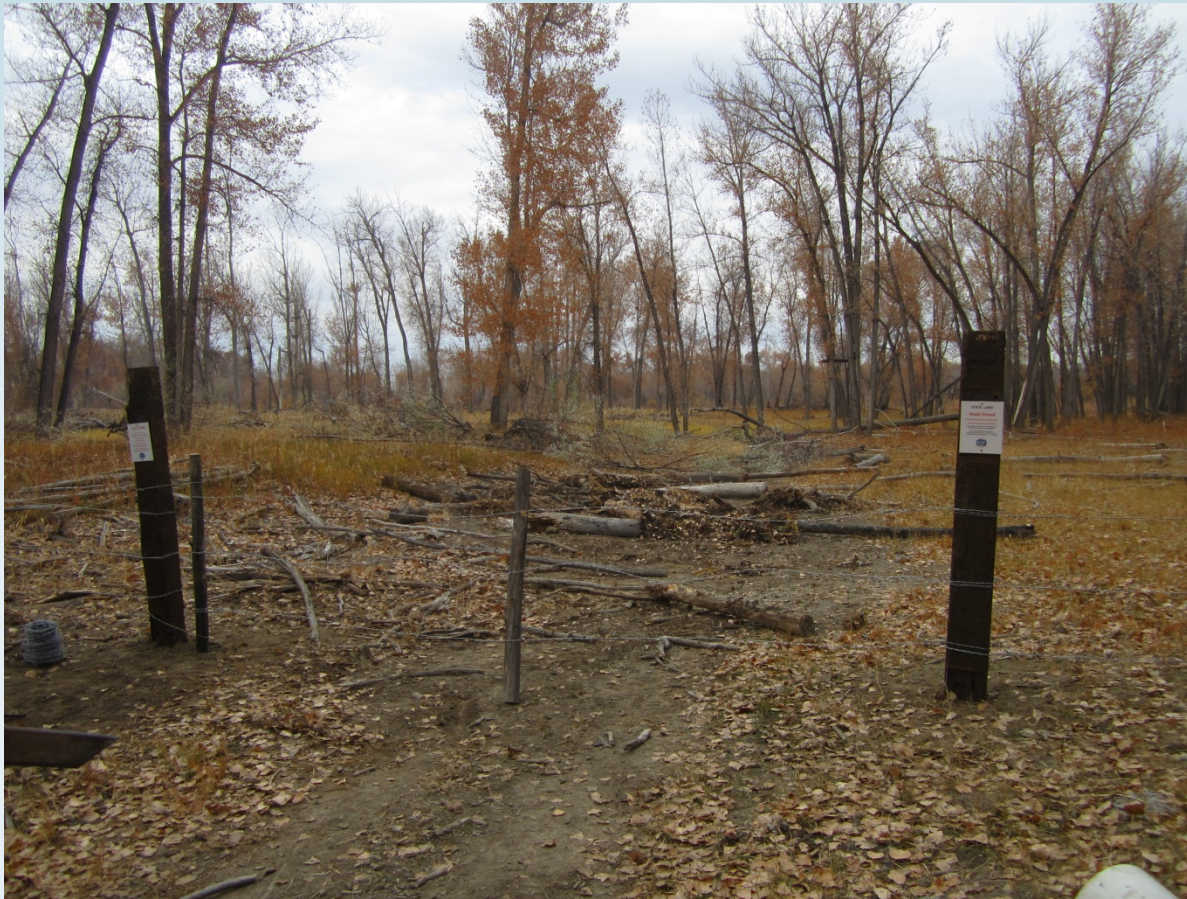
Woody Debris Placement
