Stabilization and Reclamation of the Pensacola Dam West Abutment

Rock Fall Protection System Evaluation and
Implementation

By Means of Anchored Mesh

Steve Jacoby, P.E.
Chief Engineer, Hydropower

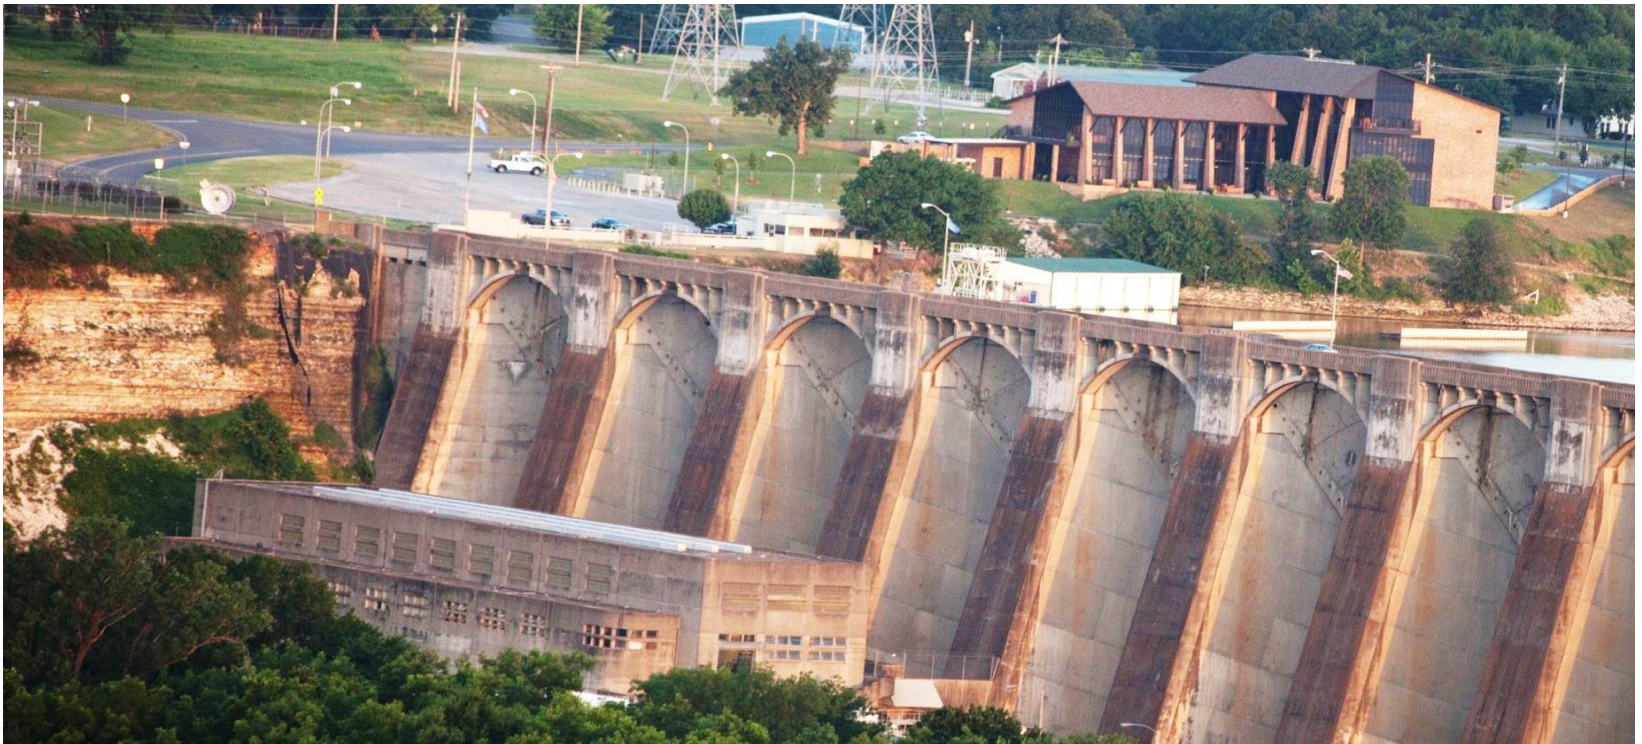
Pensacola Dam West Abutment

- Weathering and Slope Destabilization
- Significant Talus Accumulation
- Significant overhangs/eyebrows
- Personnel safety and equipment damage issues

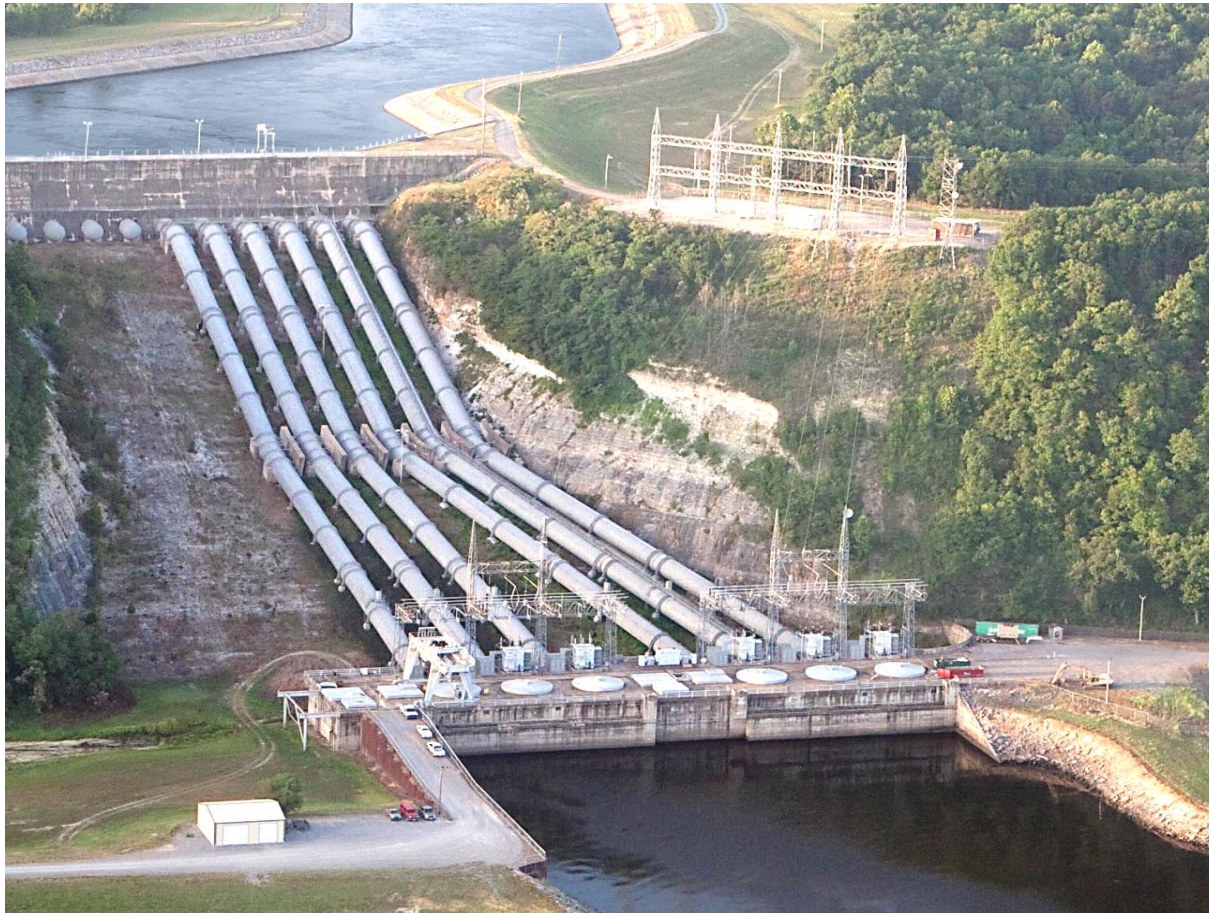
Salina Pumped Storage Facility

Similar weathering and safety concerns at downstream Salina plant

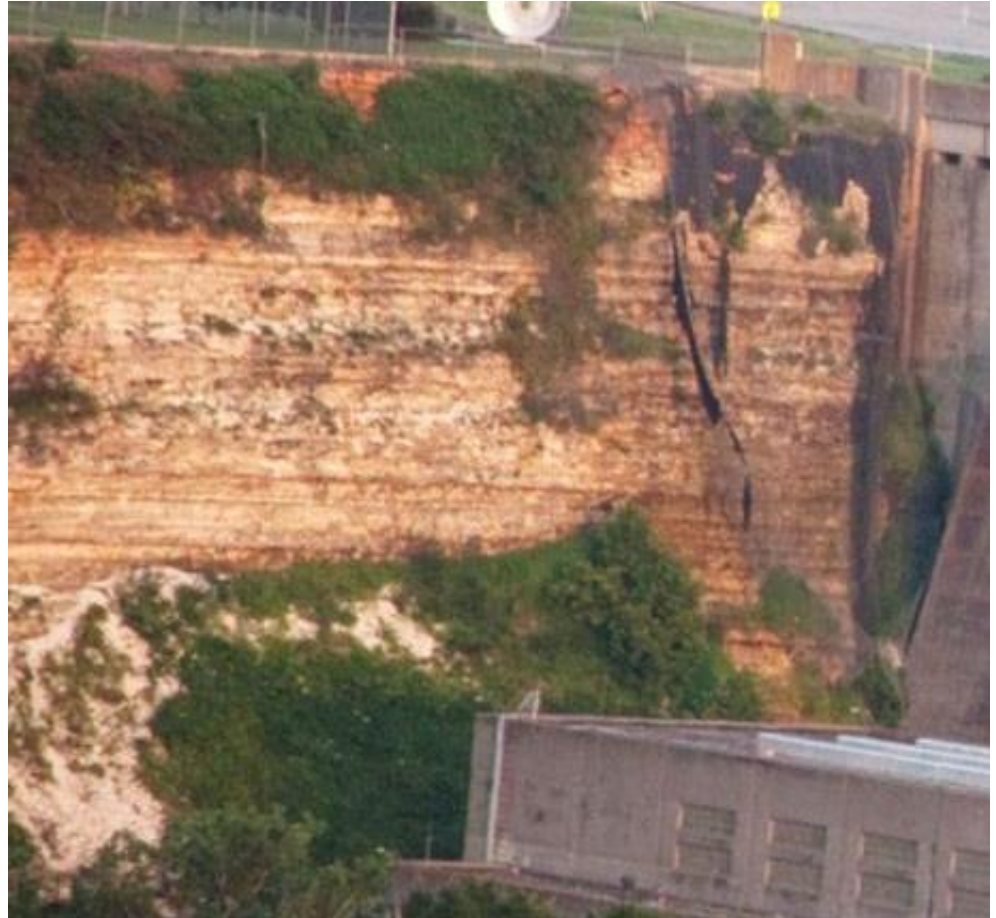
1998 Vintage Reclamation

- Recover Valve Room
- Provide Valve Room Access
- Personnel Safety
- Remove Talus (partial)
 - Access
 - Safety
 - Structural pressure
- Marginally successful

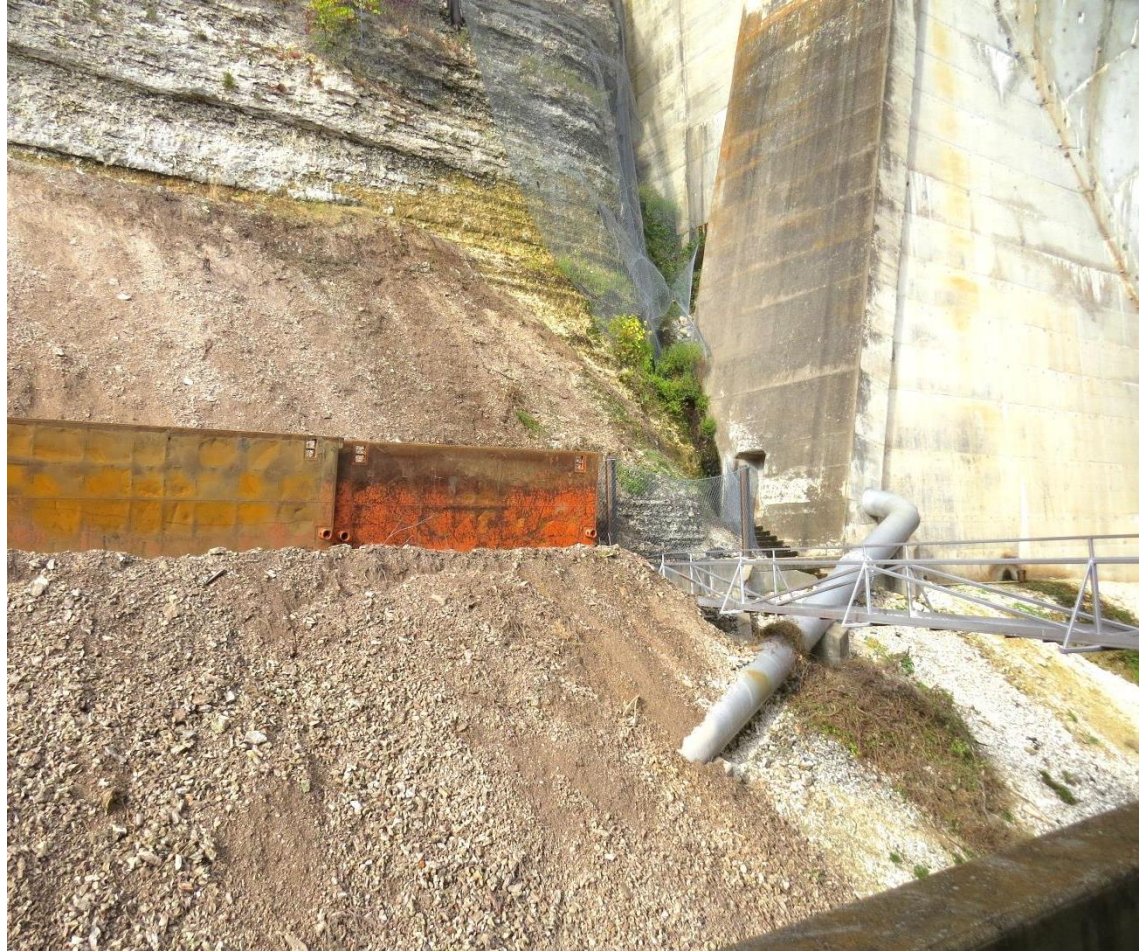
1998 Reclamation

2013 work
beginning

Significant talus
accumulation in
12 years since
1998 reclamation
activity

Valve vault
access bridge and
Bypass line

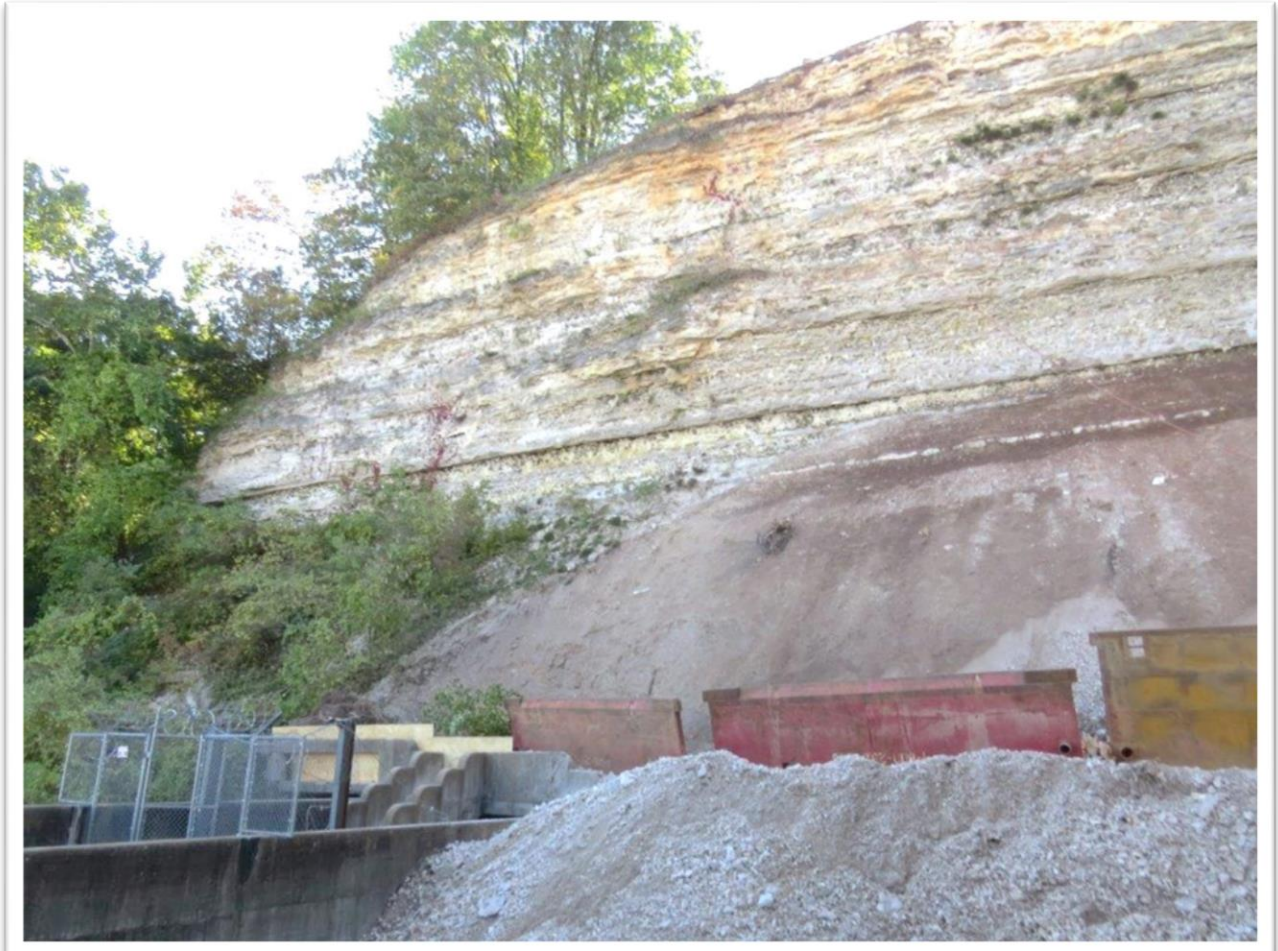
1998 Reclamation

2013 work in progress

Significant talus accumulation in 12 years since 1998 reclamation activity

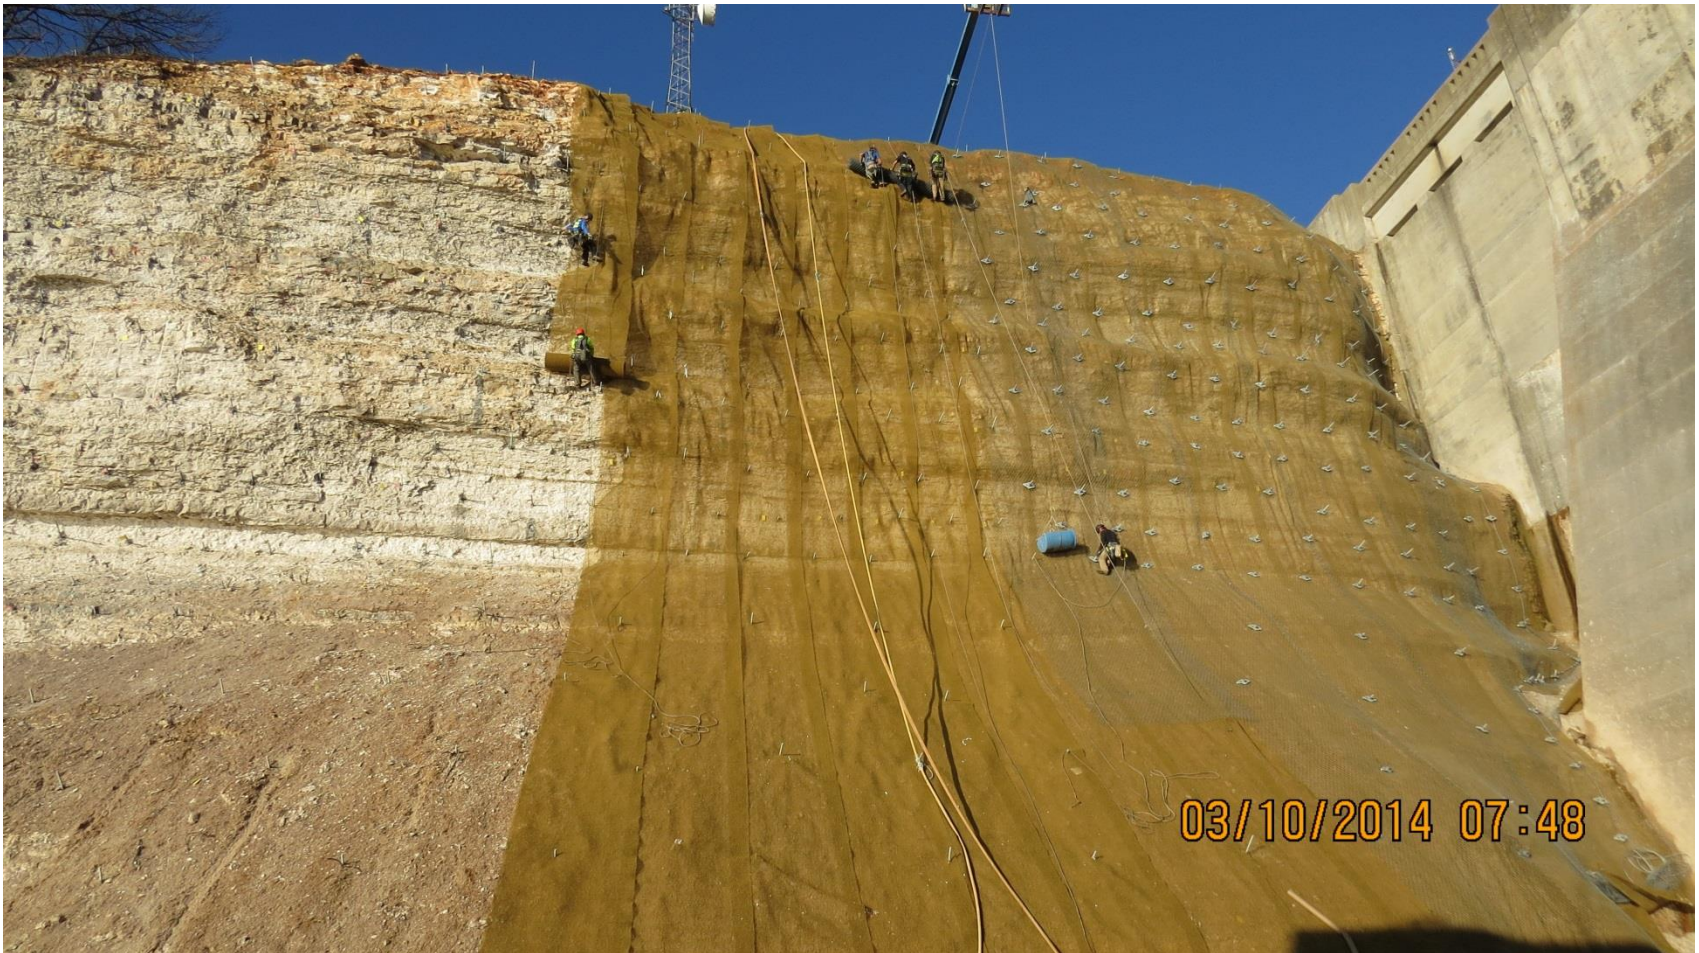
Installing Underlayment Erosion Control Mat - TECMAT

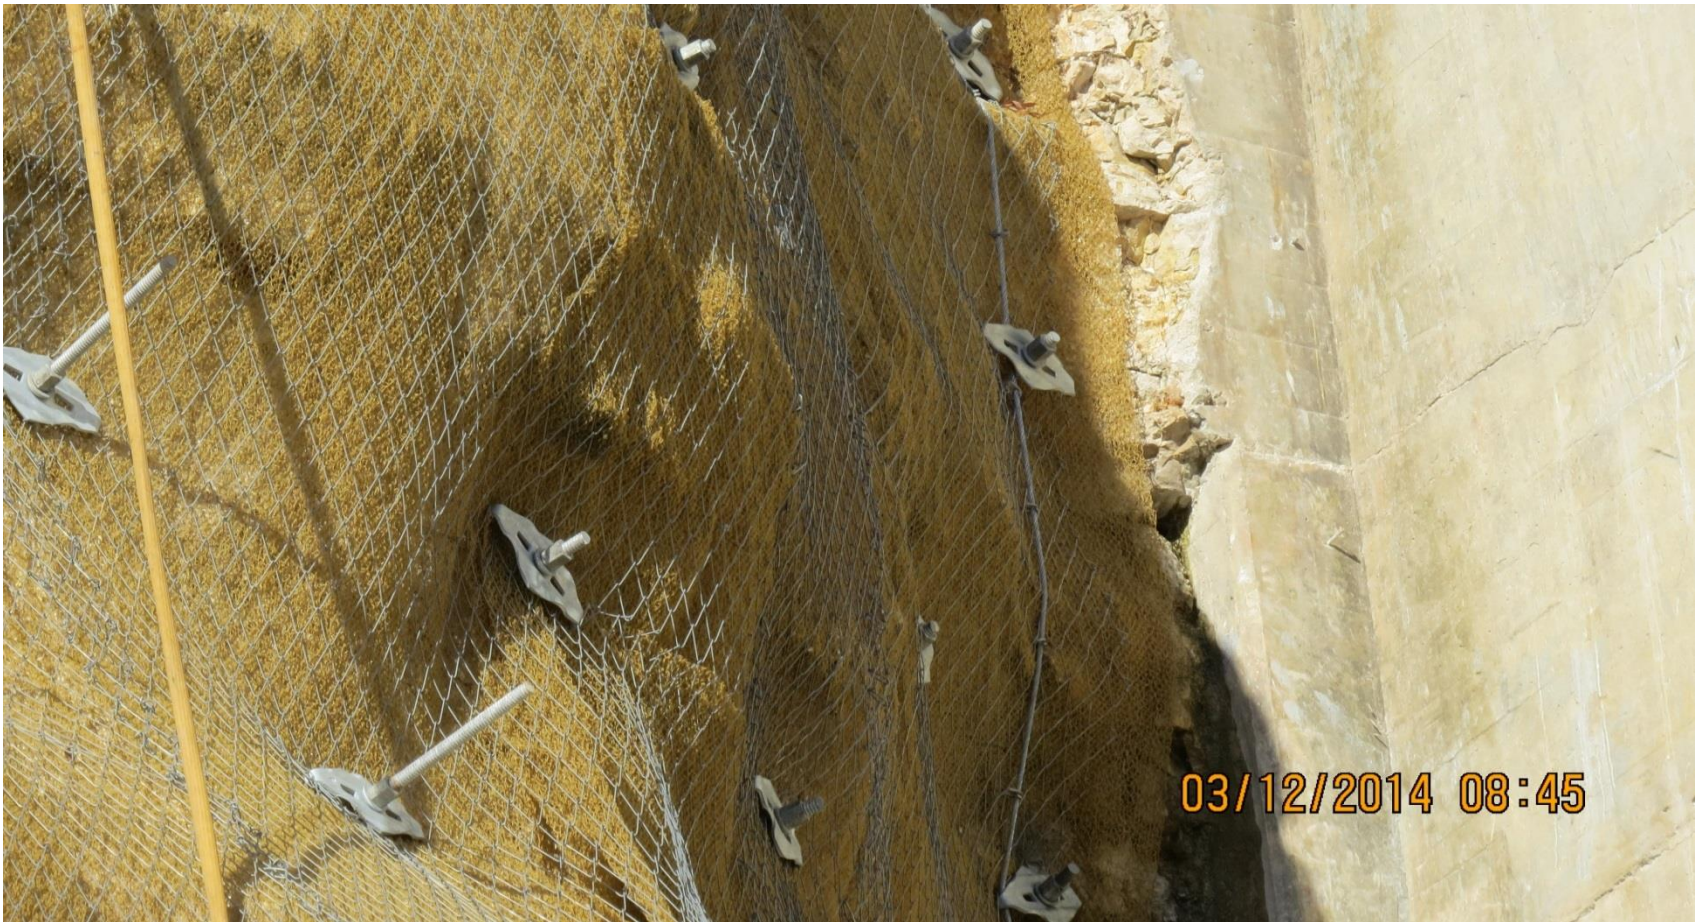
Final Installation

Mesh Connectors, Boundary Rope & Trimming Anchors

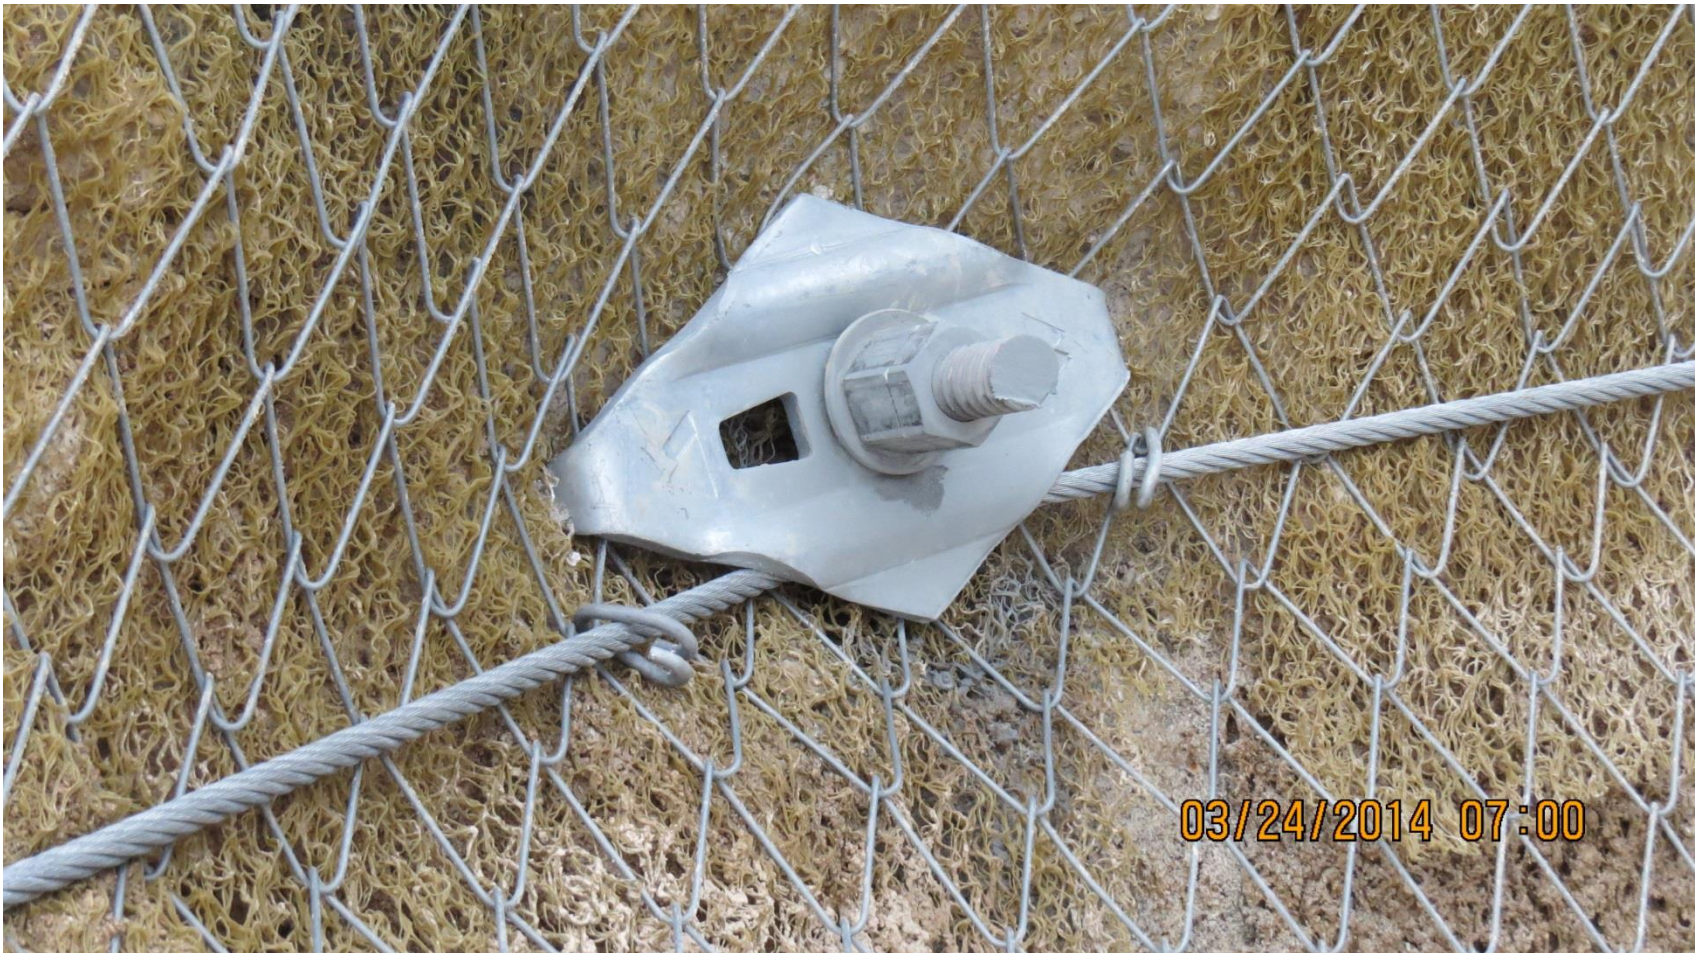
Mesh Connector with Boundary Rope
