# Use of Spoil as a Low Permeable Barrier

Mariana da Rosa, Carmen T. Agouridis, and Richard C. Warner

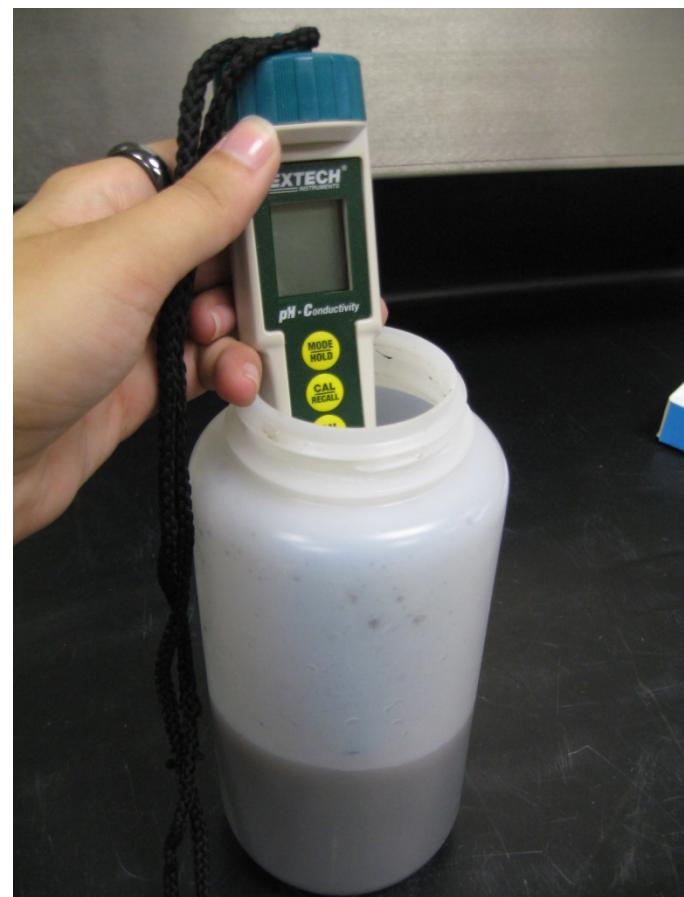
- Specific conductivity
  - 1:3 mixture of spoil and deionized water
  - Multiparameter meter
    - HI991300; Hanna Instruments, Woonsocket, RI
- Selenium testing
