# REHABILITATION OF PENNSYLVANIA PASSIVE TREATMENT SYSTEMS

Presenter: Ryan M. Mahony

# OPERATION AND MAINTENANCE: PARTNERING FOR SUCCESS

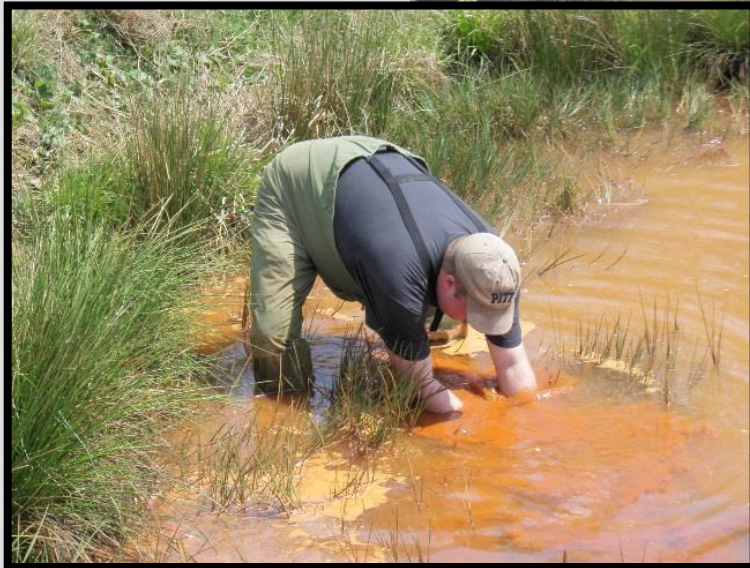
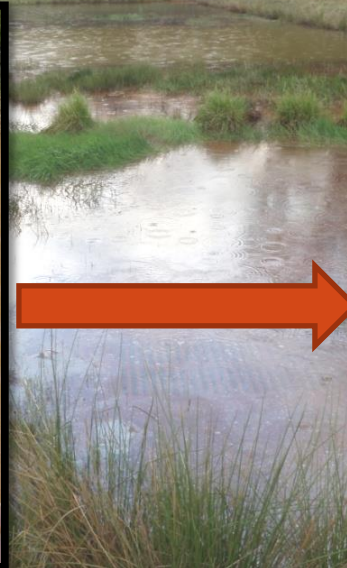
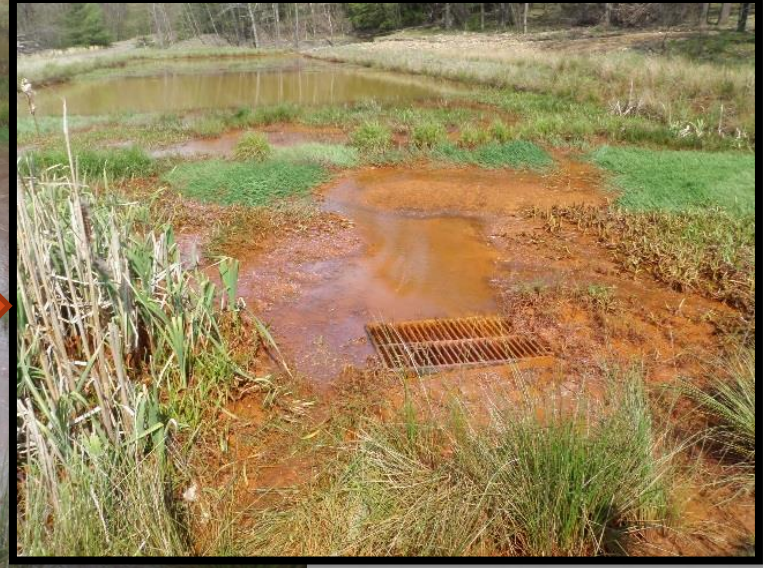
- Bear Run Phase 1
- Grate plugged with Fe & debris
- Sometimes getting a bit dirty makes for a simple fix!

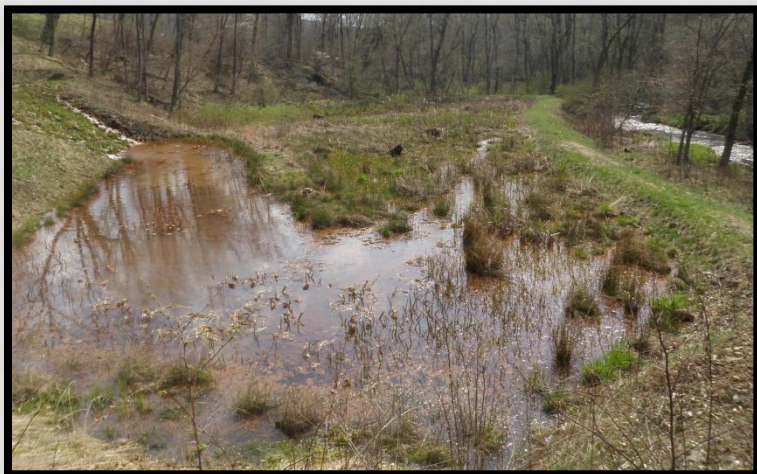
**AMD Source:** Underground  
**Watershed:** Semiconon Run  
**City:** Connoquenessing Twp  
**County:** Butler  
**State:** Pennsylvania  
**Primary Funding Partners:** OSM  
Watershed Cooperative  
Assistance  
**Stream:** Semiconon Run

Parameter	Coll. Pool	WL Effluent
pH	6.4	6.8
alkalinity	106	81
acidity	neg.	neg.
Fe	18.5	3.3
Mn	3.8	3
Al	<1	<1

Total metals mg/L, acidity and alkalinity as CaCO<sub>3</sub> mg/L

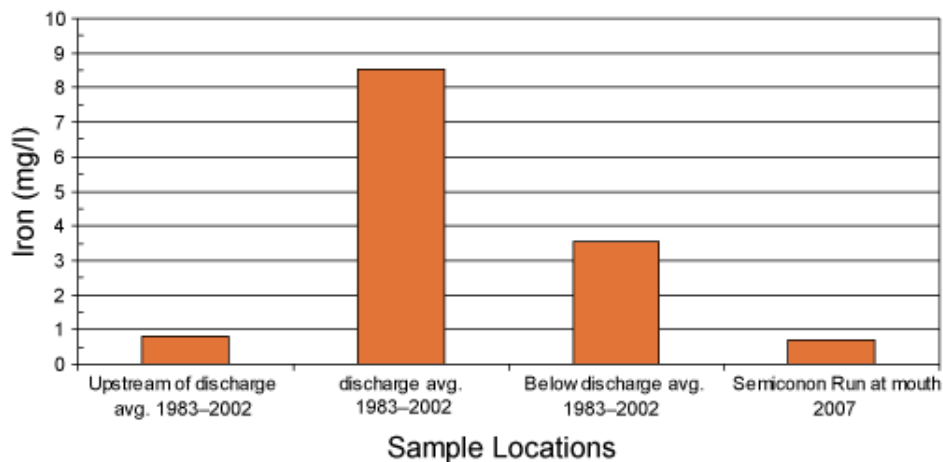
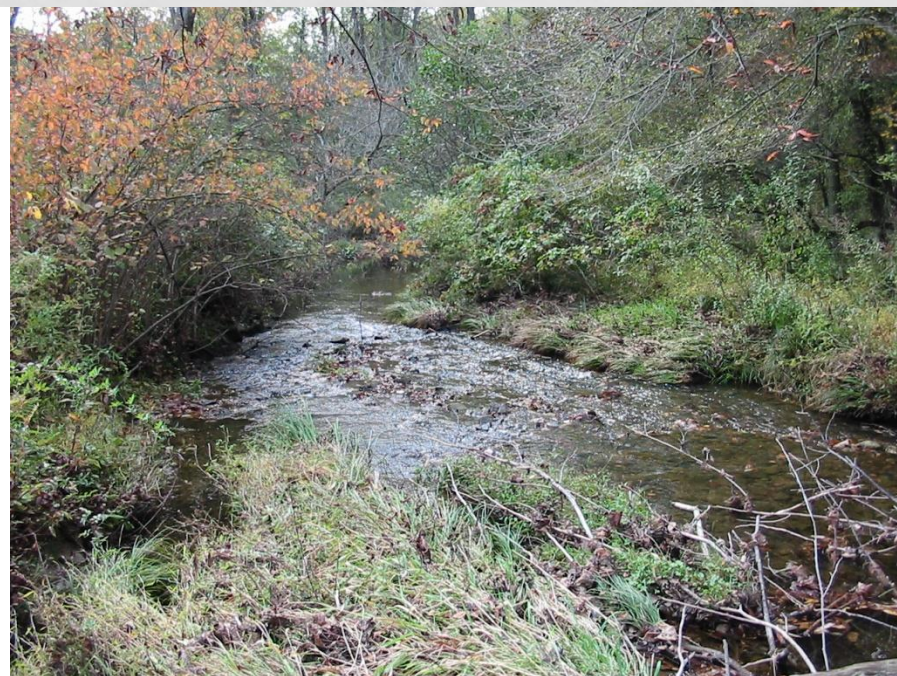
Figure 4. Measurements of iron concentrations.

- Successful Passive Treatment resulted in removal of Semiconon Run from the 303(d) list in 2008

## Iron levels in Semiconon Run

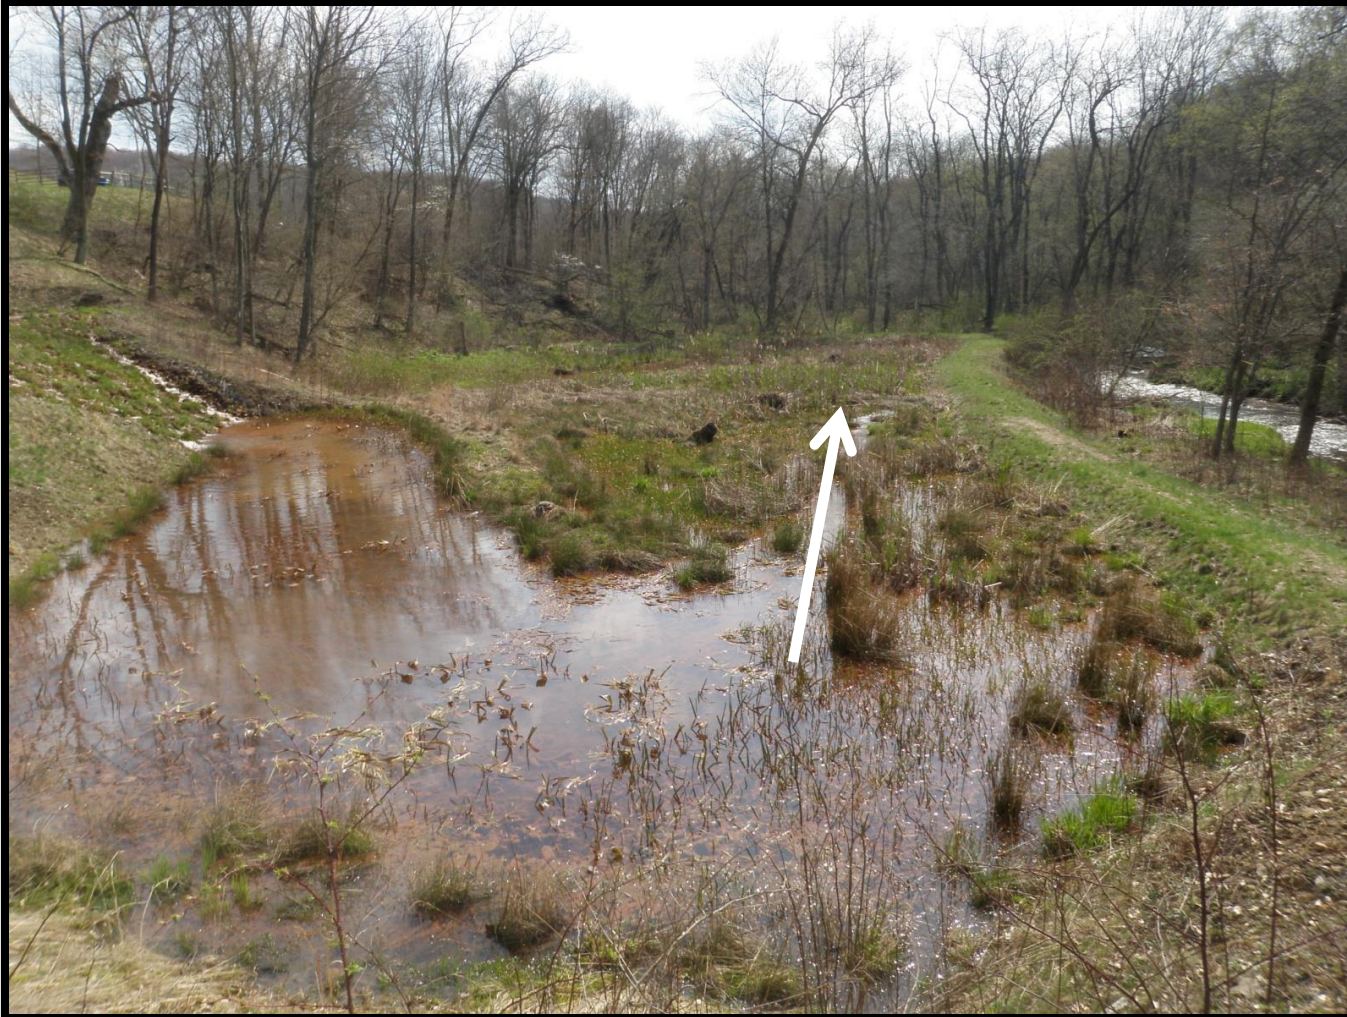
- Channels within the wetland caused short circuiting = increased Fe in effluent

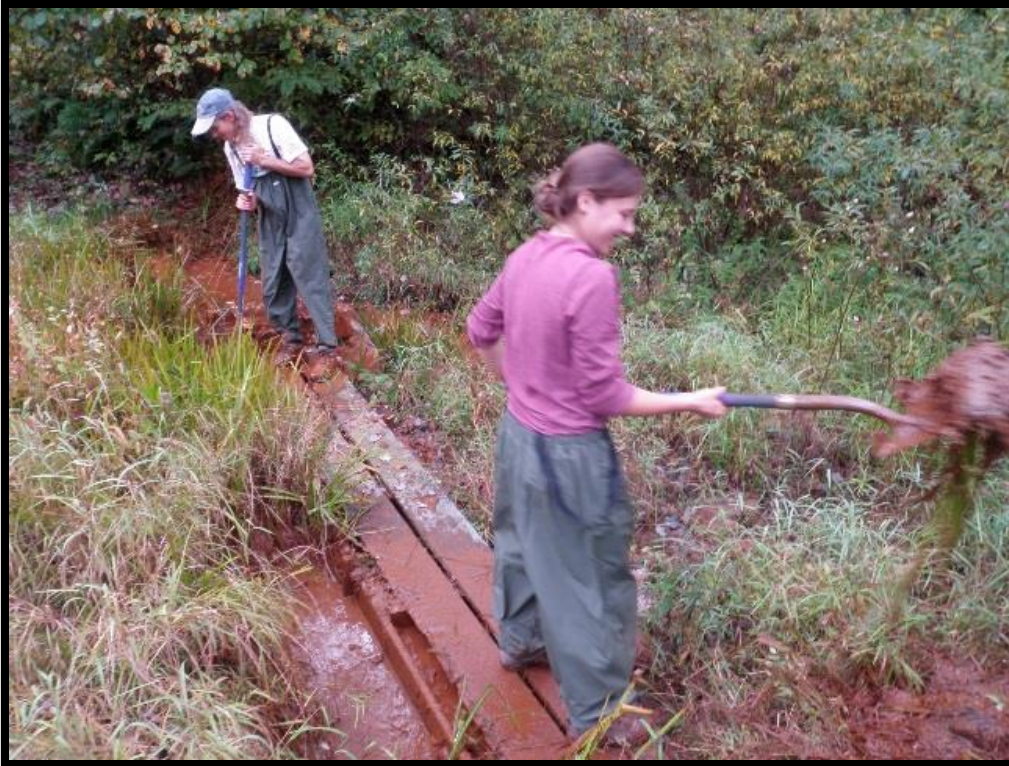
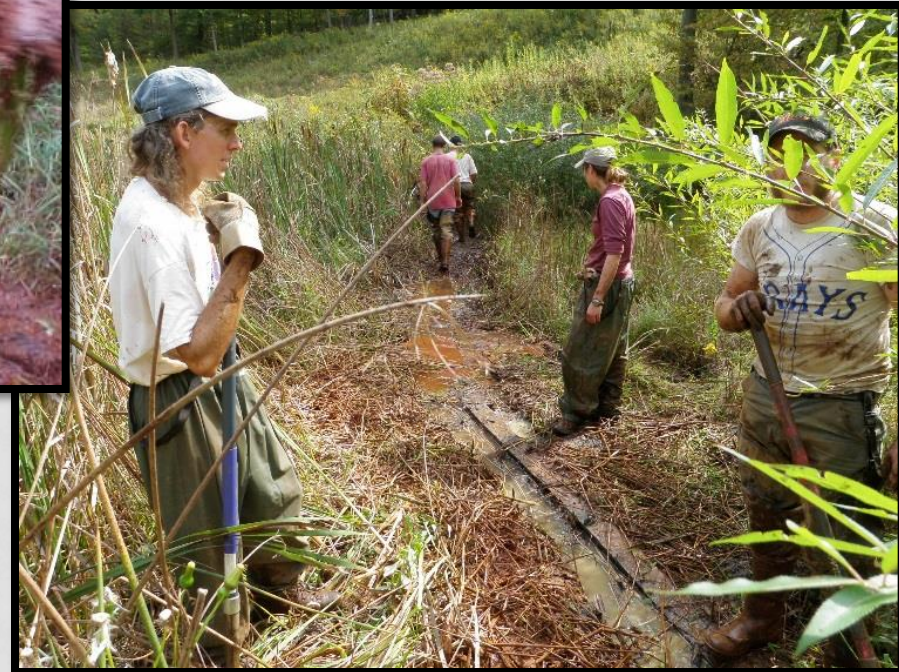
- Successful vegetation led to overgrown level spreaders increasing channelization and adding to the problem rather than preventing

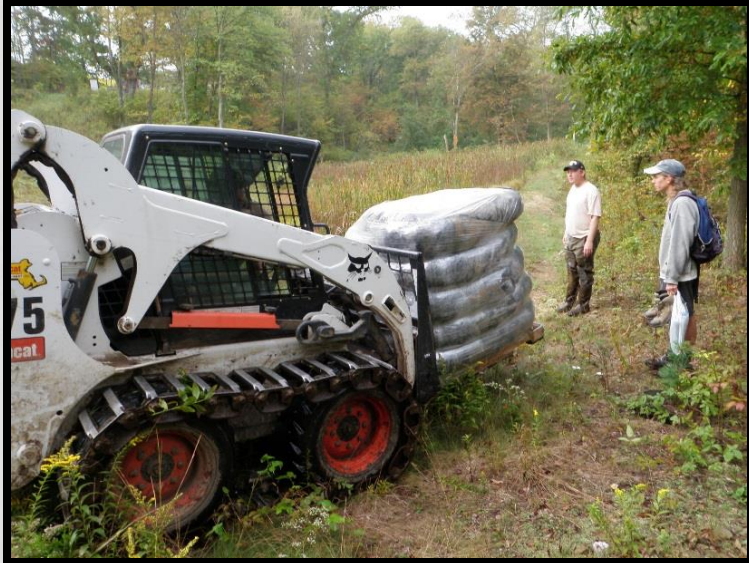
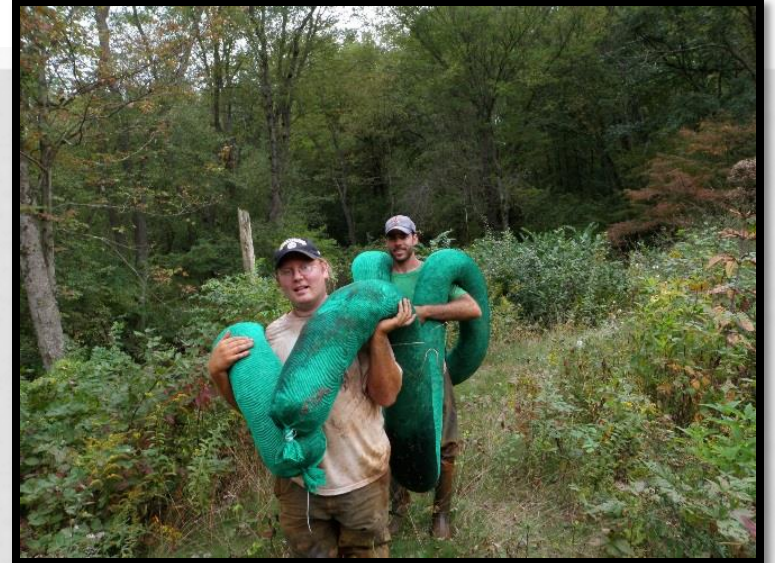
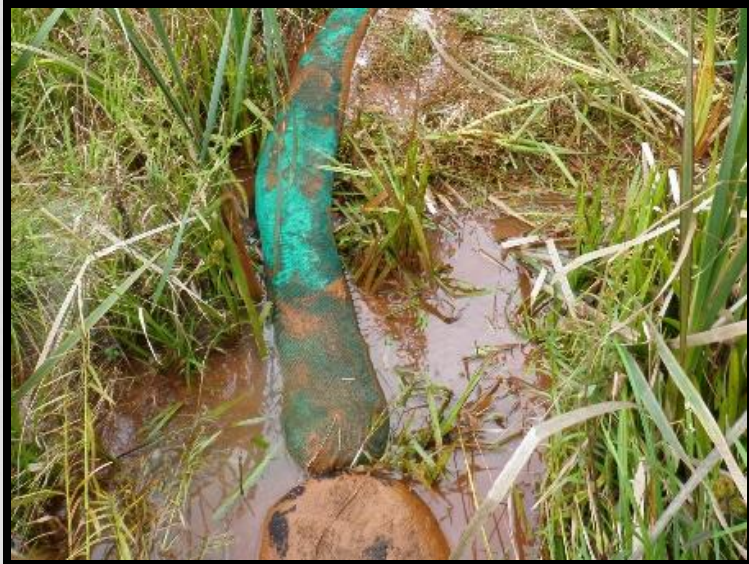
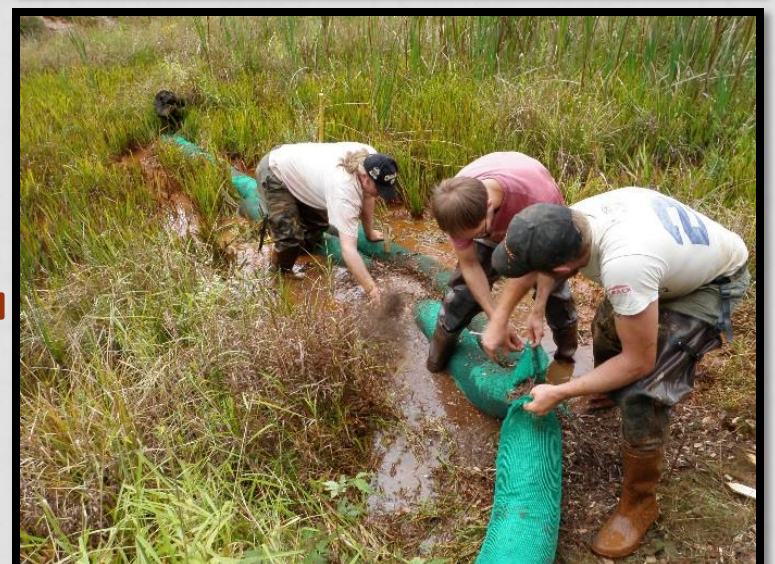
Parameter	Pre-O&M	Post-O&M
pH	7.0	6.9
alkalinity	~60	~70
Fe (mg/l)	4-8	0.5 - 1

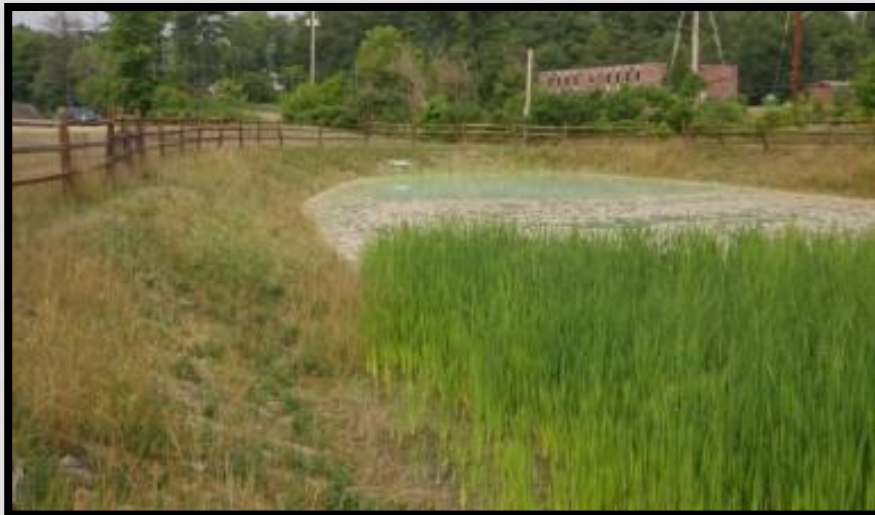
Parameter	Raw	Effluent
pH	3.6	6.6
alkalinity	0	28
acidity	263	neg.
Fe	39	1
Mn	15	6
Al	15	2

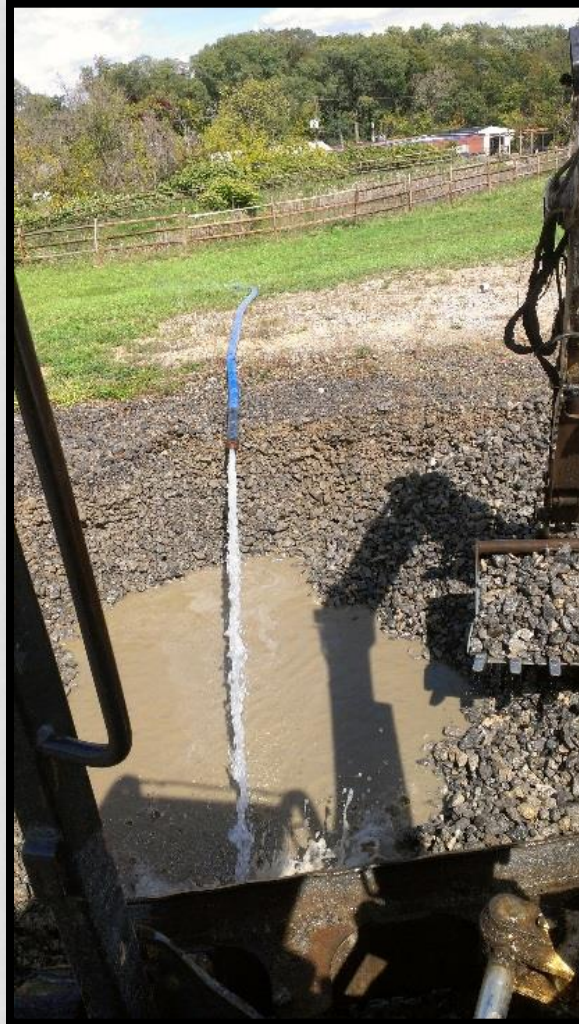
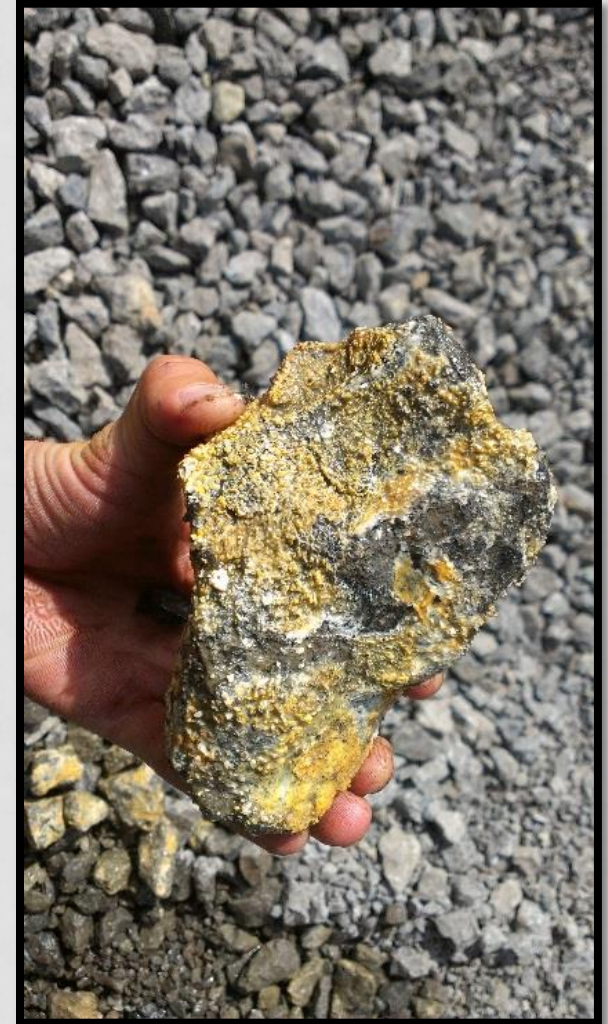
- Reduced treatment performance after several years of operation
- Water quality decreased due to plugged media
- BMI stirred & flushed the limestone media within the VFP in 2011

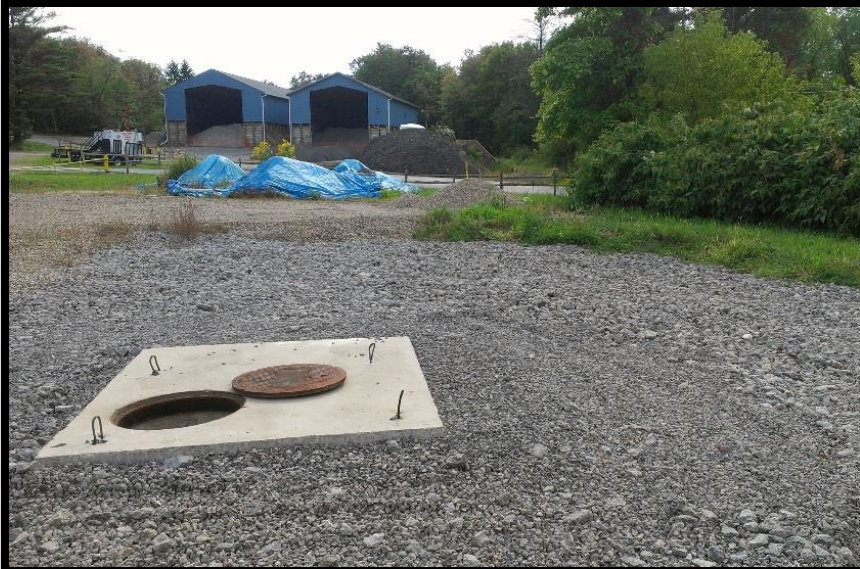
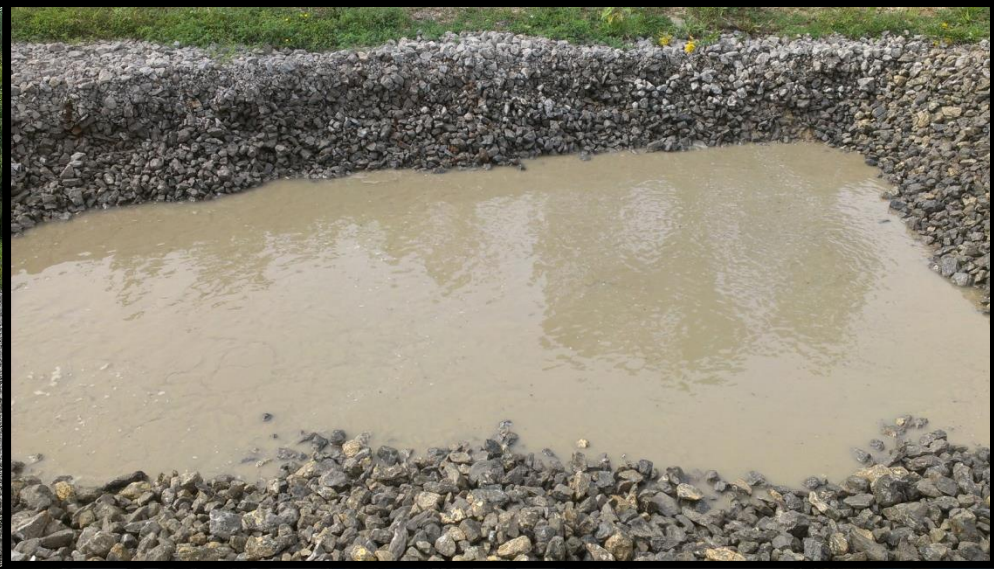
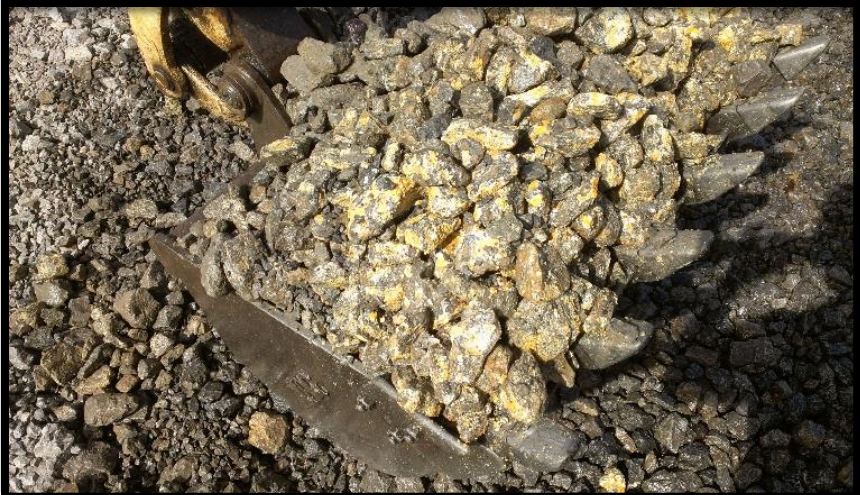
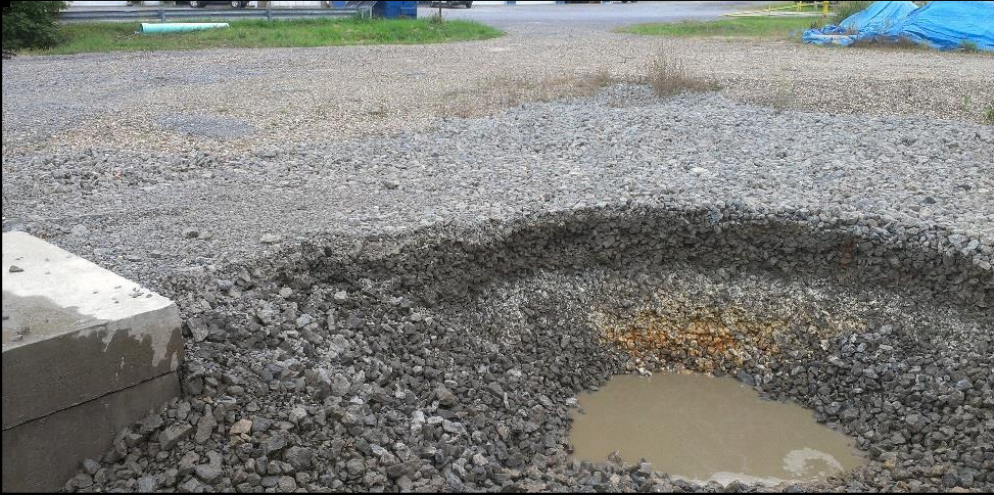
Parameter	Pre-O&M	Post-O&M
Date	5/15/12	12/4/12
pH	4.3	6.2
alkalinity	0	22
acidity	113	-8
Fe	0.4	0.4
Mn	5.2	3.8
Al	20.9	1.0

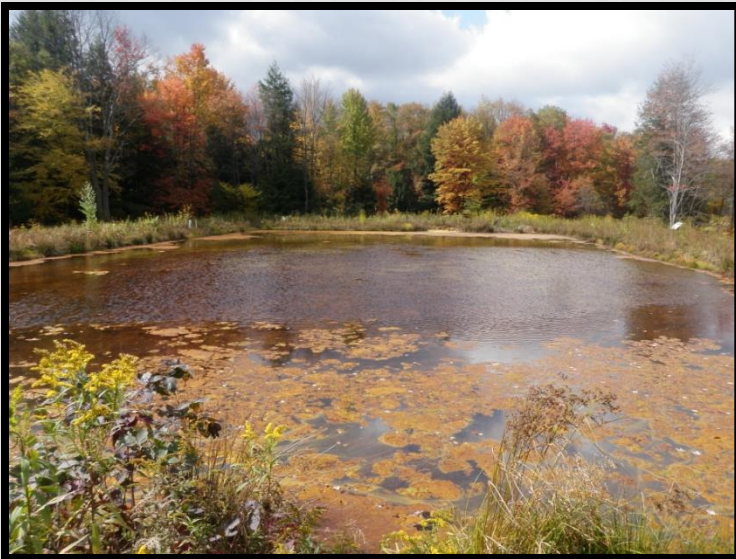
Parameter	Raw	Effluent
pH	3.5	6.7
alkalinity	0	150
acidity	113	-74
Fe	27	10
Mn	8	6
Al	7	2

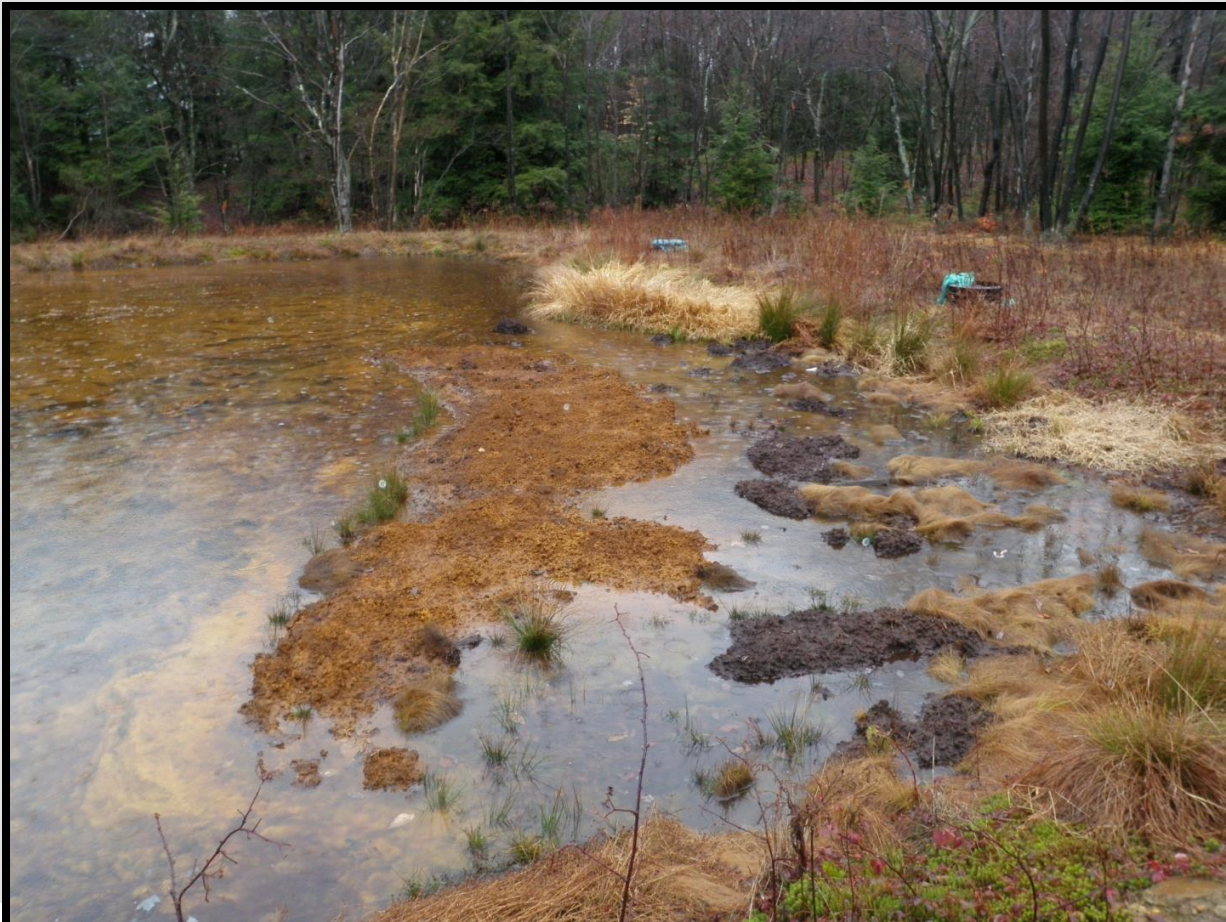
- Unknown event pushed compost across system causing significant variation in compost depth = short-circuiting & reduced performance
