Jennings Passive Treatment System Rehabilitation

Jennings Rehab

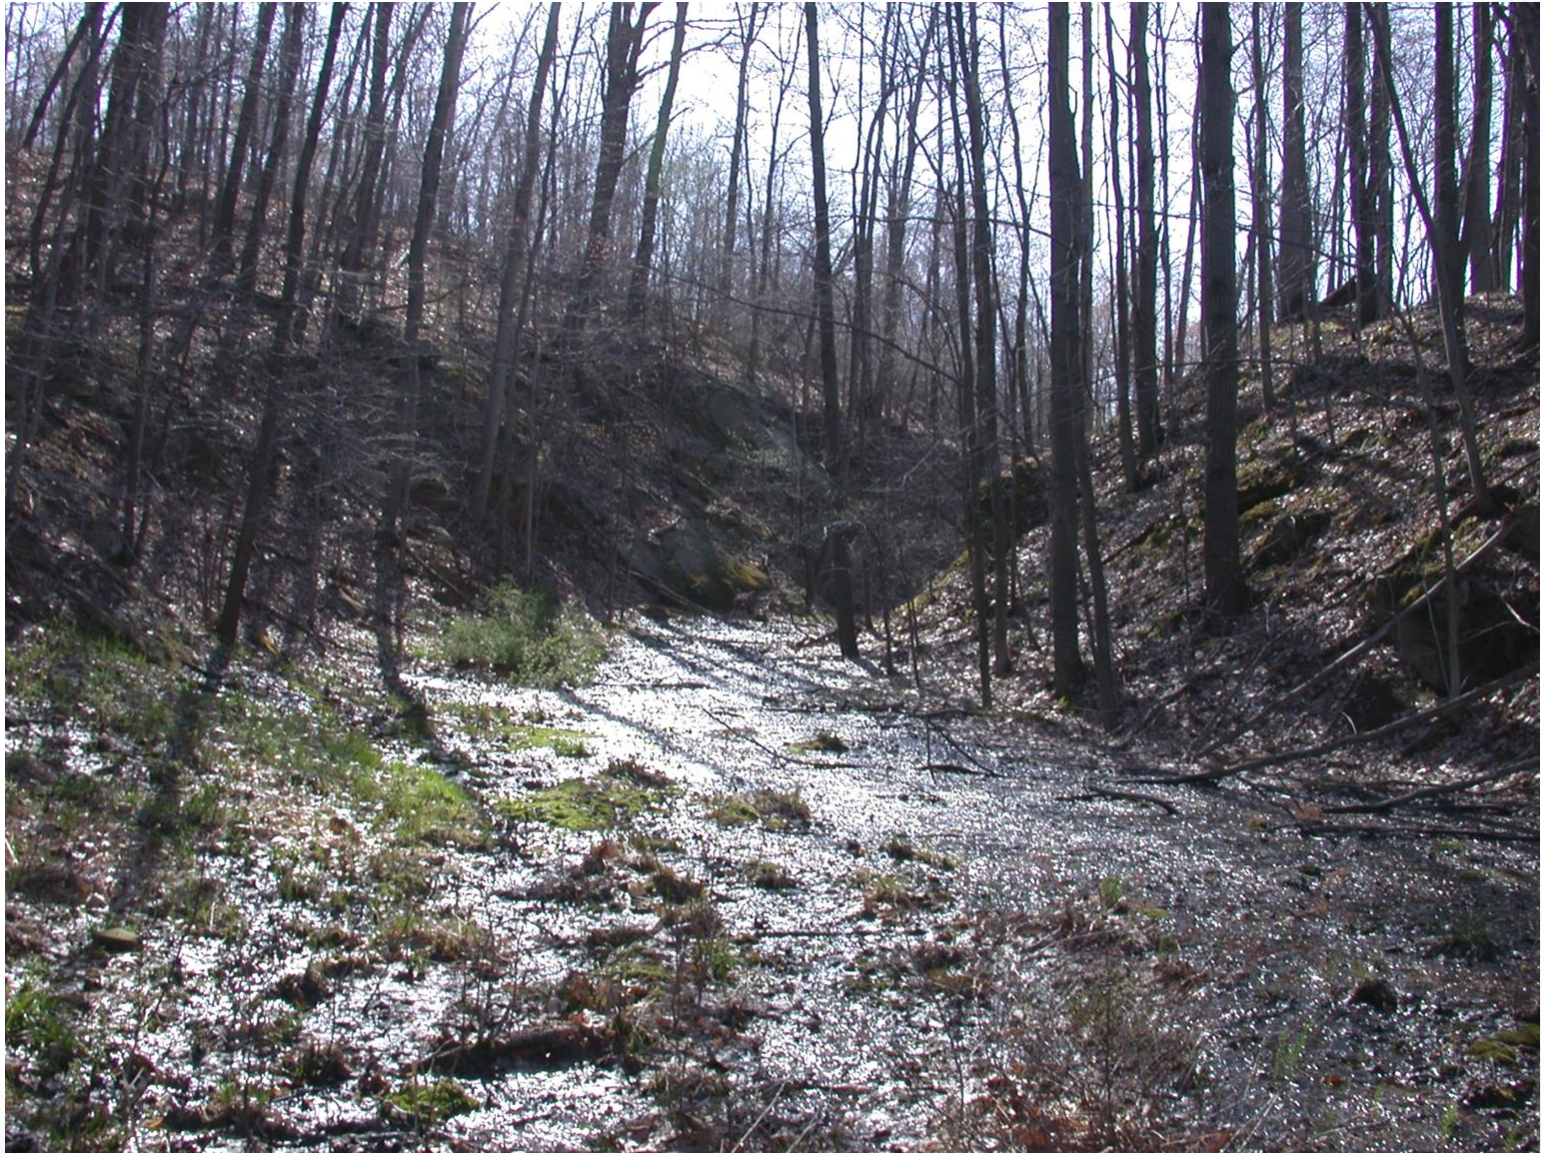
Mine Seal Blowout ~1984

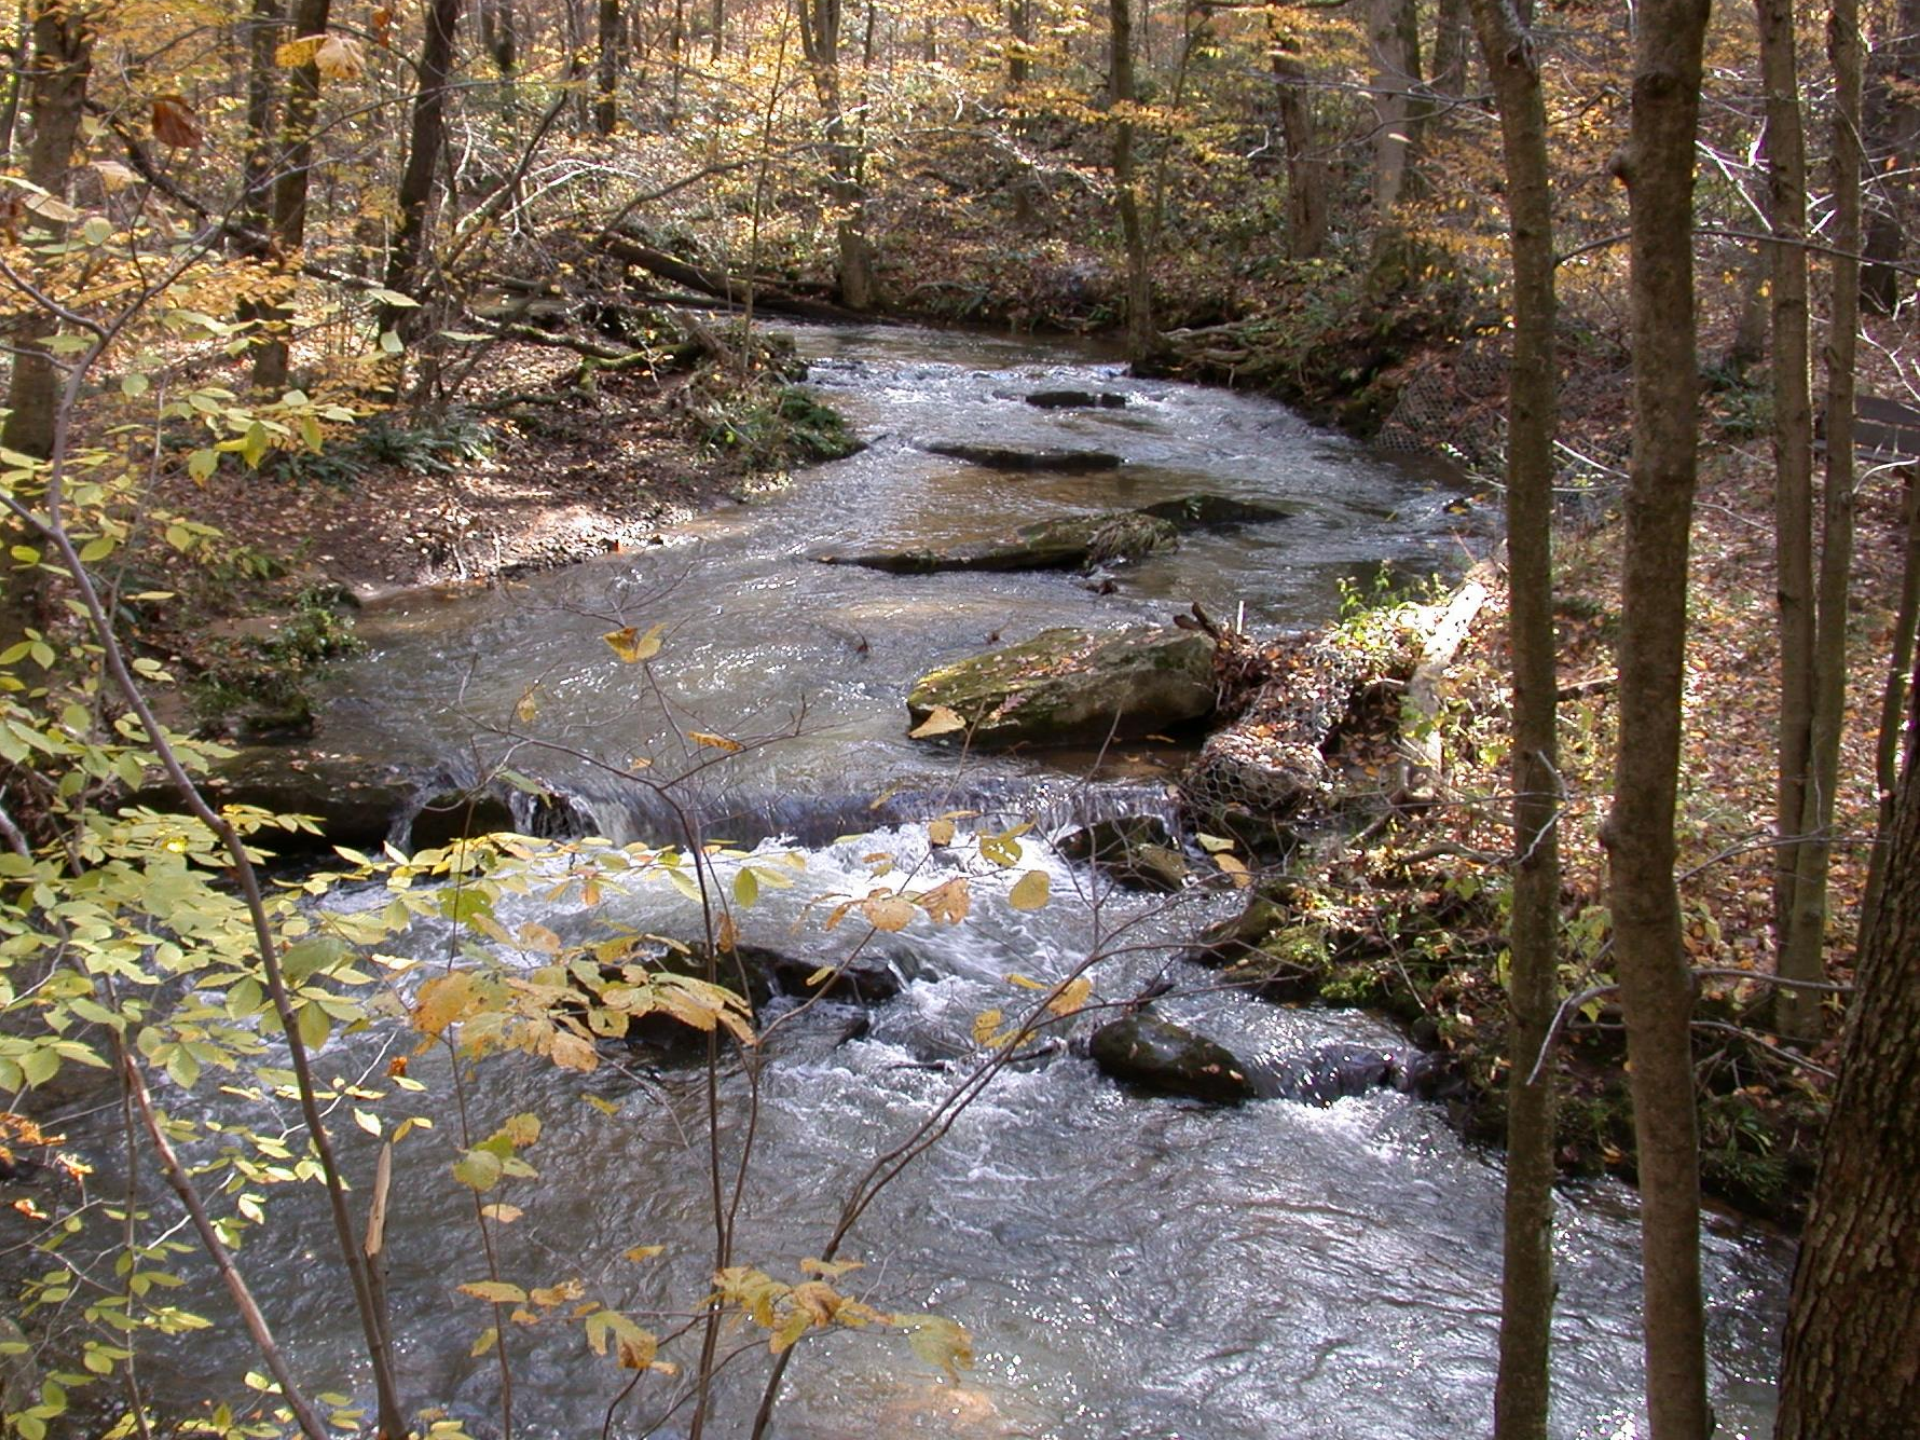
Original Wetlands System Constructed ~1988

Point	Flow LPM (GPM)	pH	Alk mg/L	Acid mg/L	T. Fe mg/L	T. Al mg/L	T. Mn mg/L	SO4 mg/L
In	129 (34)	2.9	0	258	22	19	6	516
Out	NA	3.3	0	154	15	14	6	519

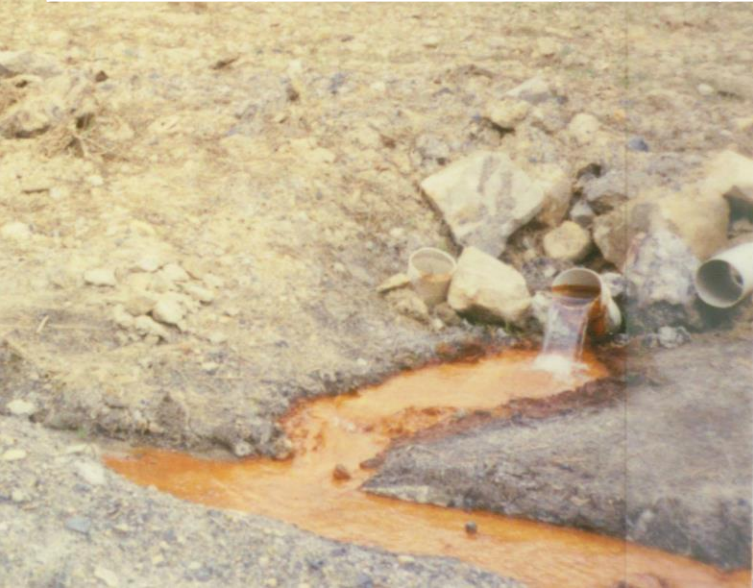
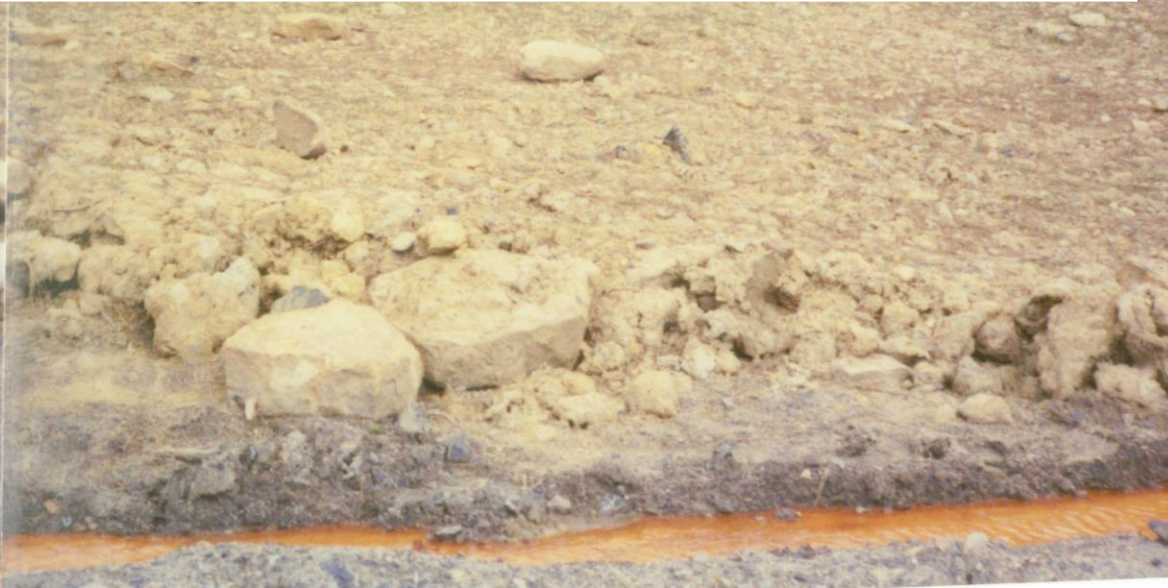
ALD – Installed 1993

Plugged with Al within ~9 months

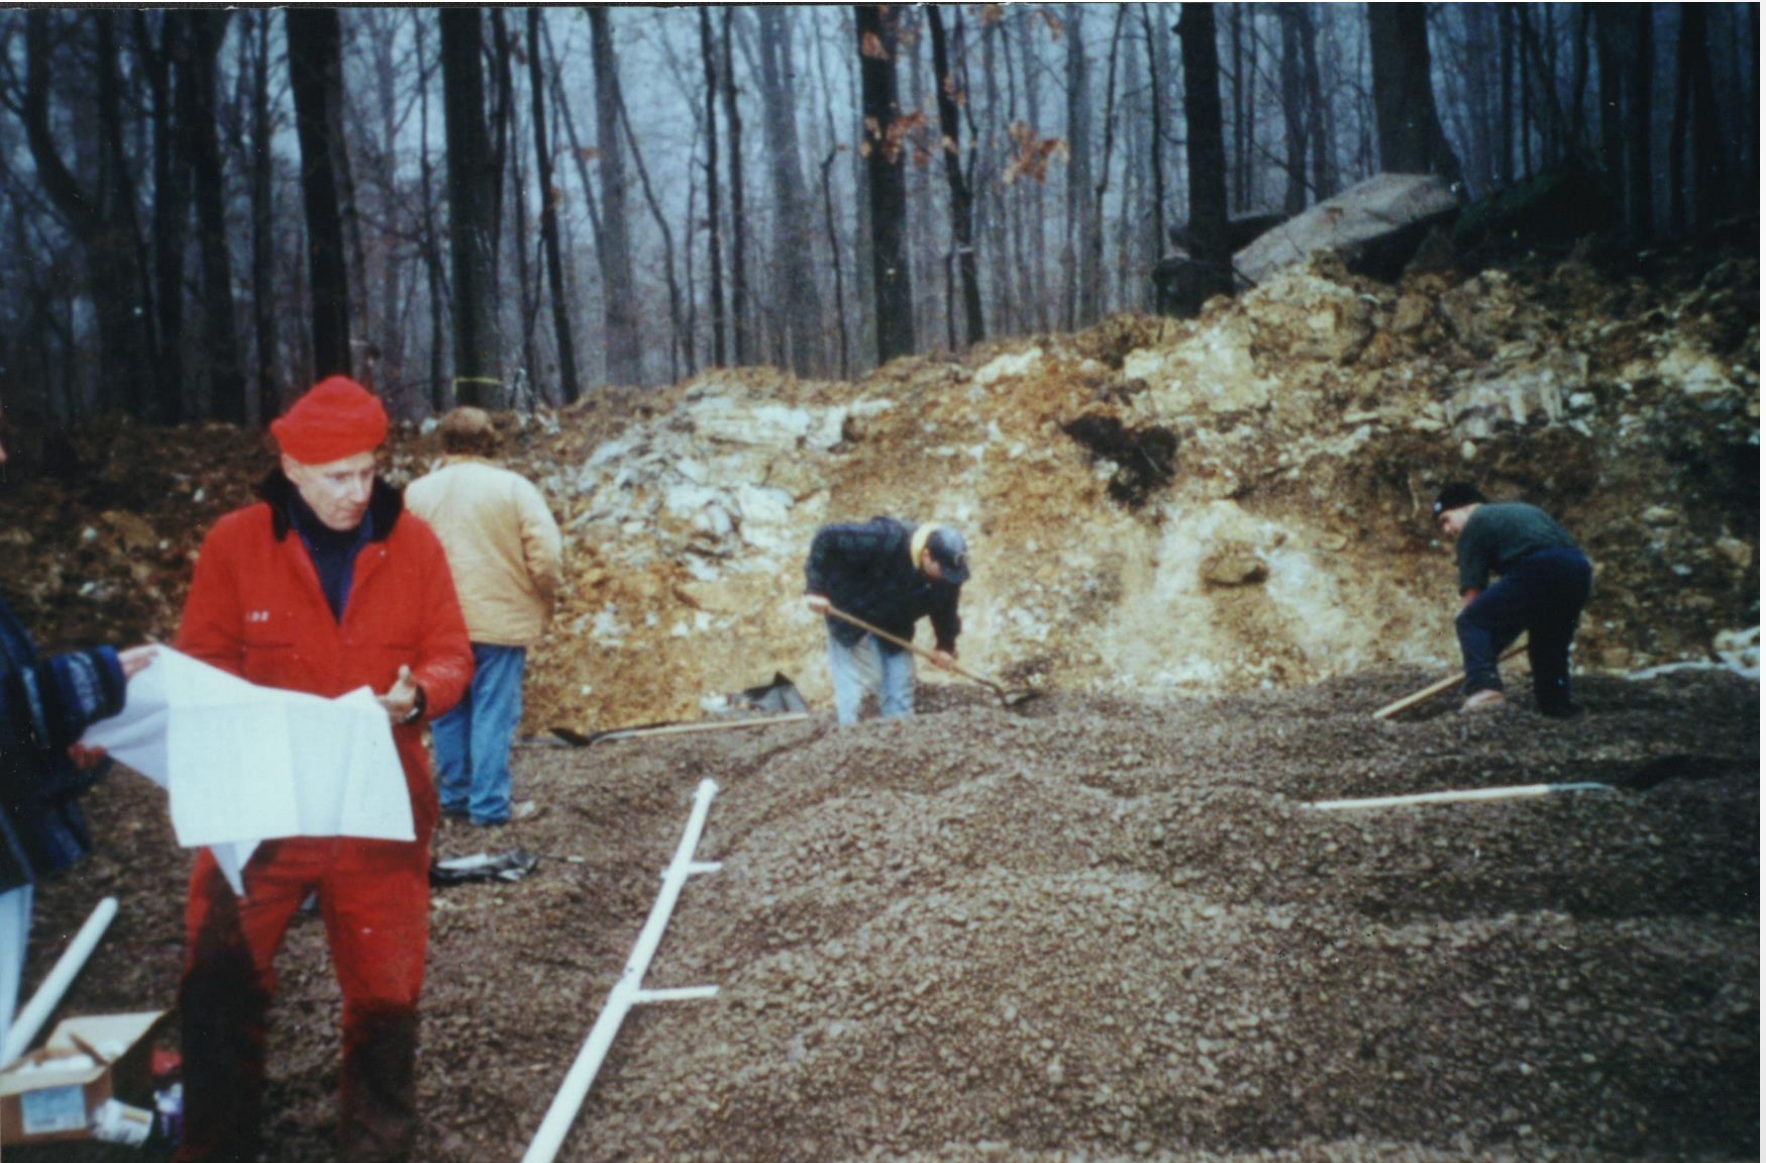
1997 VFP Built – Student Labor

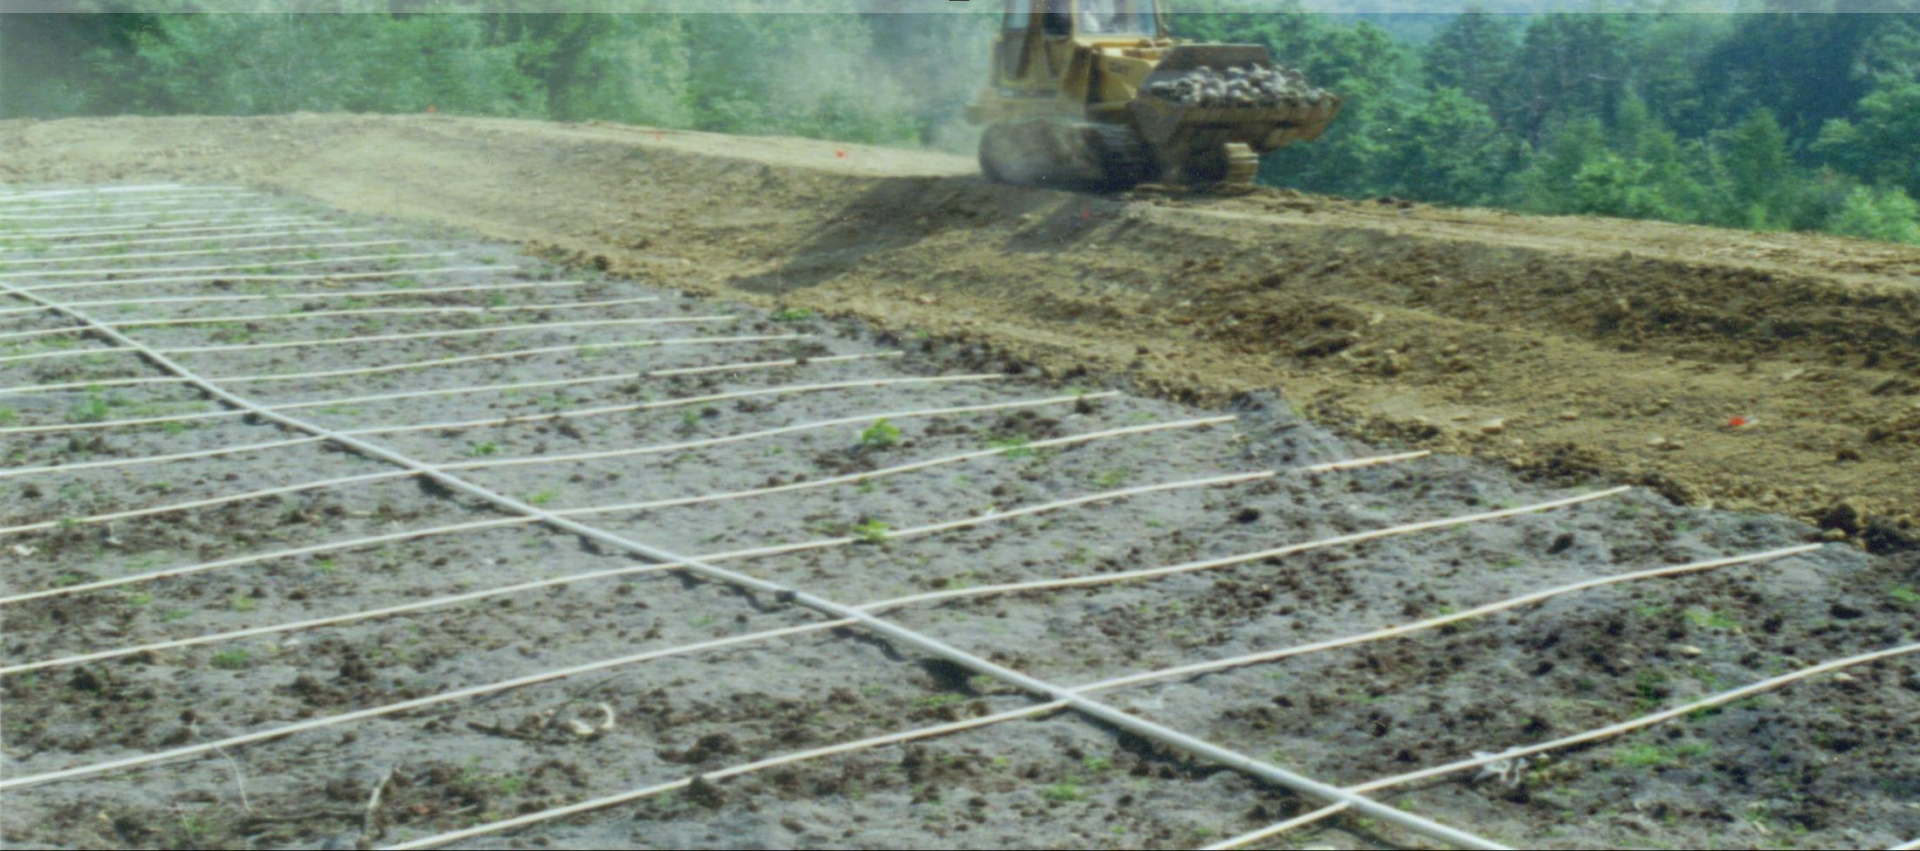
Completed VFP with Overdrain

- 300 Tons (272 Metric Tons) mushroom compost
- 280 Tons (345 Metric Tons) #9 limestone aggregate
- 7-10 year design life of substrate
- 2004 – 2007 would be expected to fail

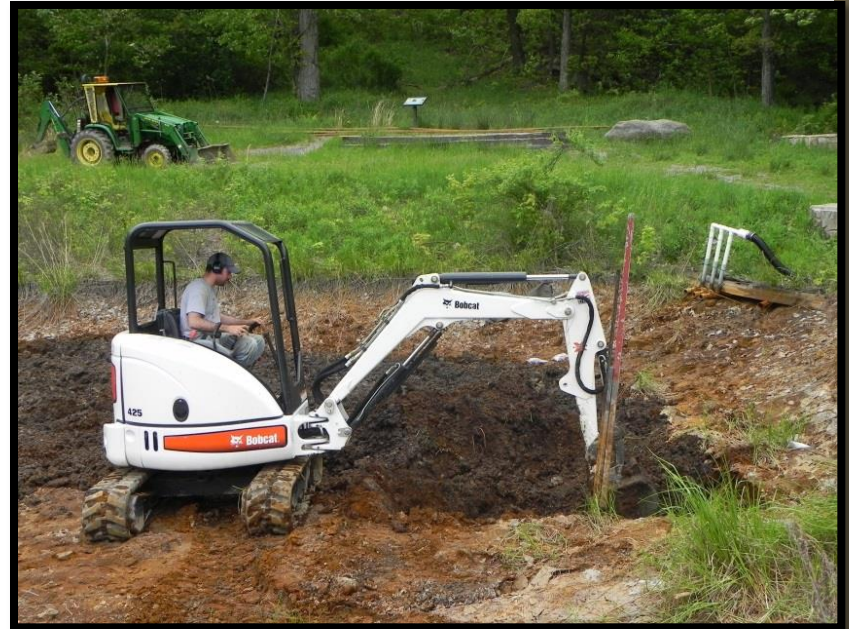
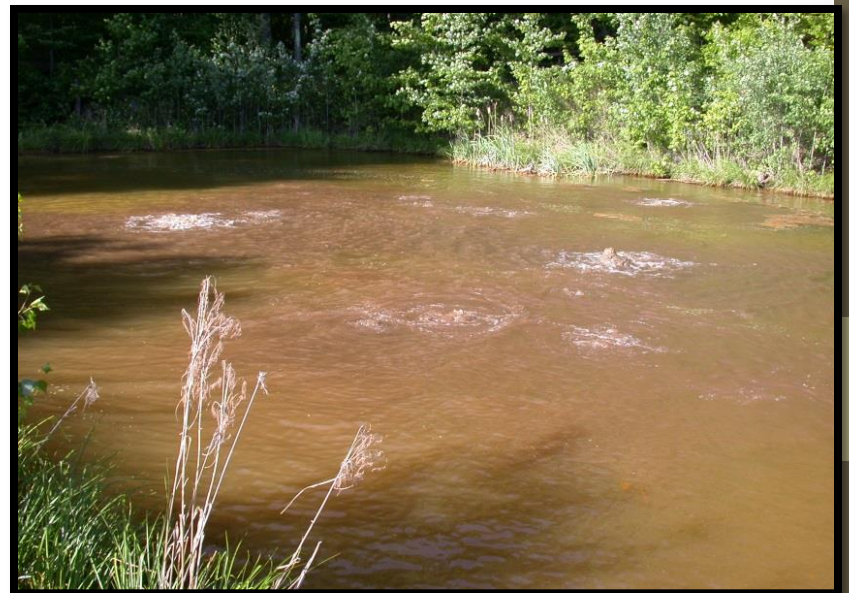
- Occasional maintenance such as stirring the treatment media in 2004 (7 yrs) and 2007 (10yrs) is believed to have extended the life of the media
- In 2011(14 yrs), neither backflushing nor stirring events that were conducted were able to effectively increase sufficient permeability for significant time period.
- Rehabilitation necessary

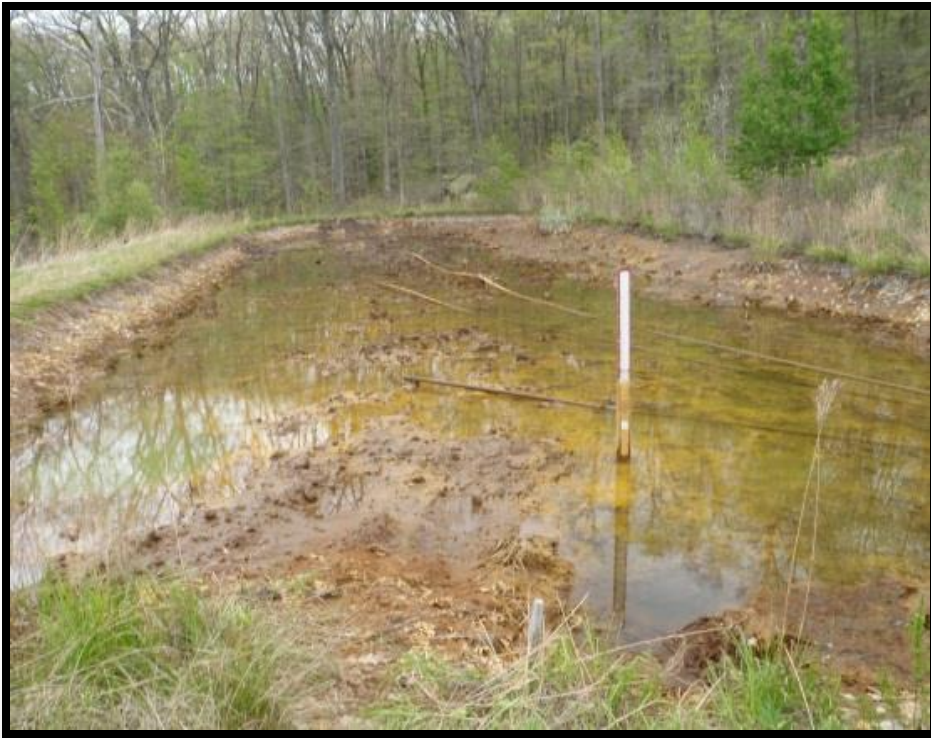
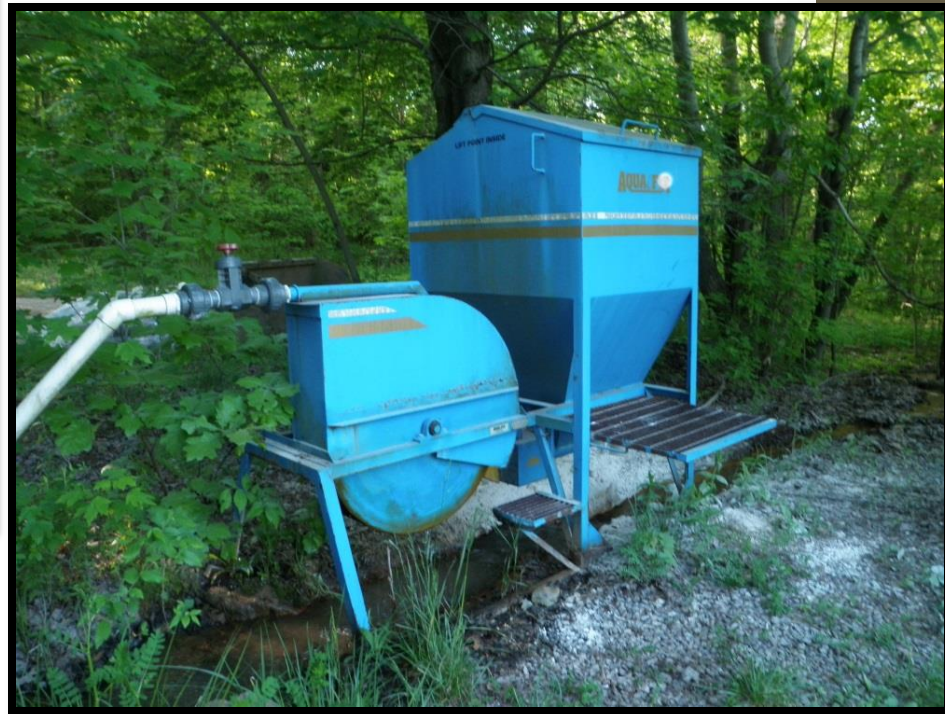
- VFP drained to remove spent media – started April 18, 2012
- AMD diverted temporarily to AquaFix system for treatment

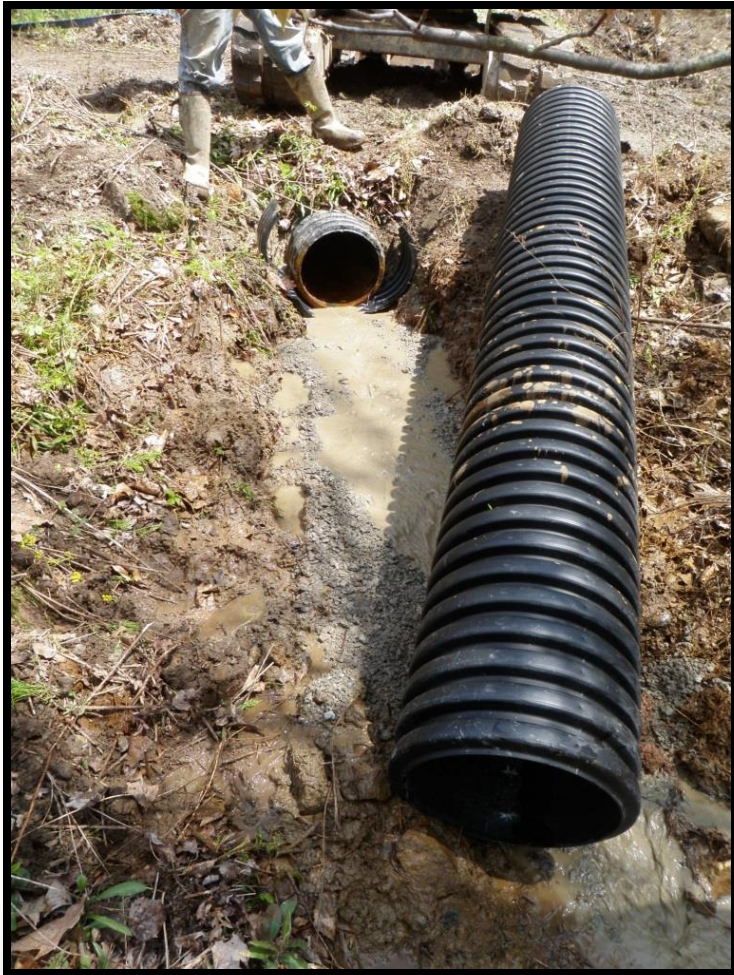
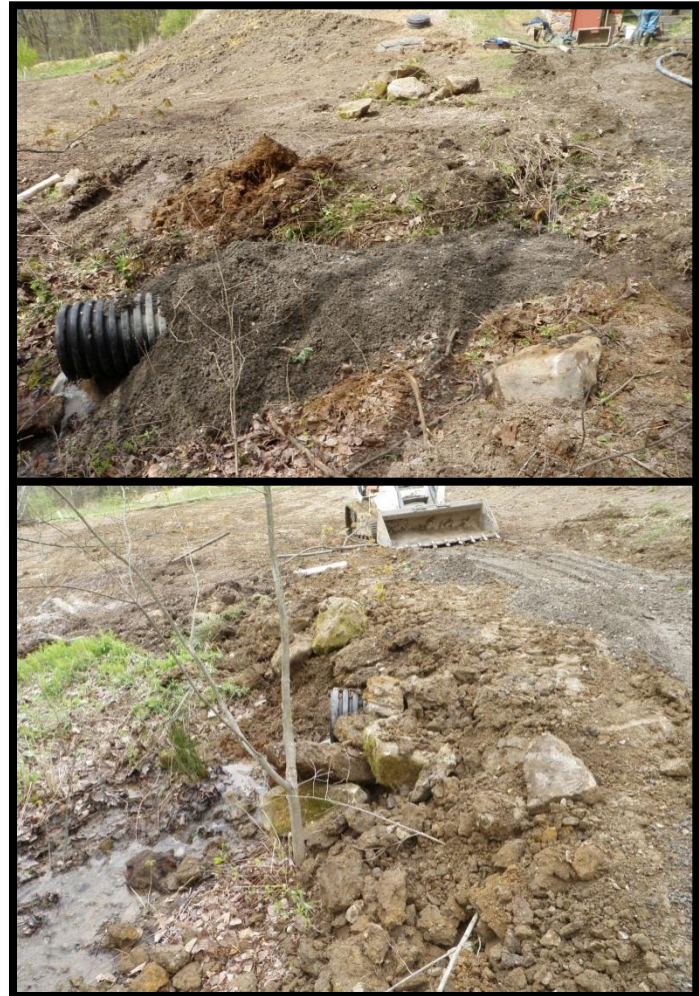
- New culvert pipe installed for better truck access to bring in materials

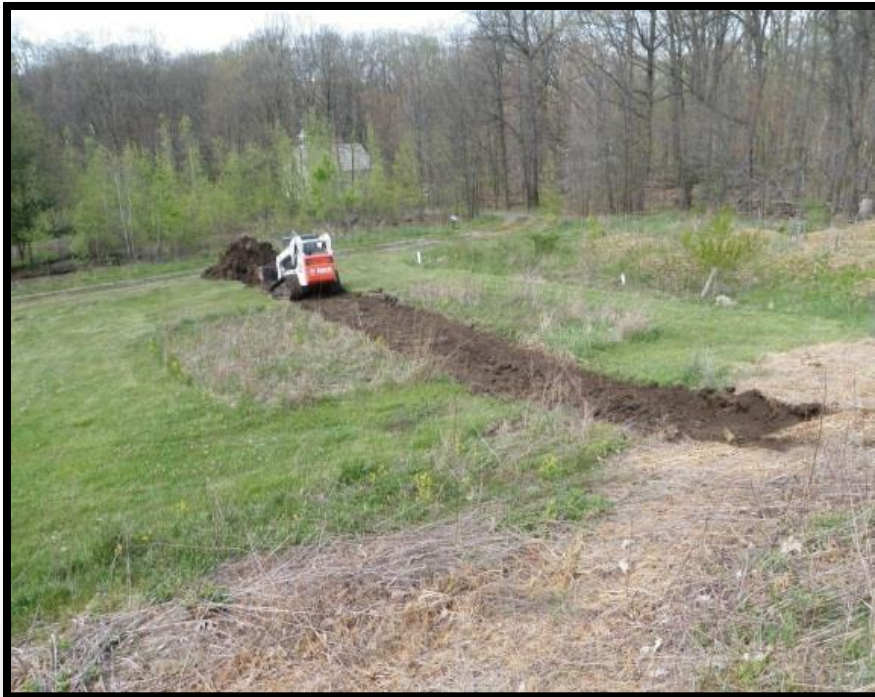
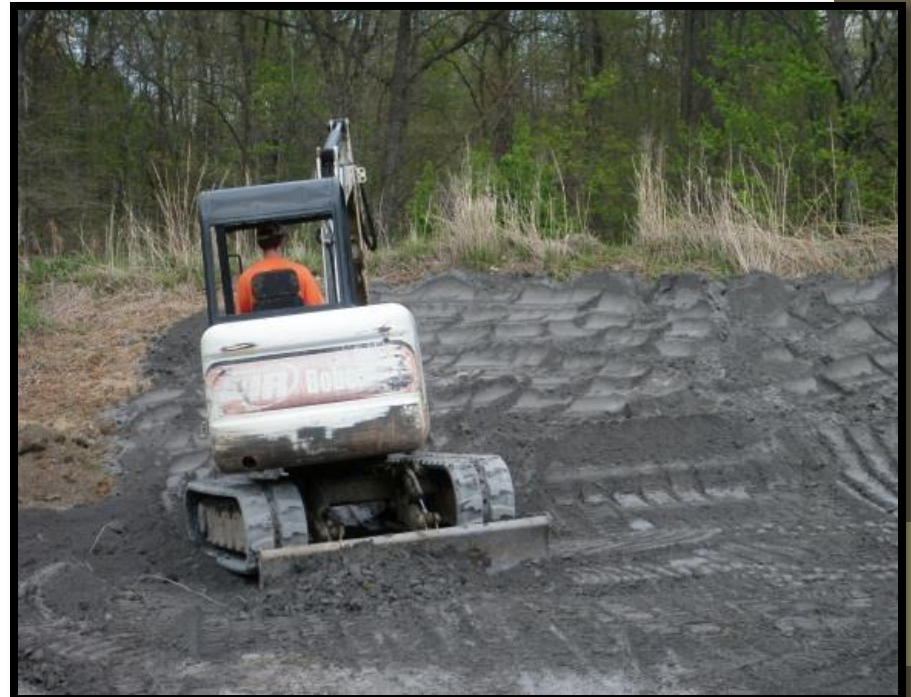
- Topsoil removed & stockpiled to create staging & encapsulation area
- Used Mineral CSA as pad to encapsulate old media/mix new media
- Mineral CSA Donated by Harsco Minerals

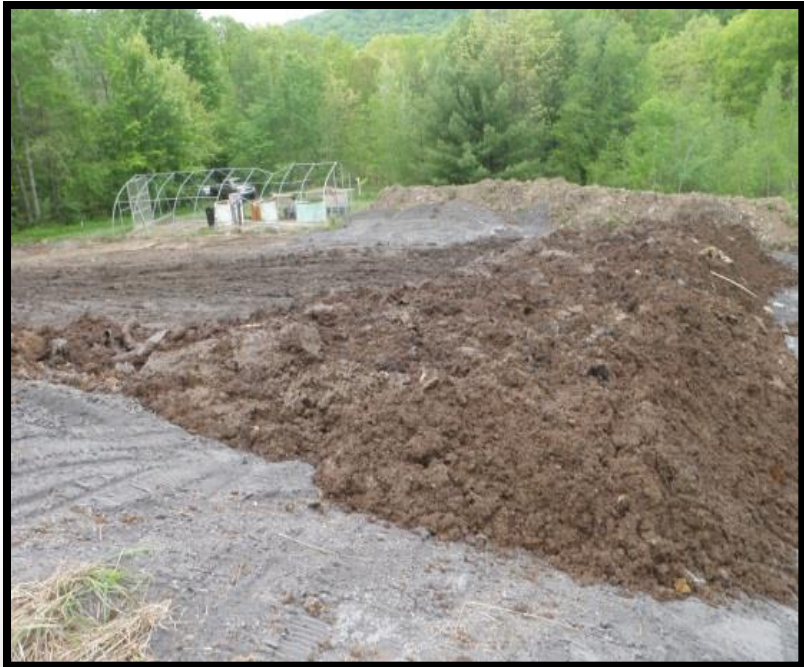
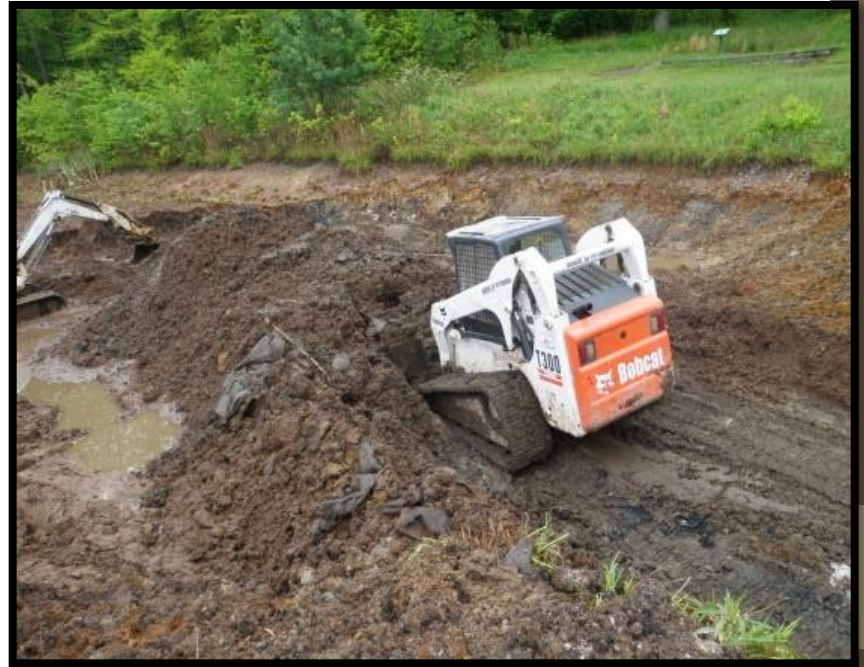
- Spent media and clogged underdrain bedding stone was removed from VFP and placed on CSA pad – began May 9, 2012
- Removed clogged underdrain piping
- Spent media encapsulated within mineral CSA to prevent exposure to oxygen and to maintain an alkaline condition.
