Jennings Passive Treatment System Rehabilitation

Jennings Rehab

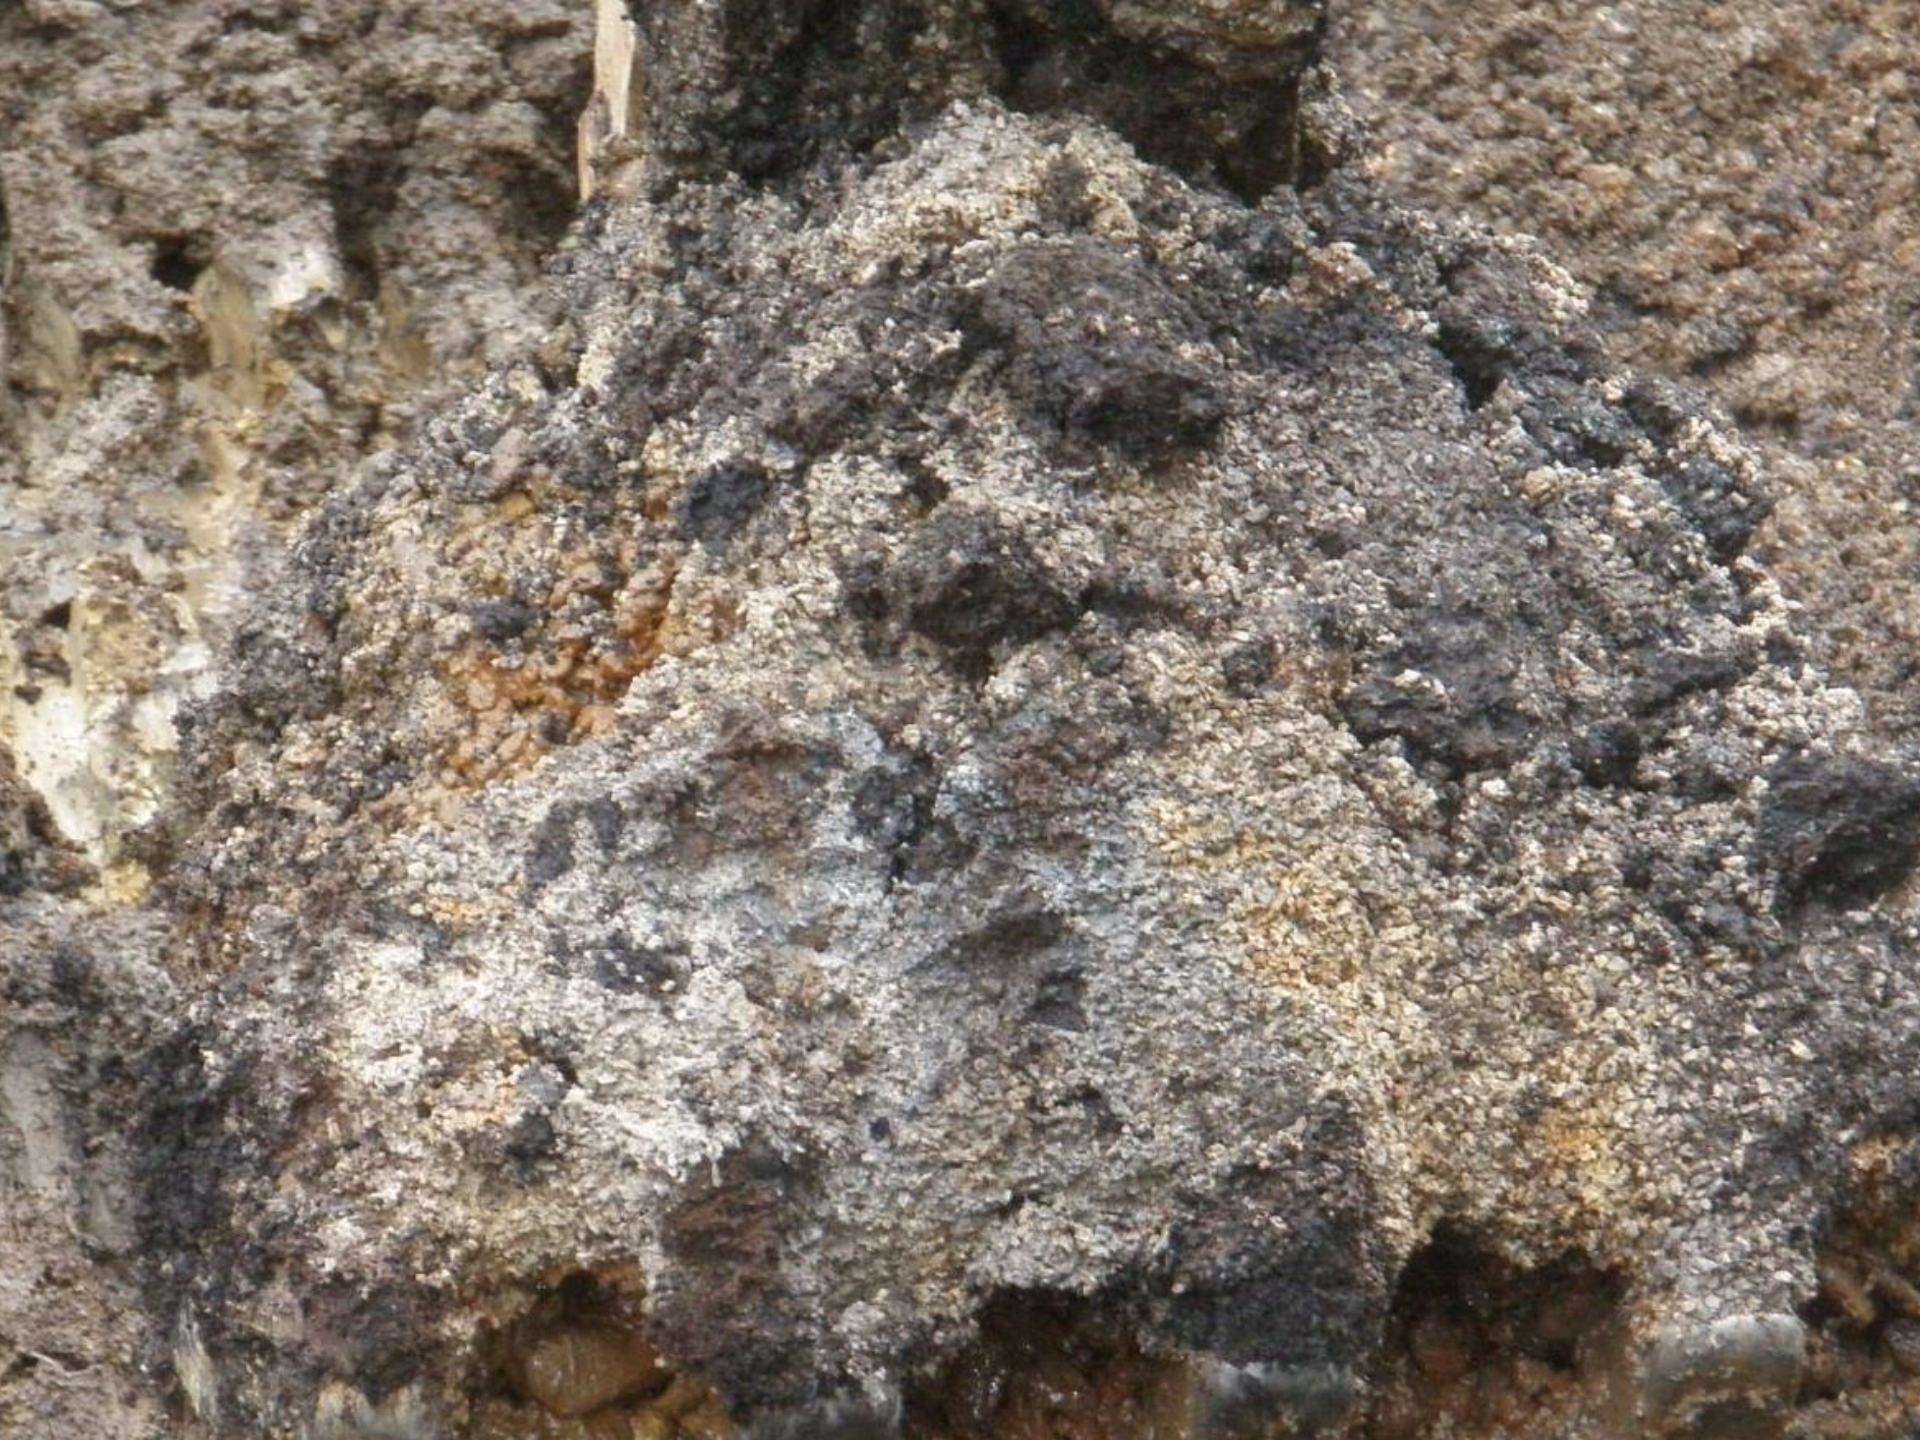
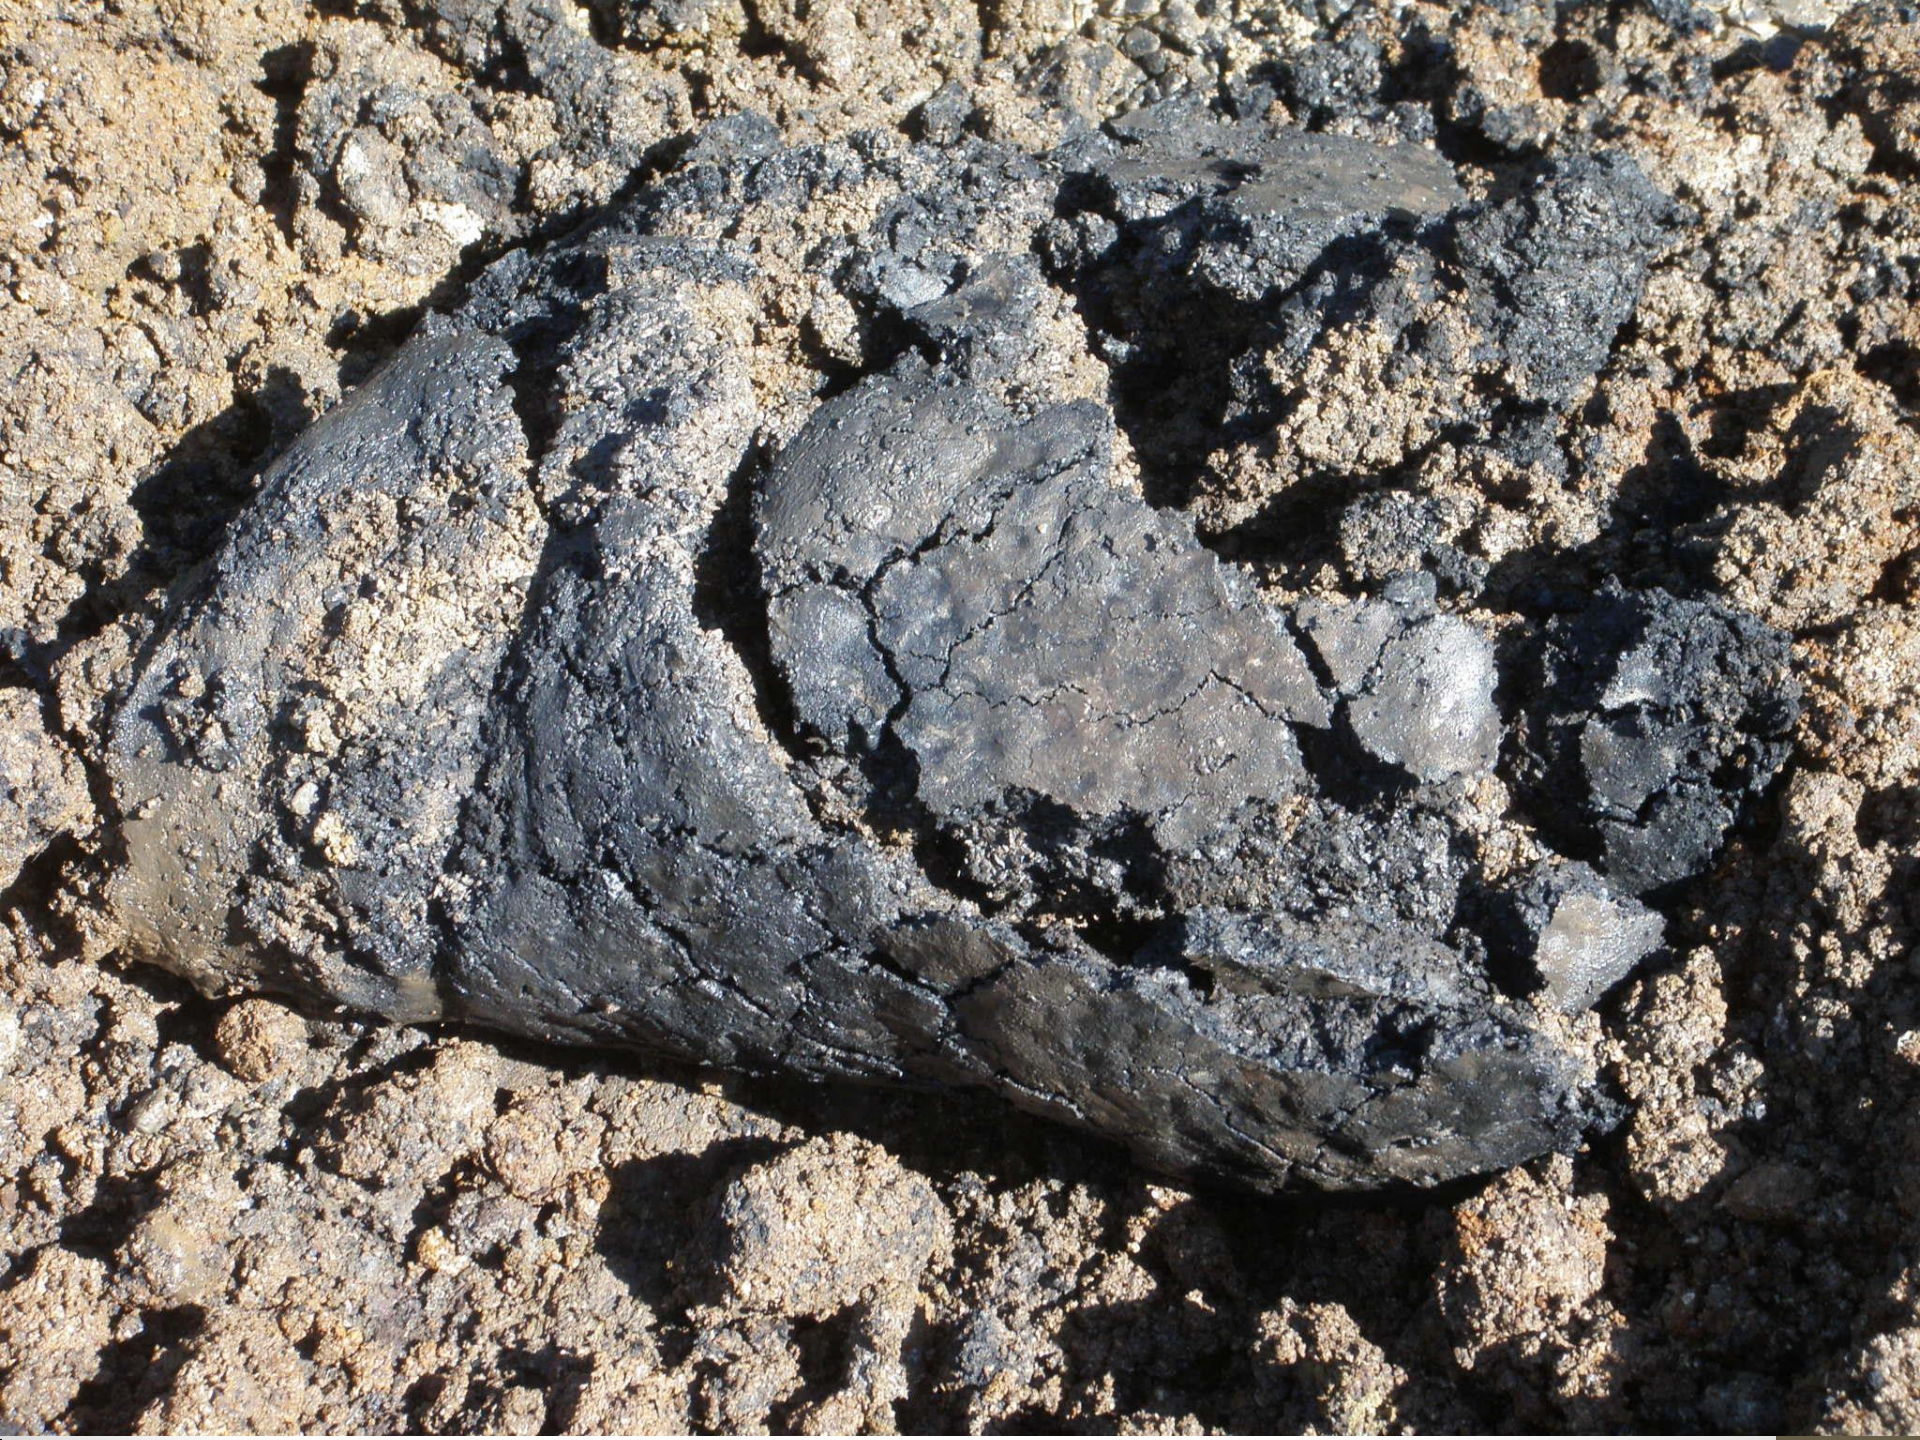
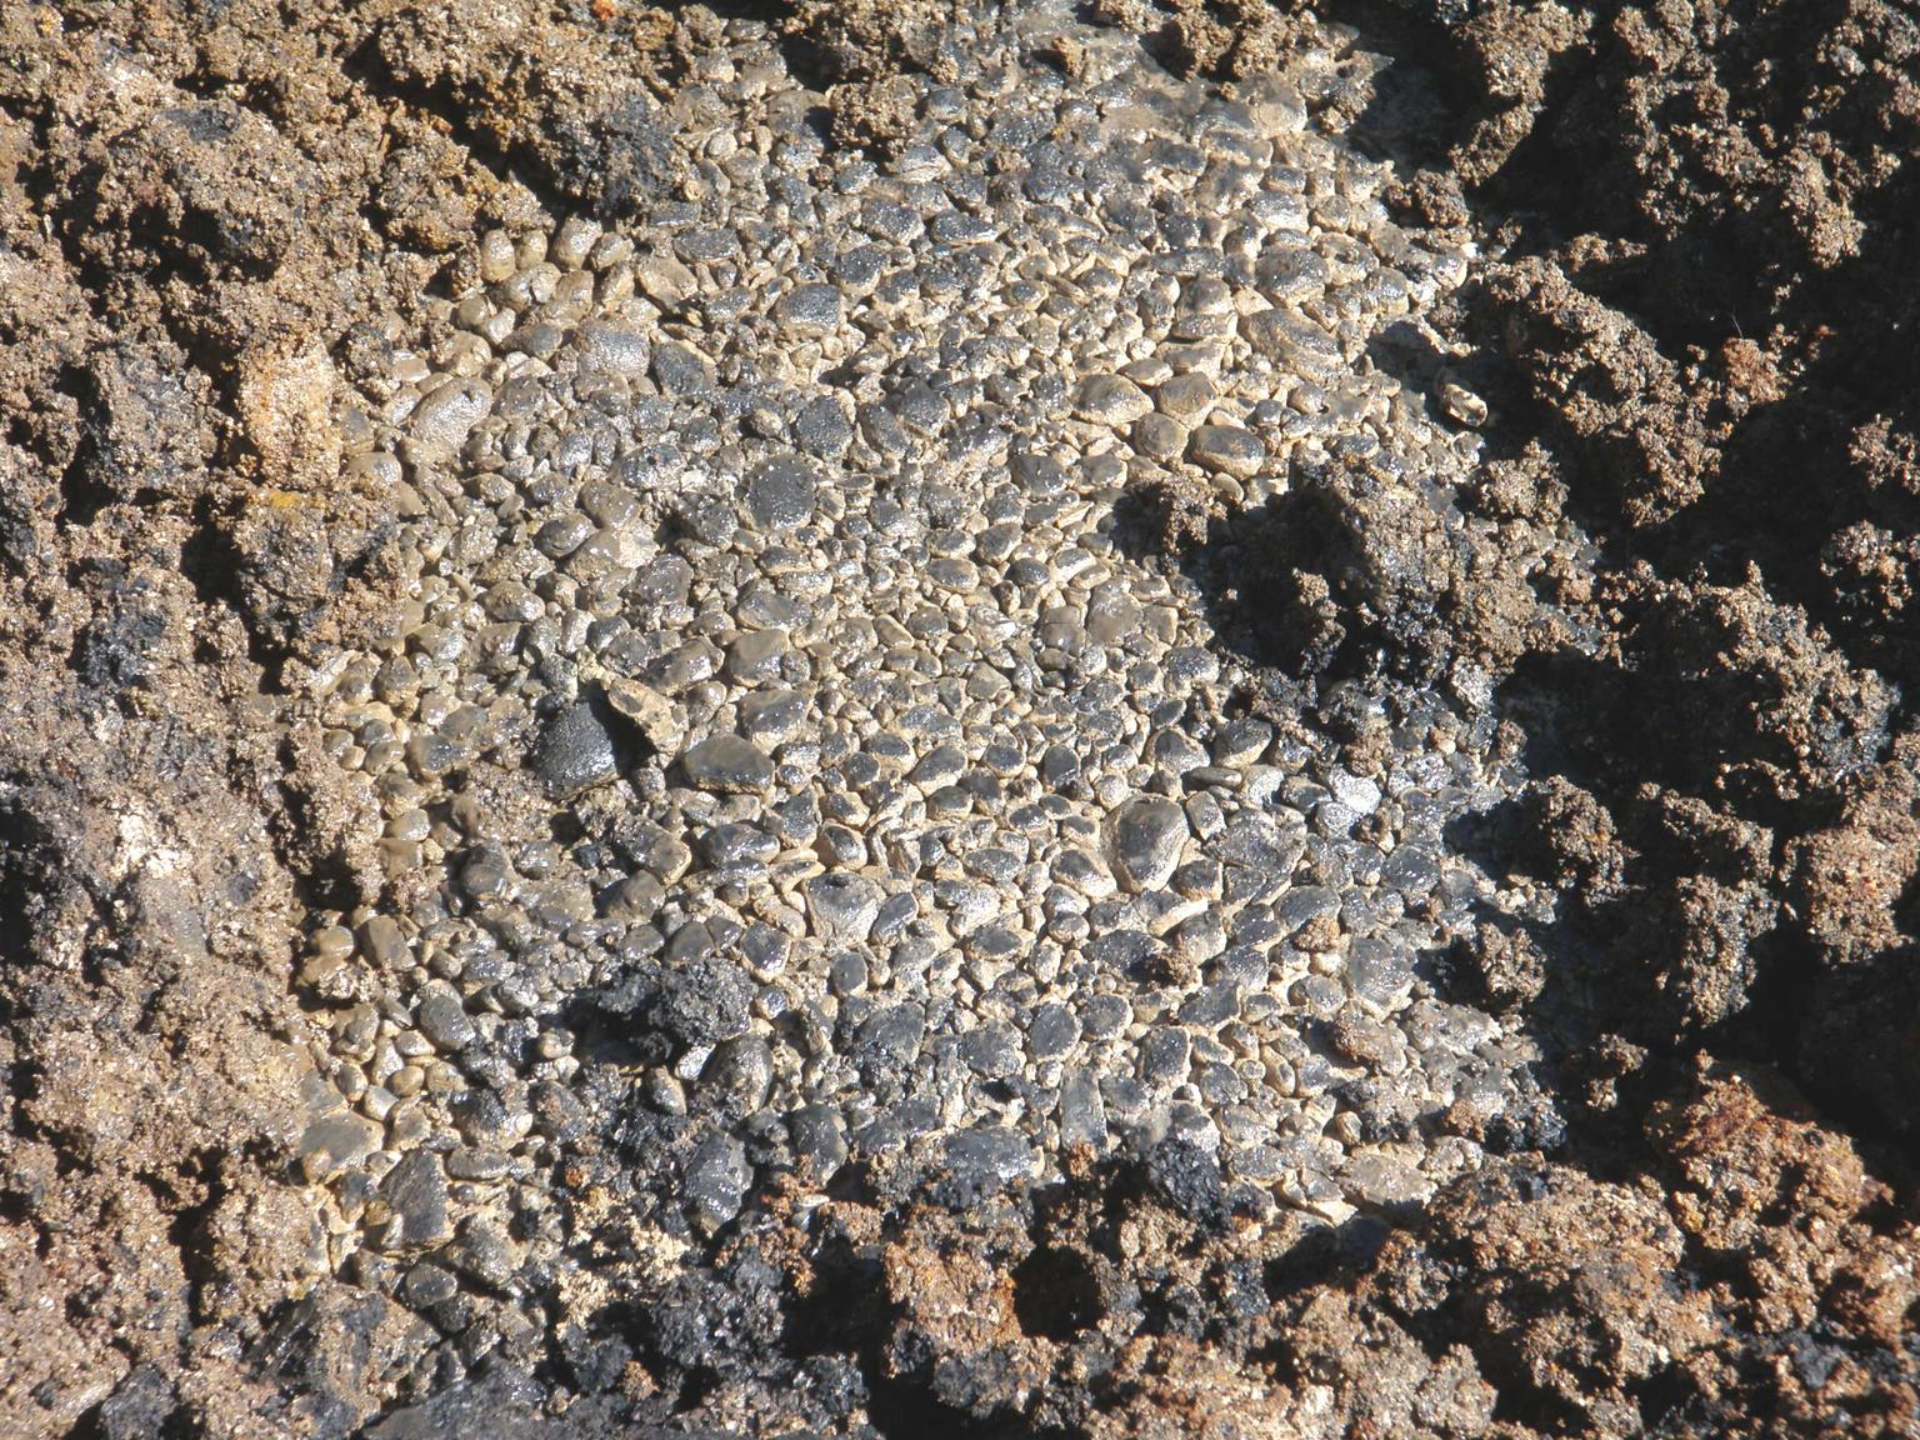
- Spent media and clogged underdrain bedding stone was removed from VFP and placed on CSA pad – began May 9, 2012
- Removed clogged underdrain piping
- Spent media encapsulated within mineral CSA to prevent exposure to oxygen and to maintain an alkaline condition.

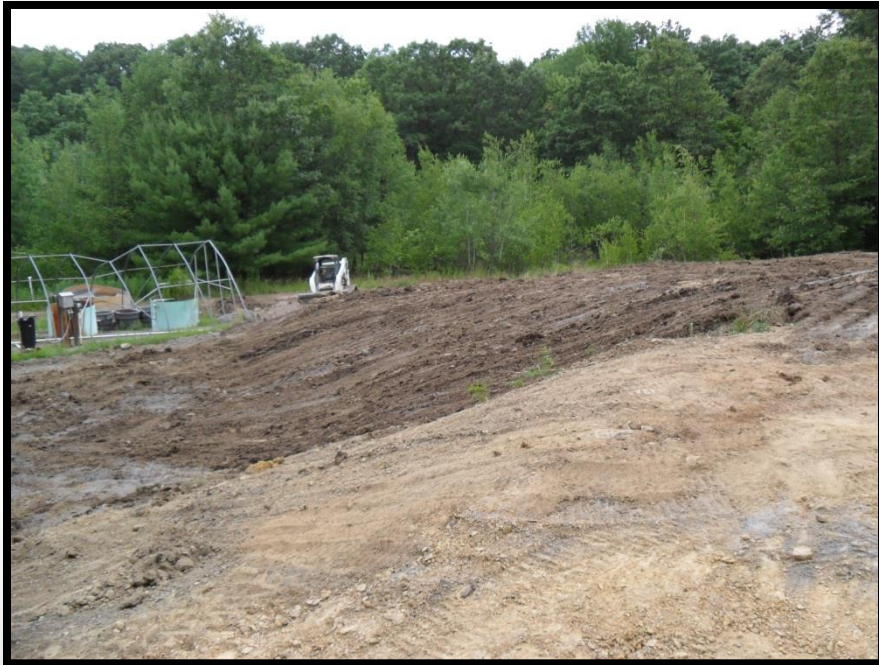
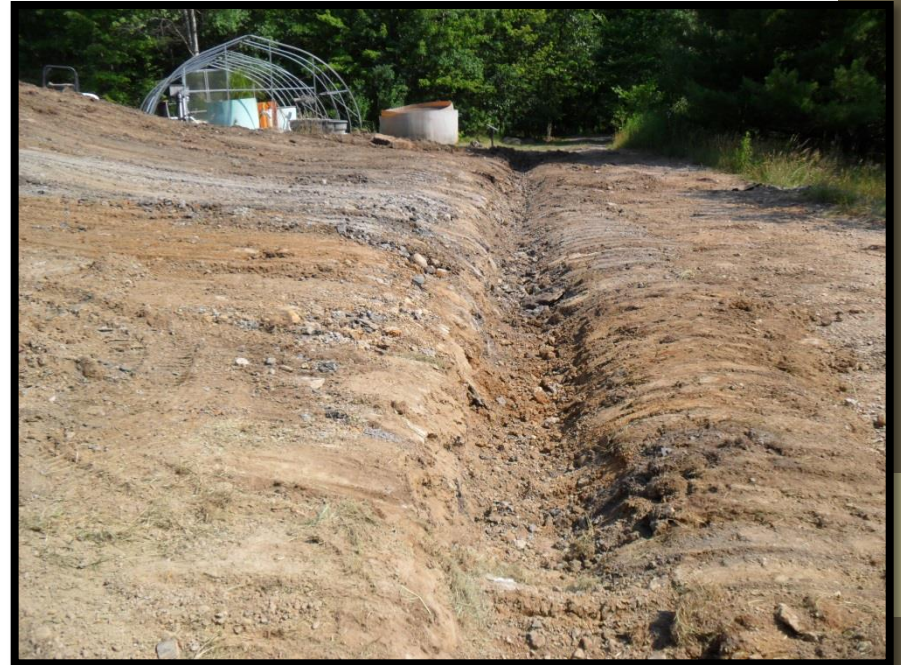
- Topsoil placed on top of encapsulated spent media
- Seeded with warm season grasses
- Drainage ditch along toe of spent media to collect water and direct into the passive system

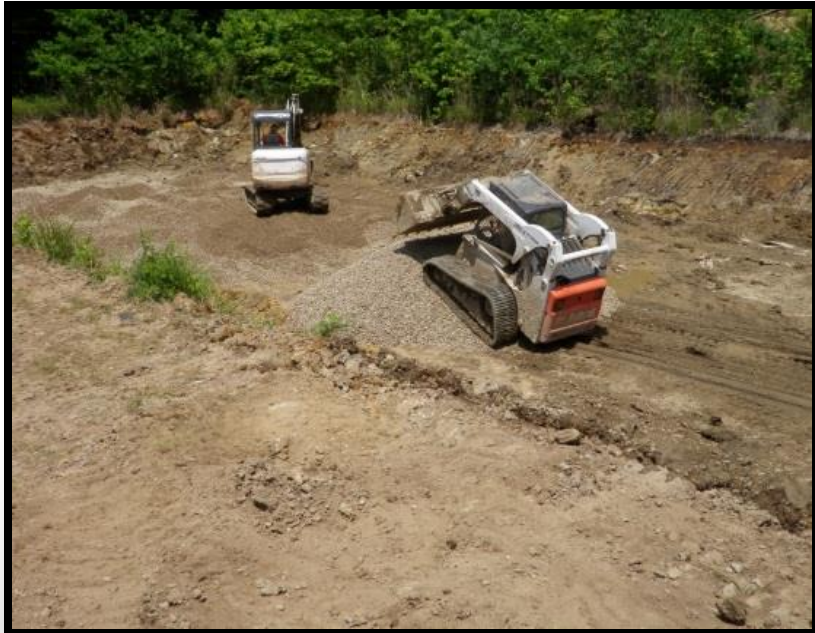
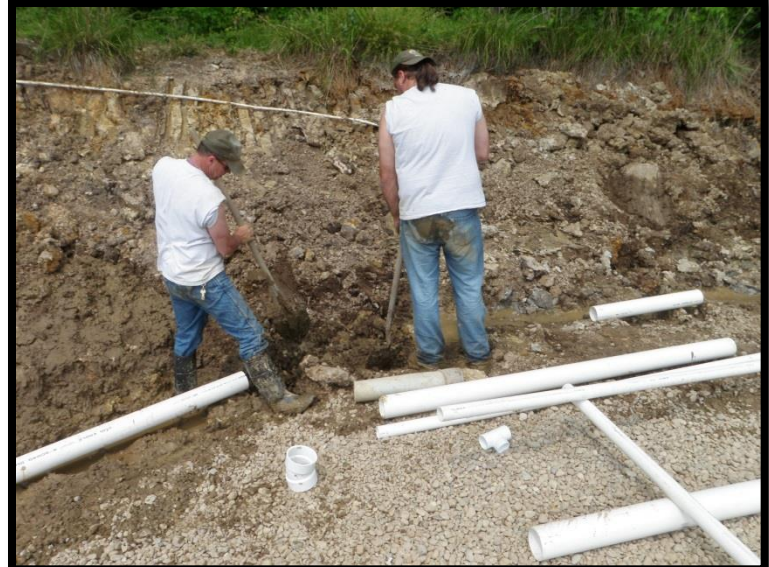
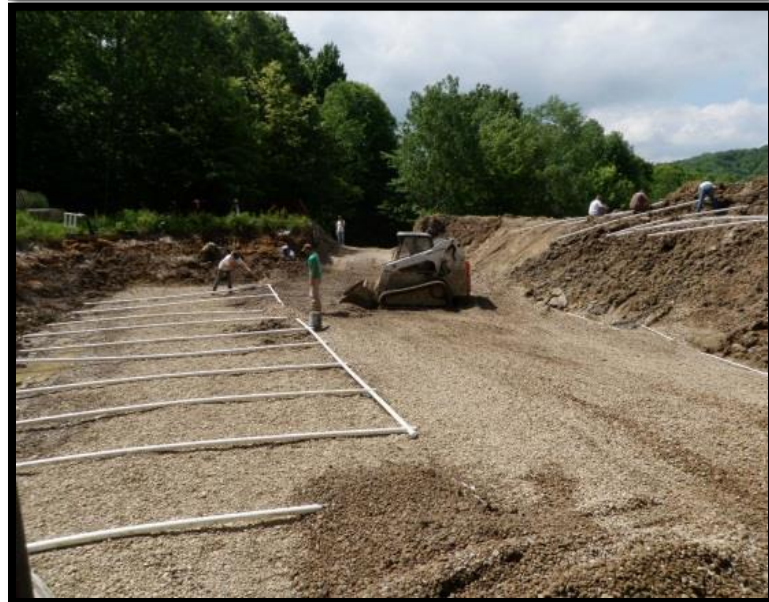
- Non-reactive river gravel for underdrain bedding
- 2" underdrain piping installed
- New flush valve installed

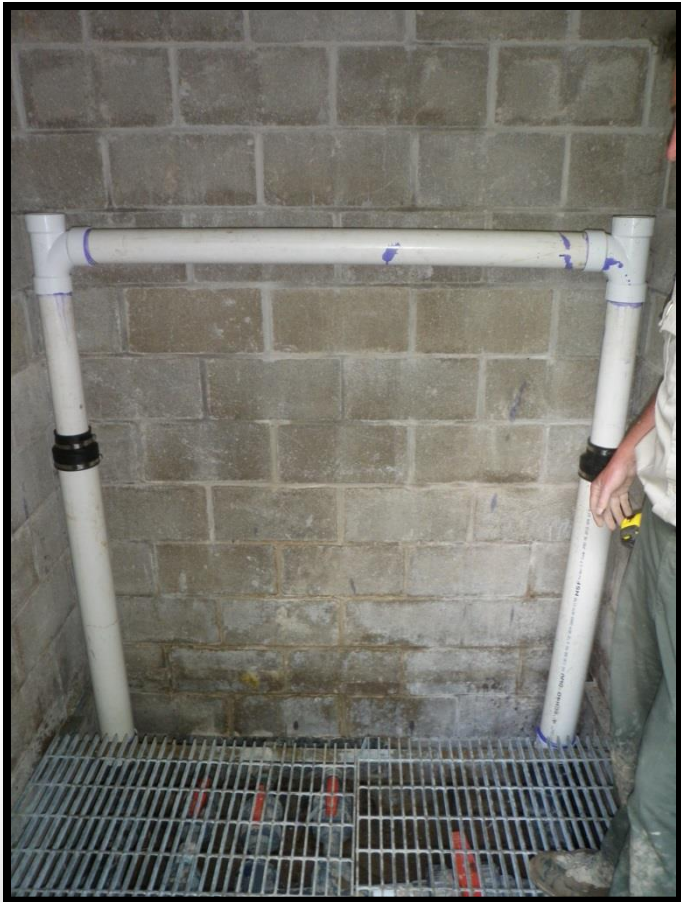
- Updated VFP water elevation control structure installed

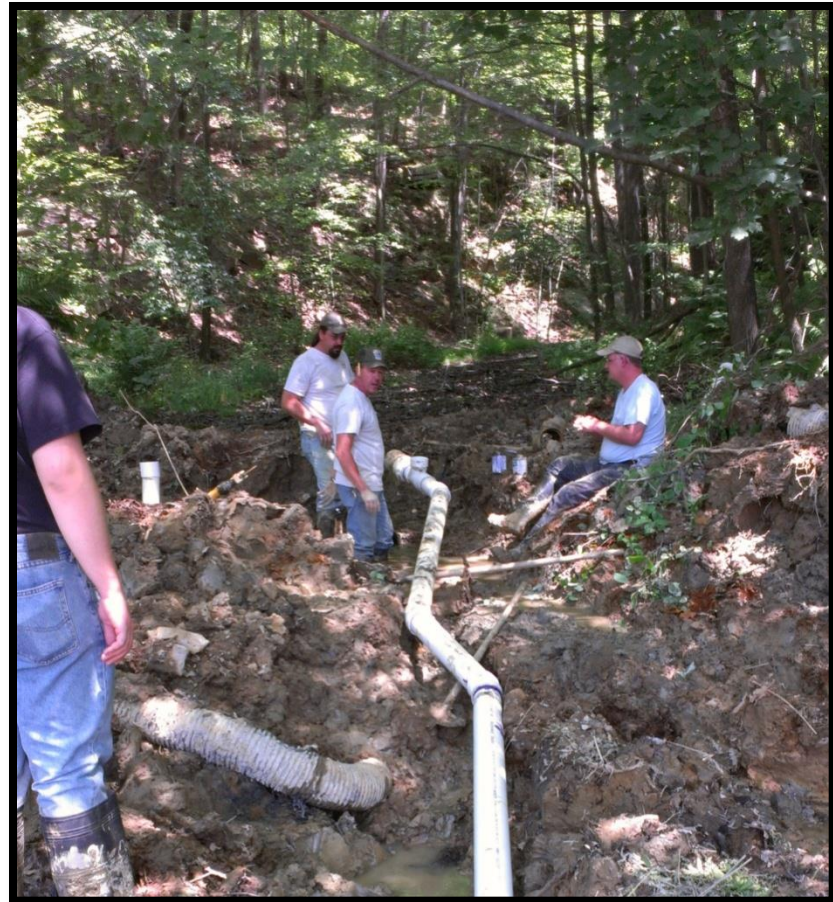
New valves & raw water conveyance/ distribution system

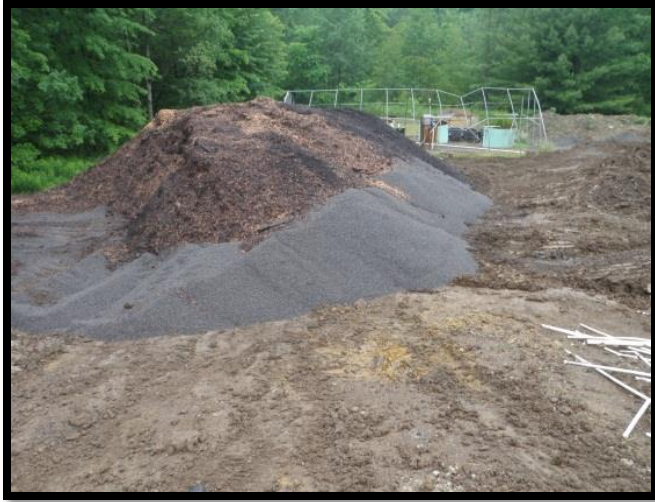
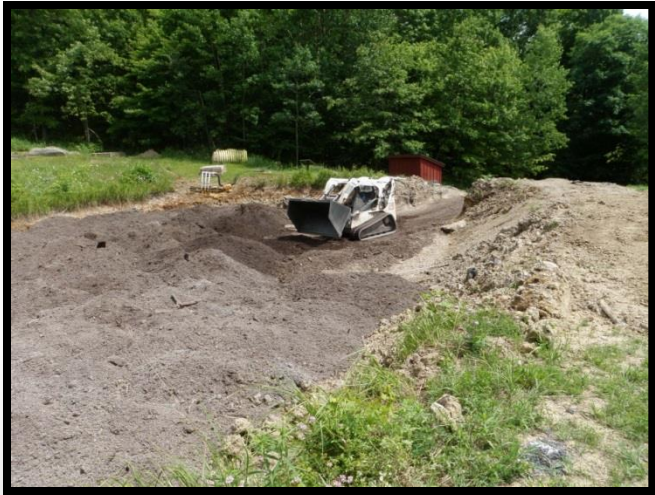
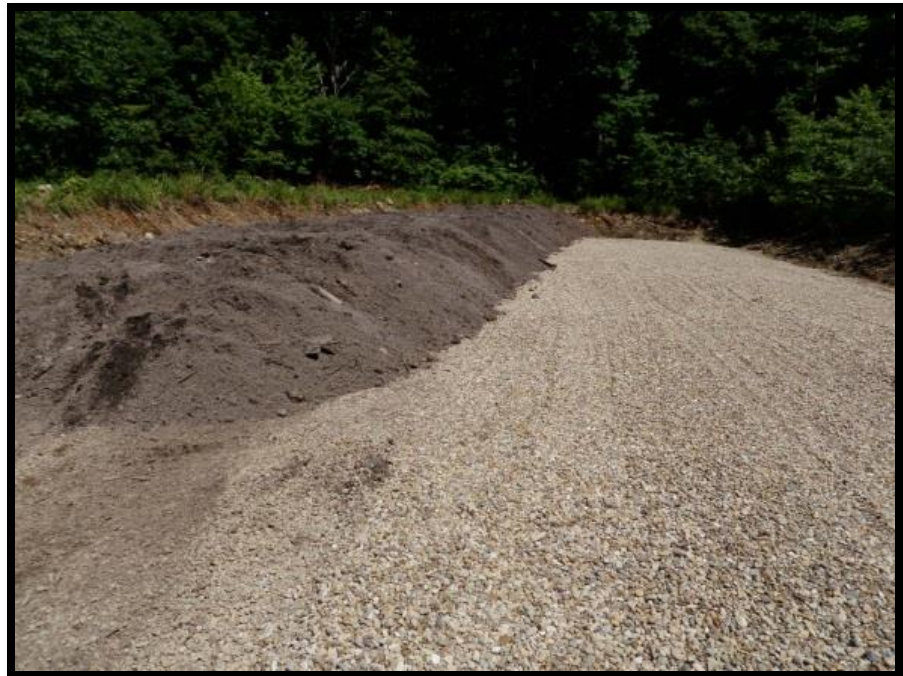
- New treatment media mixed by excavator and placed with loader
- 281 yds³ single shredded wood chips
- 281 yds³ spent mushroom compost
- 388 tons high CaCO₃ Vanport #8 limestone

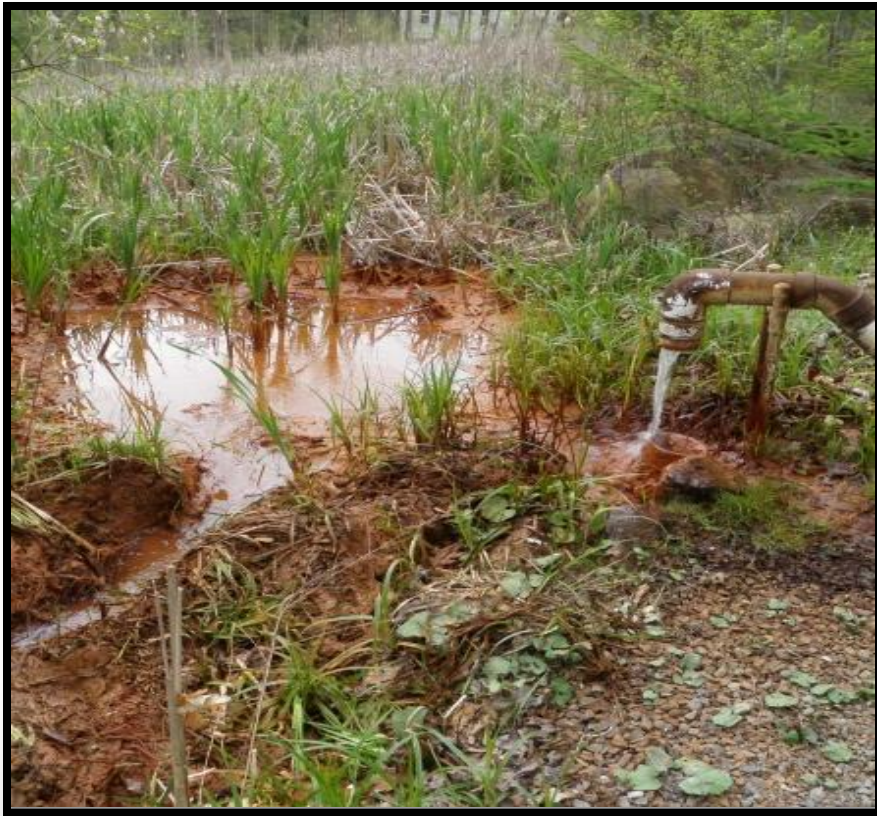
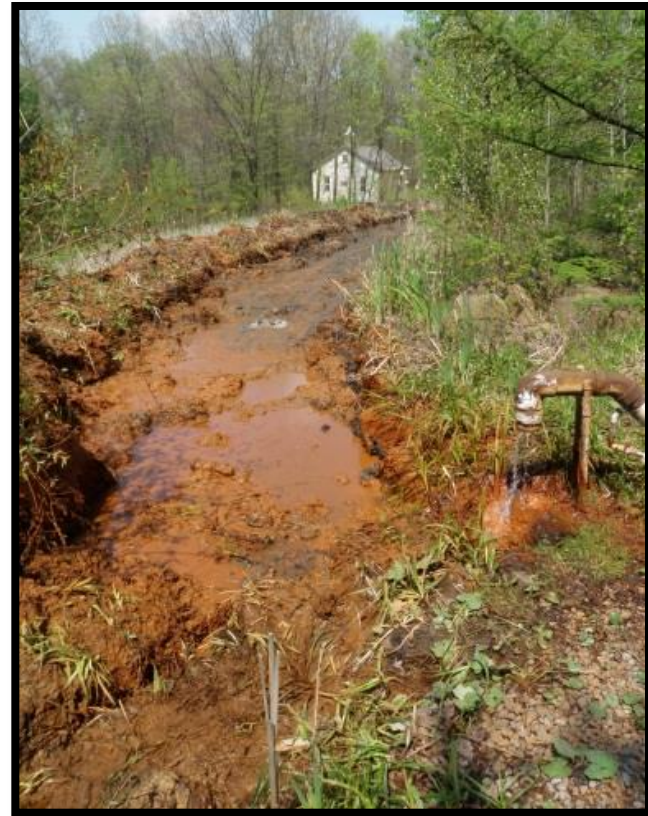
- Iron, vegetation, & debris removed from Bioswale to address overtopping of the berm & short-circuiting into lower wetland
- Inlet pool created

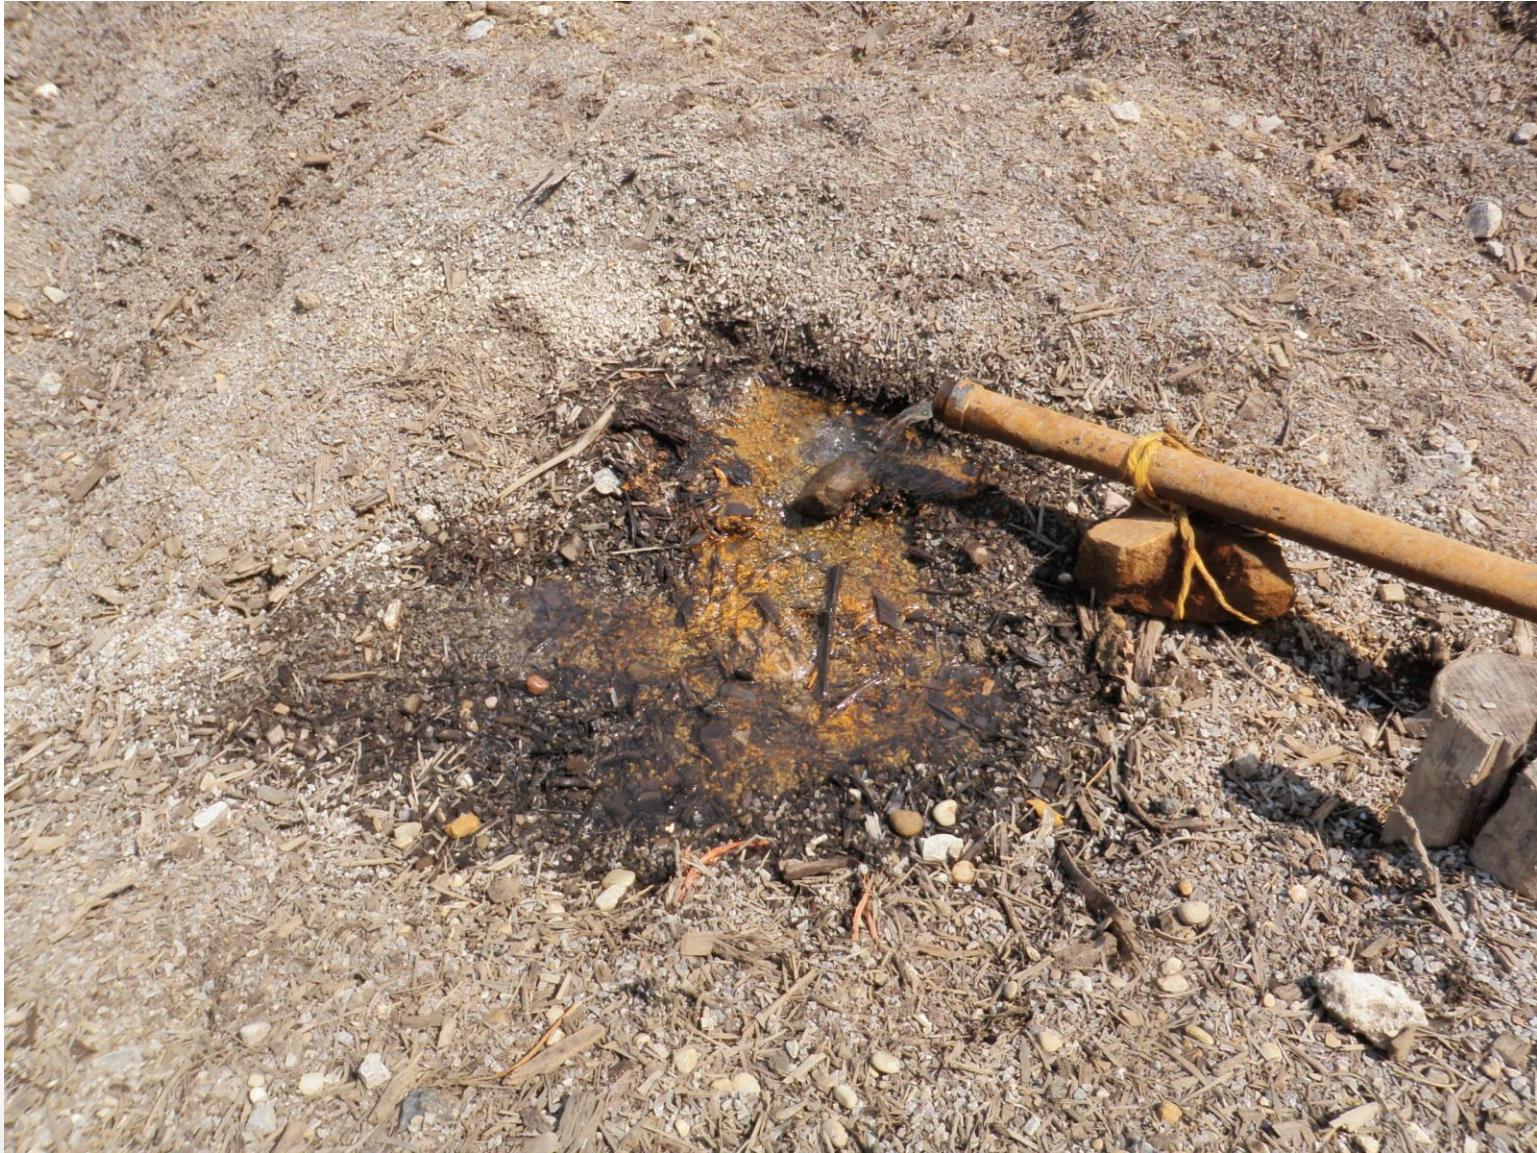
Water turned in back in July 5th
~ 3 months from start
