Long-term Effectiveness of Three Passive Systems Treating Acidic, High-metal, Abandoned Coal Mine Discharges near De Sale, Pennsylvania

De Sale Restoration Area

De Sale Phase 1

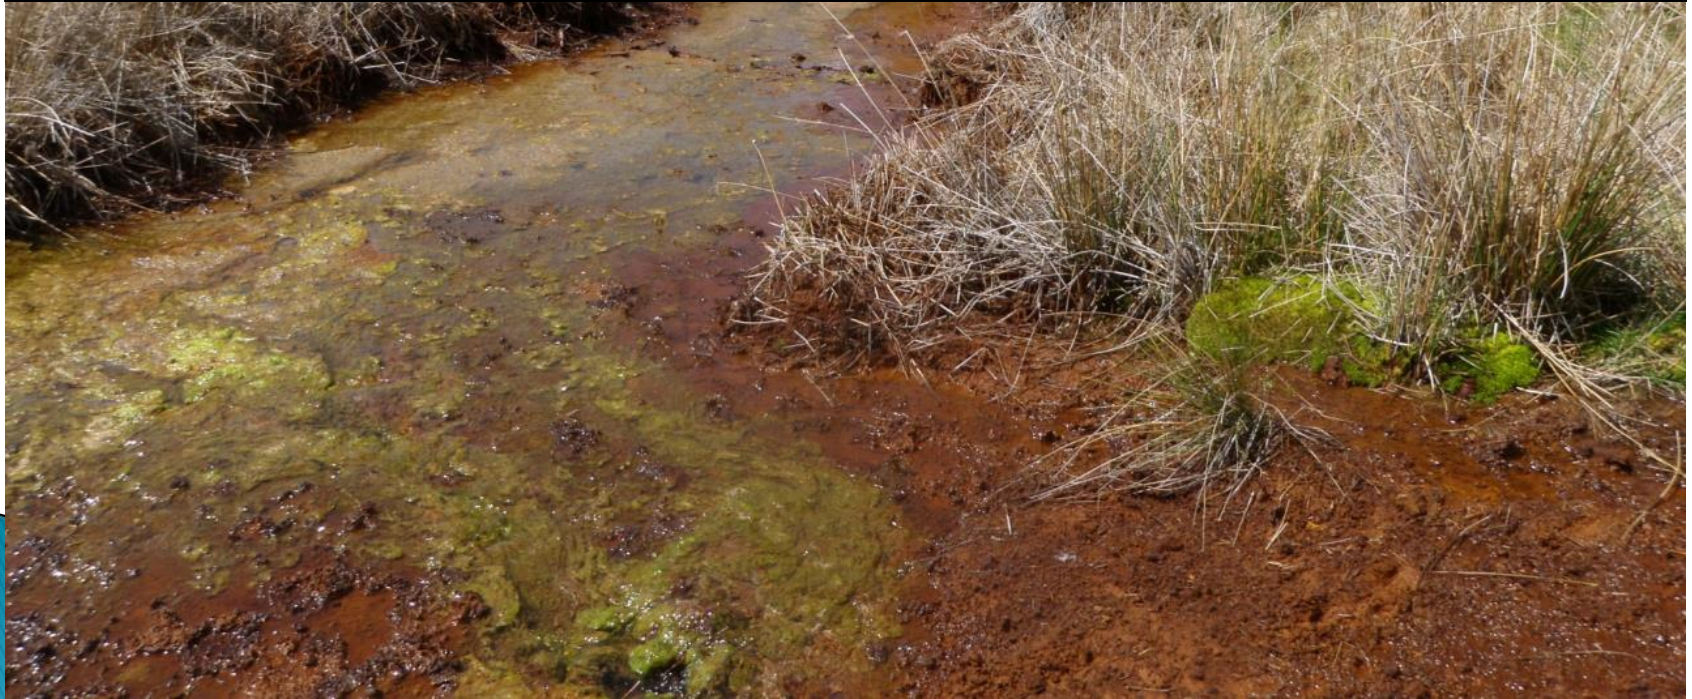
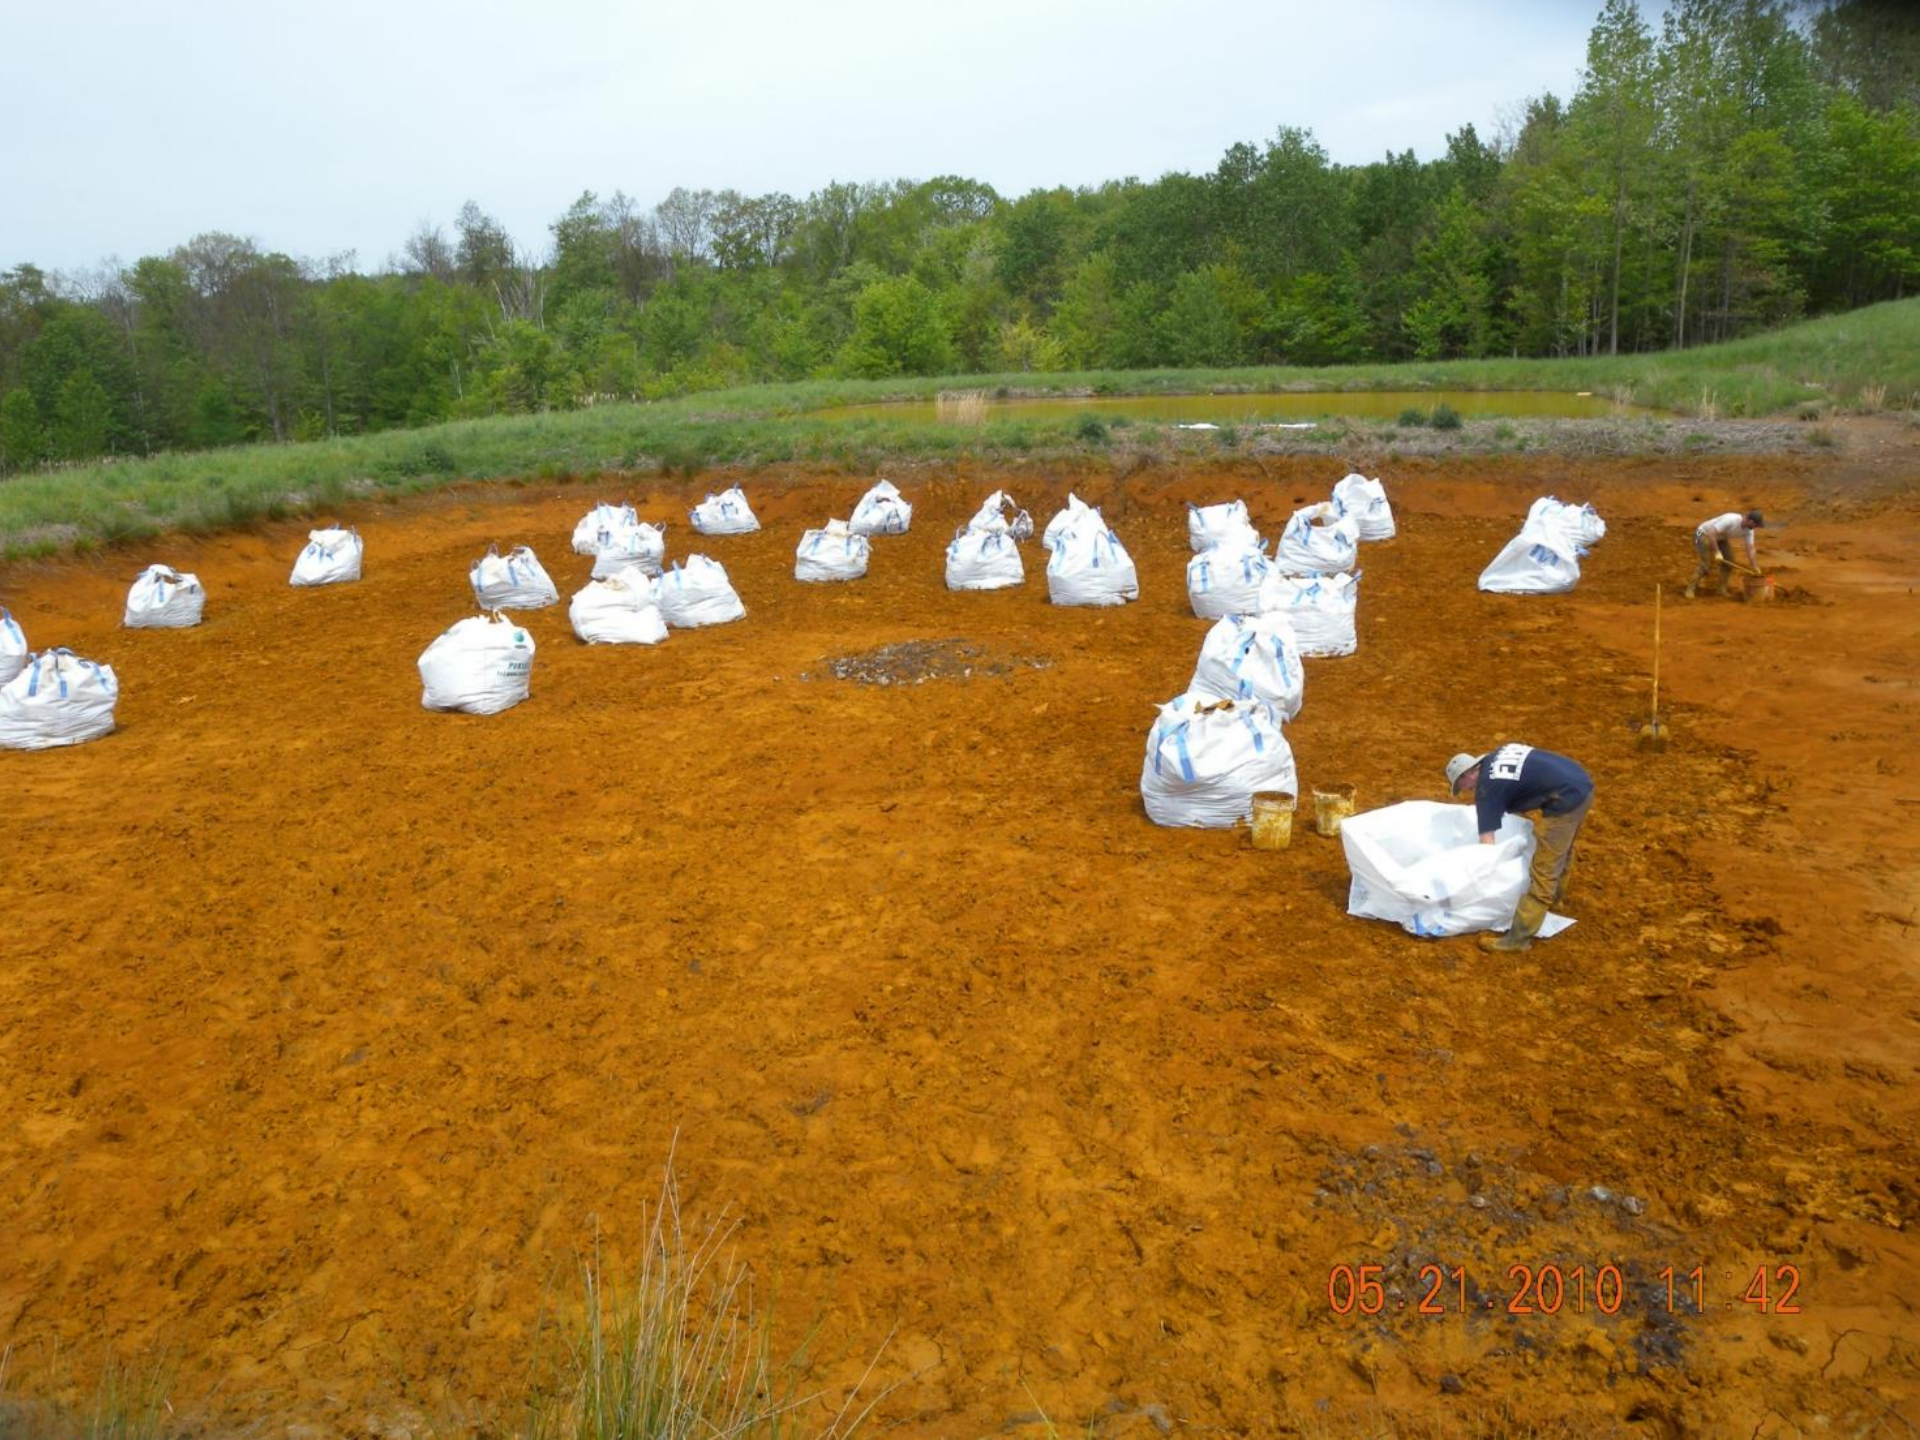
De Sale 1 O&M & Upgrades

Upgrades

- Installed Forebay
- Replaced VFP Outlet Pipes to adjustable peri-pipes
- Inlet & Outlet pools in HFLB

O&M

- ▶ Flushing/Backflushing
 - ▶ Cleaning out low pH iron from pipes
 - ▶ Removed low pH iron from top of VFPs
 - ▶ Stirred top layer of VFP treatment media
 - ▶ Stirred HFLB
-

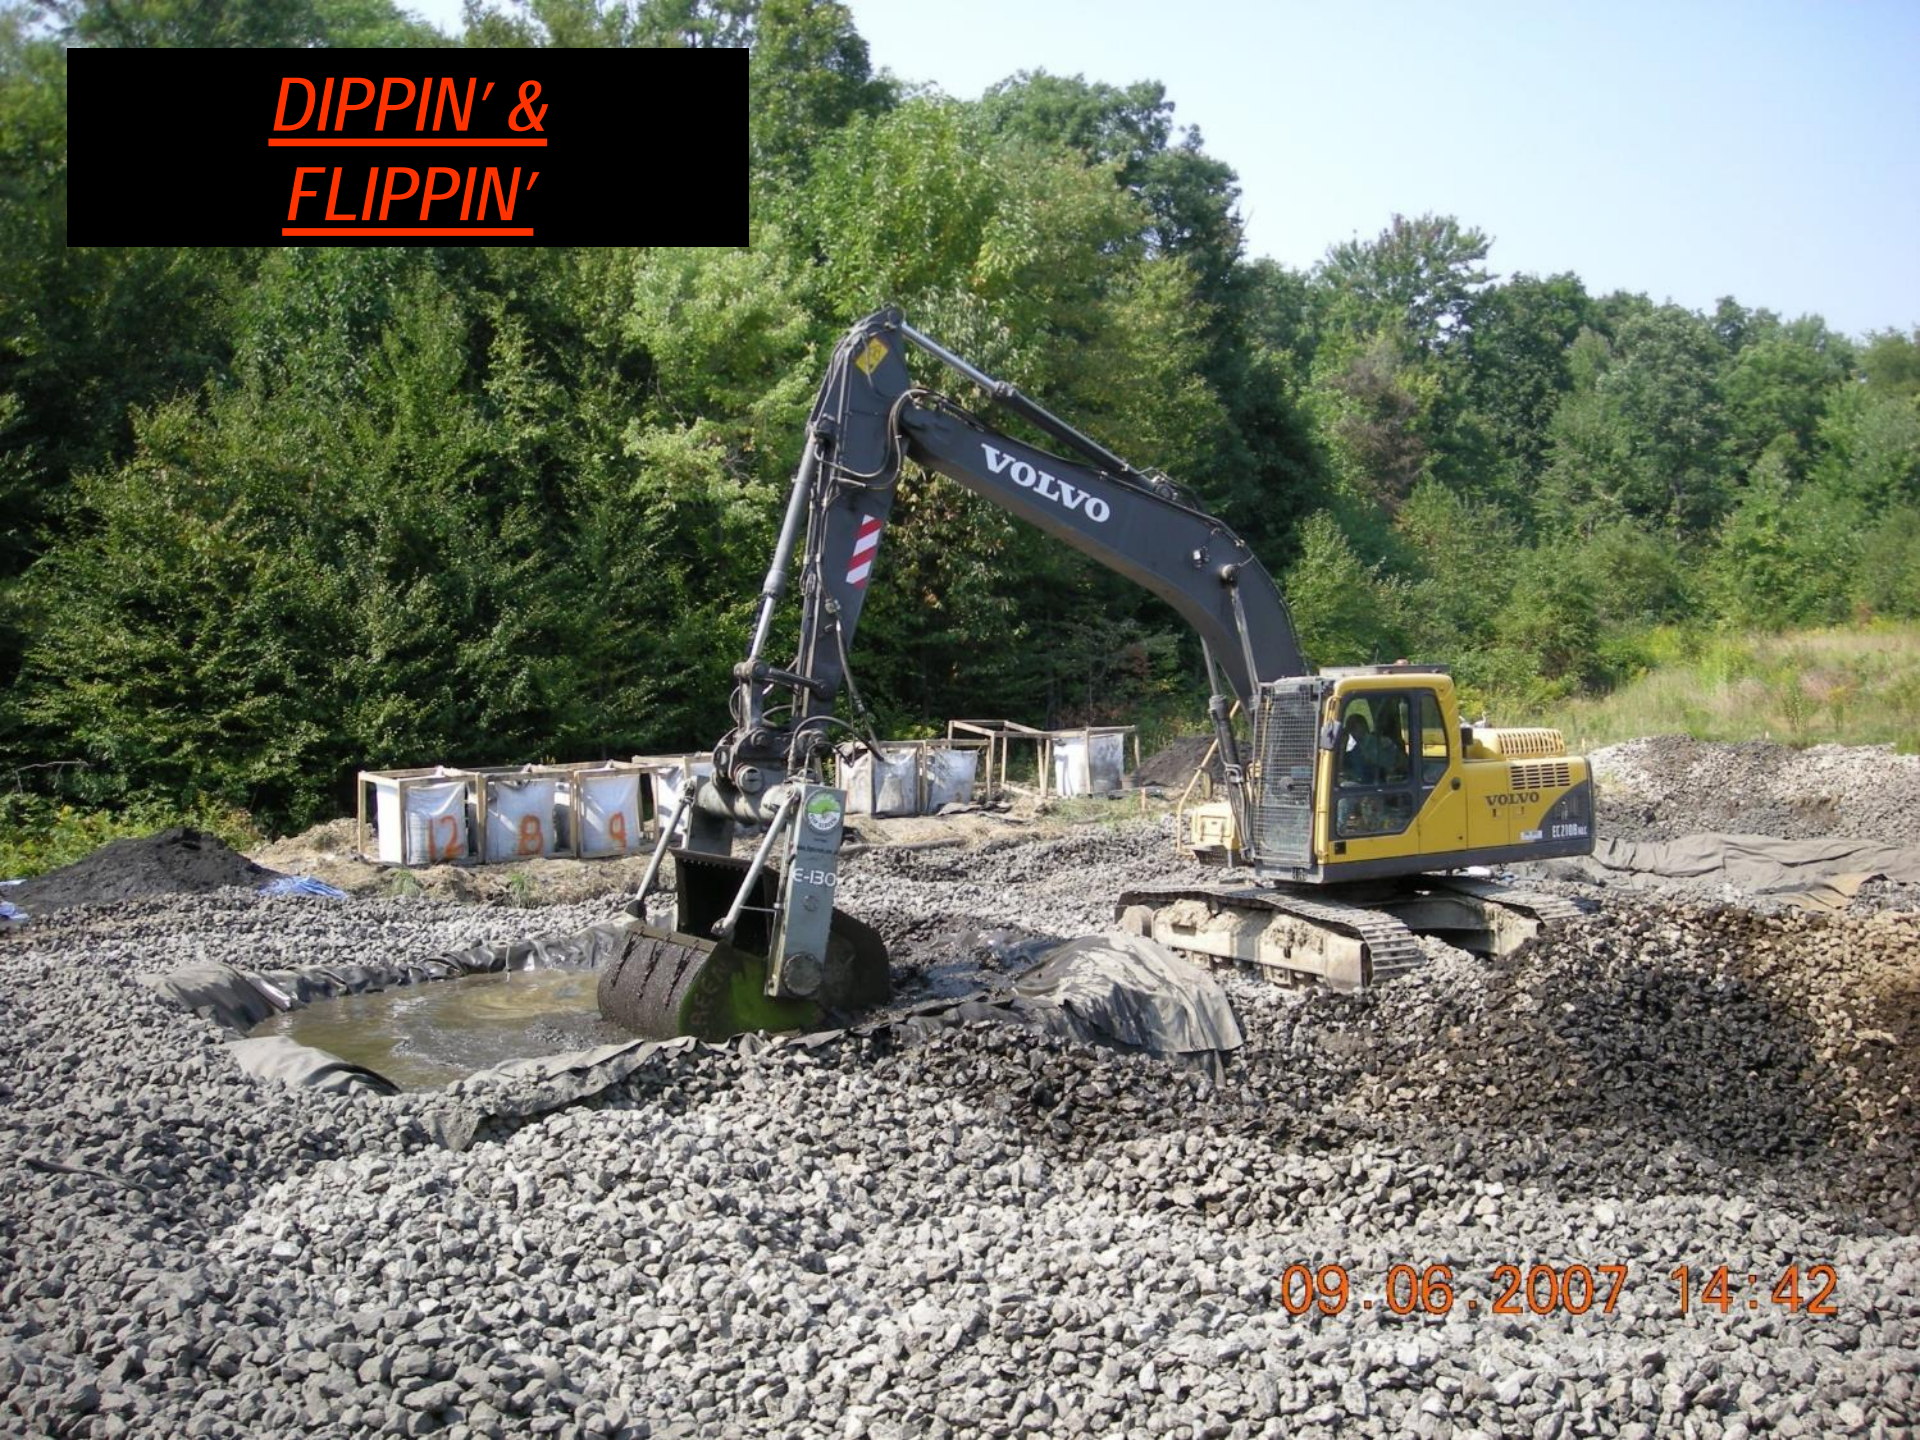
Opportunity!

Clean Stone

Clogged Stone

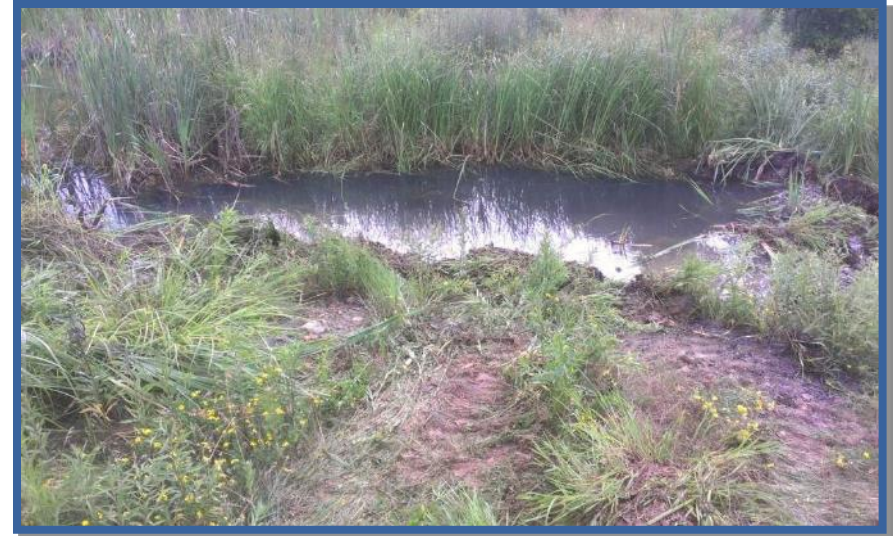
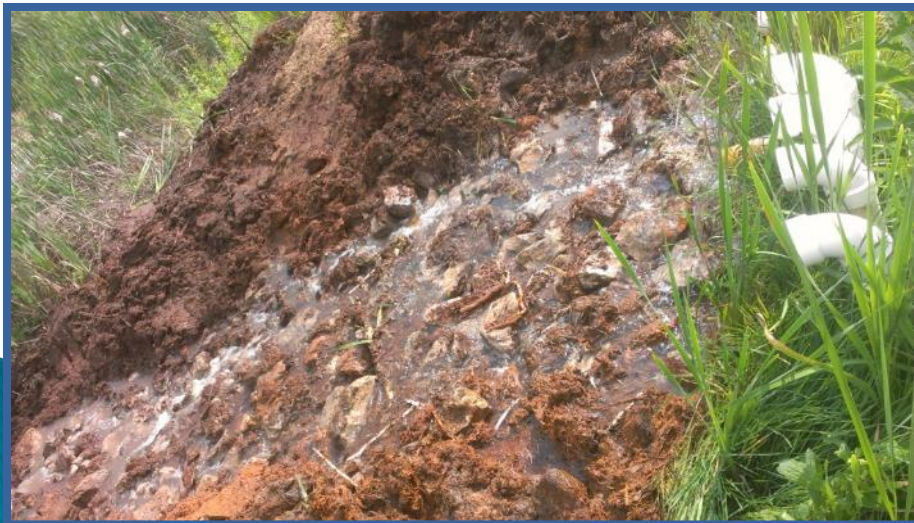
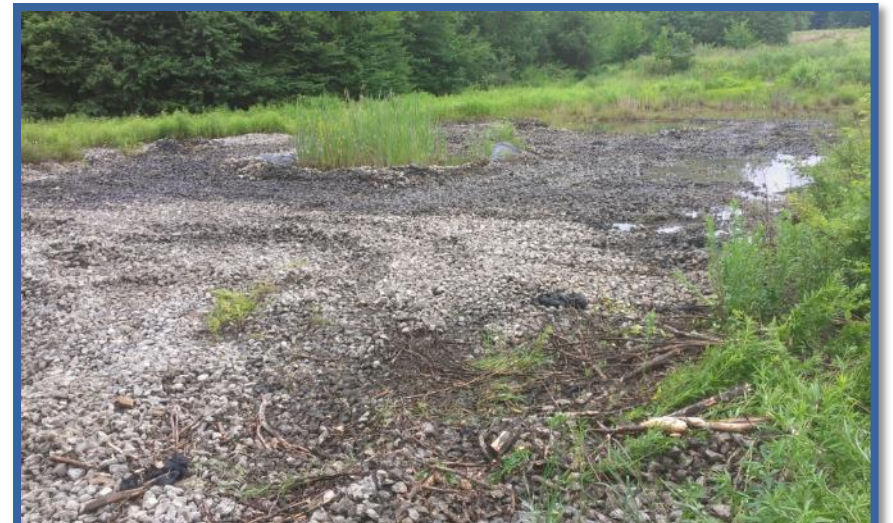
De Sale II– History/Maintenance

- ▶ WL outlet cleared of vegetation
- ▶ HFLB stone re-leveled
- ▶ VFP outlet spillway cleared of vegetation buildup

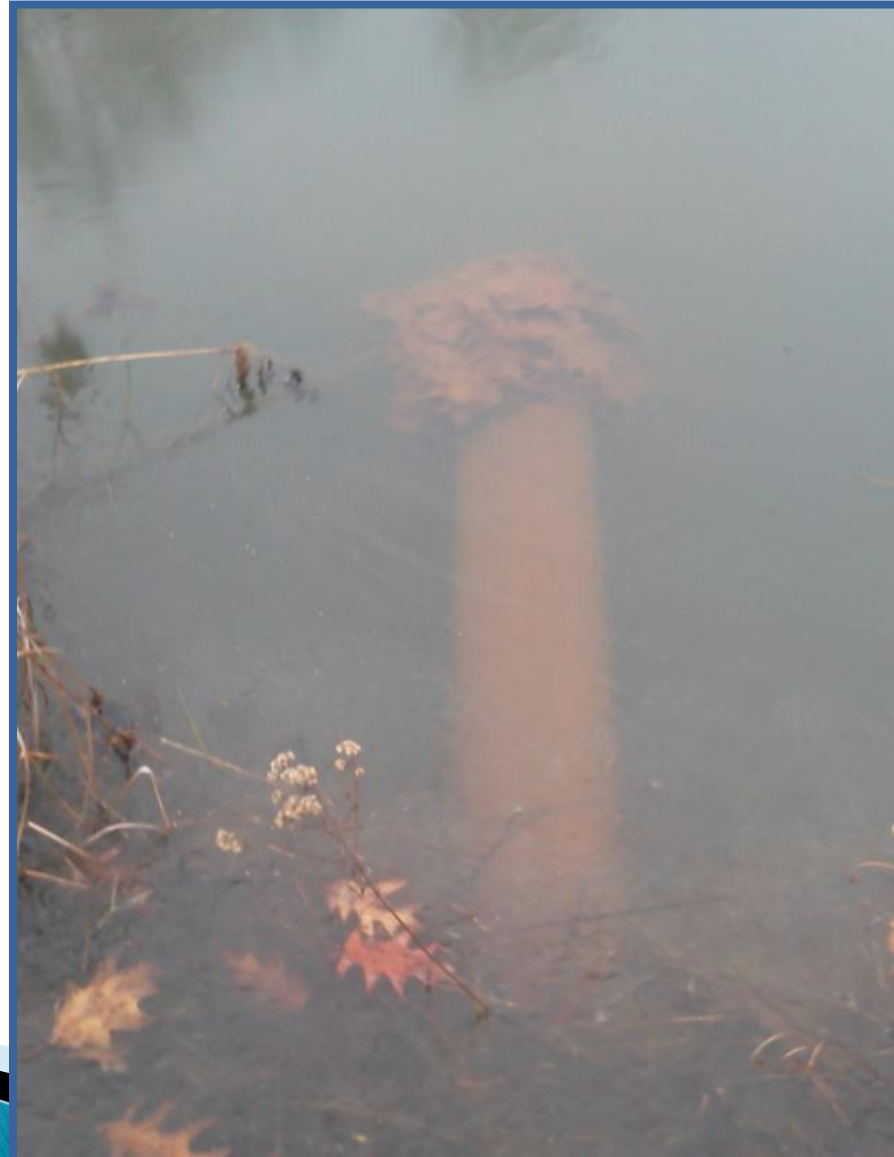
De Sale II– Recent Maintenance

- ▶ Forebay pipe inlet clogged

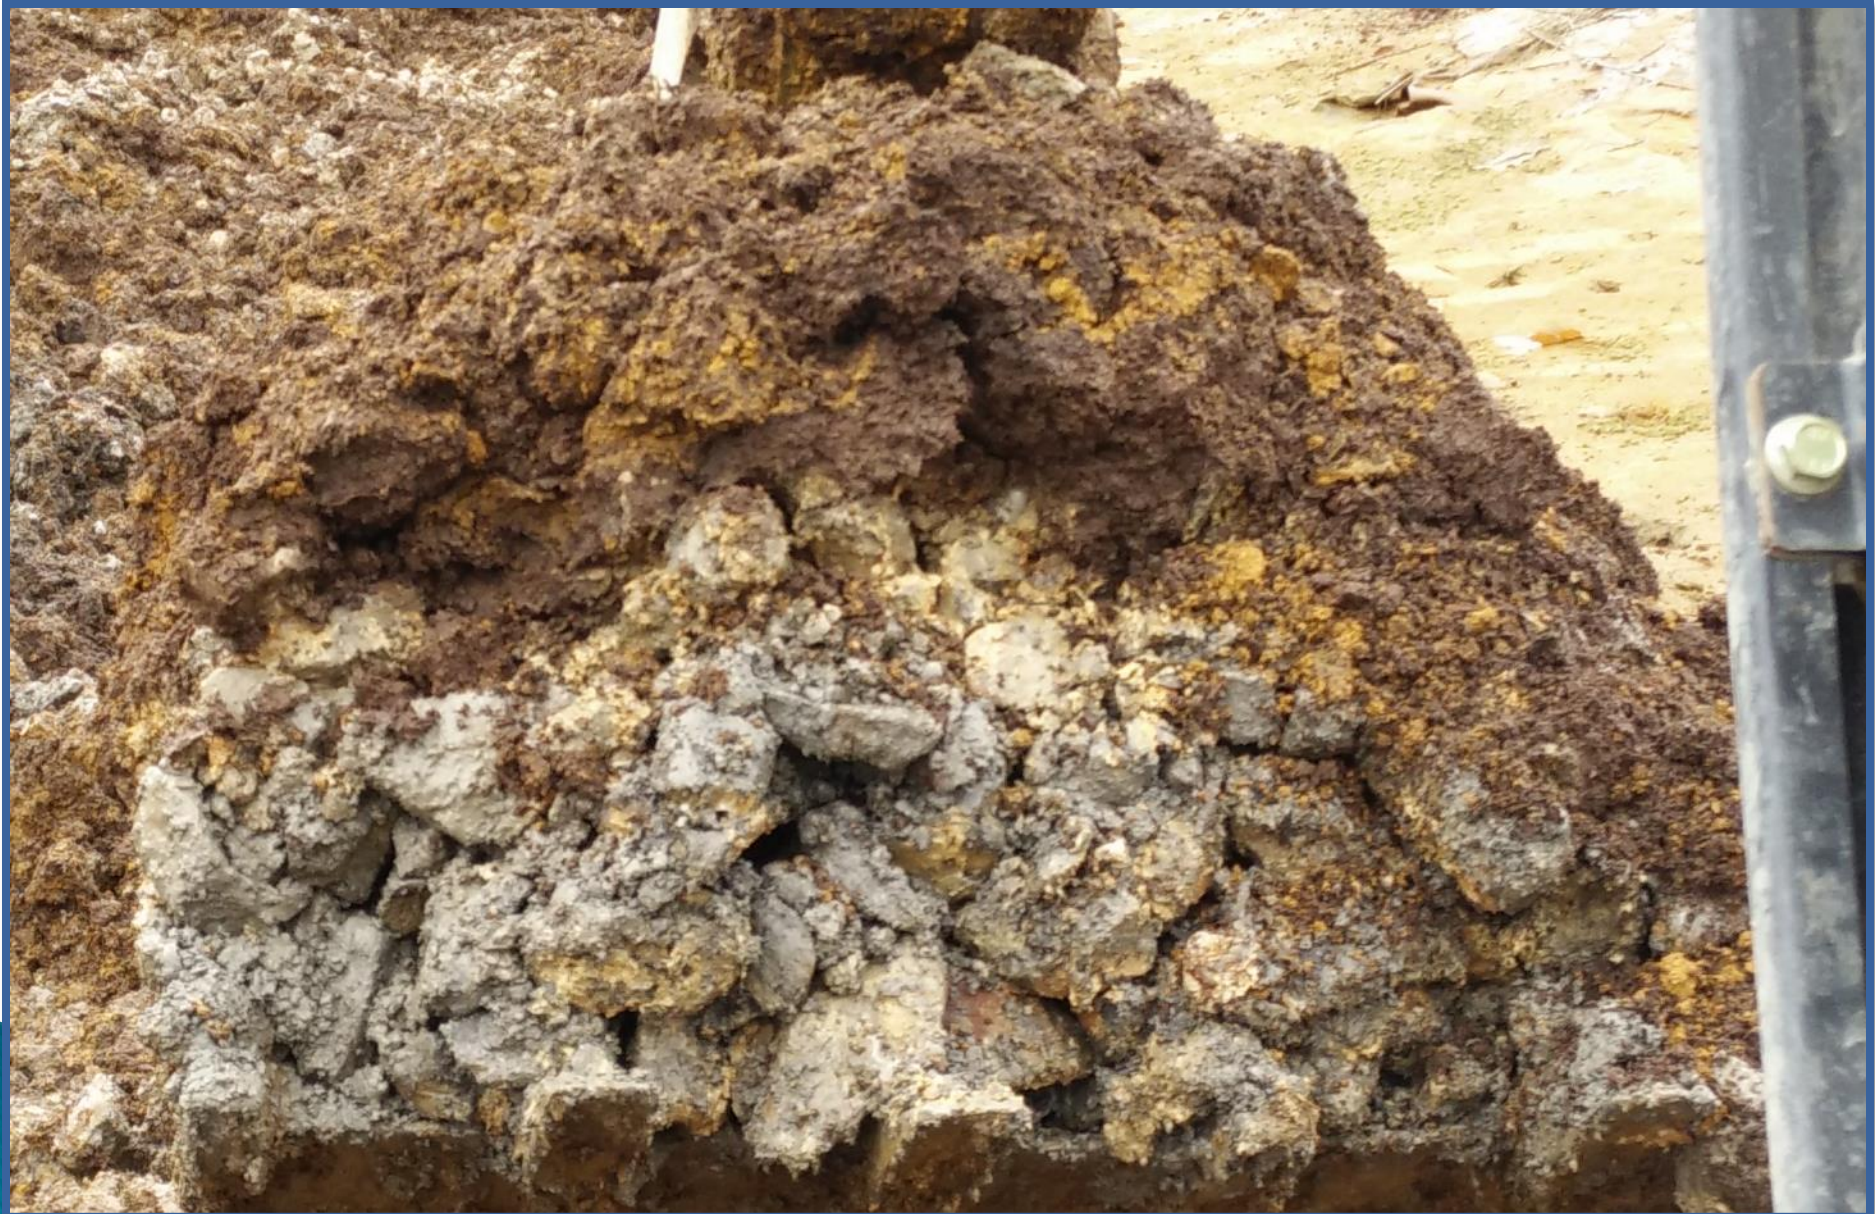
De Sale II- Vertical Flow Pond

De Sale II– Recent Maintenance

- ▶ VFP performance decreased

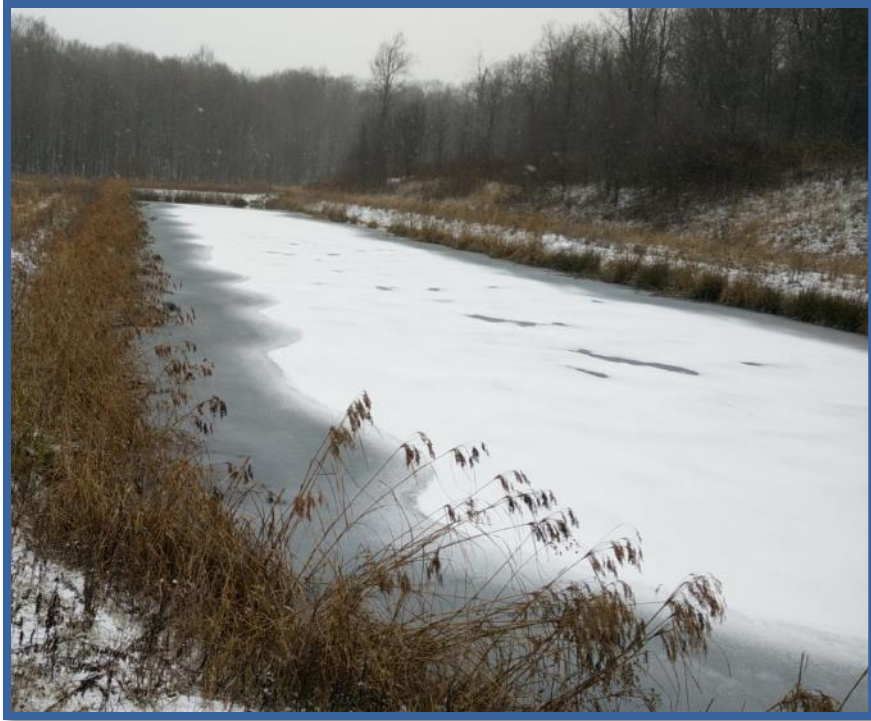
O&M– De Sale II

Pre- and Post- O&M Effluent Field Water Quality Data

Parameter	Pre- O&M	Post- O&M
pH	6.0	6.9
alkalinity	20	~70
Fe (mg/l)	4-8	0.5 - 1
