Interstate-Callahan Upper and Lower Rock Dumps RA Construction Project

East Fork Ninemile Creek, Idaho
June 8, 2016

Pioneer Technical Services, Inc. and North Wind Group

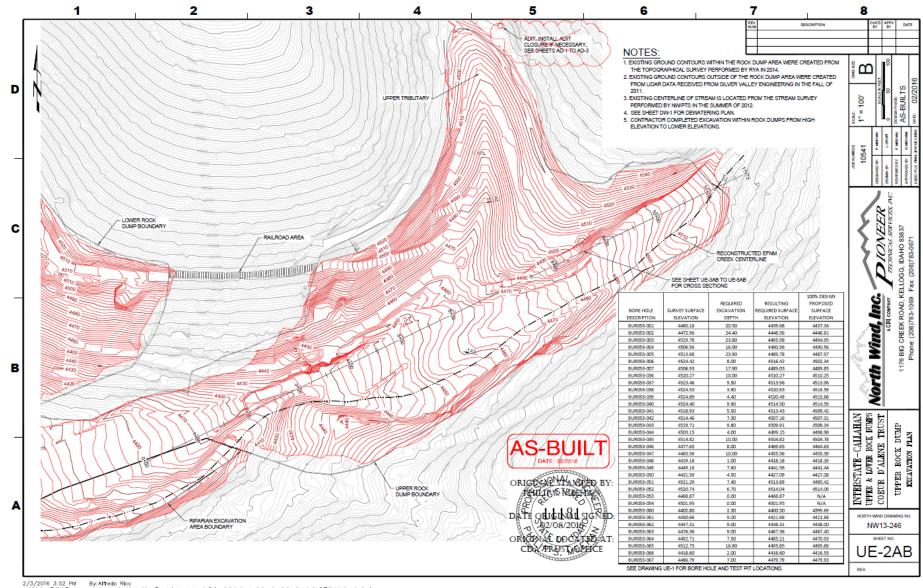
Upper Rock Dump Excavation

- Soil boring and test pit data used from 2011 and 2012 Trust site characterization investigations
- Achieve soil and sediment concentrations less than or equal to 530 mg/kg lead
- Characterization showed minimal leaching into native soils

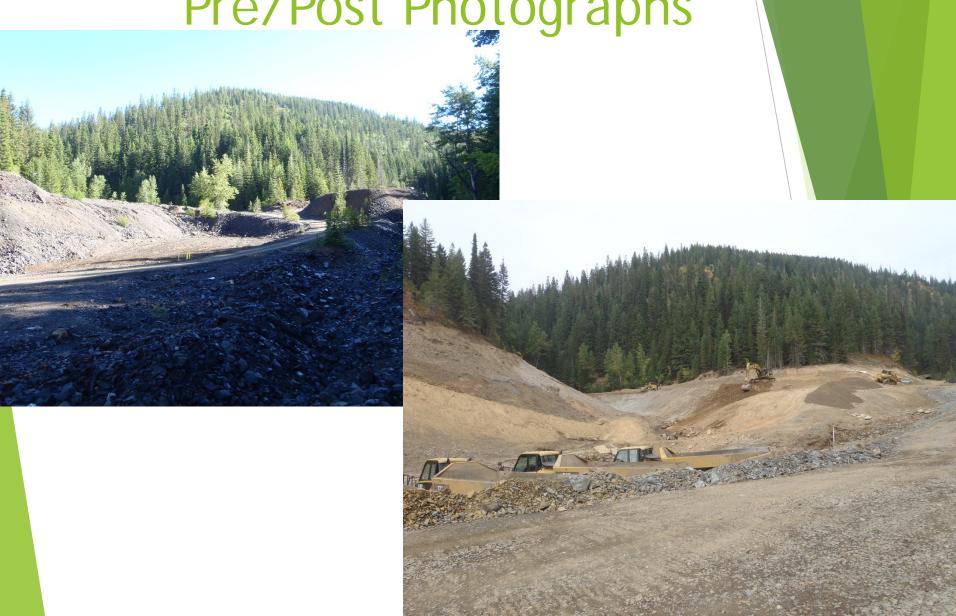
Upper Rock Dump Excavation Pre/Post Photographs

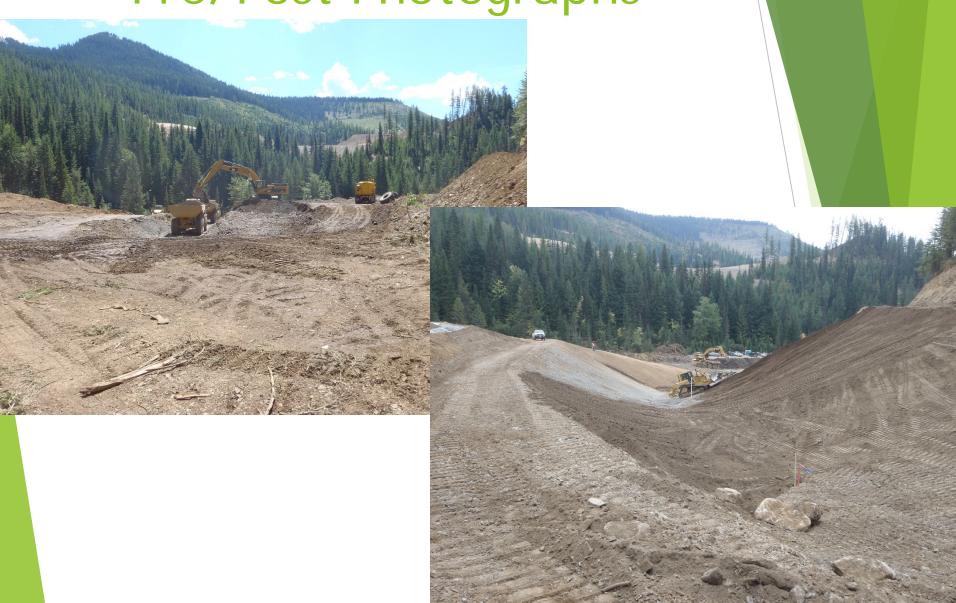
Lower Rock Dump Excavation Pre/Post Photographs

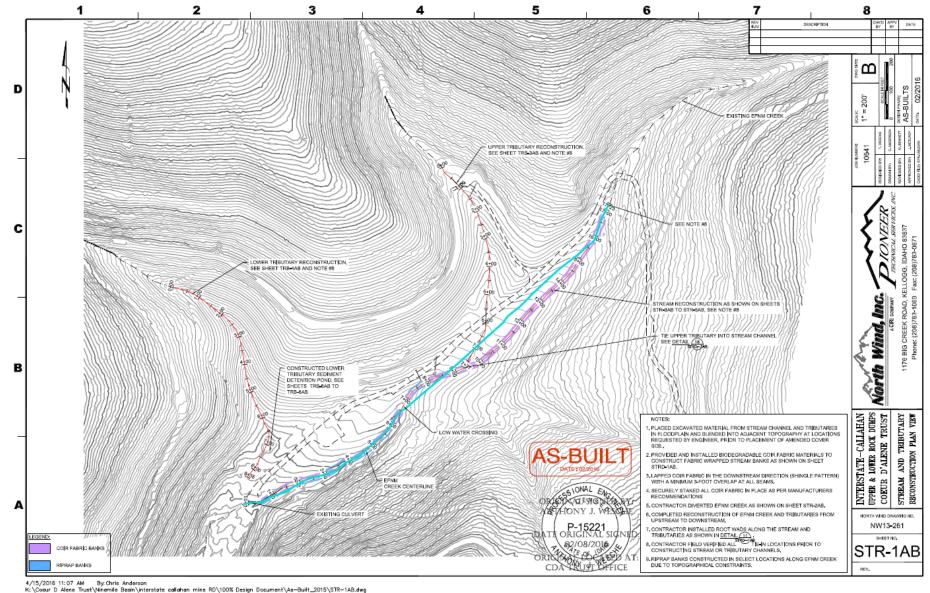
EFNM Creek Channel Alignment

- Design based upon upstream reference reach
- Diversion of EFNM Creek required during construction for waste excavation and stream reconstruction.

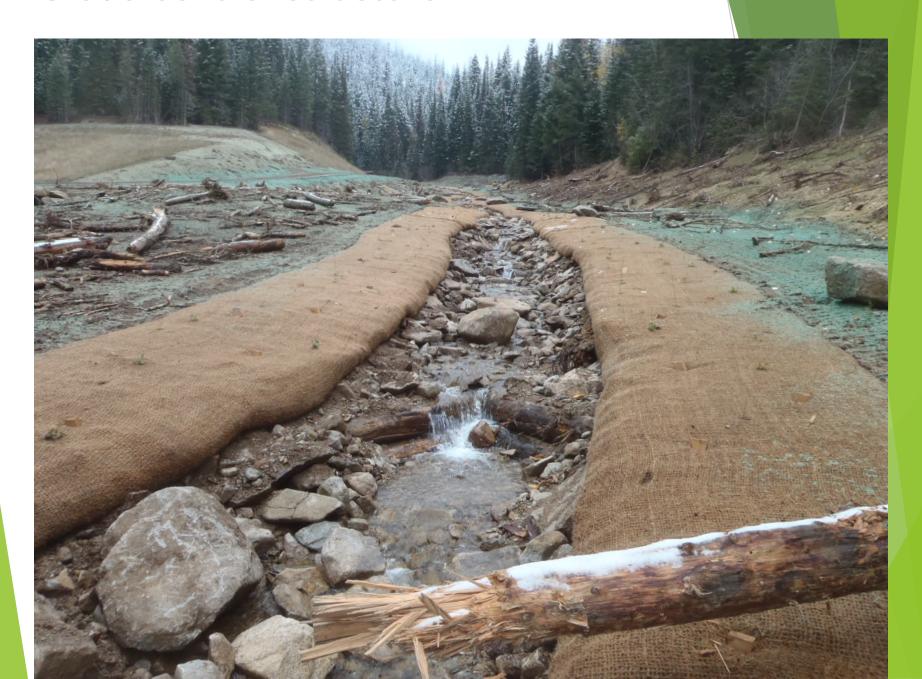
Grade Control Structure

► Four designed structures incorporated (Rock Cross Vane, Double Log V-Structure, Armored Angled Log Step-Down, and Angled Rock Step Down)
