Kerber Creek Restoration Project

Case study employing statistical techniques to analyze effects of restoration activities, Saguache, CO

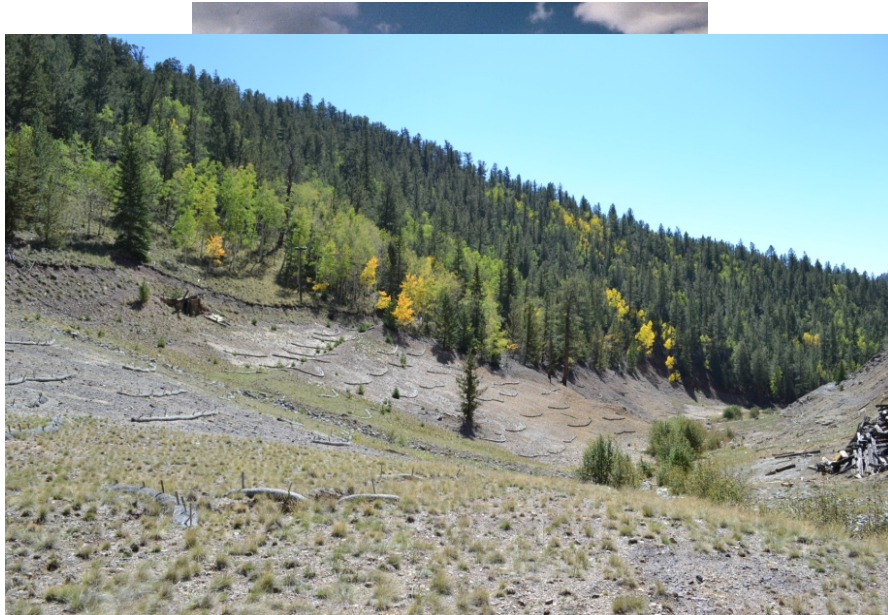
Squirrel Creek, 2012
Squirrel Creek, pre-1992

- ▶ 1994–1999: Restoration projects implemented (upper watershed)
- ▶ 2002: ASARCO, Inc. declares bankruptcy, halting restoration projects

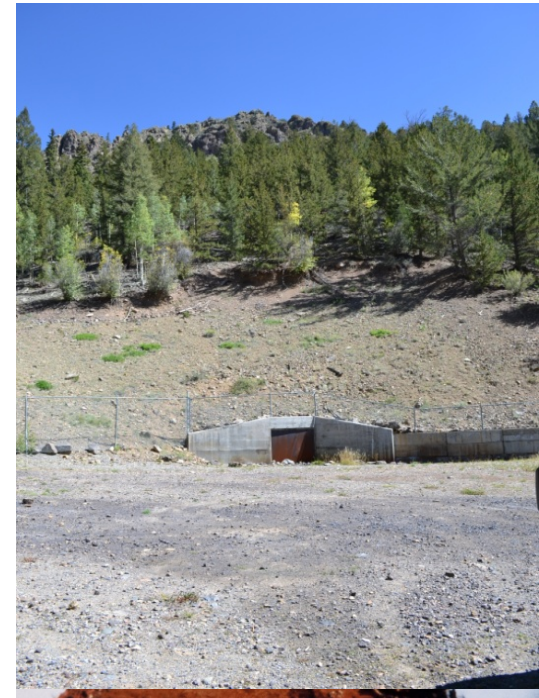
Squirrel Creek, 1996

- ▶ 1991: USFS & CDPHE investigate for Superfund designation
- ▶ 1994: Bonanza Group (ASARCO, Inc., USFS, BLM, Local Landowners) approved to pursue Voluntary Cleanup

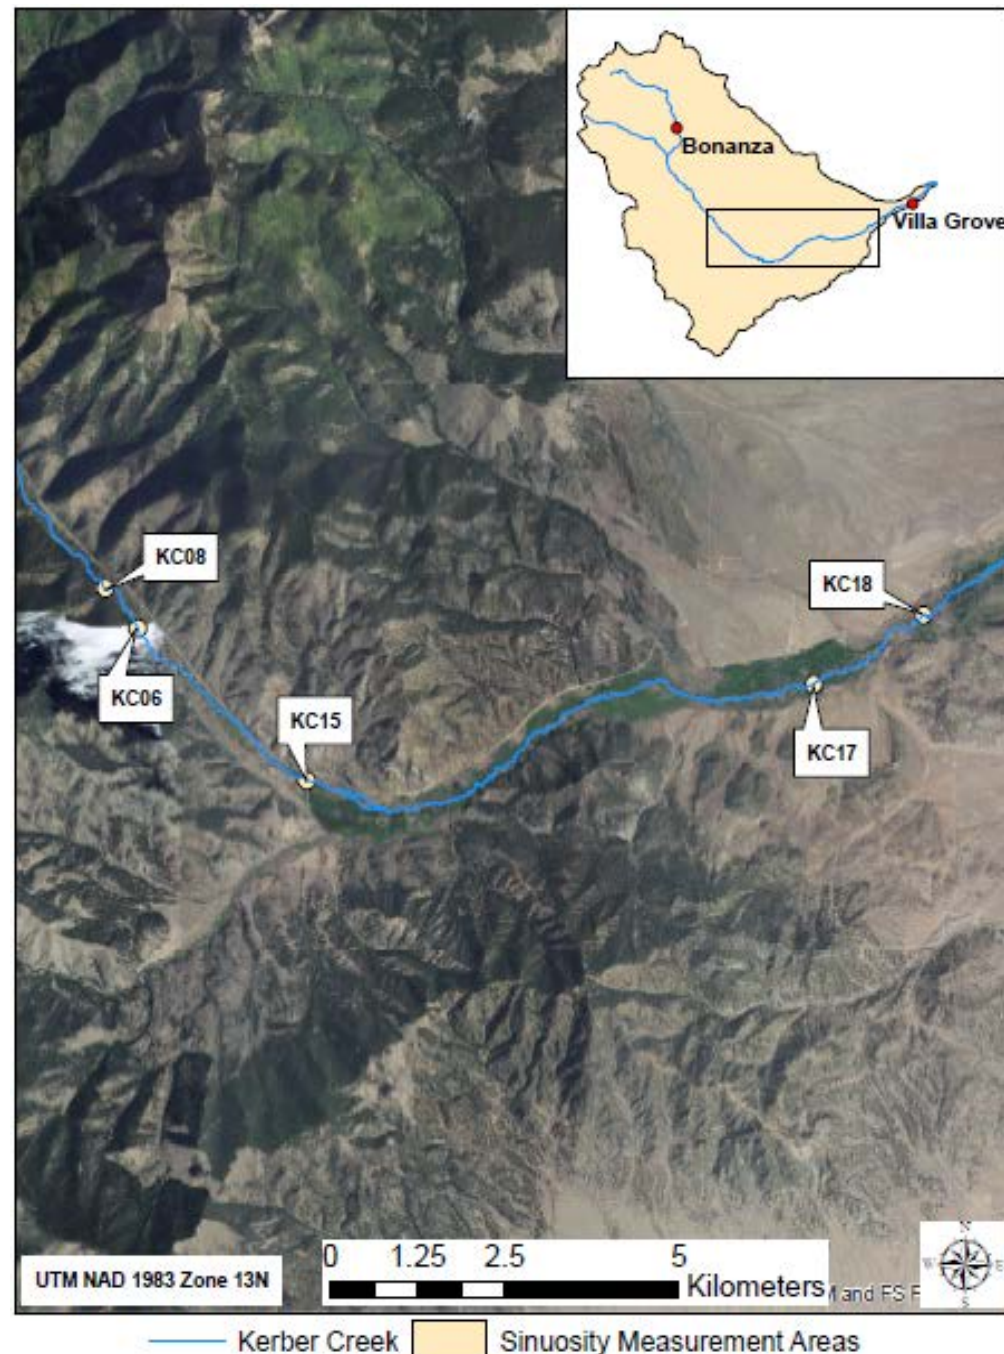
- ▶ **Geology:** Dominated by tertiary igneous rock (latite)
- ▶ **Precipitation:** Low elevation, 25.4 cm; High elevation, 76.2 cm
- ▶ **Ecology**
 - Vegetation: grasses, willows, sedges
 - Fishery: brook trout, some brown trout & longnose dace
- ▶ **Hydrology**
 - Avg. high flow: 60 cfs
 - Avg. base flow: 4 cfs
 - 100-yr flood: 464 cfs
- ▶ **Geomorphology**
 - Avg. bankfull width: 4.3 – 4.9 m
 - Avg. bankfull depth: < 0.3 m
 - Avg. gradient: 3%
 - Medium-to-large cobble substrate

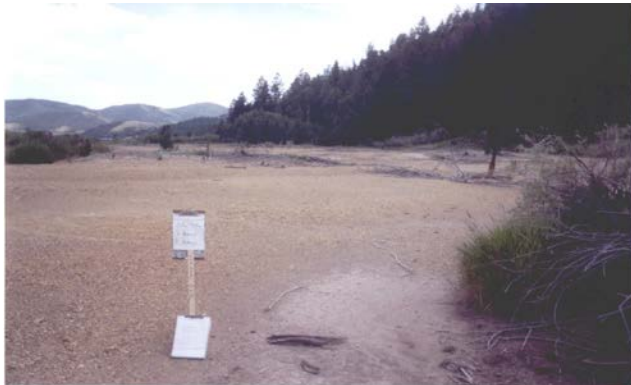
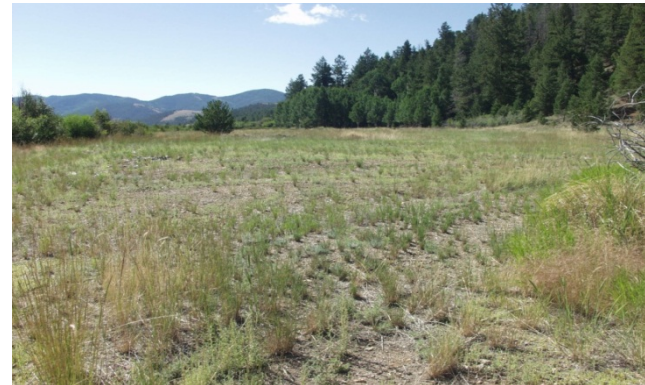
- ▶ No statistically significant differences; all null hypotheses could not be rejected
