AZURITE MINE REMOVAL ACTION OVERVIEW

Dustin G. Wasley, PE, Principal – CES

**2013 American Society of Mining and Reclamation Conference
Laramie, Wyoming -- June 6, 2012**

2011 Removal Action Summary

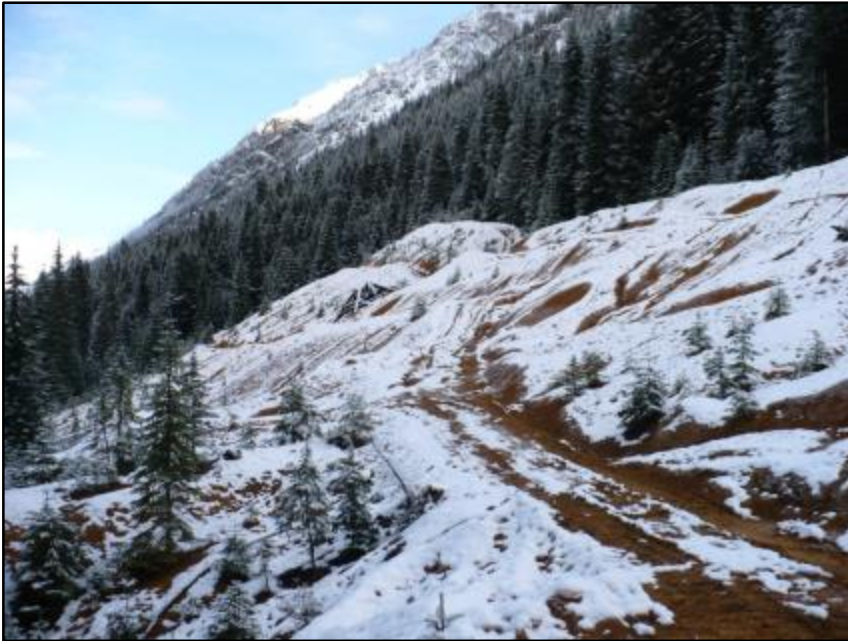
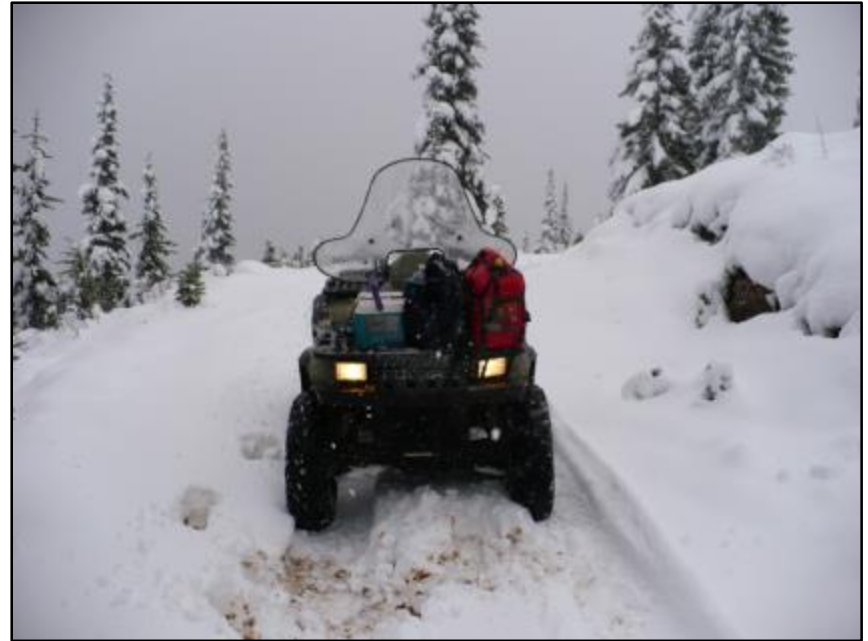
Construction Challenges

- Weather Conditions (rain, snow, heat)

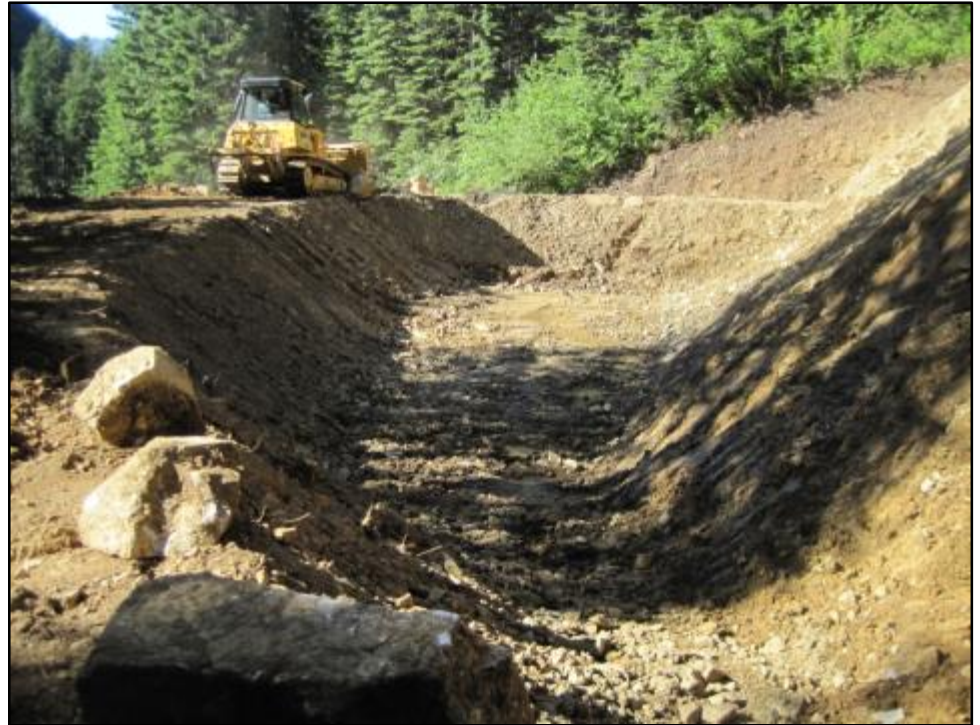
Erosion and Sediment Control

- Run-On Ditches
 - Waste Rock / Tailings
- Silt Fence
 - Borrow Area / Waste Rock
- Filter Berms
 - Borrow Area / Waste Rock
- Sedimentation Pond
 - Tailings / Repository

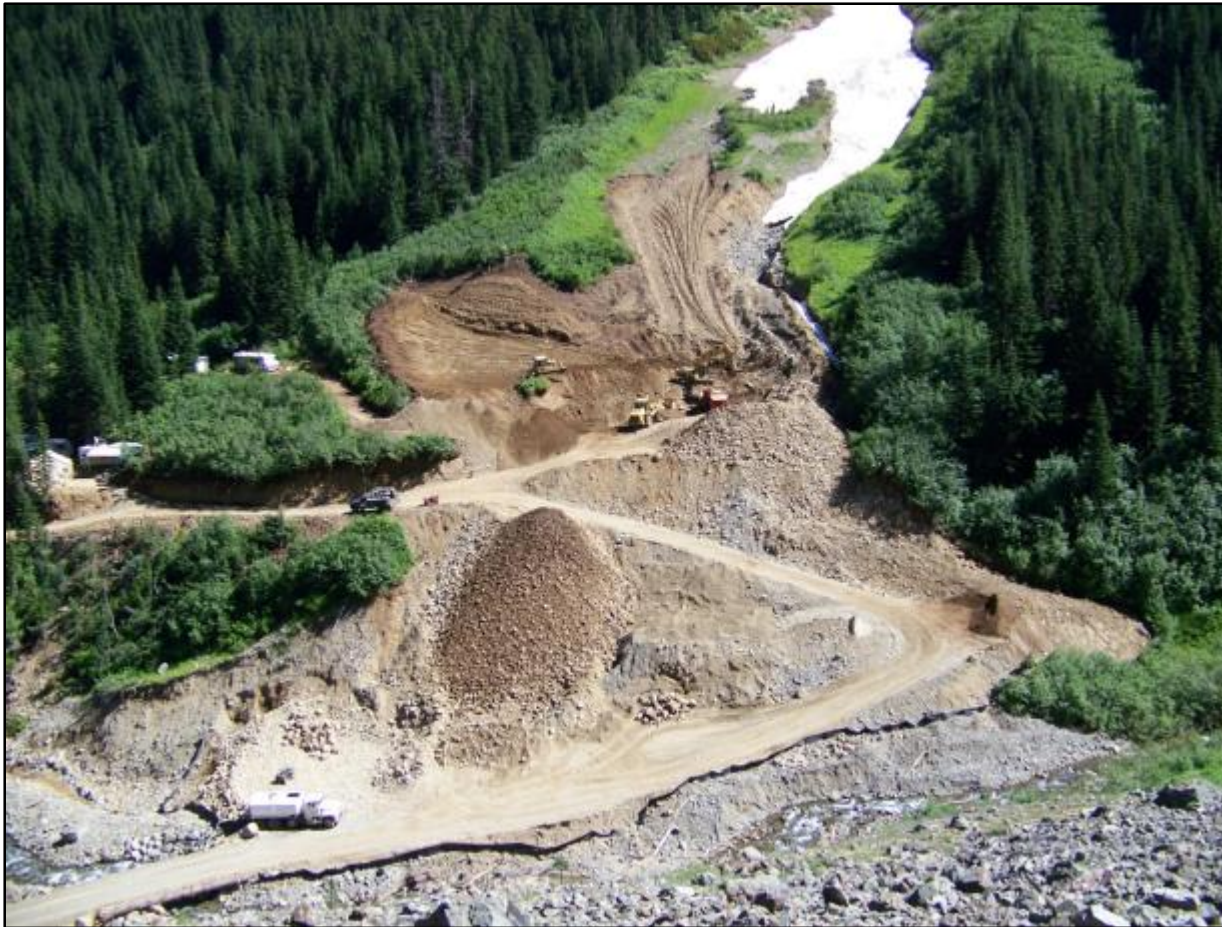
Borrow Area Development

- Onsite Source for Screening / 3 Products
- 2-inch minus
 - Stabilized Slope Fill, Road Bed/Base, Fill Material
 - 40,000+ cubic yards used, more remains onsite
- 2-inch to 36-inch
 - Repository cover, rockered diversion ditches
 - ~20,000 cubic yards
- 36-inch plus
 - Misc. Placement, armoring

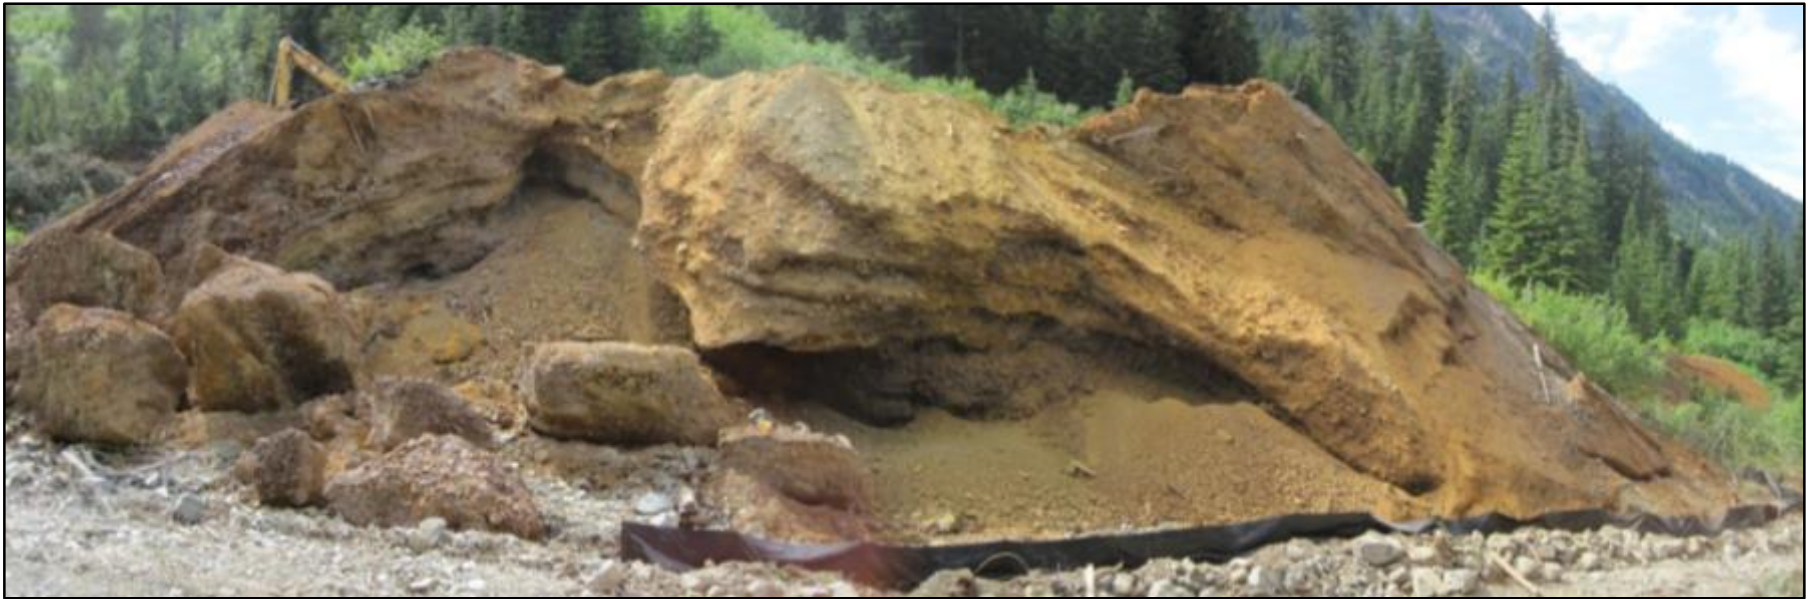
Waste Rock Pile – Before

- Design Estimate was 22,000 bcy of Waste Rock
- Risk Assessment Cleanup Goal – 104 mg/kg Total Arsenic
- Revised Cleanup Goal – 204 mg/kg Total Arsenic
 - Additional Background Soil Sampling
 - Used MTCA Stat 3.0 to Calculate Natural Background
- In-Field Screening with Niton XRF (RPDs \leq 33%)
- Final Quantities ~ 16,500 bcy
