Case Study: Baird Wetland Mitigation

Presented by: Shaun L. Busler, GISP, Biologist BioMost, Inc.

2016 American Society of Mining & Reclamation Spokane, Washington

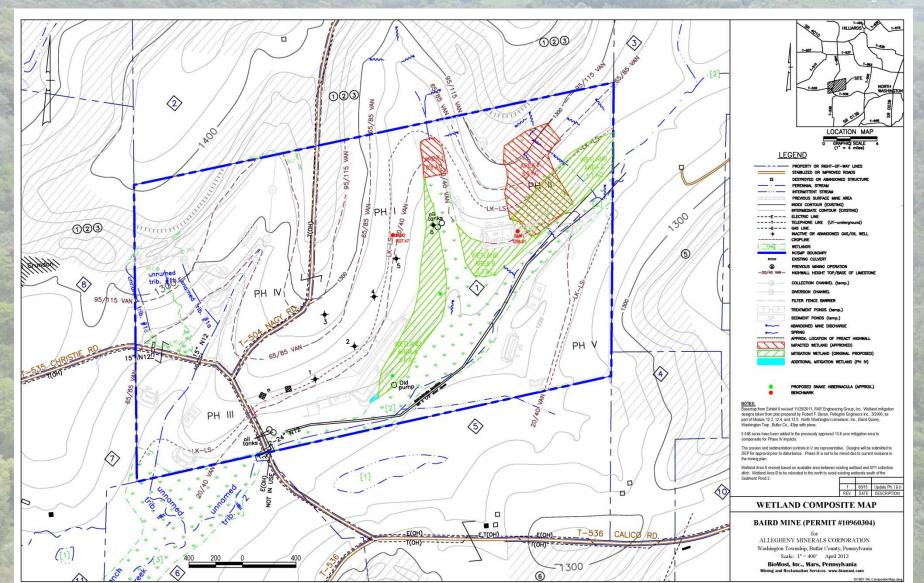
Proposed Mitigation Plan

- Two wetland impacts on Phase II
 - 0.8 AC for crossing
 - 5.9 AC sloped wetland formed as a result of AMD overflowing old sediment pond
 - Small impacts to Phase IV
- Required to construct a total of 13.6 acres of wetlands (2:1)
 - Required to be prior to or concurrent with impacts

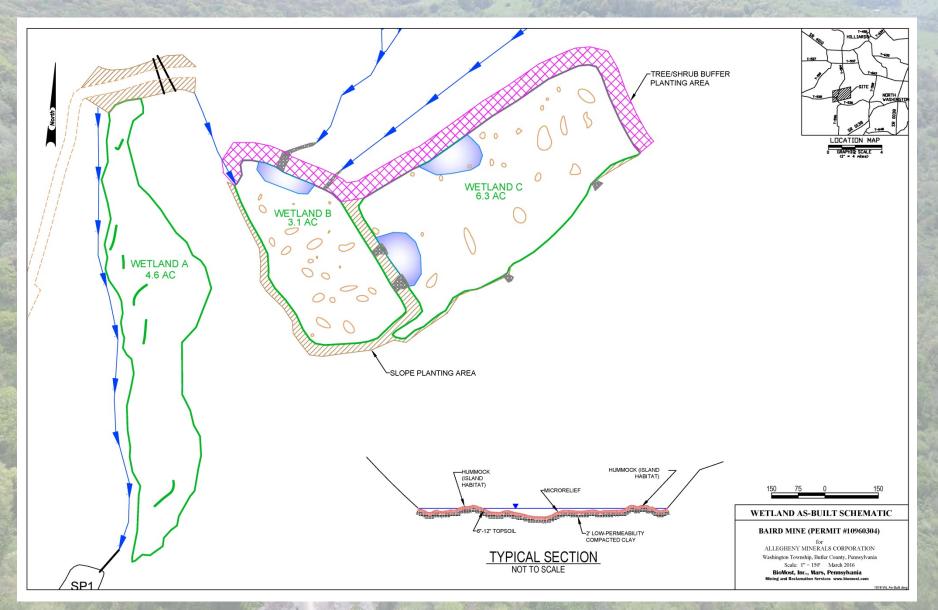
As-Built Schematic

- Constructed in 2012
 - Created 4.6 acres of wetland
- Constructed outside of mining area
- Proposed a different type of wetland construction
 - Minimize disturbance
 - Encourage terrestrial crayfish

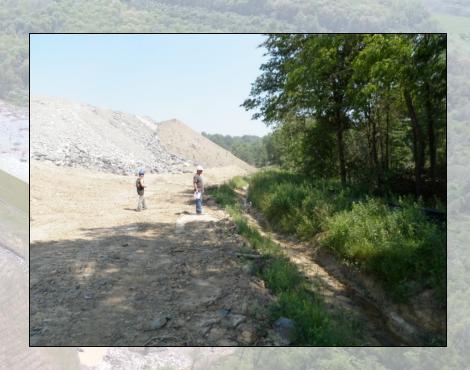
Wetland A Hydrology

- No Water!!
 - Collection ditch upgradient of wetland
 - Cuts off surface runoff
 - Elevation of Wetland A is higher than the adjacent existing wetlands
 - No springs
- Lower elevation
 portions of Wetland A
 dominated by
 hydrophytic vegetation

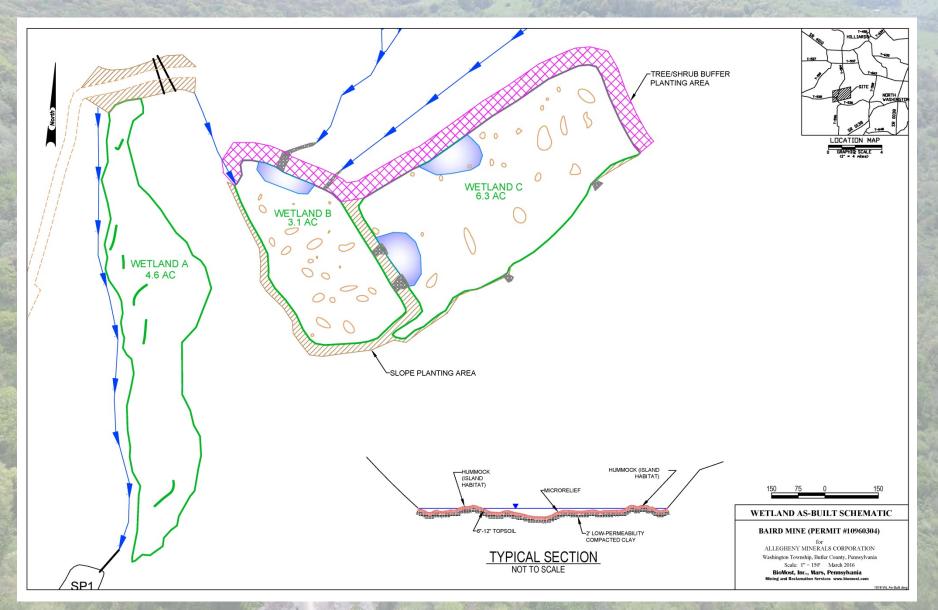
As-Built Schematic

- Constructed within the mining area
 - Took precautions:
 - Spoil tends to settle
 - 2' layer of onsite clay compacted with a roller
 - Another 1-2' of "wetland substrate" over compacted clay

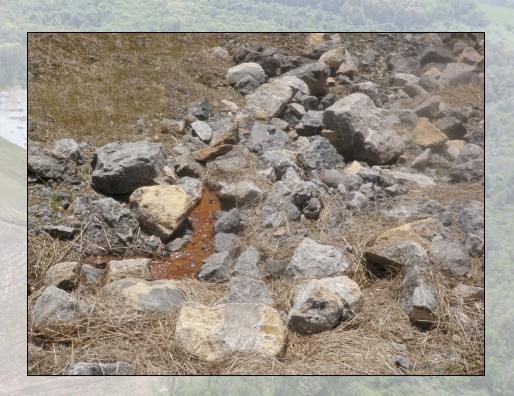
- Water Sources
 - Surface runoff
 - Abandoned mine discharge
 - Previously fed a majority of wetlands at the site
 - Flows through limestone ditch

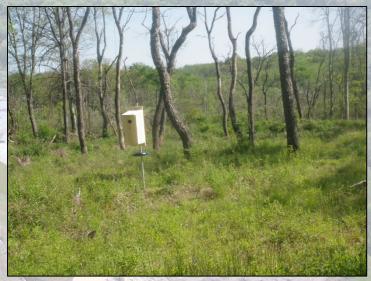
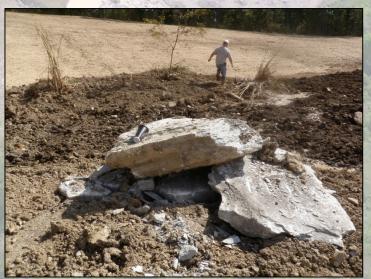
Wetland Habitat Creation

- Microtopography/ Hummocks
- Deep Pools
- Snags
- Woody Debris
- Rock Piles
 - Crevices sometimes used by Massasauga Rattlesnakes

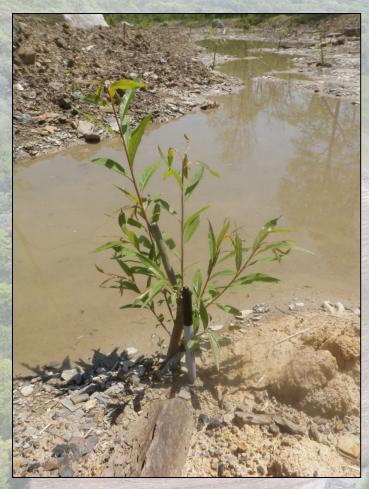
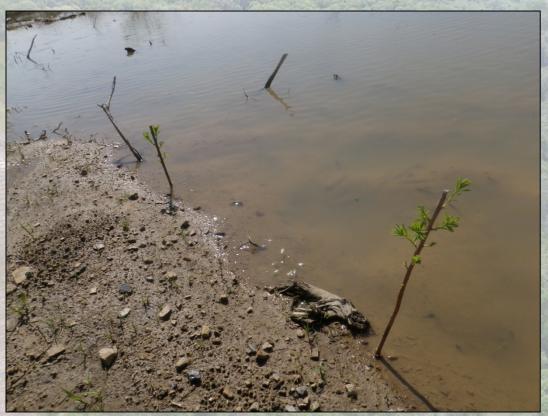
Livestakes

- Students from Geography, Geology and Environment Club at Slippery Rock University
- First time students had been on a mine site
 - Toured facilities prior to planting
- Planted 2400 livestakes
 - Purchased 2100 livestakes from local supplier
 - Mixture of willows and dogwood
 - Supplemented with 300 Spiraea alba cuttings (Meadowsweet) from adjacent wetland

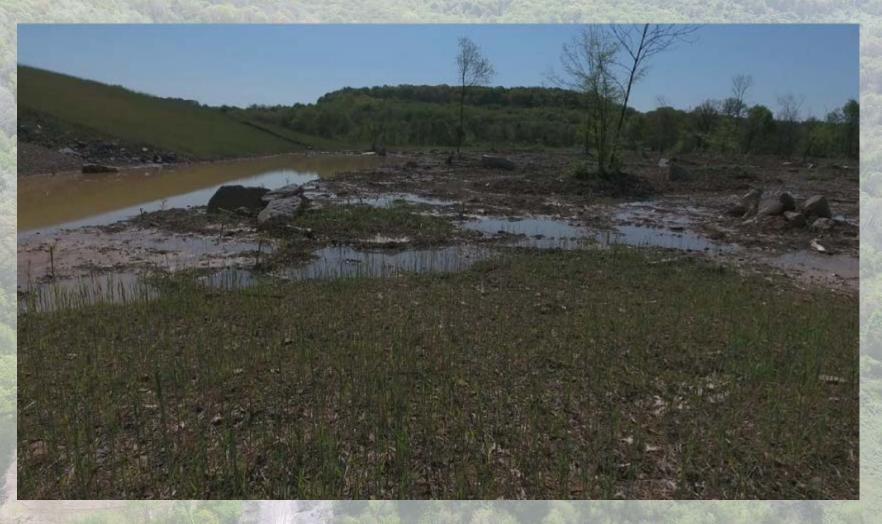
UAV Video Monitoring

- Allegheny Mineral recently purchased a "drone"
 - DJI Phantom
 - HD photos and video
 - On-board GPS
 - Inexpensive
 - Hoping to use the drone for stockpile volume calculations
- Historically took aerial photos of their mines annually
