## Reliance, Wyoming Mine Subsidence Mitigation Project

## REMEDIATION

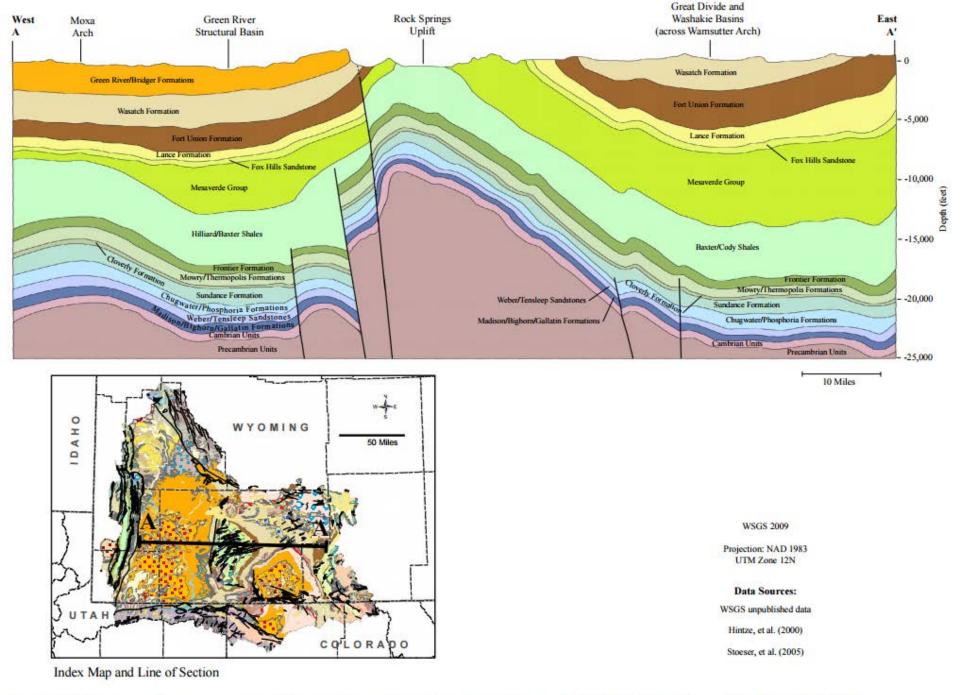
Figure 2-5. West-east geologic cross section, Wyoming Greater Green River Basin. Cross section by Fred McLaughlin and Yuri Ganshin, WSGS.

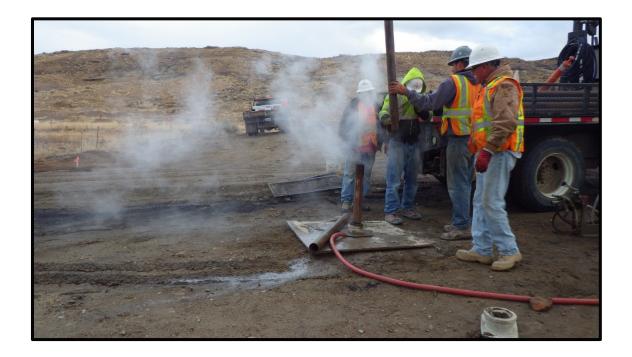
#### **Reliance County Road Grouting**

### Fire Venting Through Drill Hole

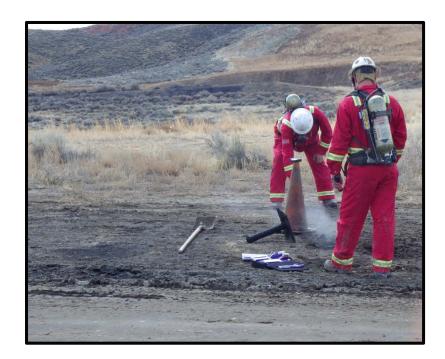
#### **Reliance County Road Grouting**

Elevated H2S Gas Requiring Use of Self Contained Breathing Apparatus / Compressed Air Breathing Apparatus (SCBA/CABA)
