# Evolution of a Monitoring System - Wyoming AML Reclamation Evaluation Program

**Presenters:**  
Joe Schroeder

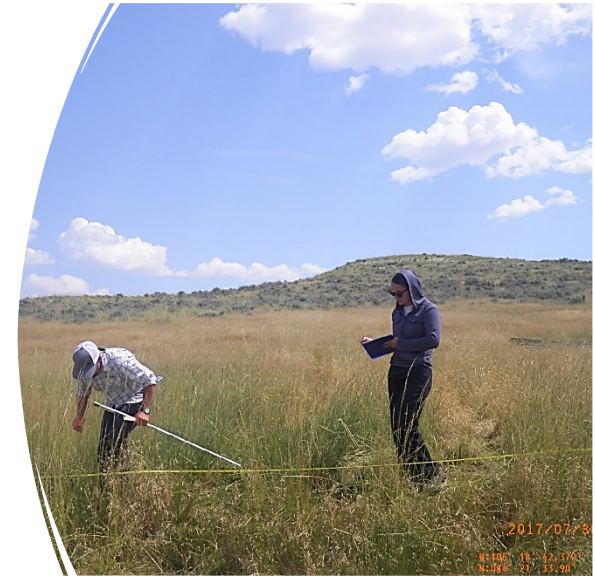
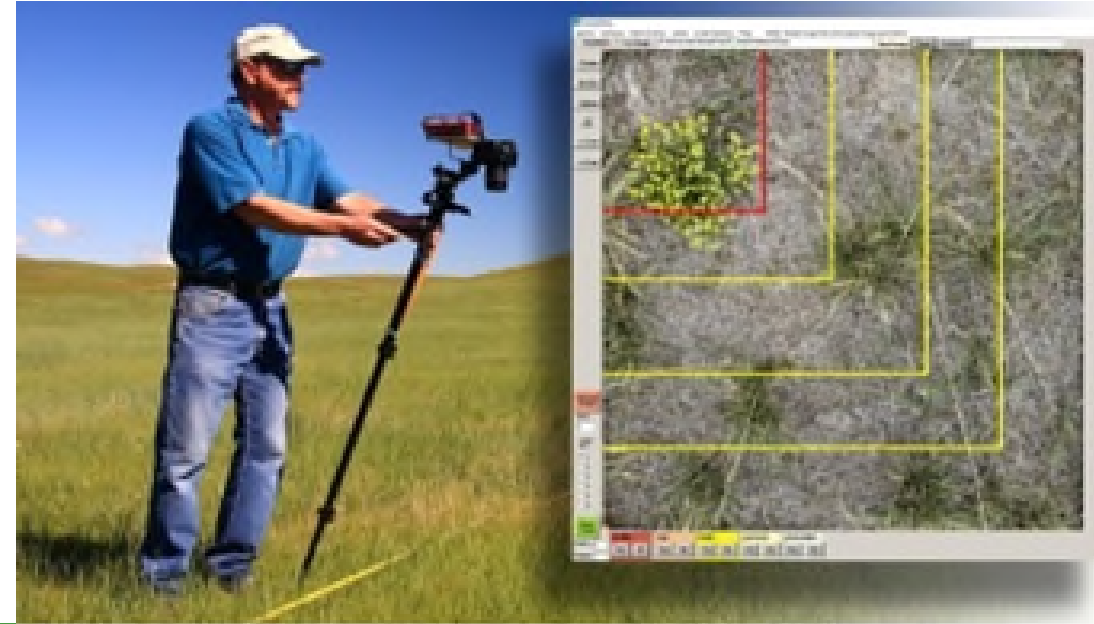
- The old monitoring system
  - Line point intersect and Daubenmire plots
    - Time intensive and takes away from field investigations
    - Quality of data likely decreases towards the end of the day.. and there's no way to evaluate data quality
- The new monitoring system:
  - Image-based monitoring and BAS sampling
    - Extremely fast to collect data
      - More time for site investigations
    - Research-grade data collected
    - Ability to revisit photo plots to answer additional questions, whenever needed.
    - Very strong platform (SamplePoint) to sample the photoplots in a controlled environment.
