GILLS CREEK, COLUMBIA, SC

RECLAMATION ENHANCEMENT PROJECT FOLLOWING 1000- YEAR FLOOD EVENT IMPACTS

Gwen Geidel, USC
Tom Kohlsaas, GCWA

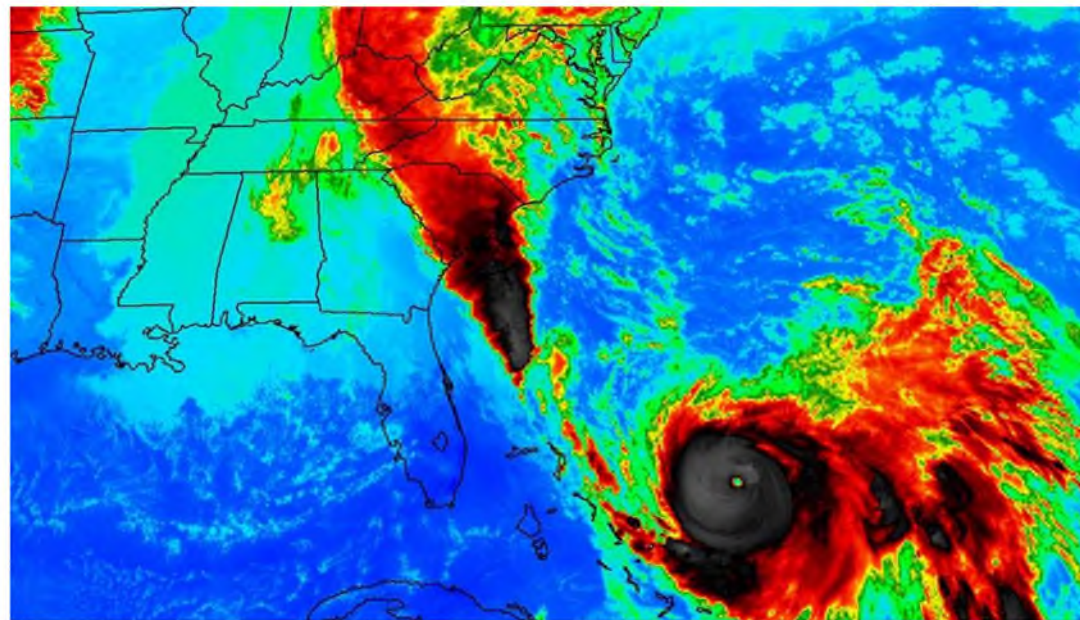
Figure 5. Infrared satellite image of the intense rainfall being funneled into South Carolina during the morning of October 3, 2015. Note the location of Hurricane Joaquin. (<http://www.weather.com/news/news/stunning-meteorological-images-october-2015-flooding>, NASA).

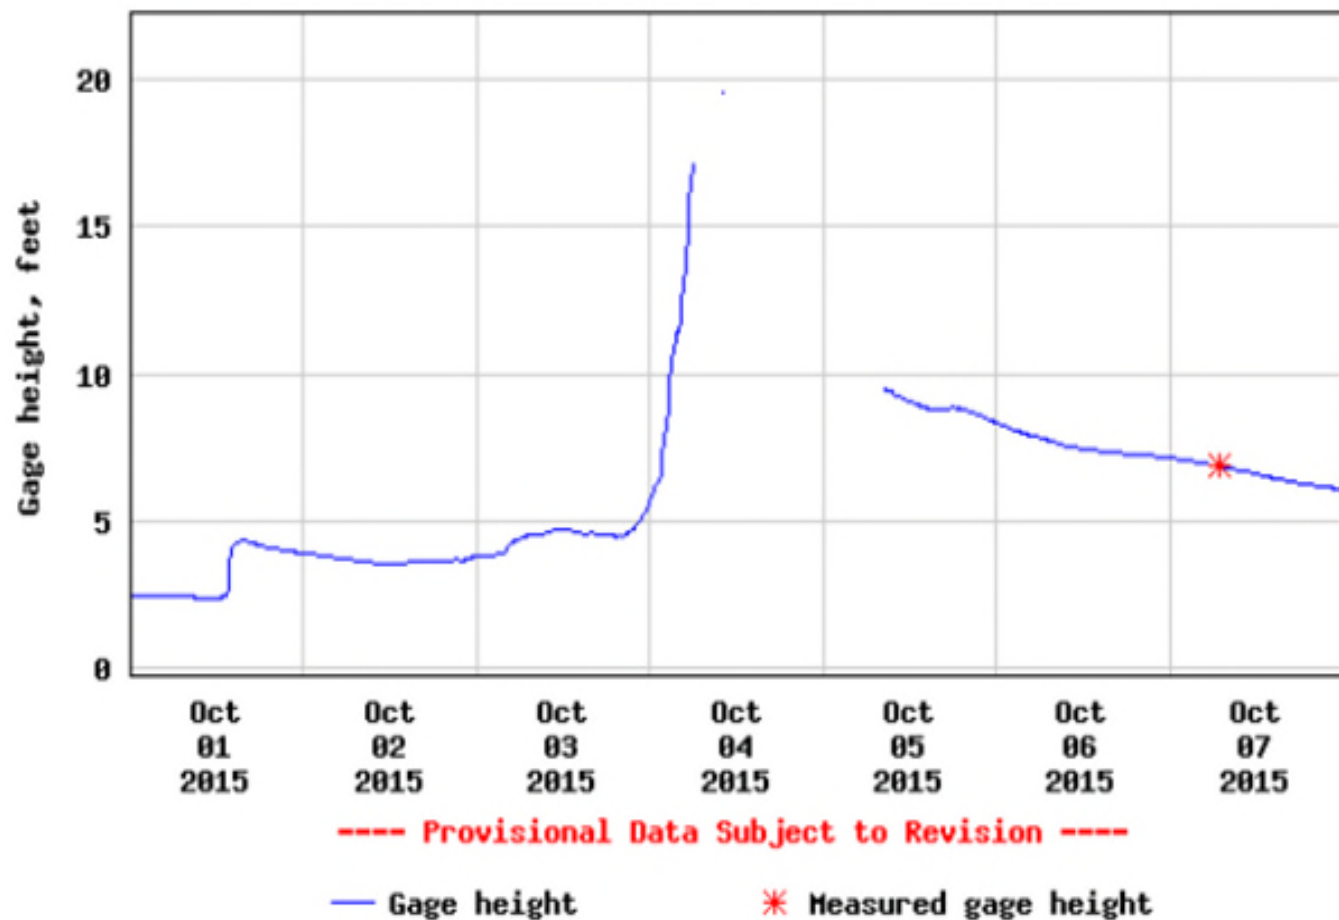
USGS 02169570 GILLS CREEK AT COLUMBIA, SC

Figure 70. Gills Creek USGS gauge 02169570 located at the US-378 Bridge over Gills Creek 1 km downstream of Lake Katherine: (a) stage with a last recorded data point of 17.08 ft (15.46 ft NGVD 29) at 6:00 EST on October 4, 2015, a single recorded data point of 19.57 ft (156.95 ft NGVD 29) at 10:00 EST on October 4, 2015 and no data thereafter until 08:30 EST October 5, 2015 (waterdata.usgs.gov/nwis).

- ❑ Over 16" of rain fell in Gills Creek Watershed
- ❑ Over 8" of rain fell in an 10 hour period
- ❑ Gills Creek gauge measured at 19.6 feet on 10/4/15
 - Previous peak streamflow: 8.7 feet (1979)
 - Gauge overwhelmed/damaged
 - 9.11 feet = 2,380 cfs

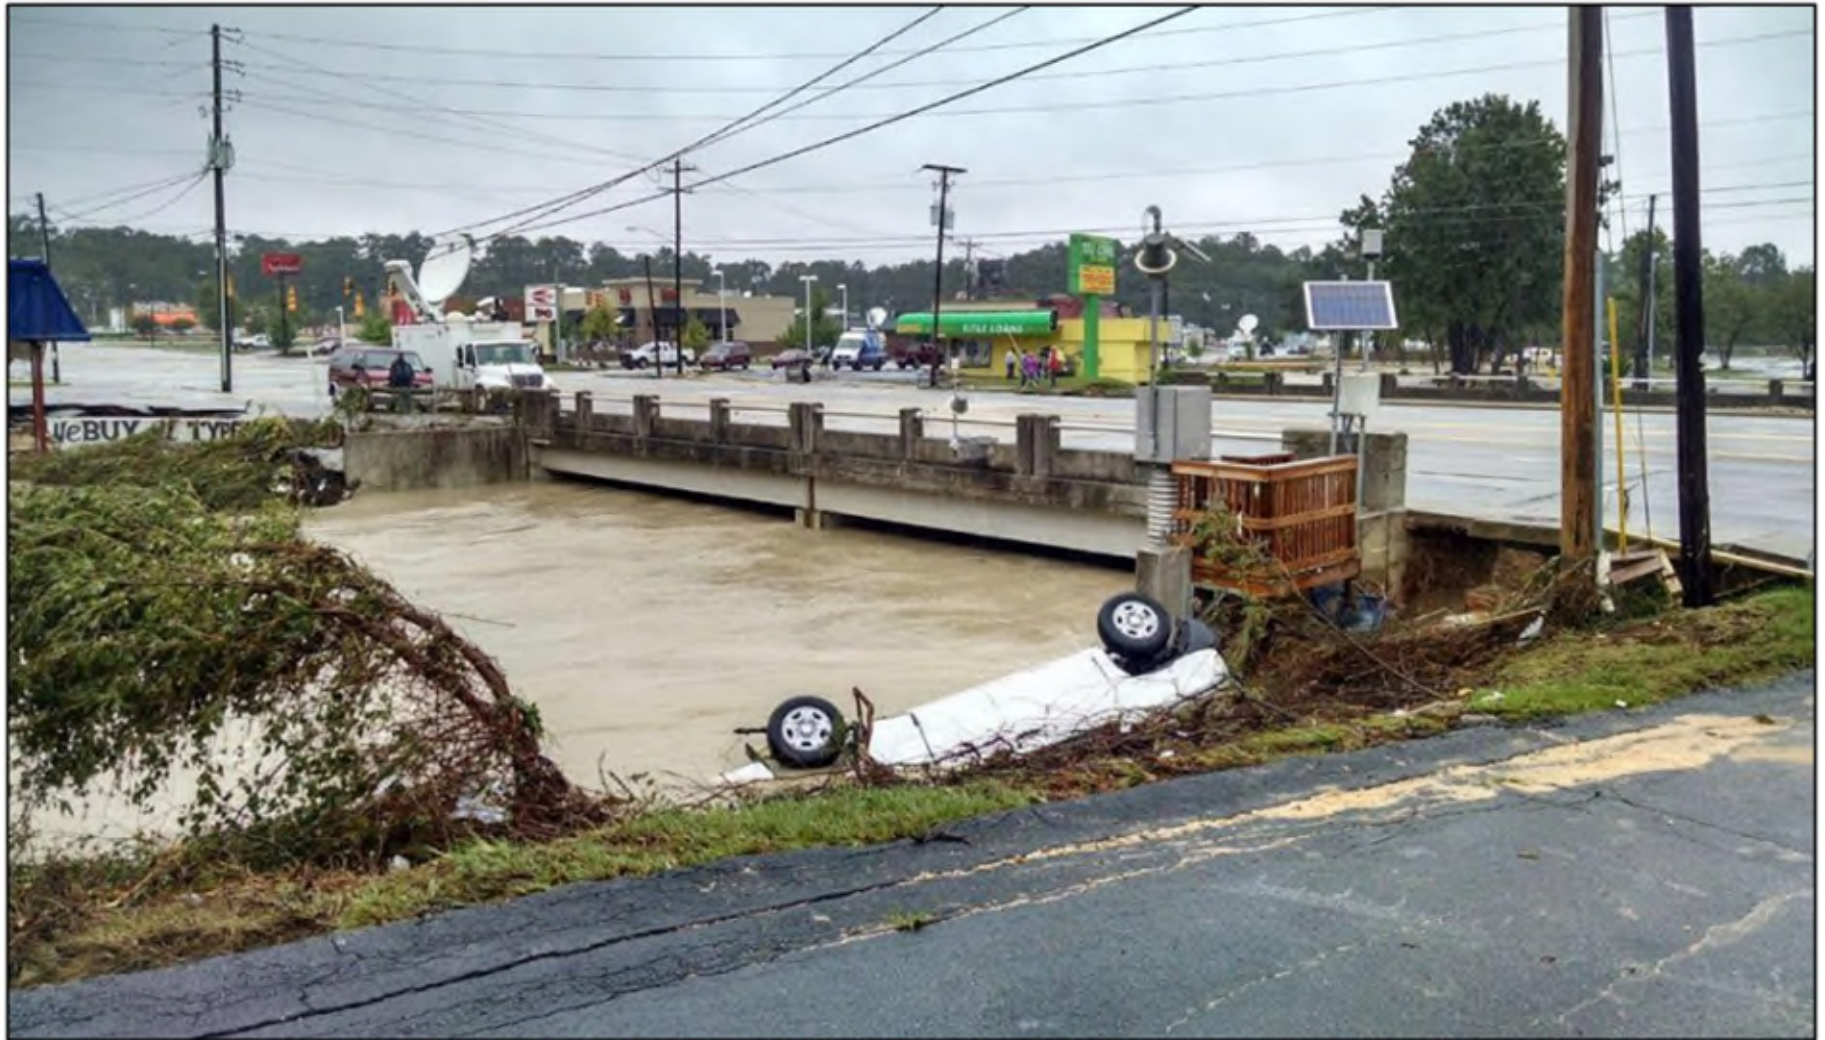
Figure 5: Conditions at U.S. Geological Survey streamgaging station 02169570, Gills Creek at Columbia, SC, on October 5, 2015. *Source: USGS*

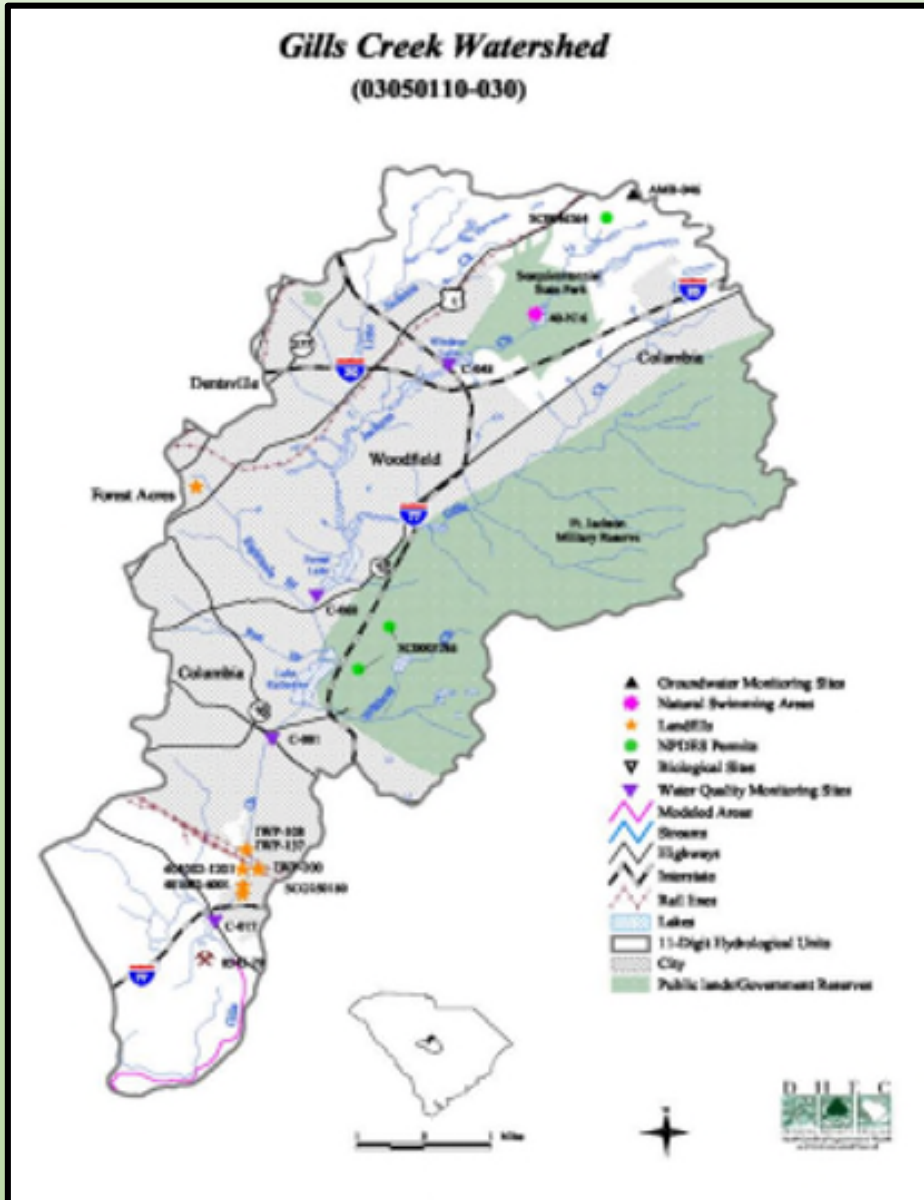
- C- 046 Sesquicentennial SP Lake
Impaired for fish consumption due to Mercury
- Site C- 048
Impaired for Aquatic Life due to DO
- Site C- 068
Impaired for fish consumption due to Mercury (historic)
- Site C- 001
Impaired for recreational uses due to fecal coliform
- Site C- 017
Impaired for Recreational Uses due to fecal coliform and Aquatic Life due to low DO & impaired with Pb, Zn

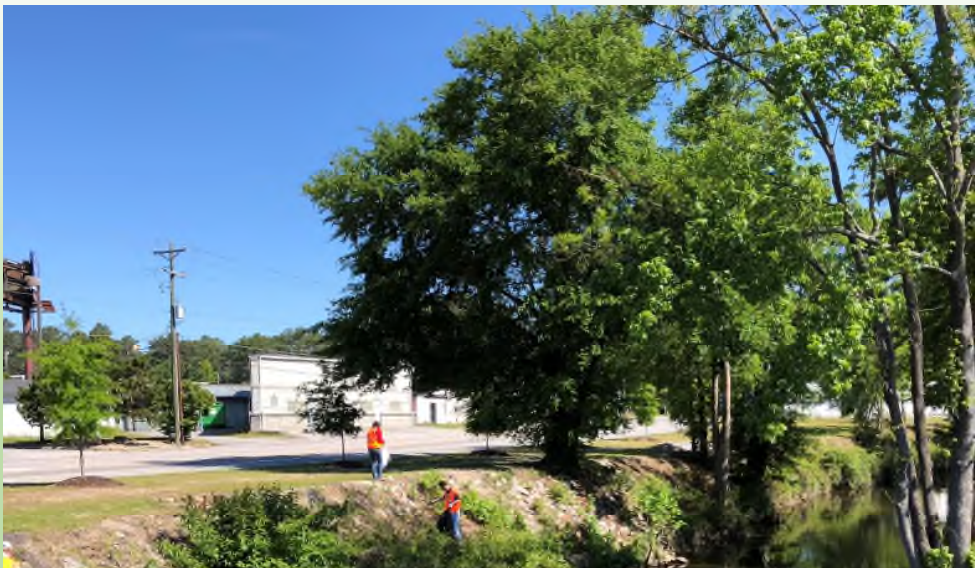
2020 Parking lot direct RO to Gills Creek

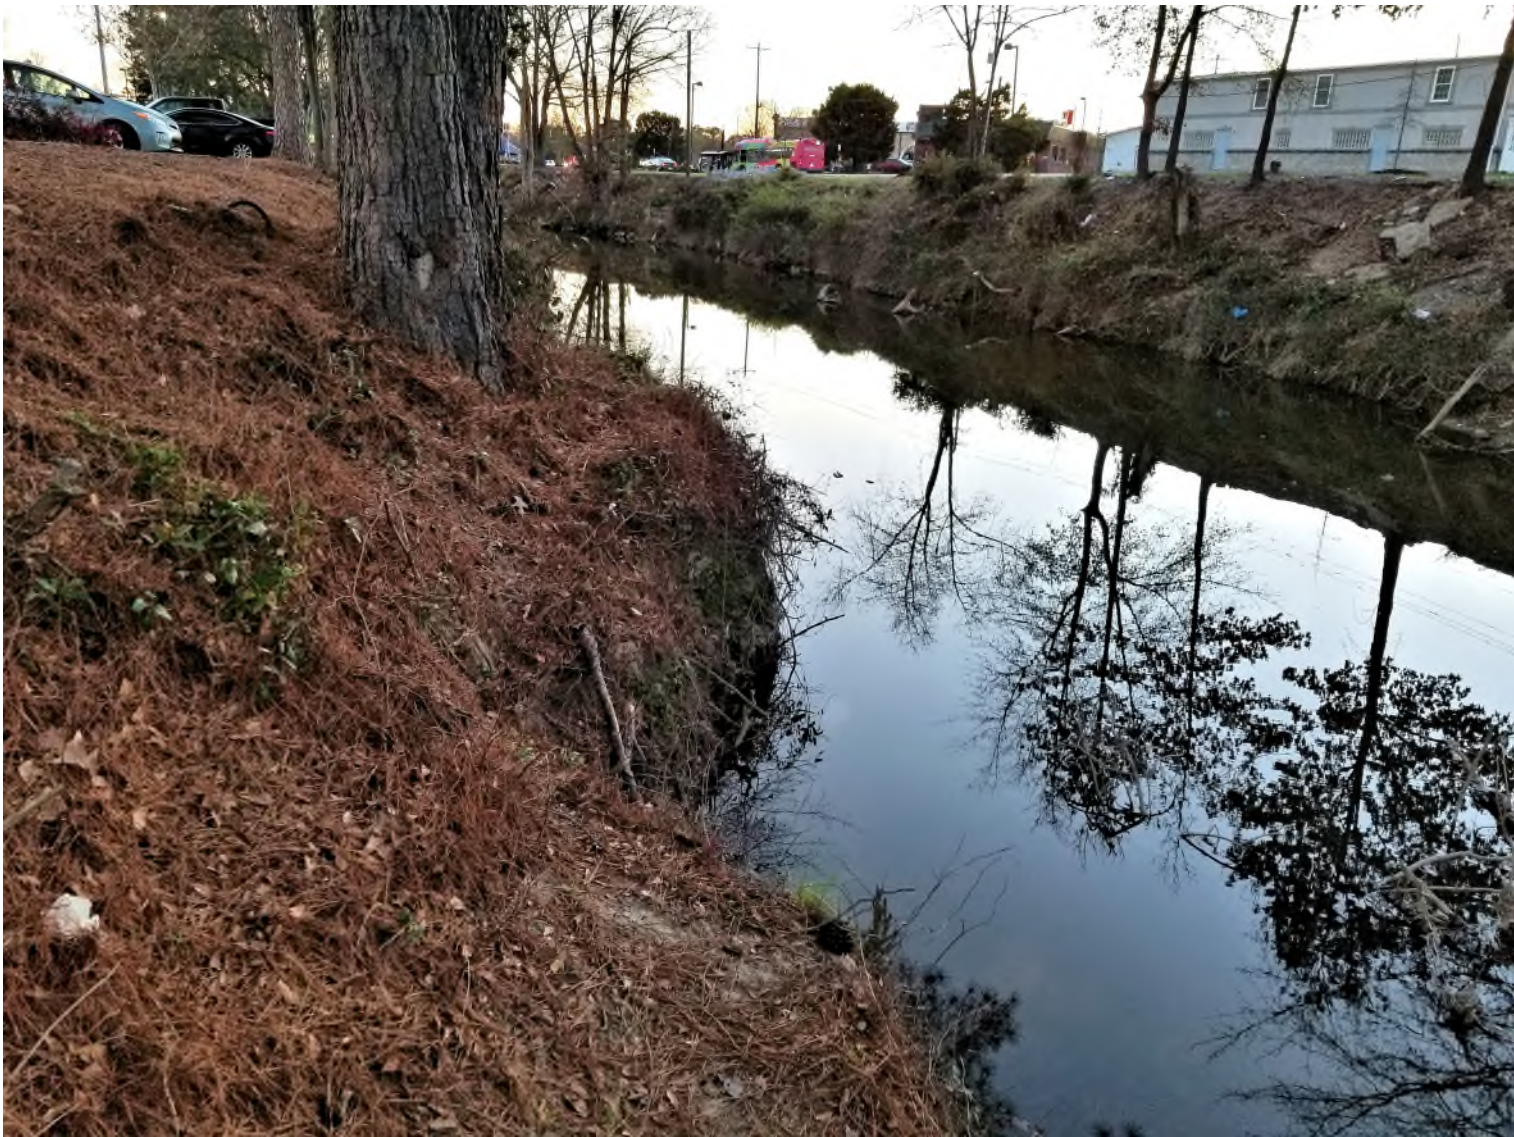
2018- Steep slopes, heavily eroded and little riparian buffer

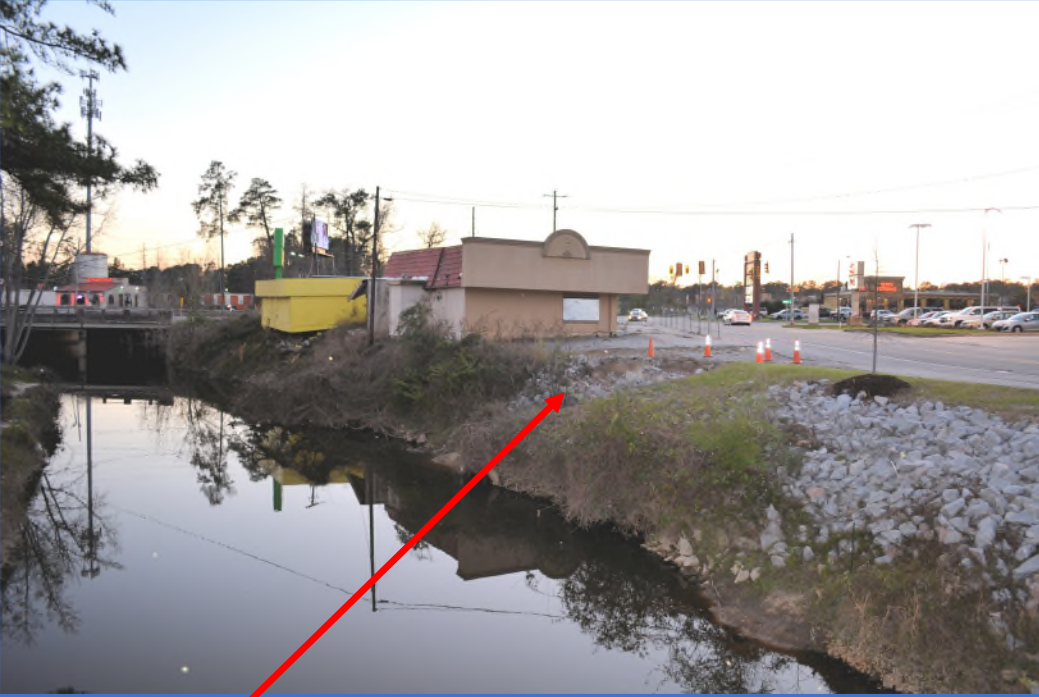
Storm water
erosion along
Crowson Road

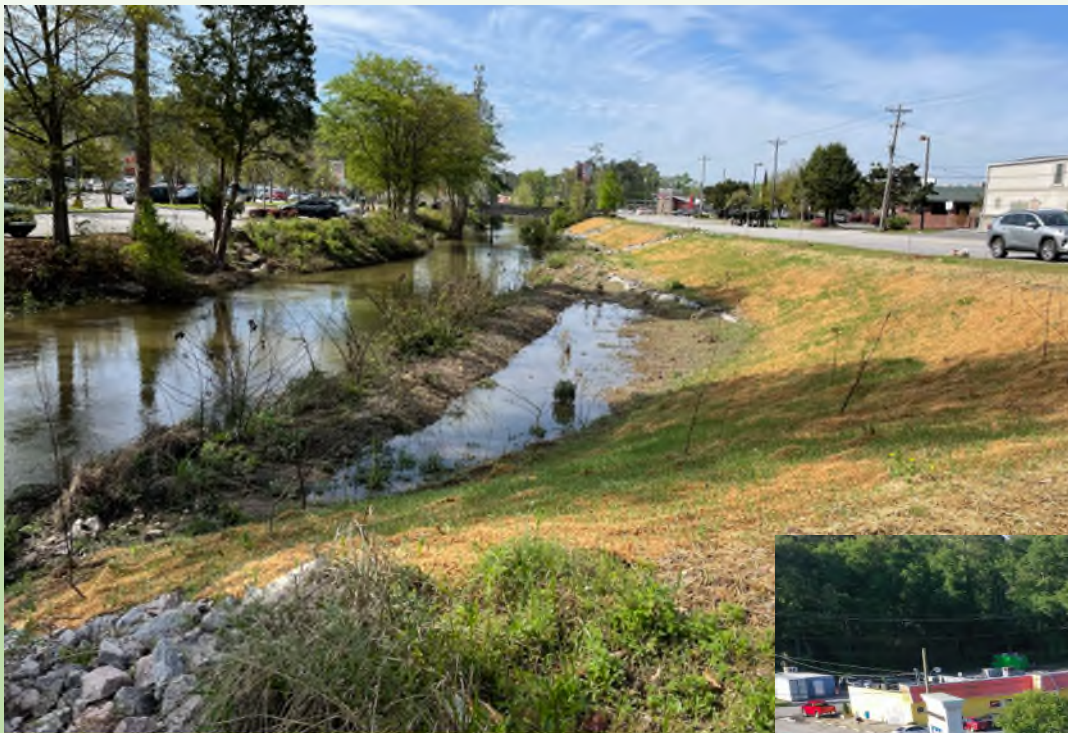
3/28/2023 – water in bioswale from heavy rain previous day

4/21/2023 – vegetation becoming established

- 1) Demolition / Removal of existing detrimental elements.
- 2) Install two large infiltration/bio-retention basins/ bio-swales allowing infiltration to groundwater and slower release as base flow;

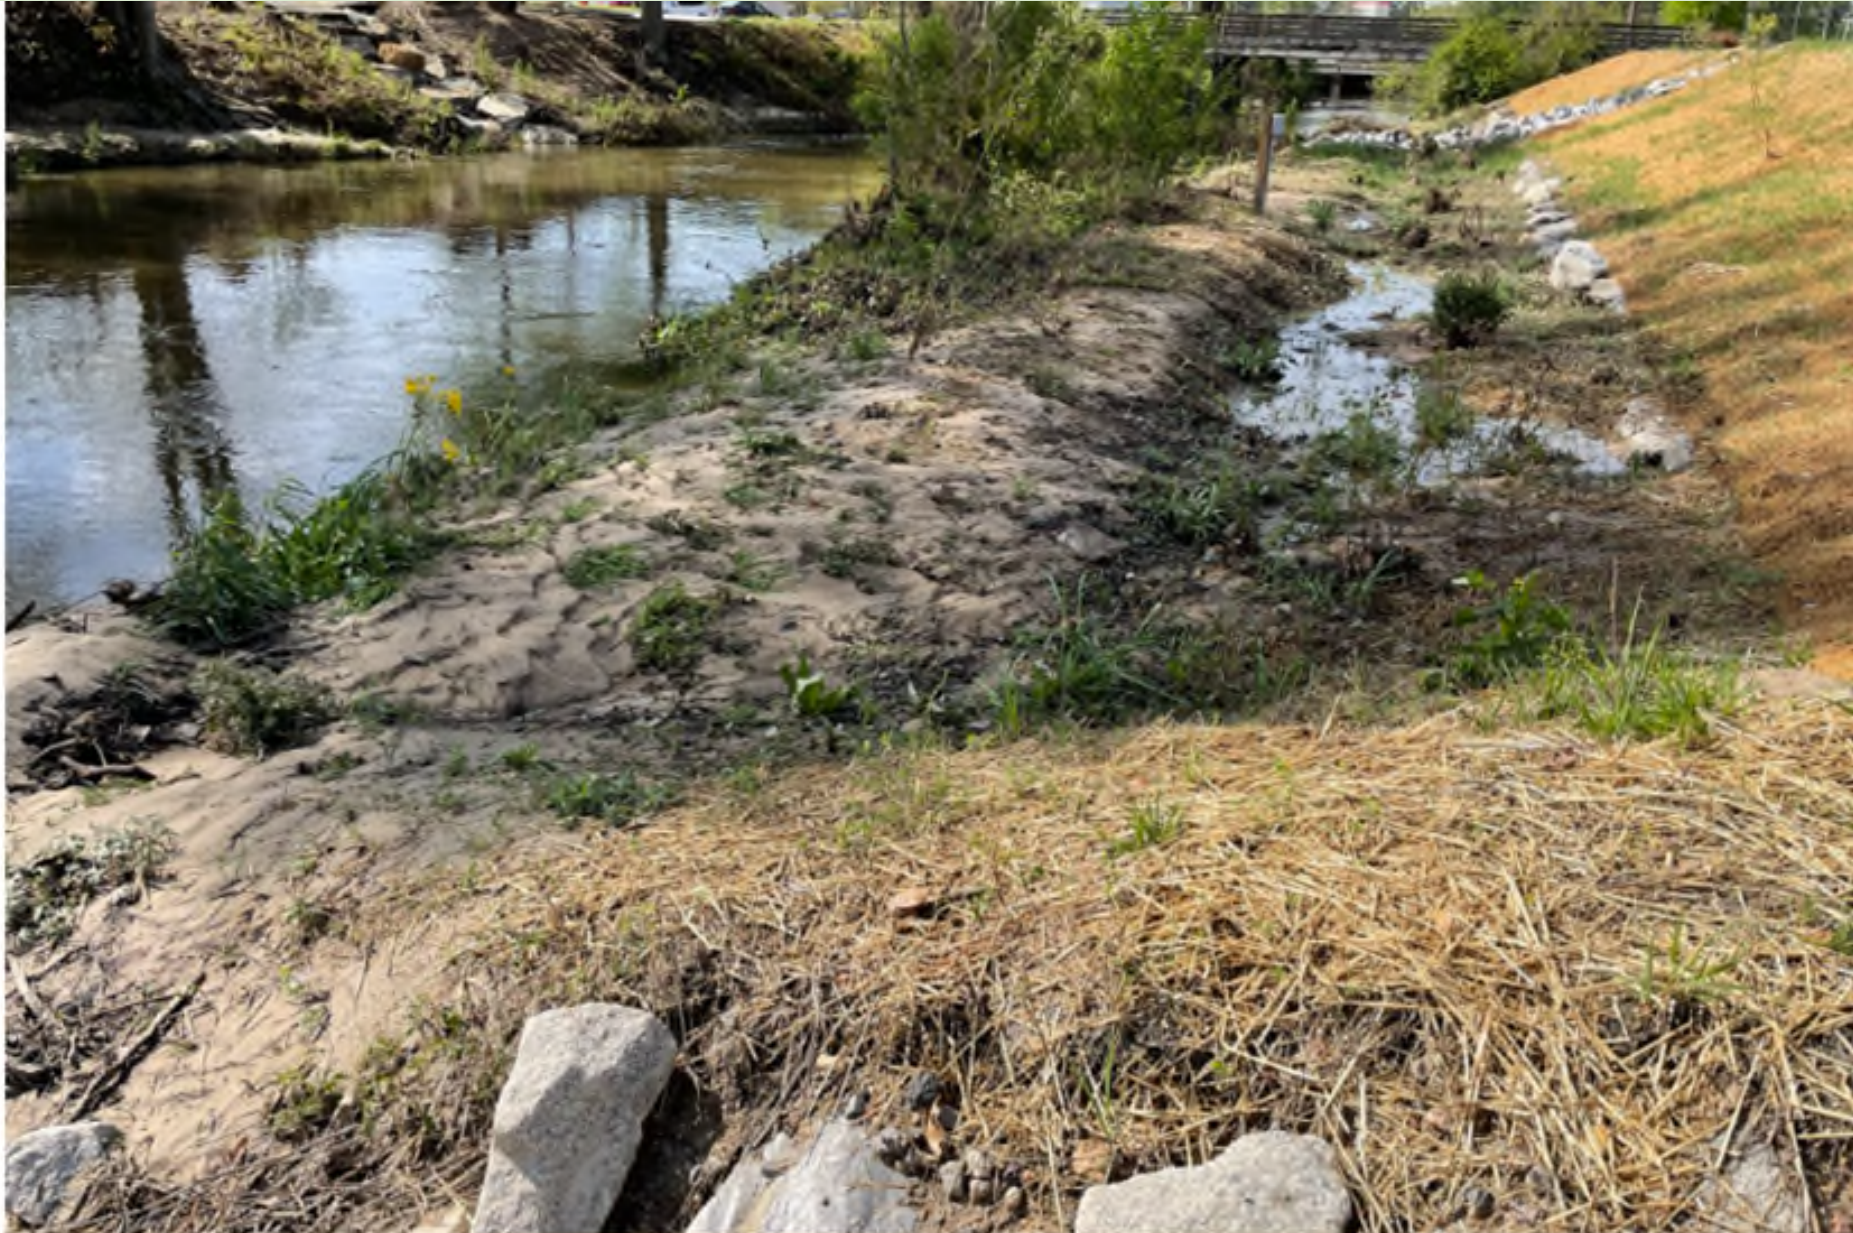
3/28/2023 Lower Bio-Swale and
toe rocks retaining sediment from high flow event

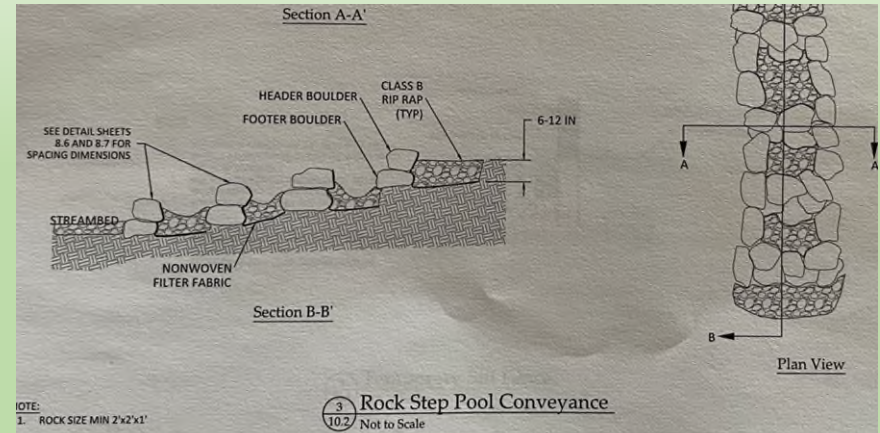
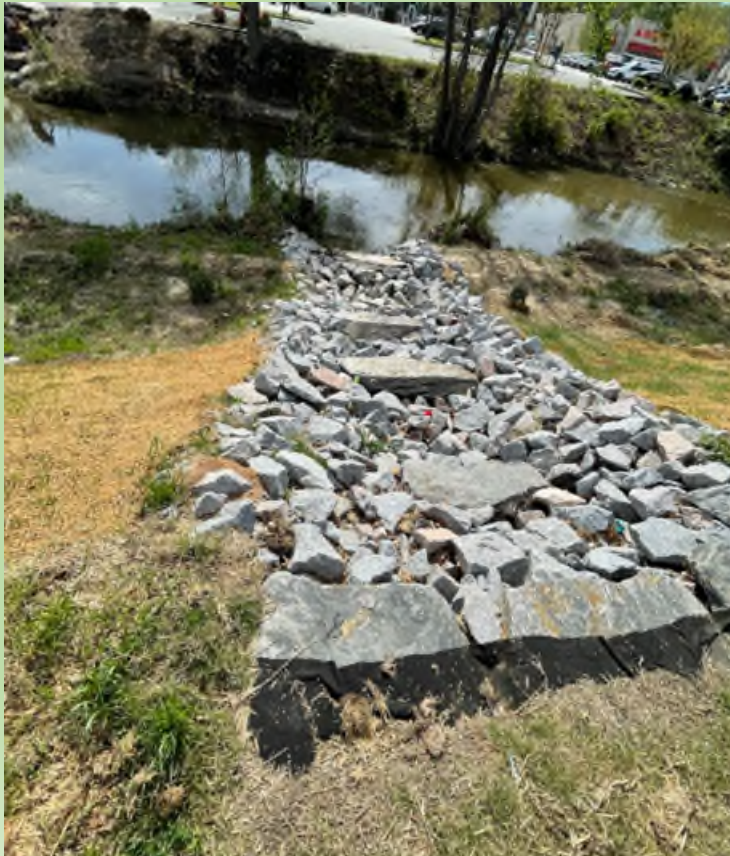
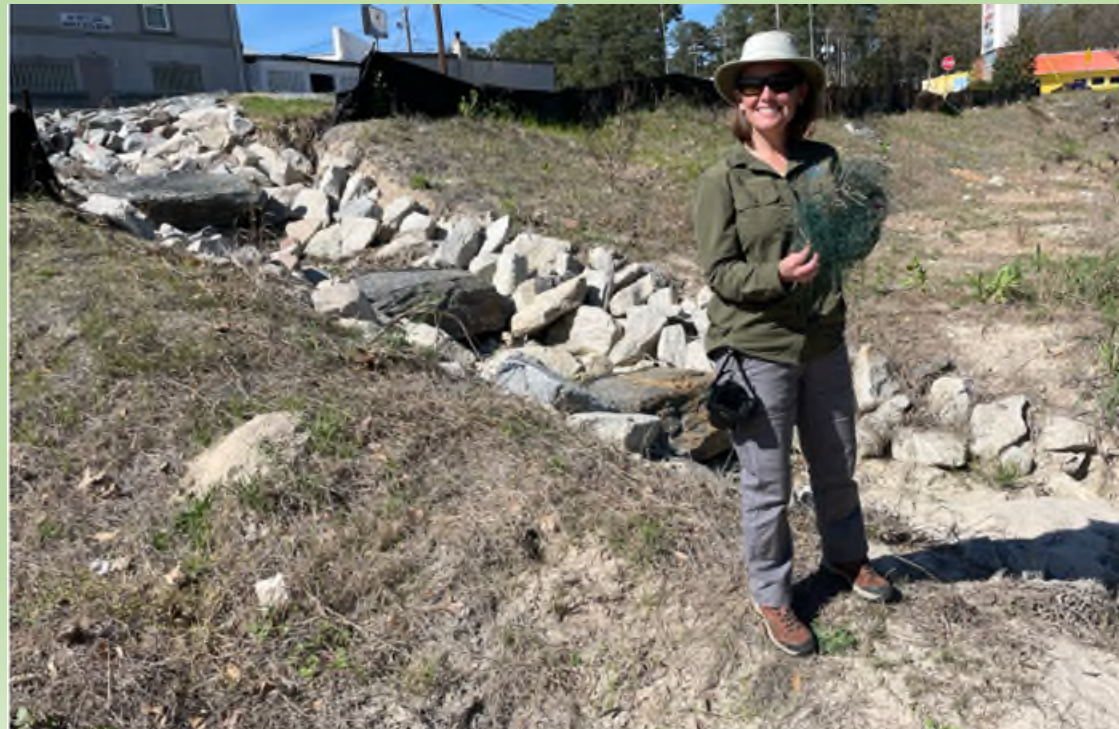
3) mini-infiltration basins thru Rock Step Pool conveyances;
Increase DO and
Increase infiltration

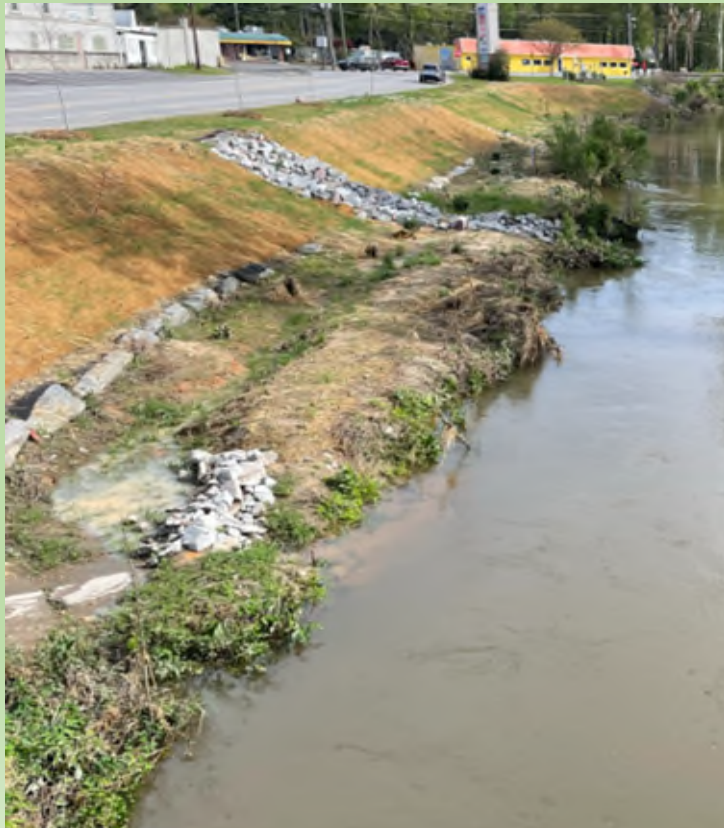
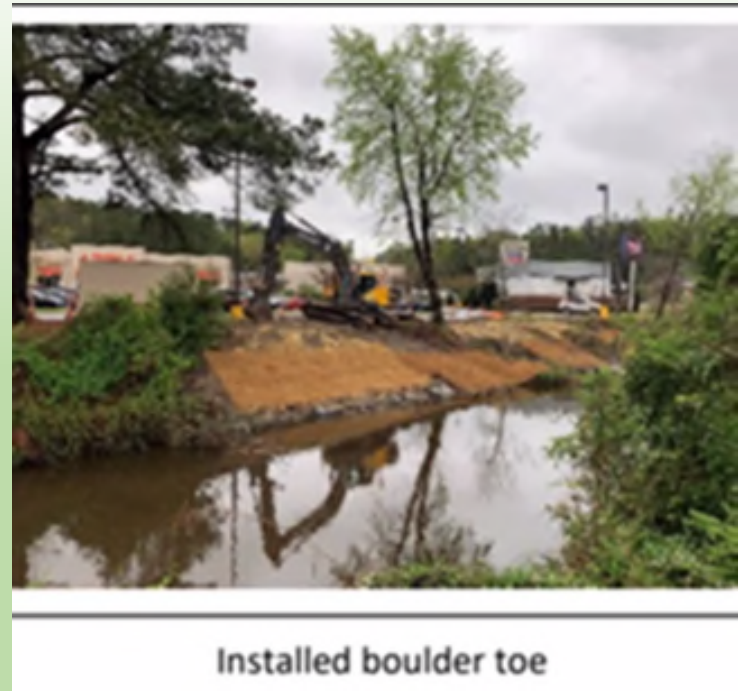
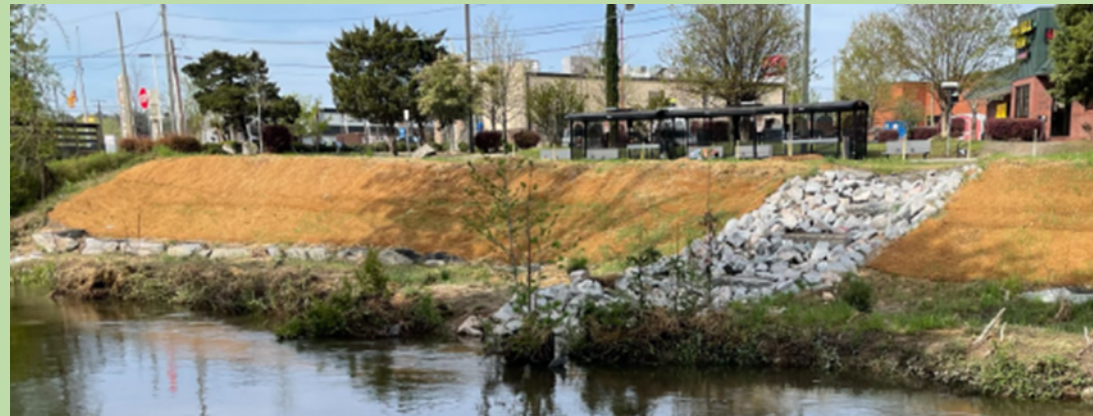
4) boulder placement along bank to reduce sediment loads from upstream;

5) boulder placement at bank toe to reduce slope pitch;

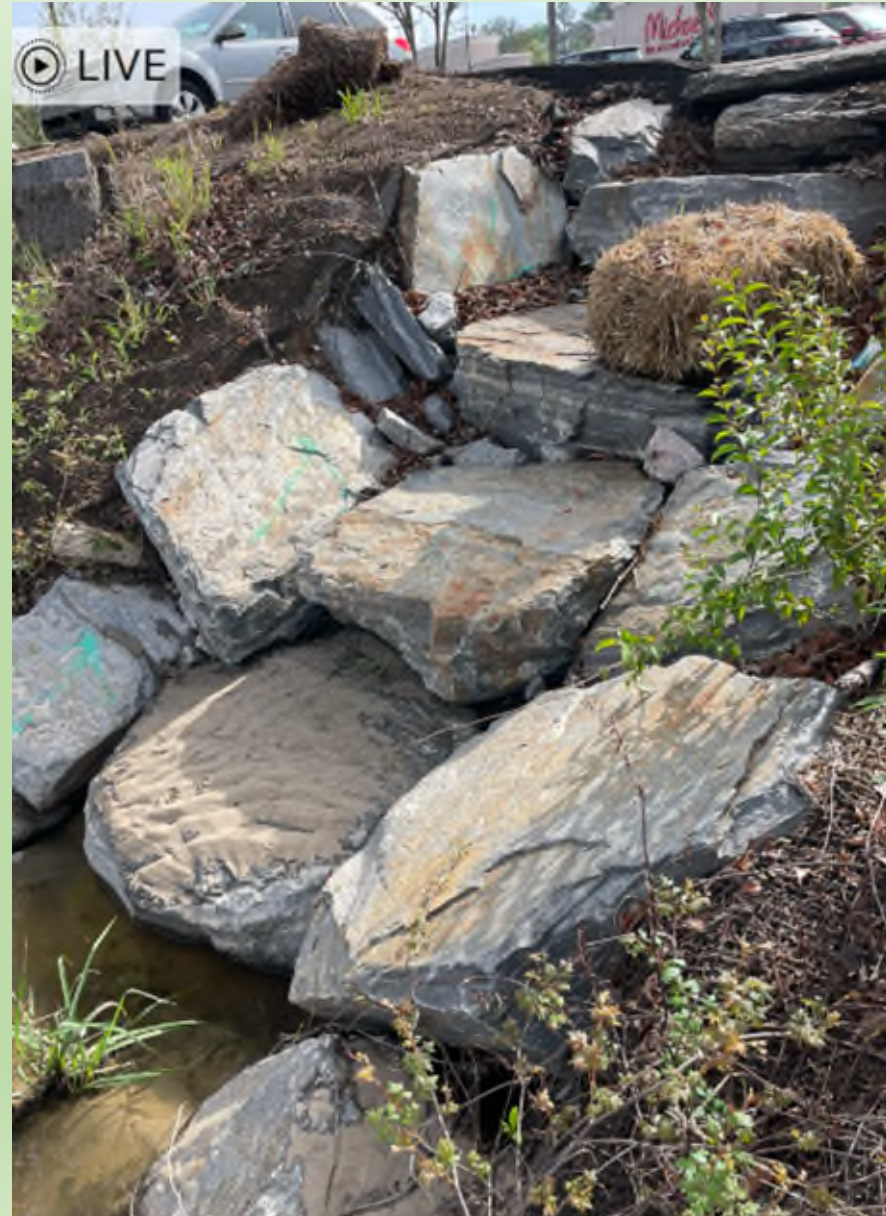
6) daylighting of stormwater pipes to rip rapped flow channels, 7) removal of asphalt stormwater discharge flumes and replacement with step boulders creating a series of small waterfalls to aerate water (increase DO)

Installed and stabilized rock cascade

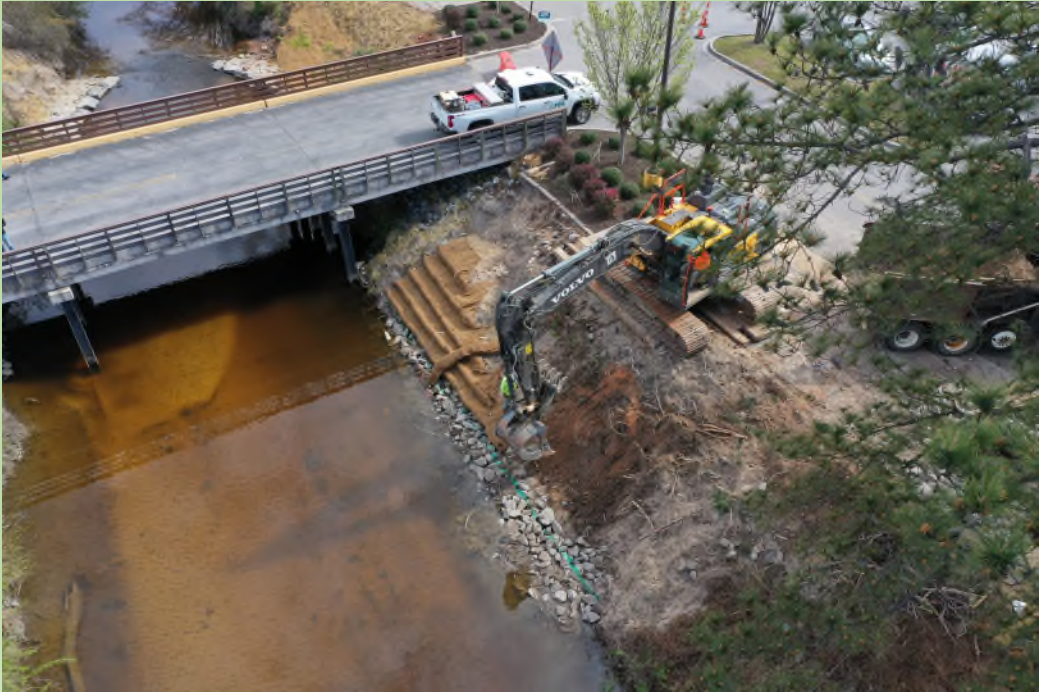
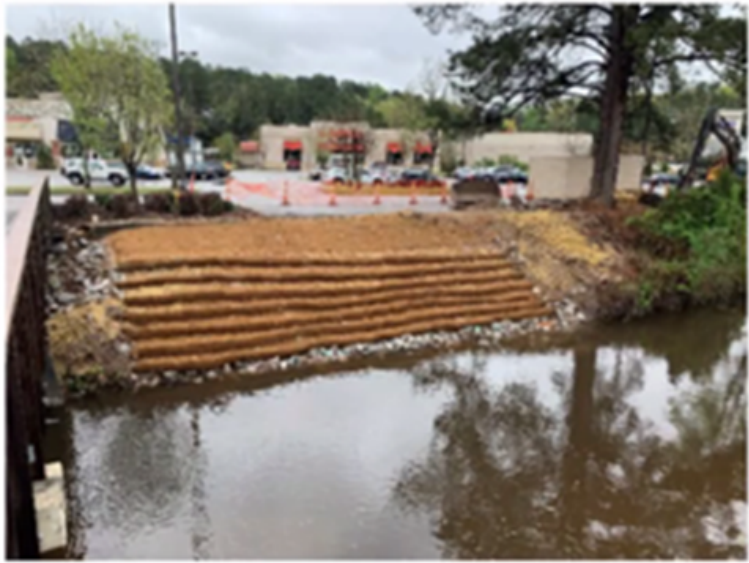
8) Geolift Installation

Installed geolifts 4/2022

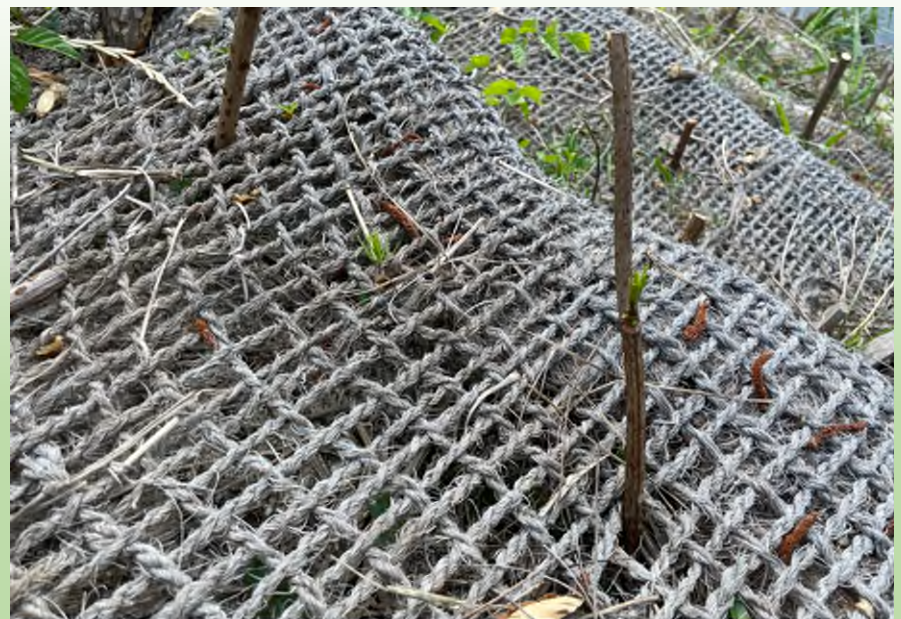
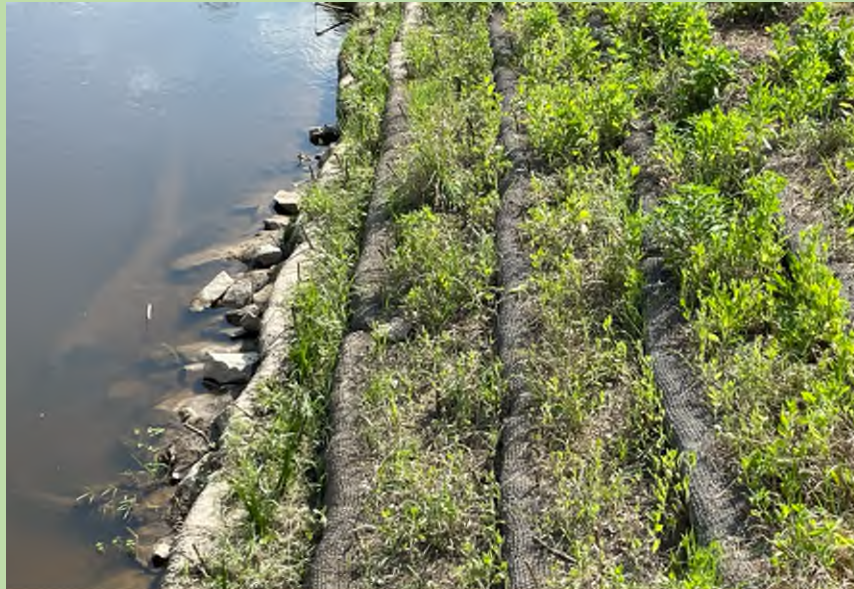
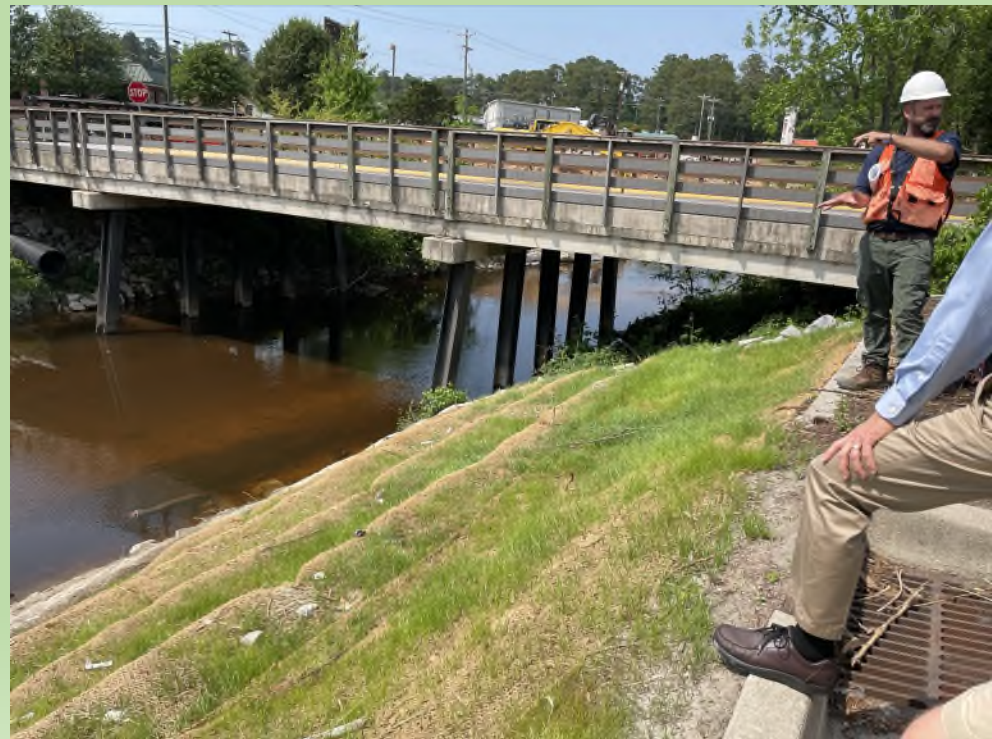
Geolift Planting

Live stakes, plants,
seeded

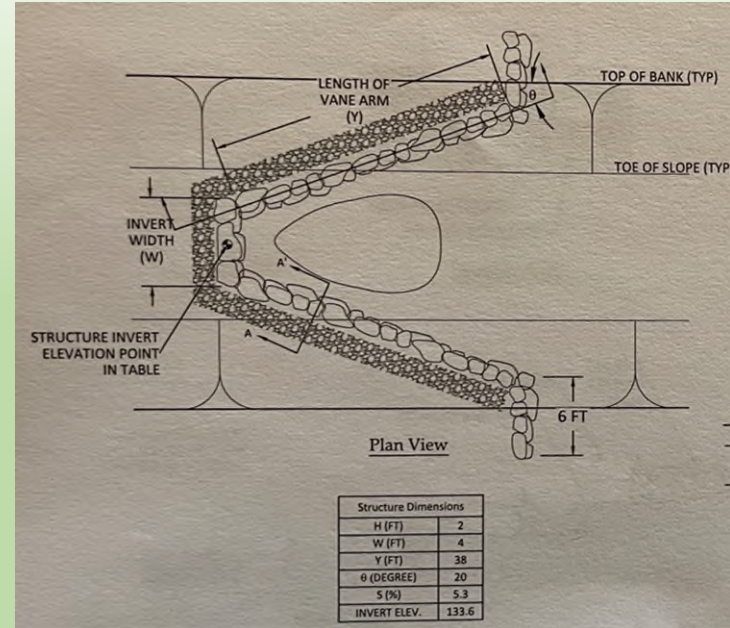
9) Rock Cross Vane and J-Vane to be installed for bank stabilization and improved habitat

Rock Cross Vane installation

3/28/2022 – during construction

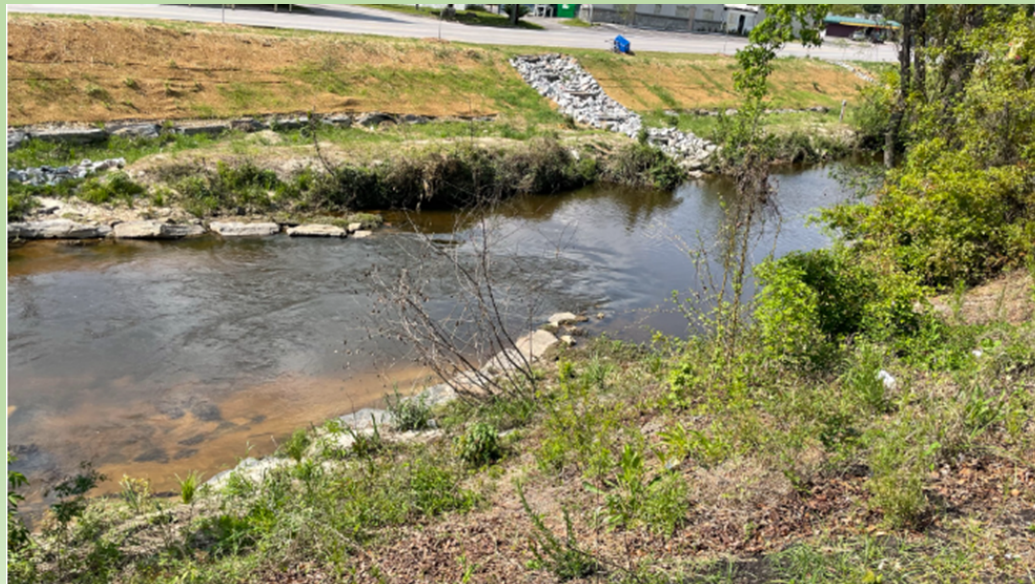
Bank stabilization, improved habitat
