Passive Treatment Systems on Life Support Pulling the Plug & Rebuilding

Case Study

By: Buck Neely, P.E.; Tim Danehy, QEP; Dan Guy P.G.;
Ryan Mahony, Logan Hauck, Cliff Denholm

BioMost, Inc.

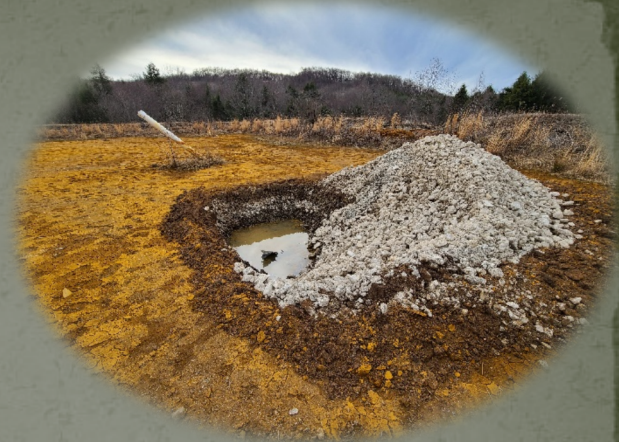
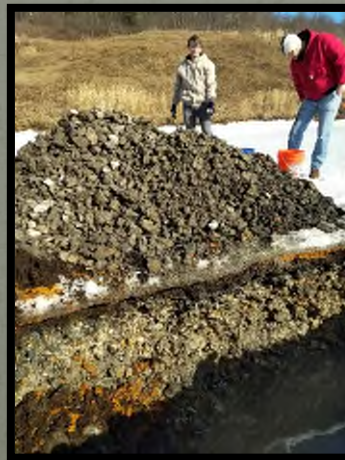
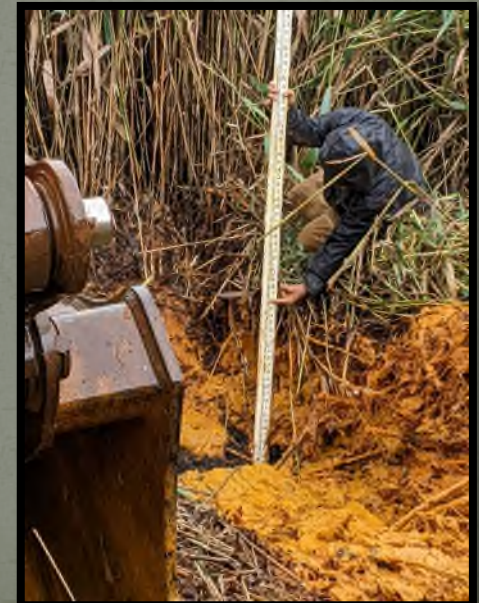
- Site Maintenance History / Logs
 - Type, Frequency, & Result
- System Diagnostics
 - Water Quality & Flow (In and Out)
 - Bypass / Overflow
- Visual Inspection of Treatment Media
 - Test Pits
 - (system necropsy)

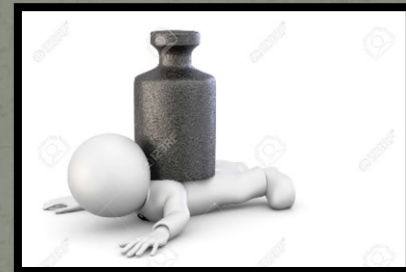
- How is the System Performing?
 - Water Quality – Effluent
 - pH, Alk vs Acid
 - Actual Flow vs Design Flow

- Any Structural Damage to Components
 - Pipes, Valves, Embankments, Spillways
- Time Between Major Maintenance Events

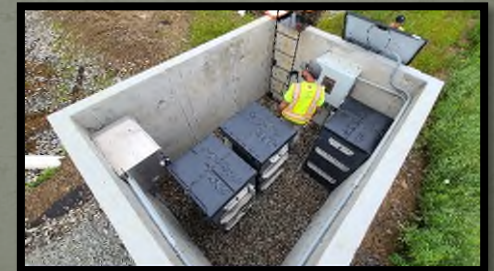
- Inlet Water Quality & Quantity
 - Changes in Raw Water Quality?
 - Flow - H Flumes
- New Technology Considerations
 - Treatment Tech (Solar Powered Flushing)
 - Remote Monitoring (Flow, pH, Water Levels)
- Treatment Component Selection
 - Not Always the Same as Existing

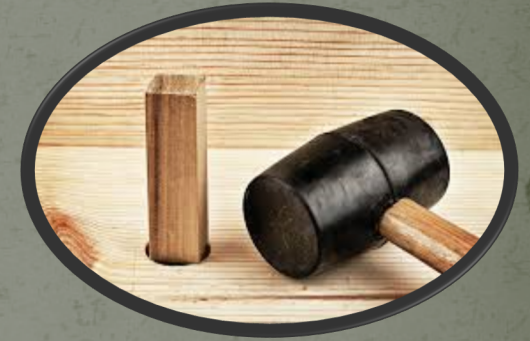
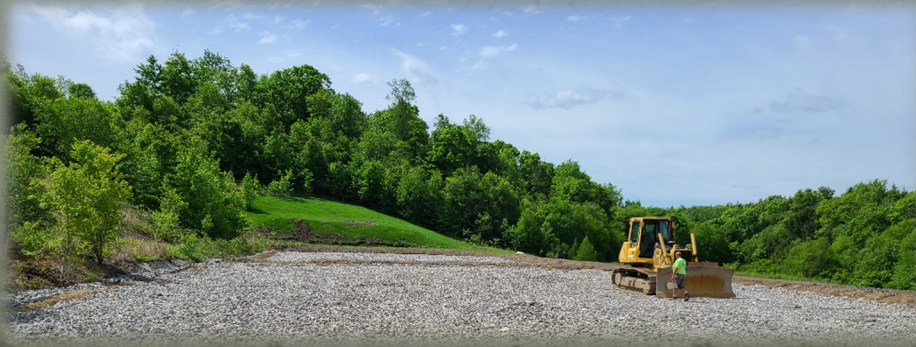
- System Footprint
 - Space Constraints
 - Reconfigure, Expand, Combine, Add
 - Available Elevation
- Spent Media Placement / Disposal
 - Organics - Spread Onsite & Revegetate
- Sludge Cells

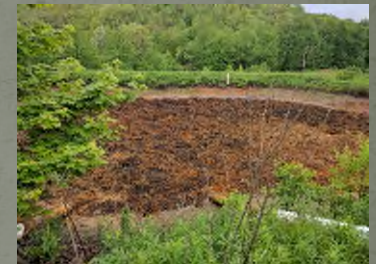
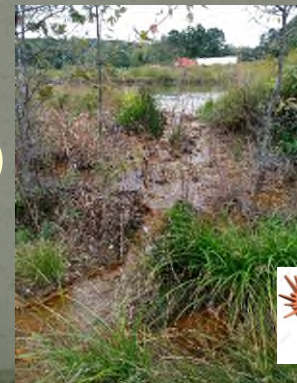
- Reconfigure Collection (3-way flow splitter)
 - Capture upwelling in channel – route to WL
- Expand system to have 3 Larger JVFPs (Mixed Media)
- Improve both wetlands (directional barriers)

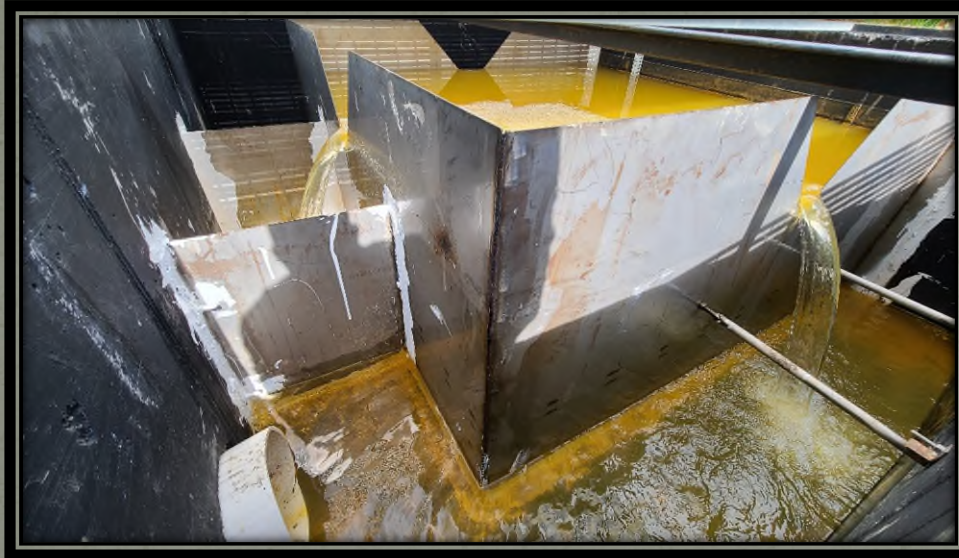
- 3 – Way Flow Splitter
 - 1 Water Level Reading (Staff Gauge)
 - 28% - 28% - 44%
 - 74° V Notch (x2) & 90° V Notch (x1)

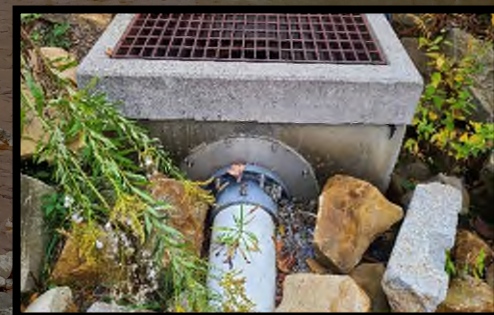
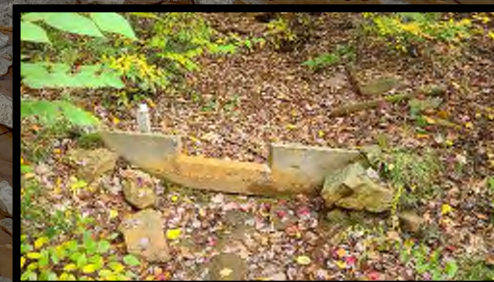
- BOLTS (Batch Operating Limestone Treatment System)
- H-Flume
- Holding Pond – AFVFP₁, SP₁, AFVFP₂, SP₂

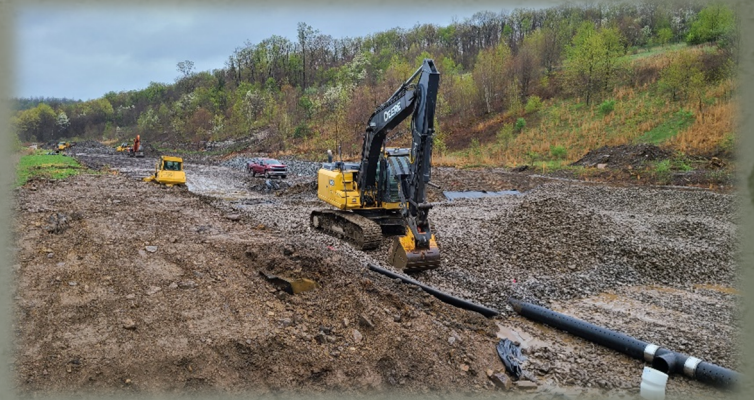
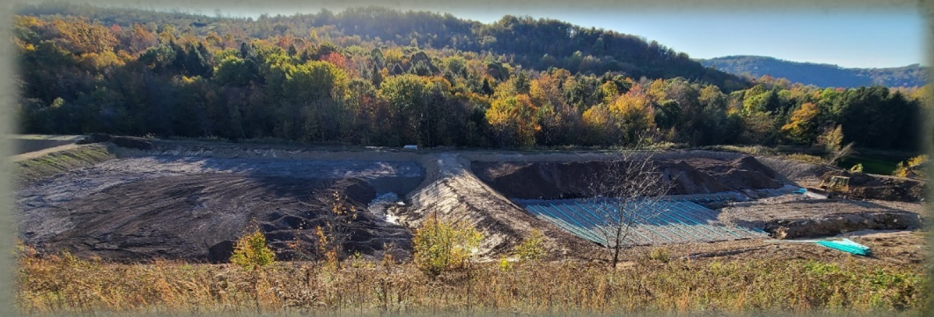
- 3 Staggered AFVFPs (Parallel)
 - 3,000 Tons LS Each
 - Adjustable Hold times (12-hour)
 - Fill on 8hr Staggered Offset
- 2 JVFPs (Parallel)
 - 2,800 Tons LS Each
- Stone Recovery Rate 82%
 - 19,886 Tons Existing
 - 16,257 Tons Recovered
Reused
