Investigation Acidic Discharges at the Monahan Abandoned Mine Lands Site, Kansas*

P. Behum, Ph.D.¹, M. Spence², J. Arruda, Ph.D.³, R. Johnson⁴ and C. Kiser⁵

*Presented at the 41st Annual Meeting of the American Society of Reclamation Sciences (ASRS), June 2-6, 2024, in Knoxville, TN.

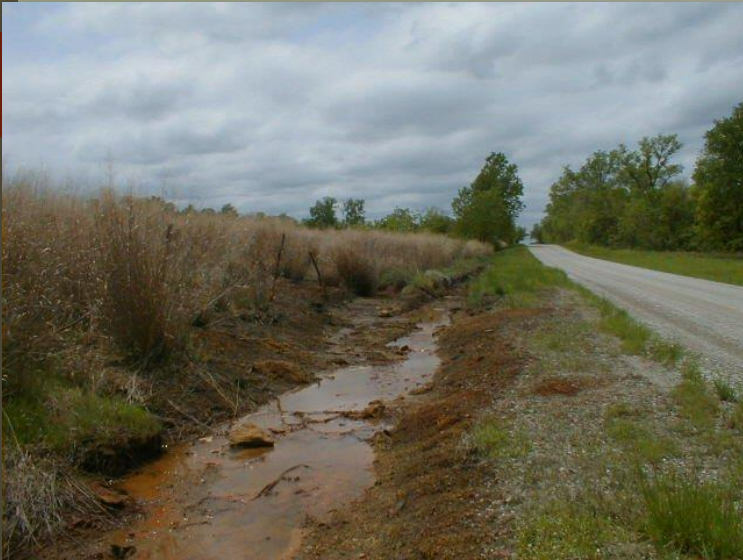
AMD along road ditch (U1 to U4).

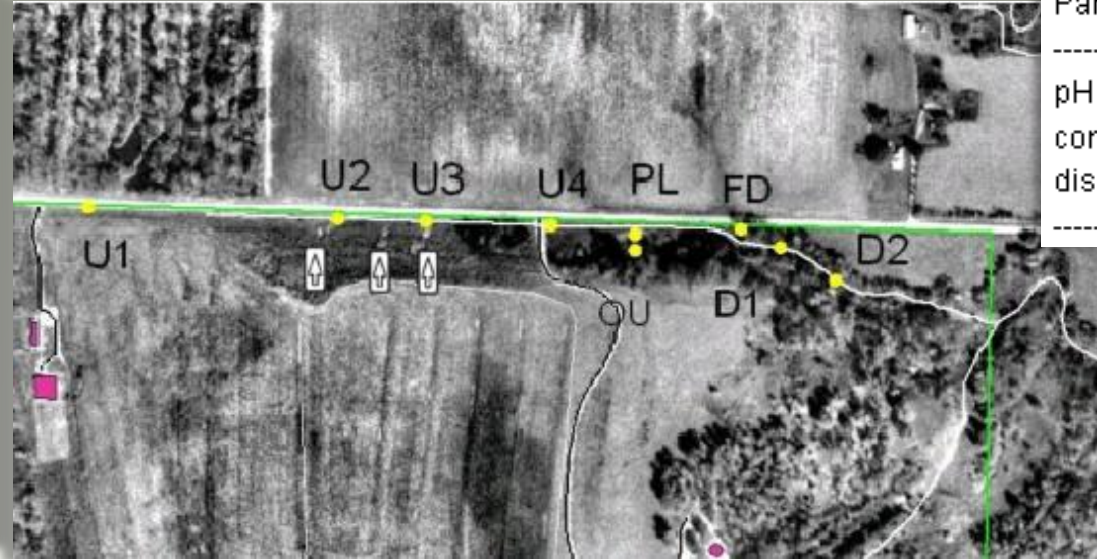
PSU well data and sample location map (Arruda, 2003)

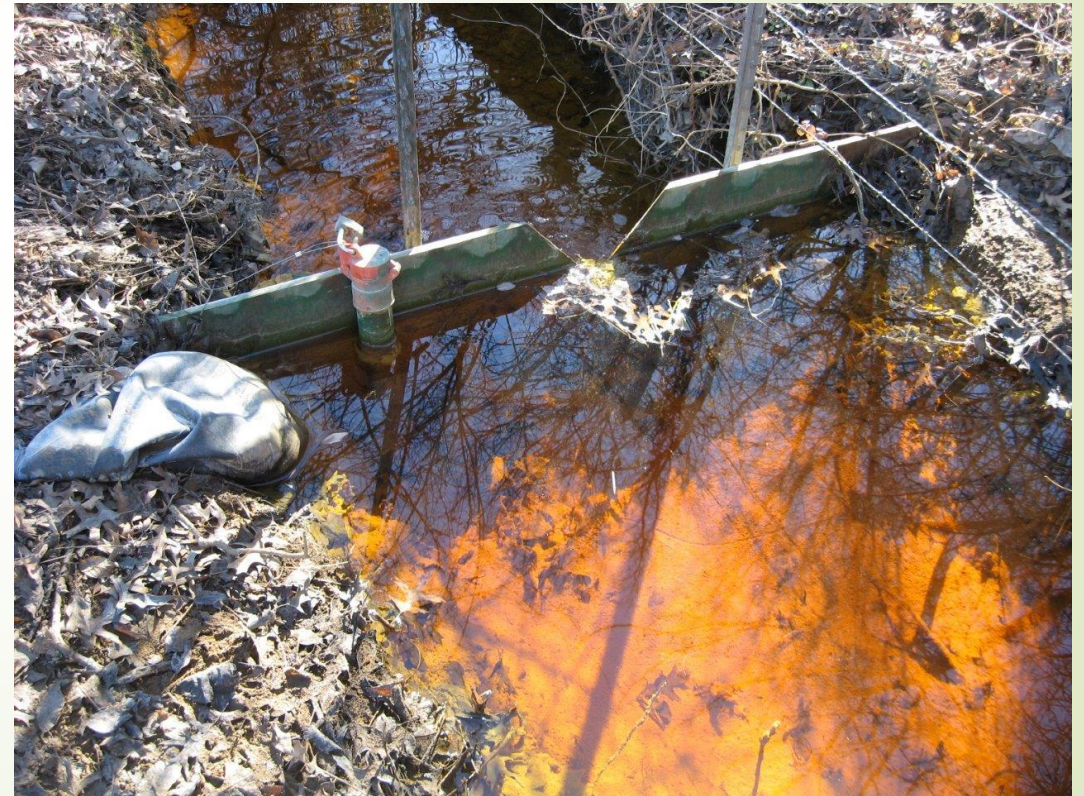
Wier installed at AMD site D-2

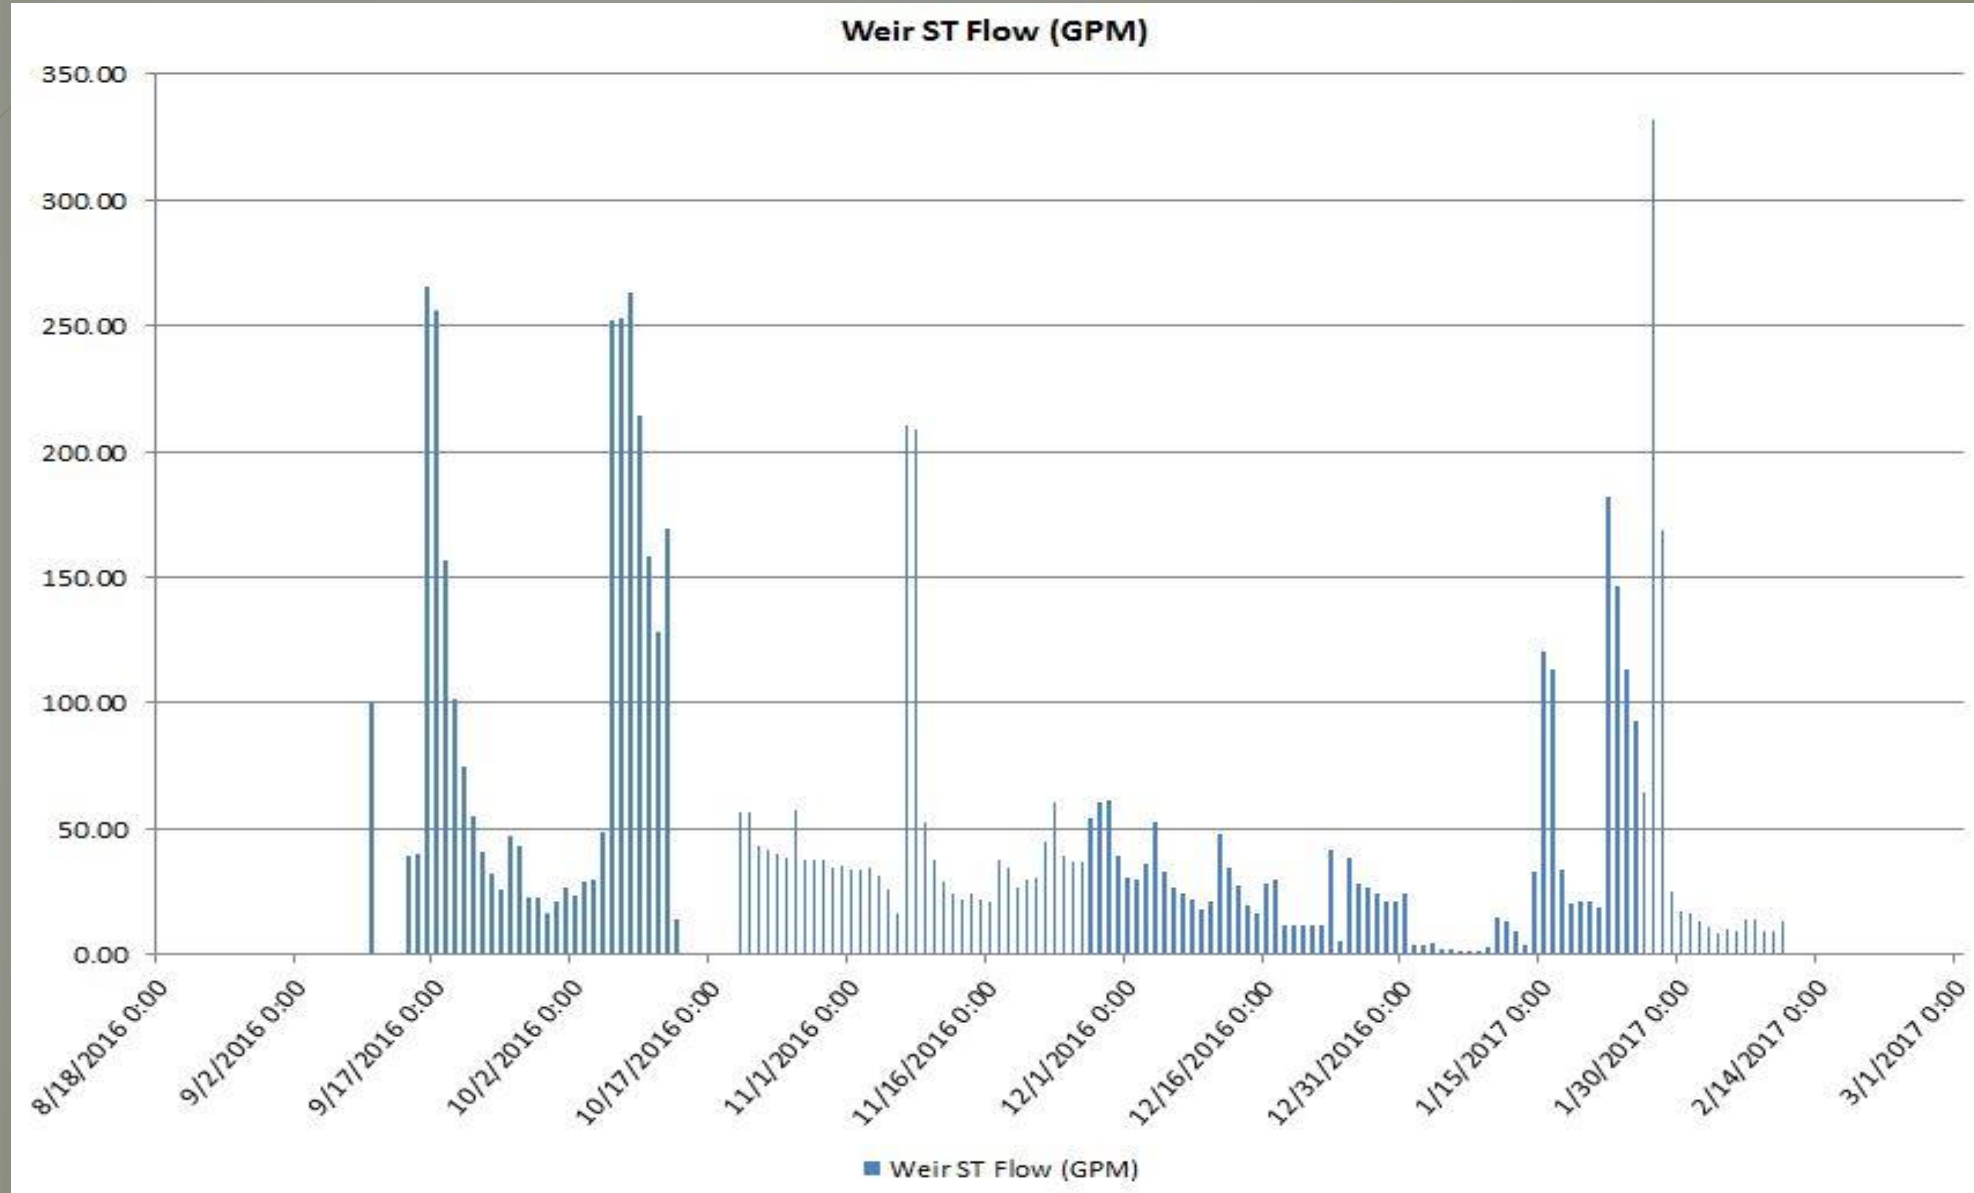
KDHE/OSMRE/PSU Baseline Hydrologic Investigation: [Site ST](#)

Dilution Water Hydrograph

Site ST Dilution

| Flow | 25.4 GPM |
| pH | 6.82 |
| Net Acidity | (-)58.5 mg/L CCE |

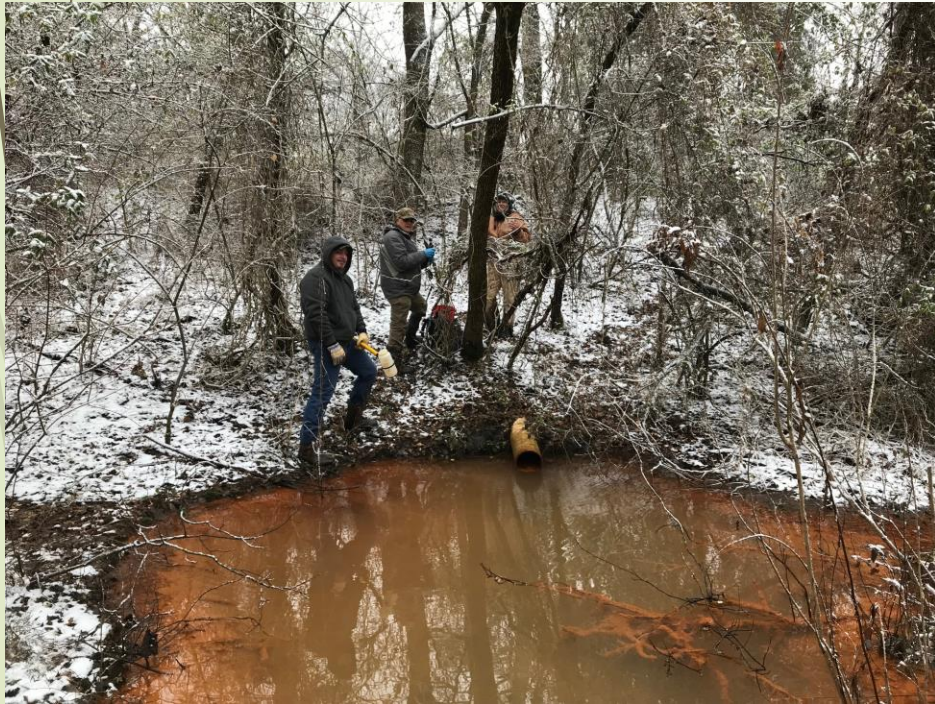
Site BP – Berm pipe discharge (runoff accumulating in the former slurry cell).

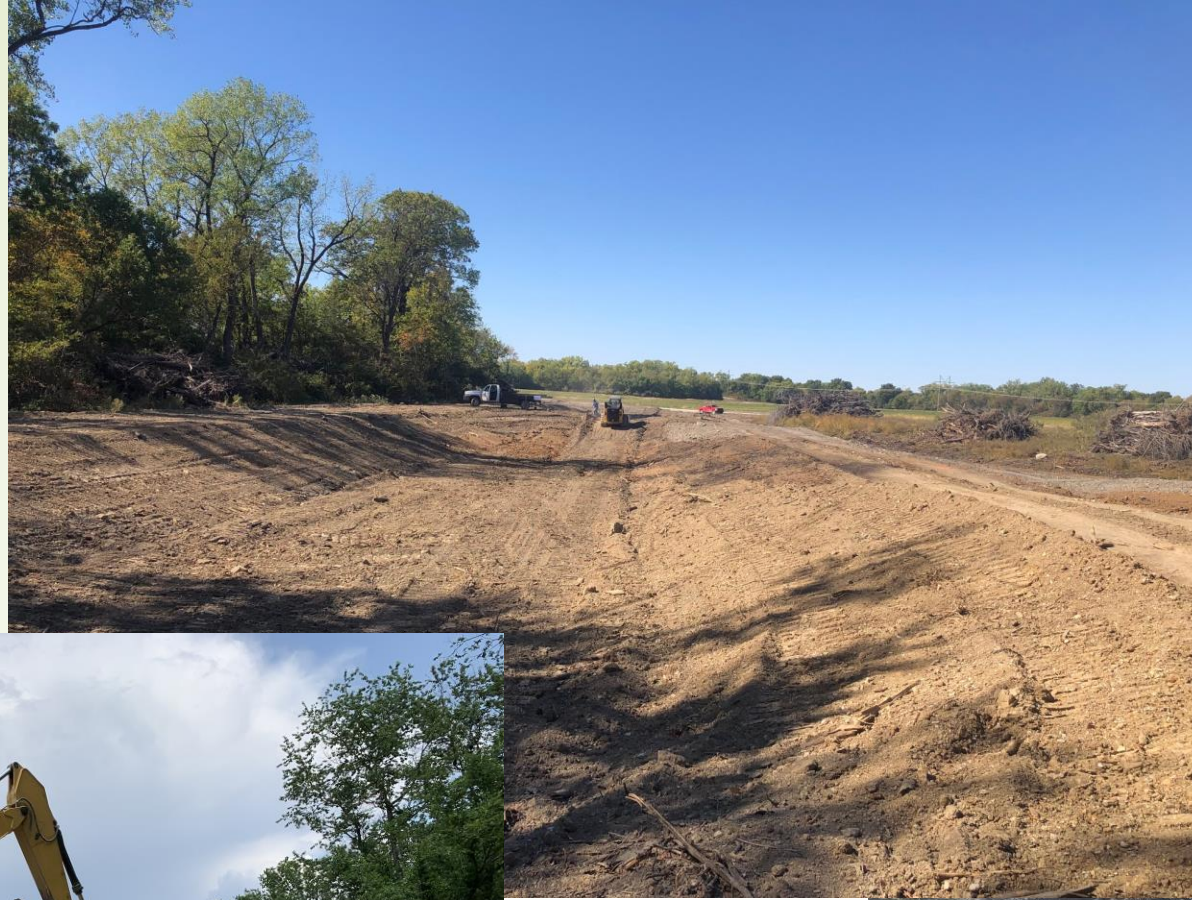
Precast Weir
Installation 2023

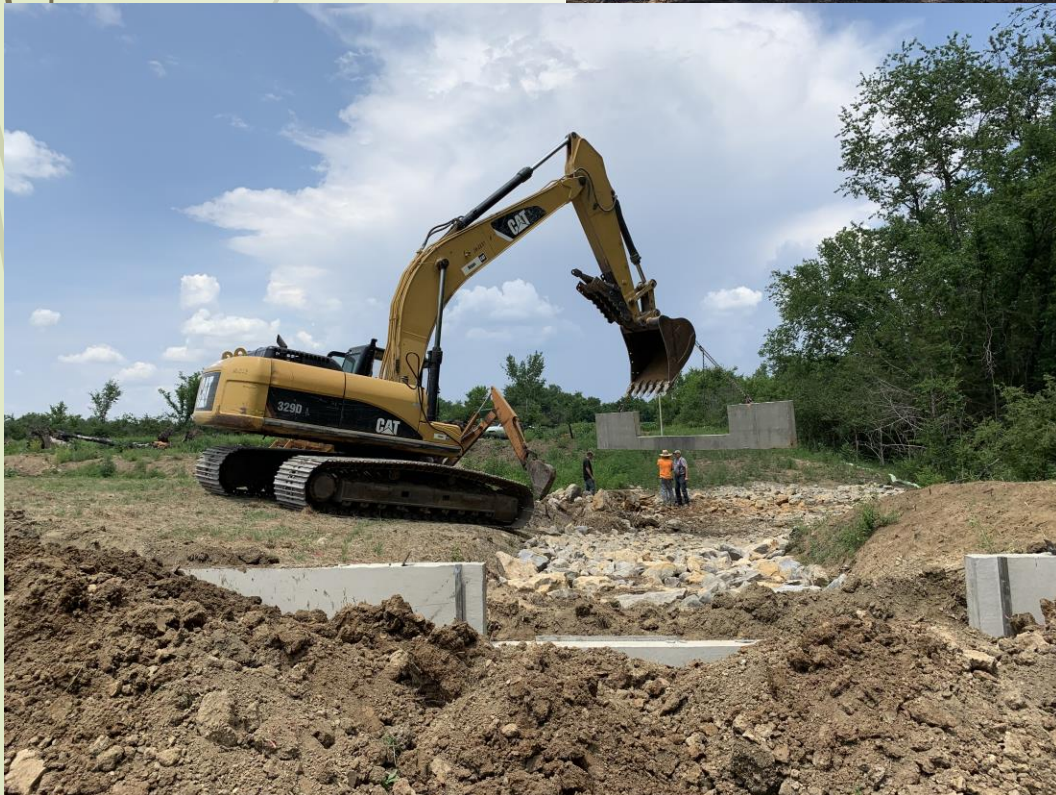
AMD collection
ditch 2022

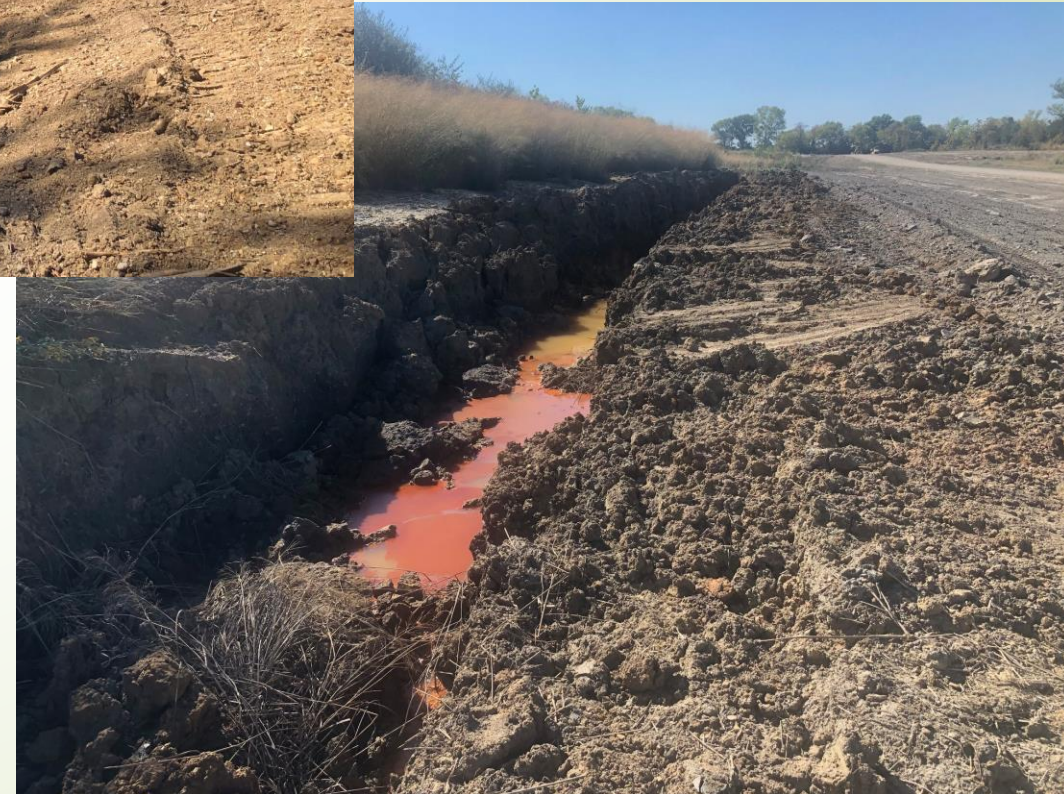
VFP May 2024

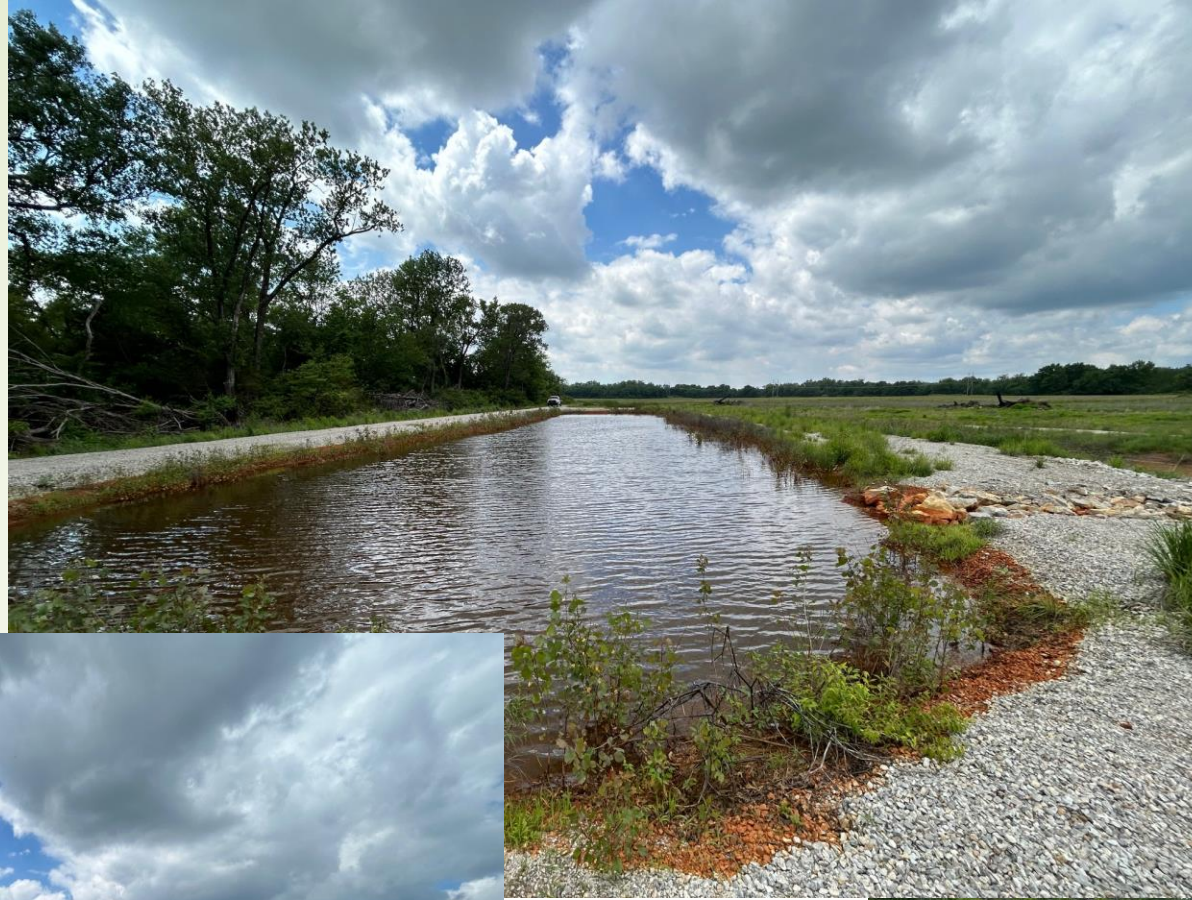
Oxidation Pond 3

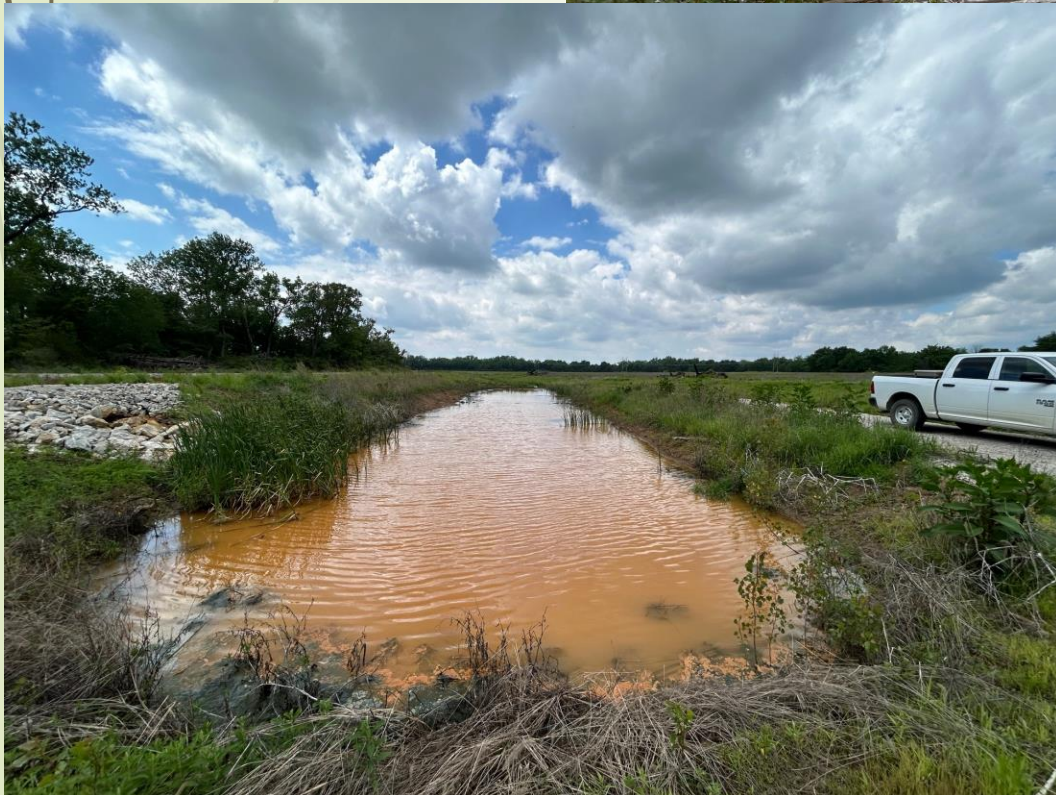
Wetland 1
May 2024
