Management of Acid-Forming Sediments at the Stafford Airport Expansion Project in Virginia

W. Lee Daniels

TerraScience LLC

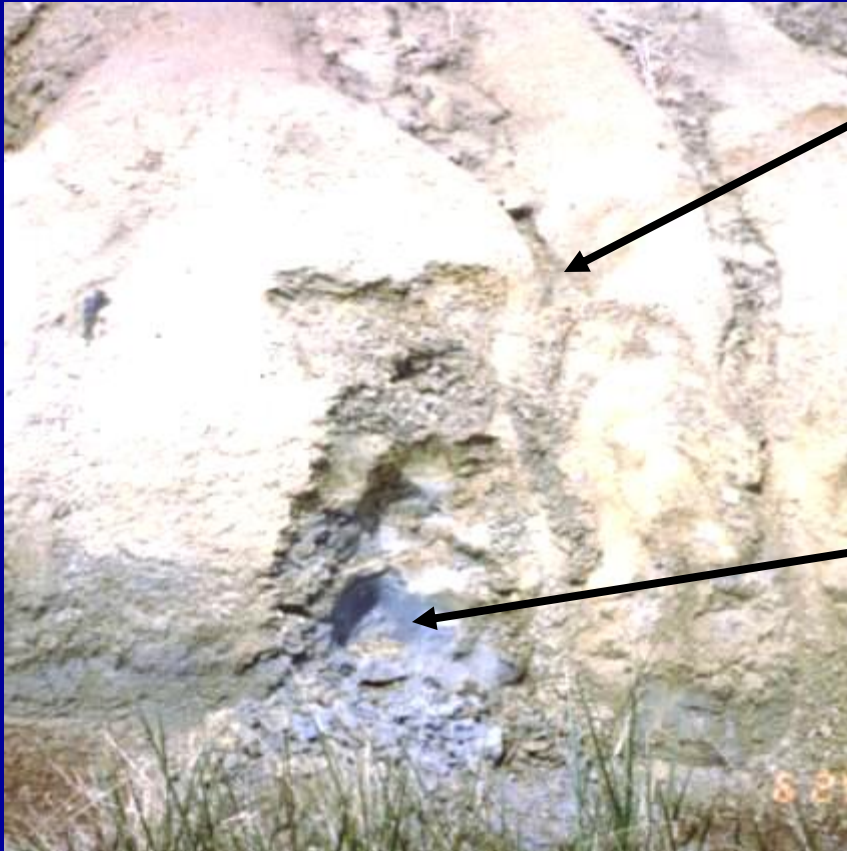
Typical young ASS weathering profile

Overlying oxidized material is typically a light yellowish brown with pH ~ 3. The yellowish salt here is *jarosite*.

Underlying reduced material is typically blue, gray or greenish, with pH > 5.5. May be pH 7-8.

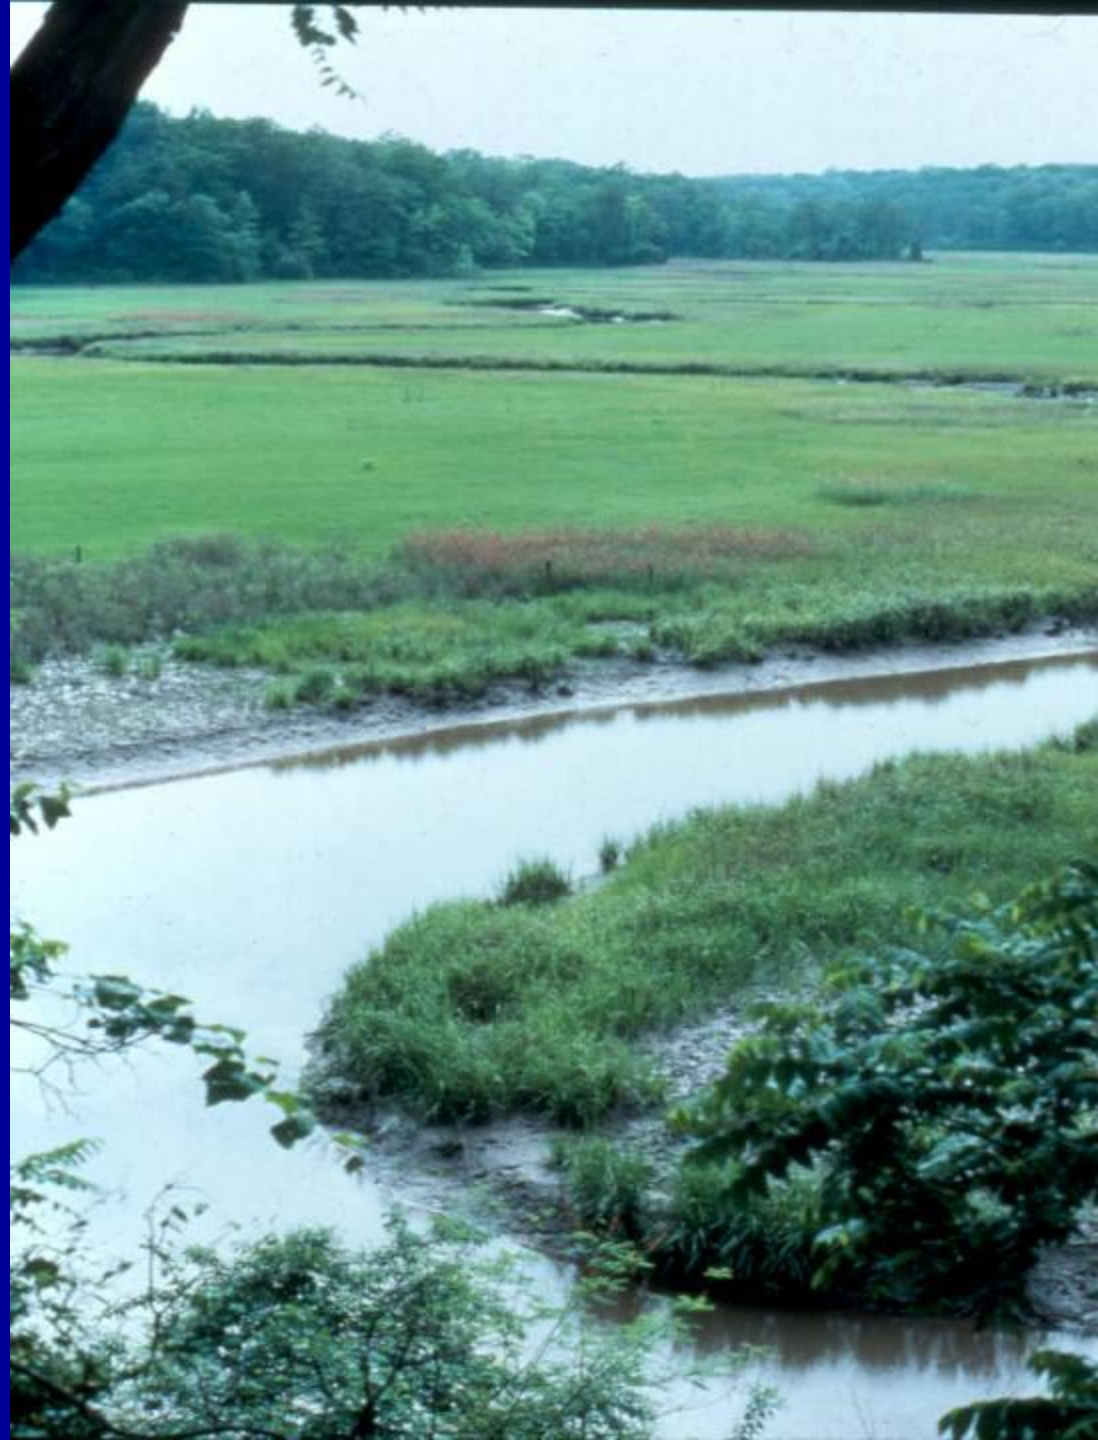
Acid sulfate materials from dredging in Queensland mangrove area.

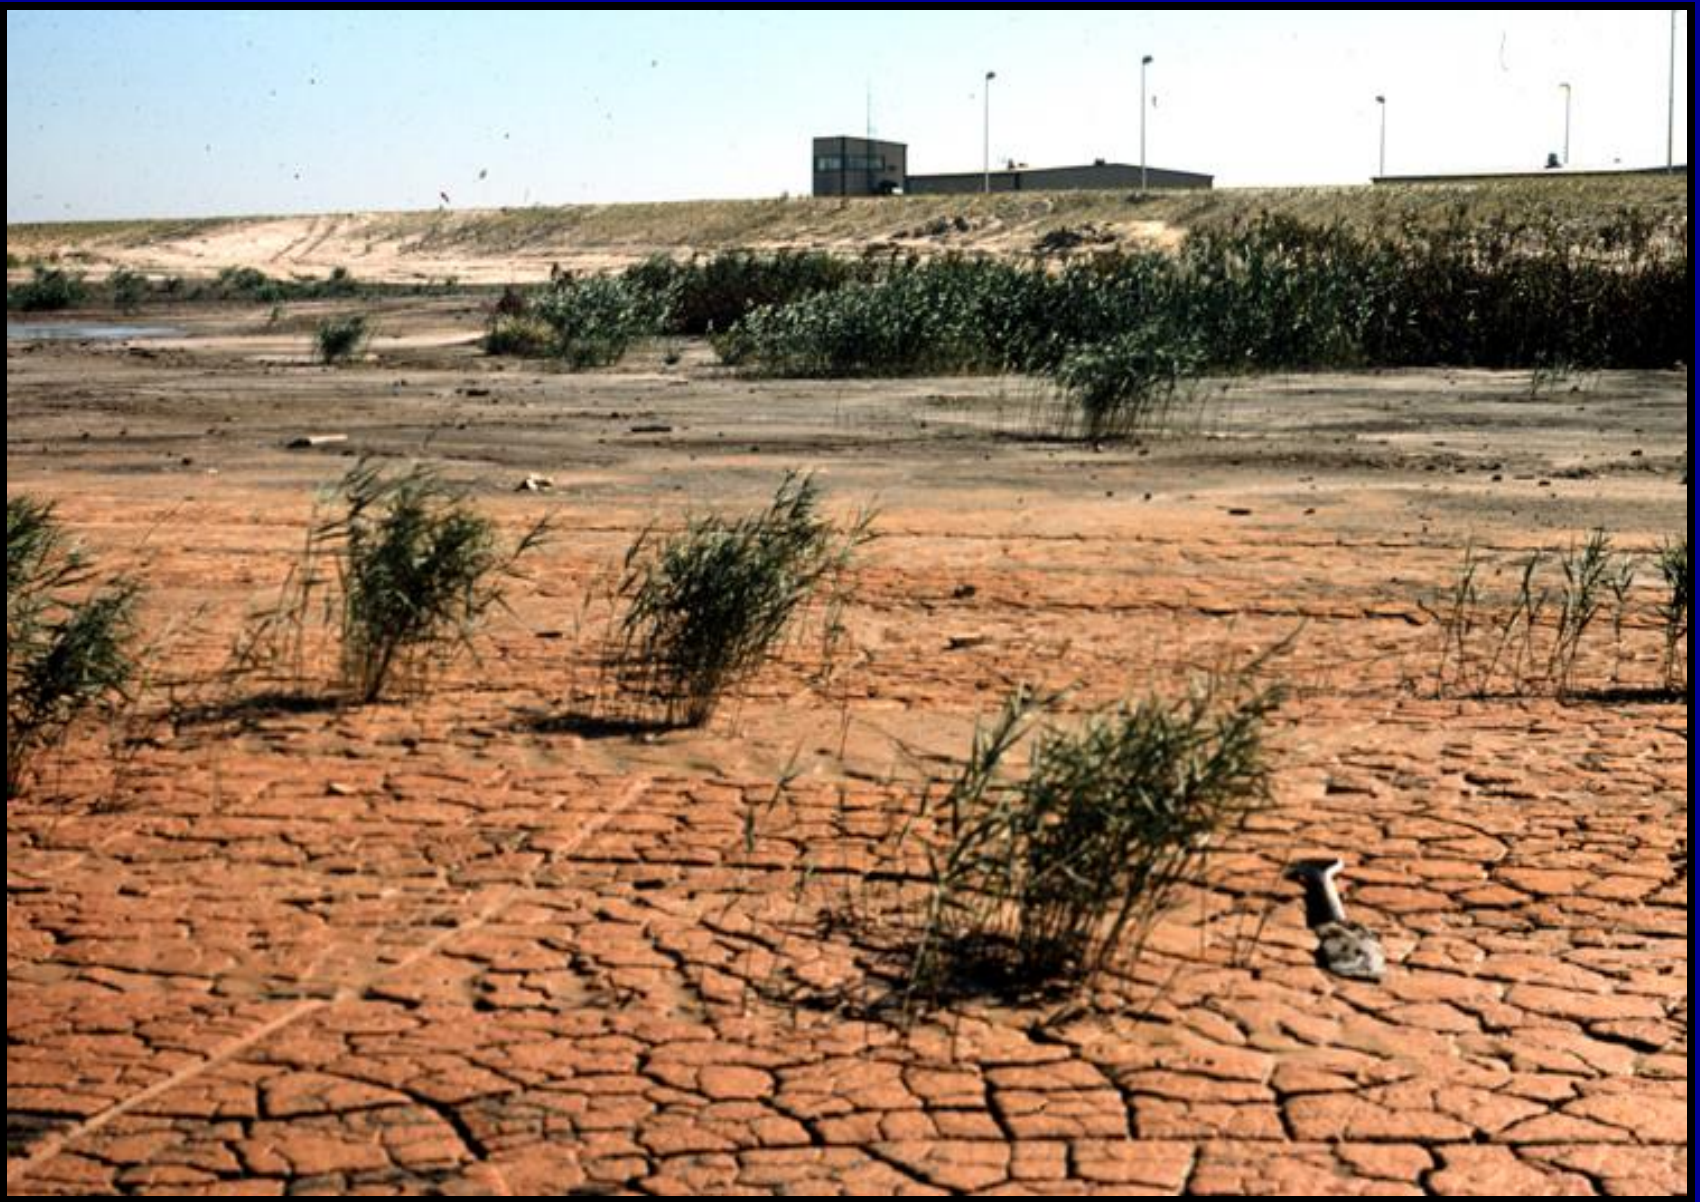
Phragmites reeds begin to invade acid sulfate soil in sulfidic dredge materials at Hart-Miller Island (MD)

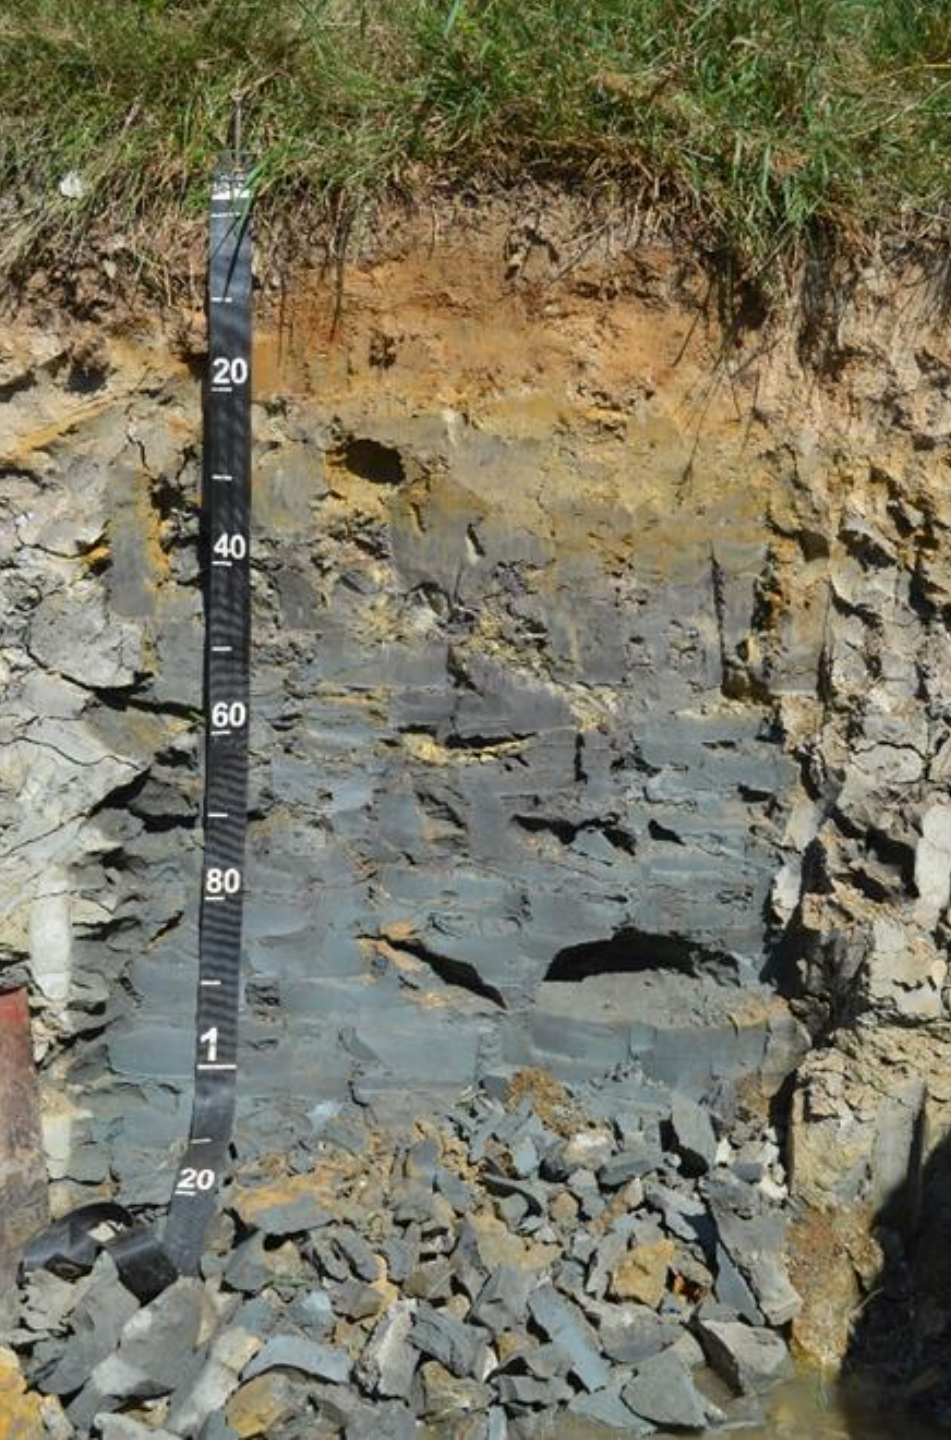
Active acid sulfate soil formed in cut Coastal Plain sediments in Stafford County (scale is in cm). This profile was originally solid gray to the surface when first exposed to weathering and this photo was taken after 15 years.

The surface was remediated via application of lime stabilized biosolids incorporated to six inches. The effective liming rate was ~50 tons per acre.

The yellow mottles in the middle of the profile are jarosite ($\text{KFe}^{3+}_3(\text{OH})_6(\text{SO}_4)_2$), an important diagnostic mineral phase that forms when the pH drops below 3.5 with $\text{Eh} > 400$ mV. Jarosite is the mineral that the Mars Rover ID'd to prove that water had existed on mars.

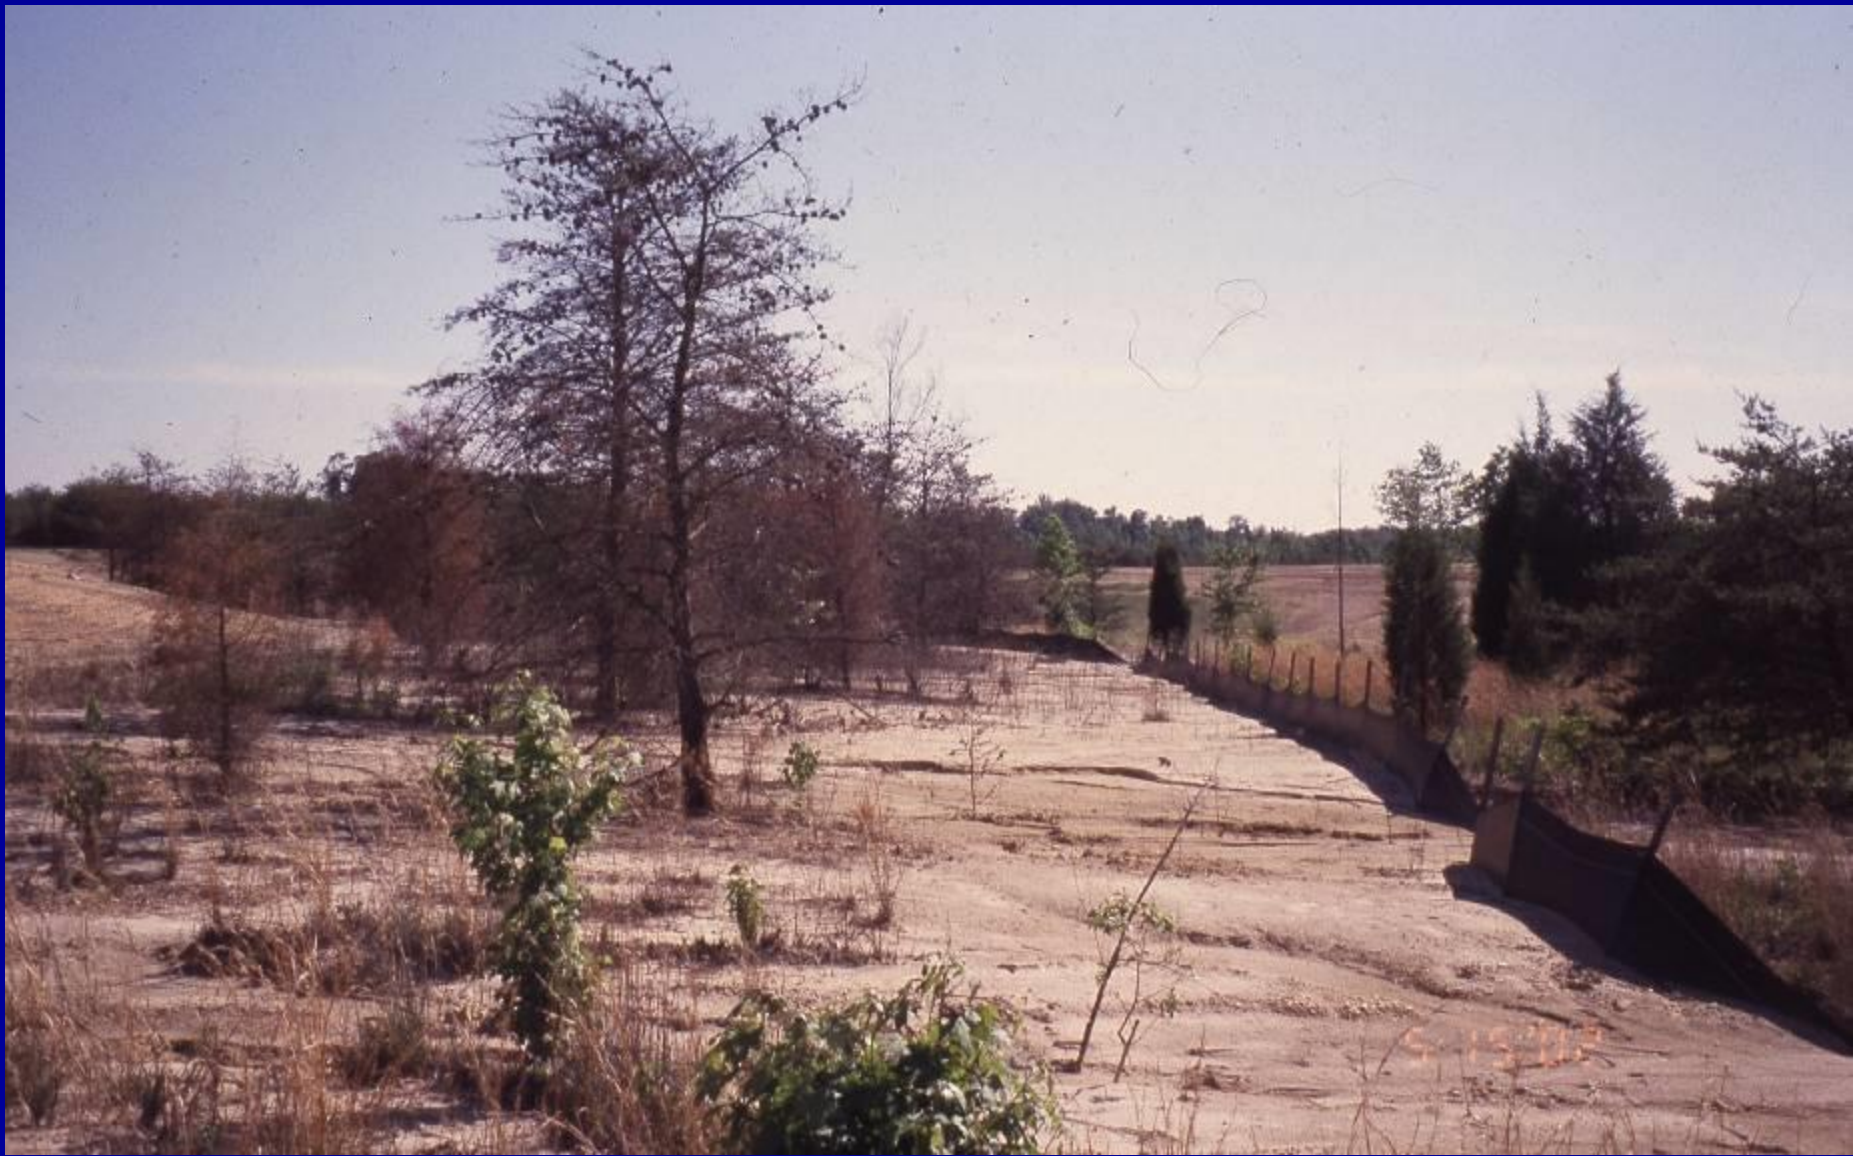
Erosion of acid sulfate sediments and acidic leachate from an adjacent spoil fill has severely impaired this wetland.

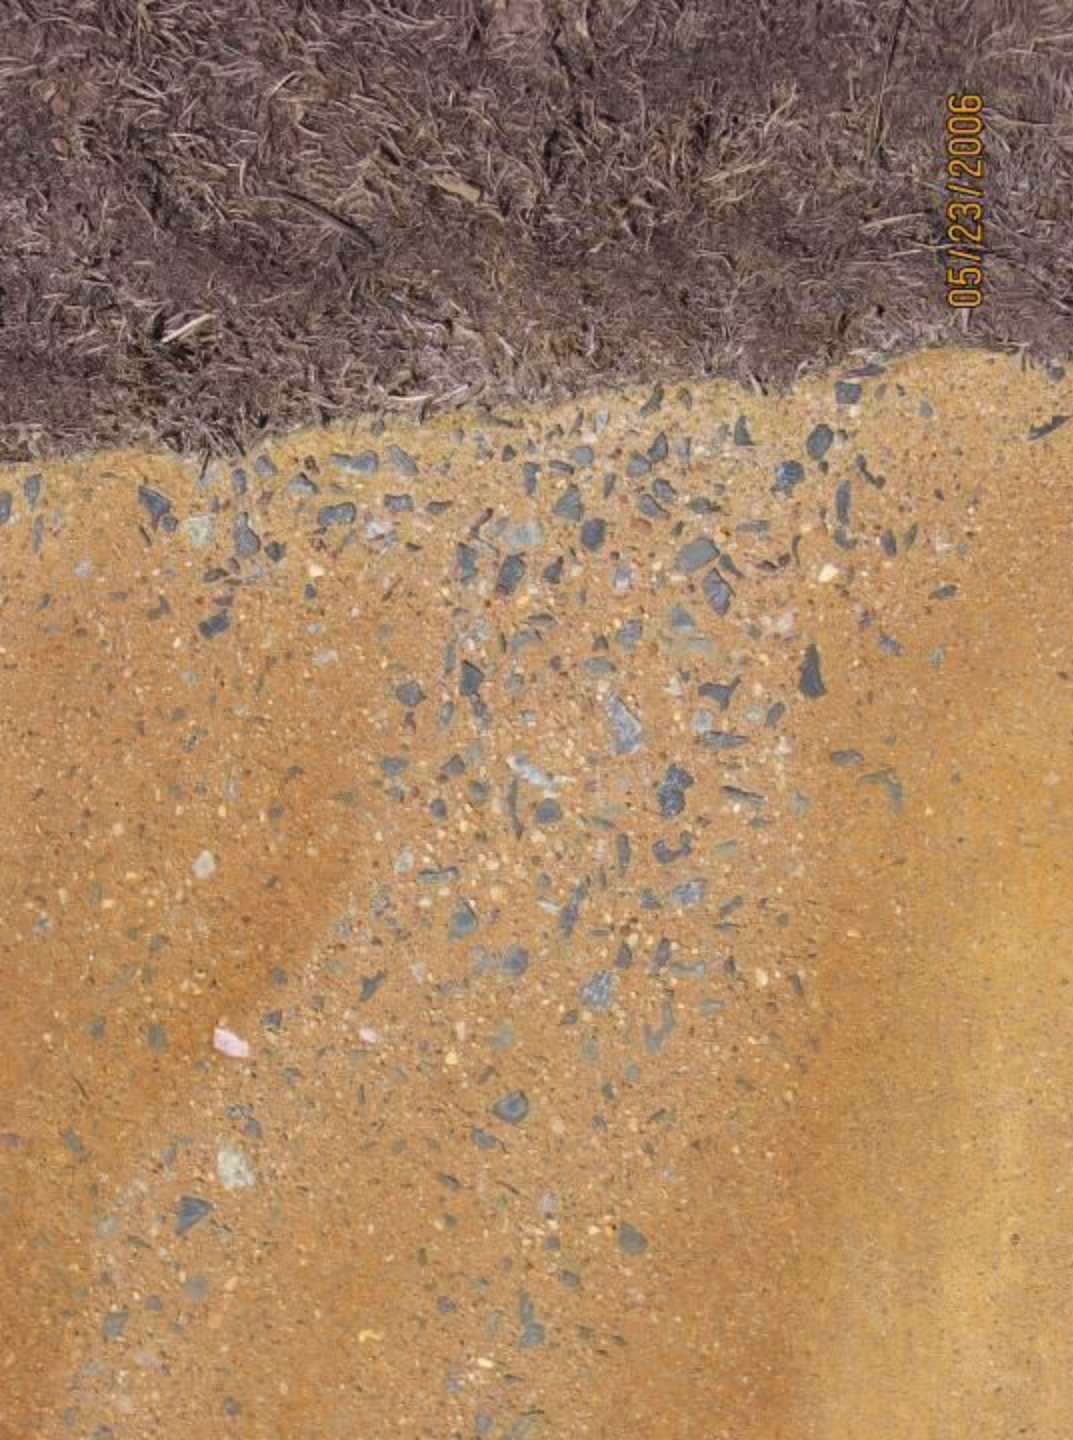
**Cement
being
stripped
out of
concrete;
leaving
aggregate
exposed.**

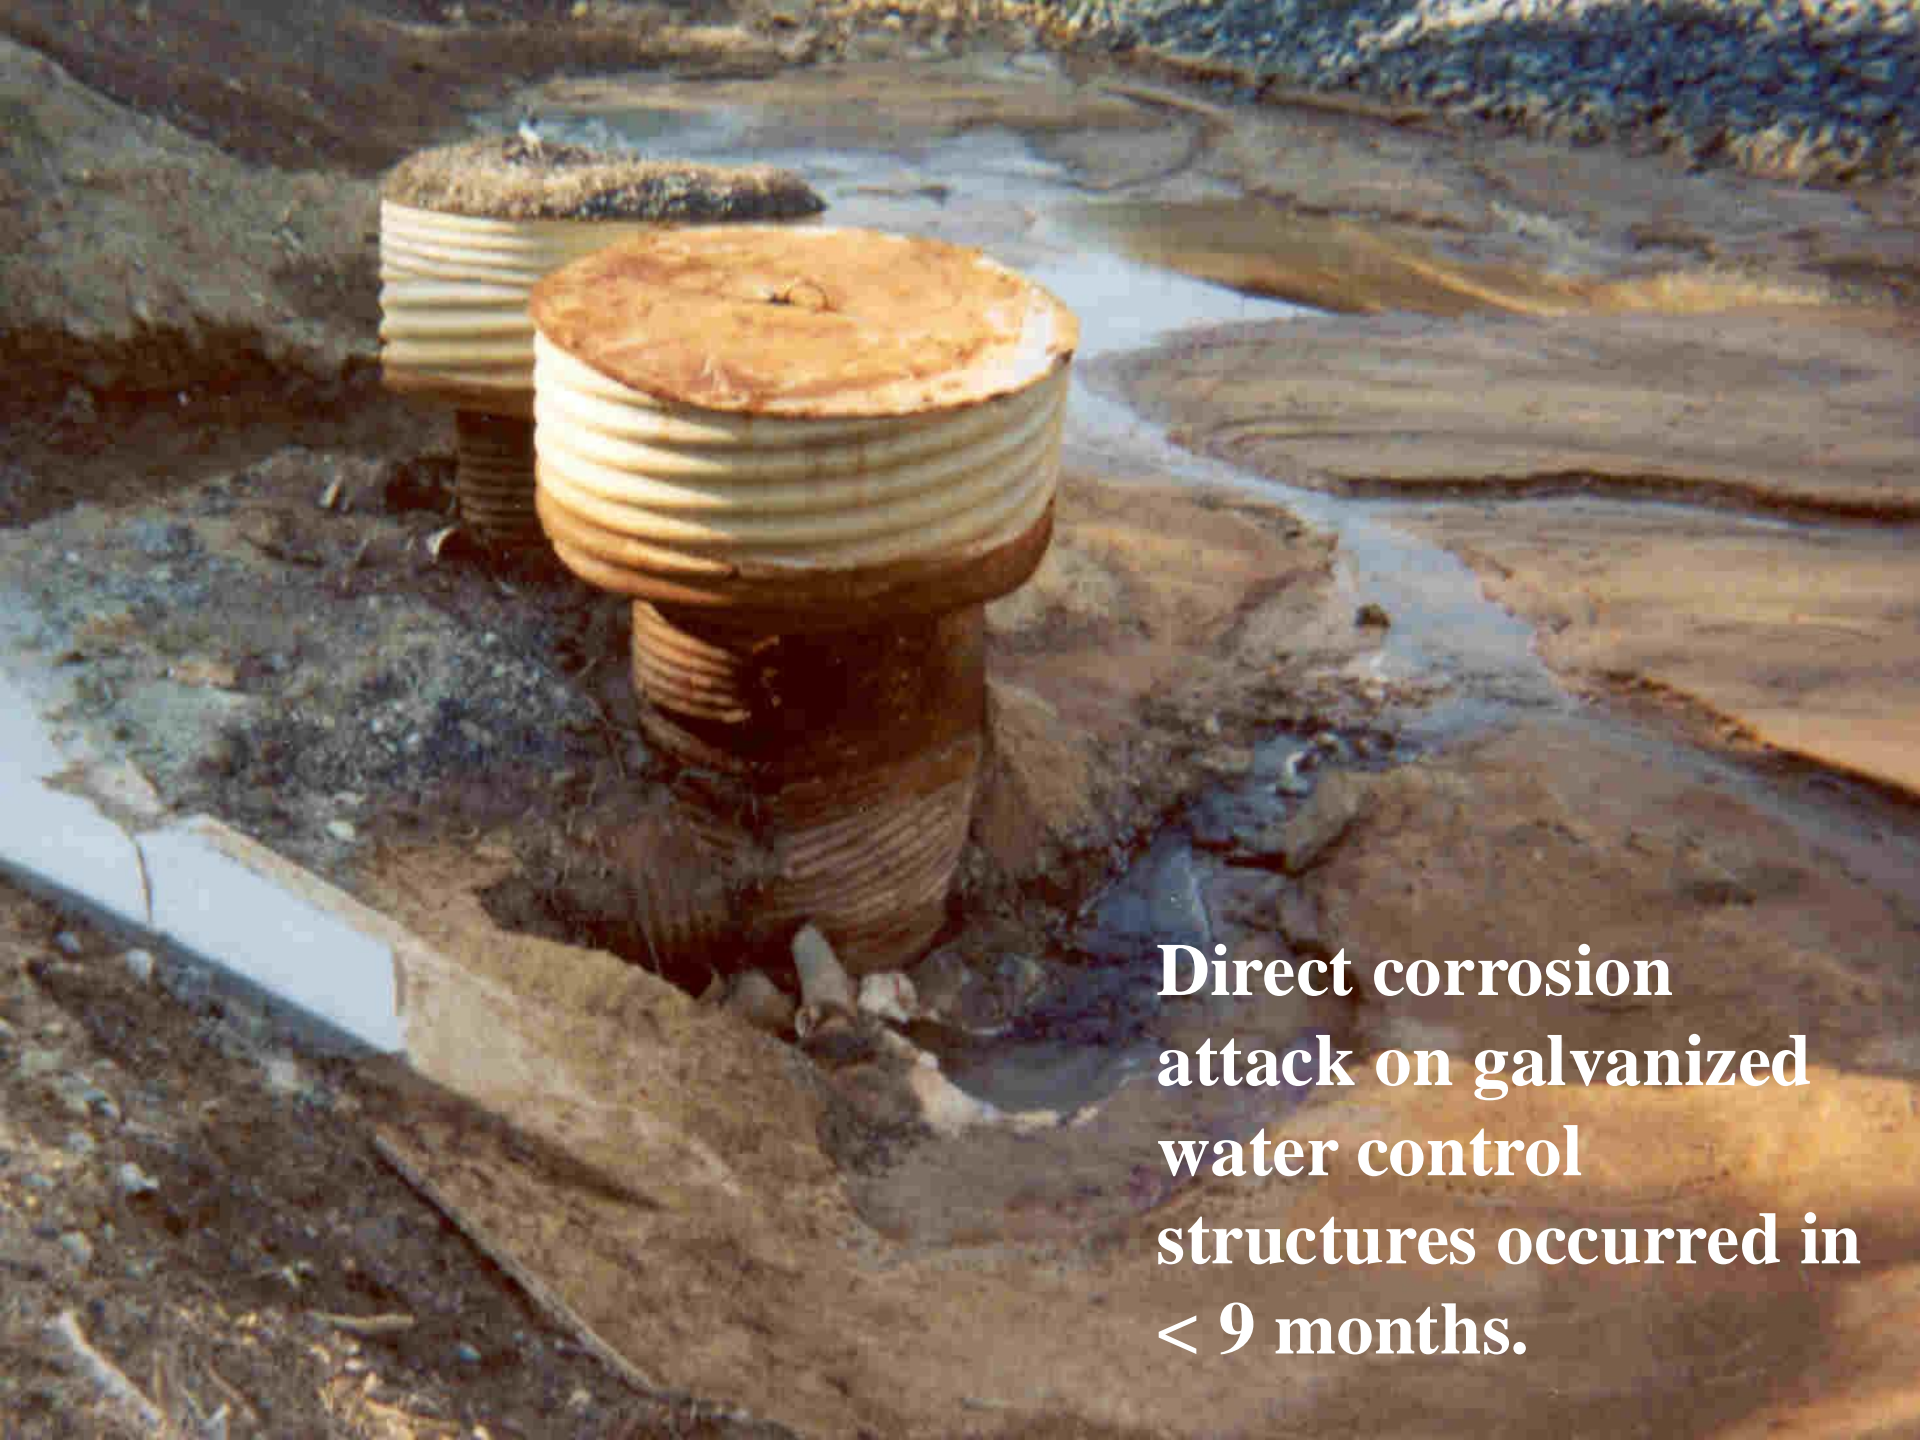
**Direct corrosion
attack on galvanized
water control
structures occurred in
< 9 months.**

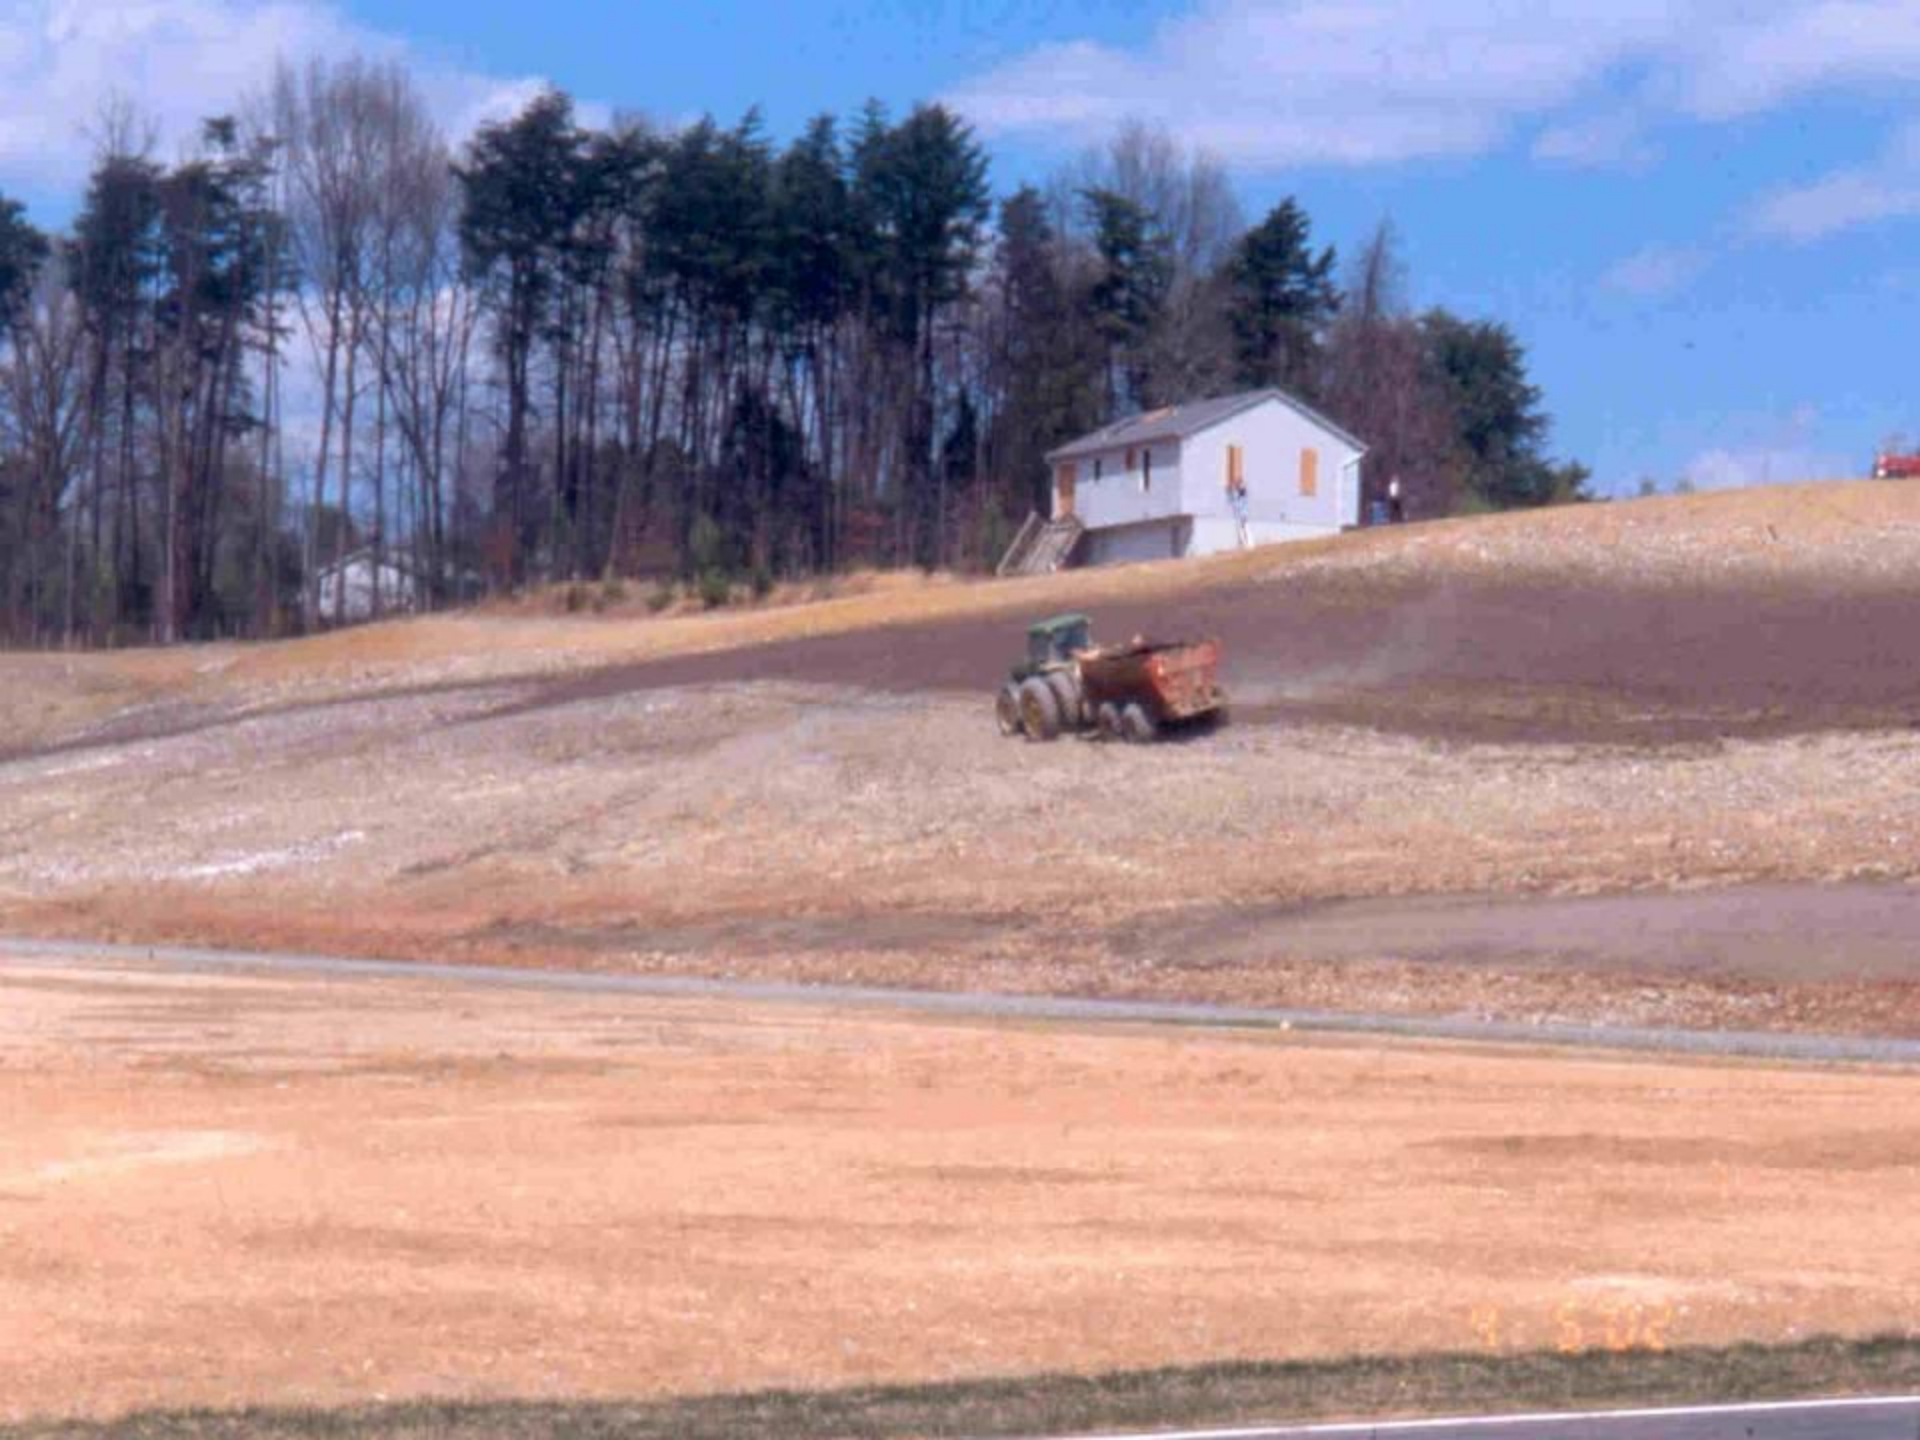
Area revegetated in late May as it appeared in July, 2002. Unfortunately, April through October of 2002 was the hottest/driest period on record.

- **A mixture of lime-stabilized biosolids (24 to 52% CCE) was applied in March, April and early May of 2002.**
- **Over 350 acres reclaimed in 2021 and 2022. Biosolids and lime utilized 3 more times for “spot work” for new hangars & terminal.**
- **Loading rates were based on predicted lime requirements of the sulfidic soils and ranged from 20 to 100 T/Acre. Average loading rate was around 35 tons per acre or 15 tons of lime per acre.**

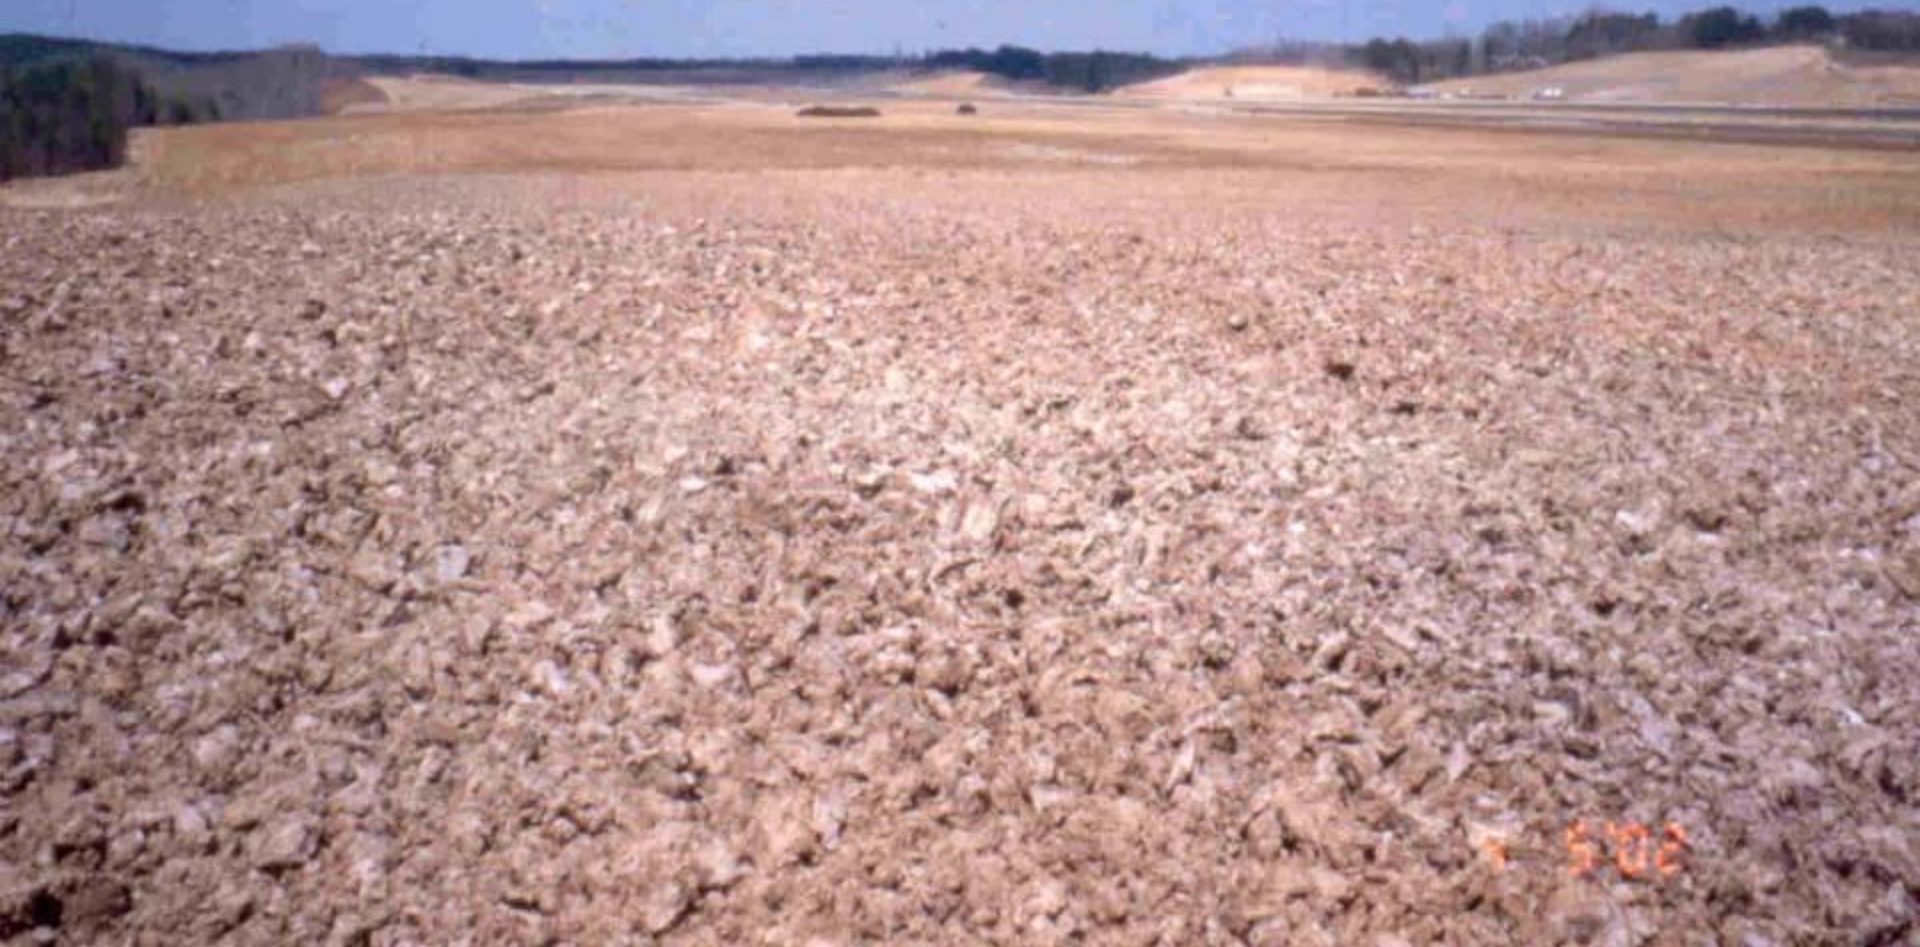
Same view of Stafford Airport after a reasonable weather year. Second-order stream draining left hand side of this picture recovered from pH 3.5 to 7.2 over this period of time.

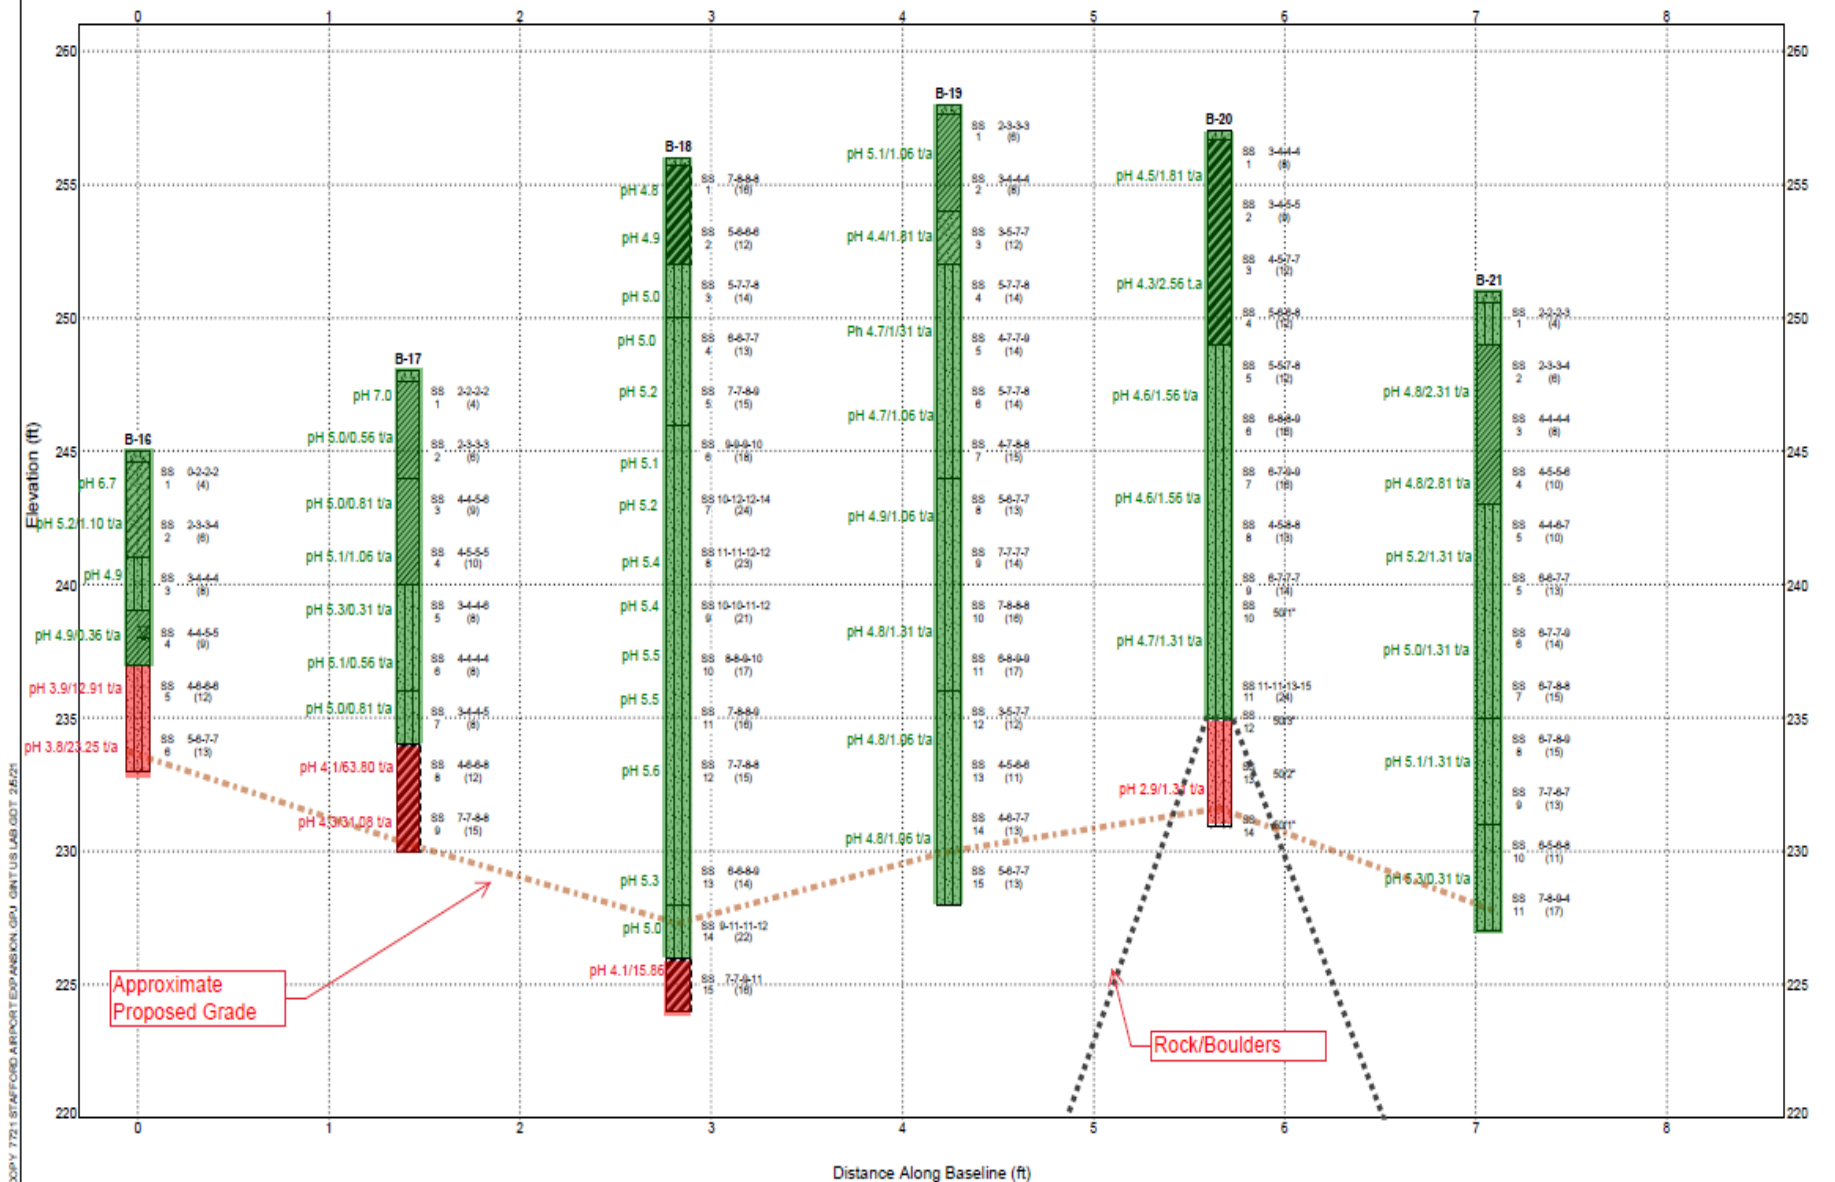
Cross Section F - F

SUBSURFACE DIAGRAM

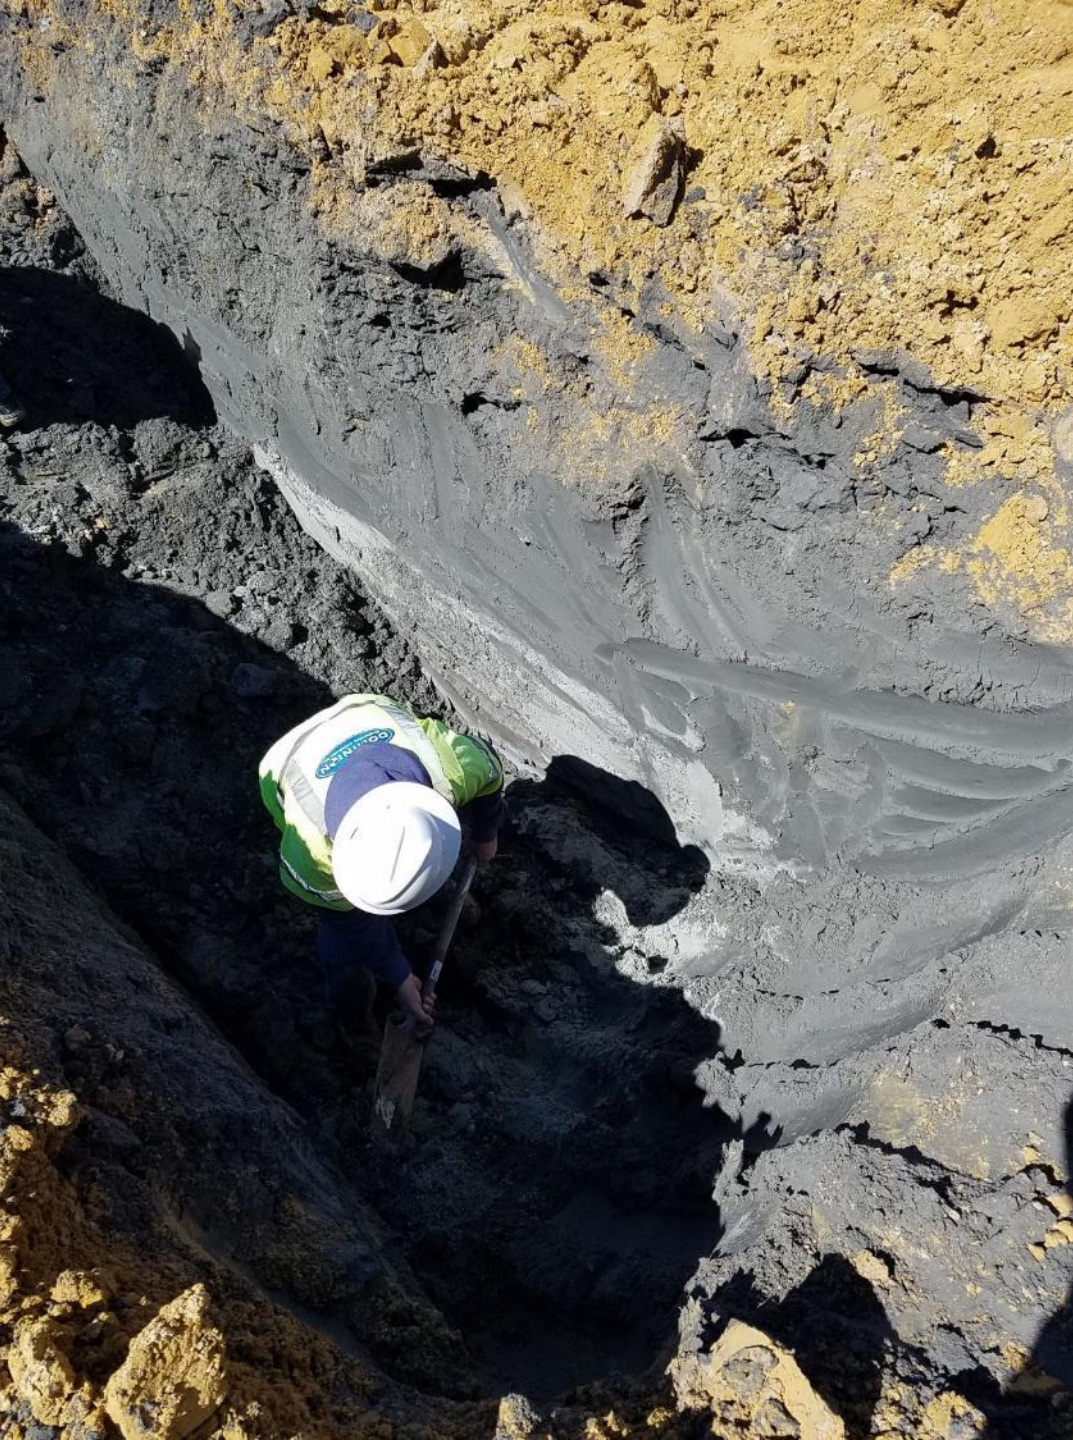
Geologist checking deeper excavation at SRAP through final elevation of the runway subgrade. The lower whitish gray material is non-acid forming, but hardens irreversibly upon drying. It commonly appears in the local landscape as hard lithic sandstone outcrops.

Using a system developed originally by VDOT for the black shales project in Botetourt County, over 120 CY of the problematic ASS materials here were isolated, limed to 1.5 x their ABA and compacted into place in lined (10^{-5} cm/sec) above grade fills.

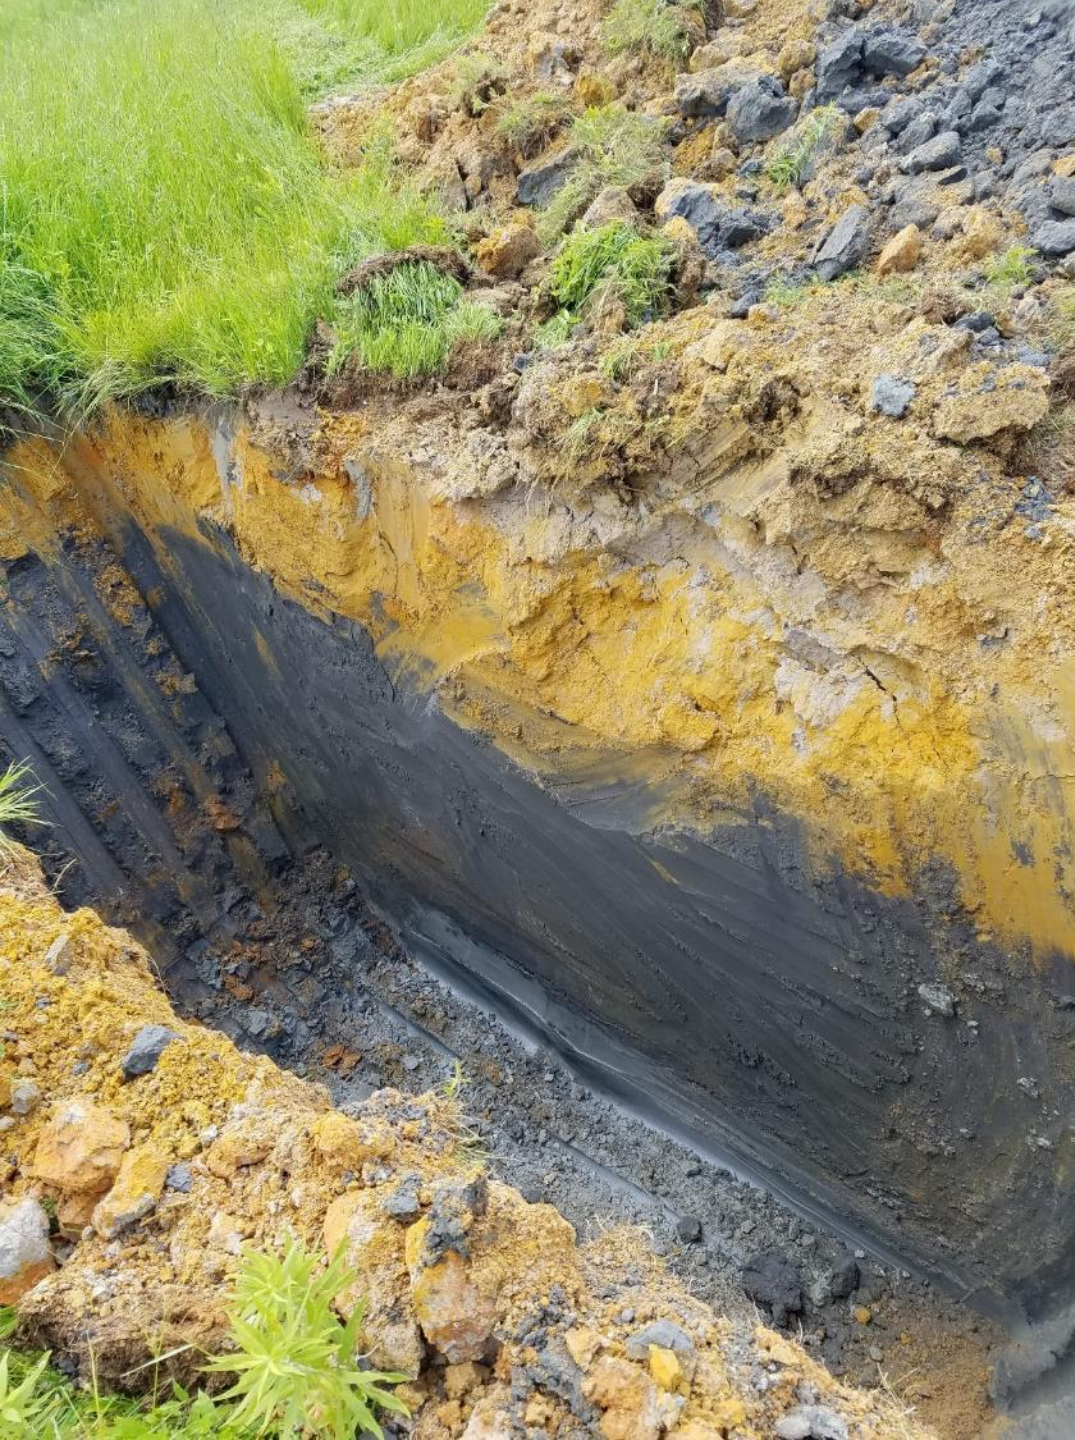
Exposure of intact ASS strata approximately 200 feet away from cut shown in last image.

Note the abrupt boundary, very bright “flame orange” colors and remnant of Cg horizon above.

This is not a typical redox feature pattern with depth!

These materials are commonly fine-textured, massive and perch local groundwater.
