Management of Acid-Forming Sediments at the Stafford Airport Expansion Project in Virginia

W. Lee Daniels

TerraScience LLC

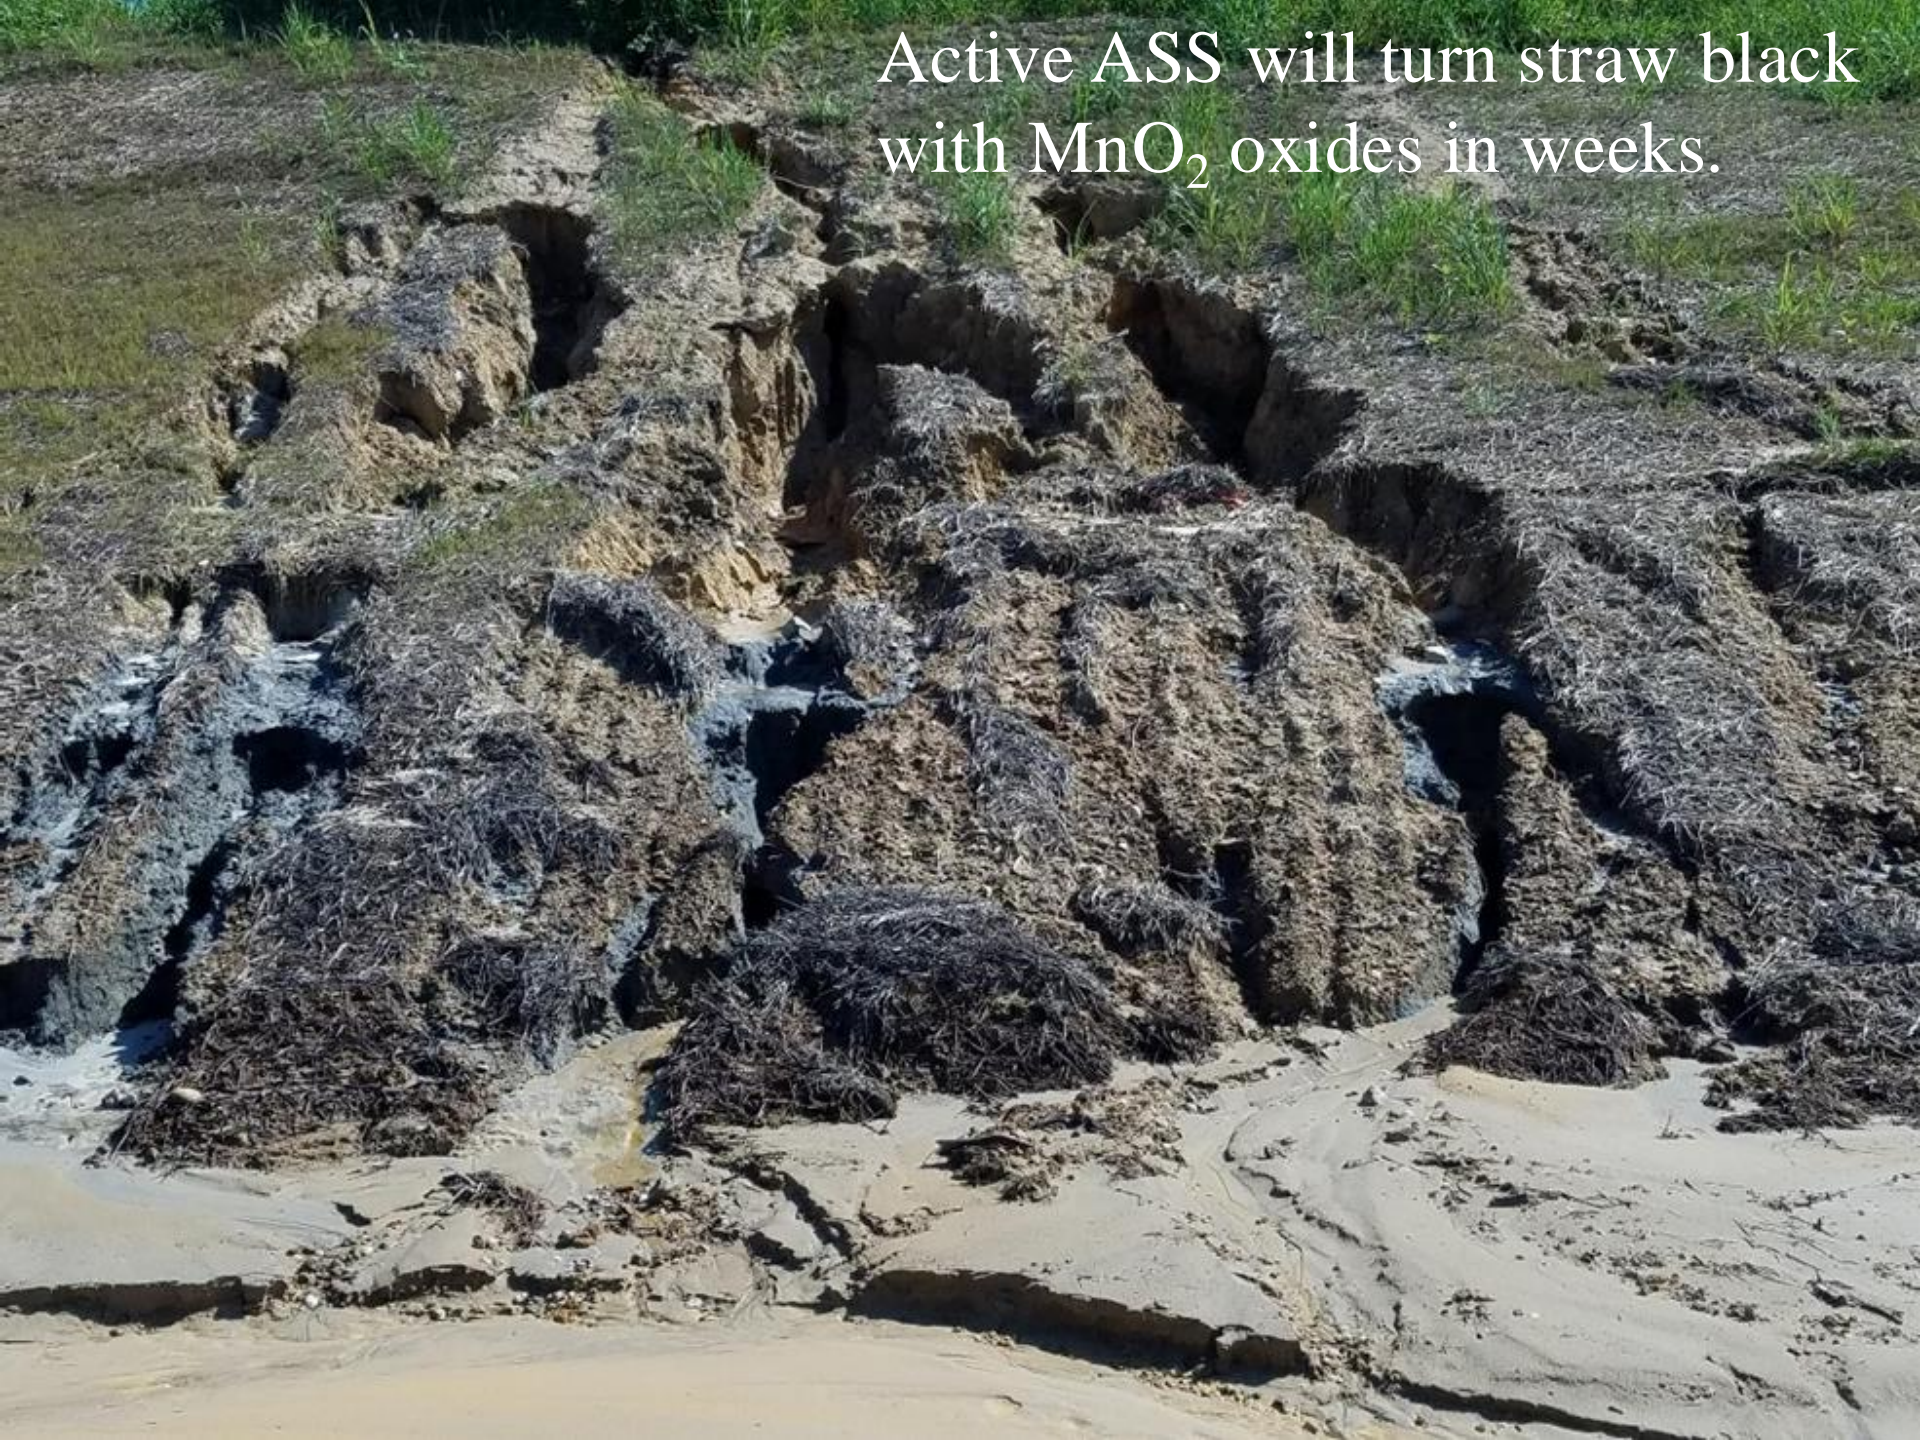
Active ASS will turn straw black
with MnO_2 oxides in weeks.

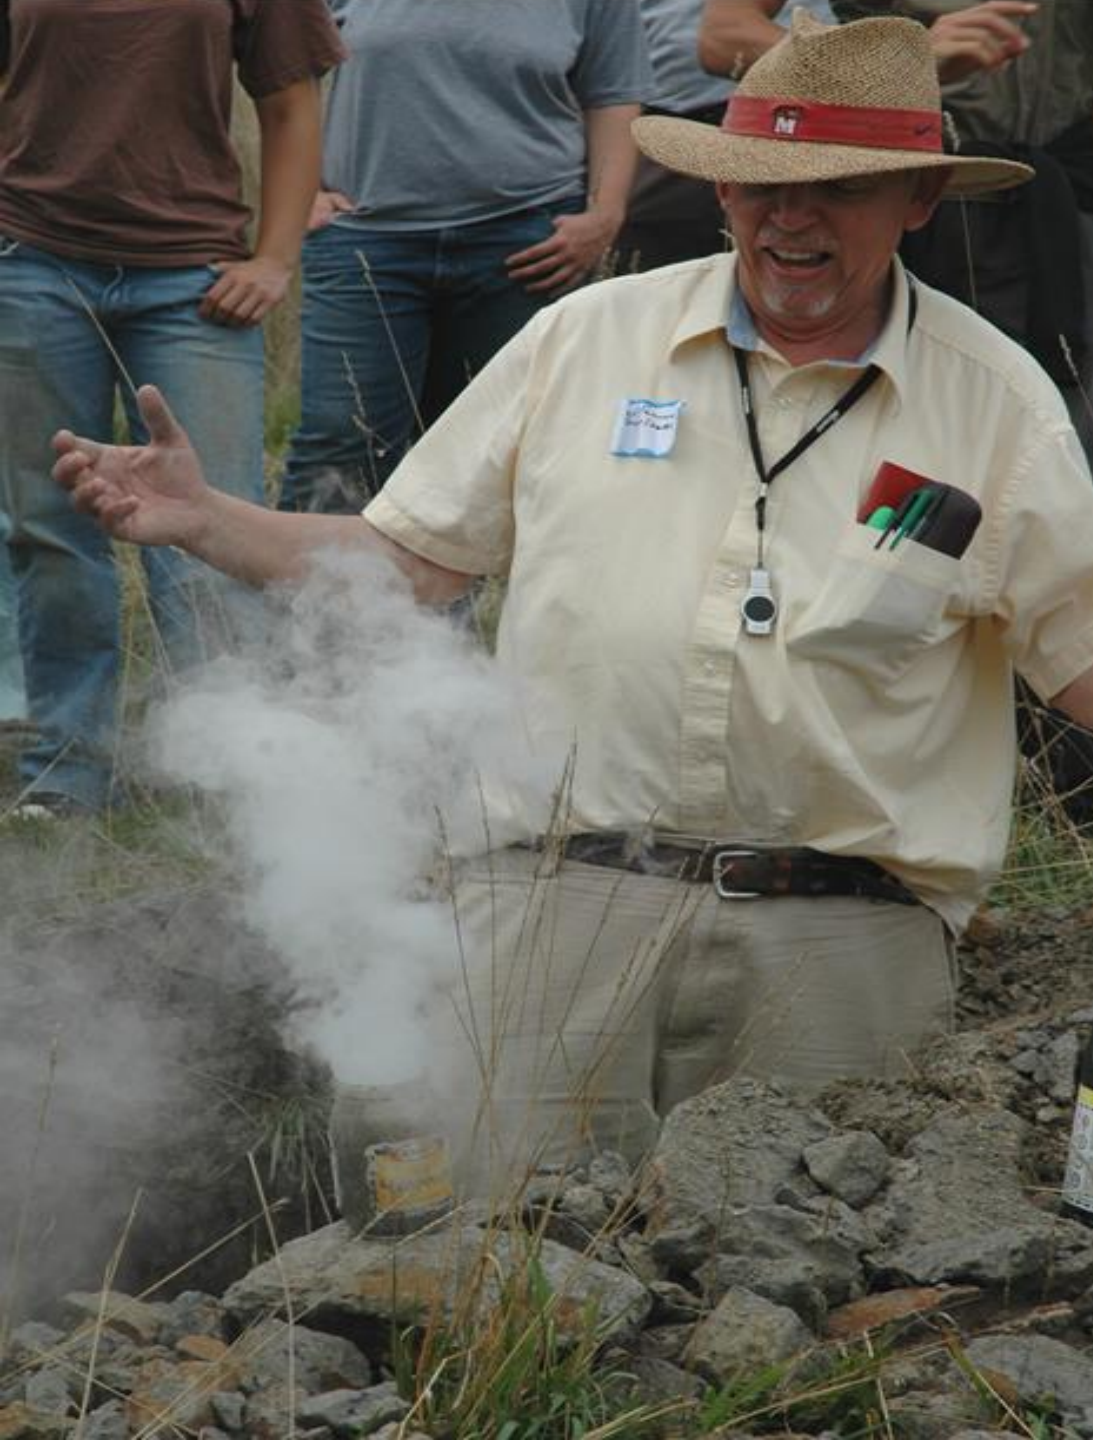
**Del Fanning
demonstrating the 30%
peroxide fizz test at
Stafford Airport for the
2013 International Acid
Sulfate Soils field tour.**

**The “fizz test” can
usually tell whether or
not the material is
“hot”, but cannot
prescribe the necessary
lime rate for
remediation. You must
run ABA for that.**

- **30% H_2O_2 “Fizz Test”** – Can be highly predictive for reactive sulfides. Even materials with 0.2 to 0.3% sulfide can give a violent frothing reaction. Industrial reagent (not available to public) and must be handled with care (goggles/gloves, etc.).

Subject to potential “false positives” due to humus and Mn oxides which will also fizz to variable extent.

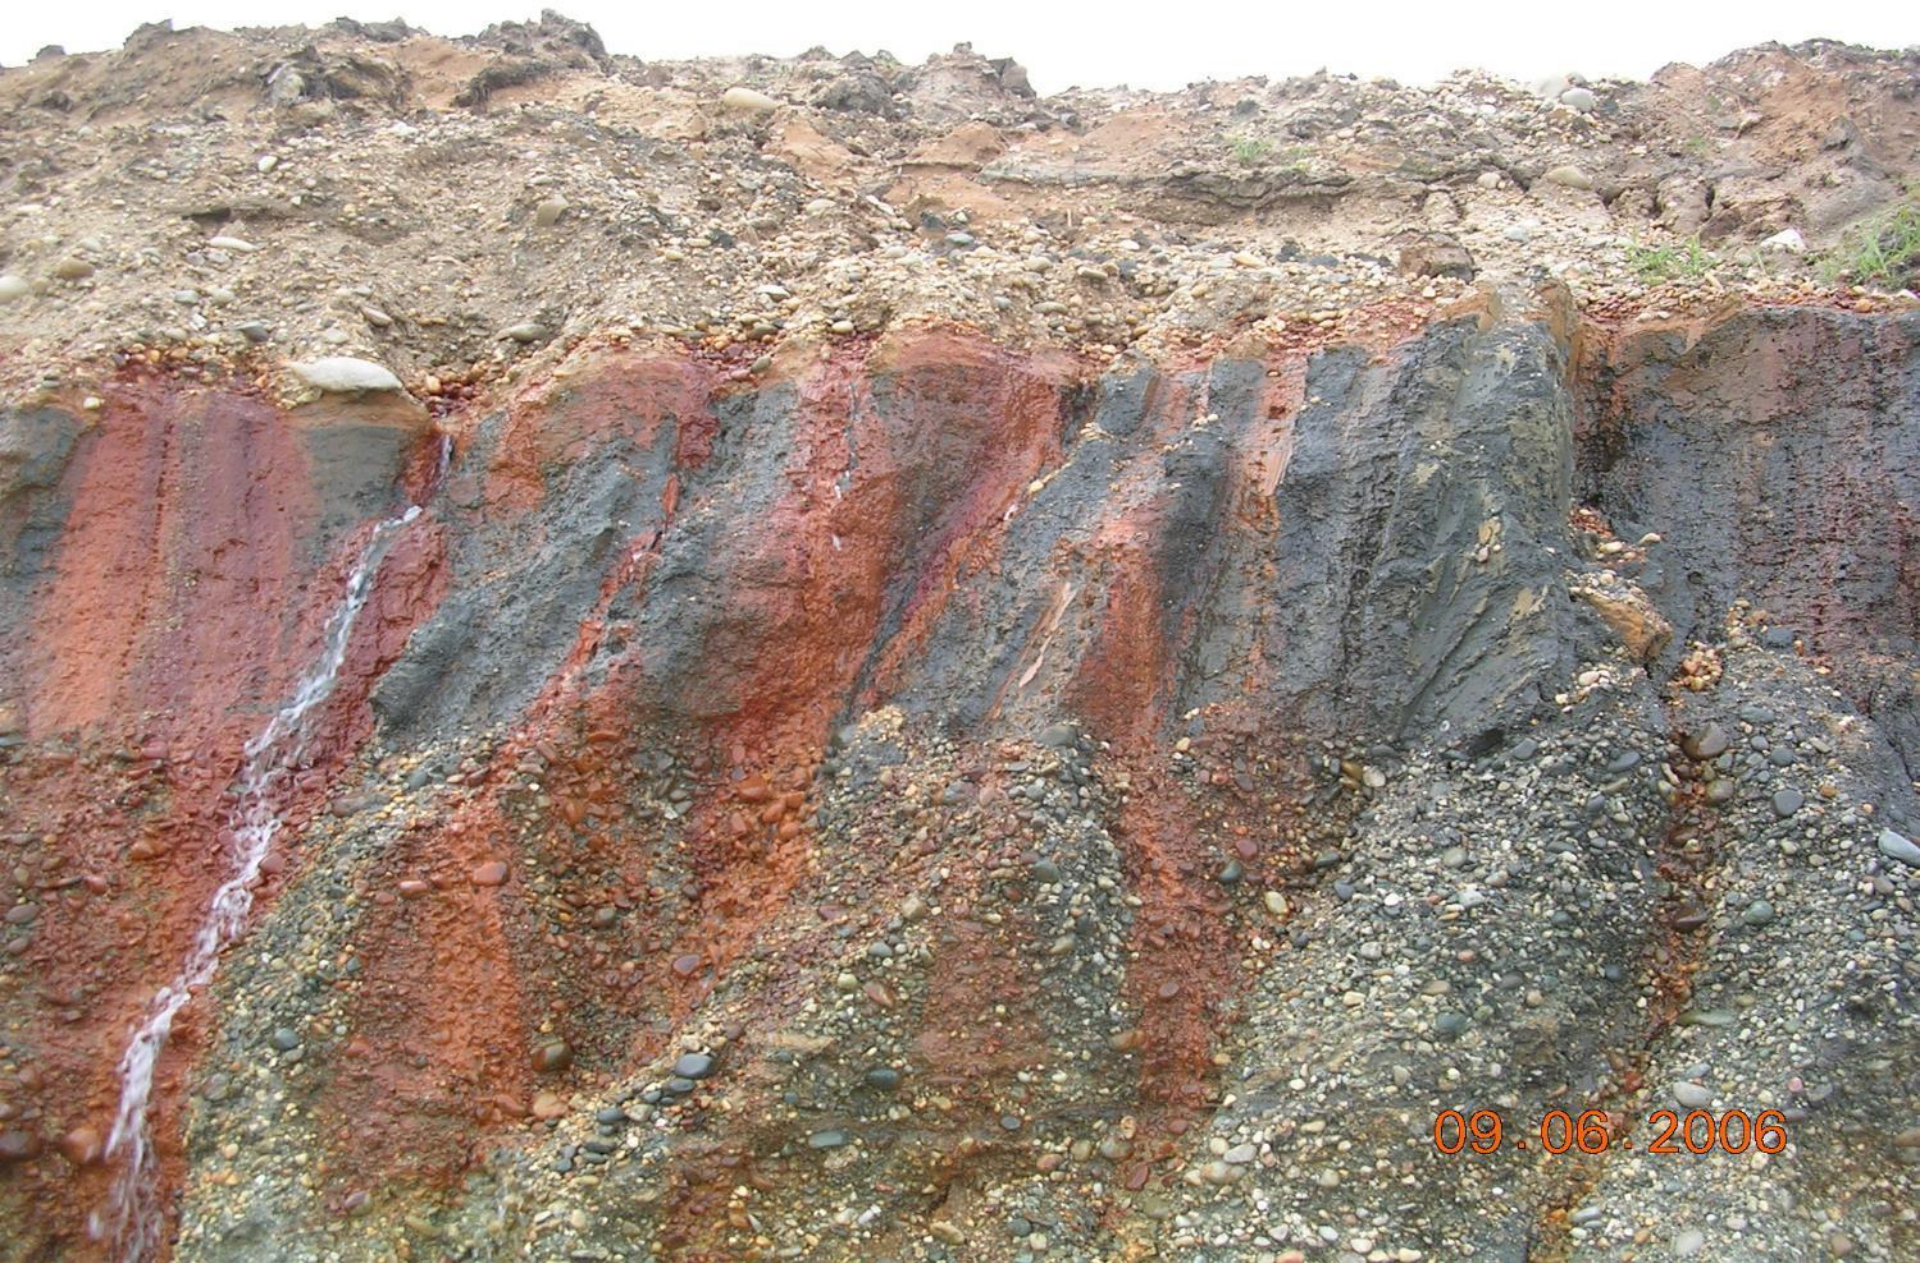
Typical abrupt contact between Plio/Pleistocene gravels and underlying Miocene ASS materials (Eastover fm). Fe-stone (ferricrete) often found at contact.

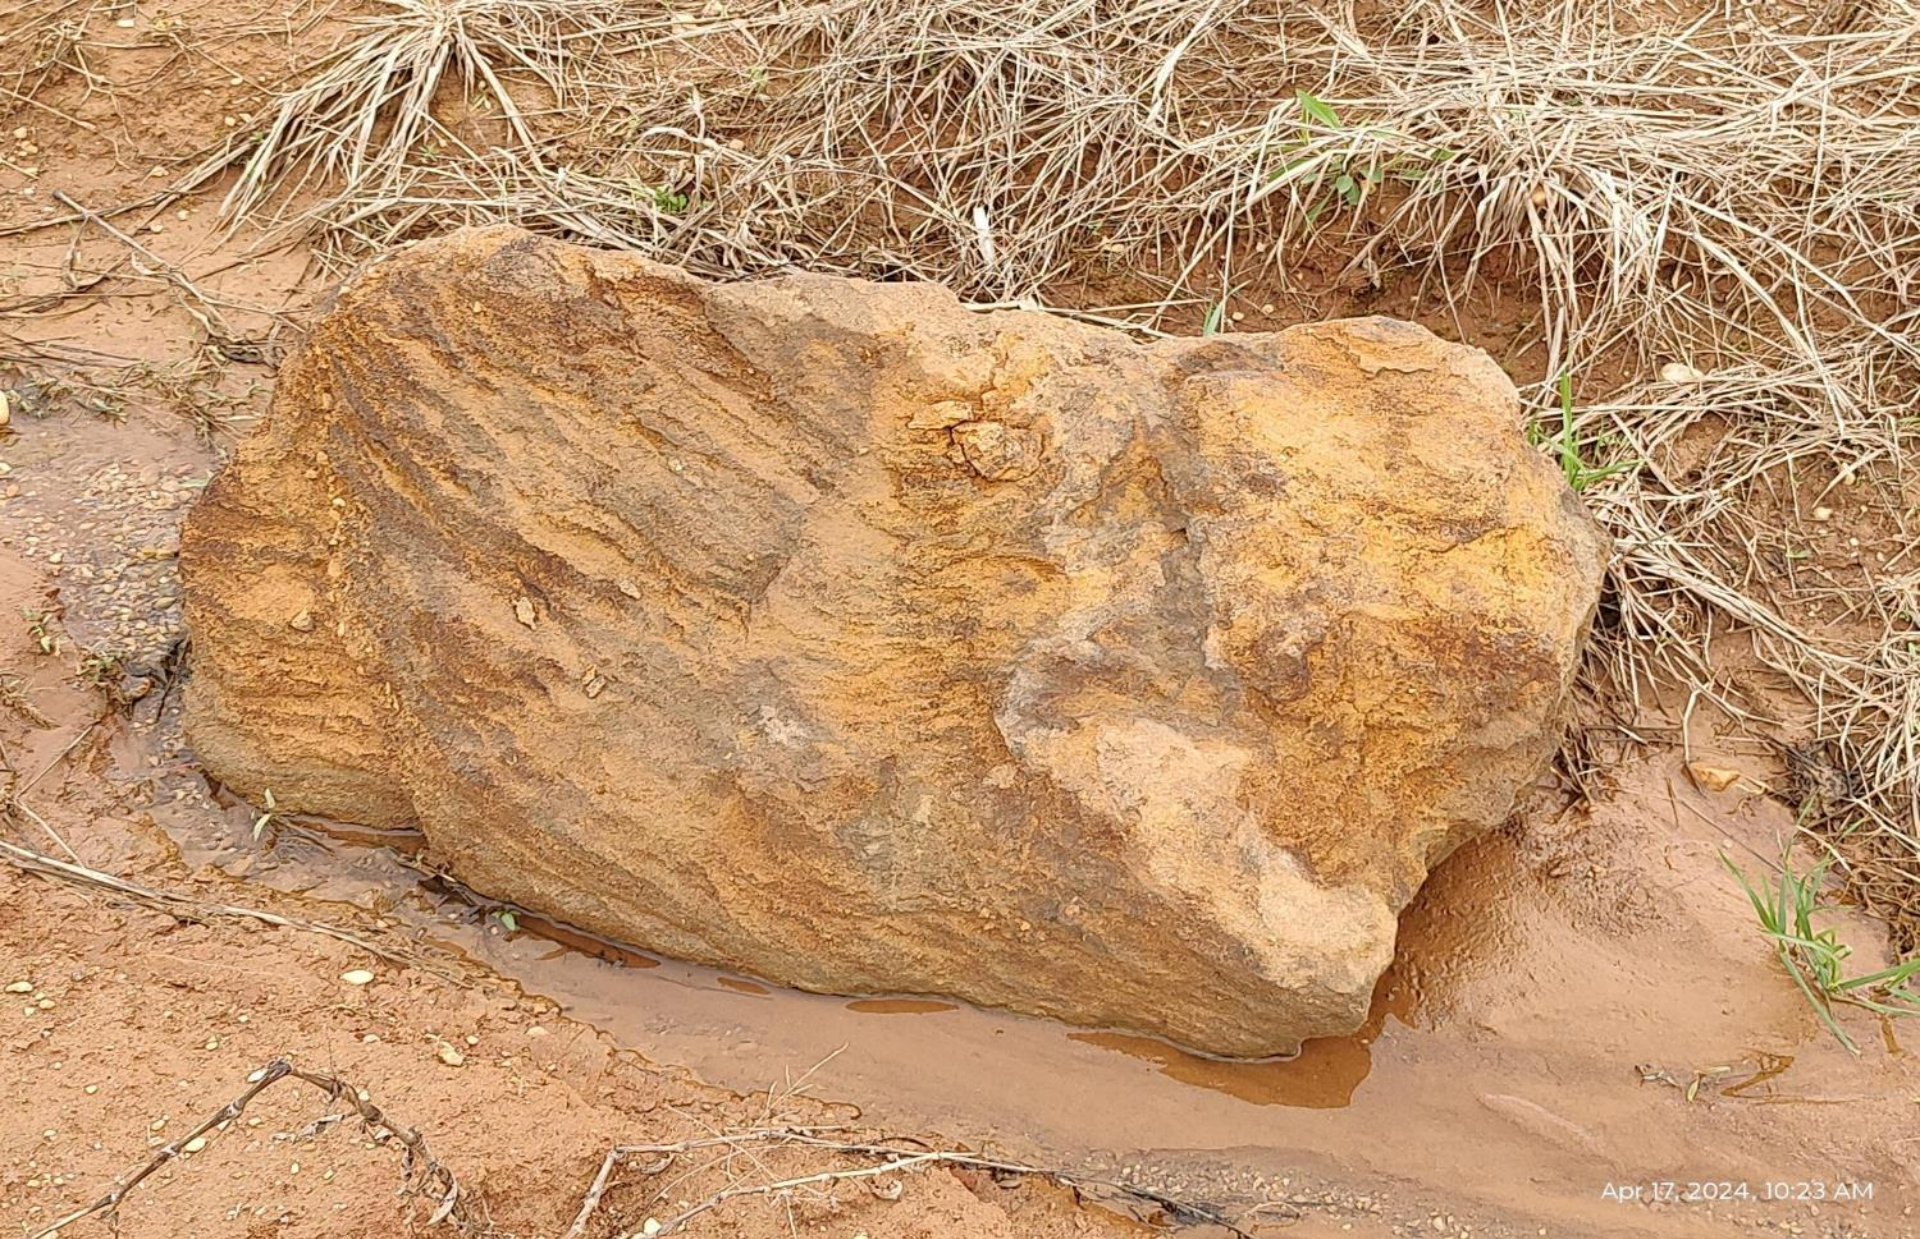
Cemented gravel/Fe-stone boulder in sand & gravel mine in Caroline County.
Pleistocene gravel abruptly overlies dark gray ASS at this location at – 25 feet bgs.

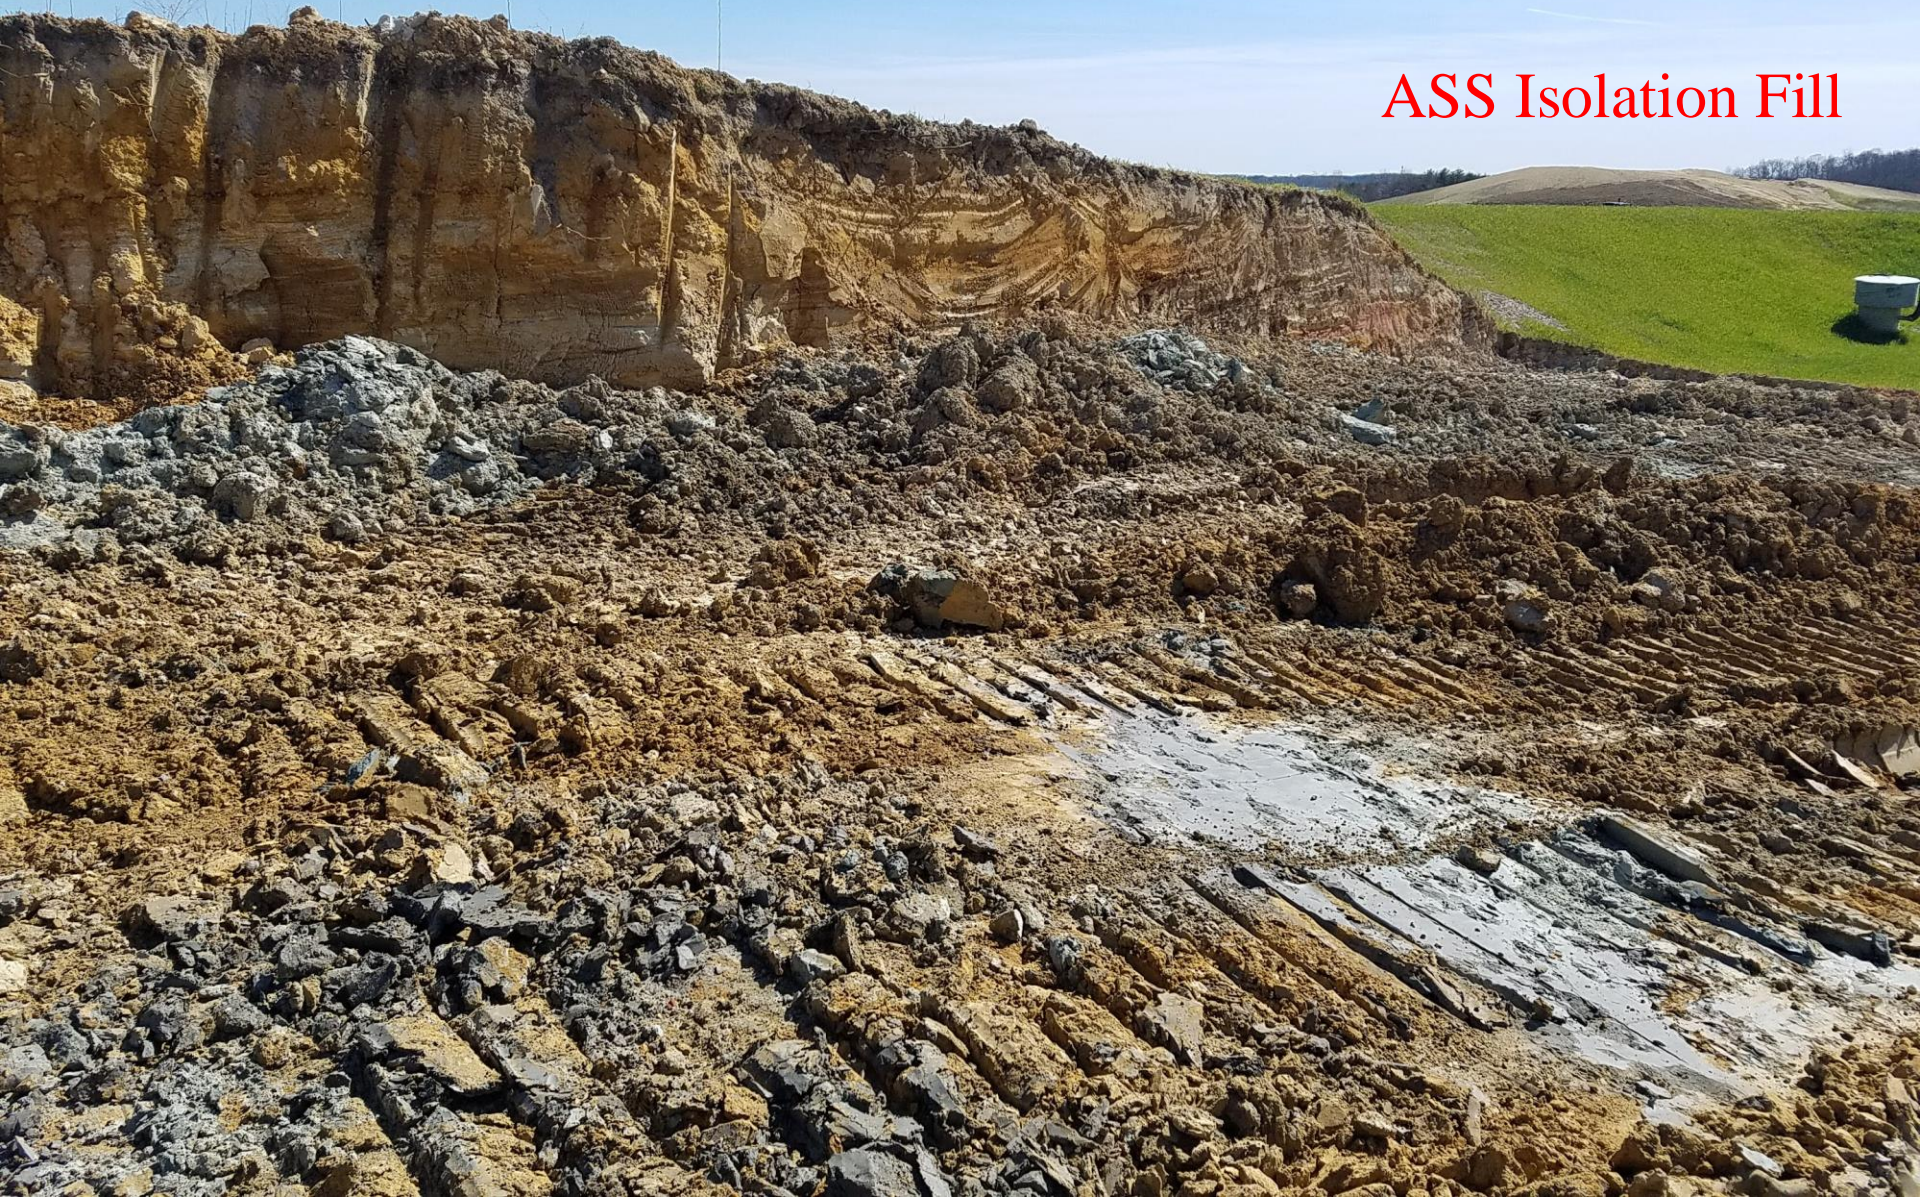
ASS Isolation Fill

- Total lime utilization was 2400 T CCE, much lower than the original VDOT criteria would have required. While not monitored rigorously, adverse water quality impacts have not been noted to date.
- All Category 3 material was isolated into two above grade fills with a 10-5 cm/s liner under/above and on the sides. All ASS was limed per the liming specification.
- However, exposed cut slopes with seepage continue to be “problematic”.

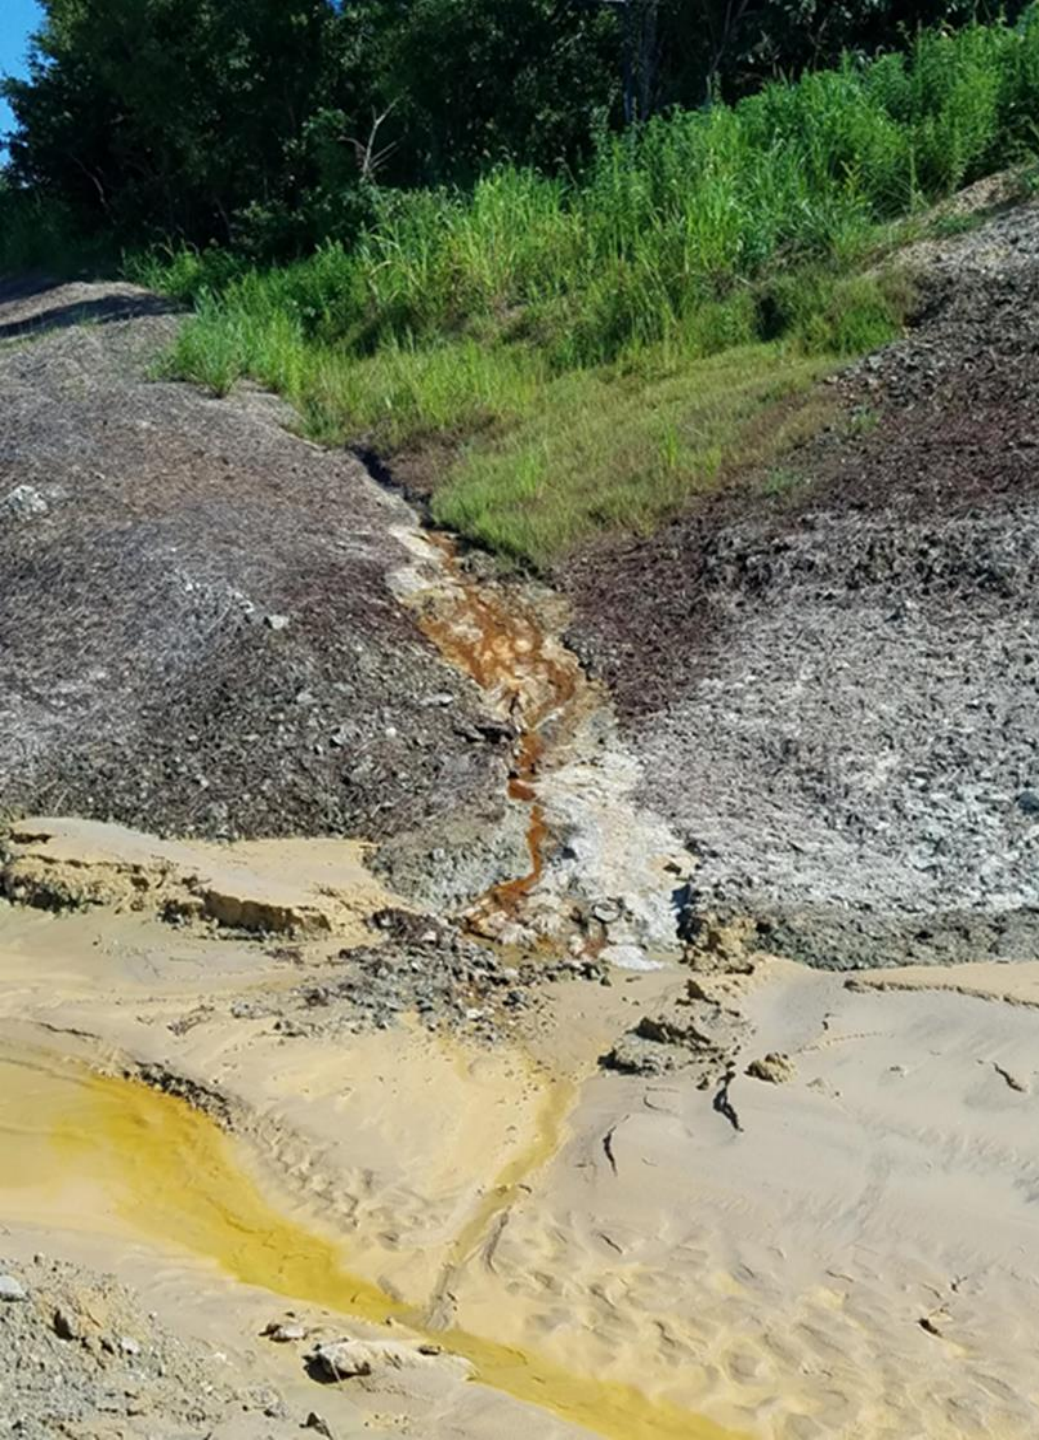
Recent exposure of lower Chesapeake Group sediments at Stafford Airport. Note the “common symptoms”.

In addition to dead plants, red water, blackened straw and white salts, if you find the following, “you’re really in it”:

Yellow jarosite mottles

Prominent S odor (burnt matches) on your fingers when the soil dries out.

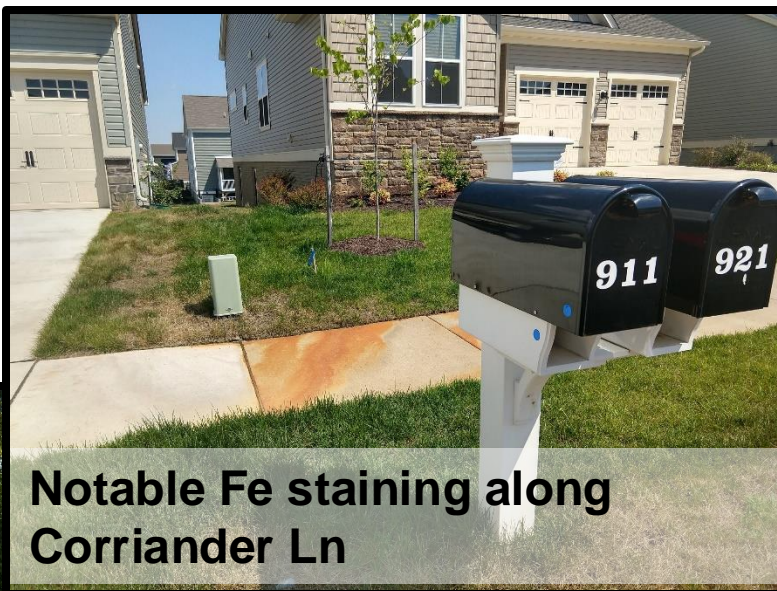
**Notable Fe staining along
Corriander Ln**

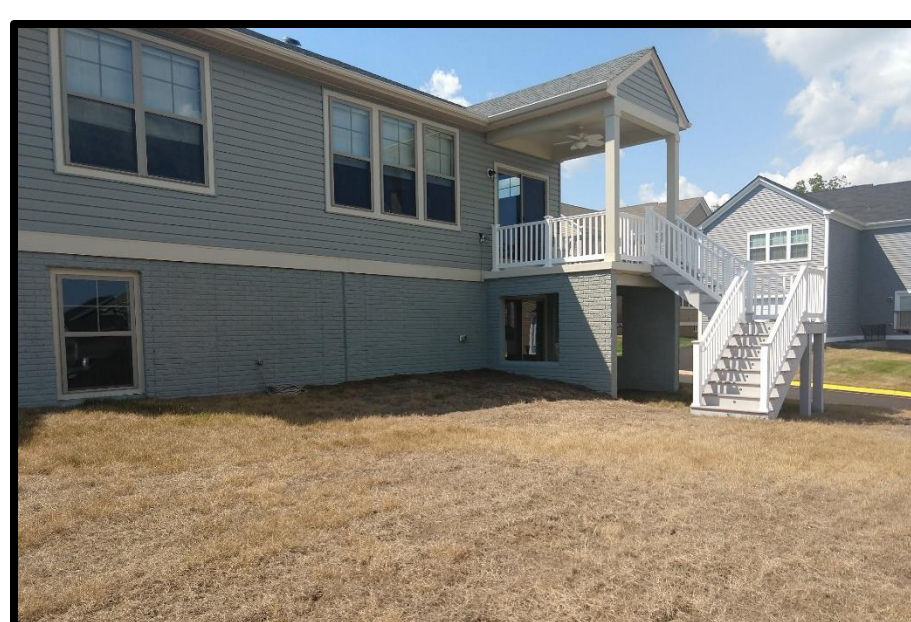
Dead sod behind 911 Corriander Ln

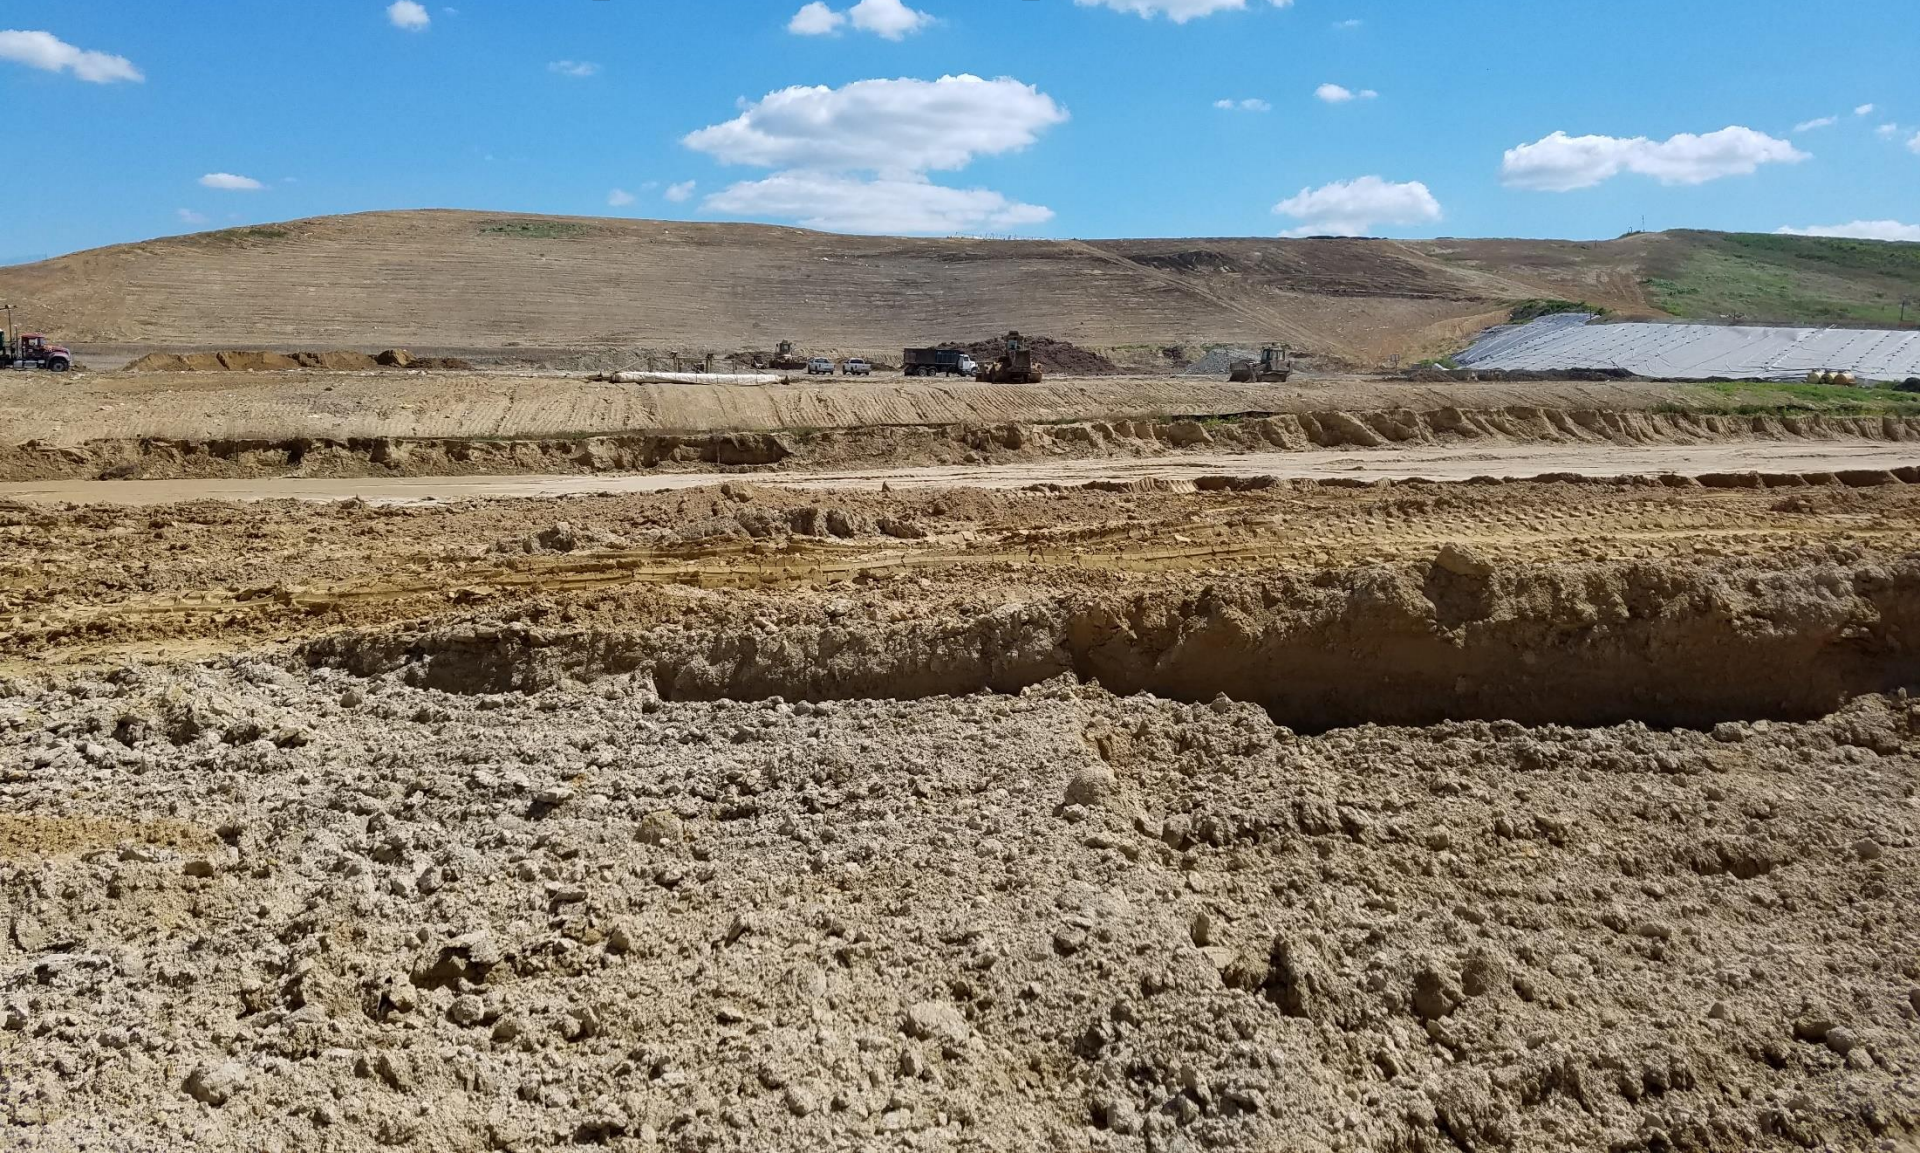
**Stafford/Spotsy/F'burg Regional Landfill (R
Board / 3). Dark material was “final soil cover”
(not ADC) placed over the plastic liner in 2021.**

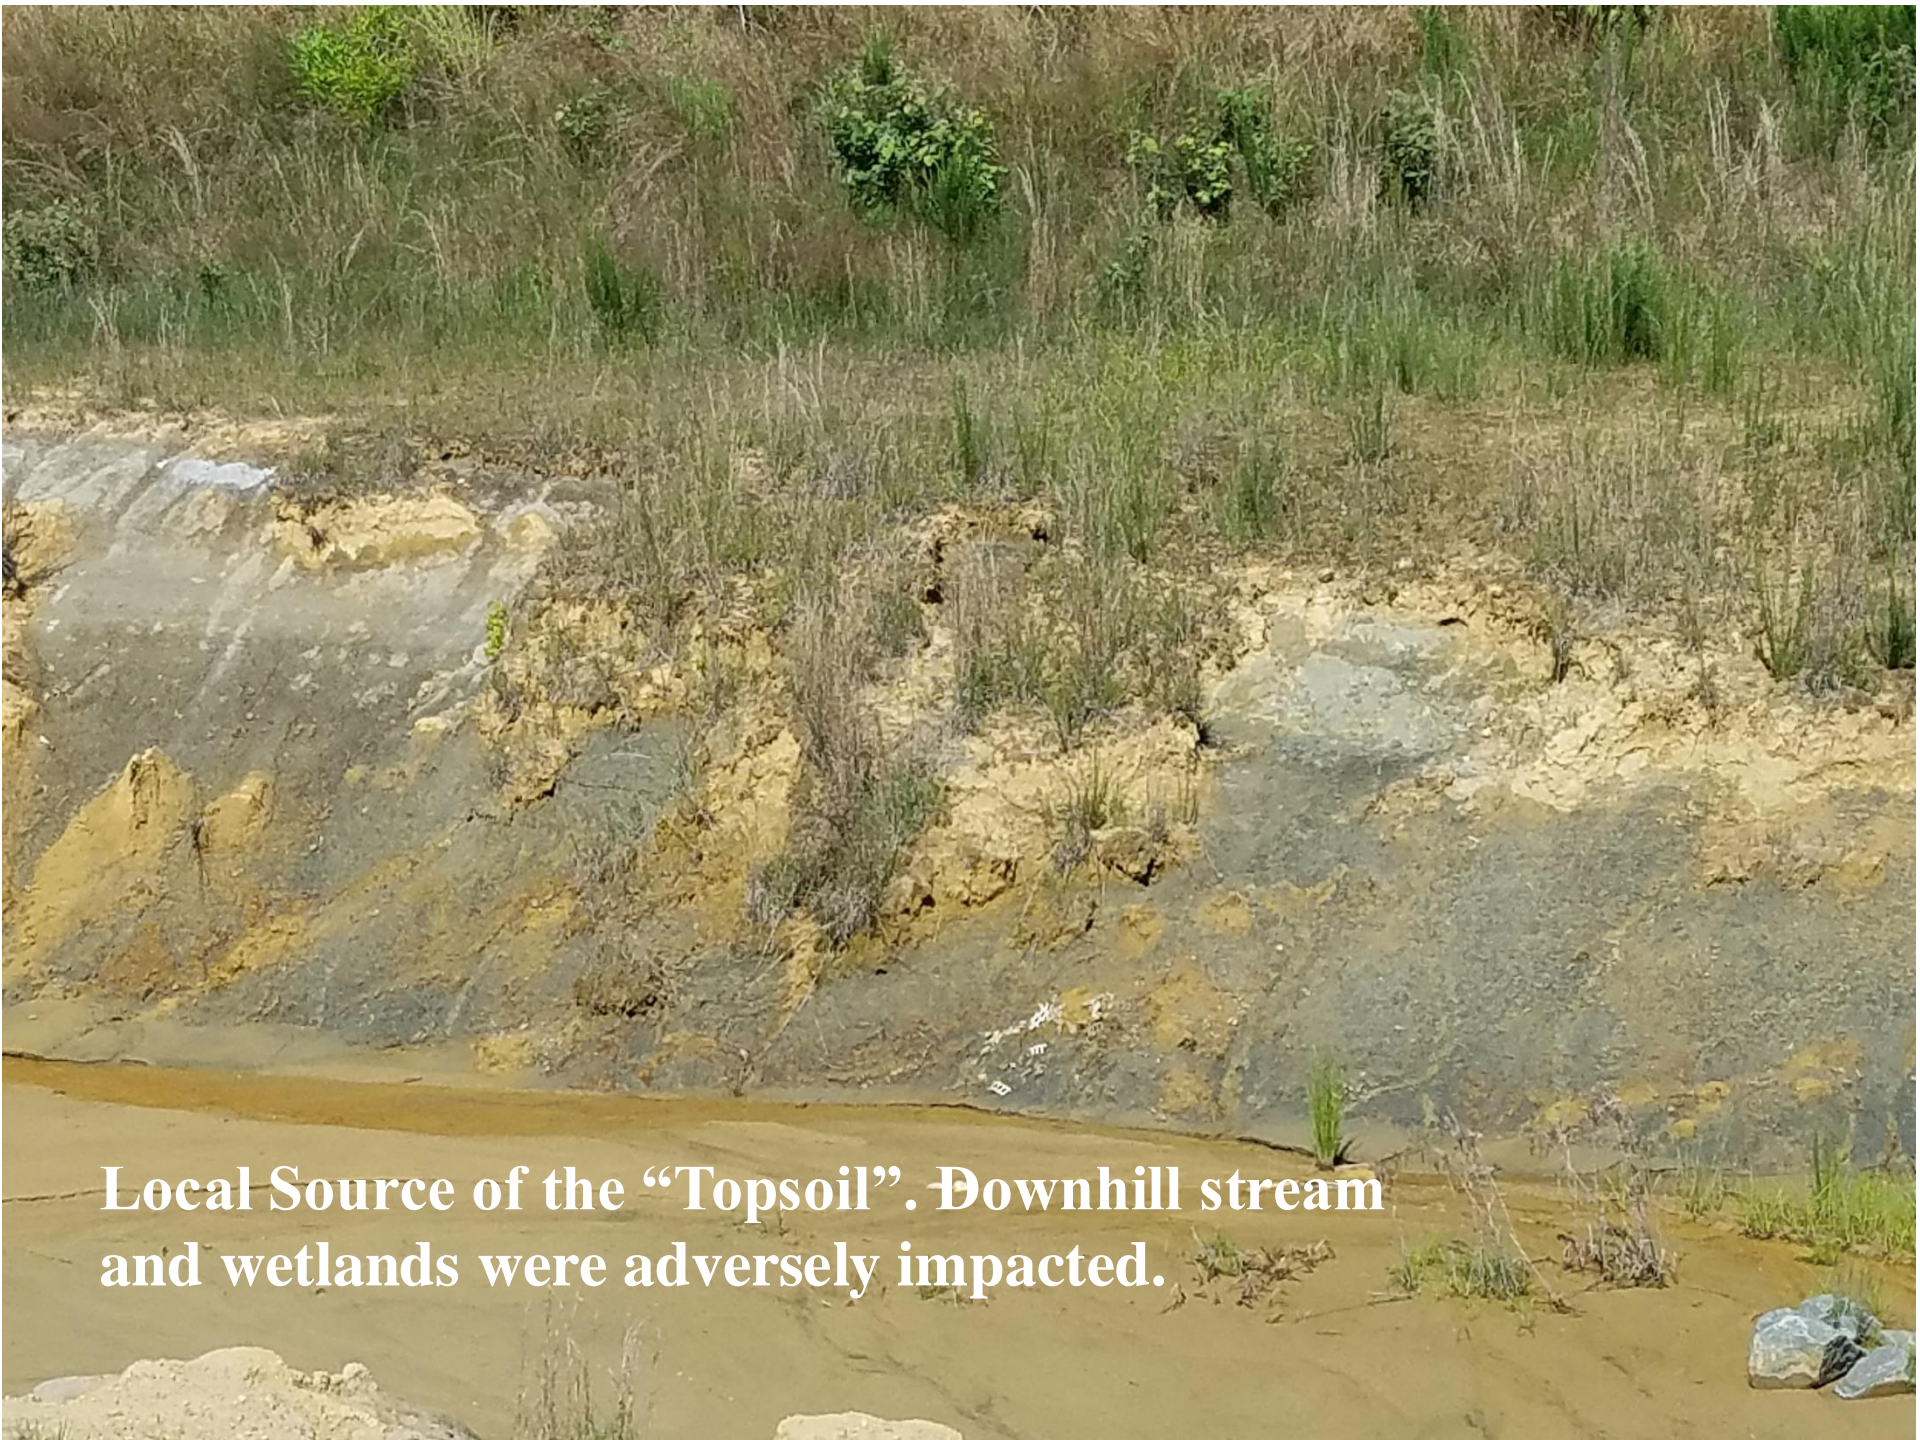
Local Source of the “Topsoil”. Downhill stream and wetlands were adversely impacted.

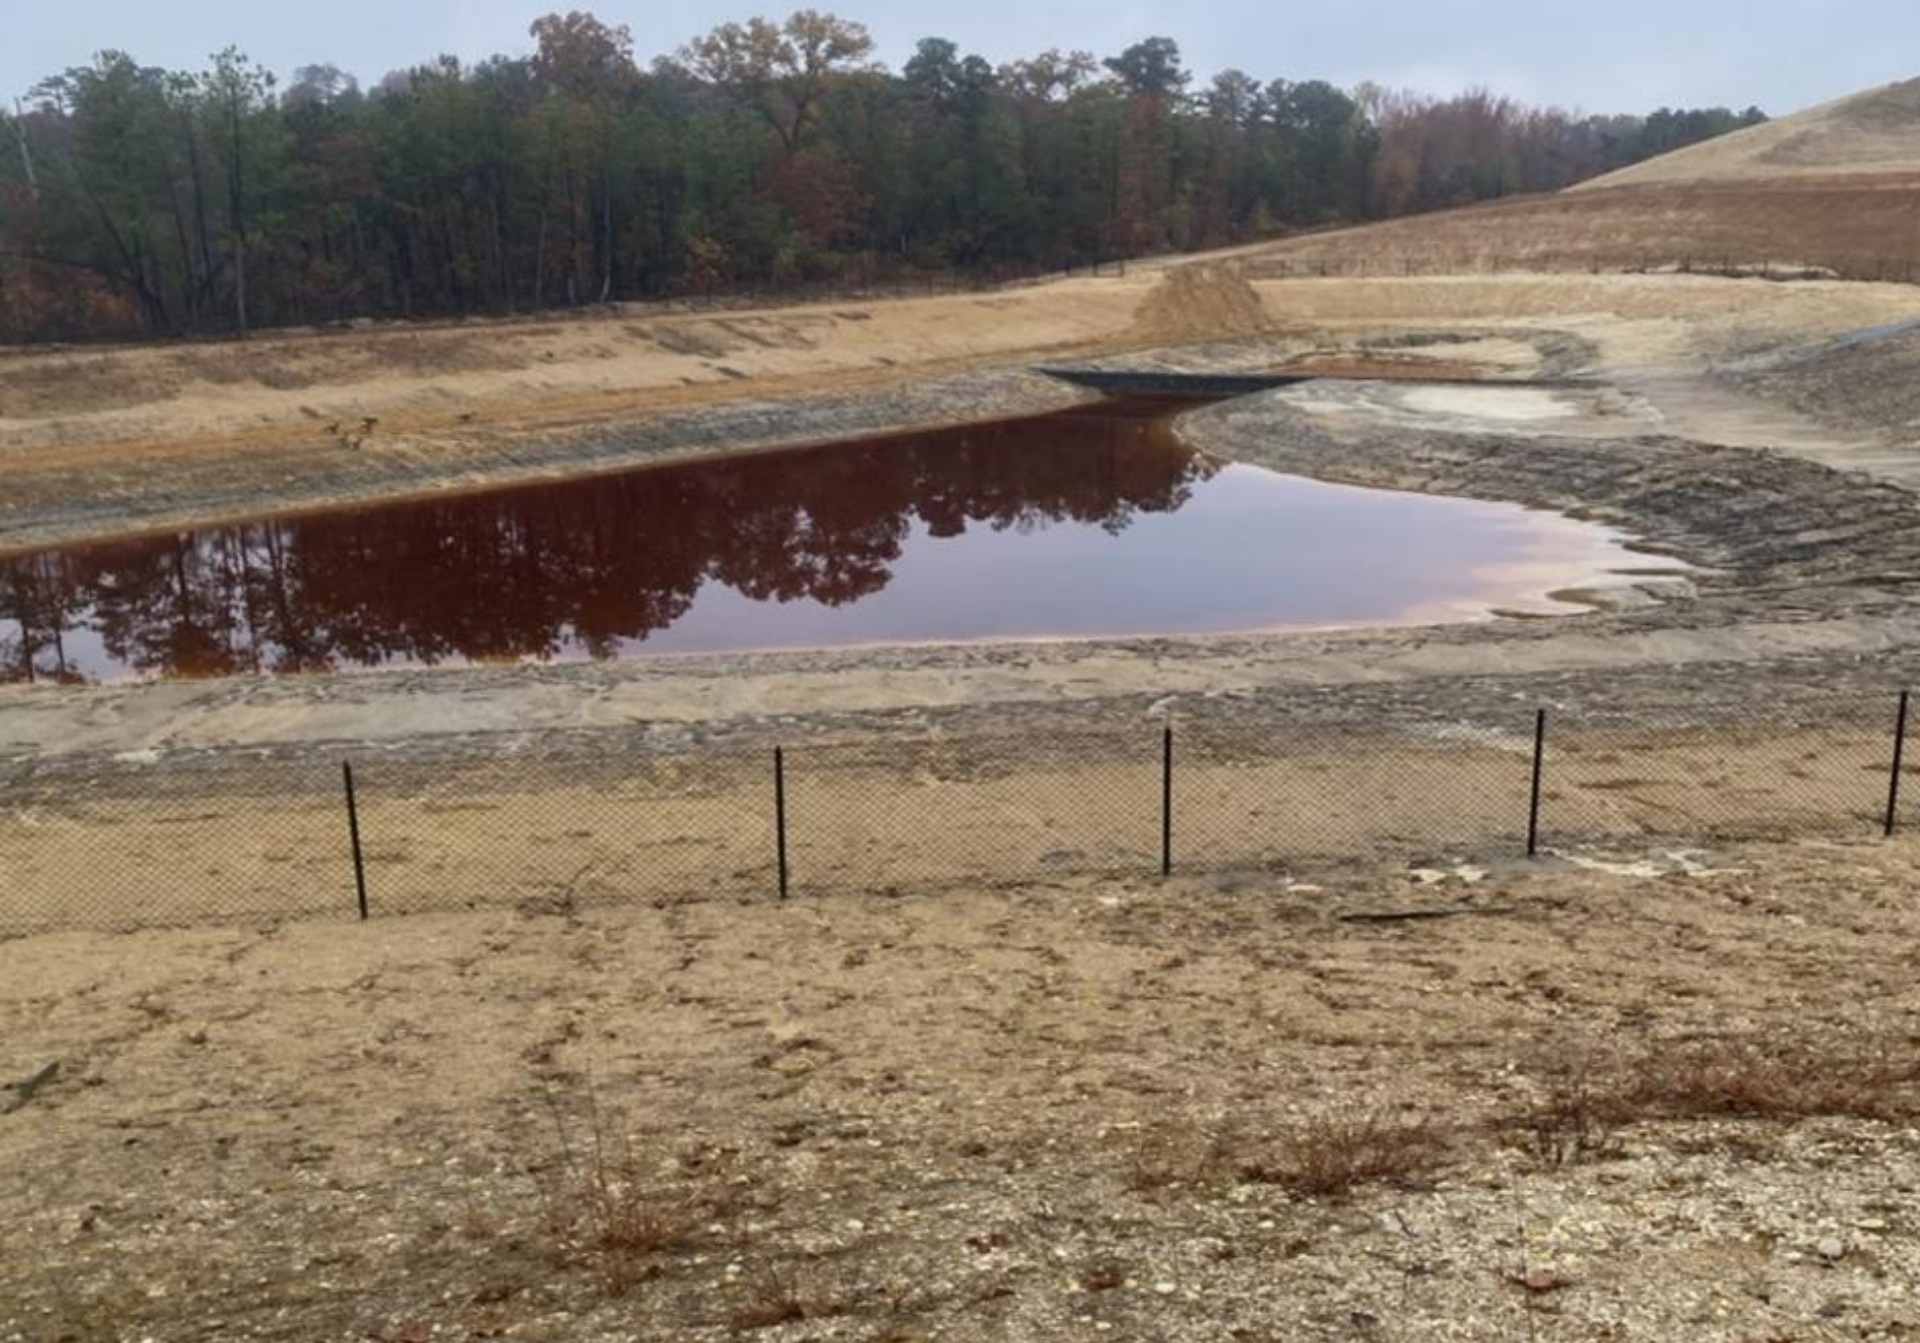
Above grade fill (> 100K CY) containing ASS from the adjacent stormwater pond. Average NNP of entire pile is – 30 T/1000. Miocene aged materials exposed in cut in previous image are – 78 T/1000
