Management of Acid-Forming Sediments at the Stafford Airport Expansion Project in Virginia

W. Lee Daniels

TerraScience LLC

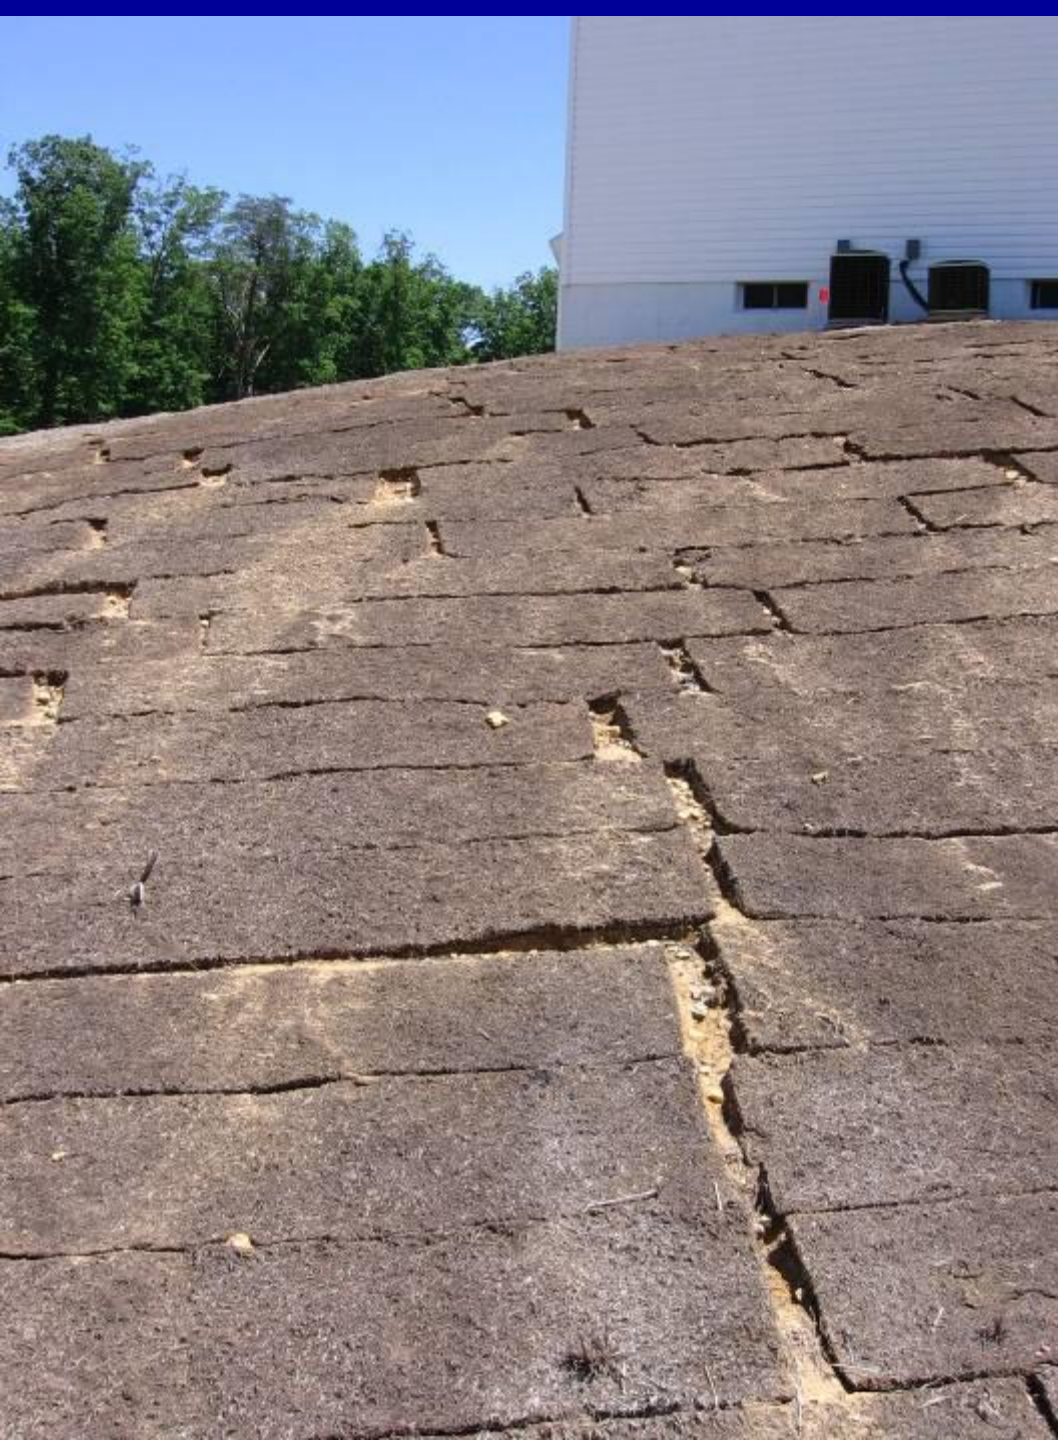
**Second
round of
sod
placed
over pH
2.5 soils
at Great
Oaks.**

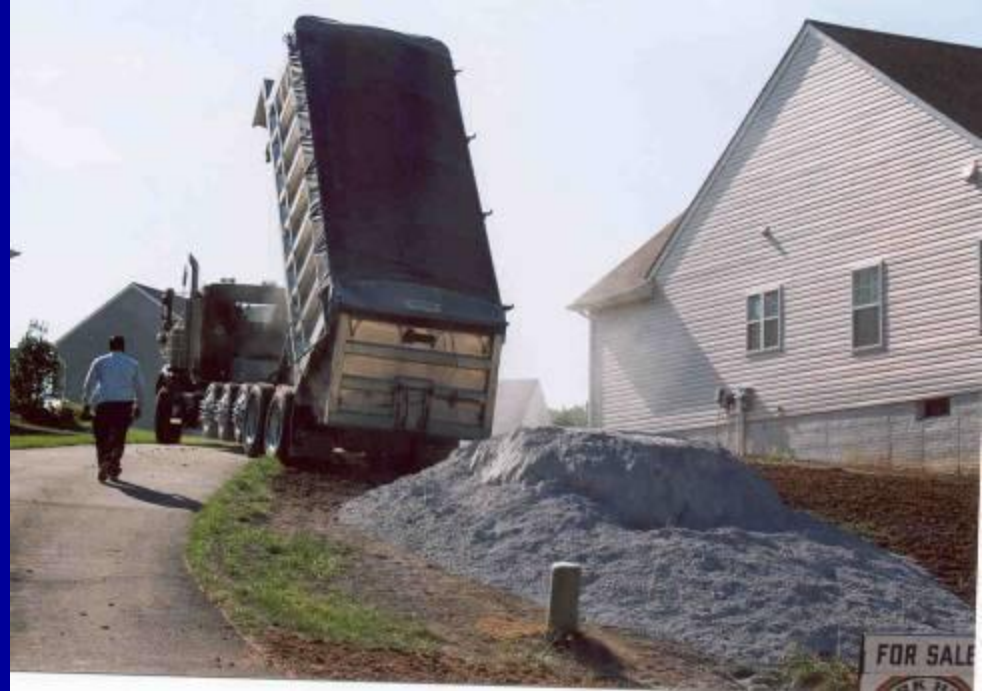
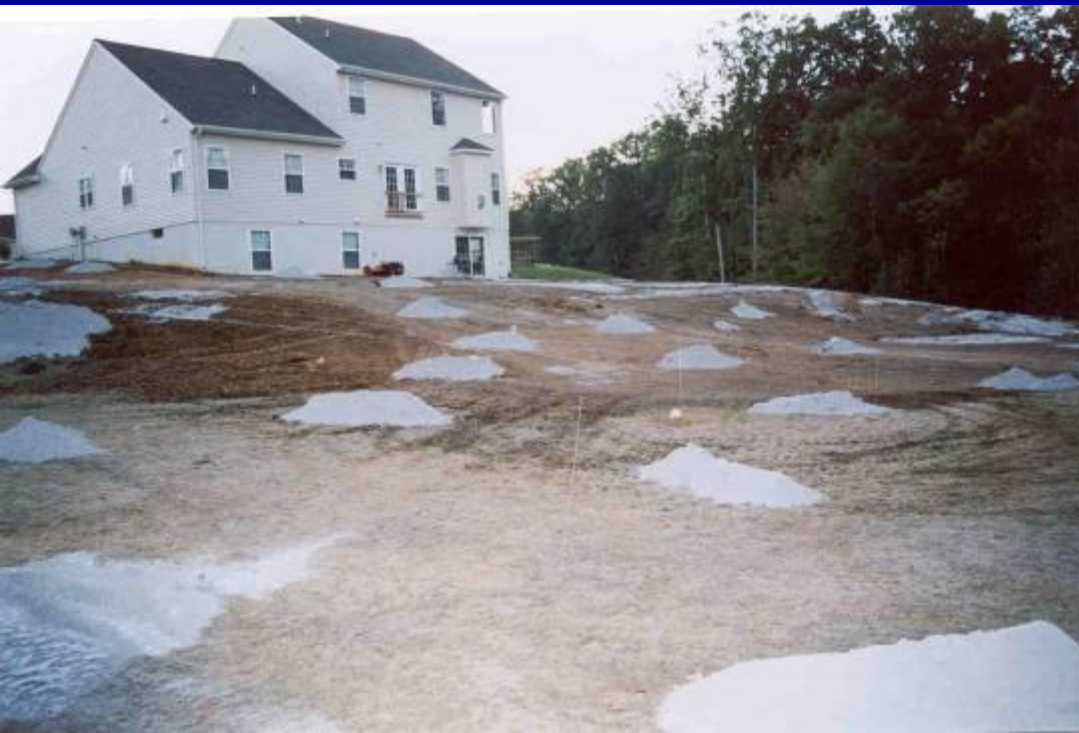
**Similar to Stafford Airport
we did a PPA test on his soil,
which yielded values as high
as 38 ton CaCO_3 /ac. But
you can't spread biosolids in
a subdivision!**

We recommended:

- 25 – 30 ton/ac lime
- 300 lbs/ac P
- compost if possible
- topsoil was also applied

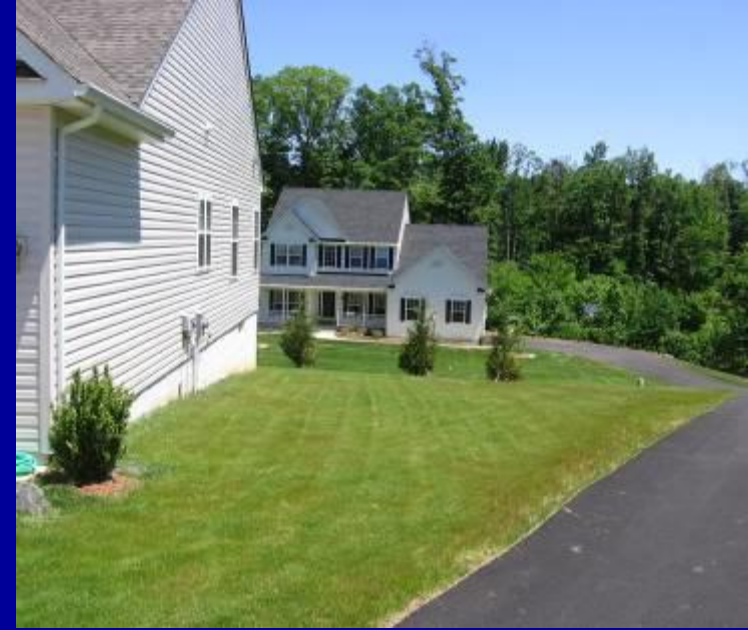
Remediated yard, summer 2006
