The Use of Terrestrial Laser Scanning to Assess the Mobilization of Contaminated Creekbank Soils in Oak Ridge, Tennessee

UTK

Tyler Musante

ORNL

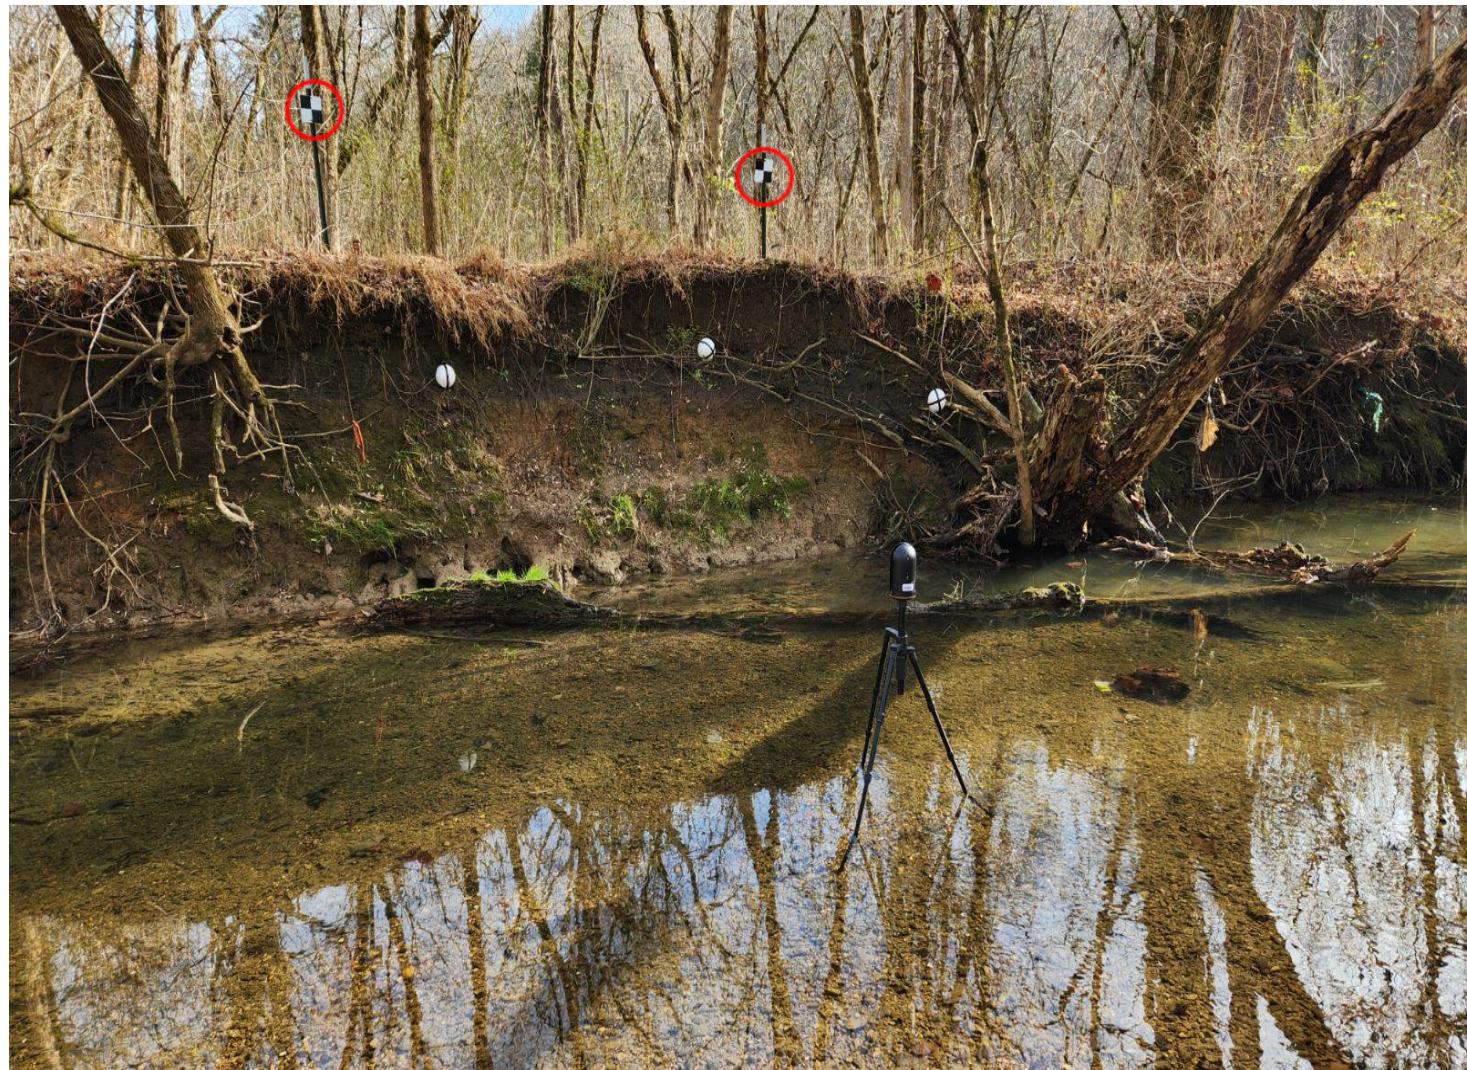
Introduction to TLS

- TLS is preferred for this research over Airborne Laser Scanning (ALS)
- The LiDAR system is mounted on a leveled tripod
- Product of scan is a point cloud
- Point clouds from different sampling times are superimposed and compared using registration software, resulting in volume calculations
- Georeferencing being added to improve overlap
- Site-specific variables will be utilized to assess dominant erosional processes

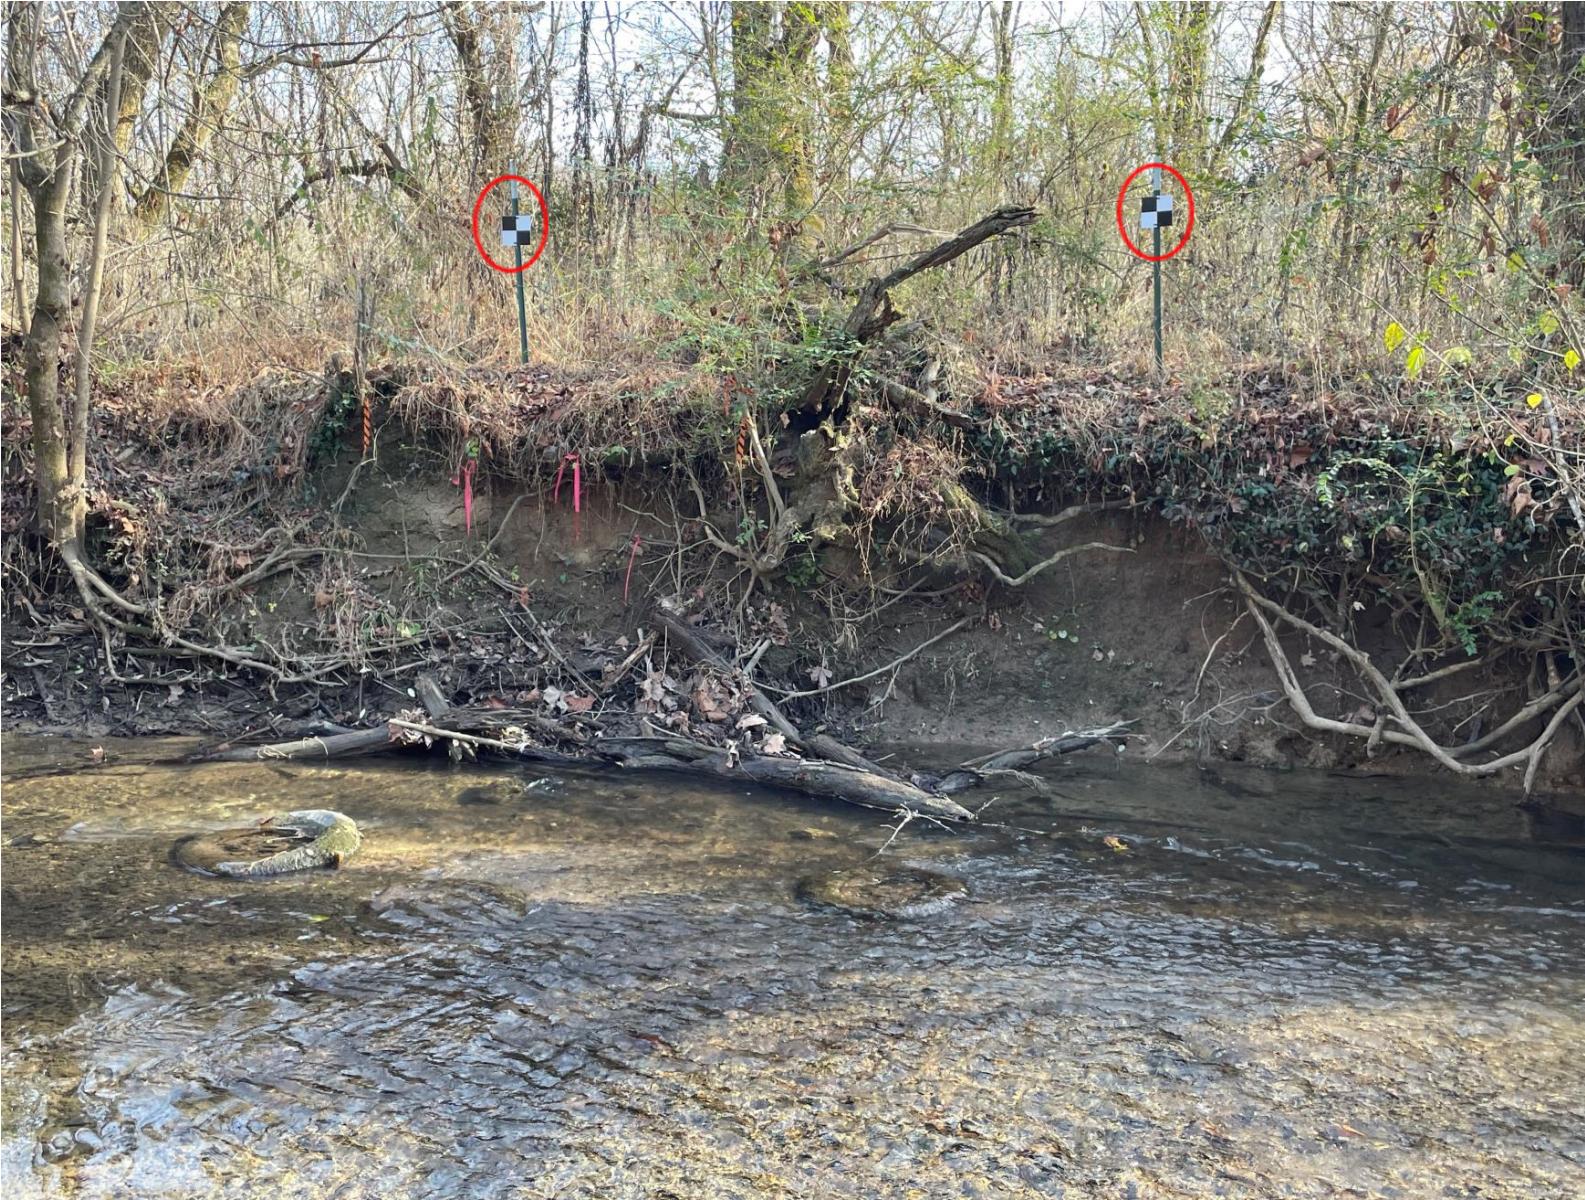
EFK 14.56 (targets circled)

Scanning site-> point cloud comparison

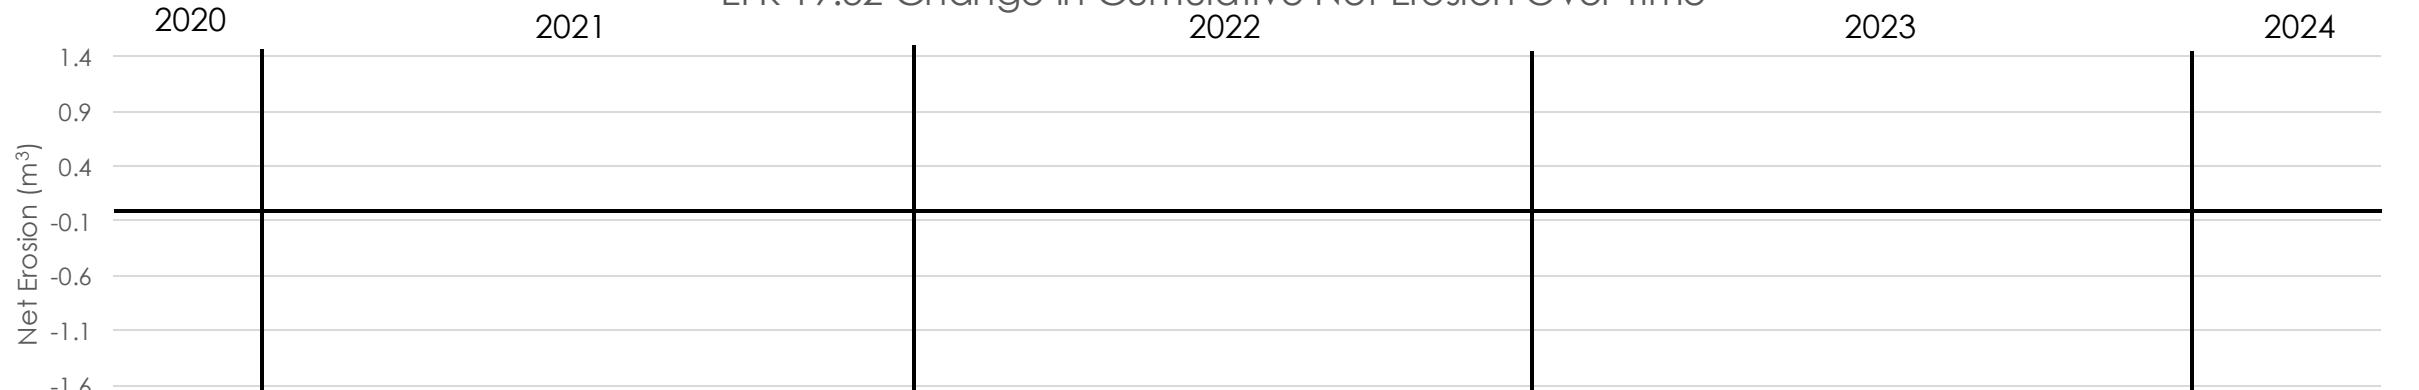
EFK 19.32 Change in Cumulative Net Erosion Over Time

- Smallest differences between methods found at 16.41 and 20.27
- The biggest differences between methods found at 19.02, and 19.32
- Issues caused by mixture of heavy vegetation, overhanging banks and unremarkable features (bare banks)

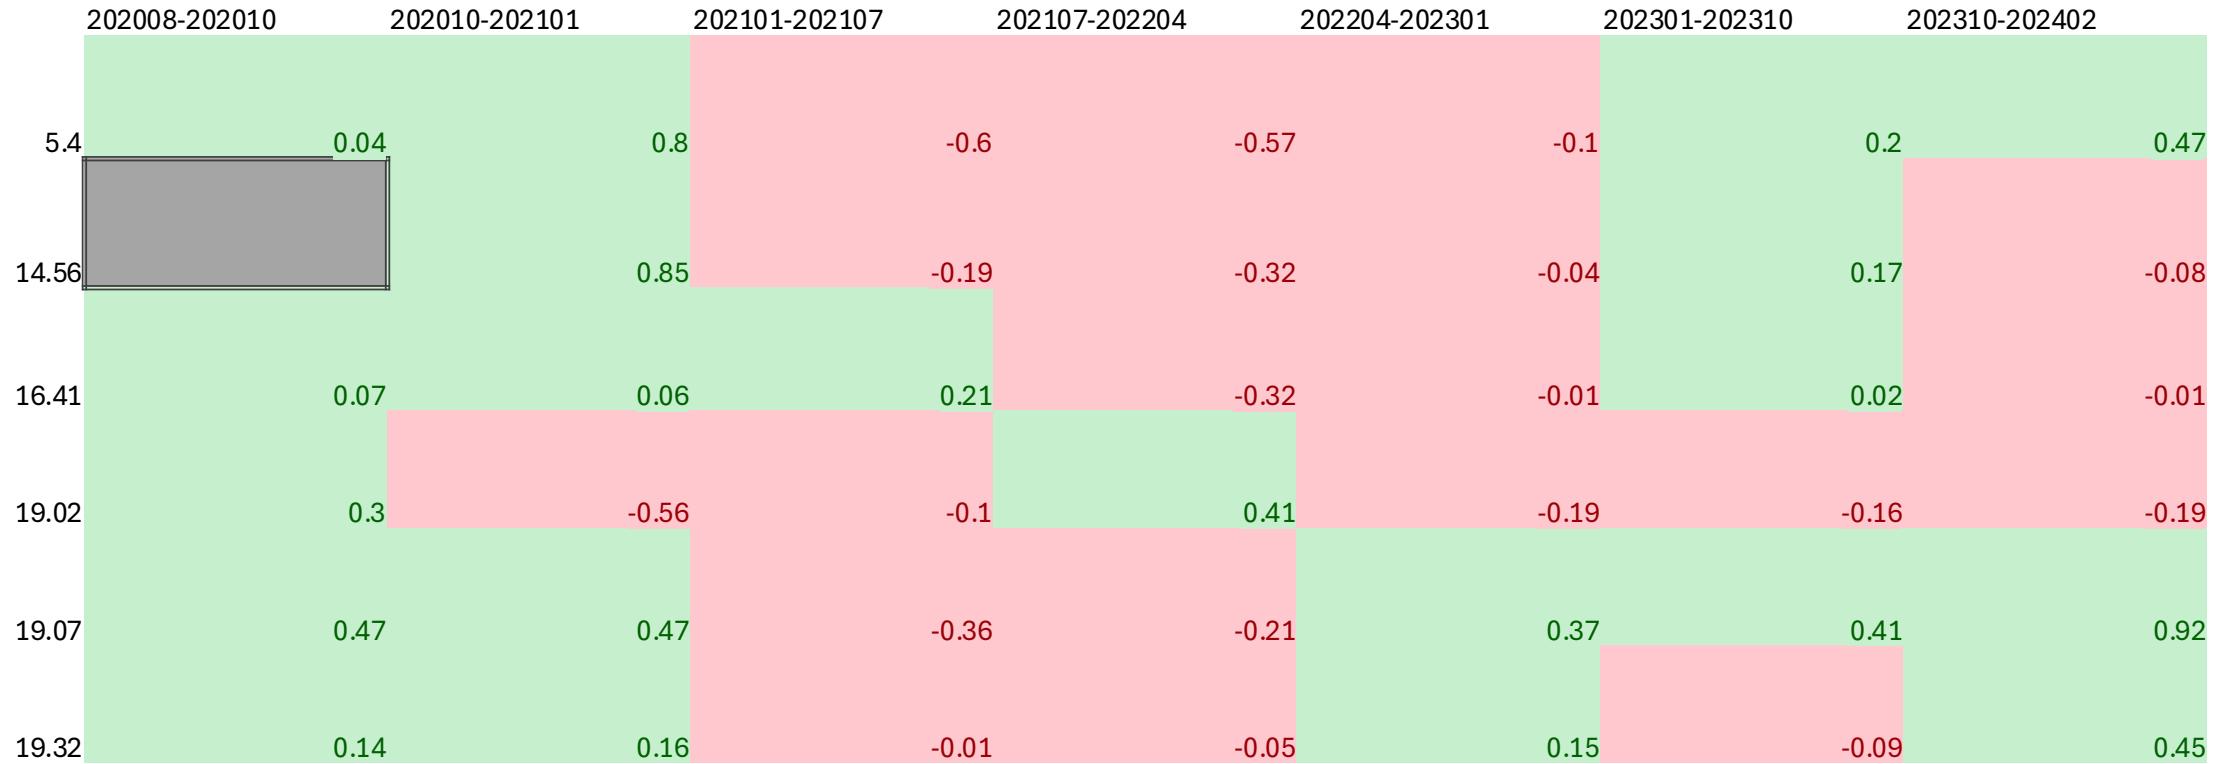
Georeferencing results (in progress)

Volume Differences Over Time (m³)

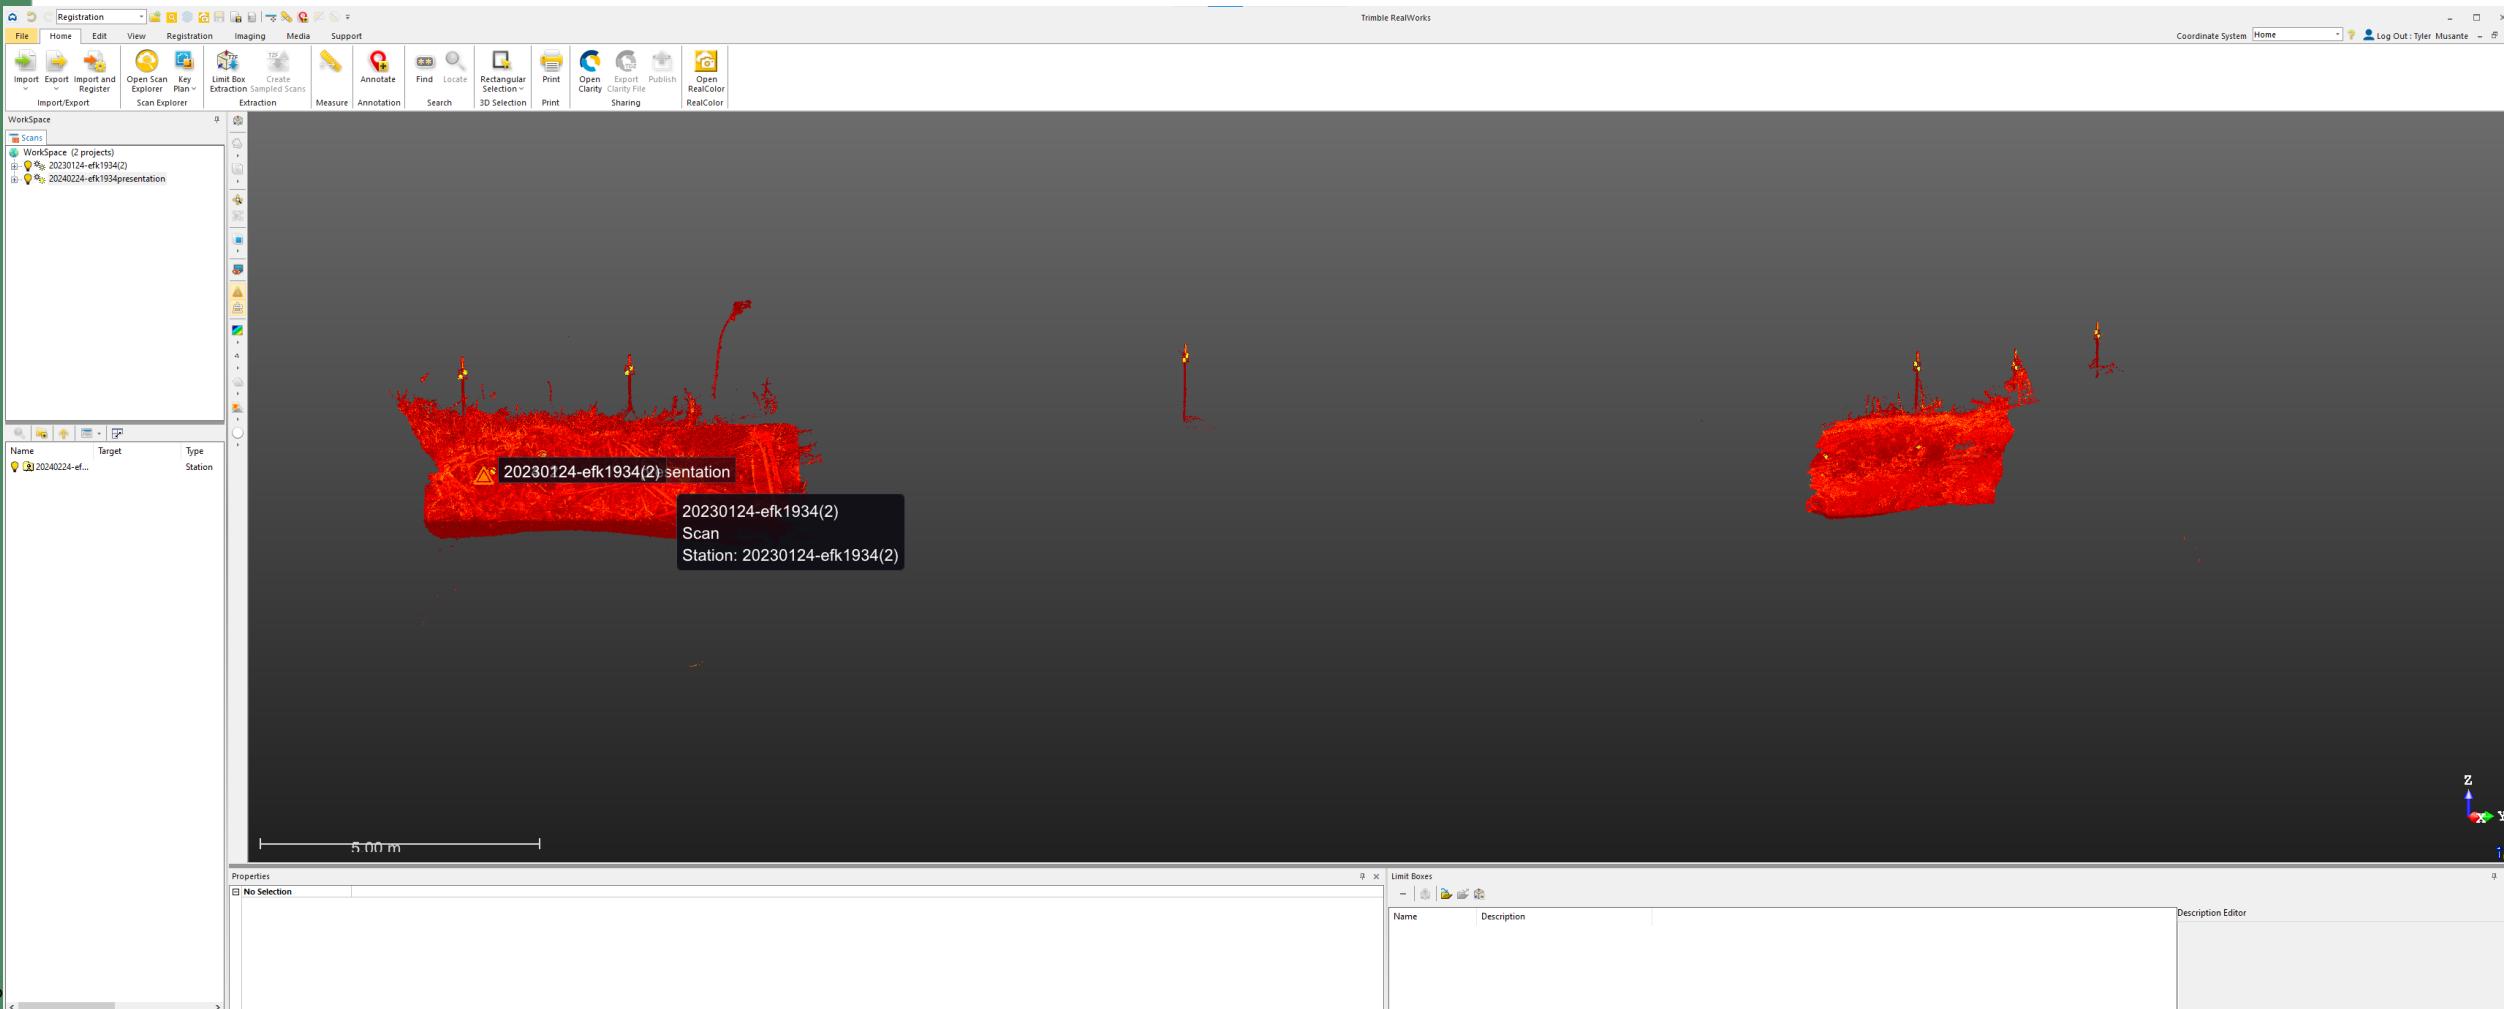
Save the calculations and Volume Breakdown Layers
