Possible Ecological Indicators of Ecosystem Function Around Mining Areas Using Soil, Water and Biological Characteristics: A Case Study

Presented at ASRS, Butte, MT, June 2025

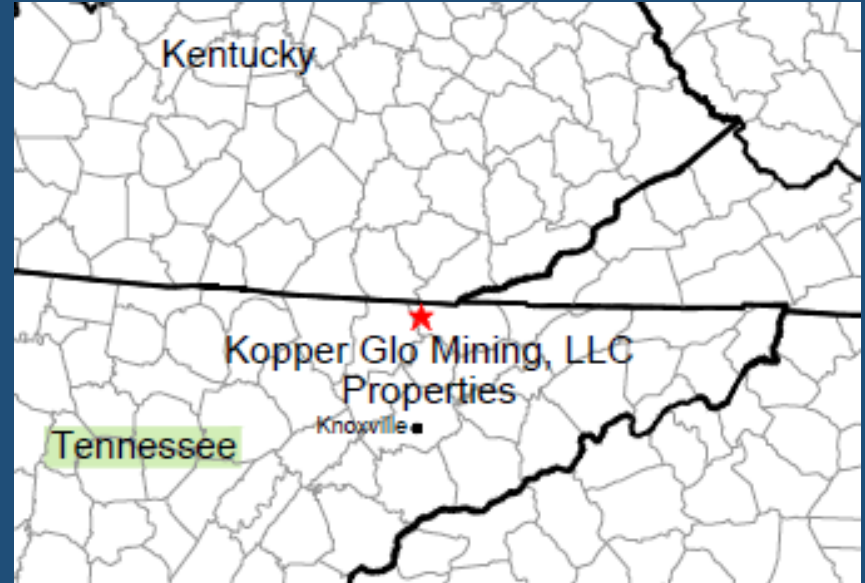
- Located in the Appalachian Coal Region with 100-year mining history.
- 65 acres located around TN-KY Border north of Knoxville.
- Borders Clear Fork to the North and Powell Valley to the south.
- Contour mining was practiced.
- Surface mined around 2007-2015 and reclaimed.
- Around 1 m of coal seams were mined.

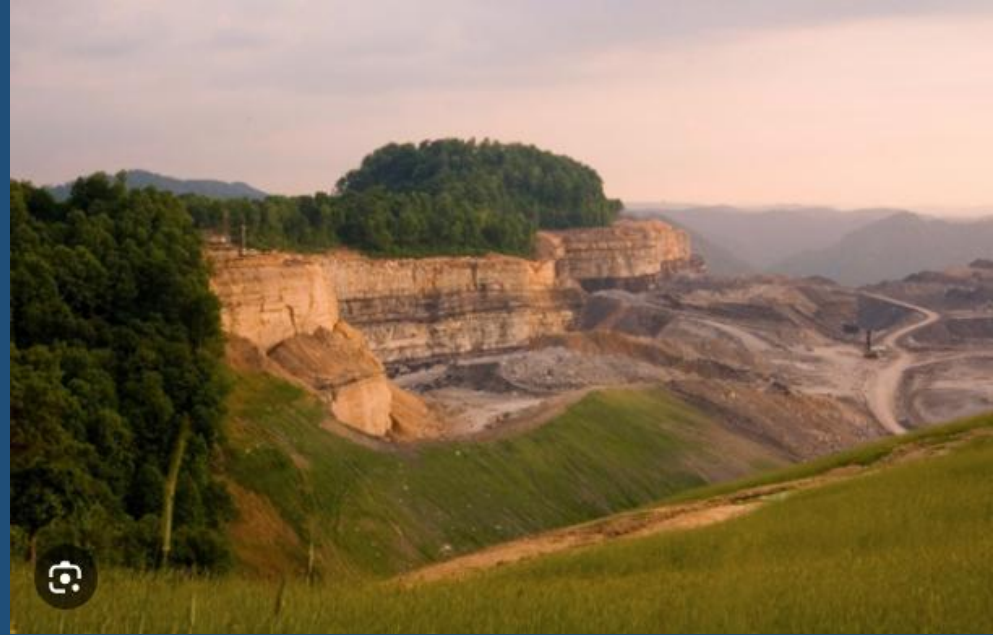
Concepts of Contour Mining

- Contour mining practiced with 1-2 cuts around the mountain.
- Pit width about 150 ft wide with haul roads about 30-ft wide.
- No topsoil removal, storage, or replacement operations
- Overburden blasted, hauled, and dumped along the mountain slope with limited selective placement, with greater sandstone-rich materials in the upper meter. Overburden was graded with no additional compaction prior to planting tree seedlings
- Overburden slopes are approximately natural slopes of about 37 deg.
- No additional soils placed on graded overburden prior to planting.
- Irrigation was through natural rains only.
- Coal was not blasted prior to removal.

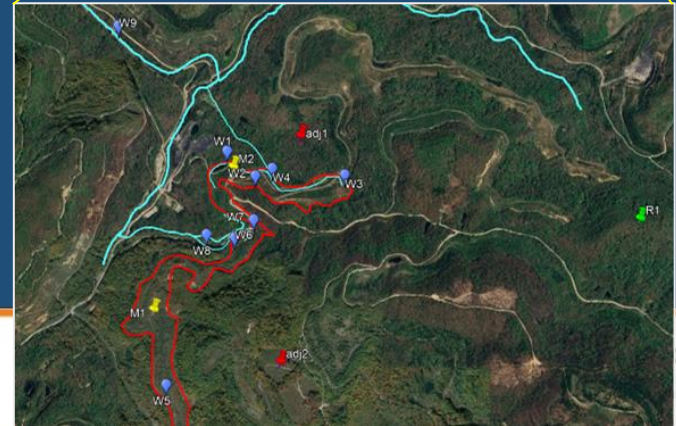
Sampling and methodology: landscape level

- NDVI - 250m 16 day average from MODIS for points at the widest section at the northern end of the site, and southern end, 2 points in adjacent unmined areas, and 3 points in forested reference areas, June & July 2000 - 2024.
- Evapotranspiration- ECOSTRESS
Evapotranspiration PT-JPL Daily L3 Global 70 m for same points as above for all available dates (2019-2024), using samples collected between 8 am and 6 pm.
- GLM test for difference between mined and unmined reference areas.

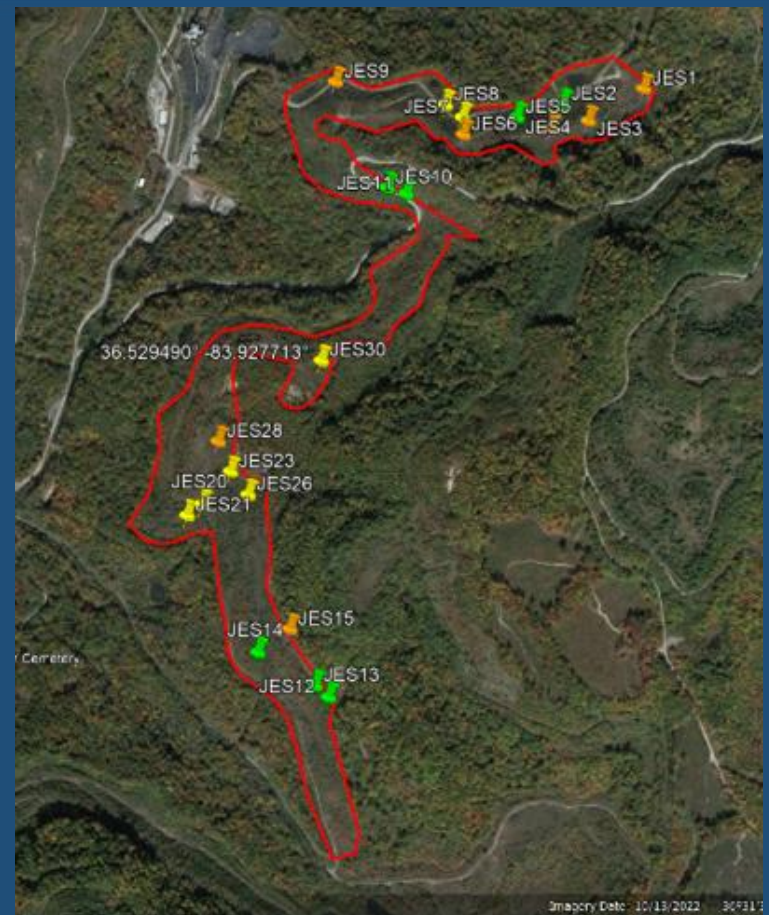
Sampling and methodology: project level

- 21 plots placed in zones of “good”, “moderate” and “poor” tree growth using stratified random sampling.
- Composite soil sample (0-10 cm depth) within each plot for soil chemistry and counts of ectomycorrhizal root tips.
- Soil core from 0-5 cm and 5-15 cm depth at plot center for soil density and texture.
- Tree species, stem count, and DBH (if ≥ 2.54 cm) on 0.04 ha plot.
- Biomass calculated for trees ≥ 2.54 cm /DBH (Chojnacky et al. 2014).
- GLM test for difference between zones.
- Partial correlation controlling for year to test site

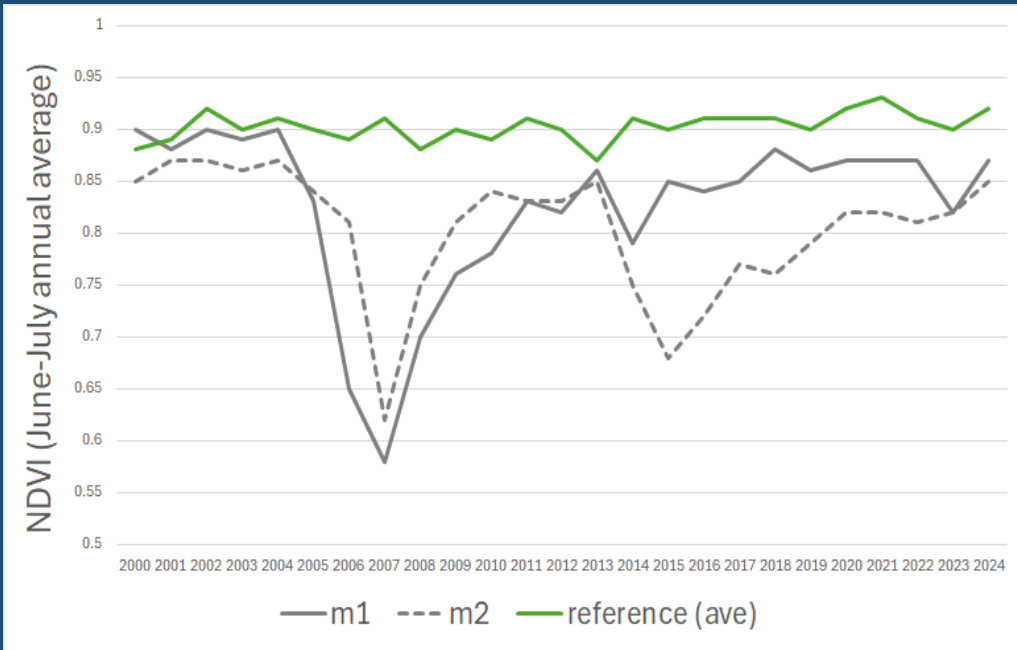
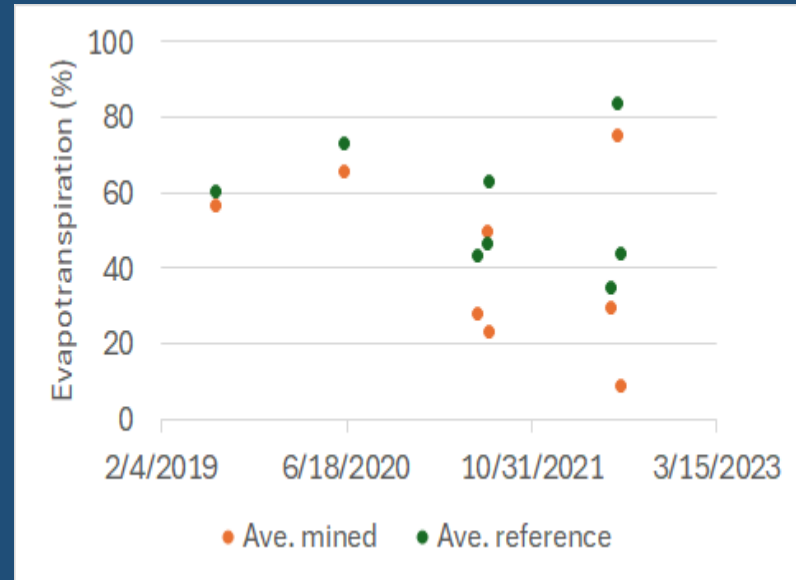
Landscape indicators Results: Vegetative cover and Evapotranspiration

No significant differences, but potential for future use as more data becomes available.

2000-2005 No significant differences 2022-2024 Ref > mined
 Spatial resolution insufficient for monitoring adjacent area

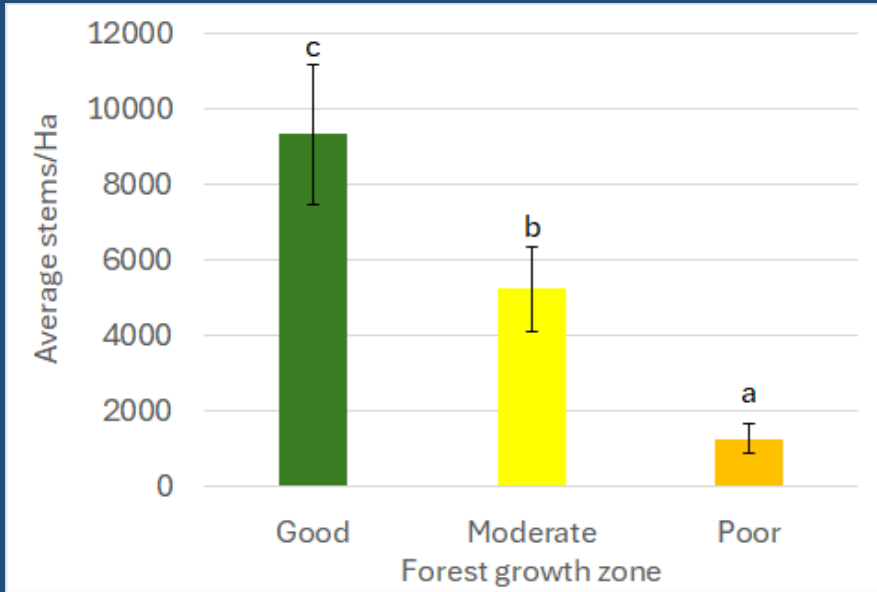
Results and Discussion: Tree growth

Growth zones differed significantly in slope% ($p \leq 0.01$), but not in elevation or aspect.
