(Bio)geochemical Evaluations of ARD in Central Montana

Scott Hensel, PG – Geochemist

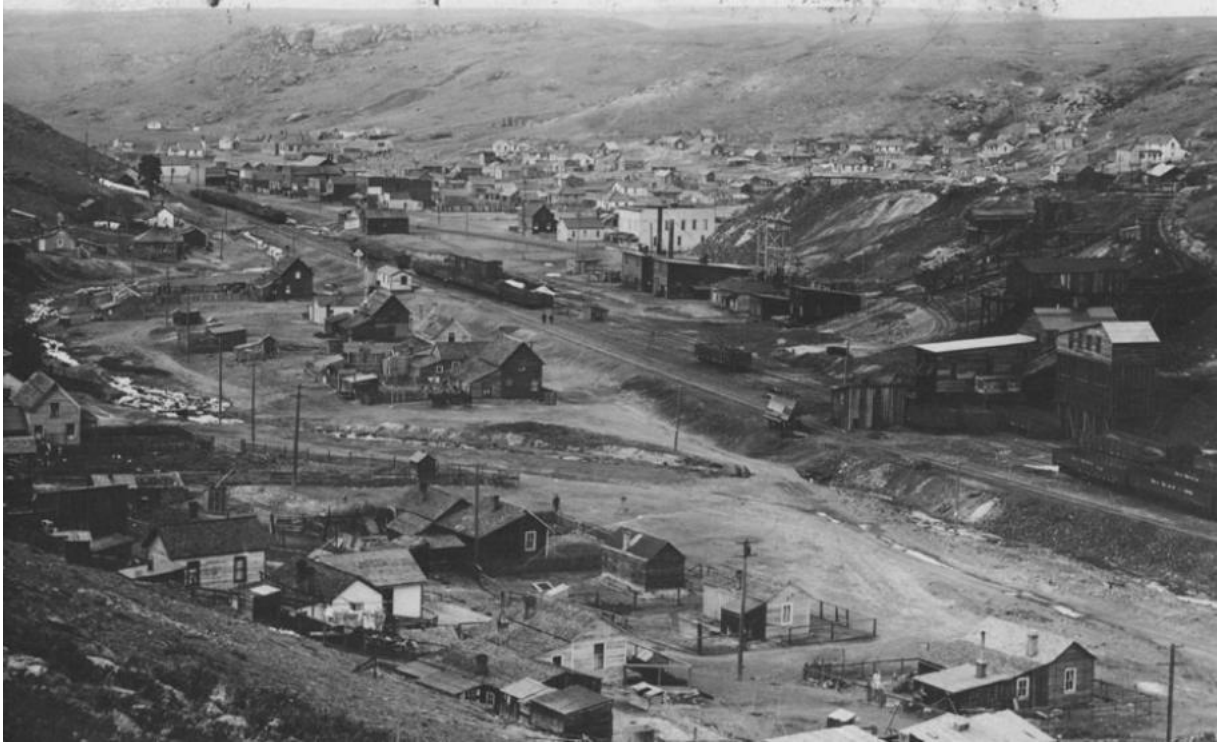
Sand Coulee, 1905

- Mining began in the Great Falls Coal Field in 1876.
- In 1887 the Sand Coulee Branch of Montana Central Railway was completed.
- Acidic Mine water is and was an issue for the majority of the mines in the area.
- It was soon discovered that the acidic mine water quickly dissolved anything made of iron.
- The majority of the mining in the area was complete by the 1940's.

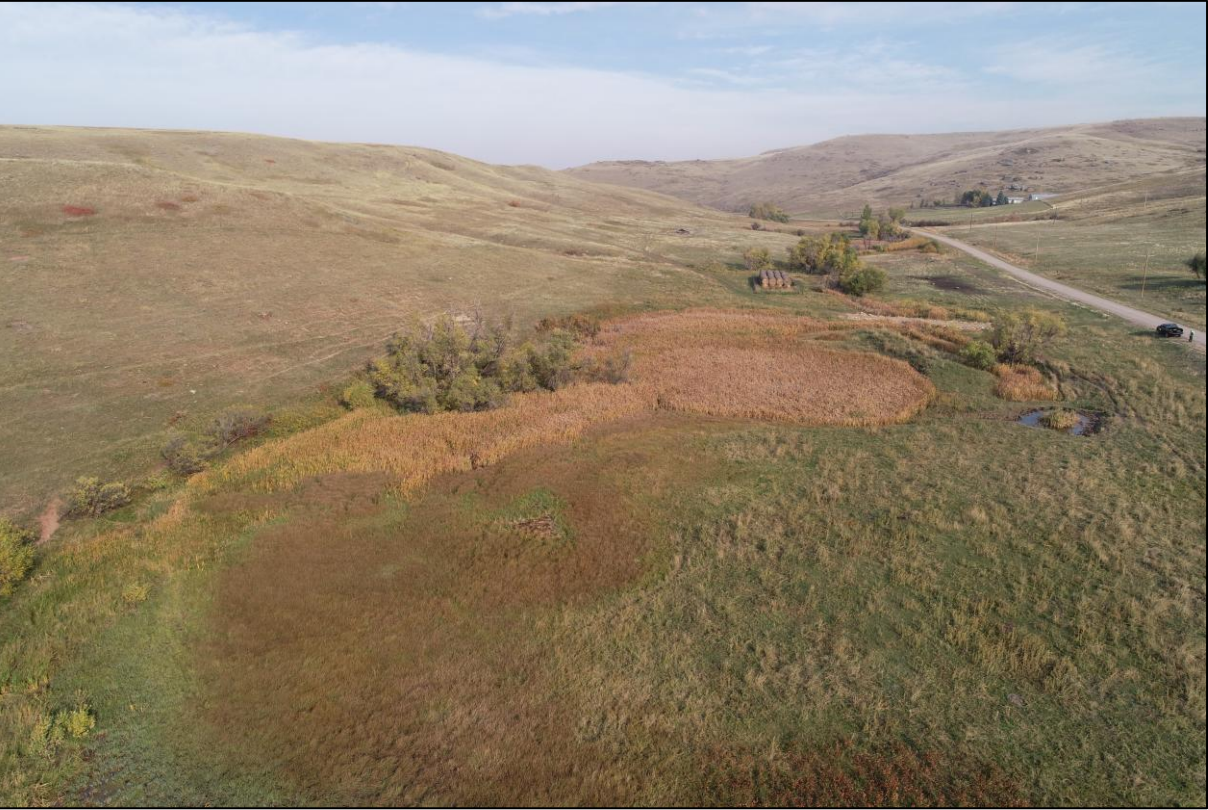
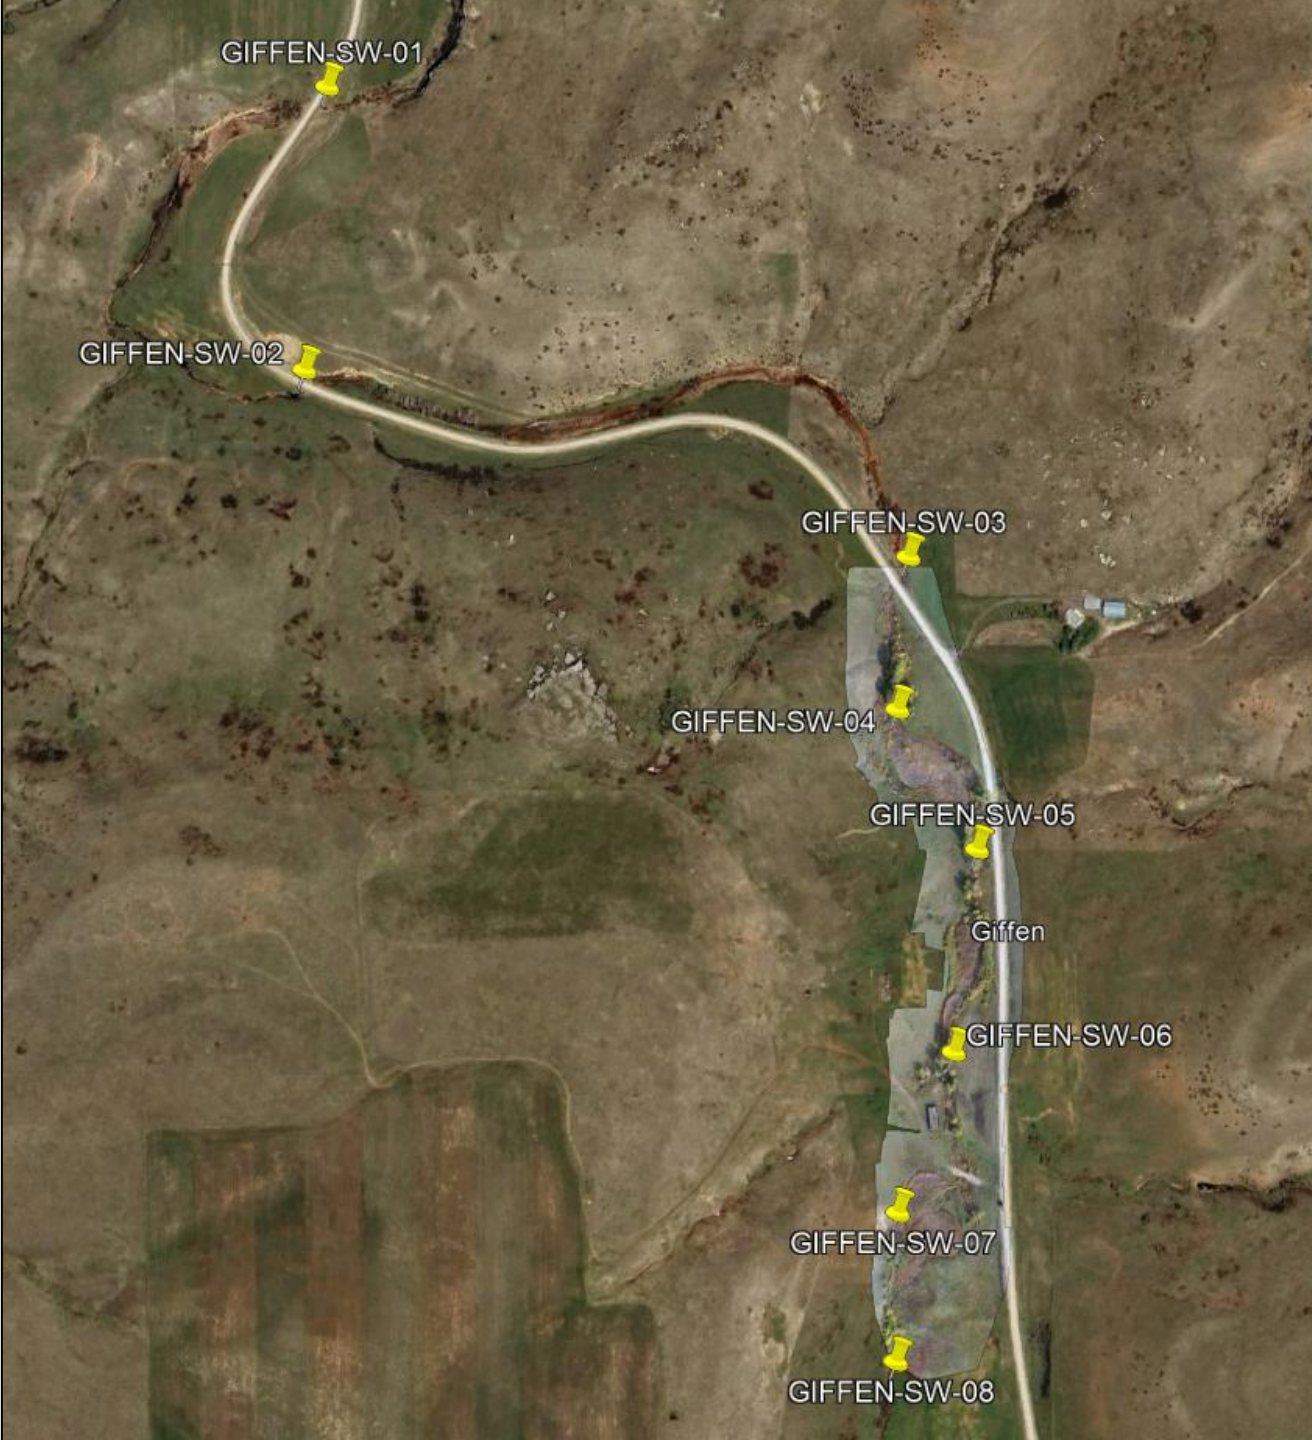
Giffen Mine Site Wetlands Complex Study

- Water quality improvement:
 - Microbially catalyzed oxidation reactions
 - Oxide mineral precipitation
 - Dilution
- All trace metals in the surface water improve throughout the flow path. Many falling below DEQ-7 Human Health Standards.
- pH increases from <5 to >7

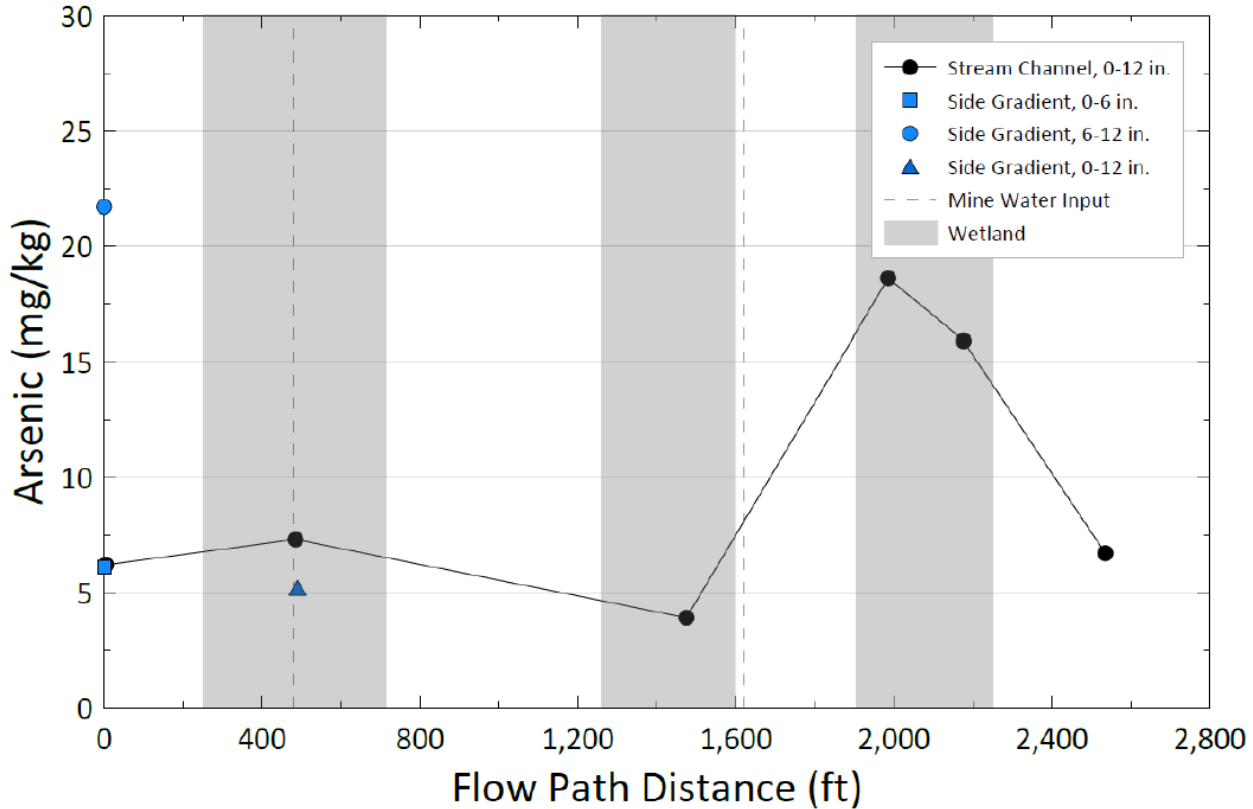
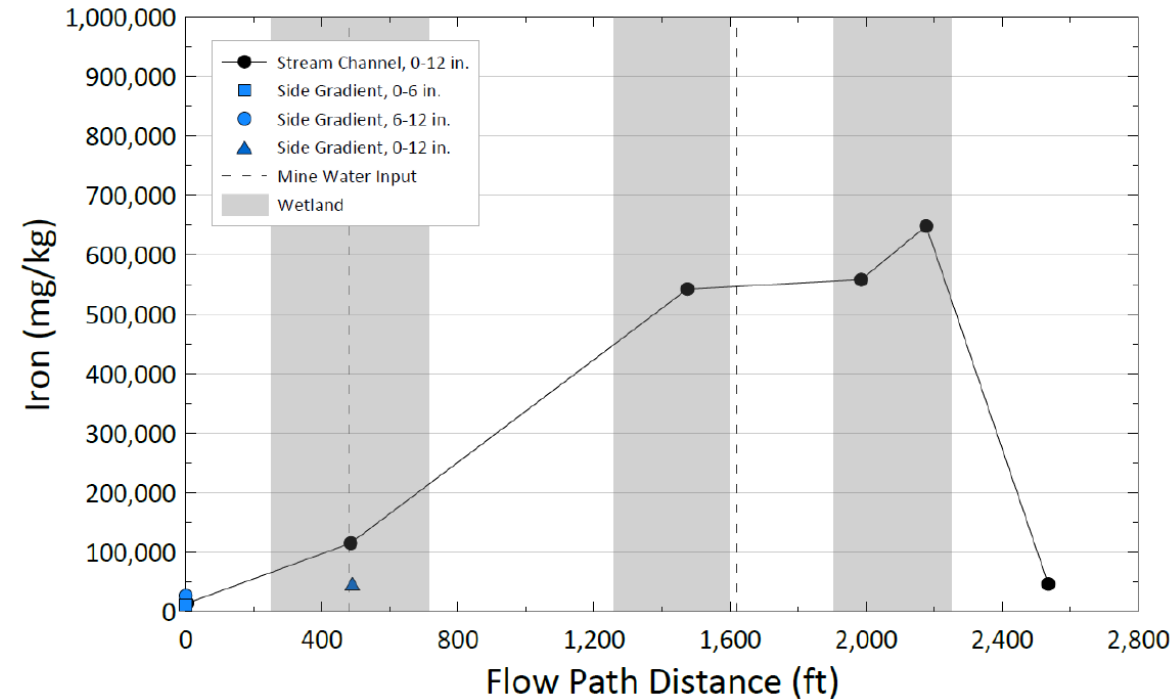
Giffen Soil

Loading of soil with mine water constituents.

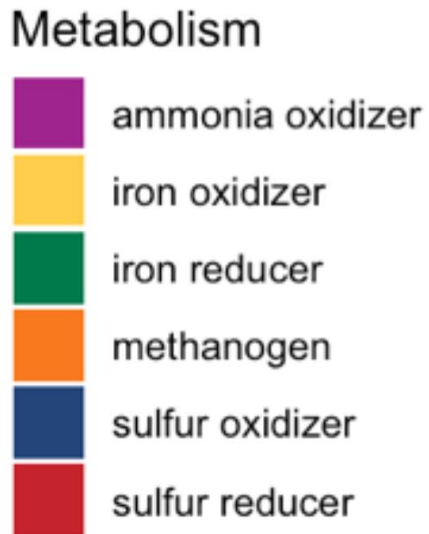
Giffen Microbes

- Samples collected at surface and at 6 inches depth.
- DNA extraction, rRNA sequencing.
- Show dominant iron oxidation following mine water inputs.

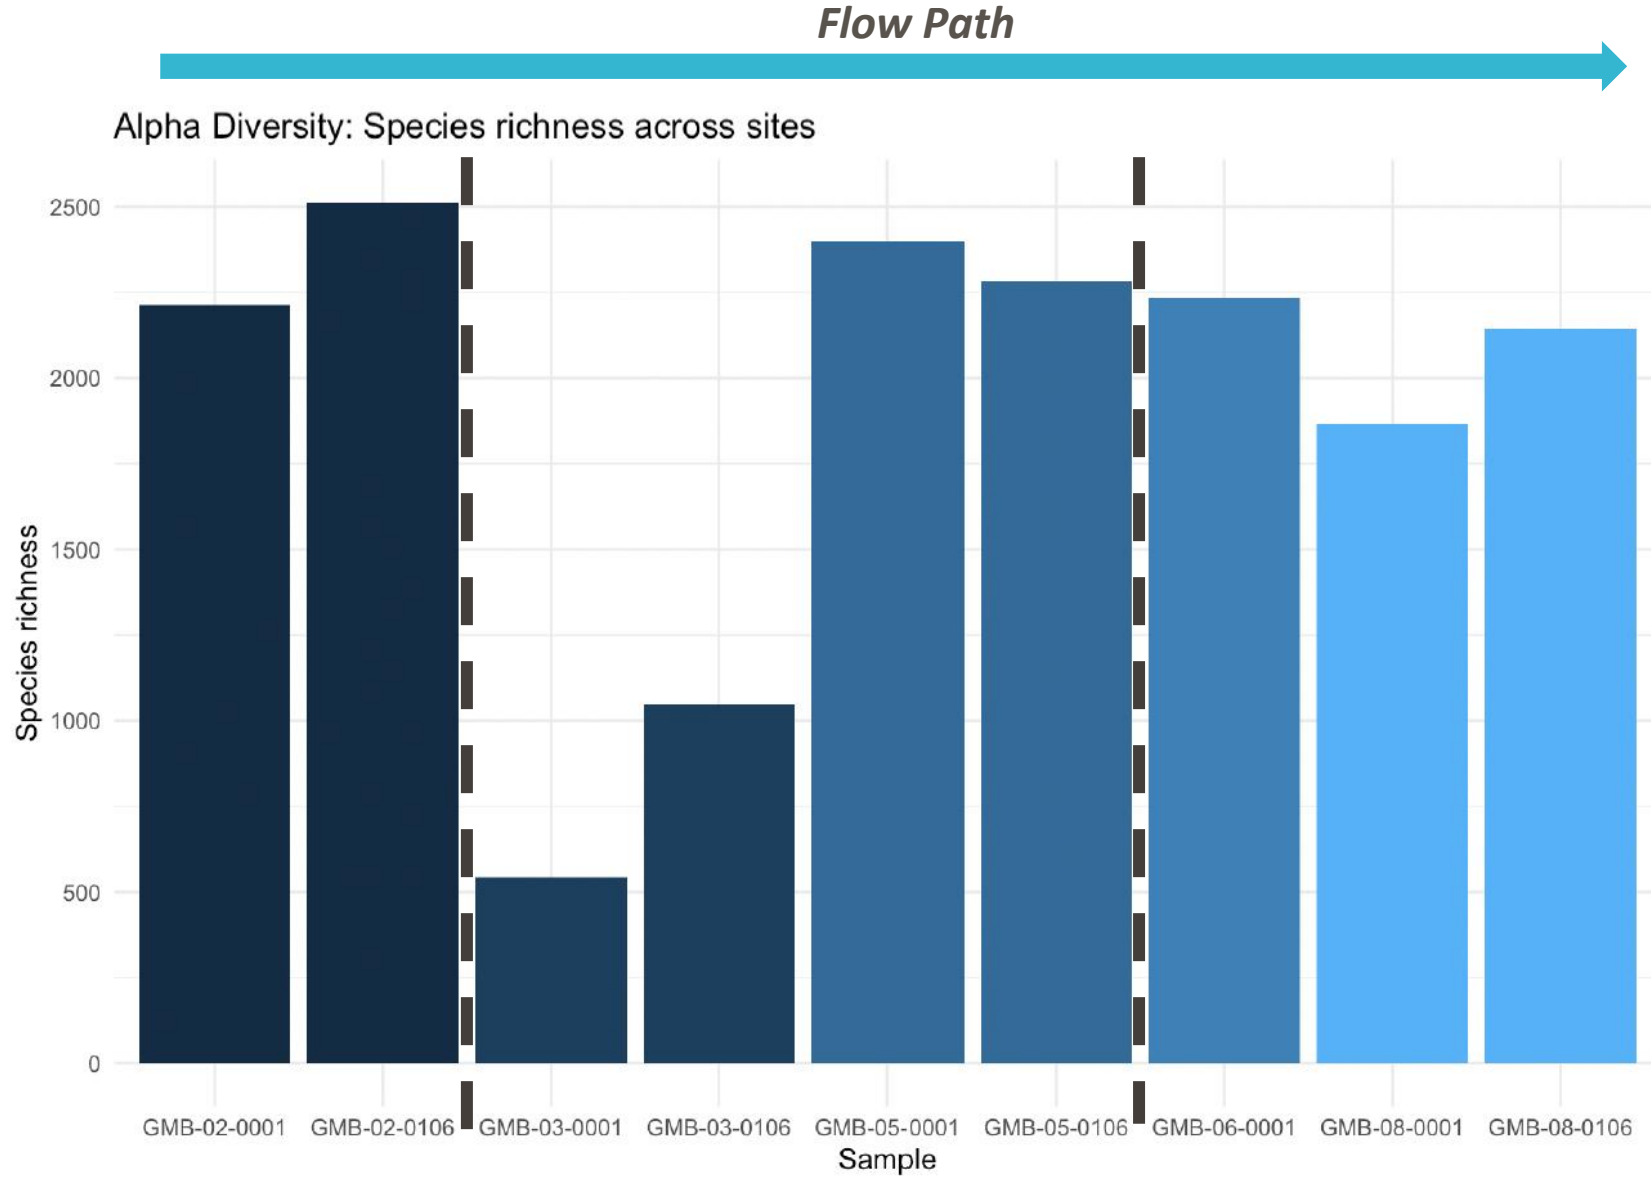
Giffen Microbes

Lower number of different species after first mine water input.

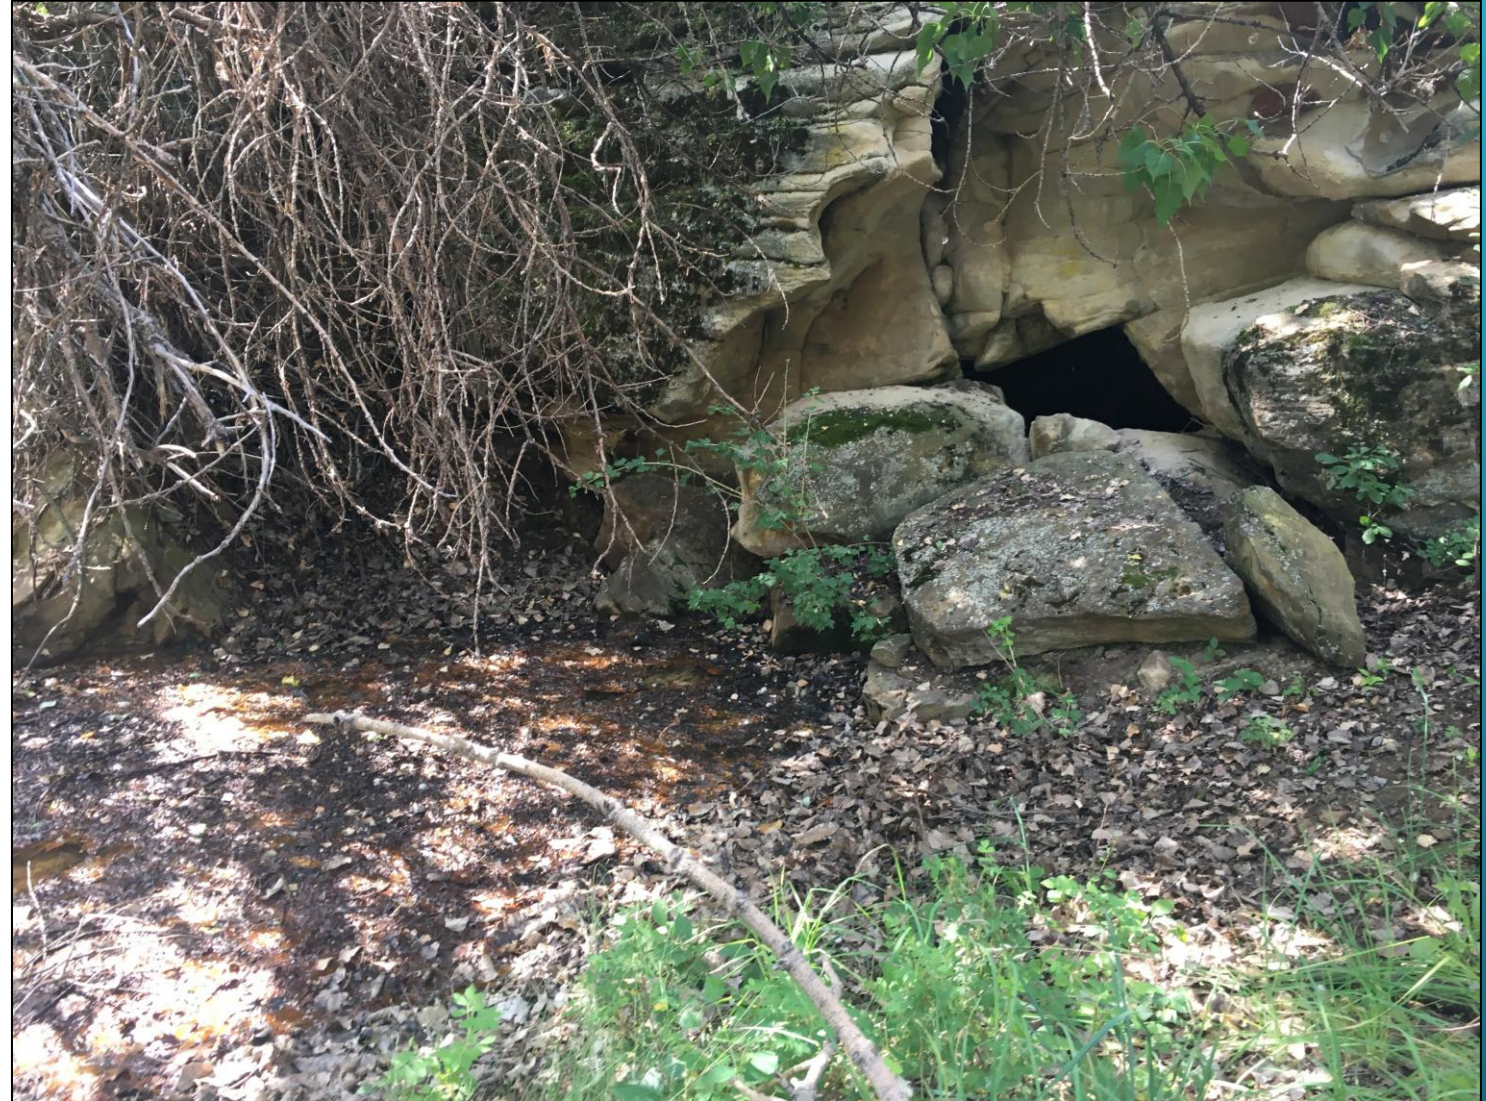
- Mt. Oregon Mine discharge flows into Kate's Coulee Creek, and then into Sand Coulee Creek.
- Kate's Coulee Creek is seasonal, rough average flow rate of 30 GPM
- Sand Coulee impacted upstream of Kate's Coulee confluence.

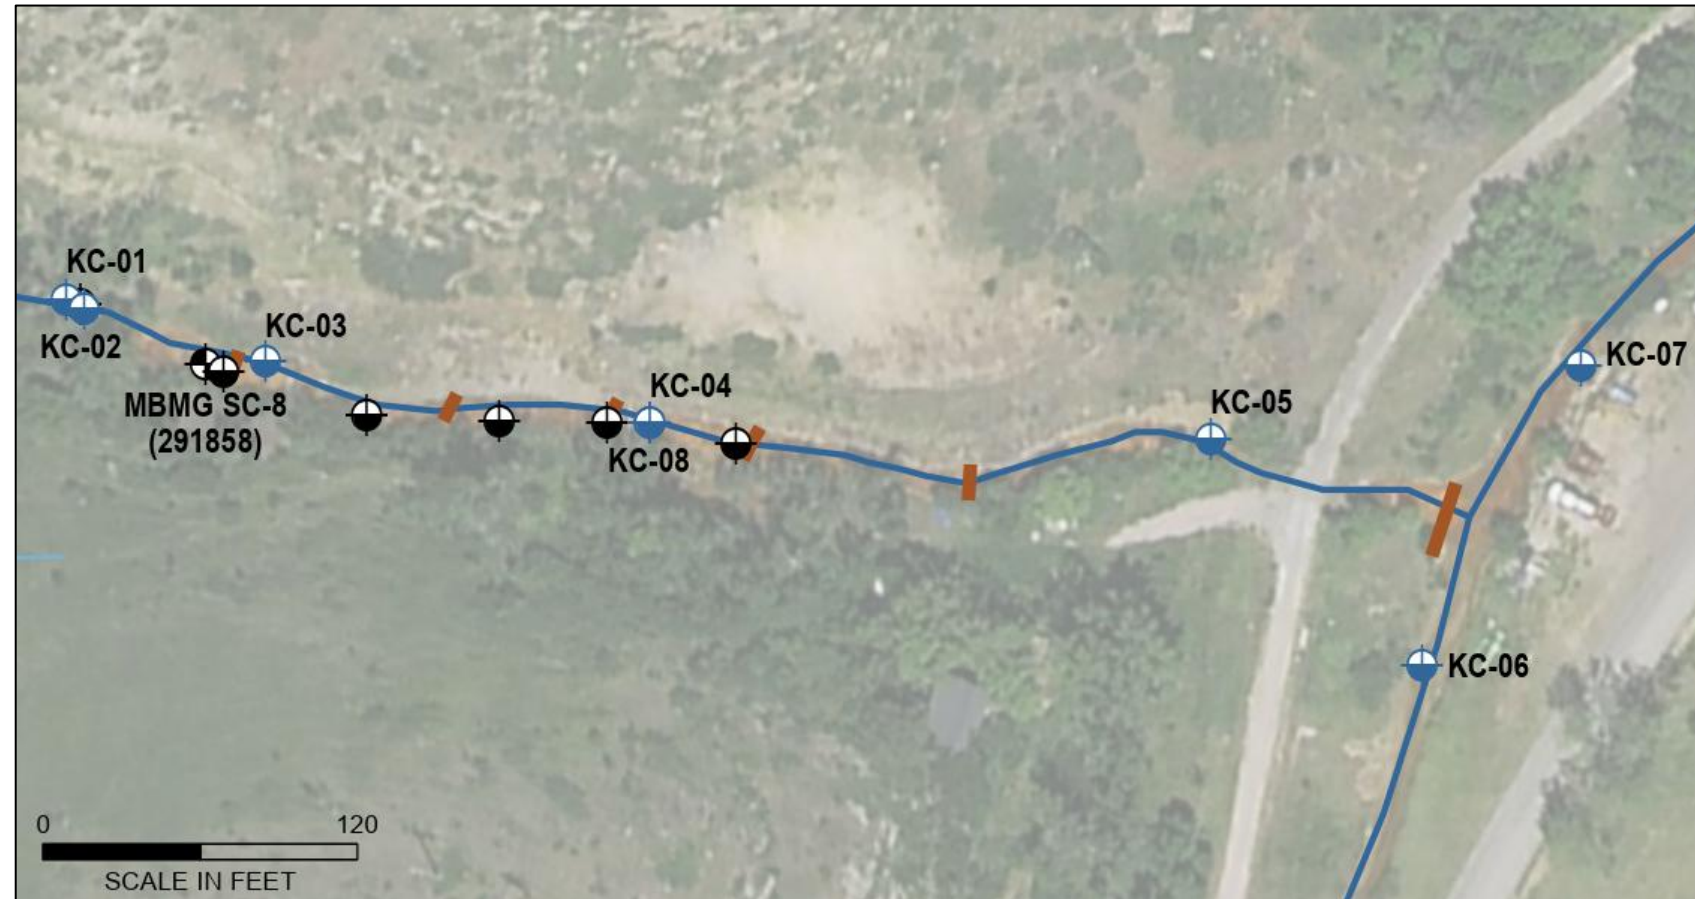
Kate's Coulee Surface Water

- Kate's Coulee relatively unimpacted upstream of Mt. Oregon discharge.
- Post discharge: low pH, high metals.

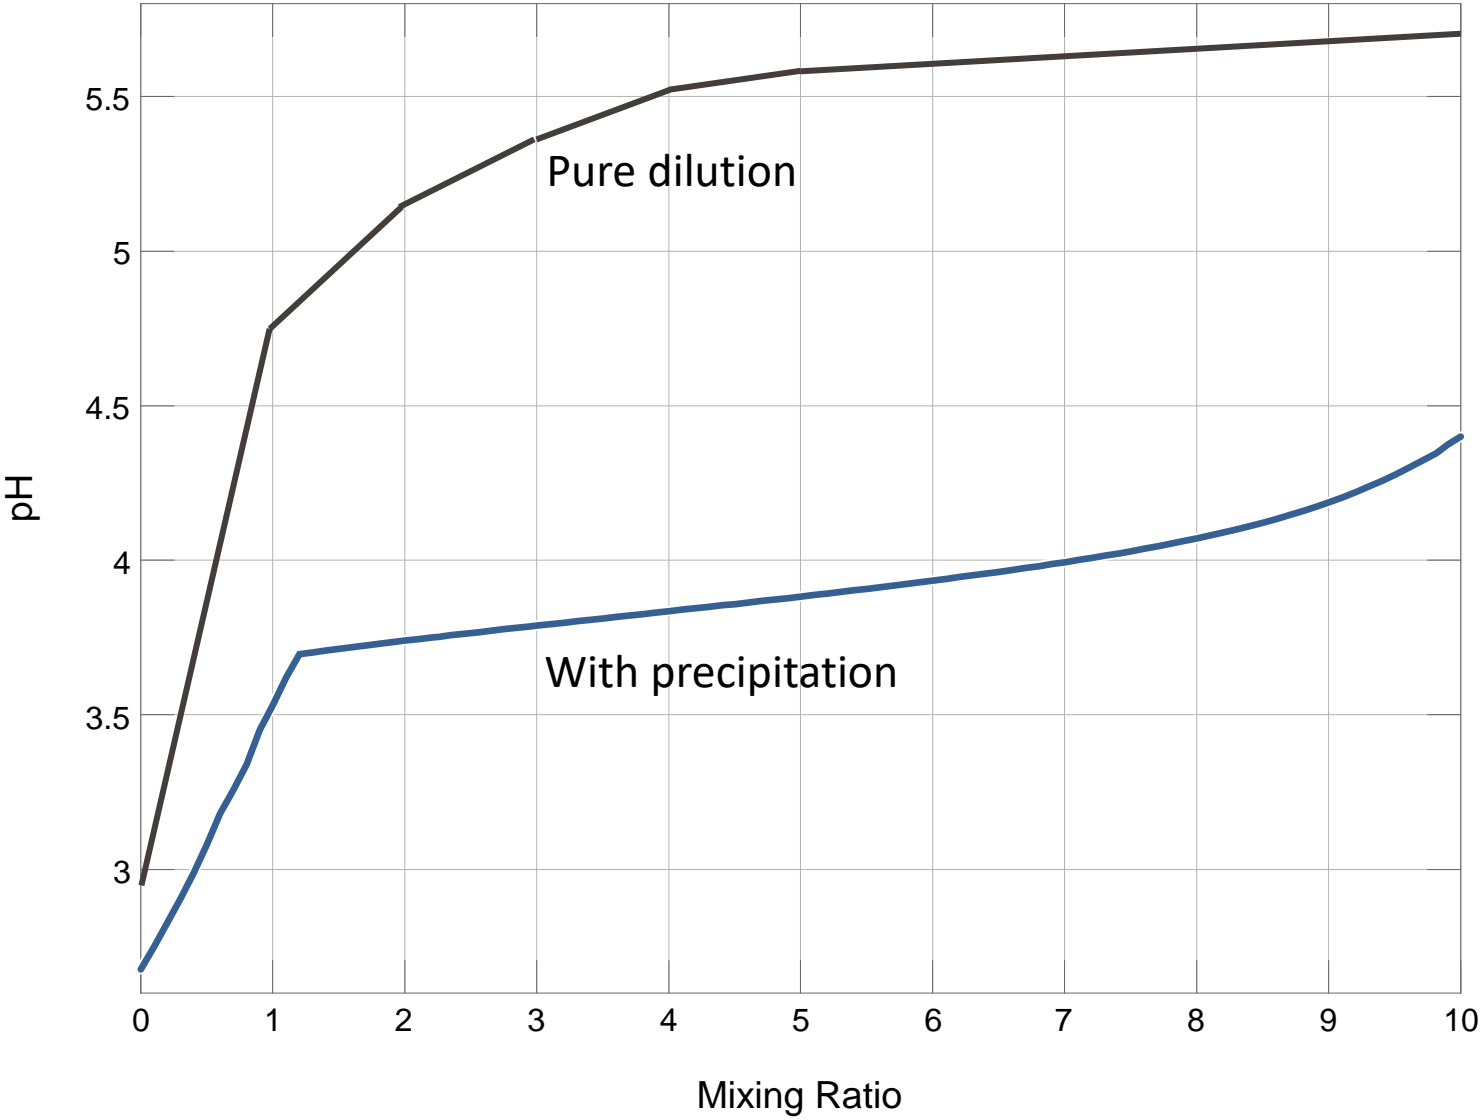
Model Results: pH

$$\text{Mixing Ratio} = \frac{\text{Well 3 Water}}{\text{Stream Water}}$$

- Comparison of water quality criteria: Sand Coulee vs. nearby Well 3 (Kootenai Formation).
- Geochemical modeling used to estimate conservative results from a variety of mixing ratios.
 - GWB (LLNL database)

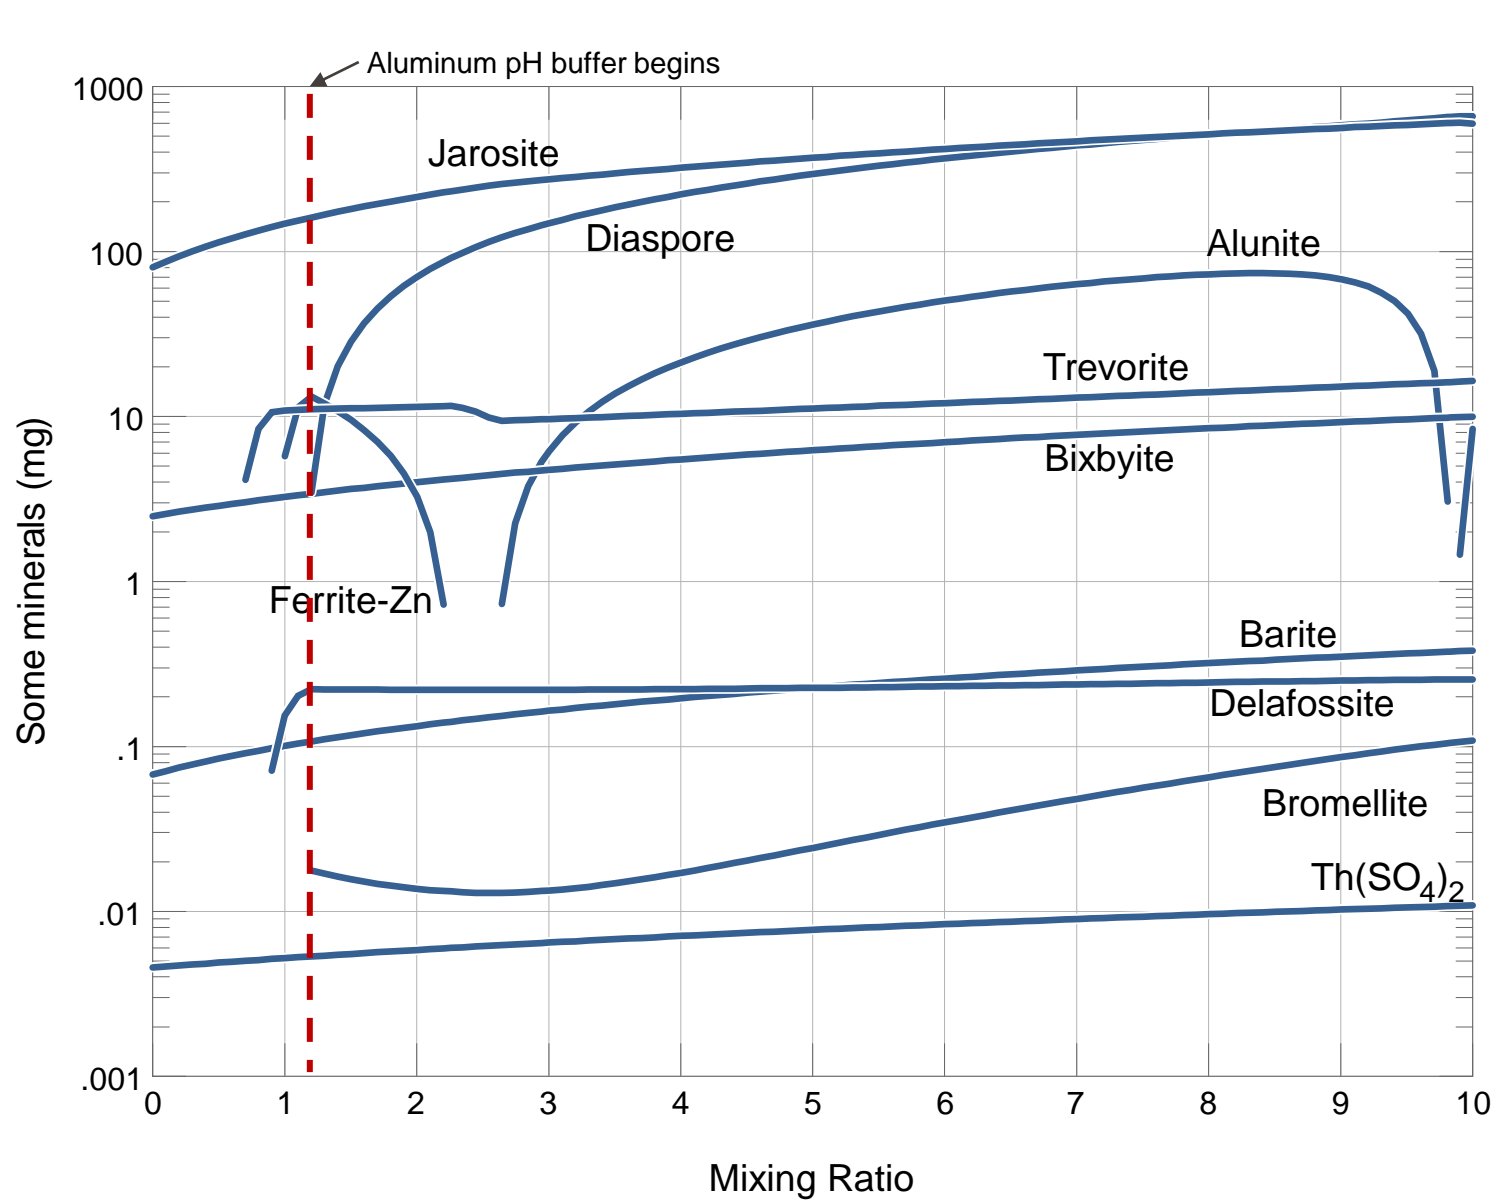
Model Results: Minerals

$$\text{Mixing Ratio} = \frac{\text{Well 3 Water}}{\text{Stream Water}}$$

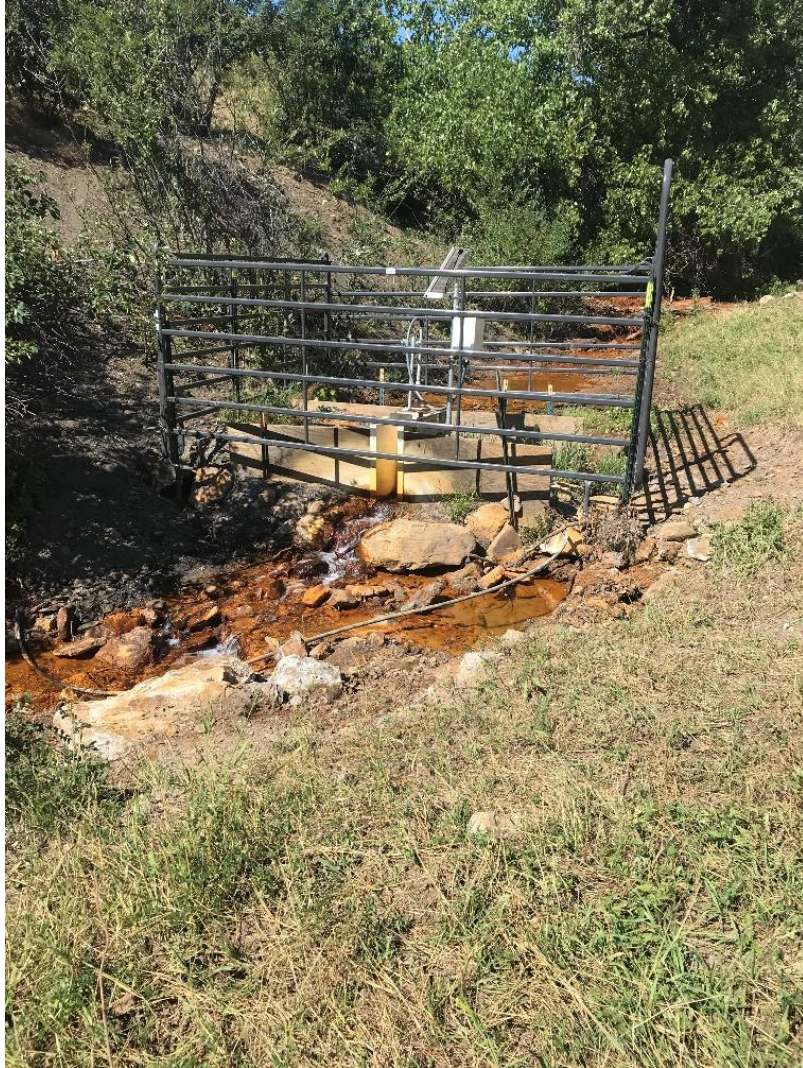
July 2019

Flooded! Looking Upstream, weir now gone

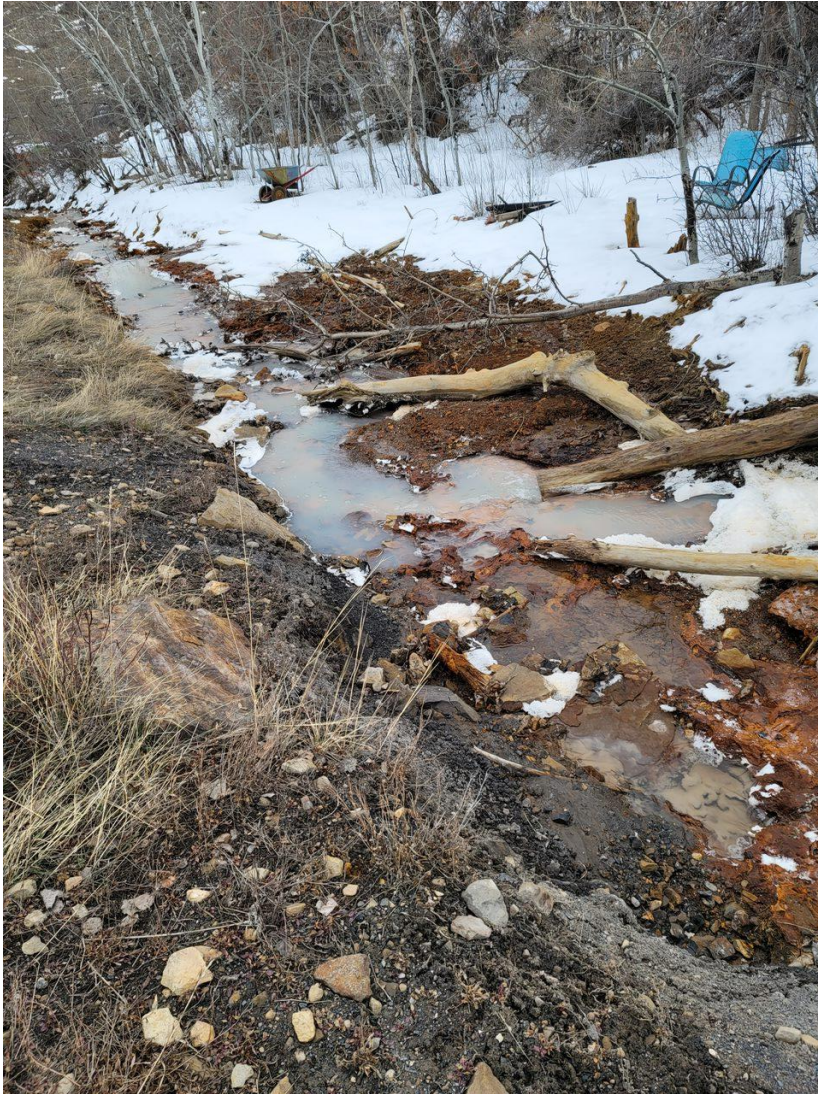
March 2023

Flooded! Looking Downstream

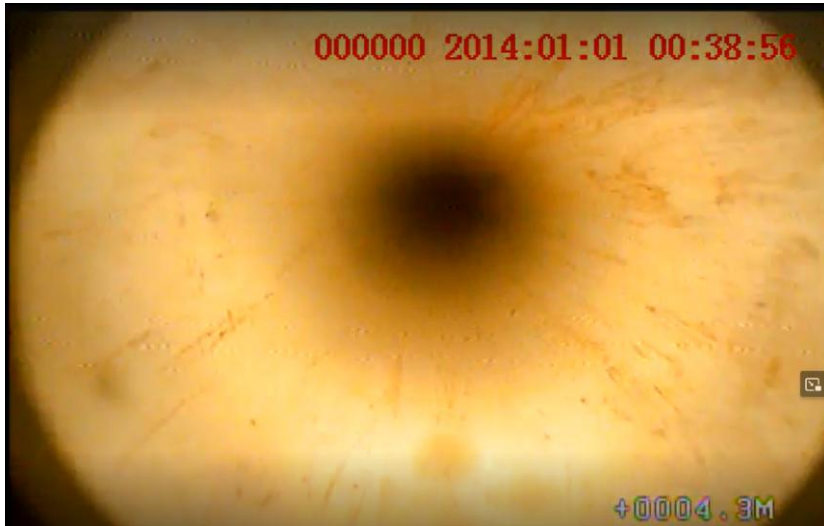
Well Inspection – Not much Flow

Oxide precipitation has resulted in problematic pumping conditions.

- Regular cleaning may be required
- Other options?
