American Society of Reclamation Sciences 2025 – Butte Montana

On-Site Stabilization of Elemental Mercury

MercLokTM

A versatile *remediation technology* designed for the rapid stabilization of mercury found in a range of soils and industrial wastes.

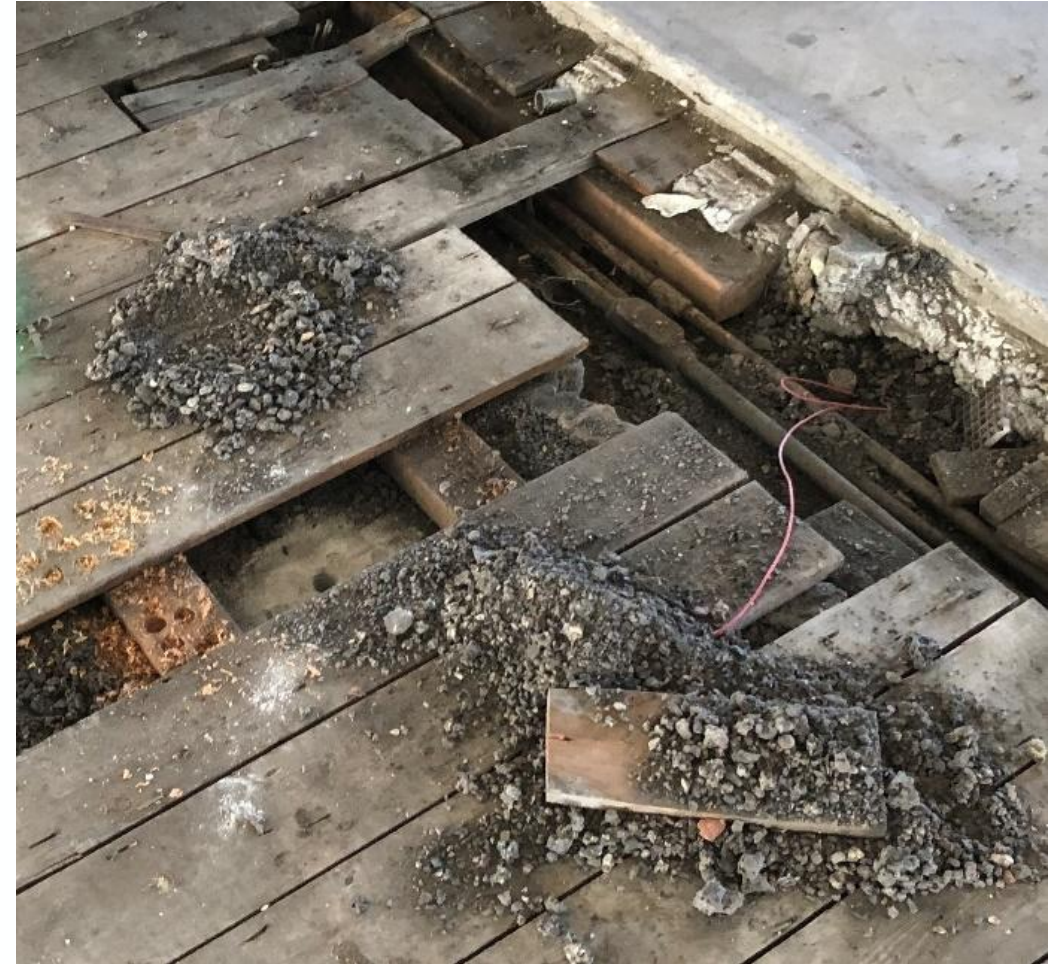
- Forge cinders were placed between a foundation slab and wood plank flooring for vibration dampening
- Spilled elemental mercury from the industrial process leaked through the floor and into the cinders
- Fugitive mercury also found its way into the soil and collected around the foundation footers

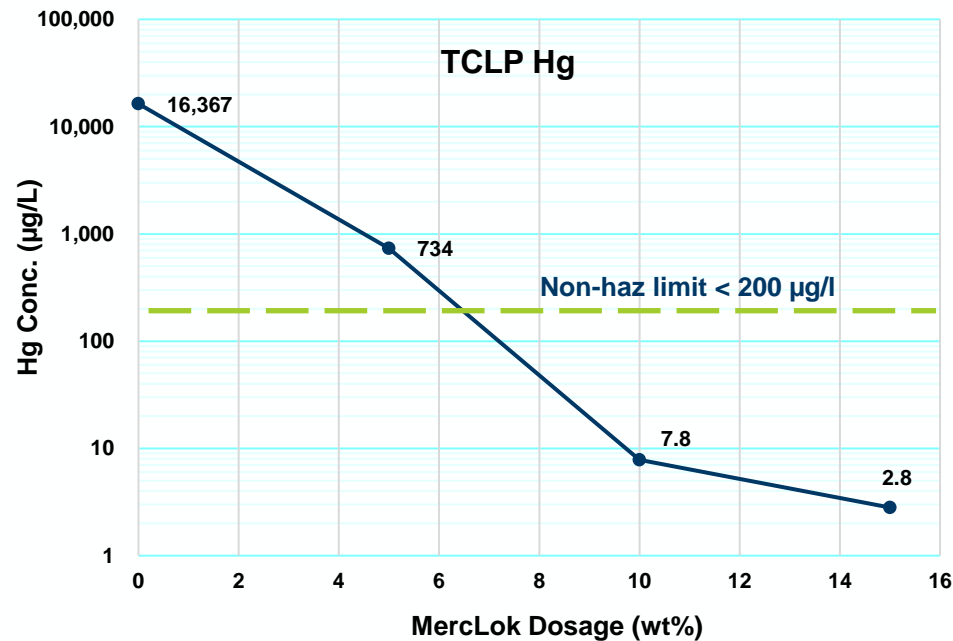
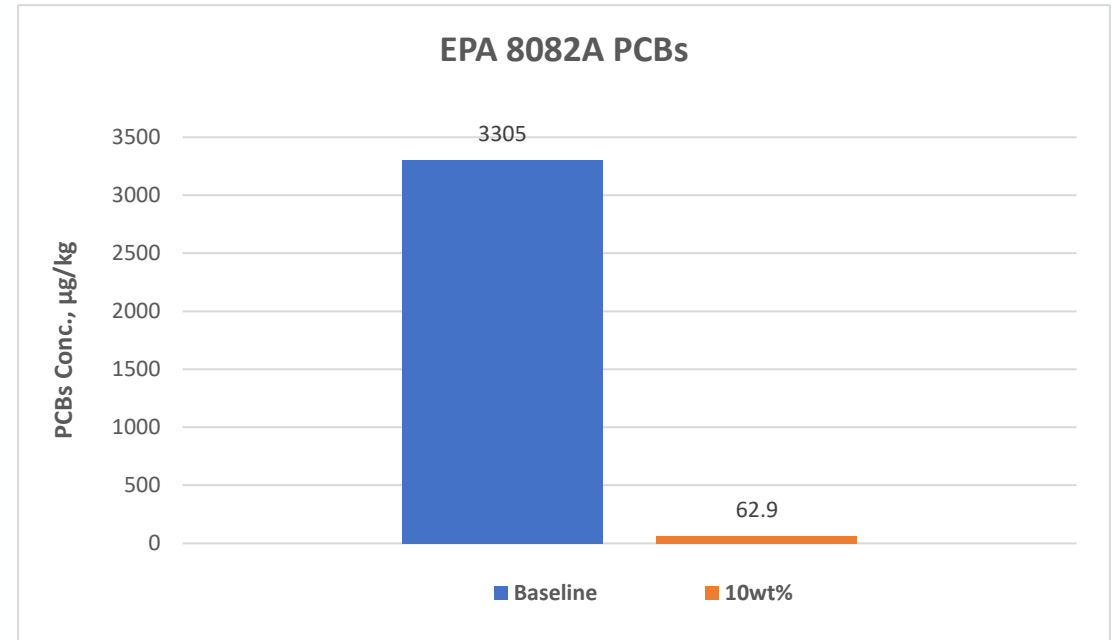
Case Study 1 – Treatability Study - Cinders

EPA 1311 TCLP		EPA 8082A
THg Analysis pH 4.5 (µg/L)	THg Analysis pH 2.88 (µg/L)	PCBs (µg/kg)
3,188.3	16,366.5	3,305.0

- Visible Hg restricts disposal in US – must be retorted
- Total PCBs > 1 ppm restricts retorting in US

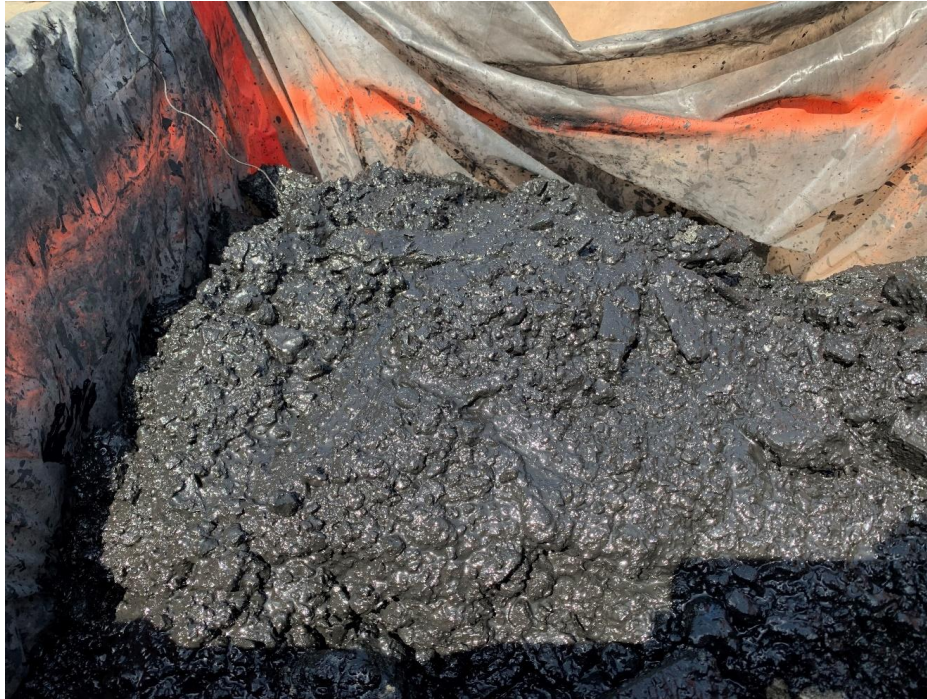
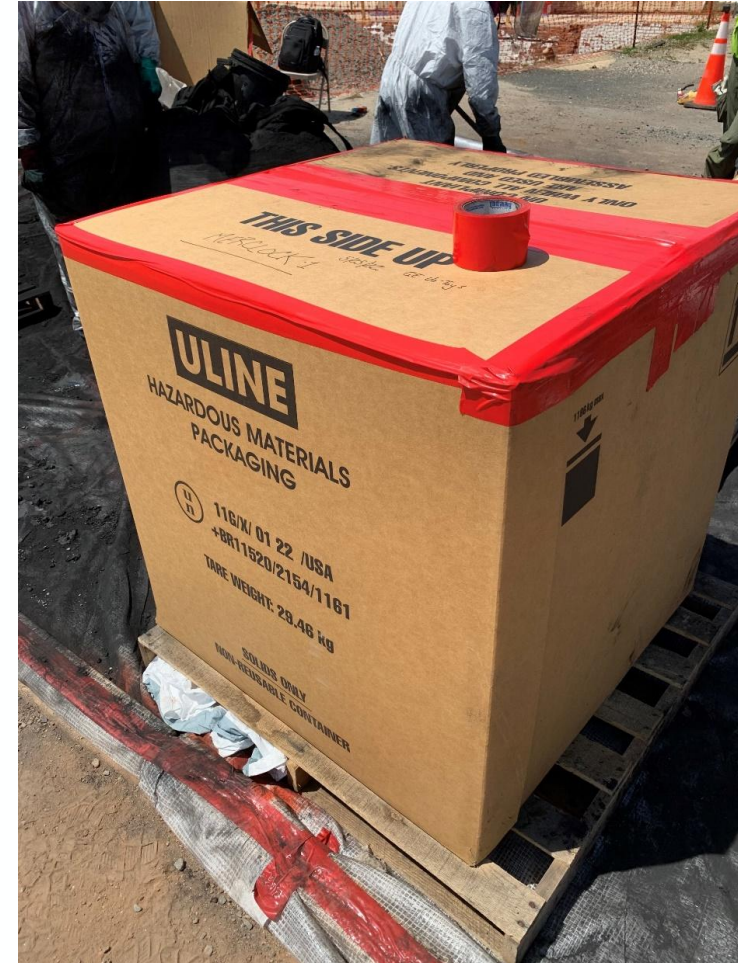
Case Study 1 – Treatment of Cinders

Total Cinders, lb.	MercLok™ Dosage	MercLok™ Added, lb.	Wt. of Water, lb.	Volume of Water, gal
4000	10%	400	640	77

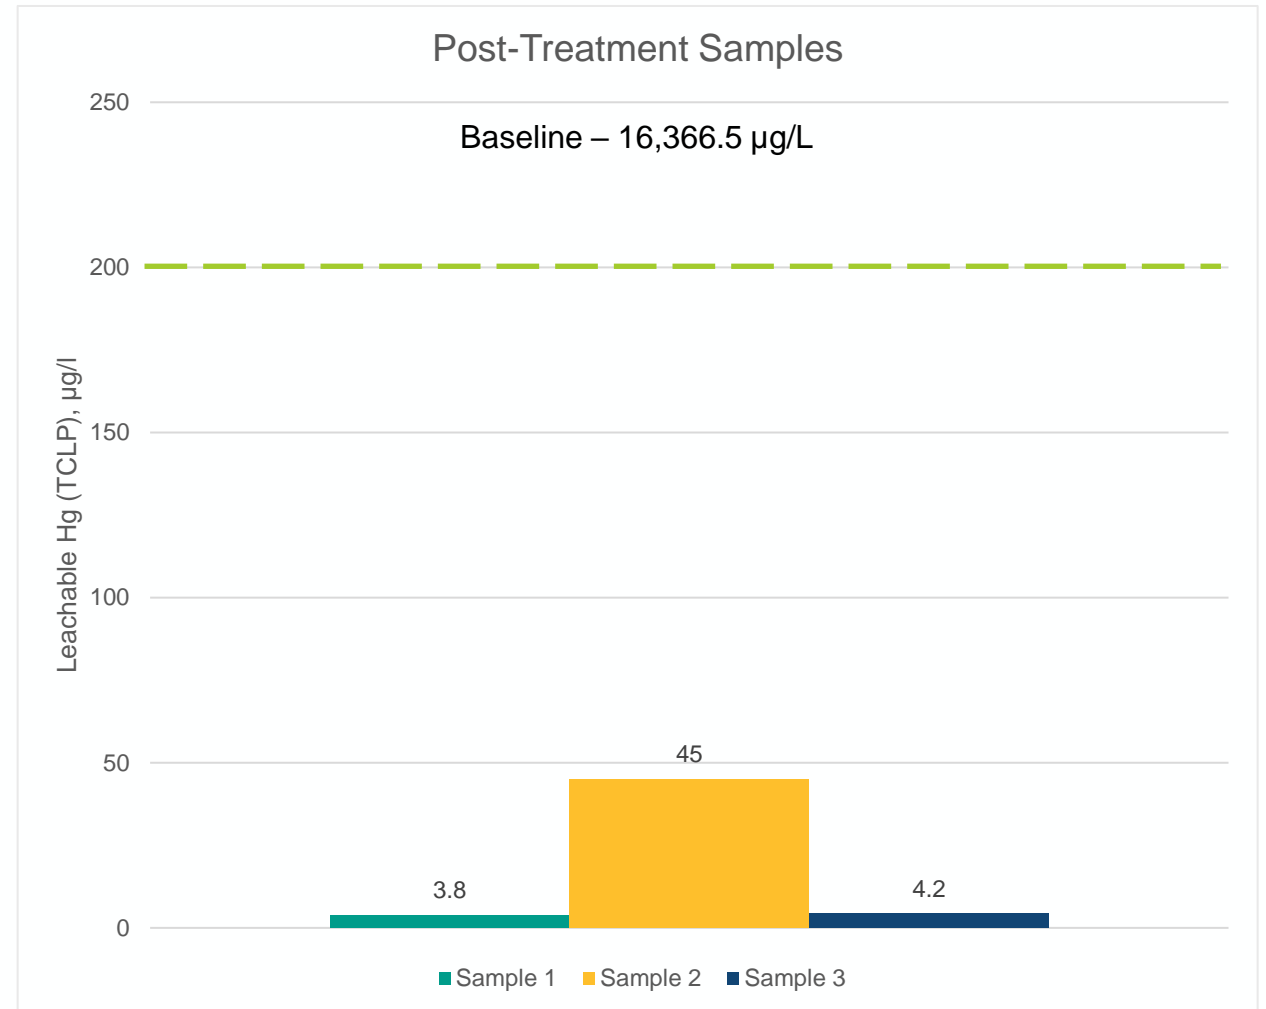
Case Study 1 – Confirmation Sampling

- Due to visible and leachable Hg above TCLP limit and presence of PCBs, the cinders did not have a disposal destination
 - Hg was reduced to much less than 200 ppb (TCLP Limit)
 - Elemental Hg was not visible in post treatment material
 - PCB detection was reduced from 3 ppm (total) to ND (<0.23 ppm)
- Cinders were disposed of in a landfill as a high Hg, non-hazardous material

- Reduction in the leachability of cinder materials containing highly leachable Hg species.
 - $>16,000\mu\text{g/L}$ to $< 45\mu\text{g/L}$
 - Concurrent reduction in PCBs
 - Elemental Hg no longer visible
- Shift in Hg species in soil from F4 (elemental) to F5 and F6 fractions.
 - Rendered more stable and elemental Hg was no longer visible via unaided visual inspection

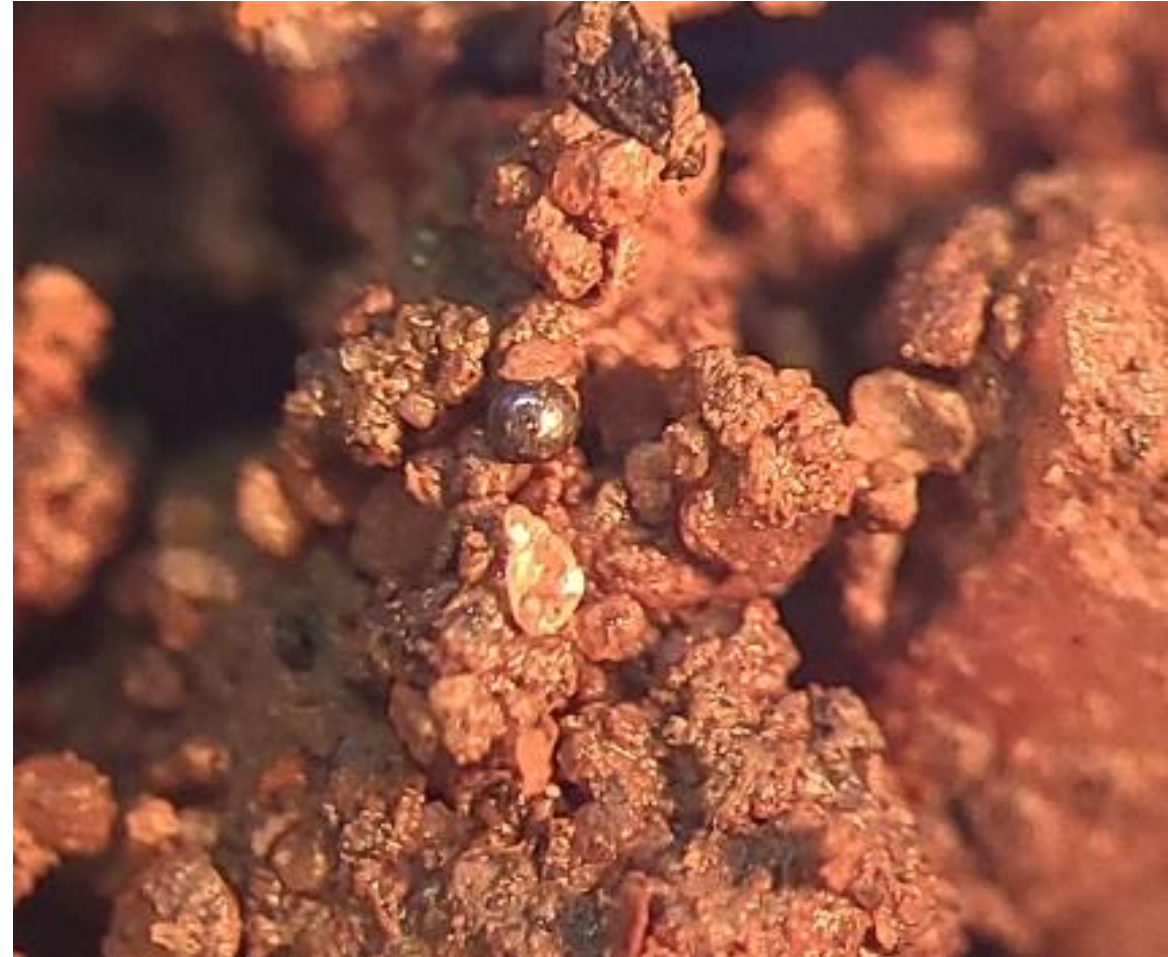
- Visible Hg located in soils beneath former building footprint and around foundation footers
- Total Hg 2,580 mg/kg
- Exceeded TCLP Limit of 200 µg/L

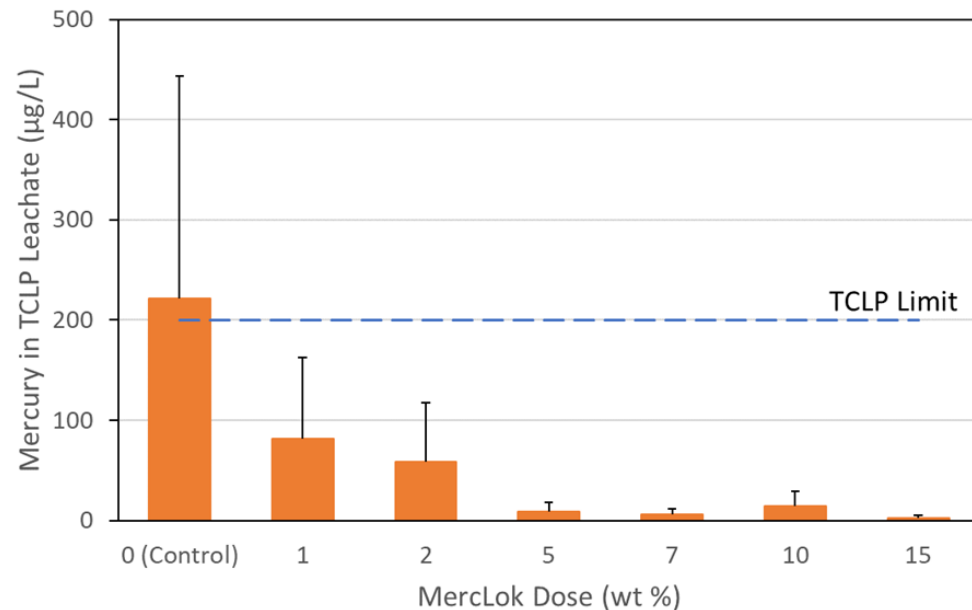
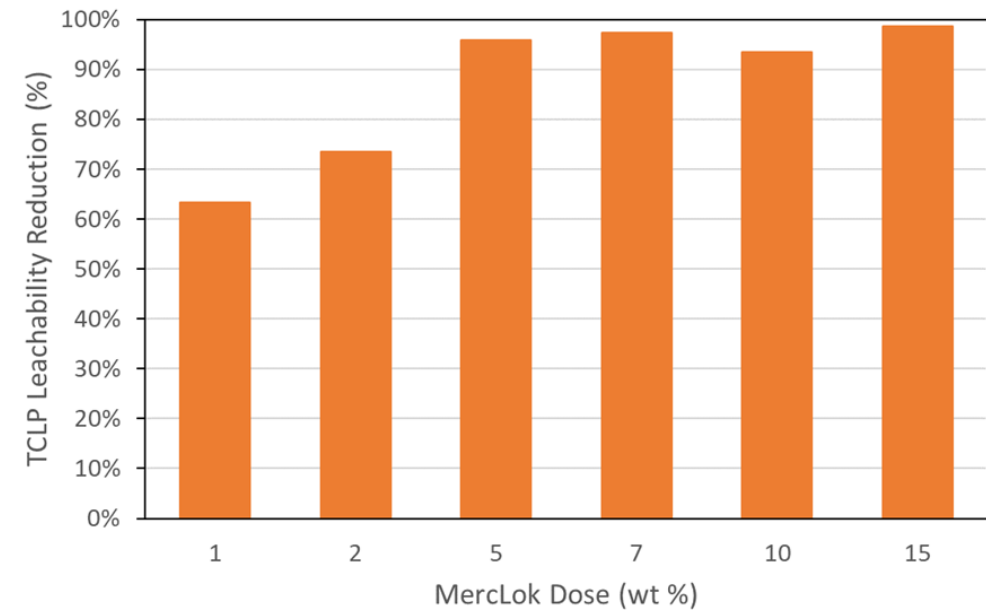
Leachable Hg Reduction – Method 1311 TCLP

- Effective leachate reduction at all dosages
- No visible Hg

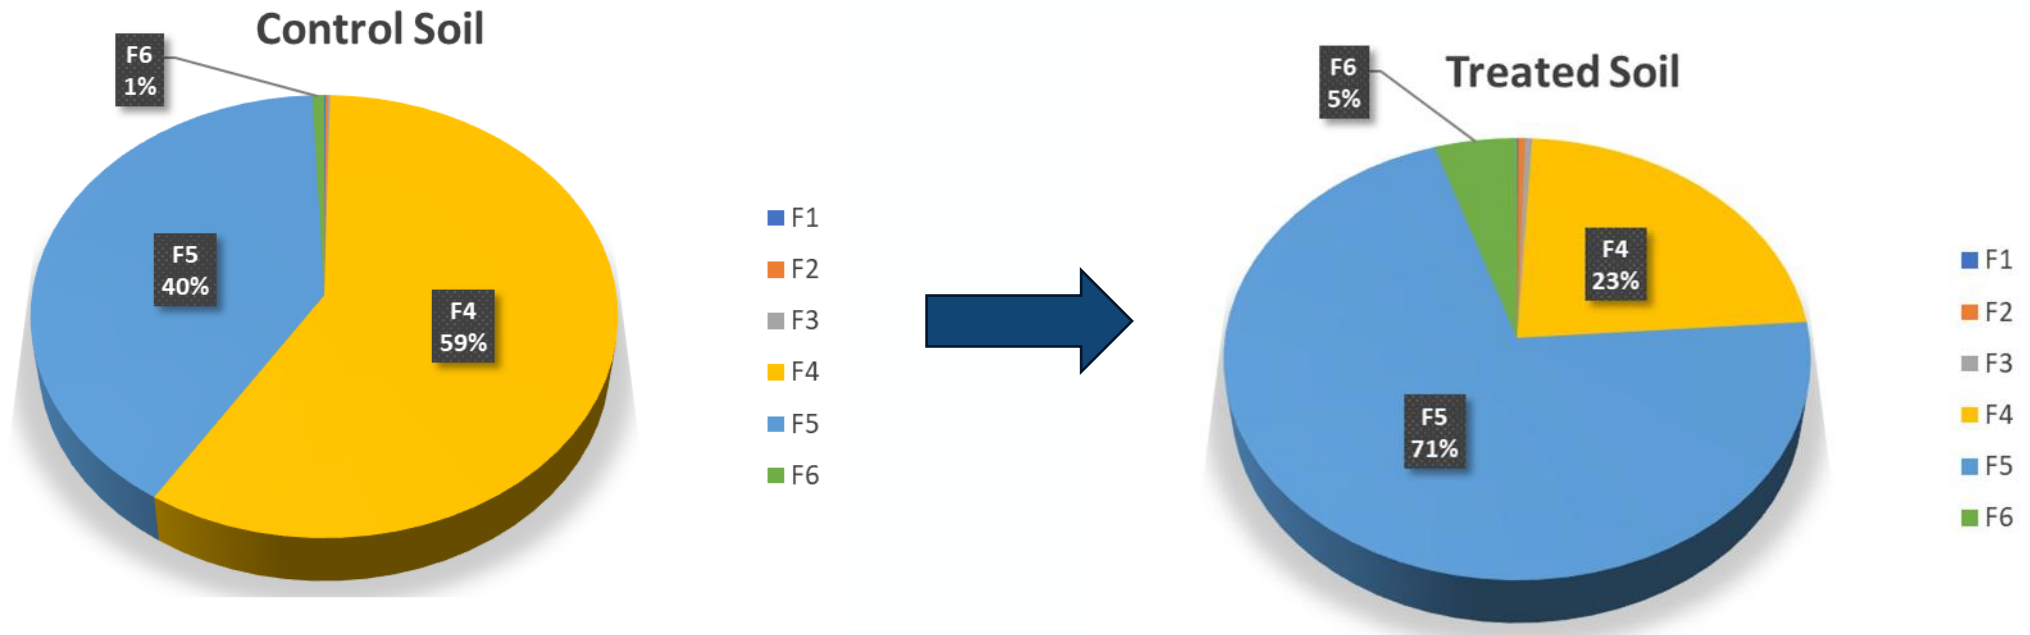
Selective Sequential Extraction

- Shift from F4 (includes elemental) to F5
- Increase in F6 fraction
- Reduction in leachability - increase in **stability**

F1: Water soluble (HgCl₂, HgSO₄)
F2: Stomach acid soluble (HgO)
F3: Base leachable (organo-complexed)
F4: Oxidizable (strongly complexed and elemental)
F5: Aqua regia (cinnabar-like)
F6: HF (crystalline silicate-Hg matrix)

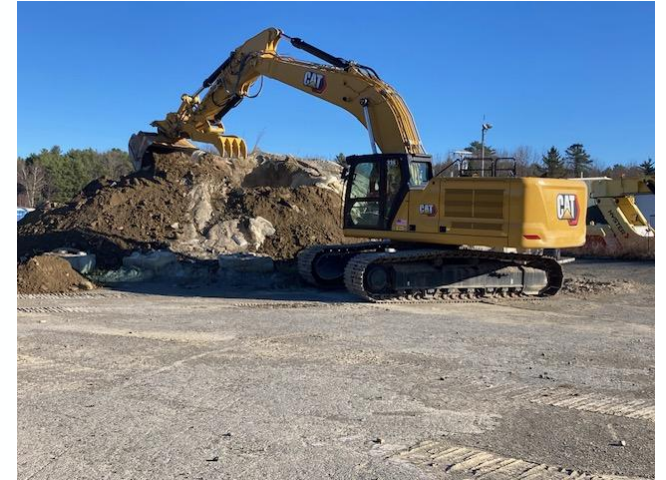
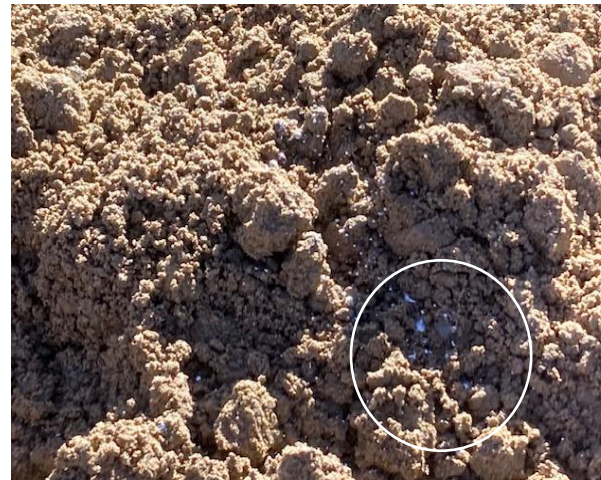
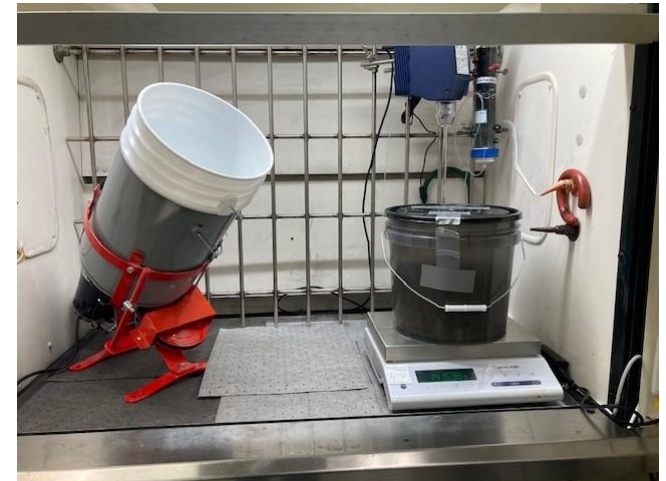
- Visible Hg when excavated, dispersed during stockpiling
- Composite soils collected from 3 locations within 500 yd stockpile
- One aliquot of soil spiked with elemental Hg at added concentration of 1,000 mg/kg
- Following treatment, soils incubated in 2.5-gallon buckets at room temperature
- Evaluation of treated soil at 1 month incubation for vapor concentration and 2 months for leachability

Sample ID	Sample Type	Dosage of P-640 (wt.%)	Vapor Concentration (ug/m ³)
TS-PA-01	Baseline	0	>500
TS-PA-02	Spiked	0	>500
TS-PA-03	Baseline	1	1.09
TS-PA-04	Baseline	2.5	0.54
TS-PA-05	Baseline	5	0.56
TS-PA-06	Spiked	1	6.78
TS-PA-07	Spiked	2.5	1.06
TS-PA-08	Spiked	5	0.74
TS-PA-09	Spiked	7.5	0.79

- Reduction in elemental Hg in vapor phase, leachability.
 - Elemental Hg bead size reduced from visible (>500 micron) to sub-visible (<100 micron), verified via enrichment/isolation of Hg⁰ followed by microscopic examination.

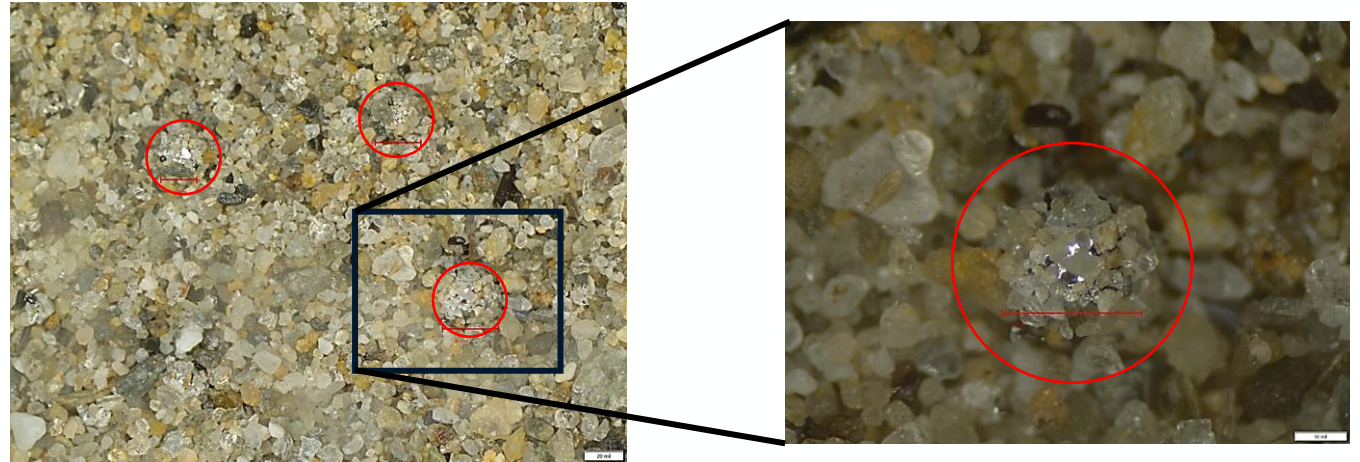
Spiked Control (Untreated)

Treatability Study			
Sample - Treatment	Total Hg (mg/kg)	TCLP (µg/L)	SPLP (µg/L)
Baseline - Untreated	92.72	355.2	54.2
Baseline - 1% MercLok™	73.55	11.7	11.2
Baseline - 2.5% MercLok™	54.92	<1	<1
Baseline - 5% MercLok™	21.92	<1	<1
Spiked - Untreated	1179.71	2579.7	249.5
Spiked - 1% MercLok™	984.31	1254.8	2340.0
Spiked - 2.5% MercLok™	807.32	143.0	156.5
Spiked - 5% MercLok™	865.80	3.3	<1
Spiked - 7.5% MercLok™	133.02	1.0	<1

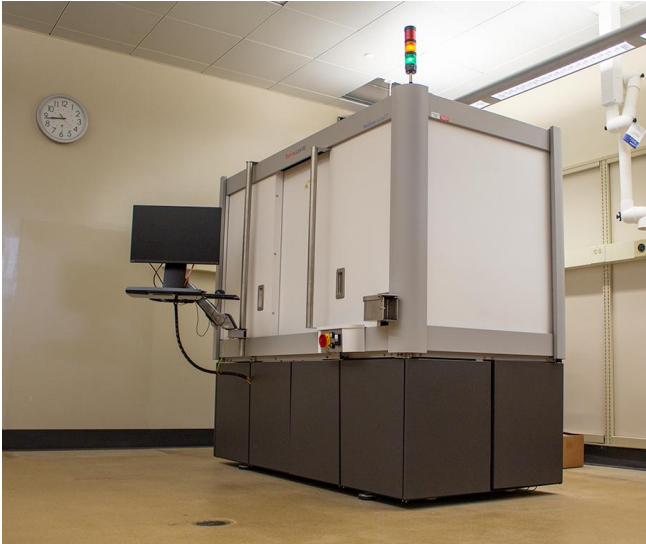
Micro CT - Proof of Concept

Thermo Fisher
Heliscan Mark II

- 10-micron voxel size

2% Hg by weight stirred with sand as
suspending agent
