Optimising Water Management at North Mara Gold Mine: Response to Excess Water Accumulation on the Tailings Storage Facility

ASRS Presentation – 04 June 2025

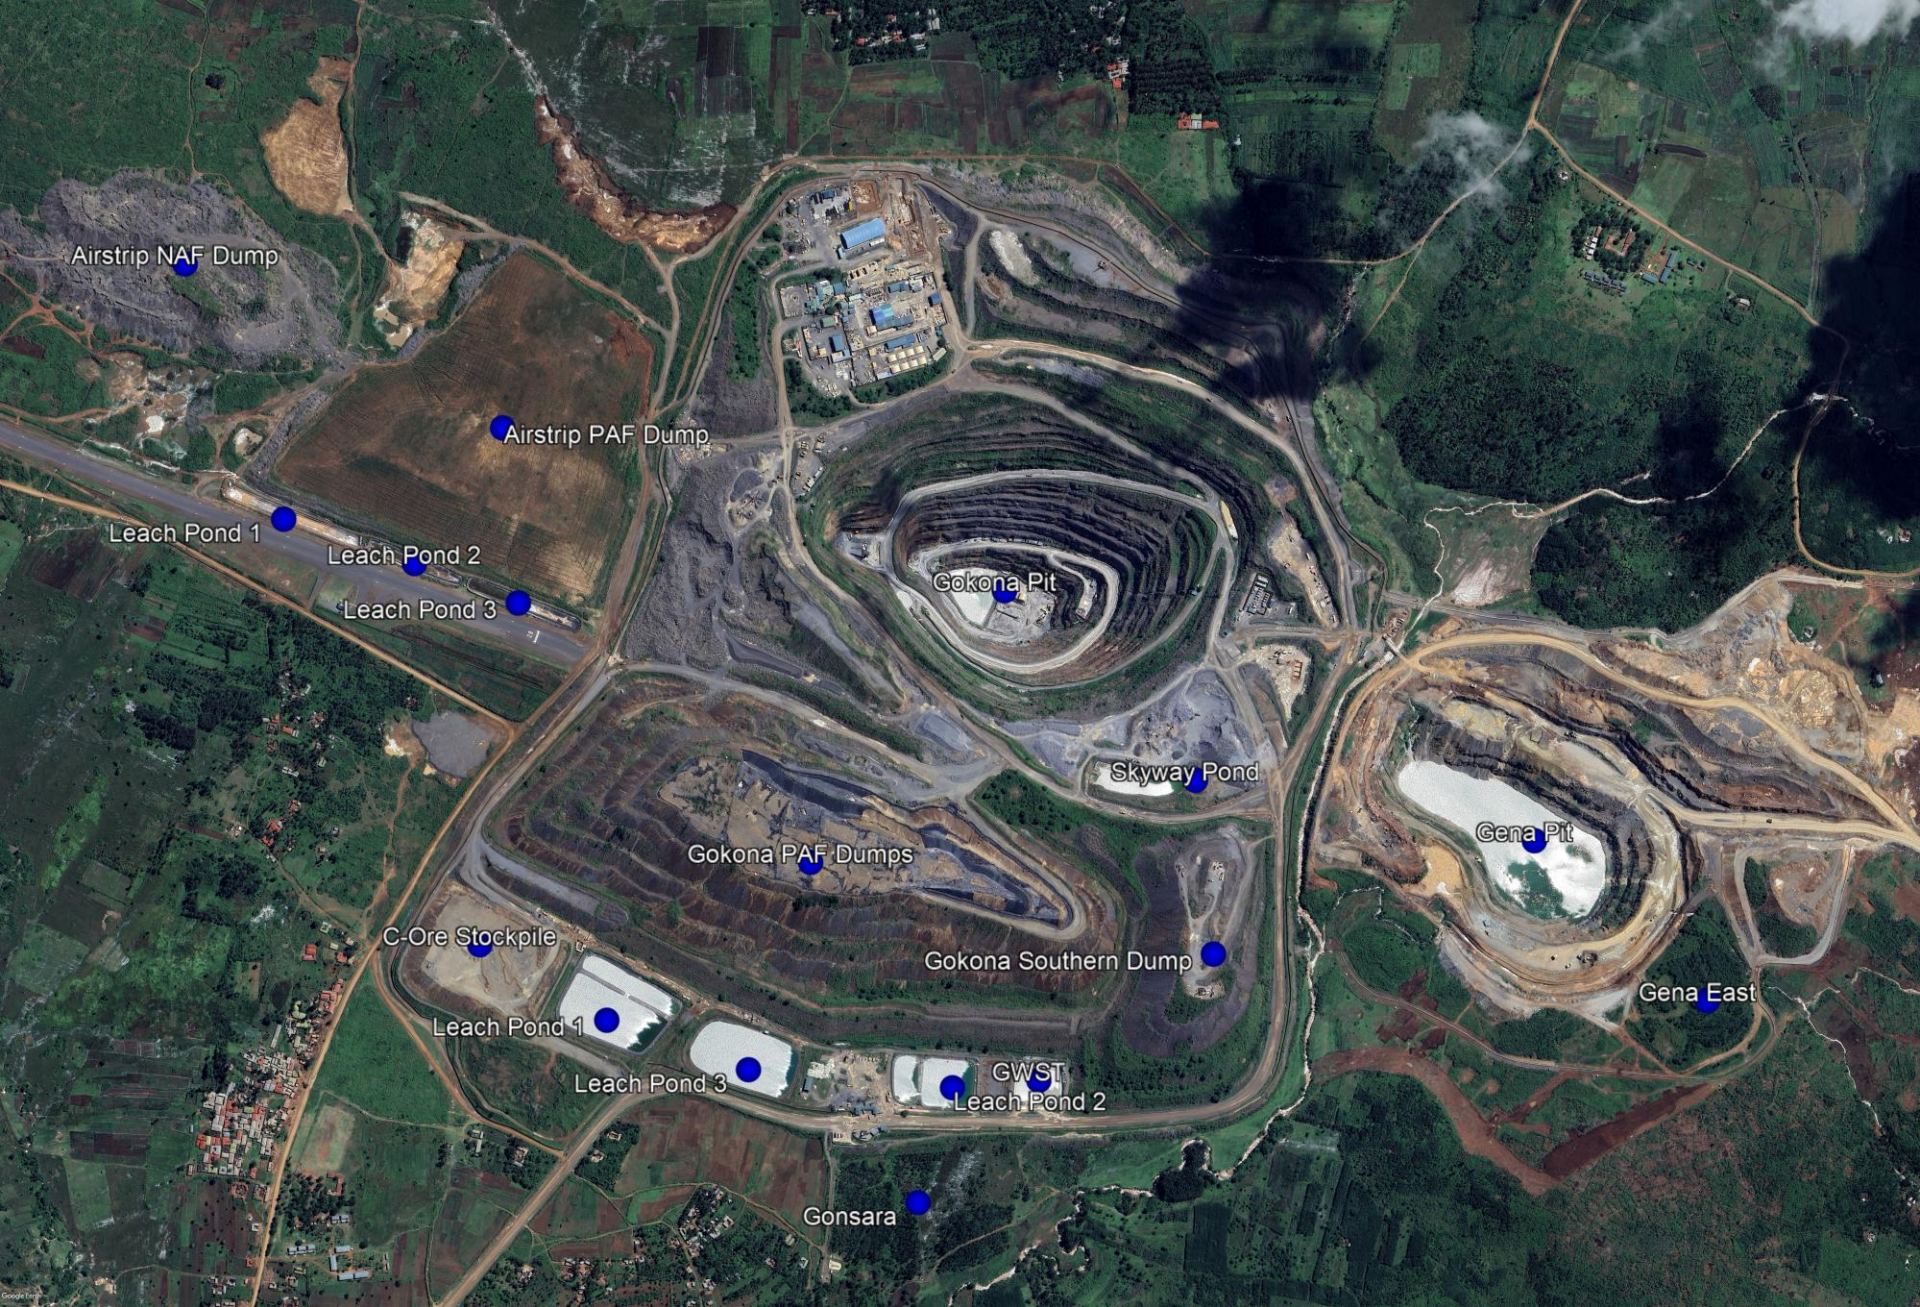
Airstrip NAF Dump

Airstrip PAF Dump

Leach Pond 1

Leach Pond 2

Leach Pond 3

Gokona Pit

Skyway Pond

Gokona PAF Dumps

Gena Pit

C-Ore Stockpile

Gokona Southern Dump

Gena East

GWST
Leach Pond 2

Gonsara

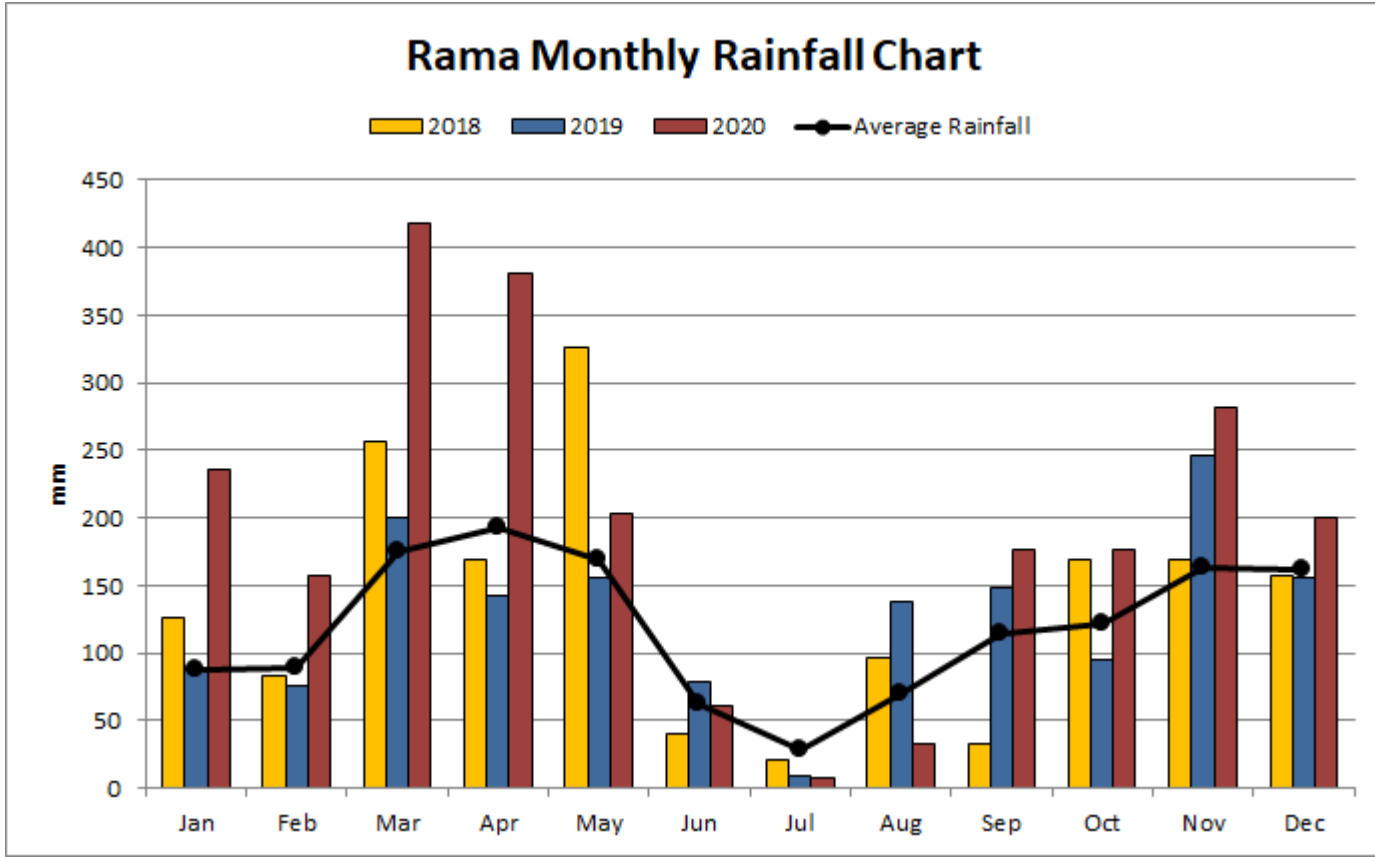
Rainfall and Evaporation

Data	mm/a
MAP	1 417
2018	1 648
2019	1 532
2020	2 331

Lake Evaporation
= 1 166 mm/a

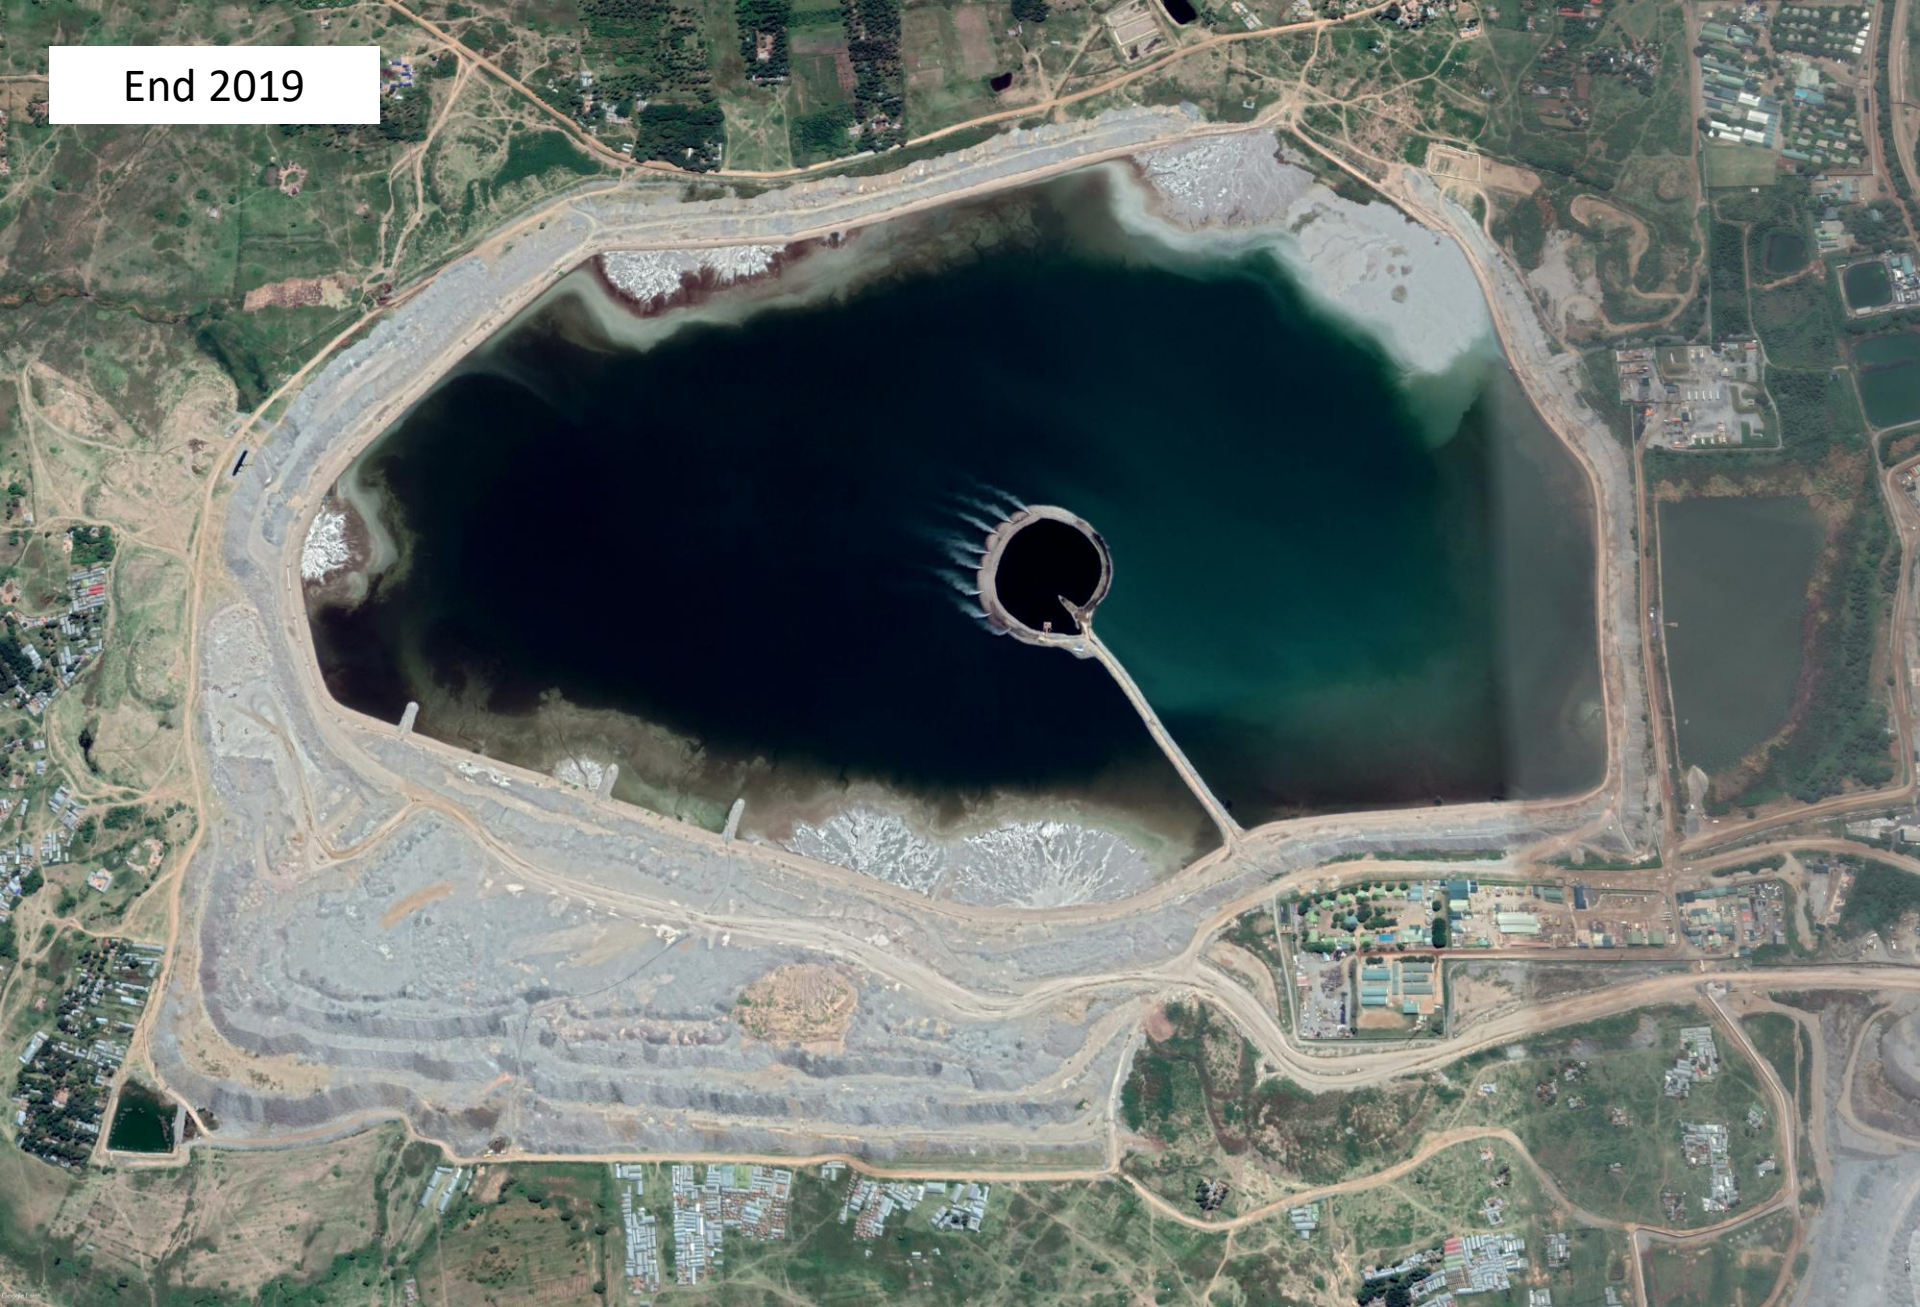
End 2019

- $\pm 8 \text{ Mm}^3$ of water on the TSF
- Super saturated TSF
- Freeboard of only 30 cm
- No designed spillway (no discharge from TSF allowed in Tanzania during operation)
- Poor planning and control of tailings deposition
- Not enough discharge capacity downstream (Ingwe Dam discharge point)
- Years of recirculating contaminants meant discharge qualities were difficult to meet

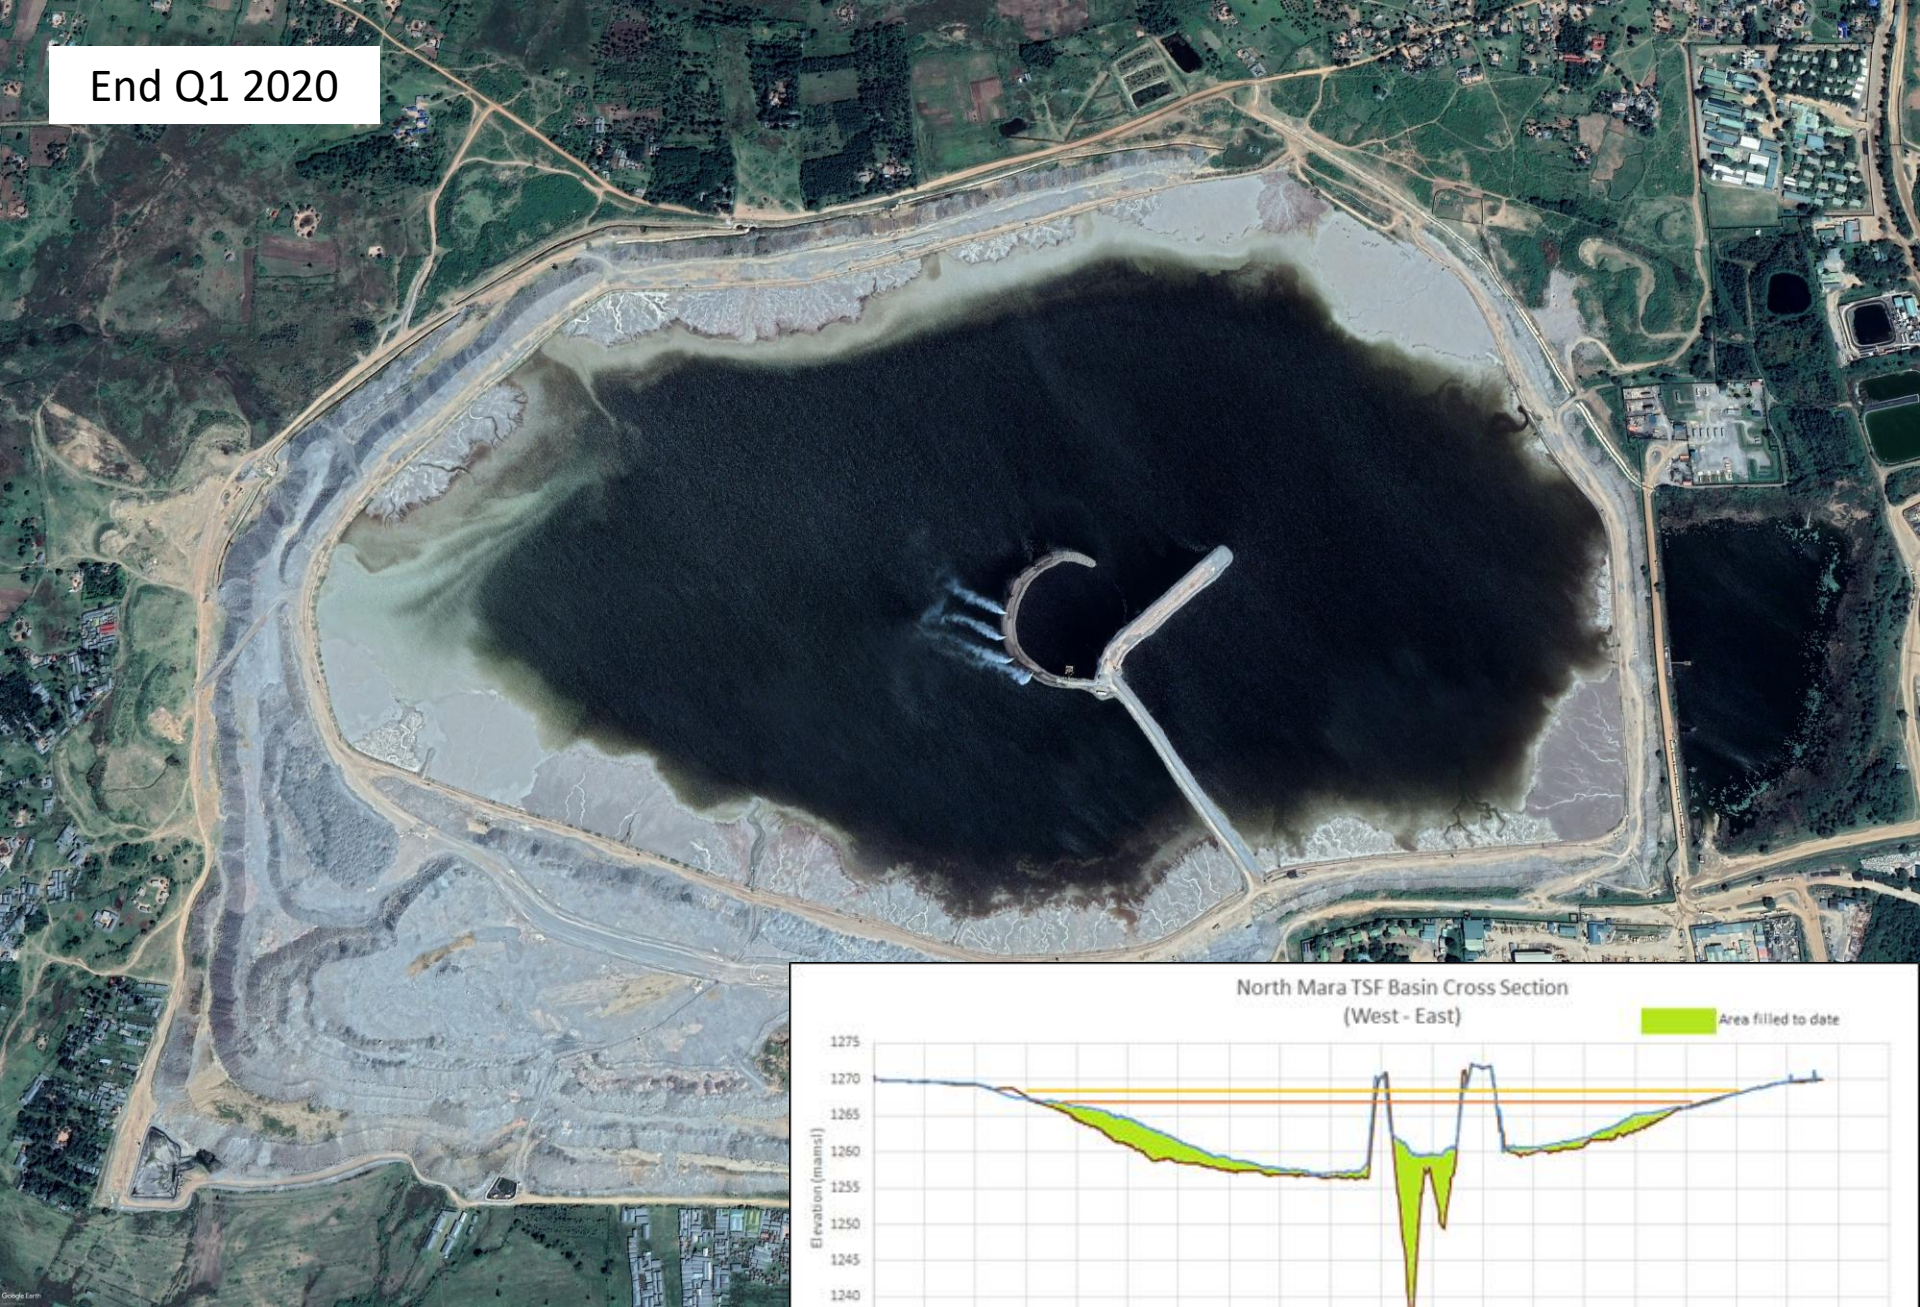
End Q1 2020

- Move 4 Mm³ into the Rama open pit
- Mechanical Evaporators (total of 12)
- Dilute and discharge through Ingwe dam at the highest volume possible under current permit (20 000 m³/d)
- Apply for an additional discharge permit (increase to 100 000 m³/d)
- Source additional pumps (new and old) and put in place emergency maintenance plan
- Develop excel water and salt balance to assist with decision making
- Source water treatment plants based on calculated capacity
- Fill in the Turkeys Nest

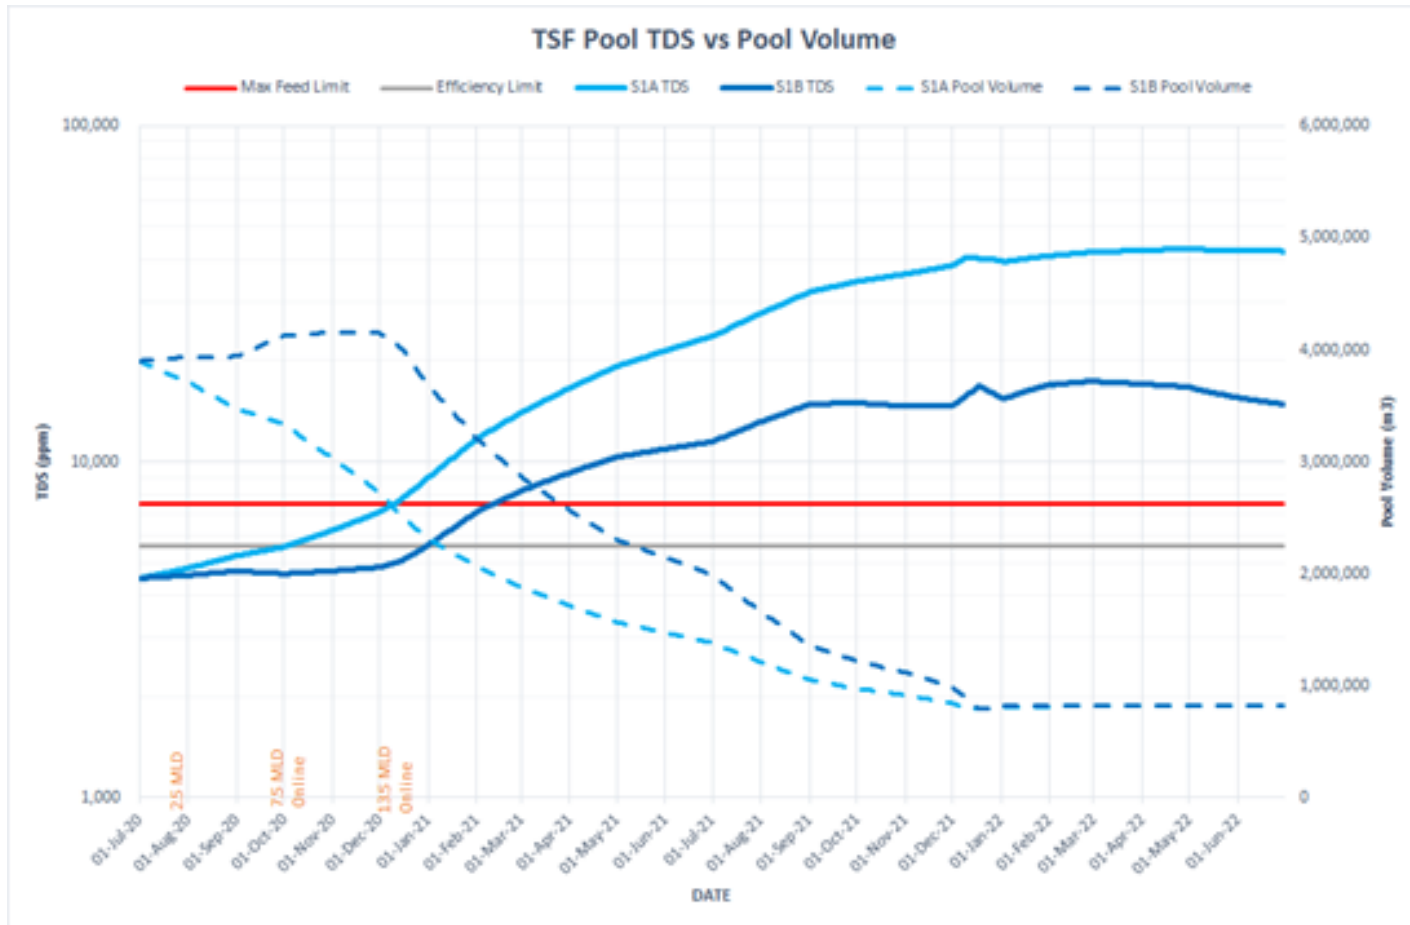
Water and Salt Balance

- WTP installation
 - July 2020 – 5 000 m³/d permeate production;
 - August 2020 – Additional 2 500 m³/d permeate production
 - October 2020 – Additional 7 500 m³/d permeate production
 - December 2020 – Additional 13 500 m³/d permeate production
- If WTPs operated at their optimum efficiency (70%) the reject (brine) stream = 11 000 to 12 000 m³/d
- Brine goes back onto TSF = TDS increases as pool decreases
- Salt balance showed we are working against ourselves in terms of chemistry

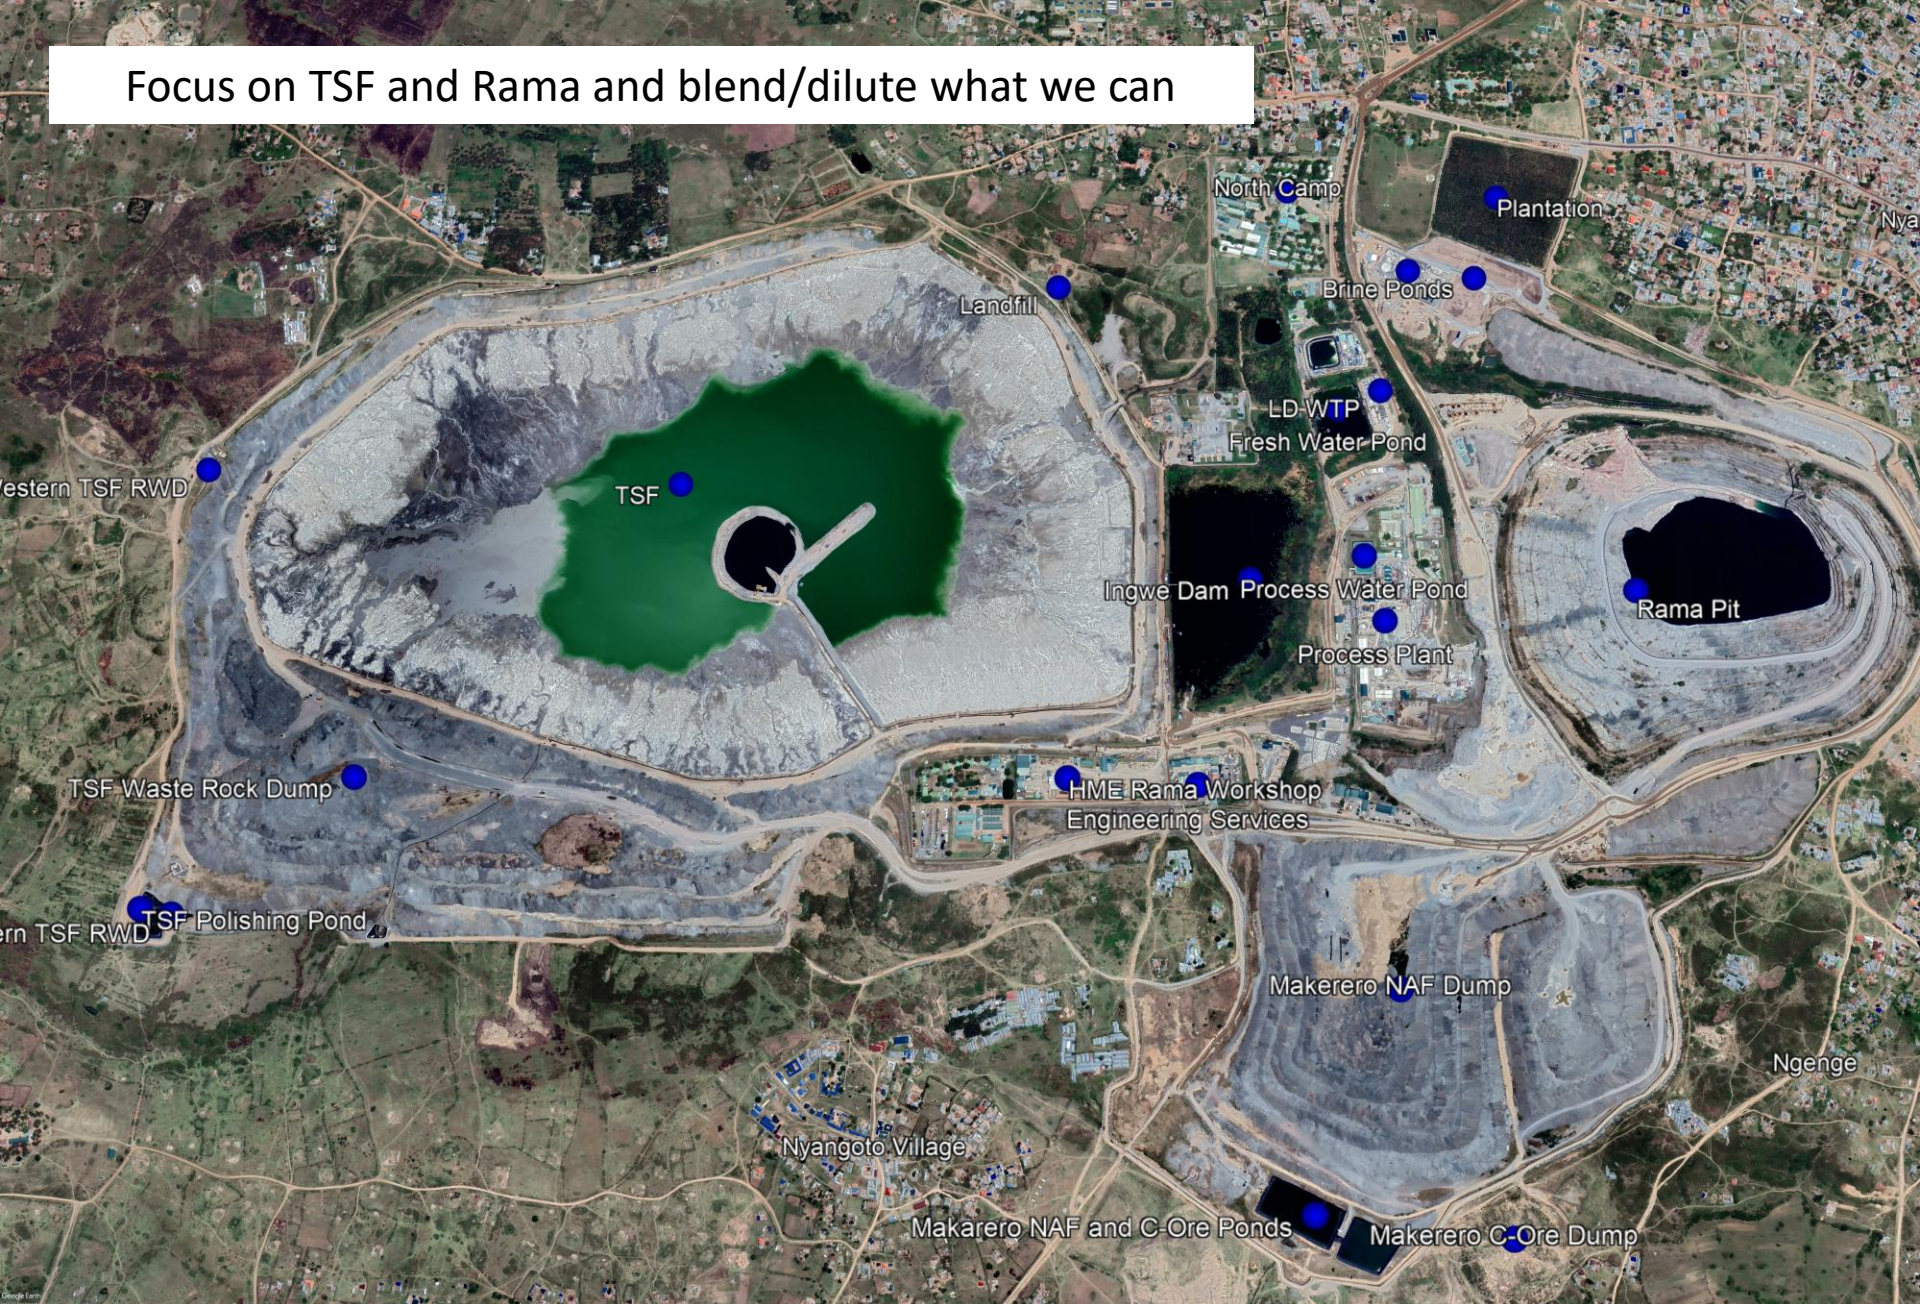
End 2019

Focus on TSF and Rama and blend/dilute what we can
