# Life Cycle Analysis of a Nearly 29-Year-Old AMD Passive Treatment System's Vertical Flow Pond

## Jennings Environmental Education Center Slippery Rock, Butler County, Pennsylvania

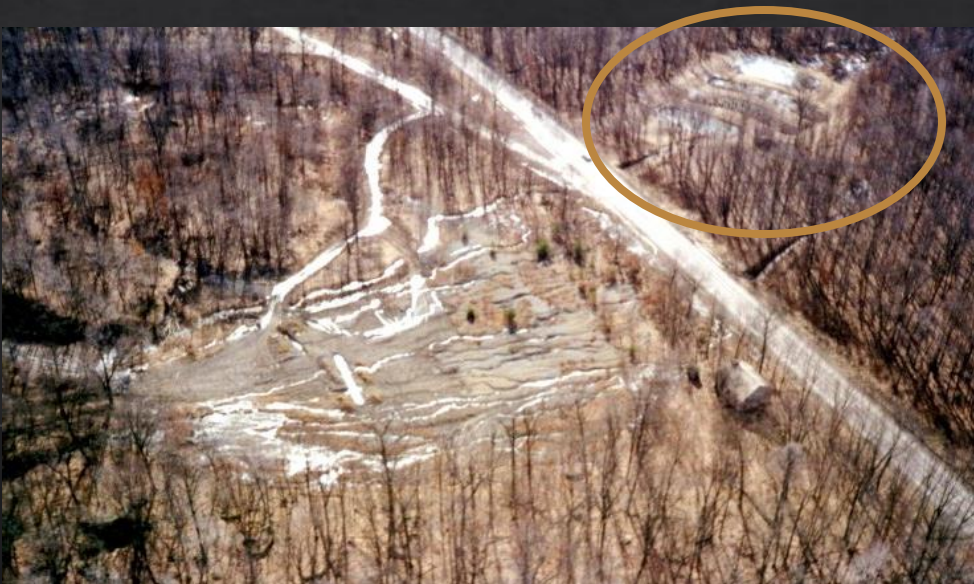
## “Lower Wetland System”

- ◇ 1984 – Wet Seal blow out
- ◇ 1987
  - ◇ Sediment Pond
  - ◇ Two Aerobic Wetland Cells

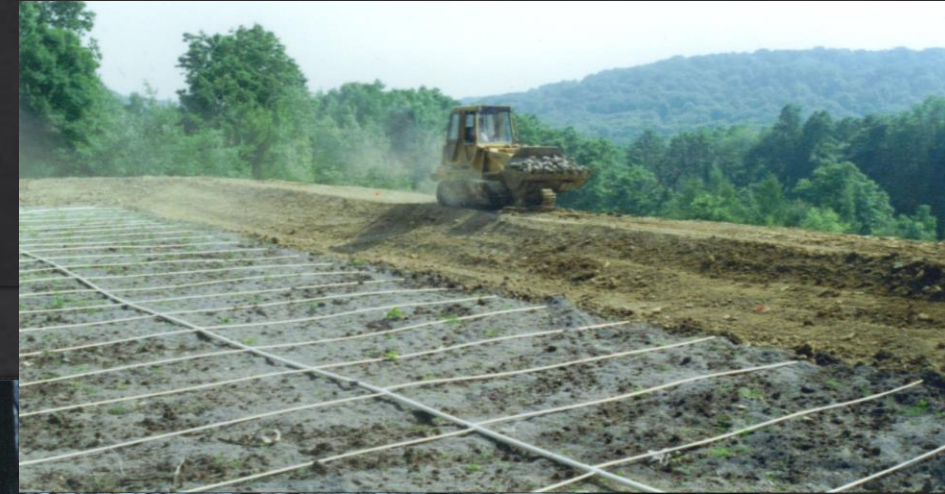
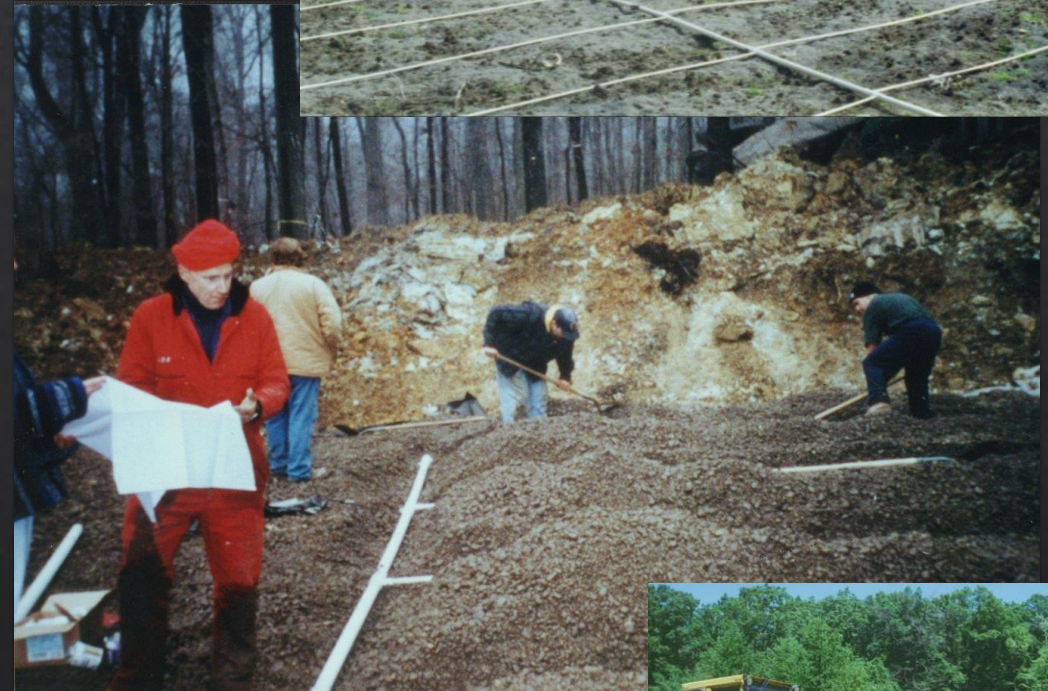
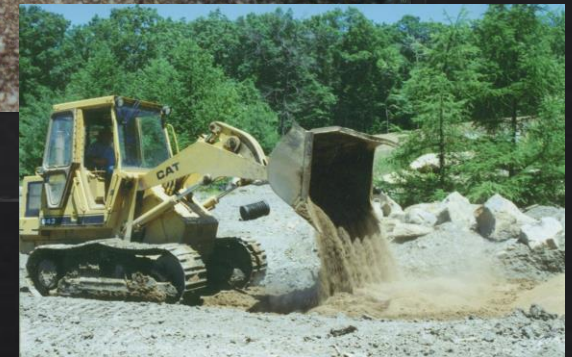
## Vertical Flow Pond (VFP)

- ◆ 1997
  - ◆ 272 metric tons (300 short tons) Spent Mushroom Compost
  - ◆ 345 metric tons (380 short tons) >90% CaCO<sub>3</sub> Limestone
  - ◆ Overdrain mimicking a sand mound
  - ◆ PVC Underdrain piping
    - ◆ 2-inch solid headers
    - ◆ ¾ inch perforated laterals
    - ◆ River gravel bedding stone
  - ◆ Technology studied in pilot scale project
  - ◆ Construction mostly performed by volunteers

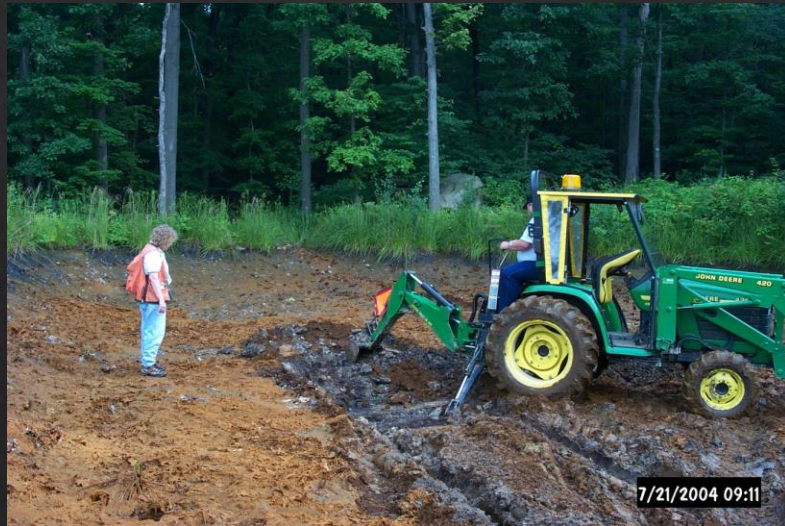
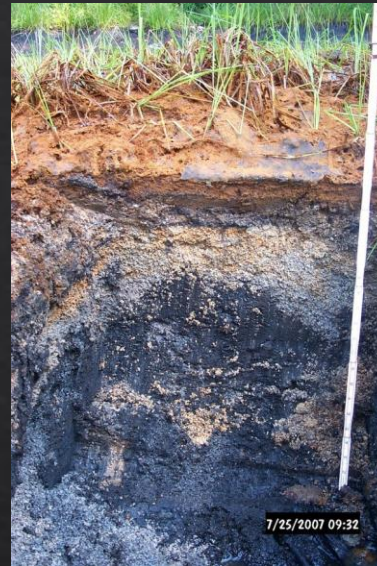
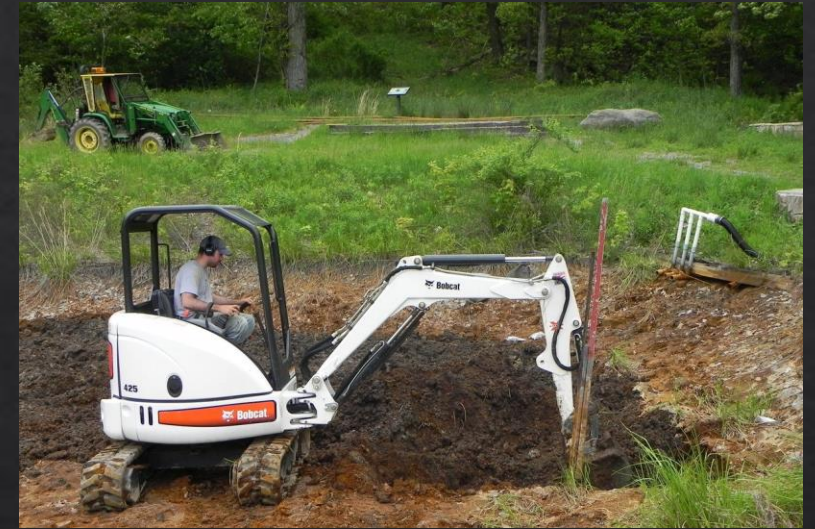
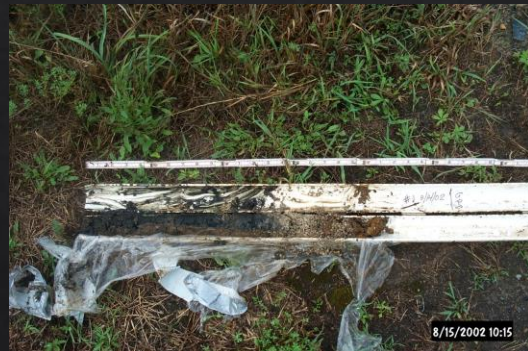
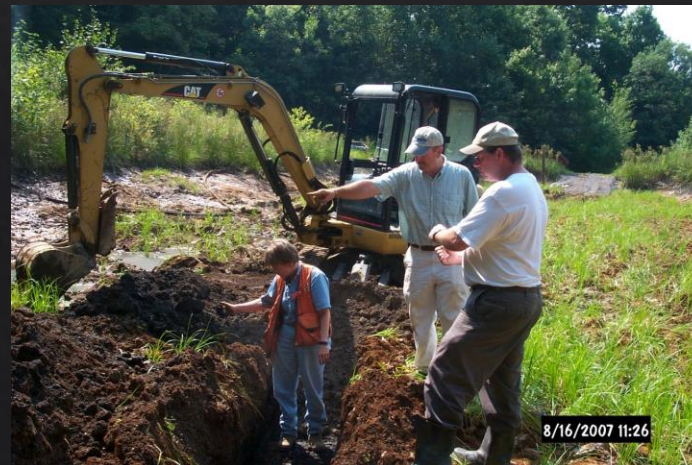
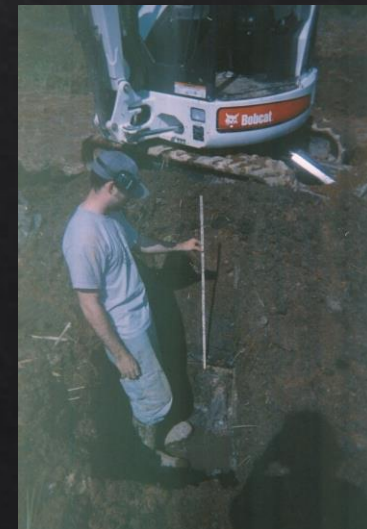
# Maintenance to VFP

Study and Stir the Media

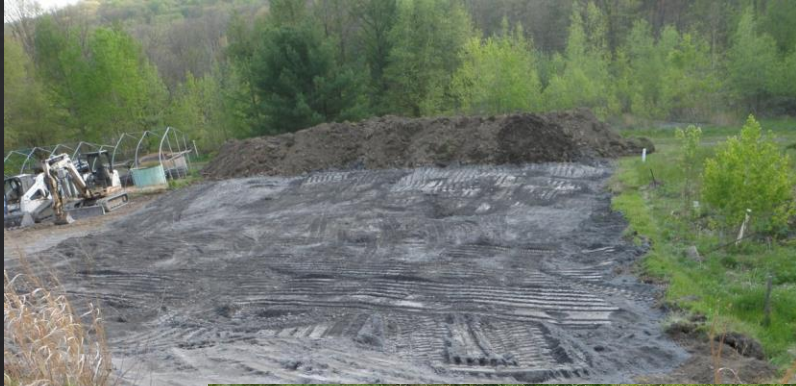
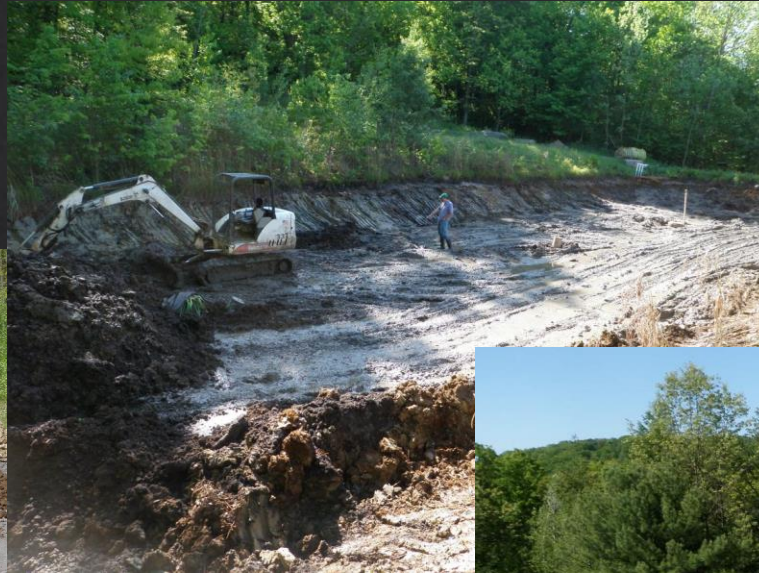
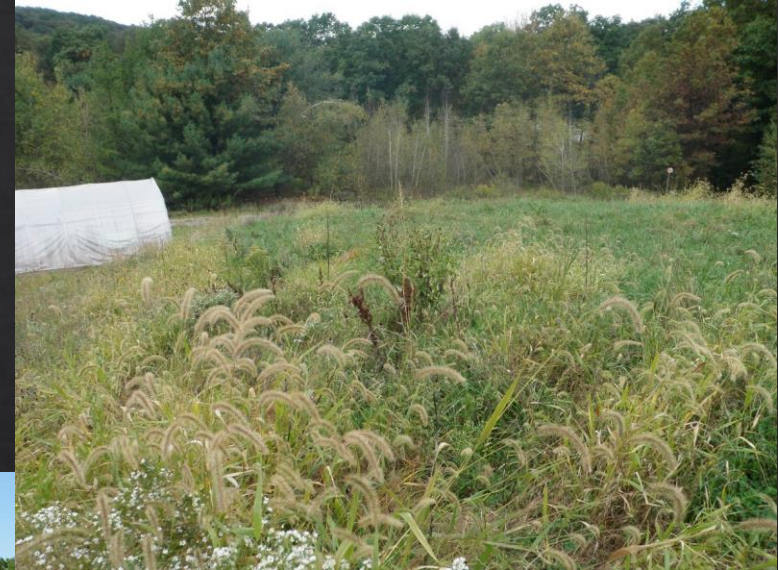
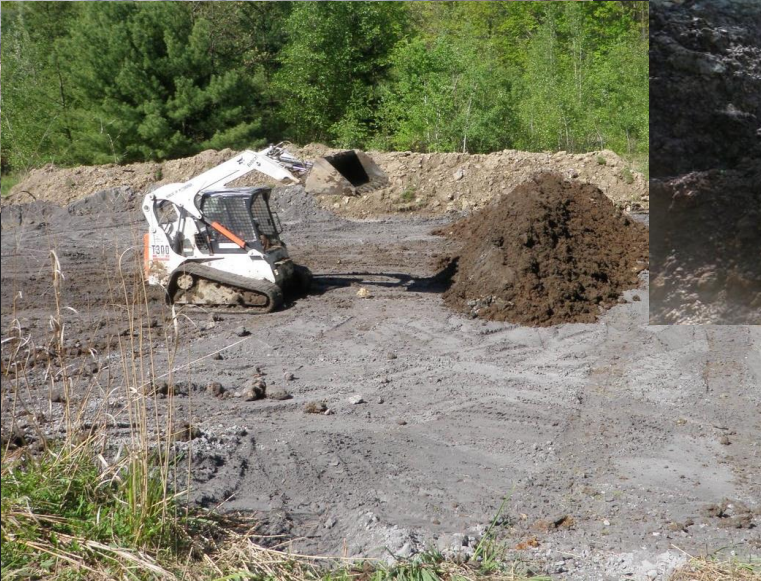
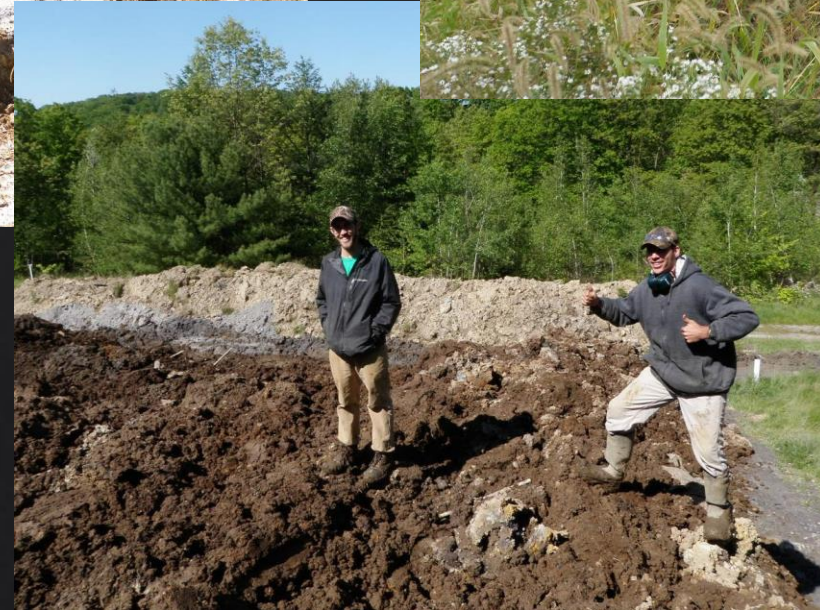
## On-Site Placement

# VFP Renovation – 2012

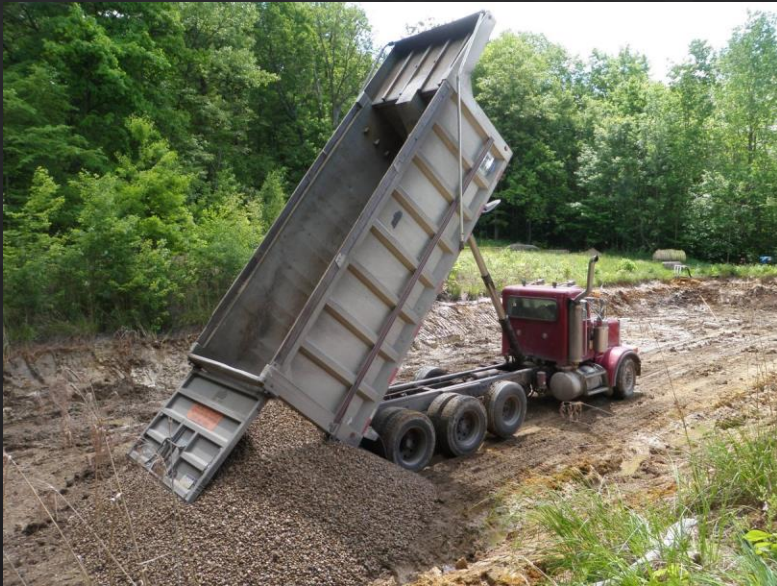
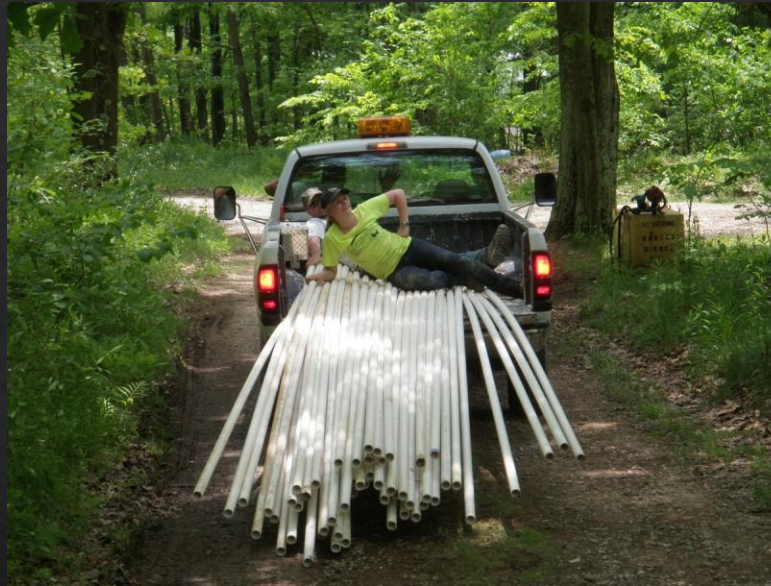
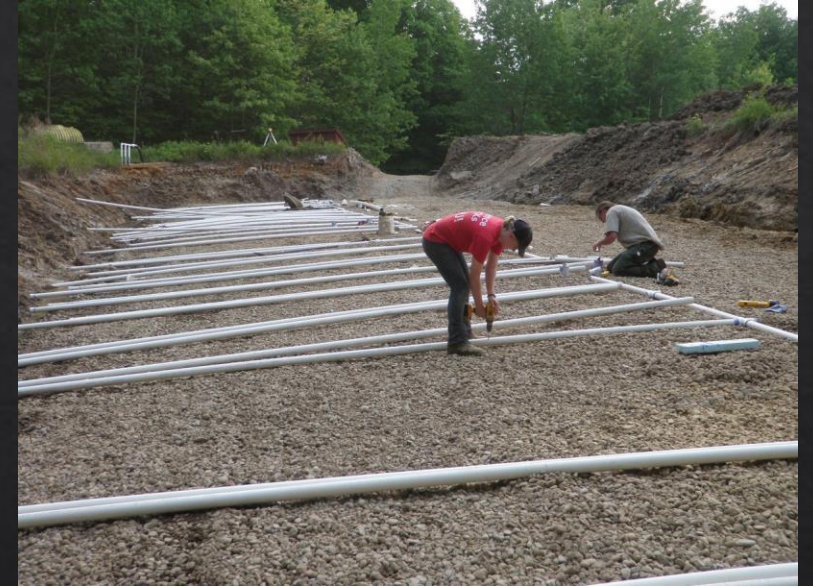
## New Underdrain

# VFP Renovation – 2012

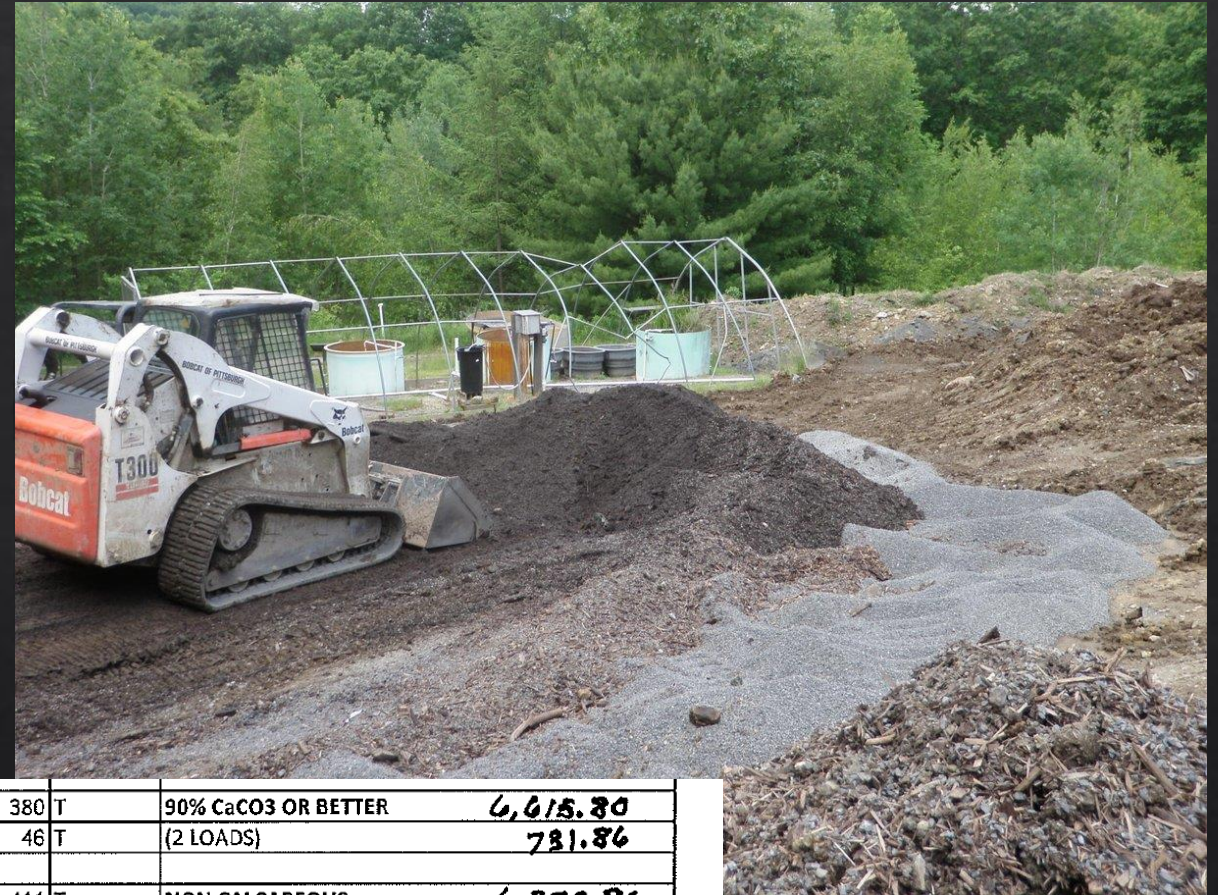
## New Media Composition

- ◇ Original: Spent mushroom compost and AASHTO #9/#8 >90% CaCO<sub>3</sub> limestone replaced with the same tonnage as original design
- ◇ New mix: Half the organic media now woodchips. Replaced 380 (short ton) AASHTO #8 >90% CaCO<sub>3</sub> limestone
  - ◇ 0.5 T/CY of organic media
  - ◇ 1.35 T/CY of clean limestone
- ◇ Reduce preferential flow to maximize surface area.

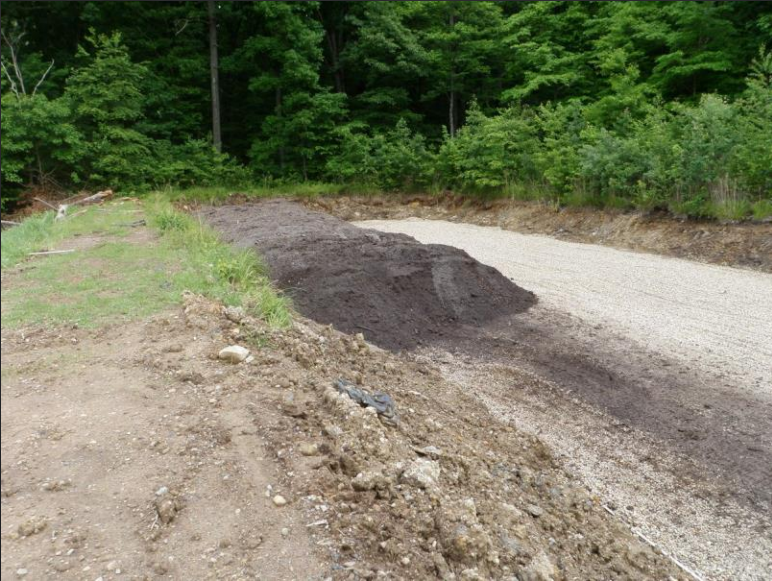
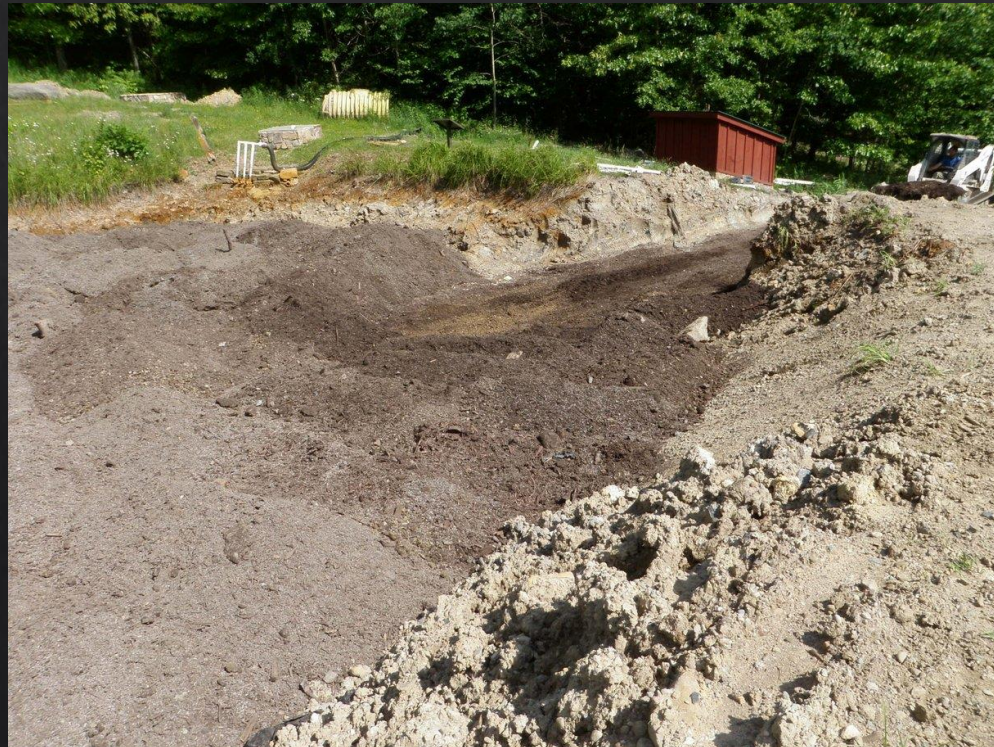
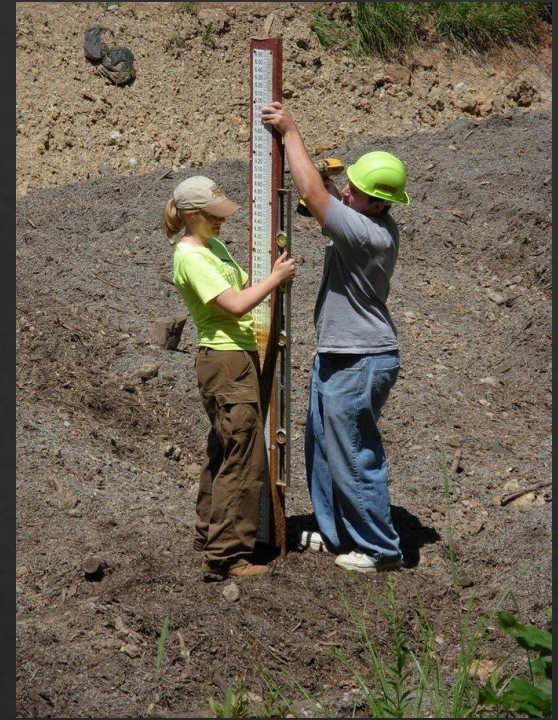
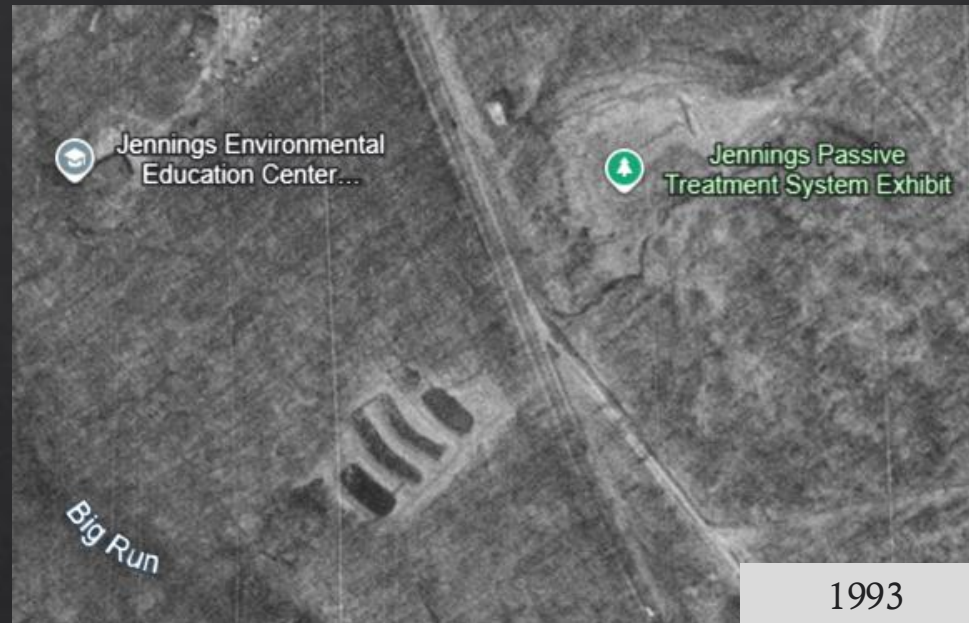
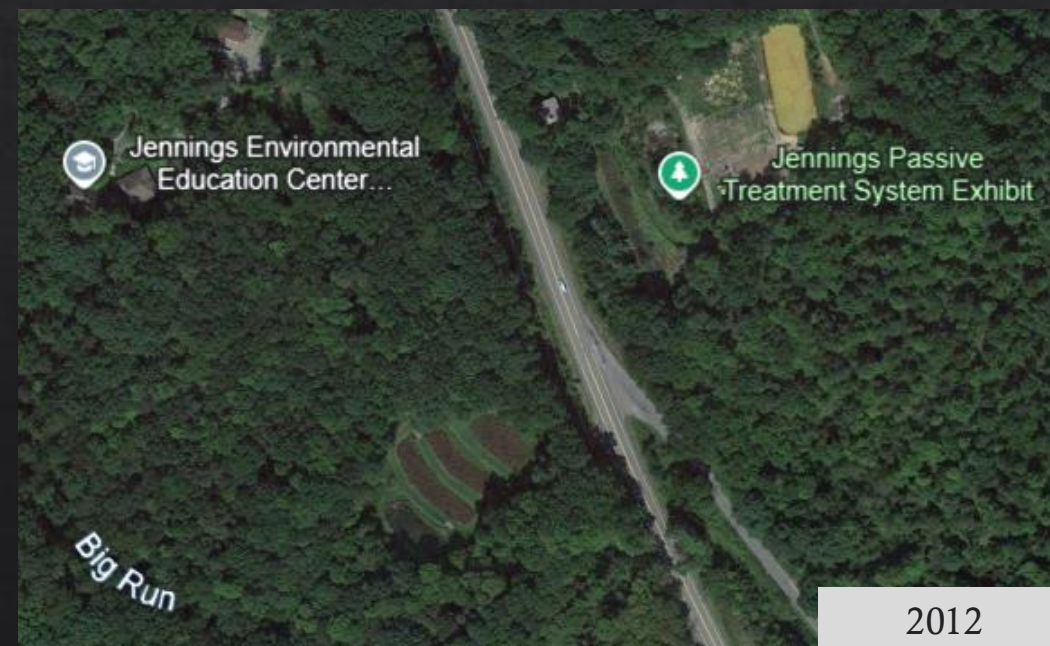
## New Media Placement Method

# VFP Renovation - 2012

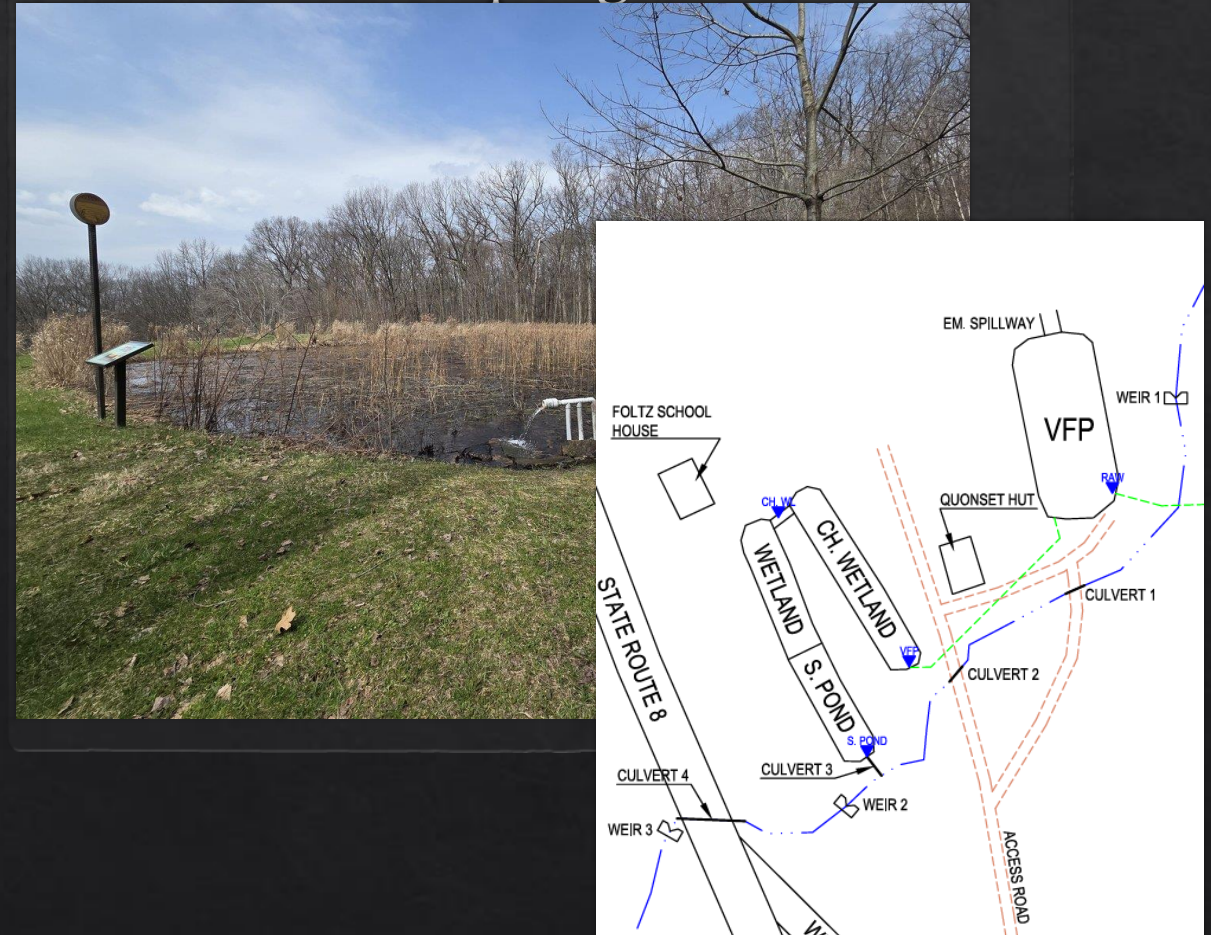
## VFP Spring 2026

- ◇ VFP to WL pipe
- ◇ pH Good
- ◇ Alk production reduced
- ◇ Diverted raw water increased in flow
  - ◇ System effluent WQ reduced

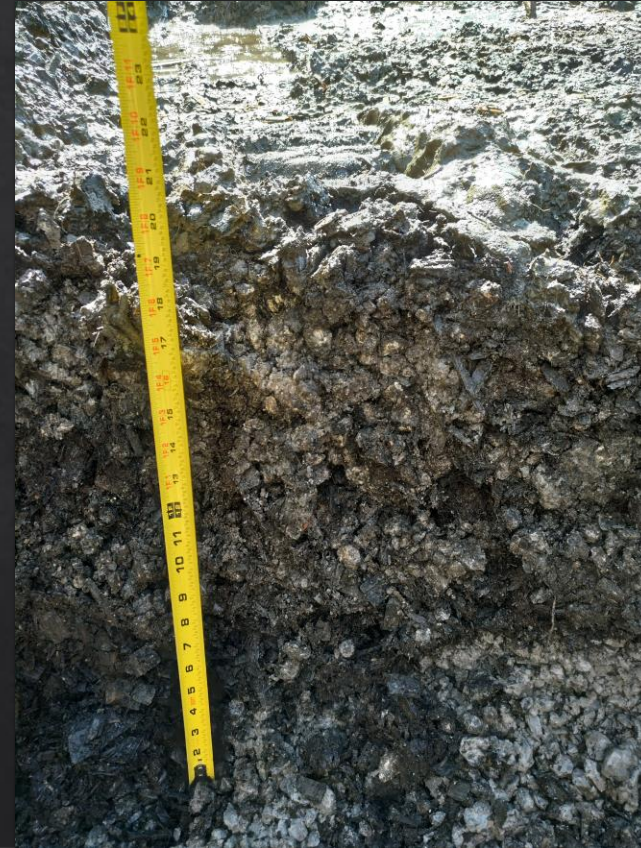
## Lamison Treatment System VFP

- ◇ Use the original Jennings VFP design
- ◇ Built in 2004
- ◇ 300T limestone, 200 CY organic media
- ◇ 1:1 woodchip:compost
- ◇ Stirred after 15 yrs
- ◇ Continues to meet effluent limits
