# AML PROJECT 160 – McINTOSH PIT EVAPORATIVE DEWATERING & BACKFILL

## ASRS Laramie 2026

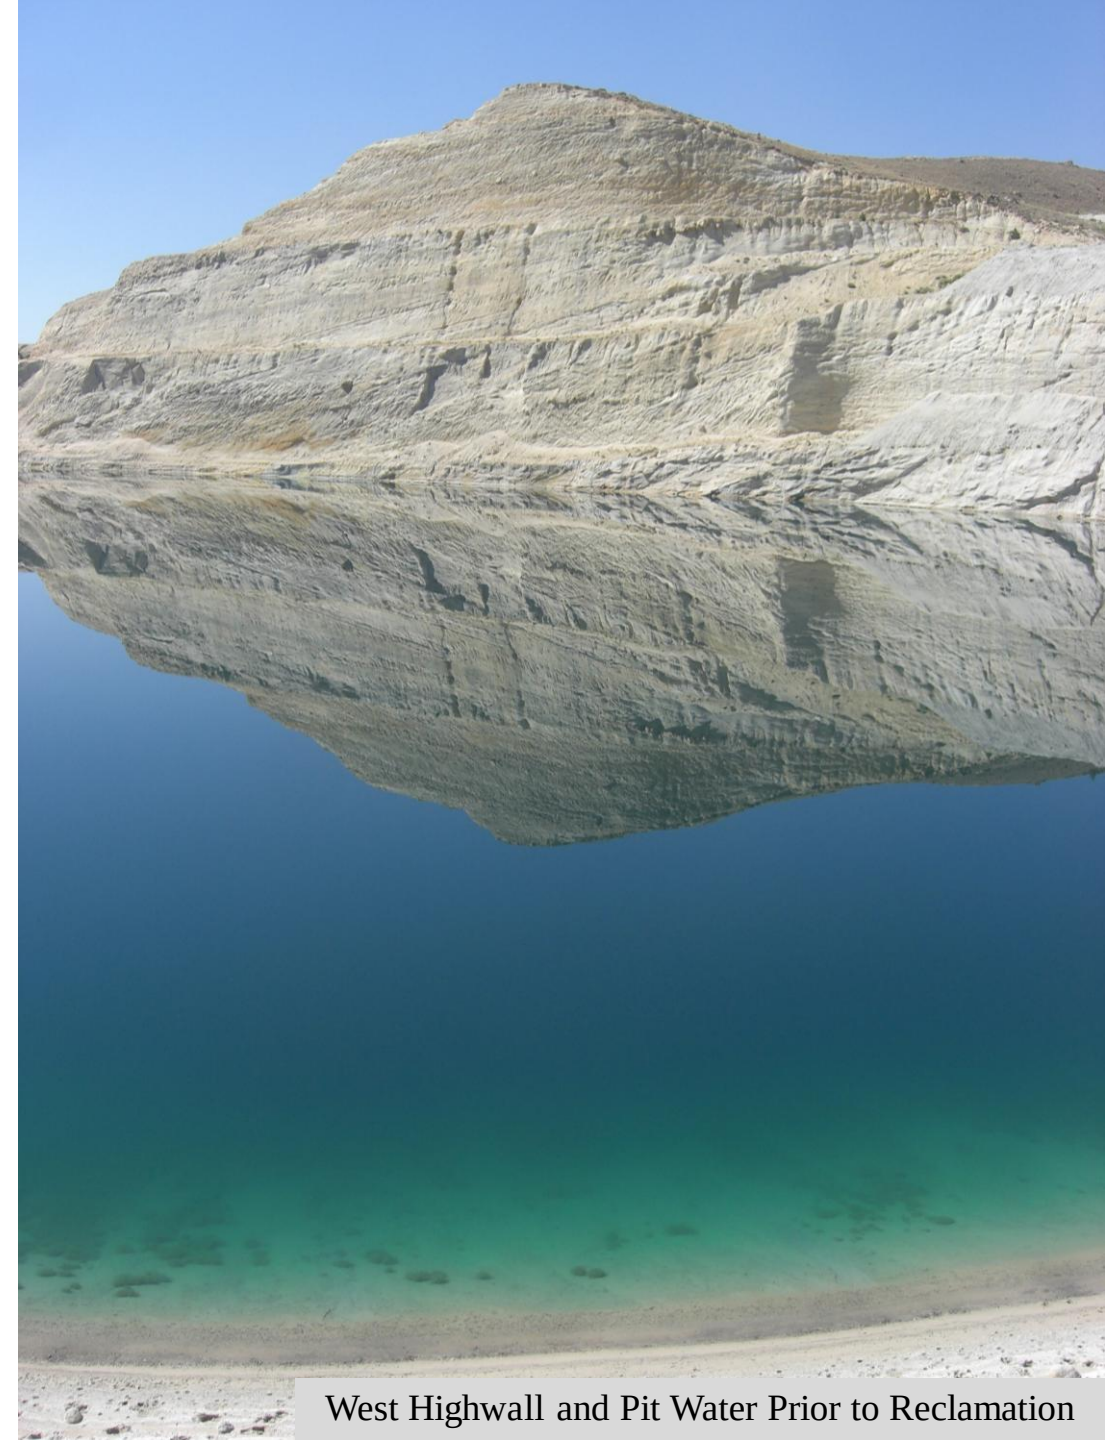
West Highwall and Pit Water Prior to Reclamation

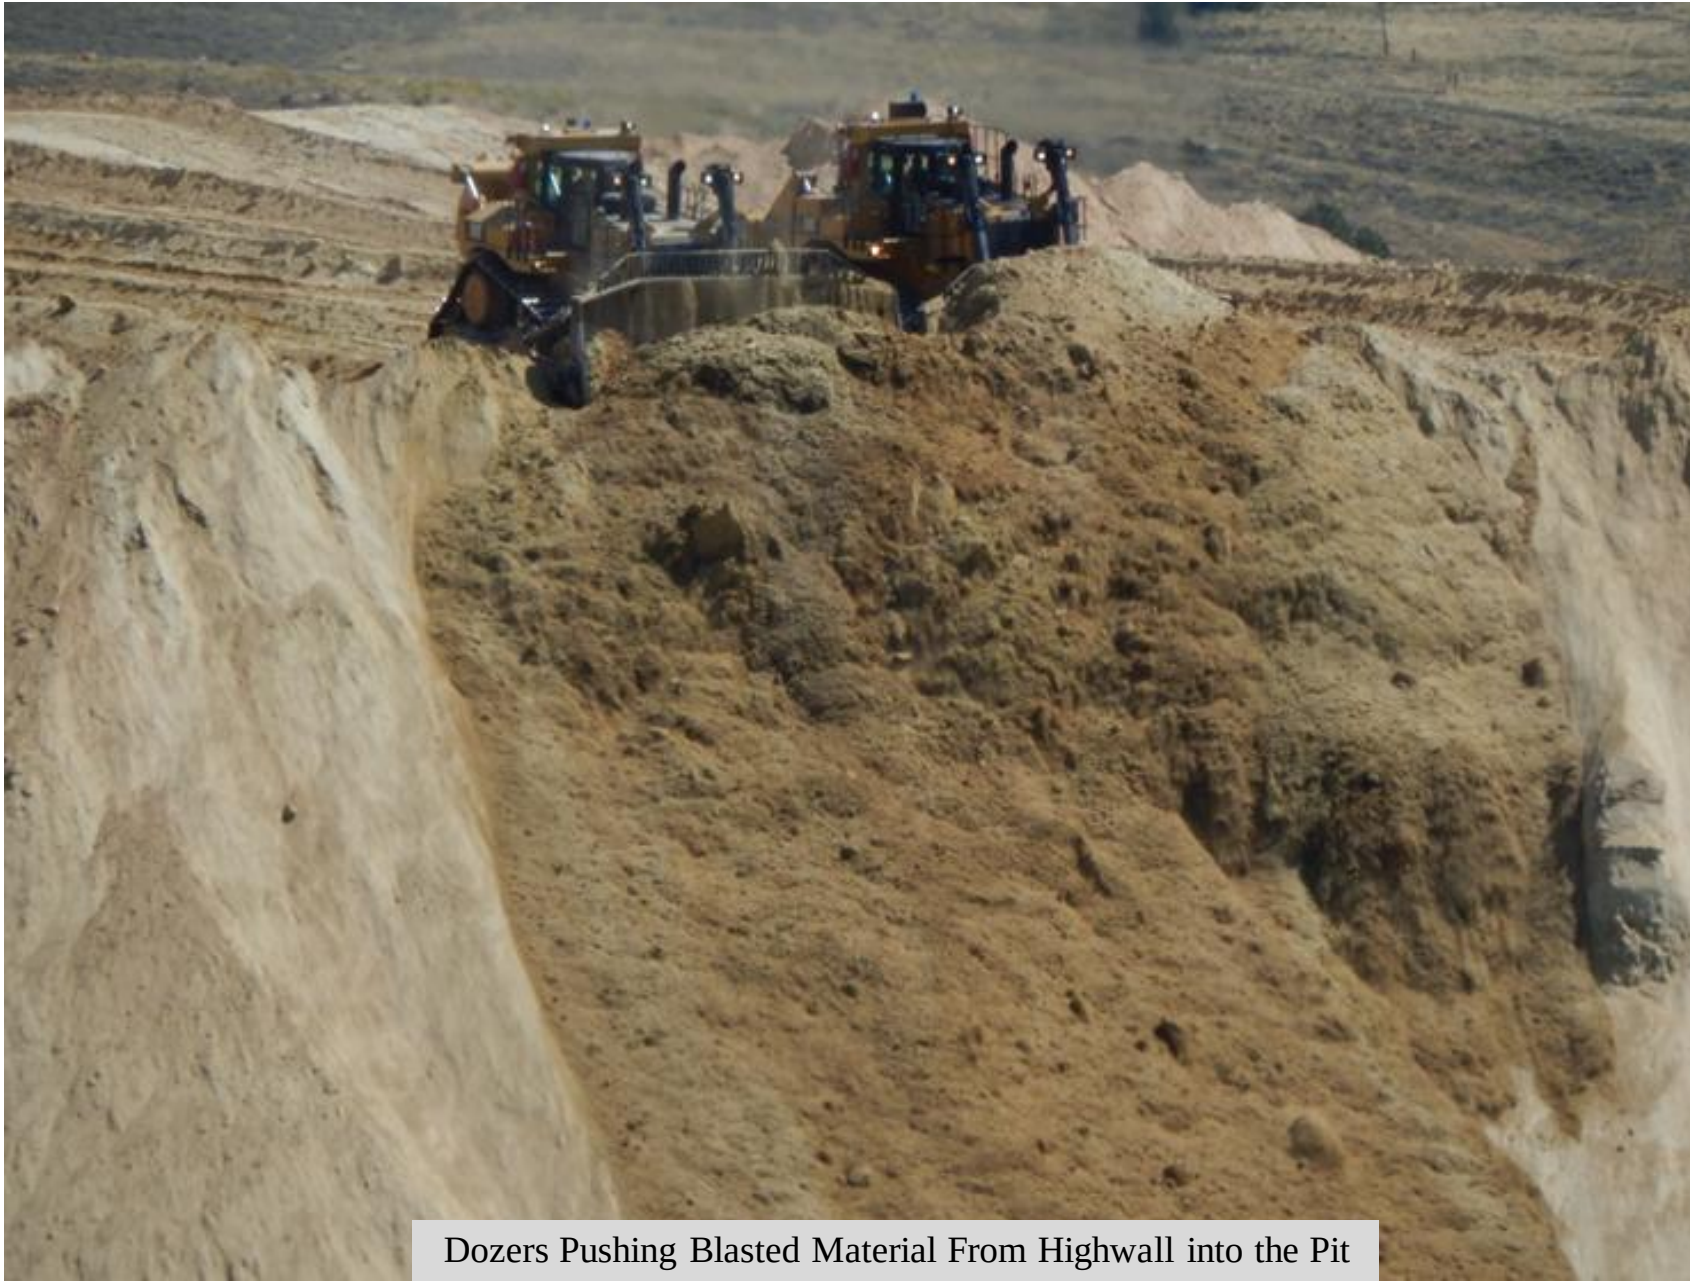
Dozers Pushing Blasted Material From Highwall into the Pit

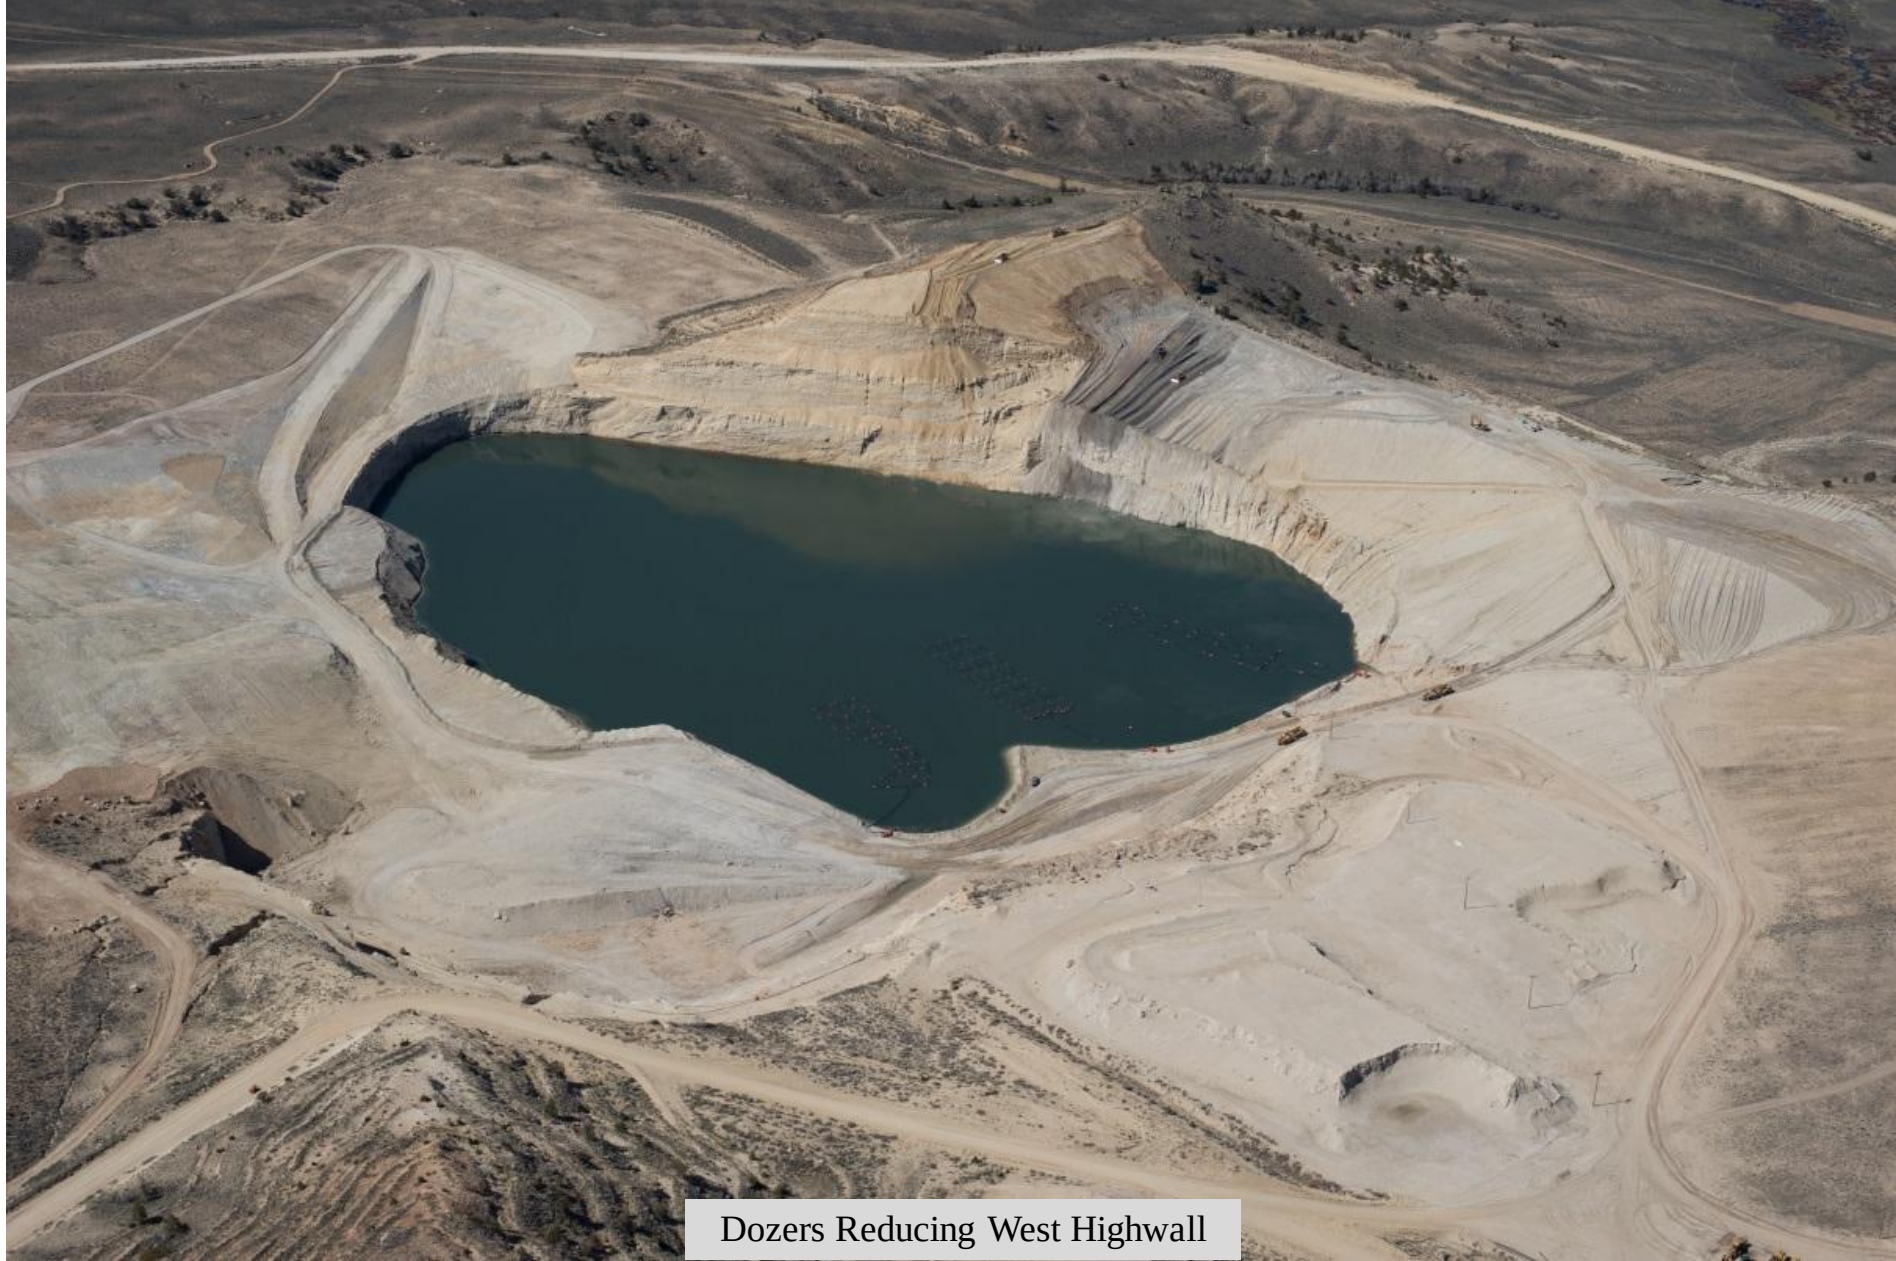
Dozers Reducing West Highwall

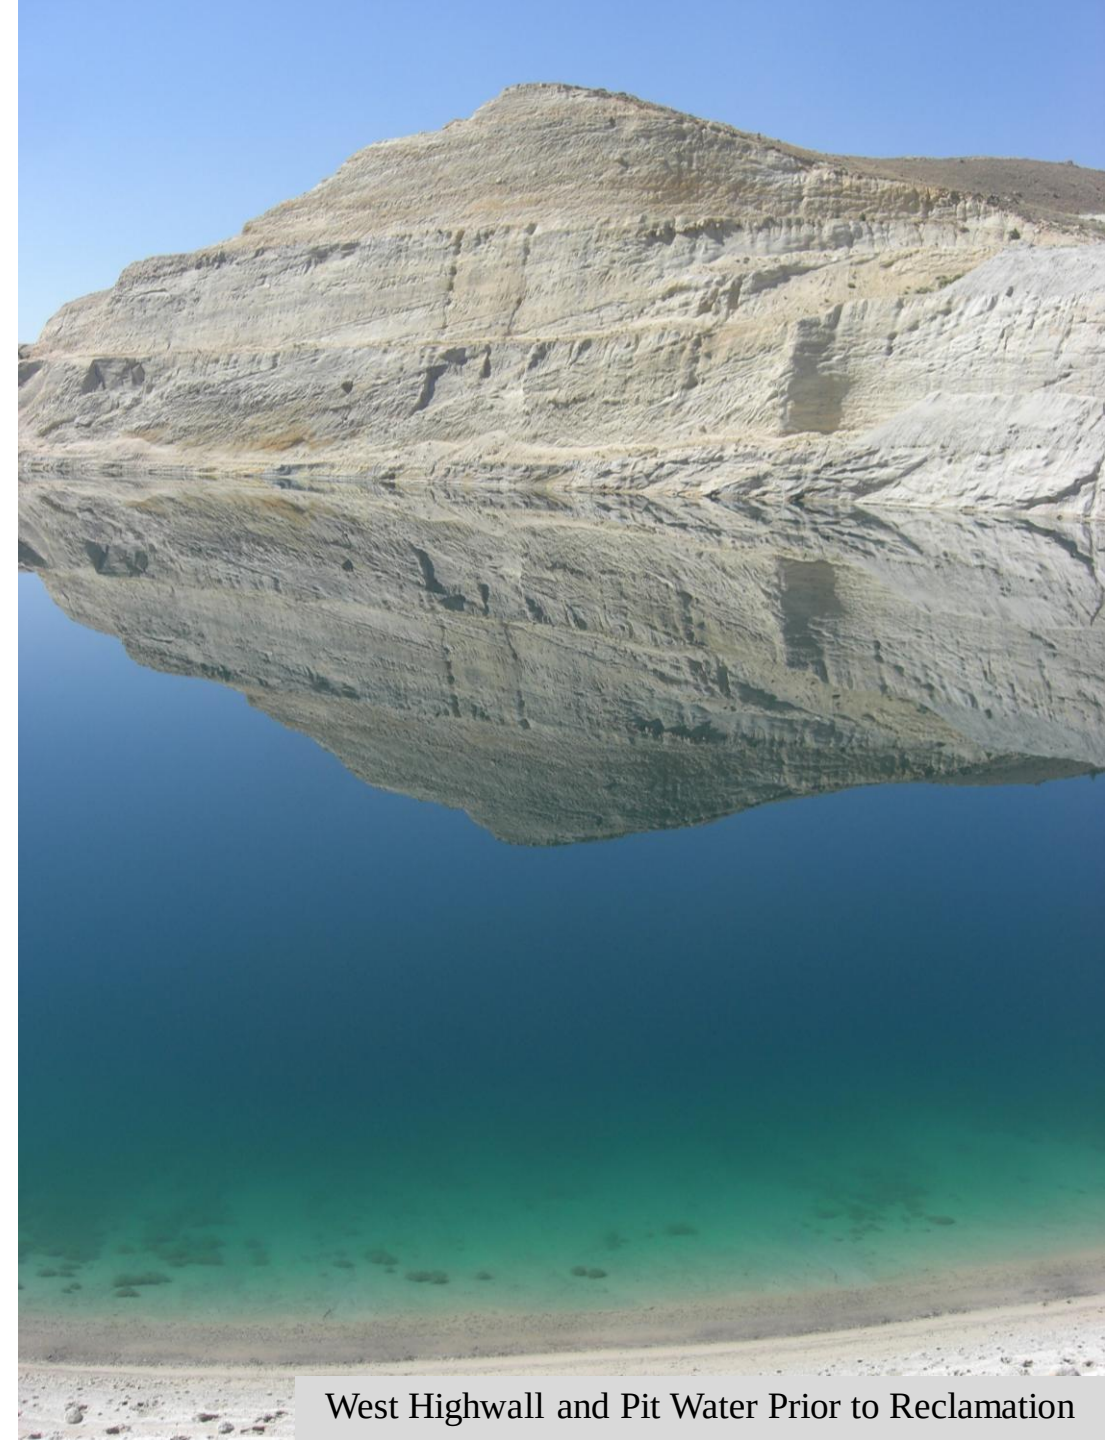
West Highwall and Pit Water Prior to Reclamation

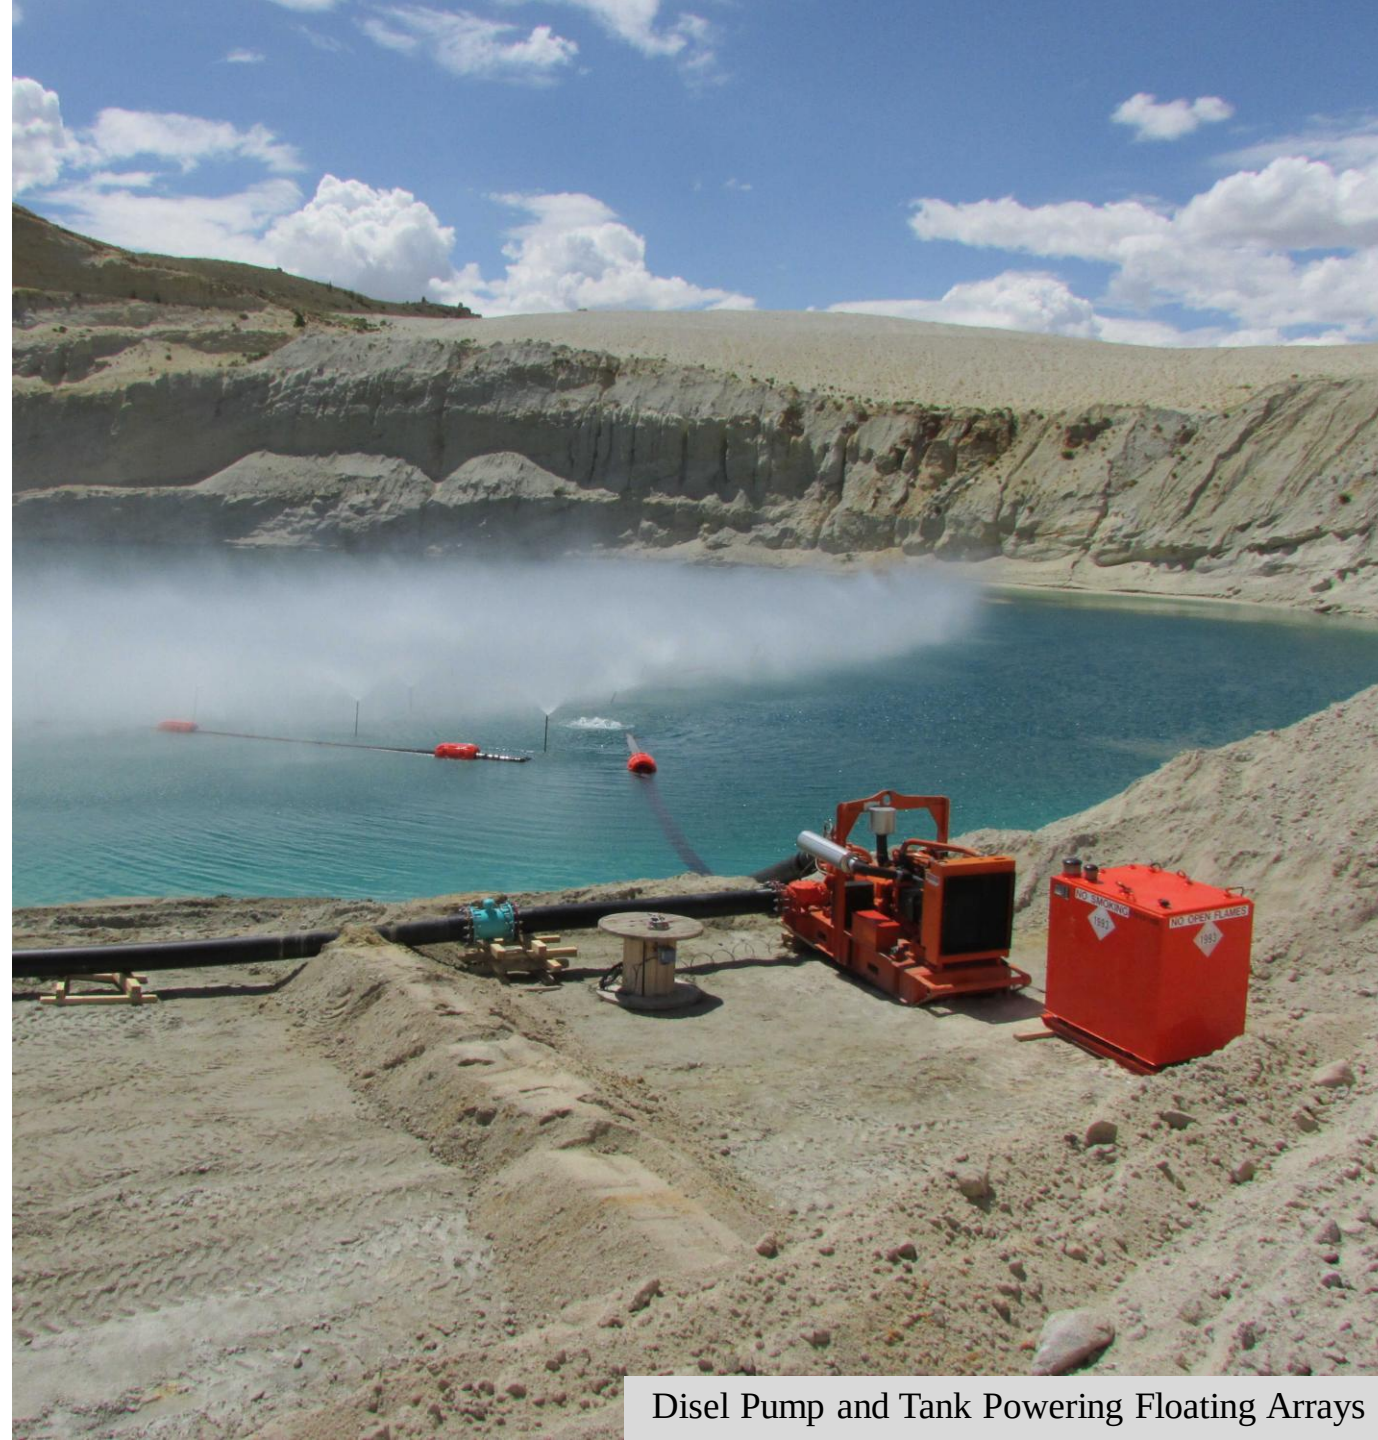
Disel Pump and Tank Powering Floating Arrays

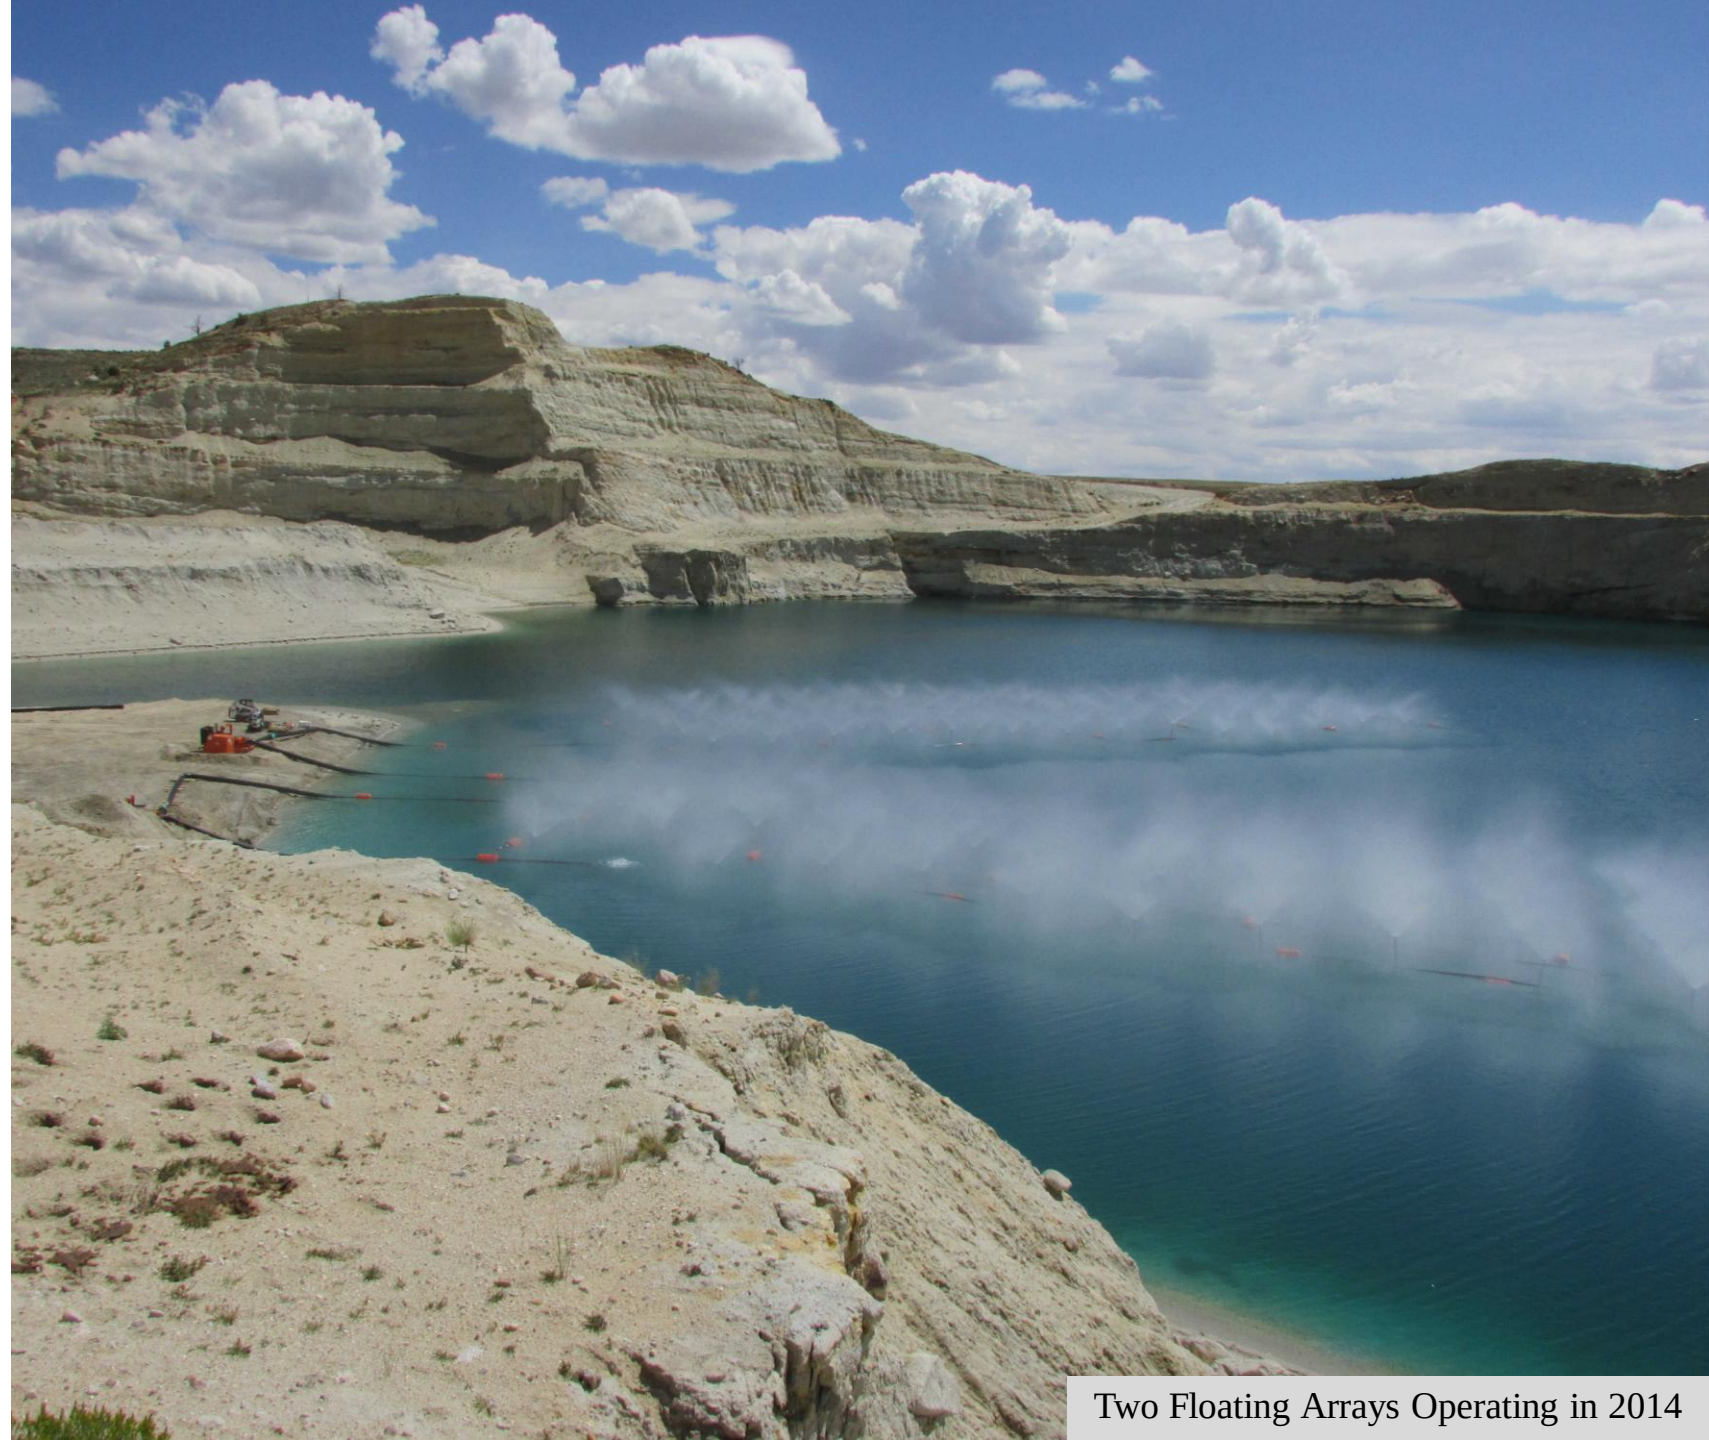
- Rental equipment
- Two Godwin Dri-Prime HL225M Diesel Pumps
- Two floating arrays
  - 6-inch HDPE
  - 76 feet x 276 feet
  - 75 nozzles / array
  - 4-foot risers
  - 55 psi at nozzle
- Began operation August 2014
- Operated to November
- Winterized by removing from water

Two Floating Arrays Operating in 2014

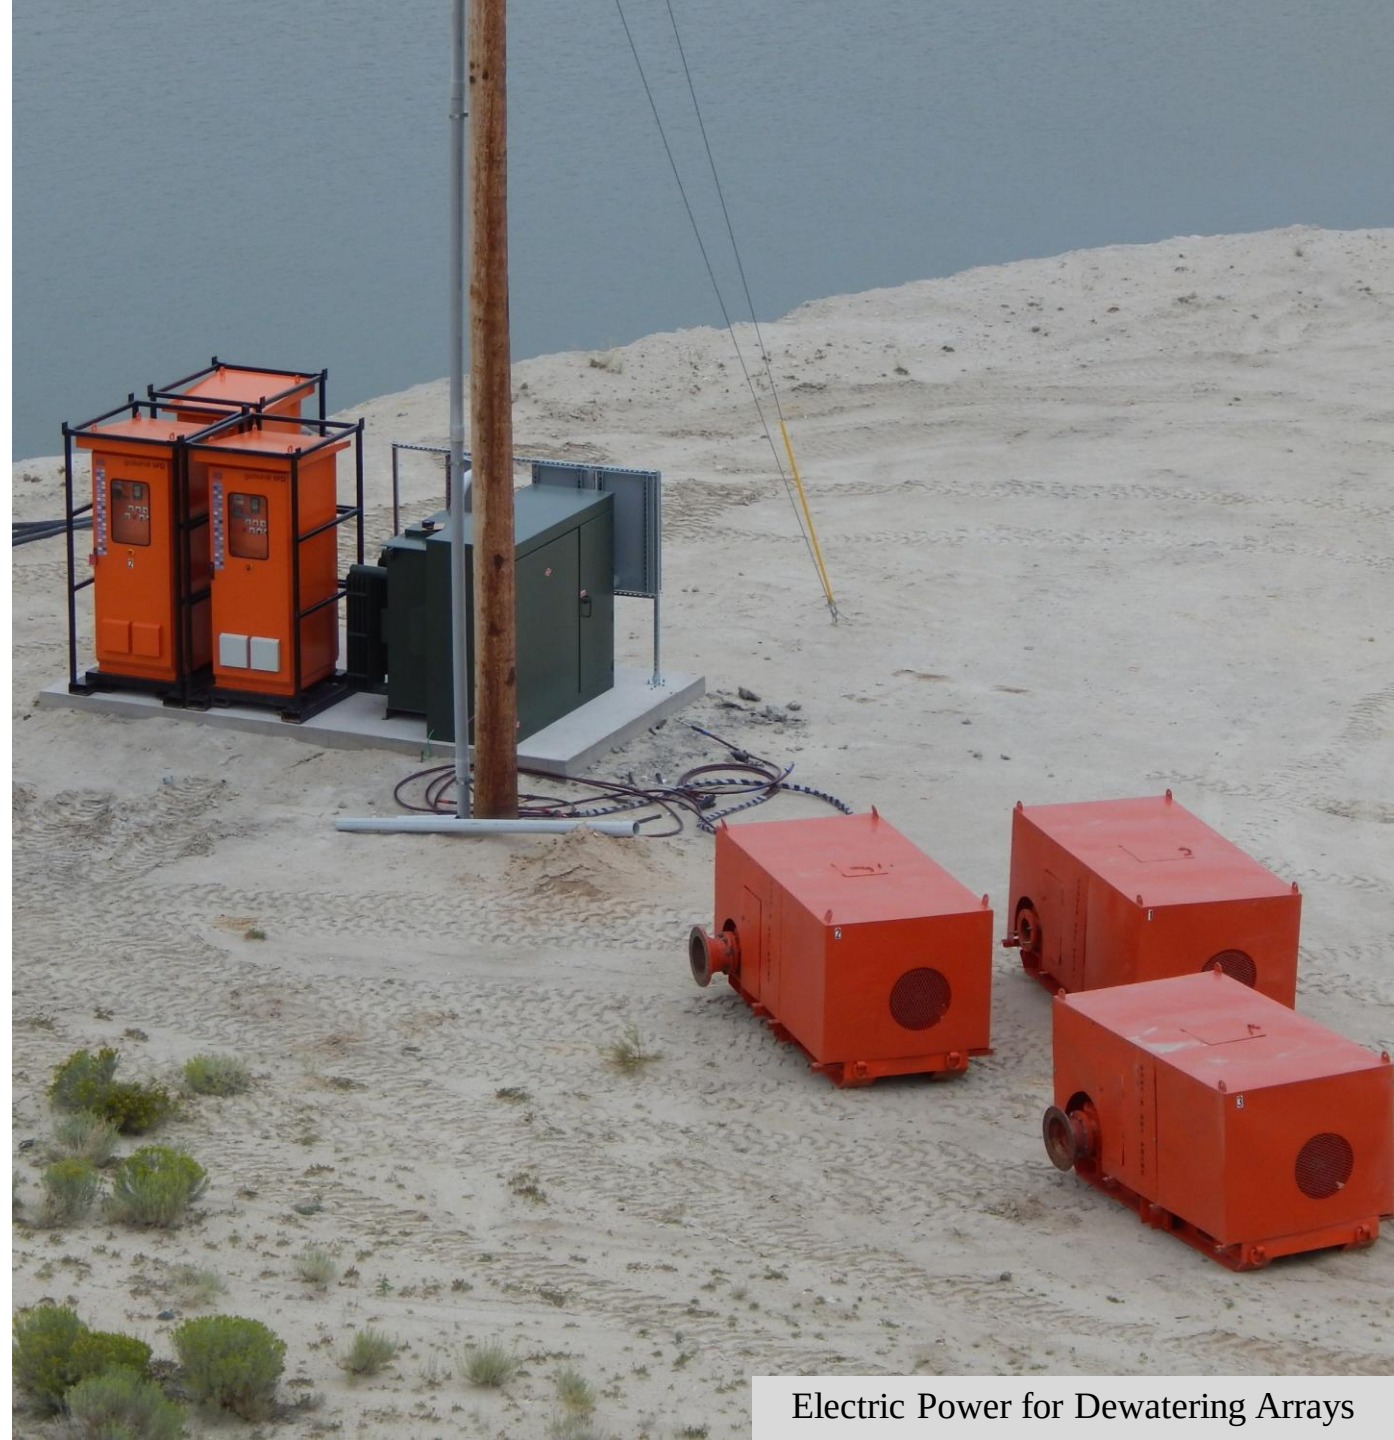
- Rapid increase in water elevation during Phase 1 winter backfill
  - August 2014: 6,778 feet
  - April 2015: 6,802 feet
- Significant downtime for diesel pump fueling, maintenance, mechanical issues
- Electric pumps estimated to save >\$1 million compared to diesel
- Powerlines and two 200 HP Godwin Dri-Prime WT225M electric pumps installed for Phase 2
- Added floating array for Phase 2
  - Same design with 6-foot risers

Electric Power for Dewatering Arrays

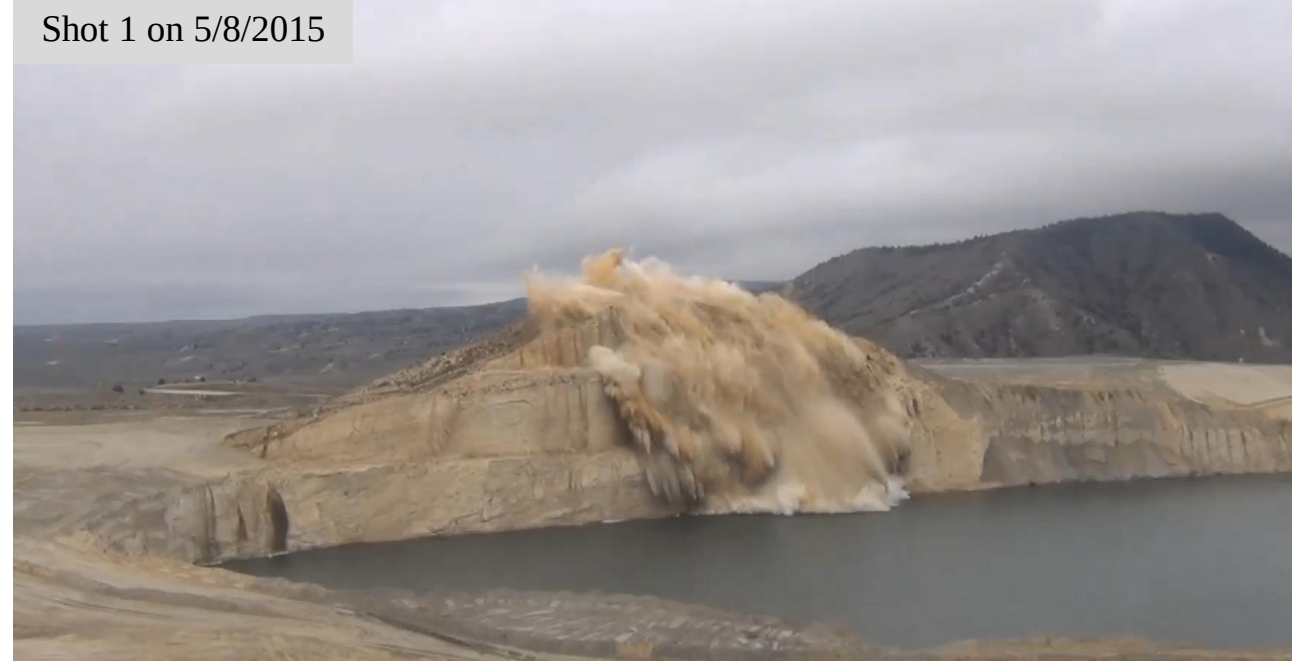
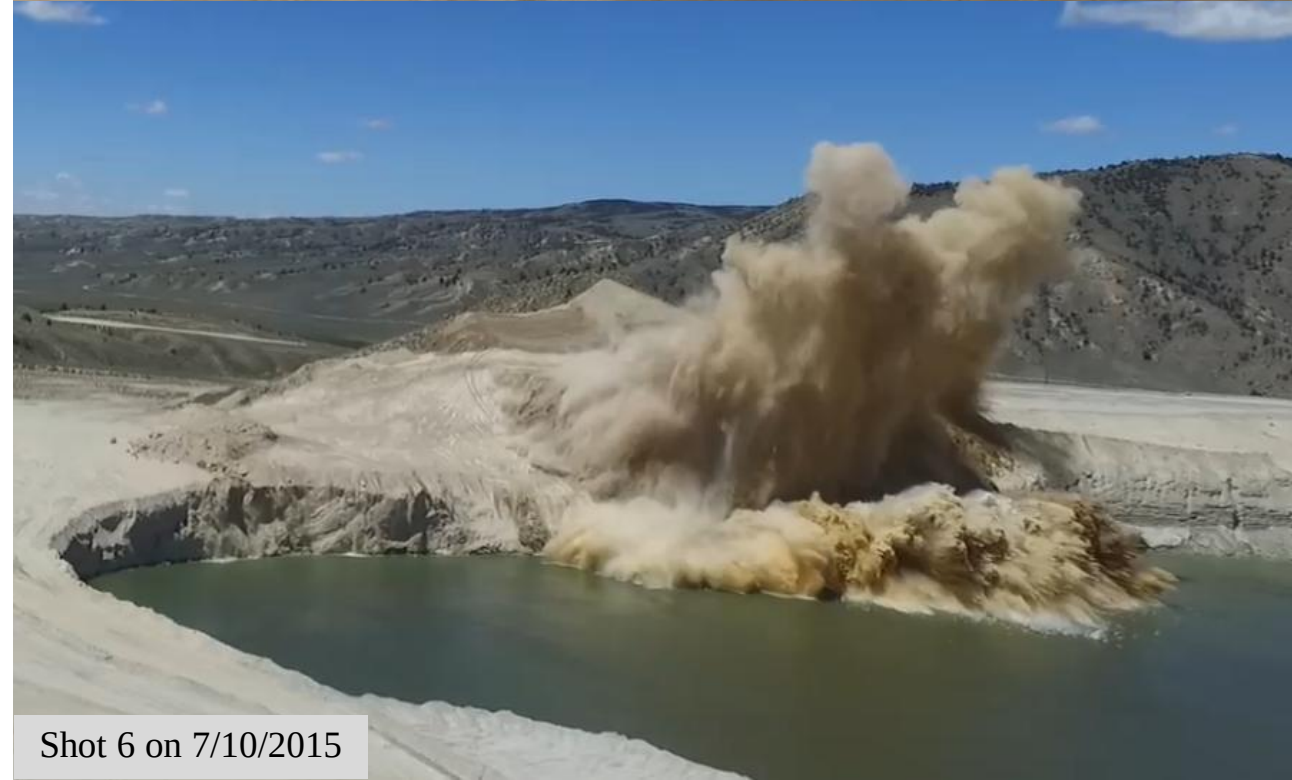
- Damage was sustained to pumps and arrays from highwall blasting in May 2015 (Shot 1)
  - Repaired by June 5
- June 30 and July 10 (Shots 5 & 6) blasting caused more array damage
  - Repaired by September 1
- Significant downtime increased pit water level
  - April 2015: 6,802 feet
  - July 2015: 6,819 feet

Shot 1 on 5/8/2015

Shot 6 on 7/10/2015

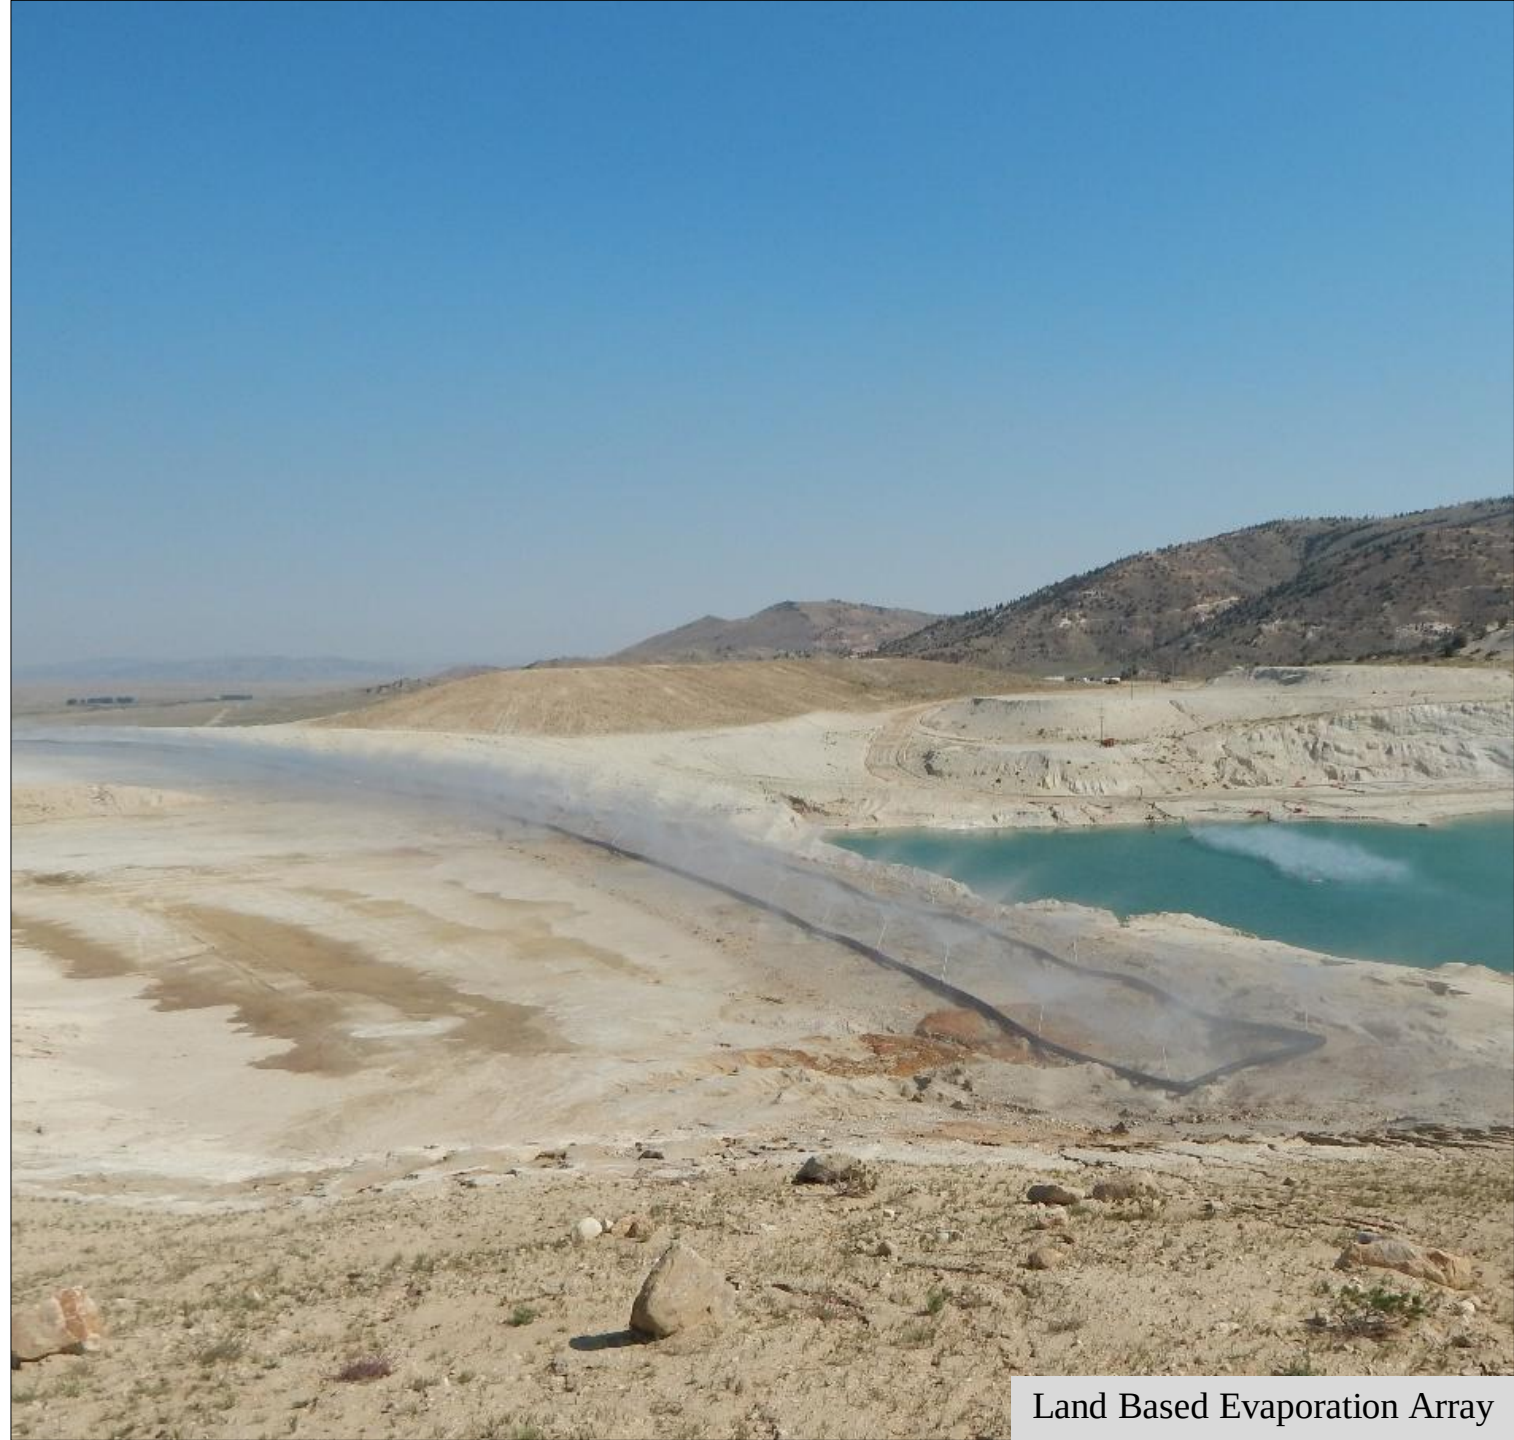
- One floating array removed
- One land-based evaporation array added
  - Two parallel 1000-foot, 12-inch HDPE lines
  - 80 nozzles at 25 feet spacing
  - One 400 HP Godwin Dri-Prime HL250M electric pump
- Water level successfully managed by upgraded system during the Phase
  - April 2016: 6,811 feet
  - December 2016: 6,815 feet
- Underwater survey showed pit bottom raised 8 feet during Phase due to backfill

Land Based Evaporation Array

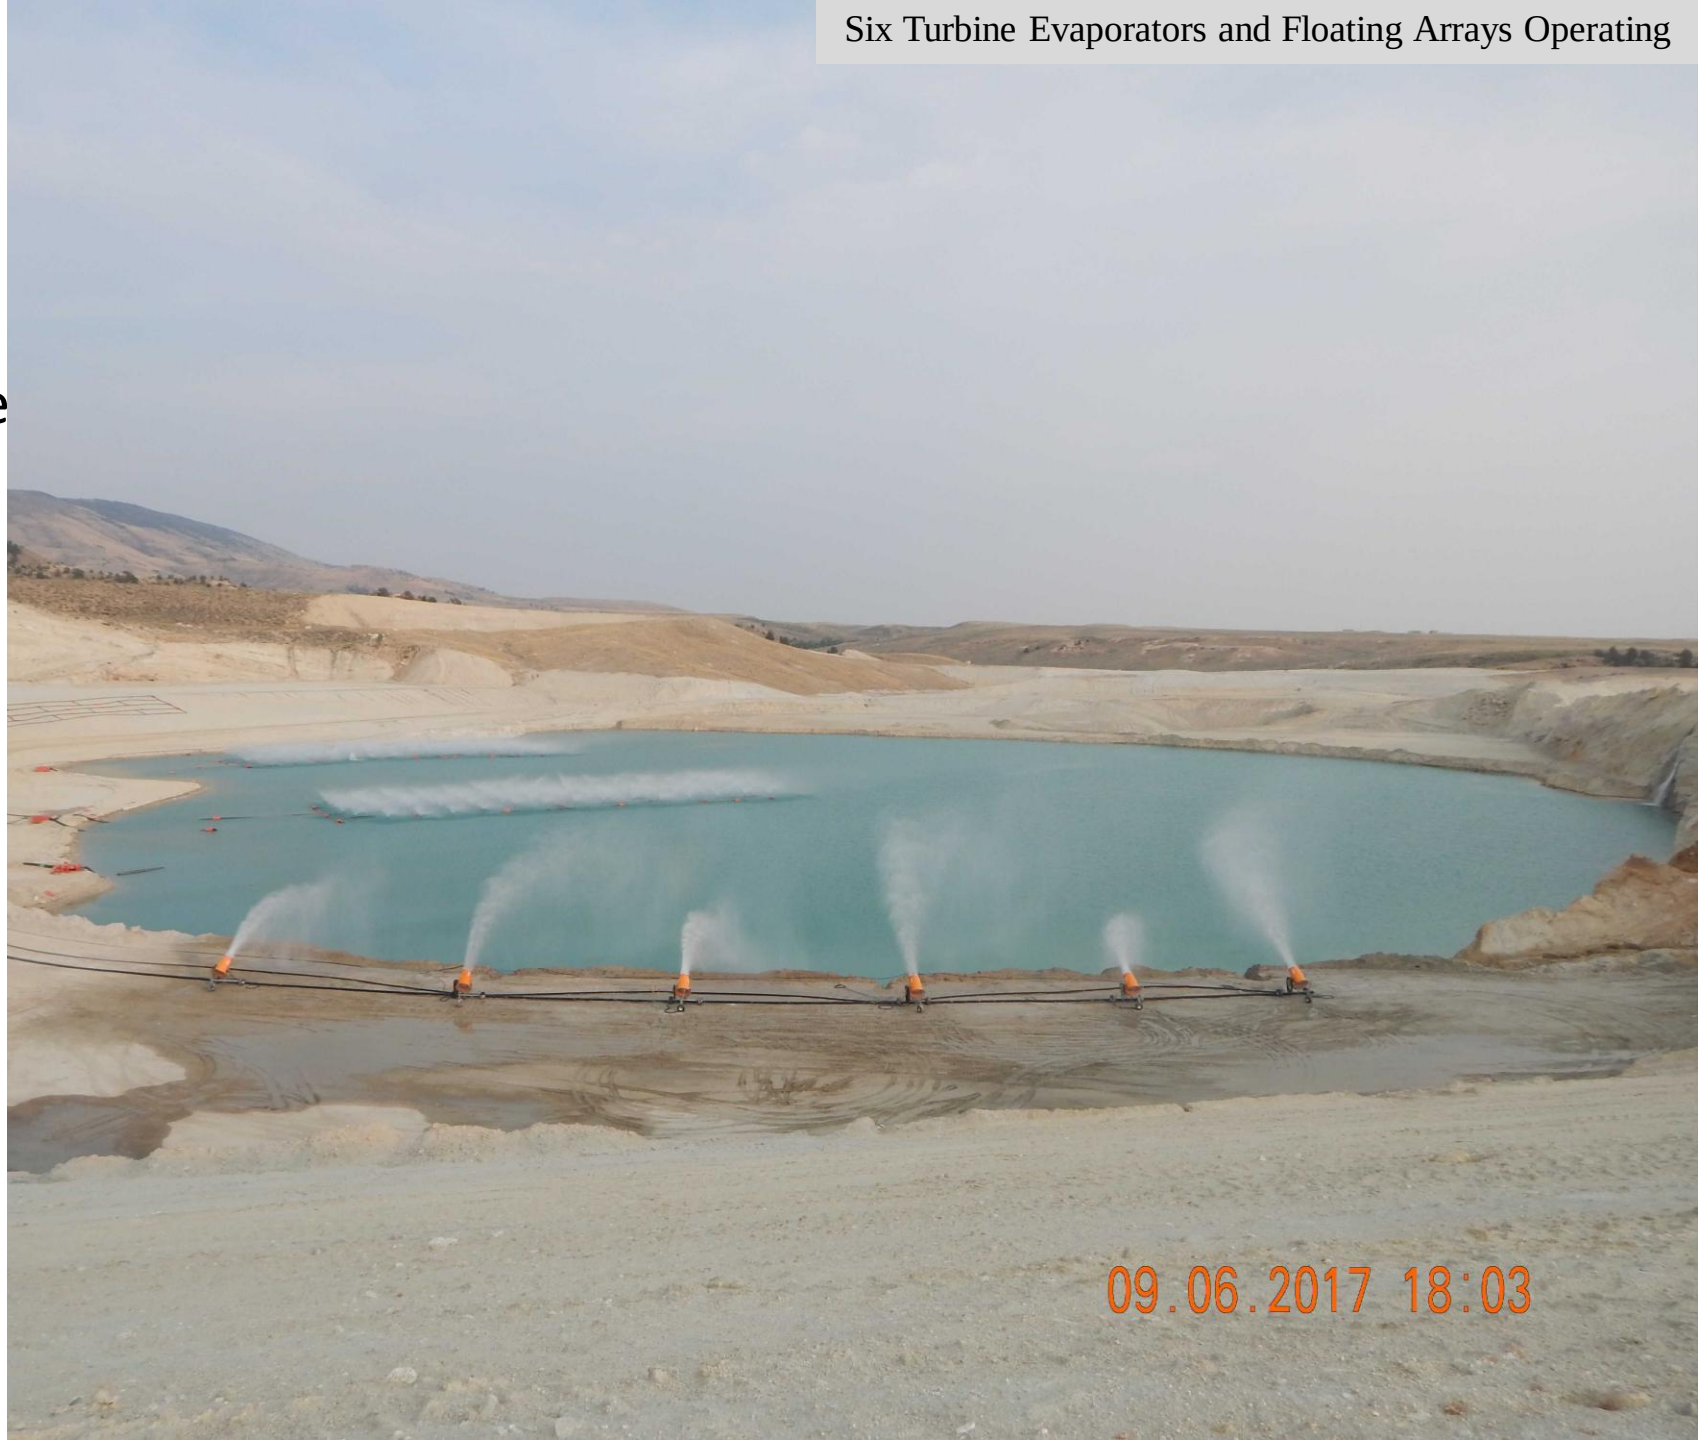
- In the 2017 season backfilling operations began significantly shrinking surface area of the pit water
  - Vertical displacement became more rapid due to decreased surface area
  - Six Pole Cat turbine evaporators added
    - 75 HP high pressure HL100M booster pump
