# AML PROJECT 160 – McINTOSH PIT EVAPORATIVE DEWATERING & BACKFILL

## ASRS Laramie 2026

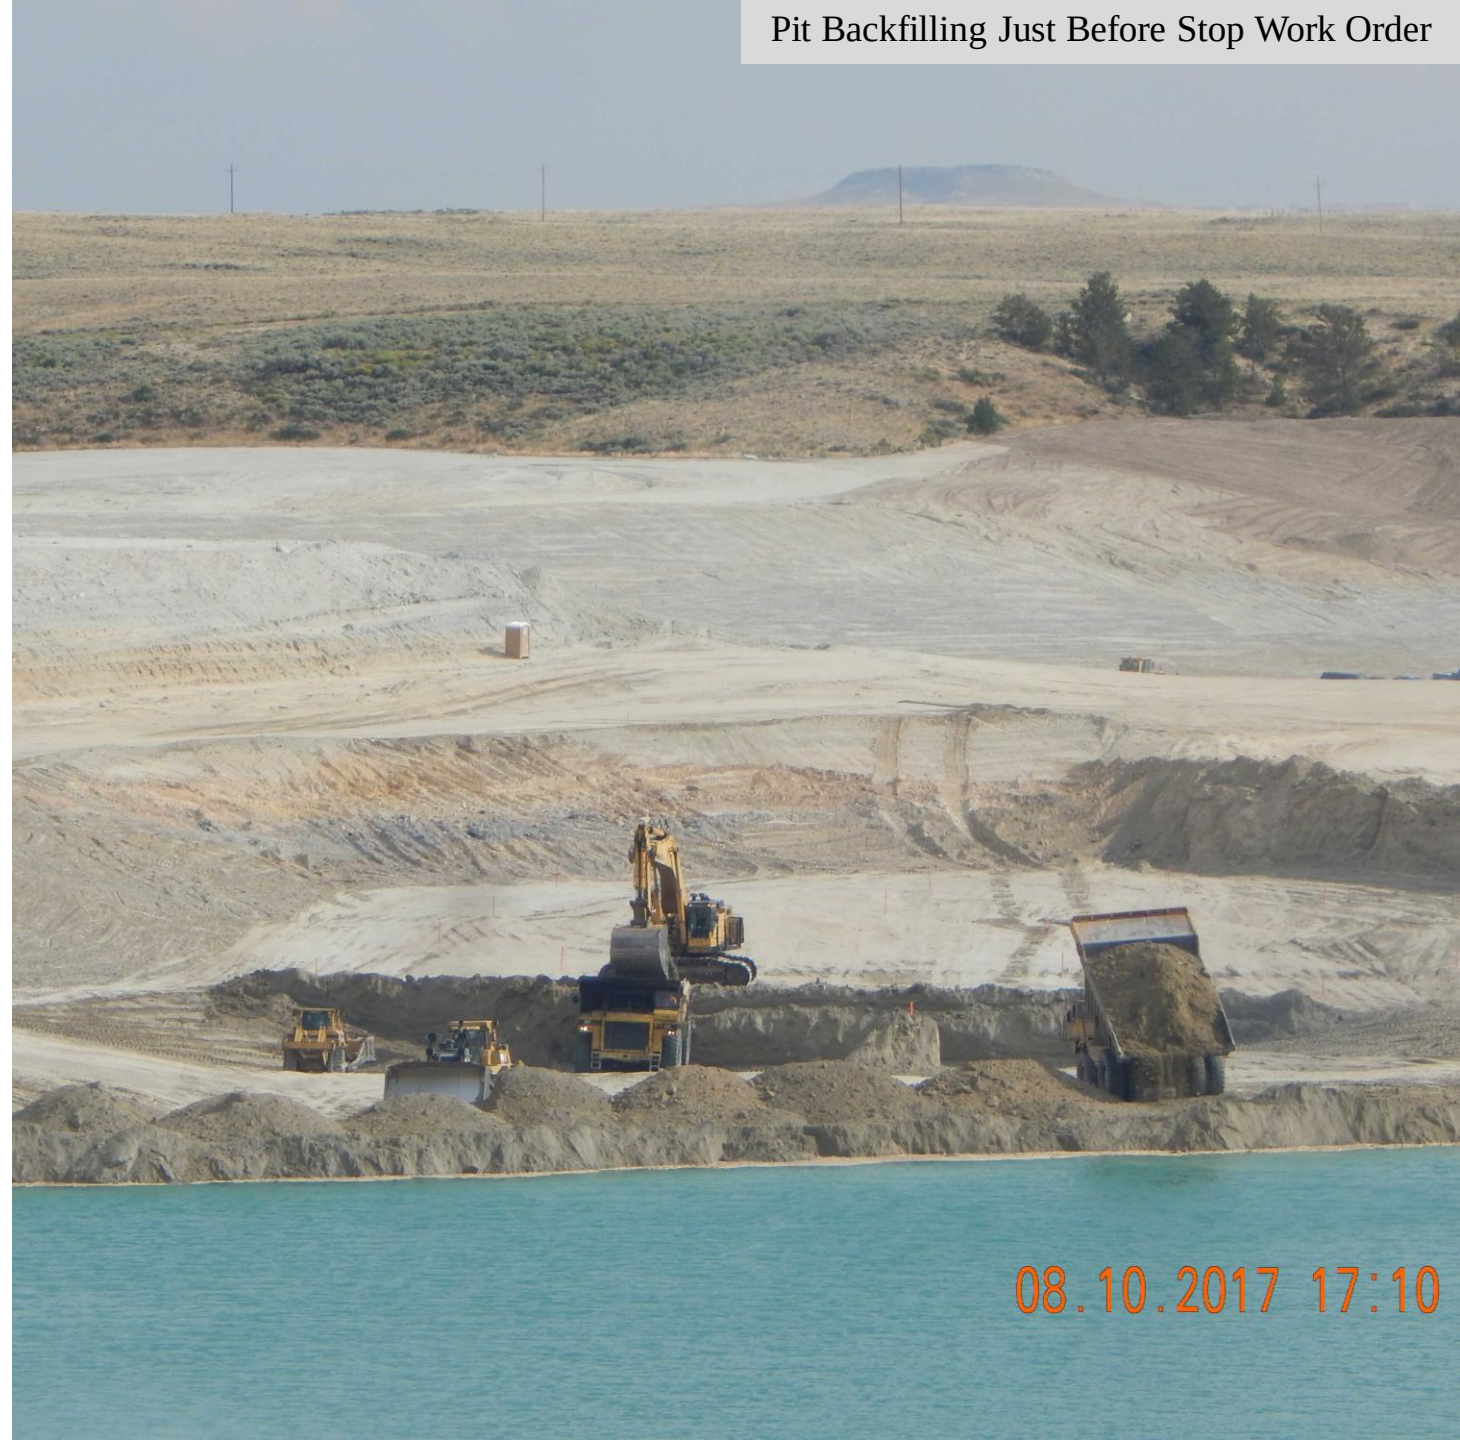
- Phase began April 2017
- Evaporation unable to match displacement due to backfill
  - April 2017: 6,814 feet
  - August 2017: 6,822 feet
- AML issued Stop Work Order August 2017
  - Contractor moved equipment to nearby job
- Only evaporation performed for remainder of 2017
  - November 2017: 6,816 feet
- No further upgrades made to system

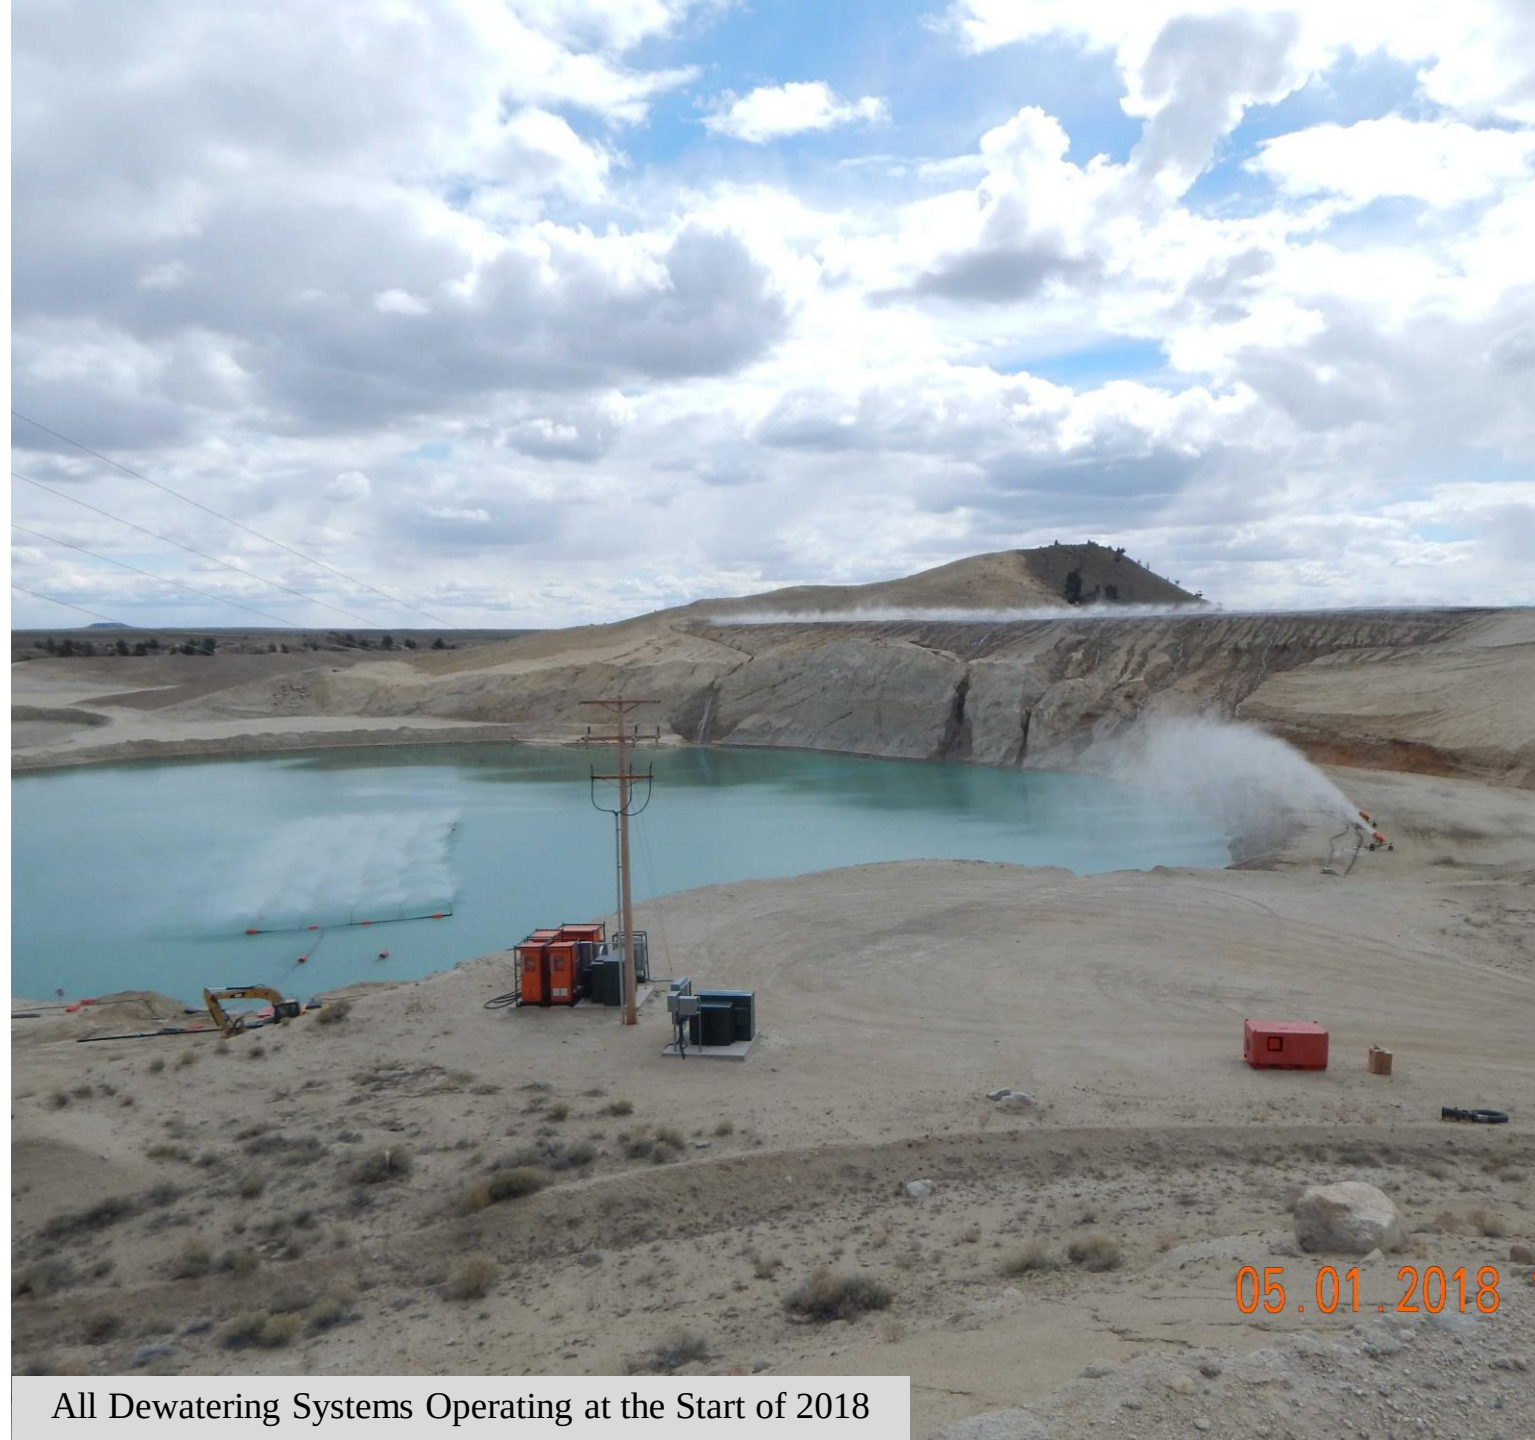
All Dewatering Systems Operating at the Start of 2018

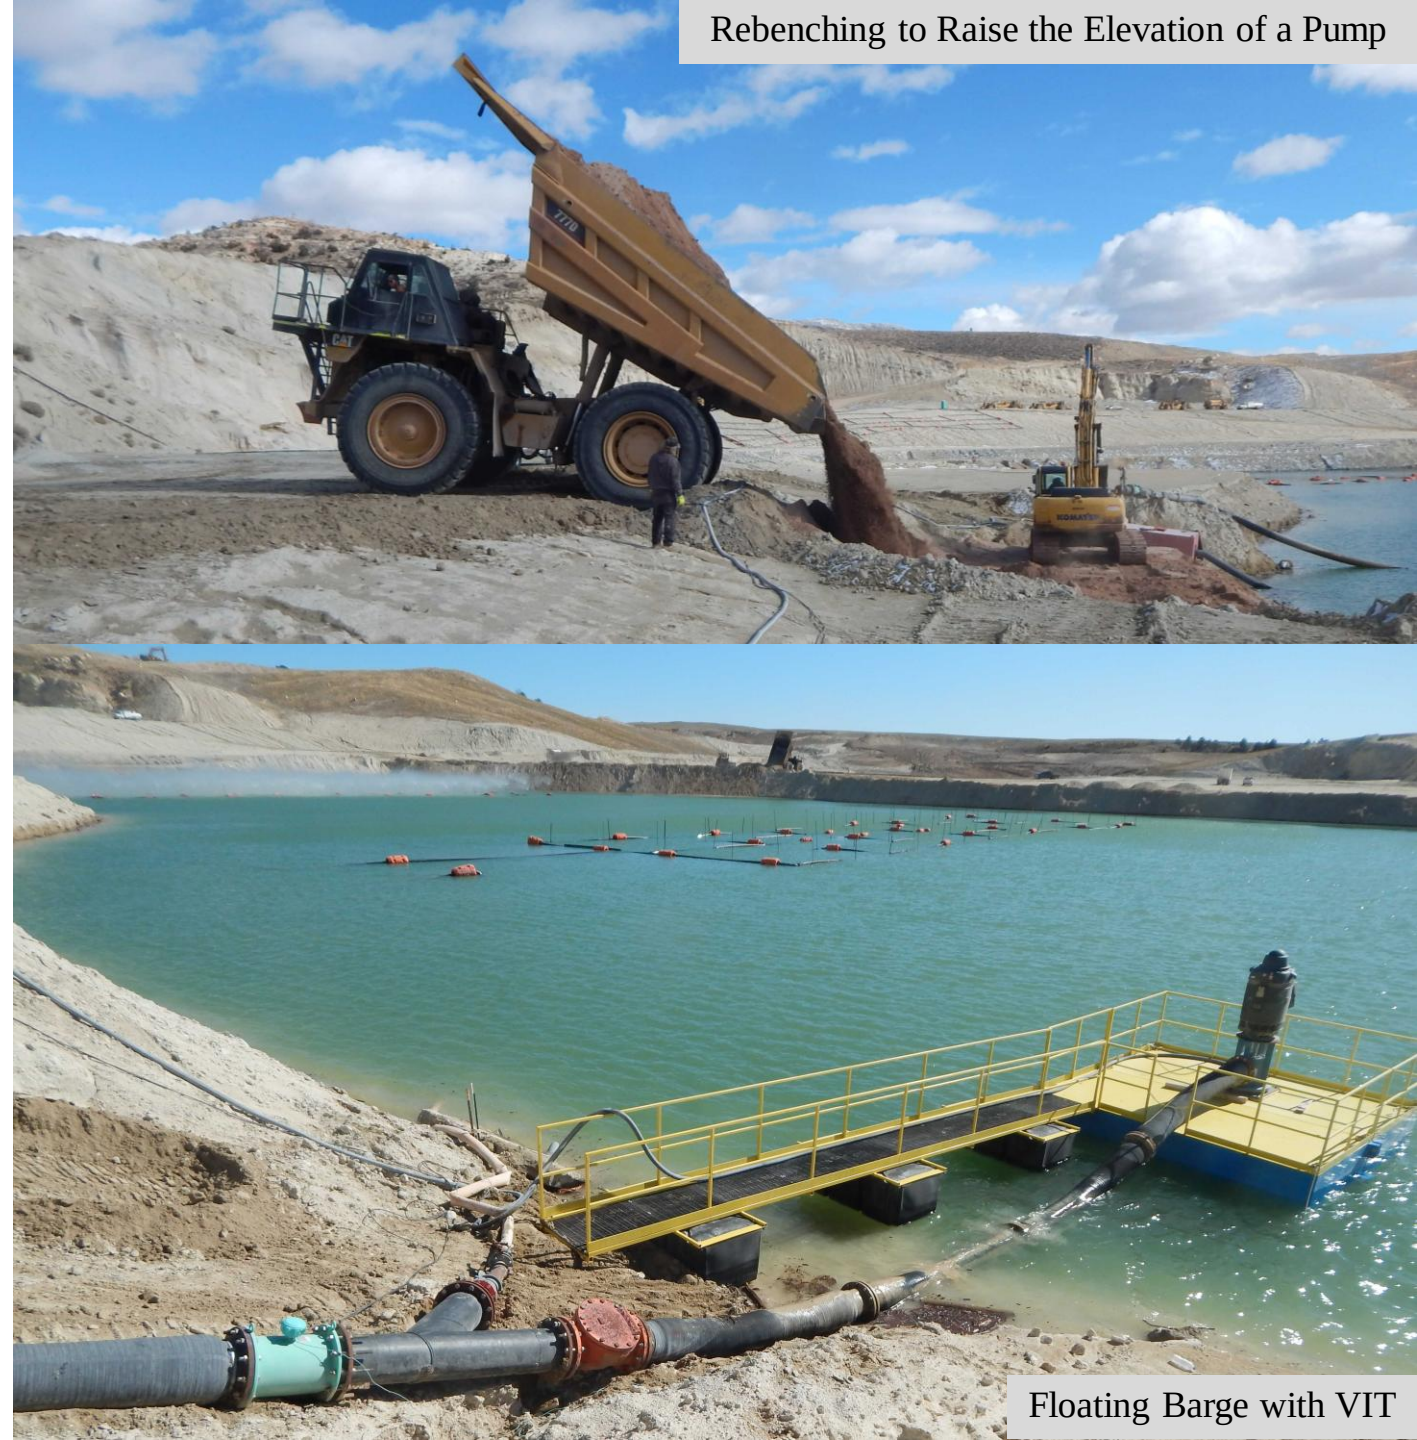
- Rising water levels necessitated raising fill around the pit
  - June 2019: 6,808 feet
  - November 2019: 6,818 feet
- August 2019 failing HL250 pump replaced with Vertical Industrial Turbine (VIT) on a floating barge
  - Higher flow of VIT pump caused flooding and erosion of Pole Cat bench
  - Water diverted away and pump rpm decreased

Rebenching to Raise the Elevation of a Pump

Floating Barge with VIT

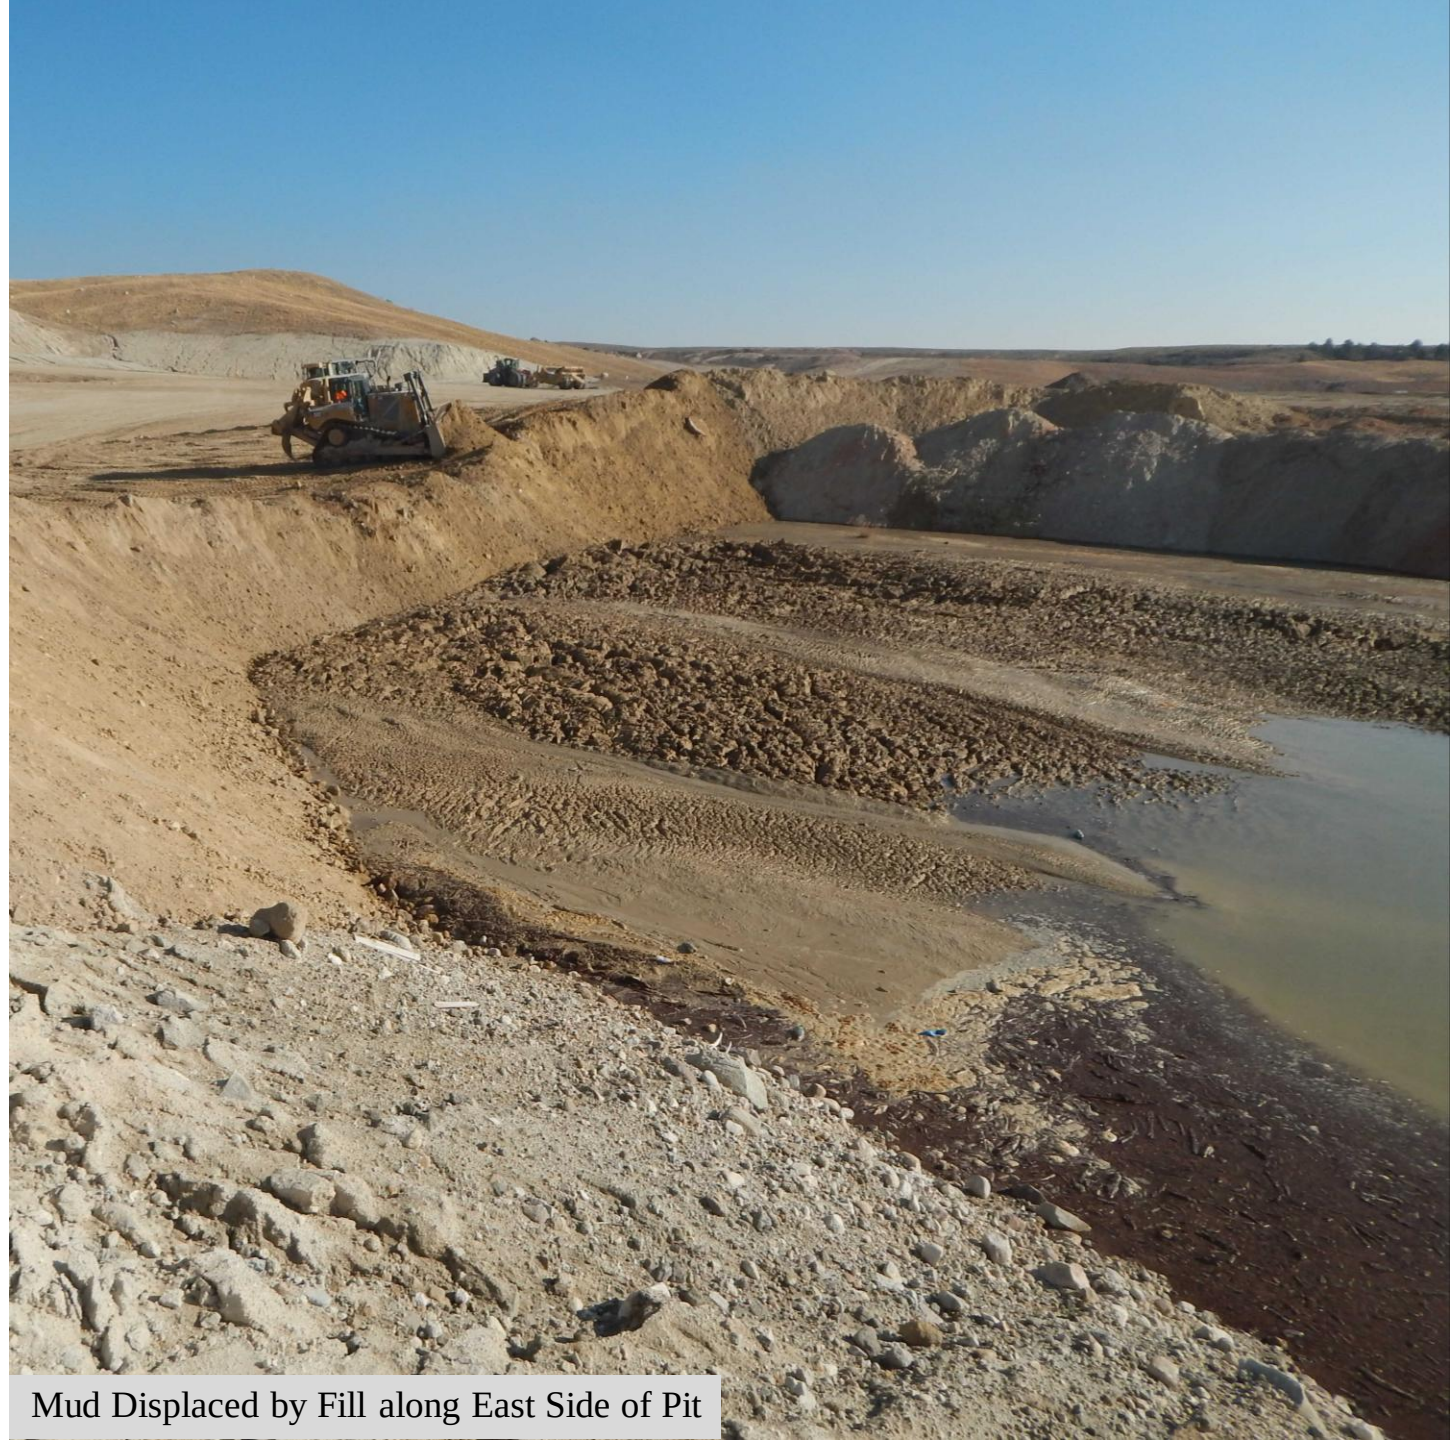
Mud Displaced by Fill along East Side of Pit

- Mud handling was conducted in Phases 5 & 6 upon completion of dewatering
- Phase 5 removed 15,000 CY mud and spread it for drying with the remainder being encapsulated in fill
- Mud left to dry at end of Phase 5 was still saturated at the beginning of Phase 6
- Excavated spoils were mixed with mud to dry it for compaction and stabilization
- Total Mud Handling Cost \$74,882.50

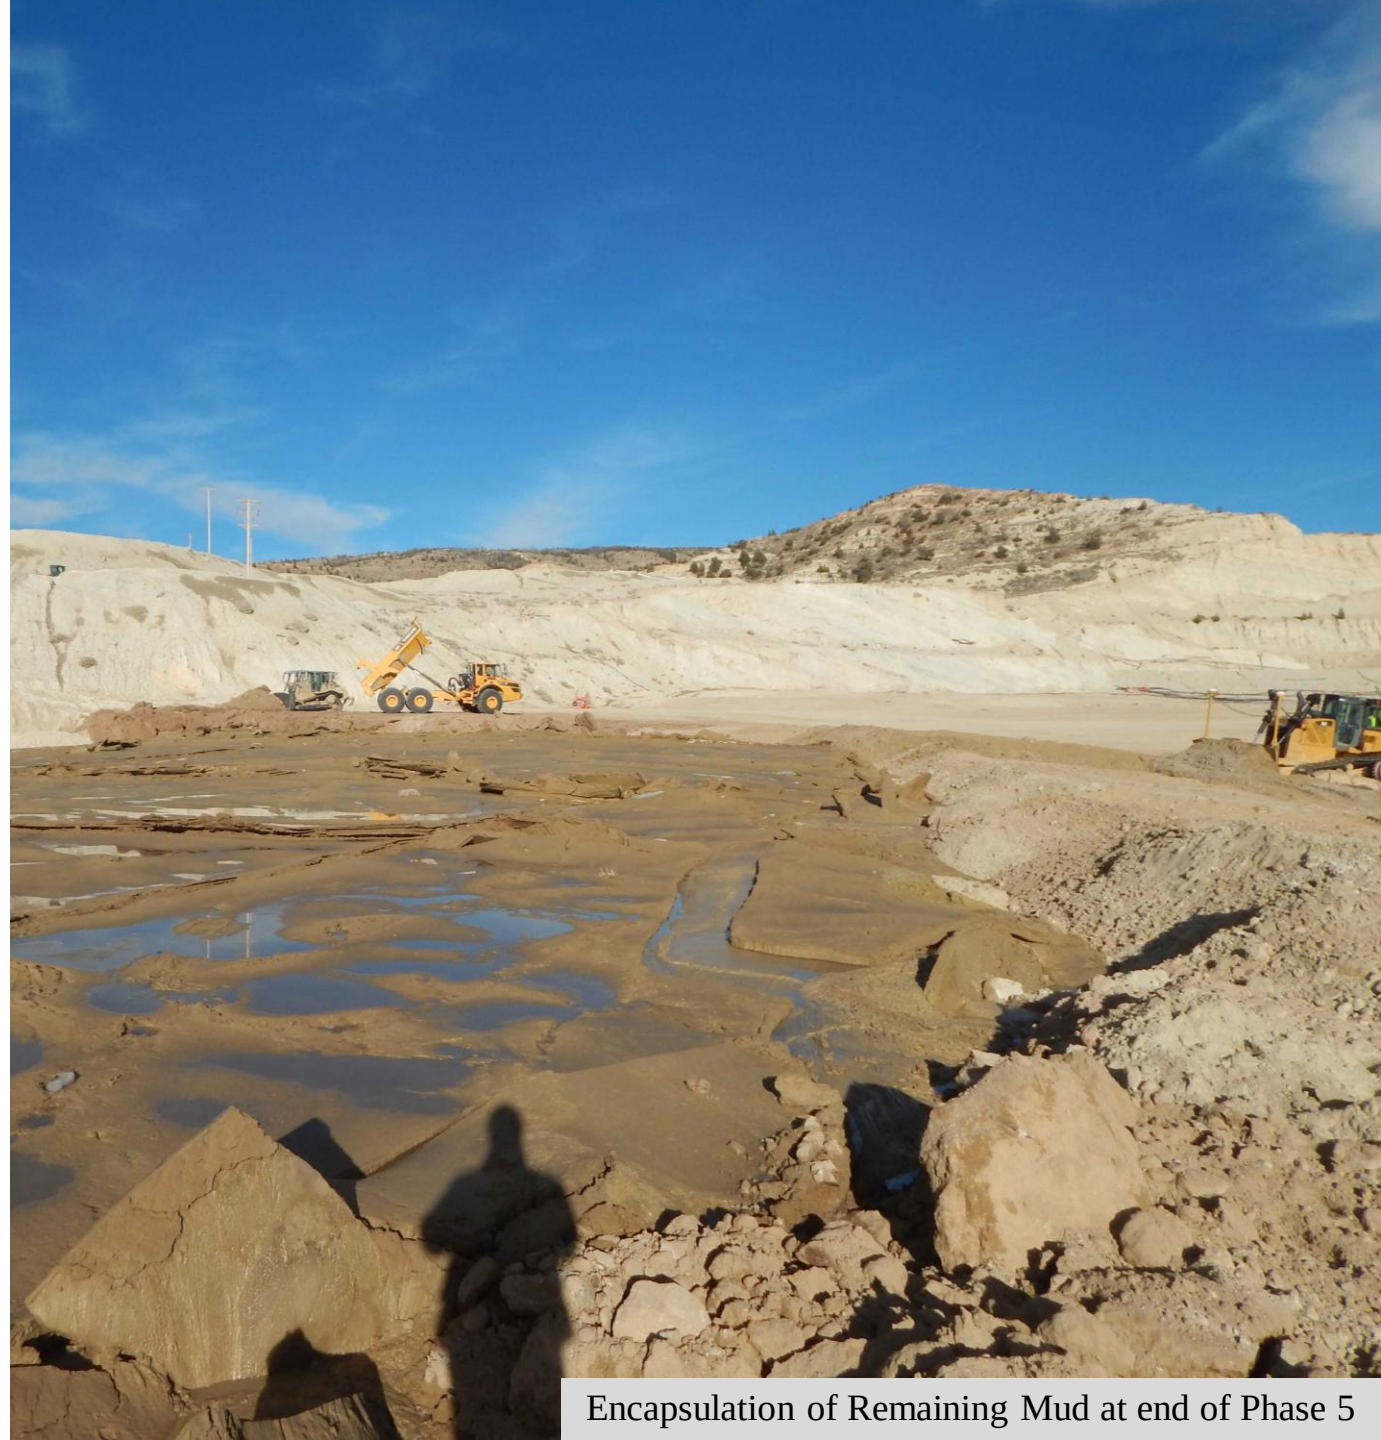
Encapsulation of Remaining Mud at end of Phase 5

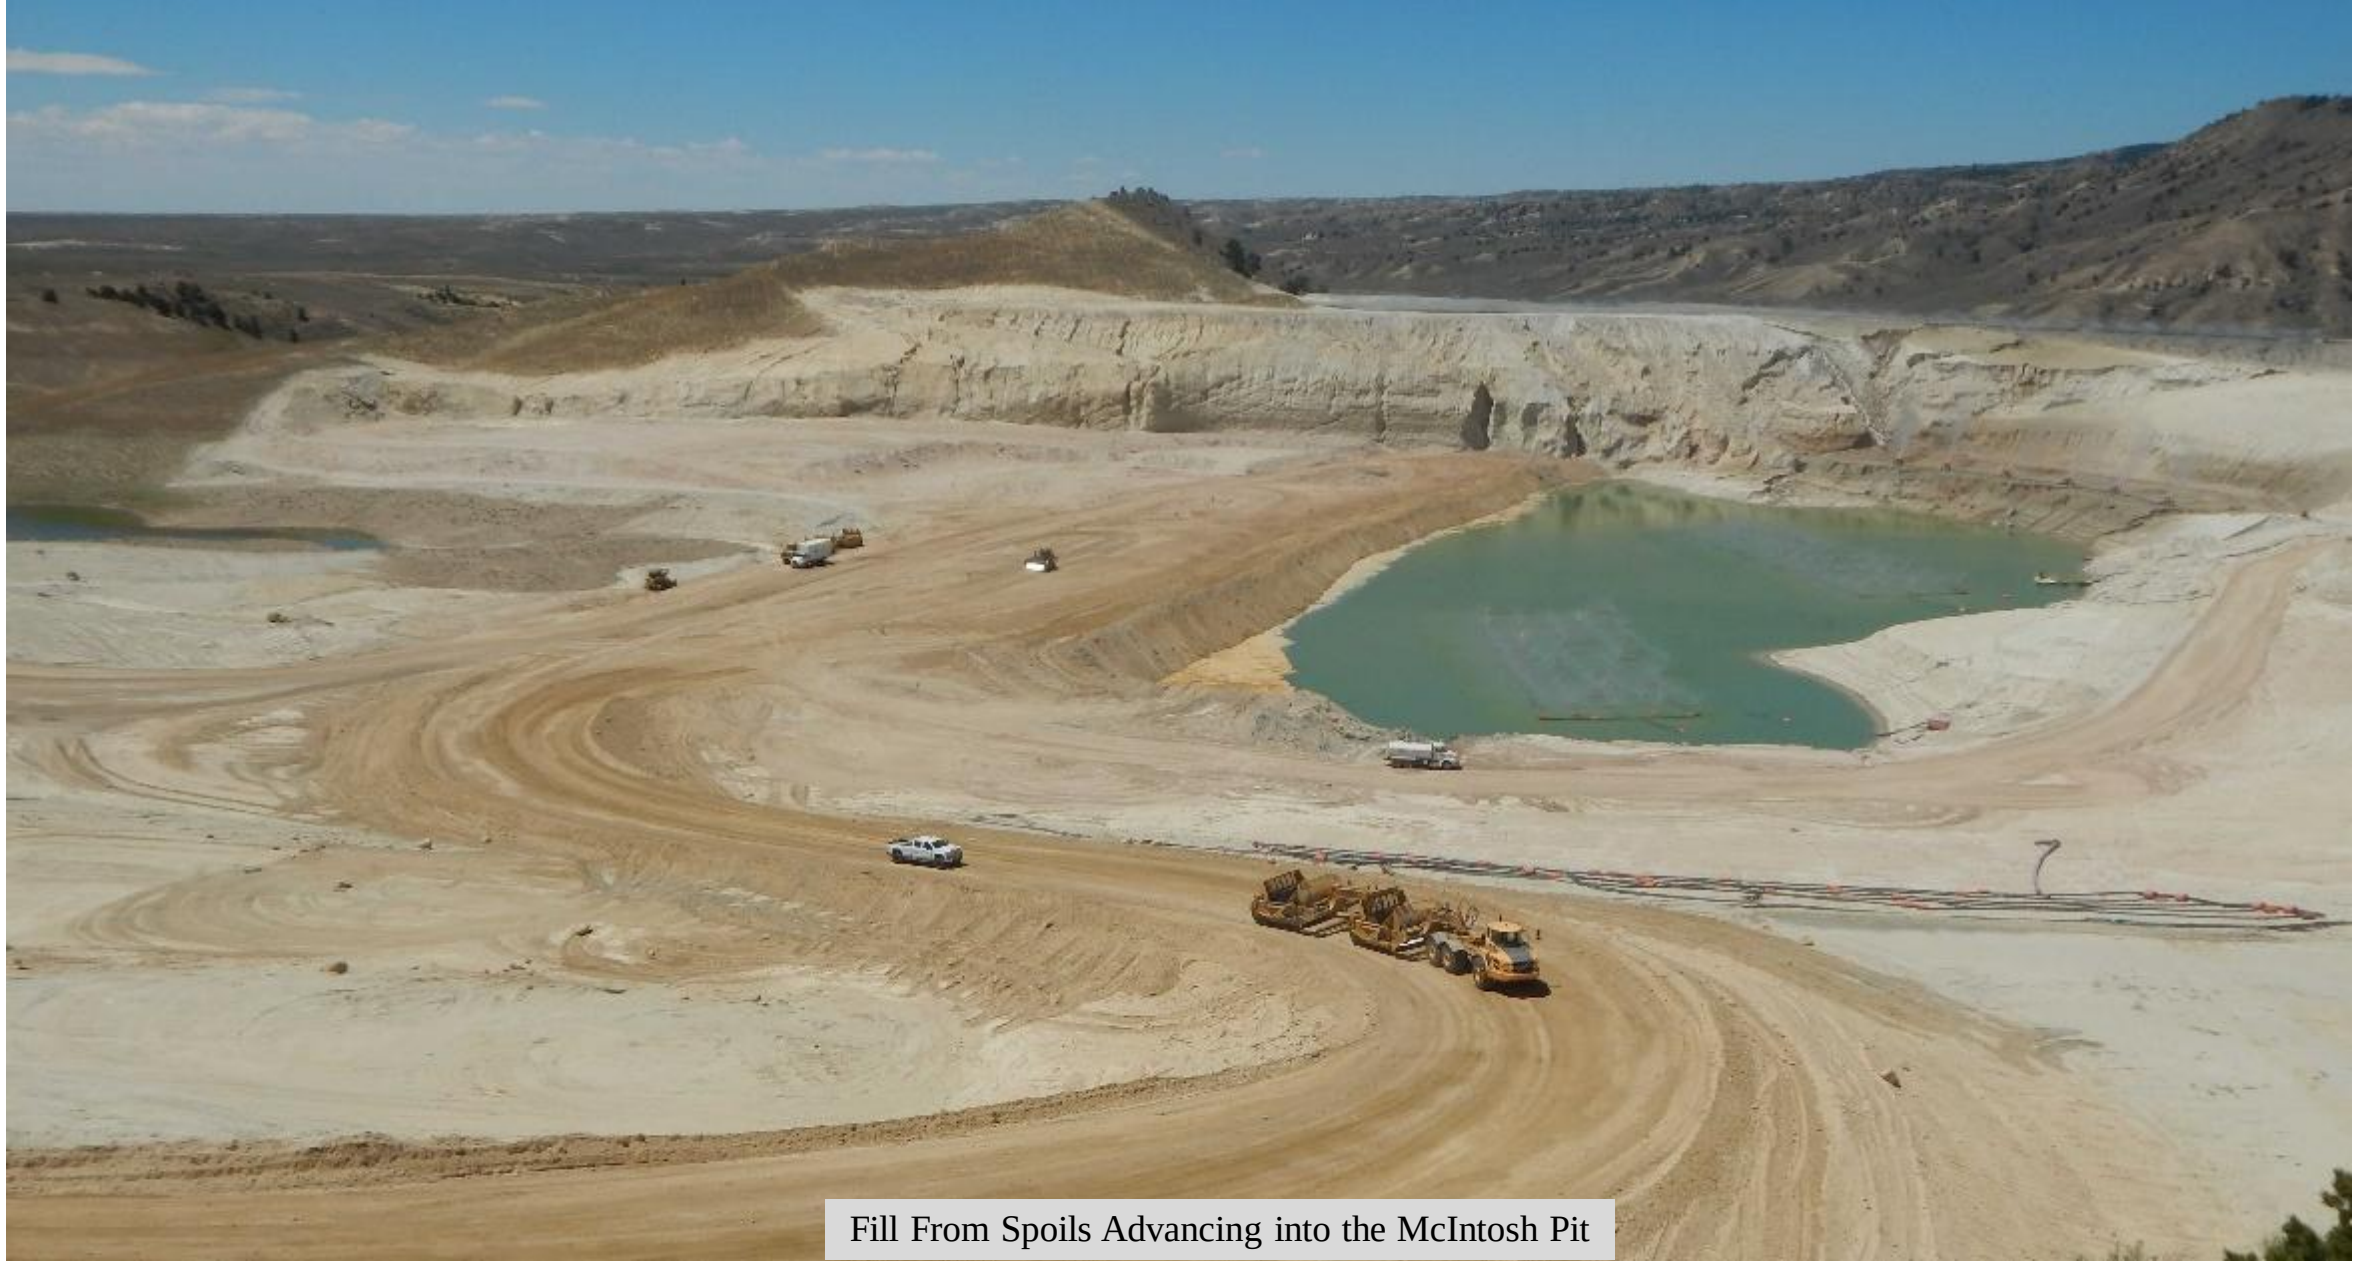
Fill From Spoils Advancing into the McIntosh Pit

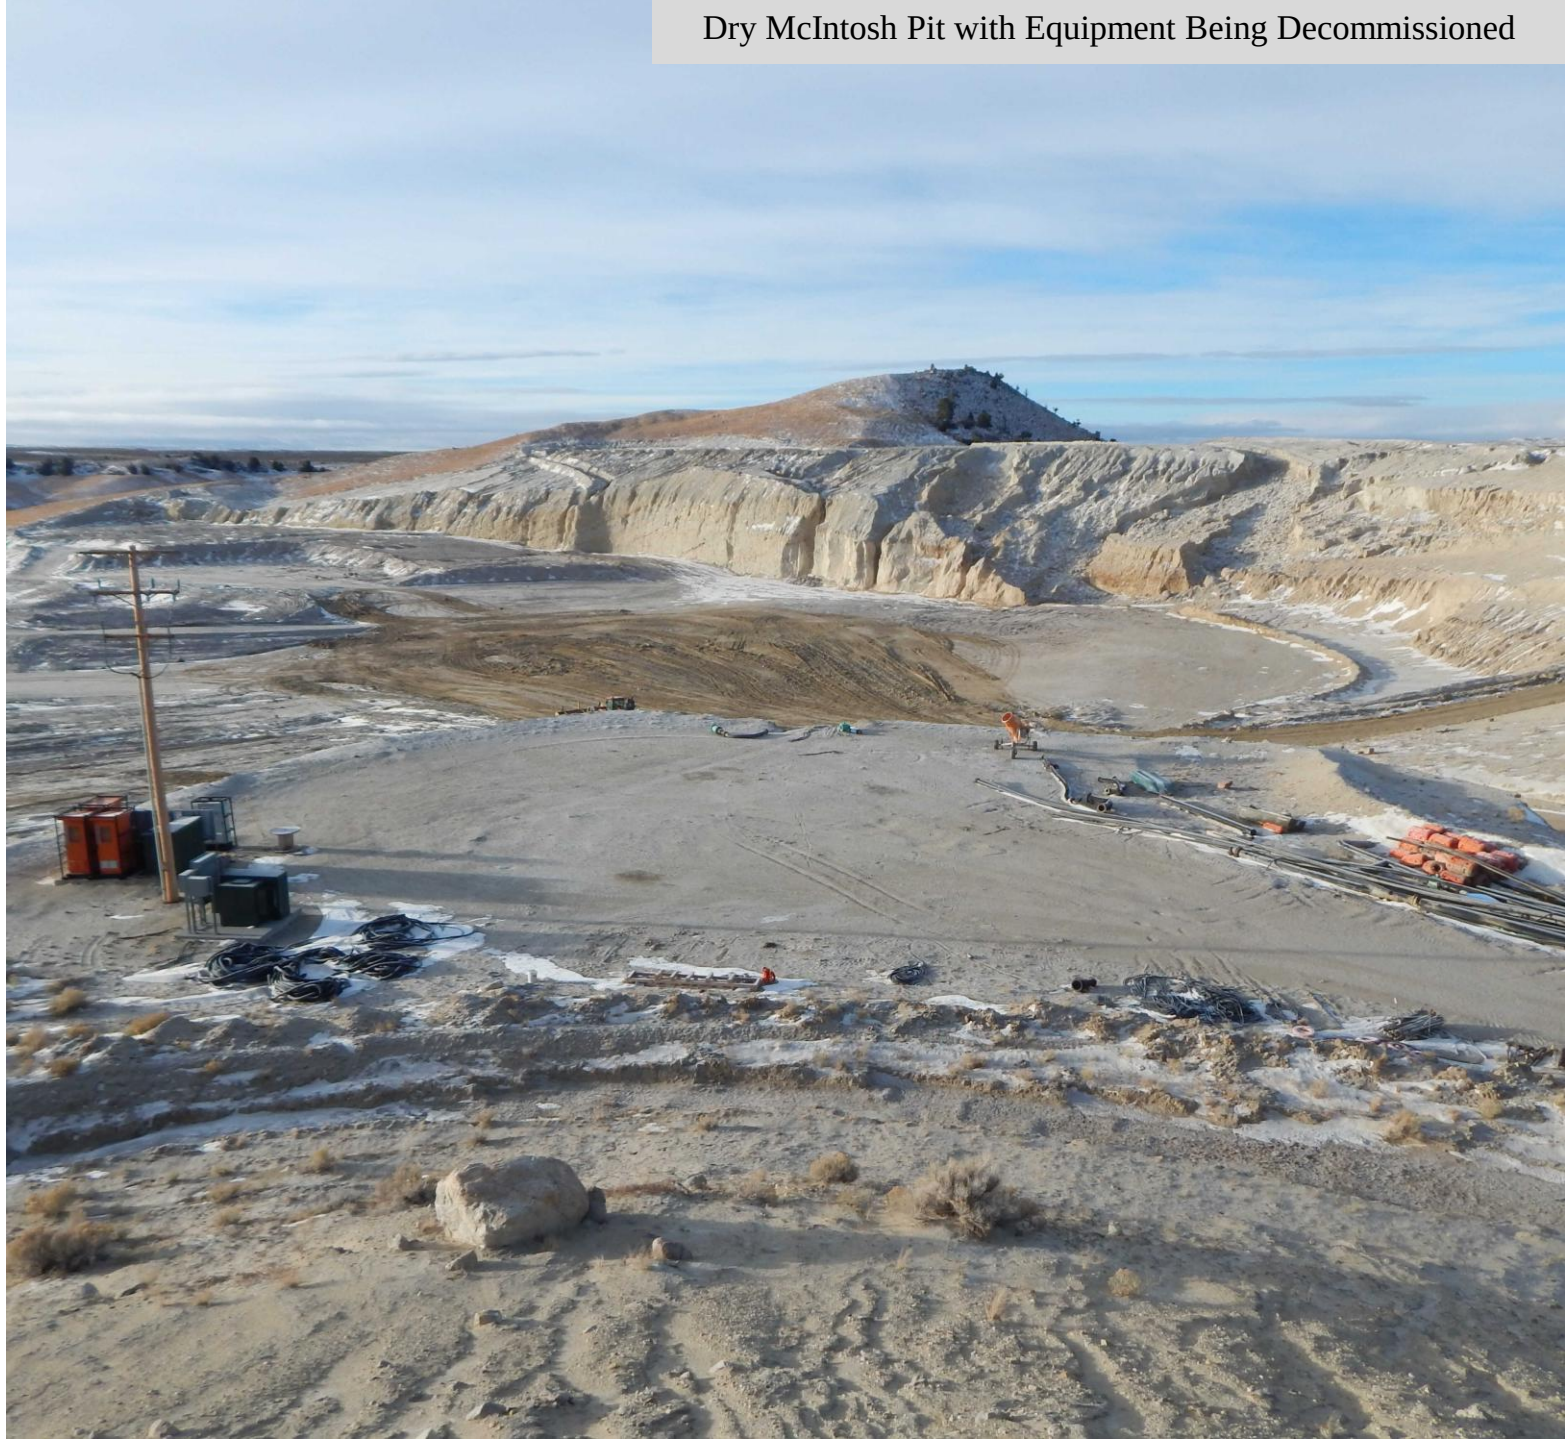
Dry McIntosh Pit with Equipment Being Decommissioned

- Reusable equipment and materials removed from site for resale
- Non-reusable materials disassembled and properly disposed
- Decommissioning completed in 2022

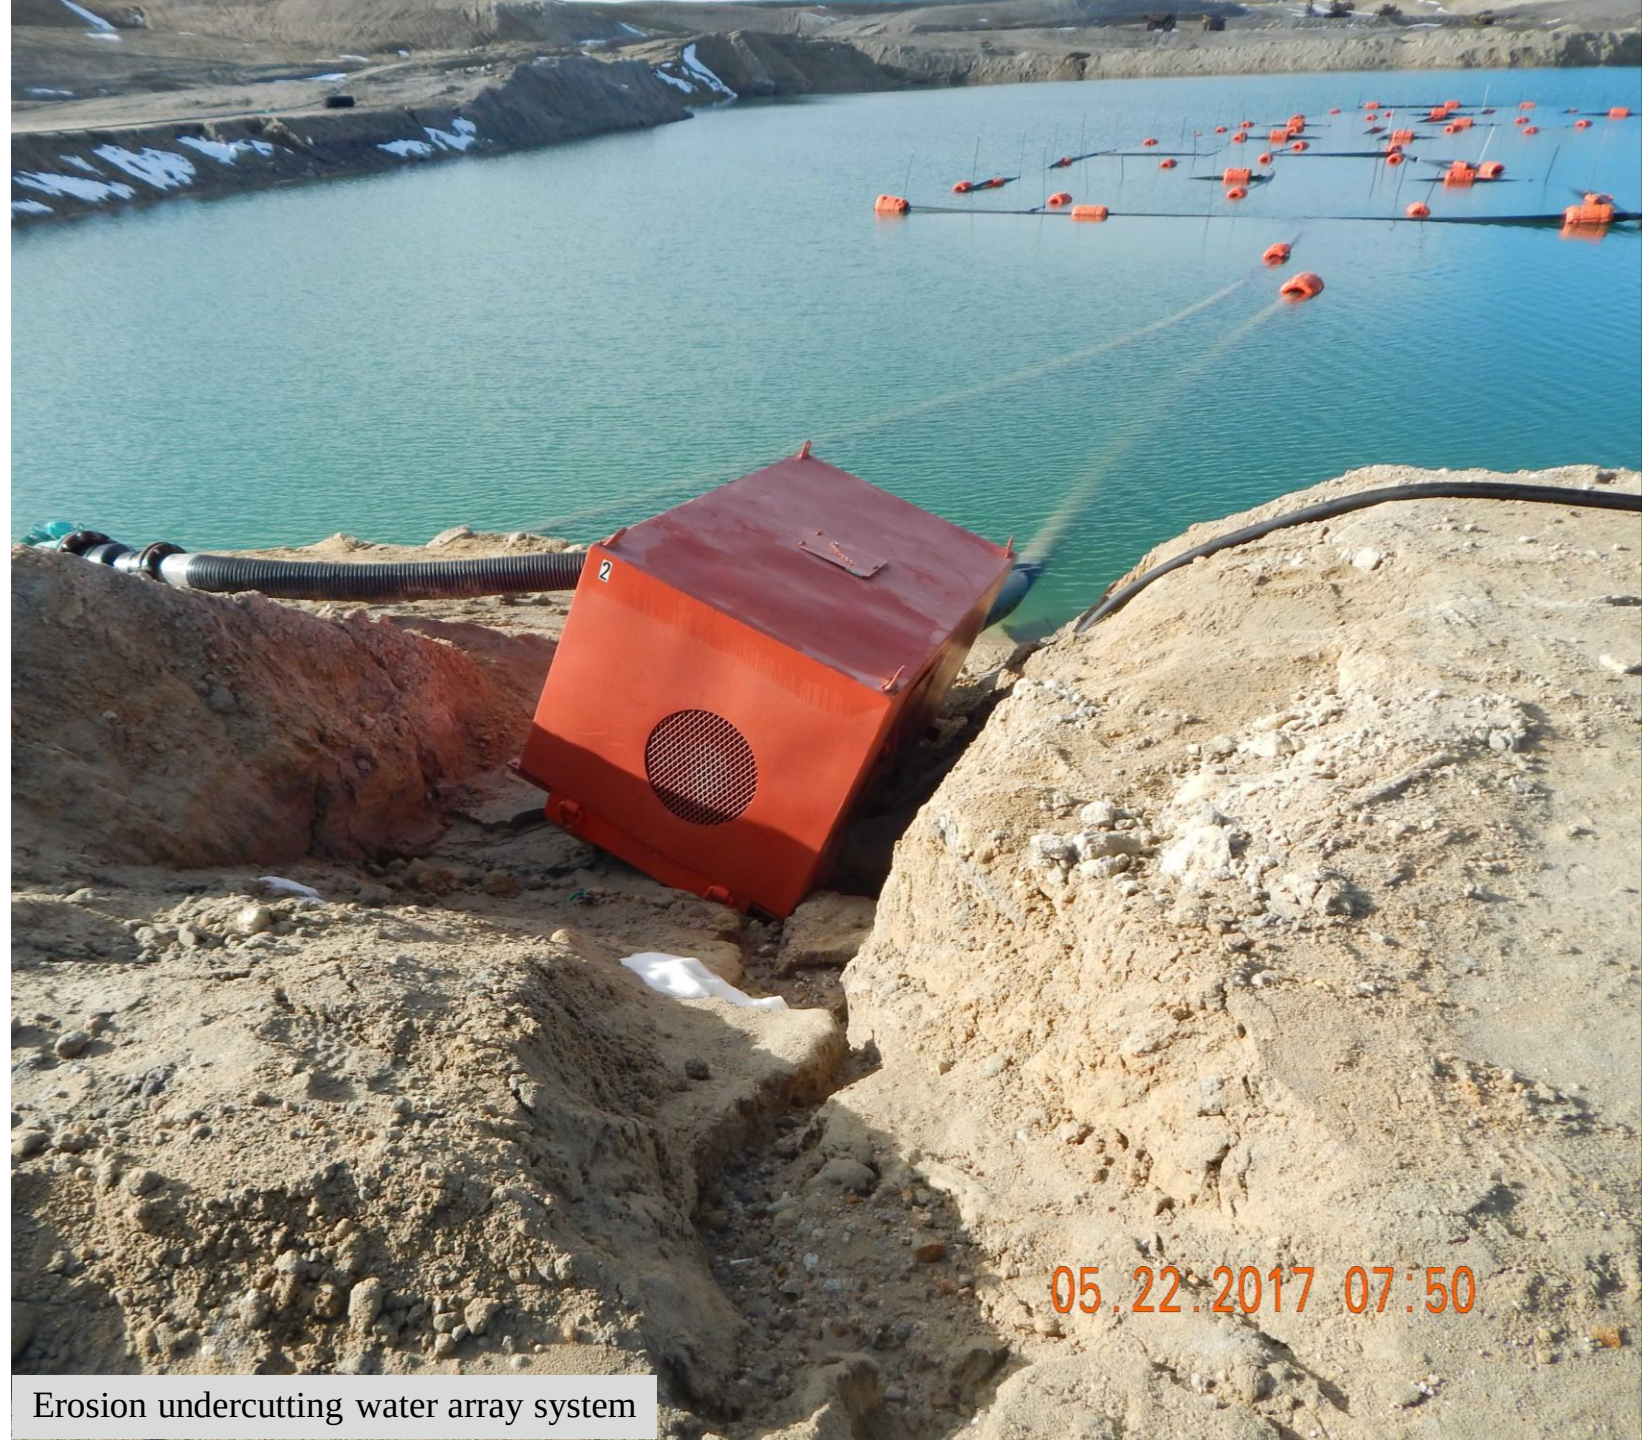
Erosion undercutting water array system

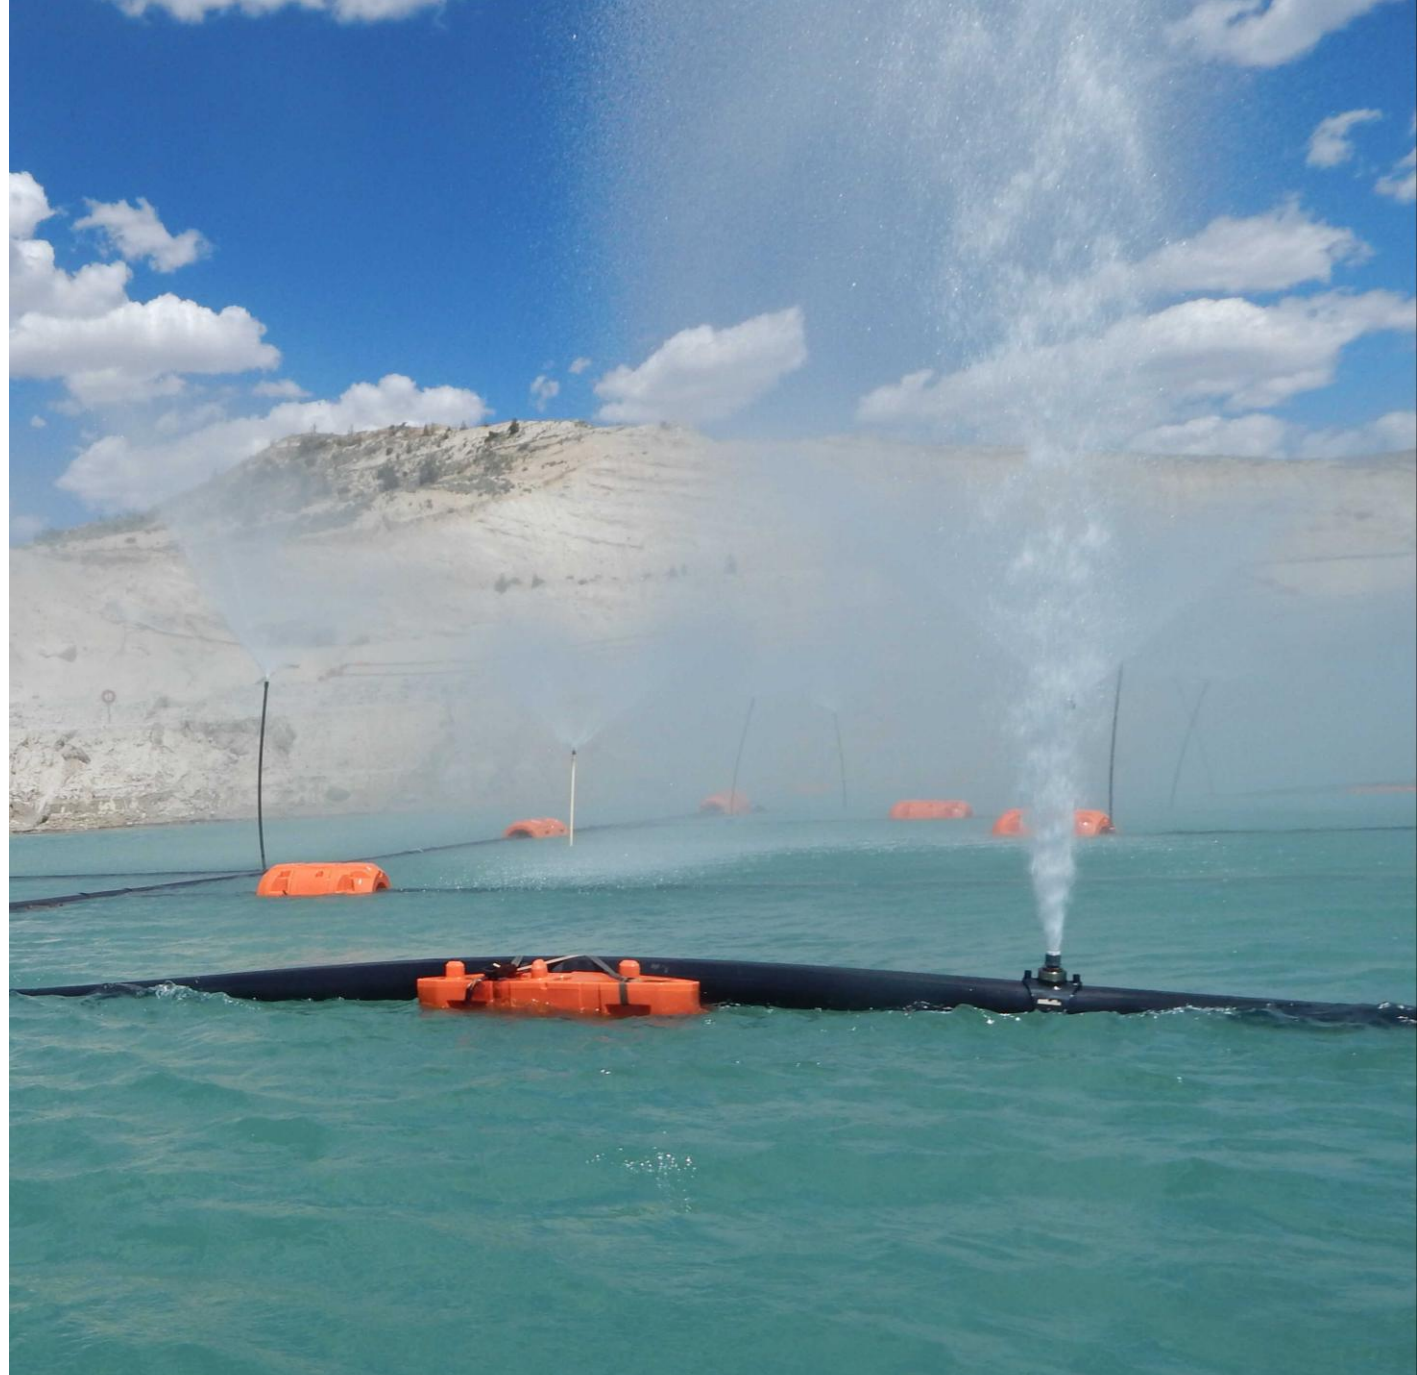
Water Array Phase 4

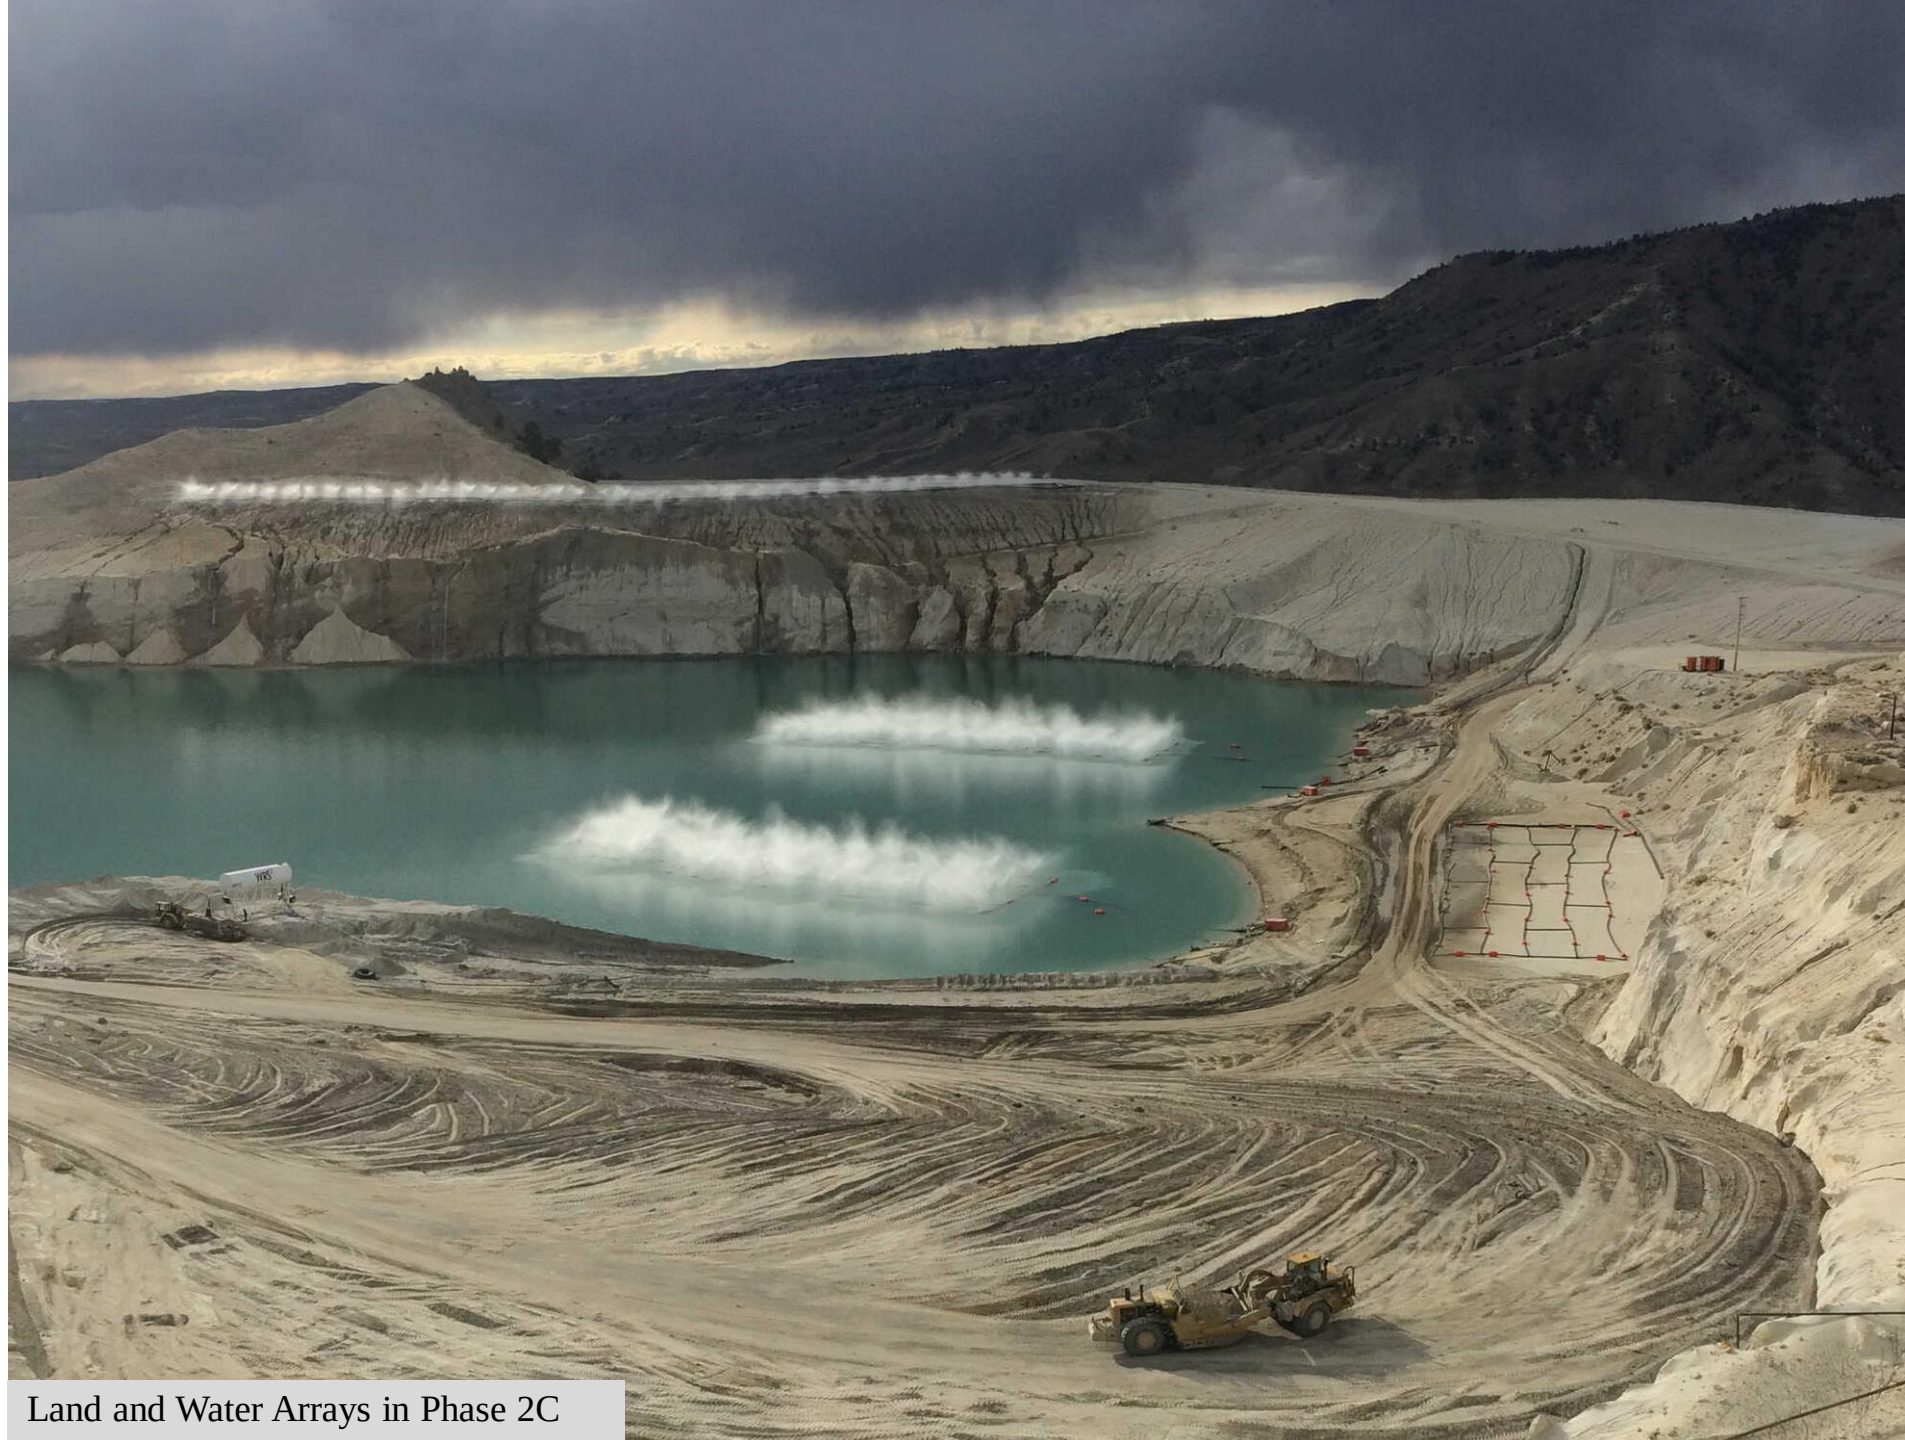
Land and Water Arrays in Phase 2C
