# AML PROJECT 160 – McINTOSH PIT EVAPORATIVE DEWATERING & BACKFILL

## ASRS Laramie 2026

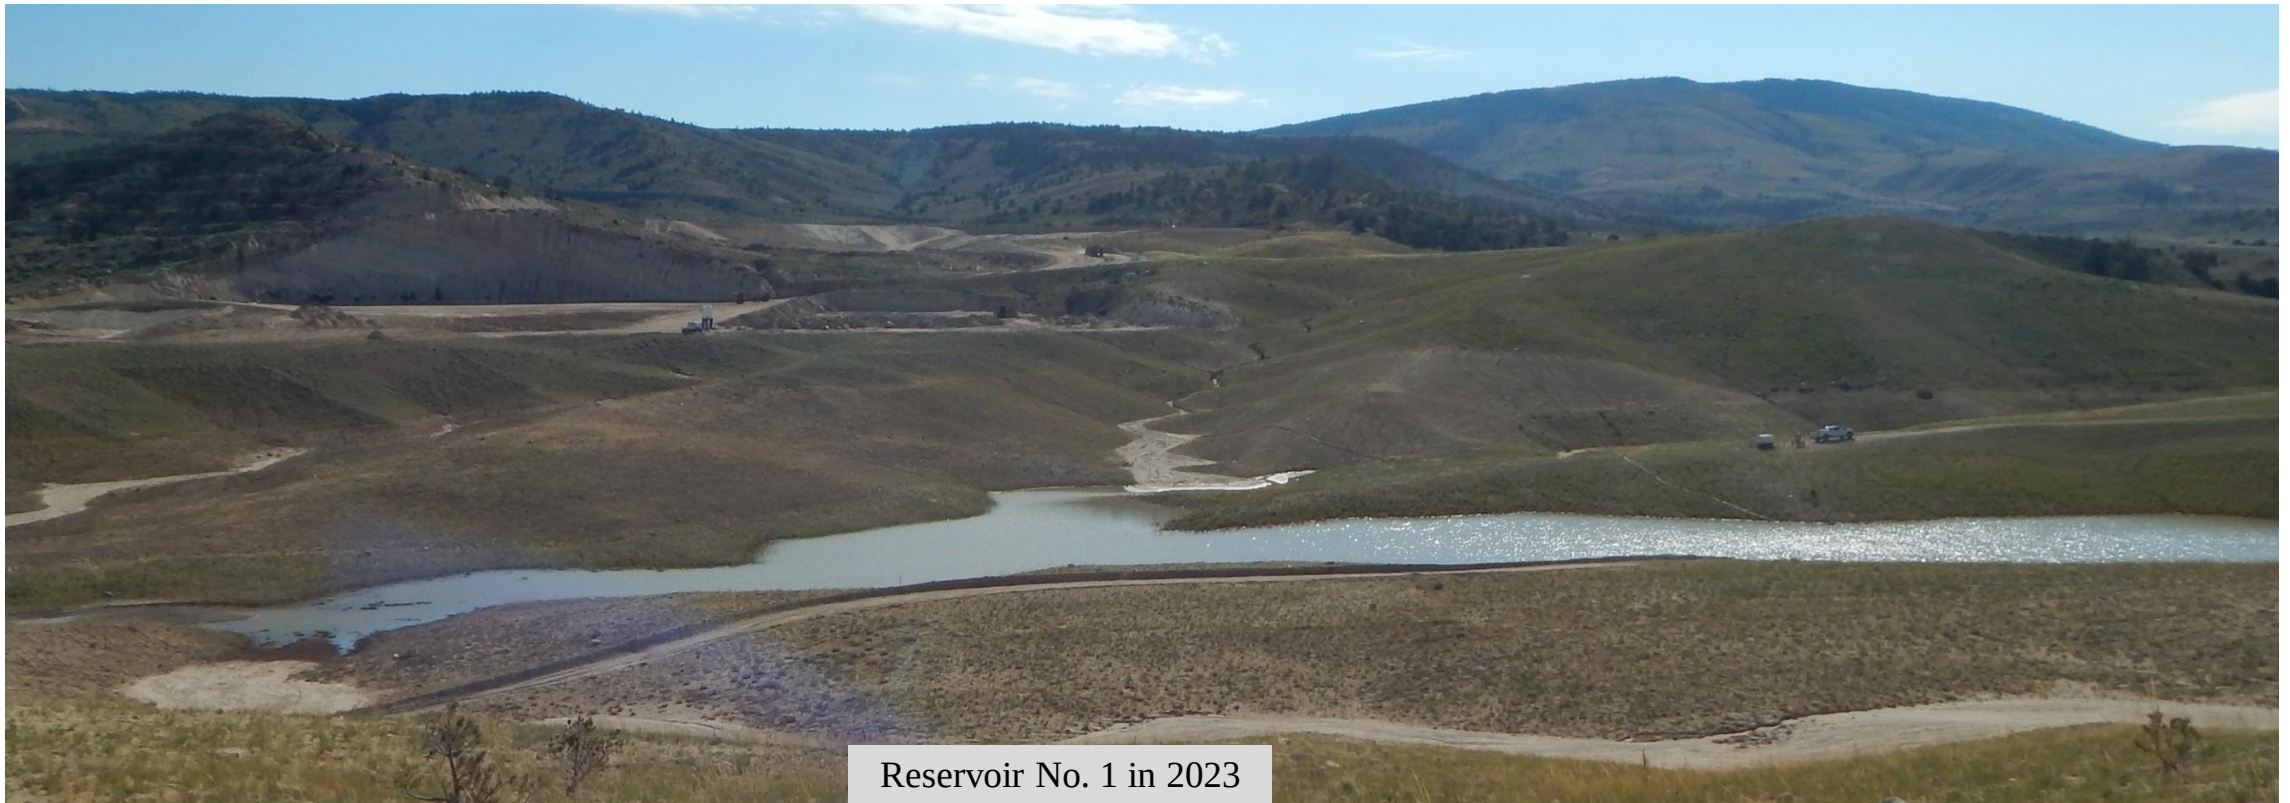
# Final McIntosh Pit condition => Reservoir No. 1

- Clean surface water impoundment constructed in pit fill during Phases 4 & 5
- Backfill of pit created an artificial aquifer
- Productive water well drilled into backfill 2020 in south and 2024 into the artificial aquifer
- Water Monitoring concluded by AML in 2025
