# ASRS 2026

## McIntosh Habitat Enhancements

**AML PROJECT 160**  
**June, 2026**

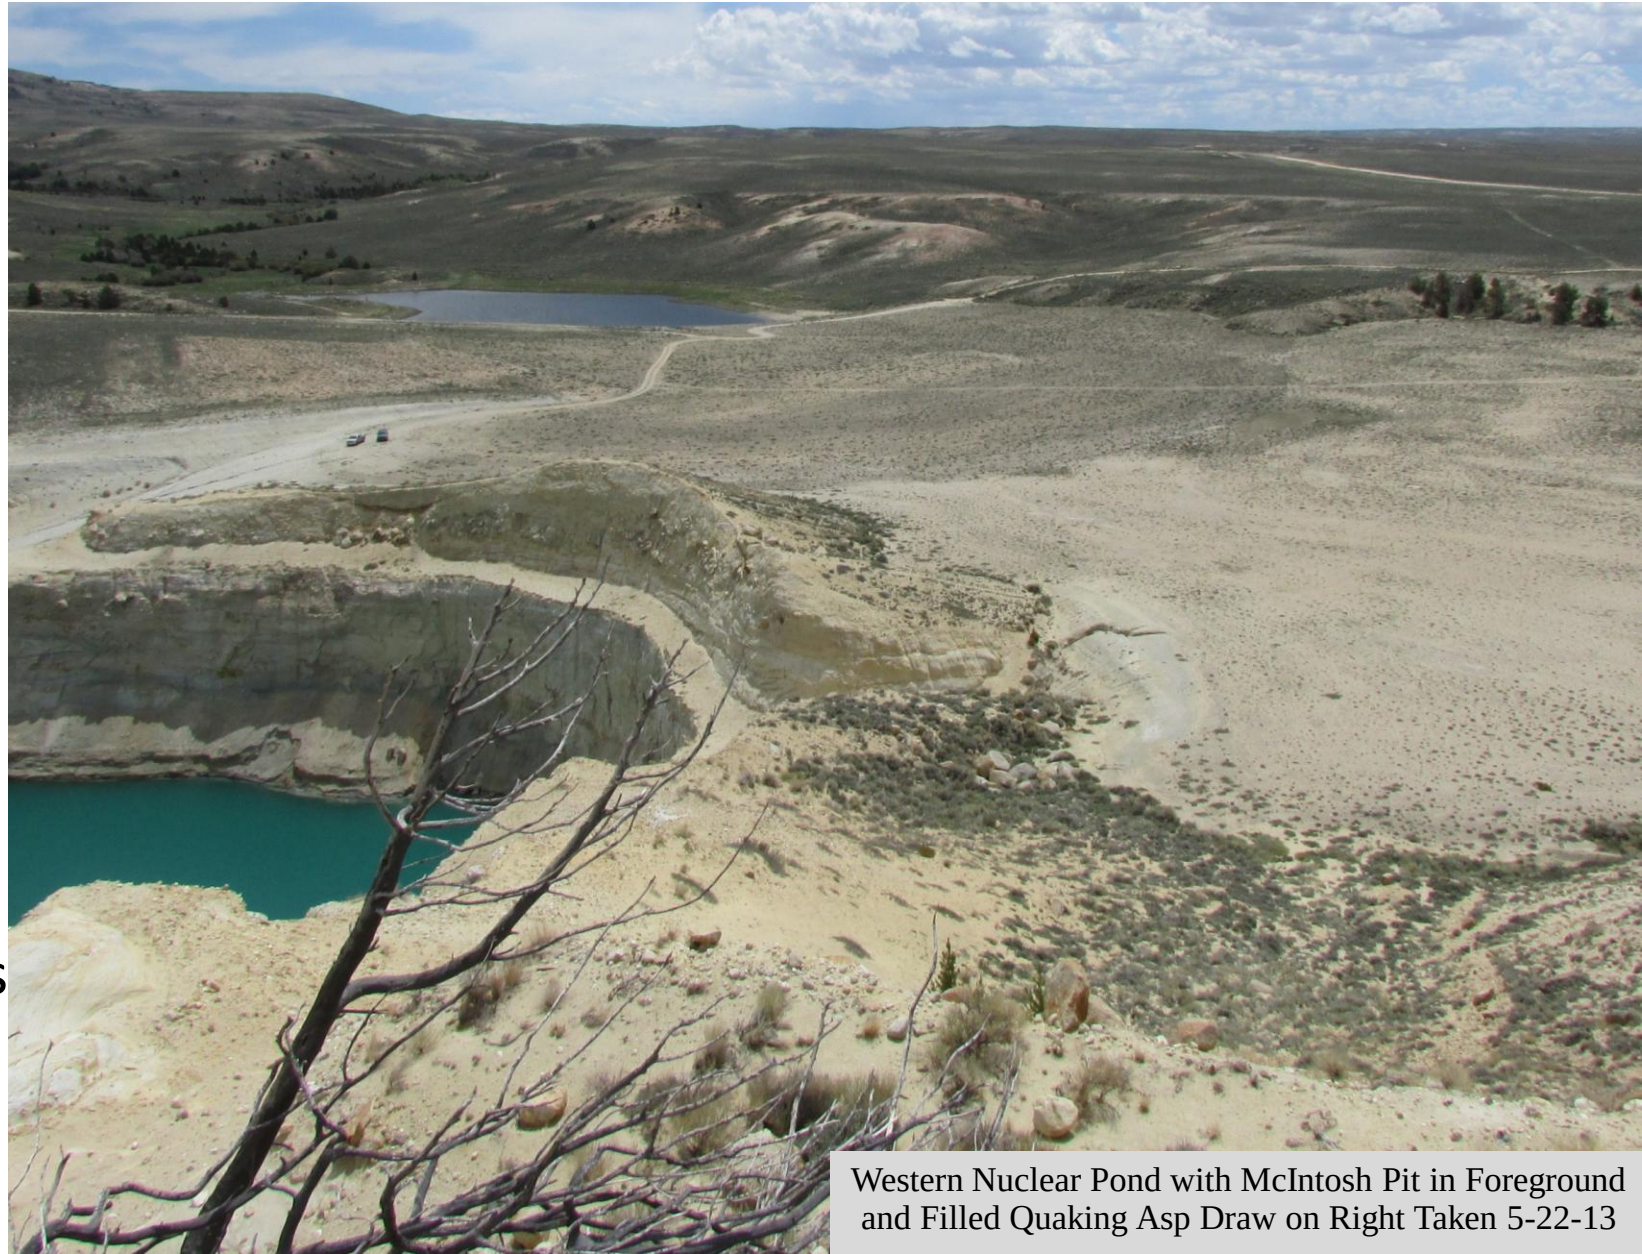
Western Nuclear Pond with McIntosh Pit in Foreground and Filled Quaking Asp Draw on Right Taken 5-22-13

- Mining activities filled Quaking Asp draw with spoils (South Spoils) creating an impoundment
- Pond known locally as Western Nuclear Pond
- Wyoming Game and Fish stocked pond with trout and smallmouth bass
- Seepage from pond was high as impoundment material was sandy mine spoils

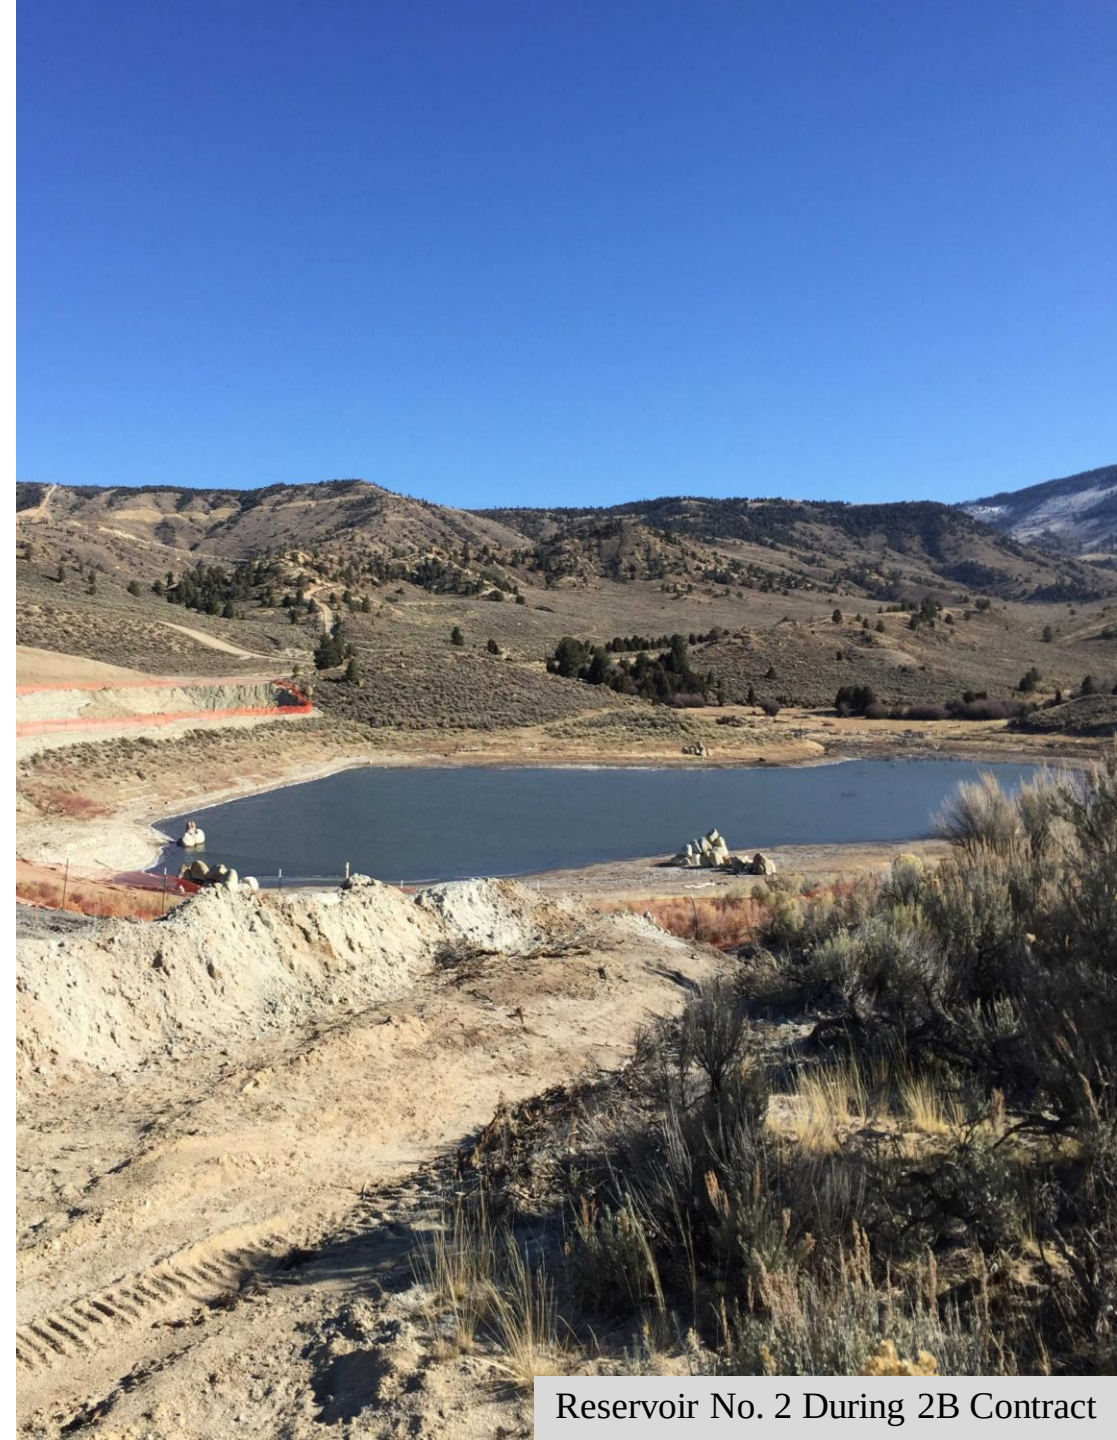
Reservoir No. 2 During 2B Contract

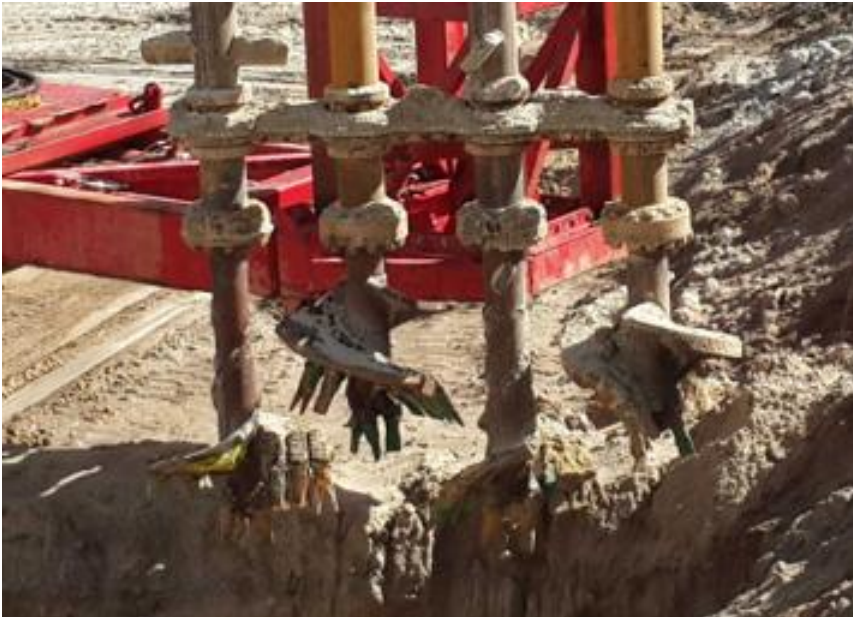
- Deep Soil Mixing (DSM)
  - Low permeability barrier
  - Cement & bentonite mixed with sandy spoils
  - Keyed into the underlying sedimentary bedrock
  - Overlapping design

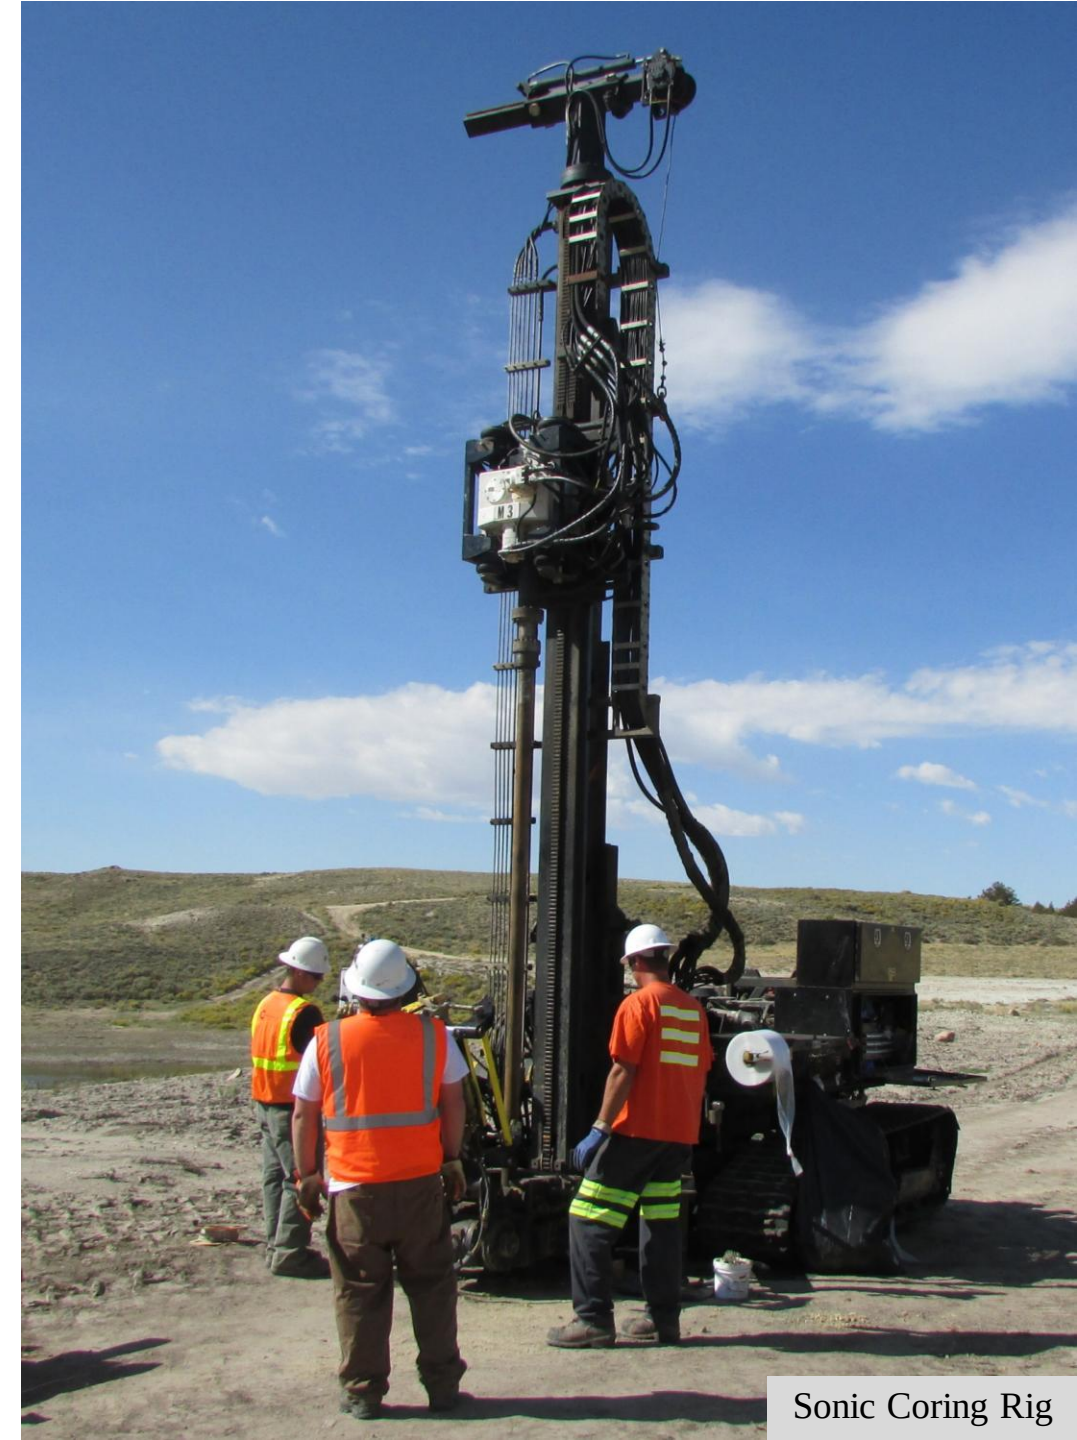
Sonic Coring Rig

- Sonic coring
  - Characterize existing impoundment material
  - Samples taken to bedrock
  - Composites created for use in testing
- Designed mixes tested before contract NTP was issued

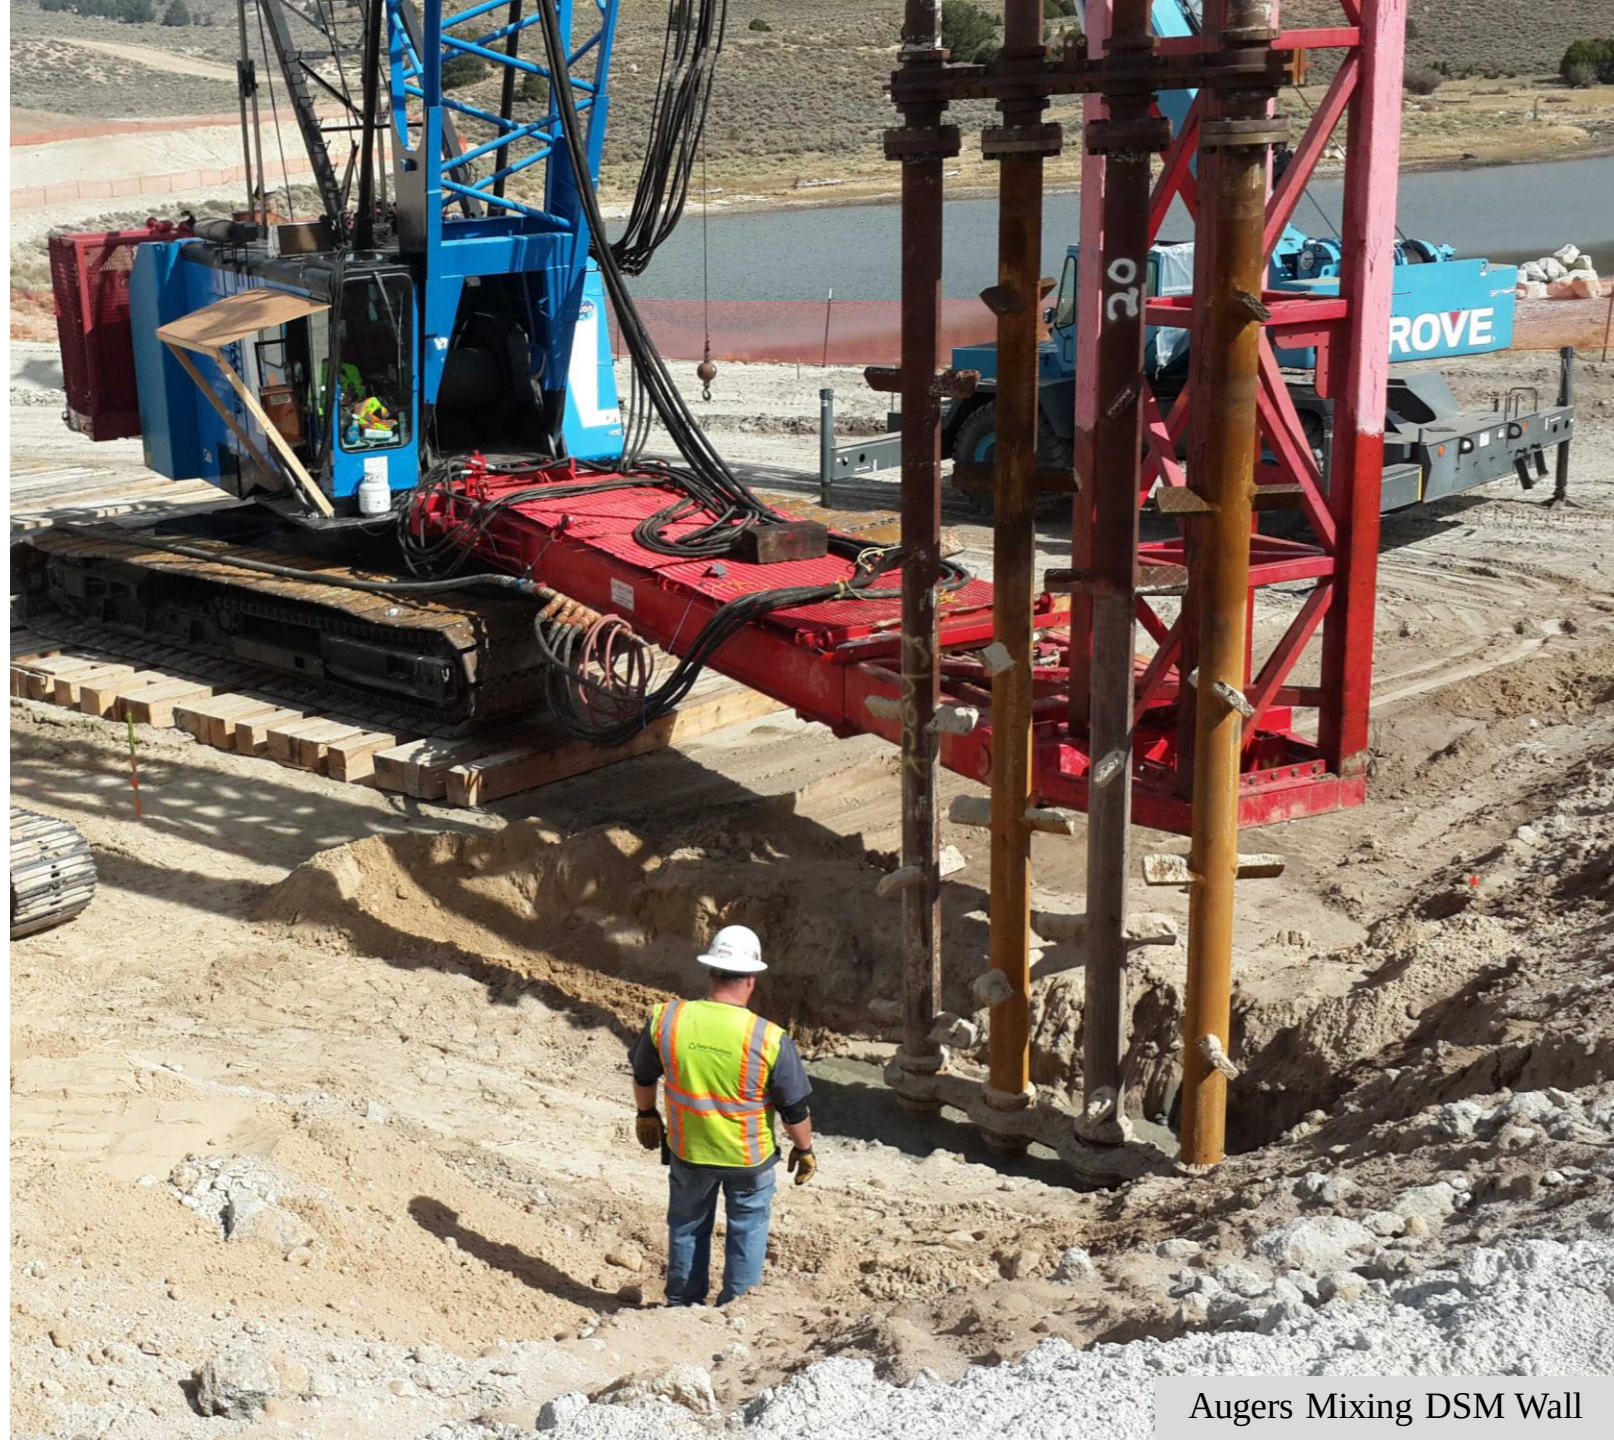
Augers Mixing DSM Wall

- NTP for August 31, 2015
- Contractor was Geo-Solutions Inc.
- Certificate of Substantial Completion issued January 13, 2016
- Total cost: \$959,385.89

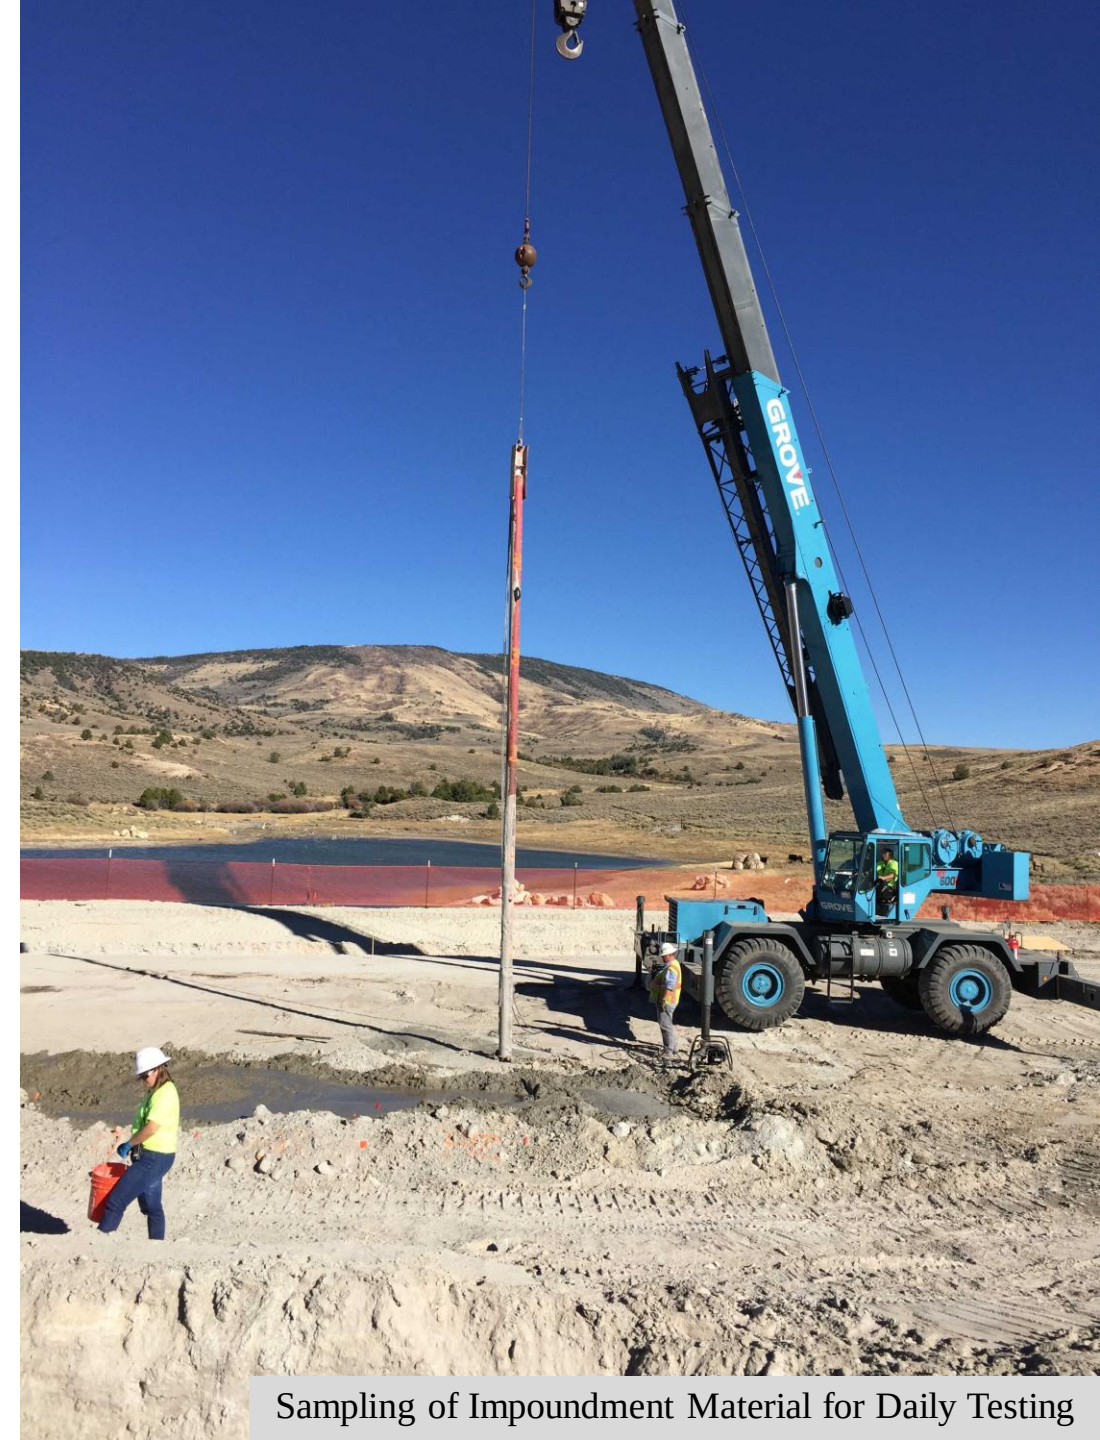
Sampling of Impoundment Material for Daily Testing

- Cement bentonite grout tested daily during construction
- Tested for unit weight, temperature, and flow
  - API RP13B unit weight test
  - ASTM C1064 temperature test
  - ASTM C230 and C1437 flow tests
- Cylinders also made from samples for lab testing for unconfined compressive strength and hydraulic conductivity

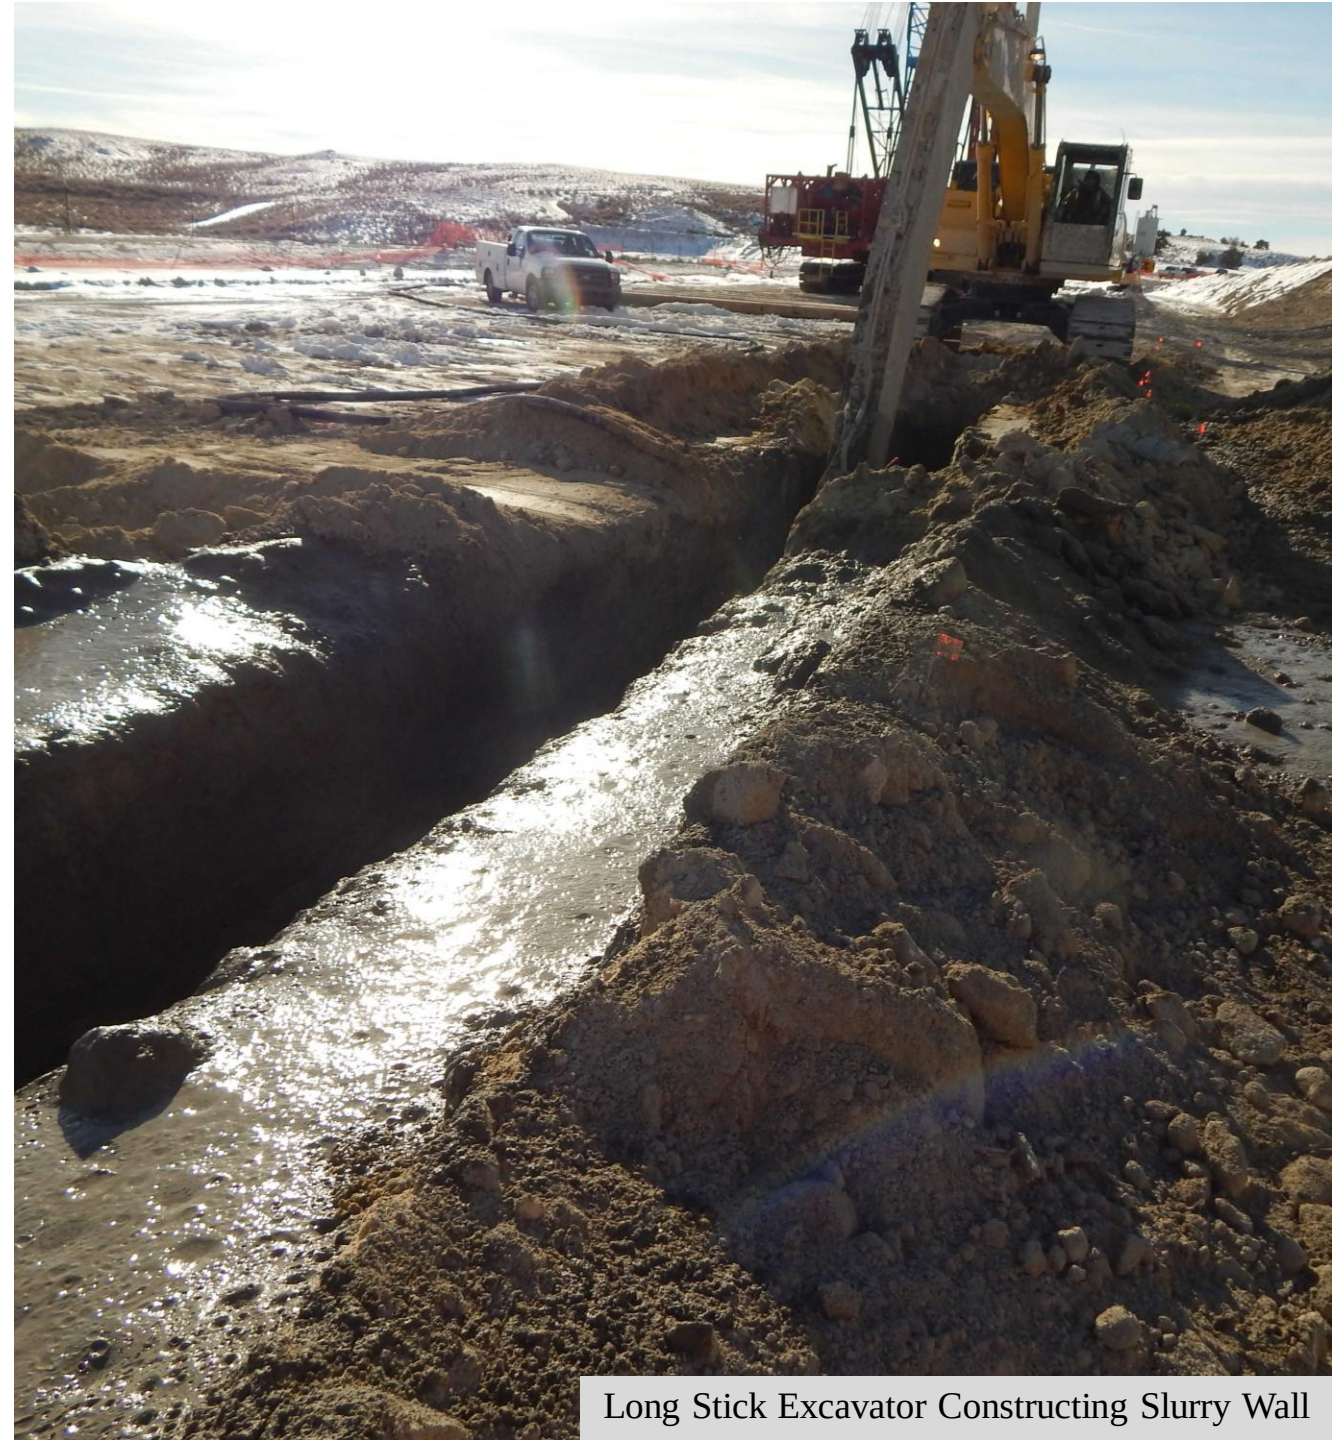
Long Stick Excavator Constructing Slurry Wall

- When contractor reached final 100 feet of wall cold weather was freezing grout lines on the auger
- Contractor proposed to construct slurry wall for final 100 feet
- Contractor dug a trench, mixed grout-bentonite slurry with sandy mine spoils in trench using long stick excavator

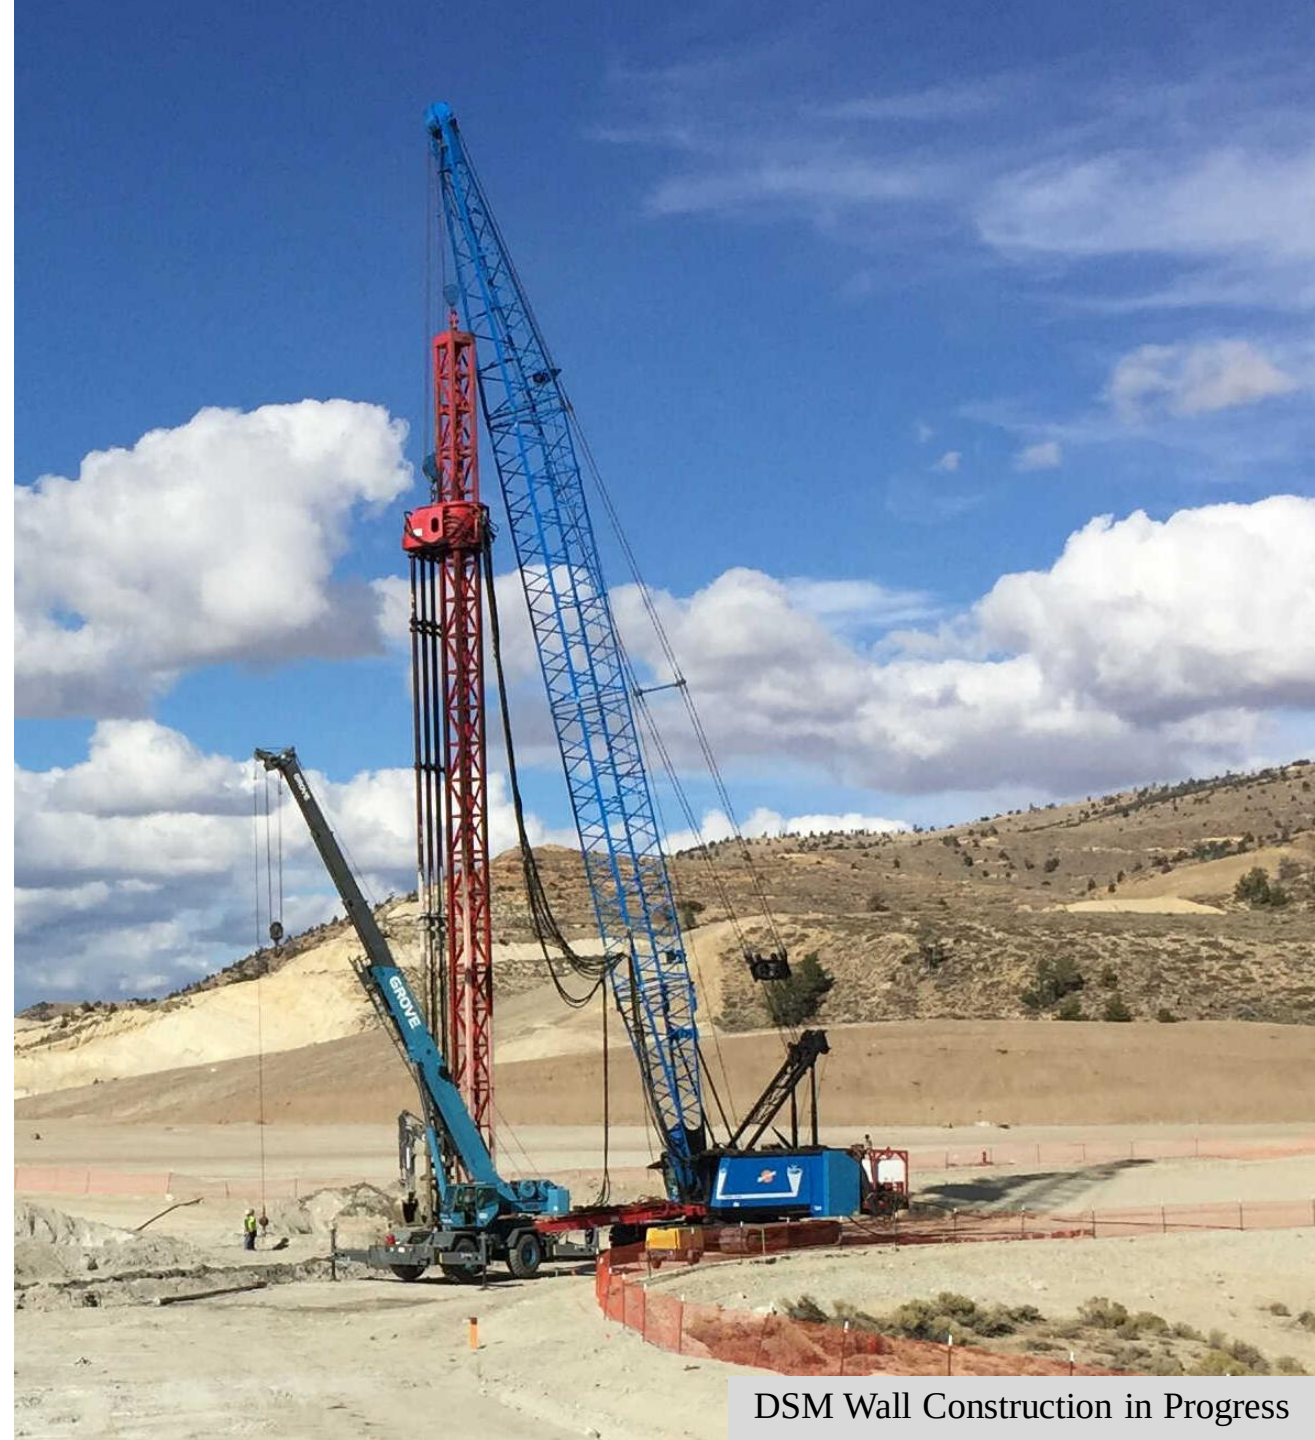
DSM Wall Construction in Progress

- DSM wall was designed to be keyed in to native sandstone below the mine spoils
- DSM wall did not reach target depth in all places
- Boulders and shot rock encountered by augers prohibited them from reaching full target depths

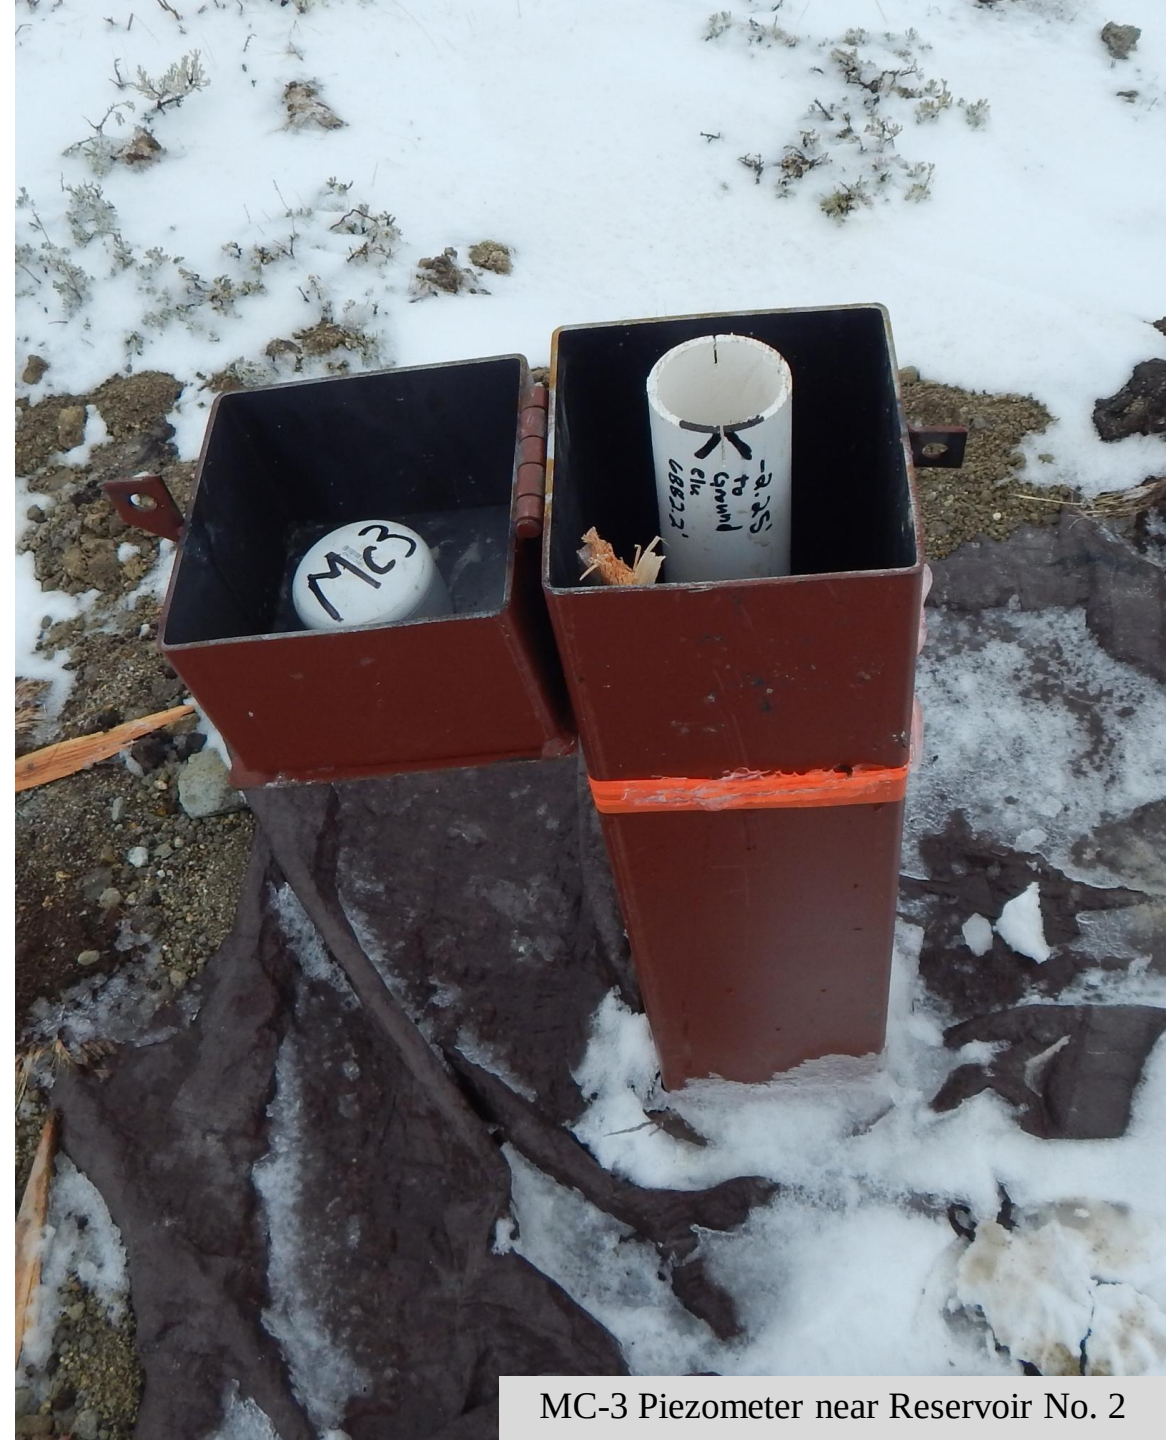
MC-3 Piezometer near Reservoir No. 2

- Five piezometers installed in spring 2015
- Four piezometers monitored 2015 through 2024
  - One piezometer had bottom collapse and readings were discontinued
- Piezometers removed and fully reclaimed in fall 2025

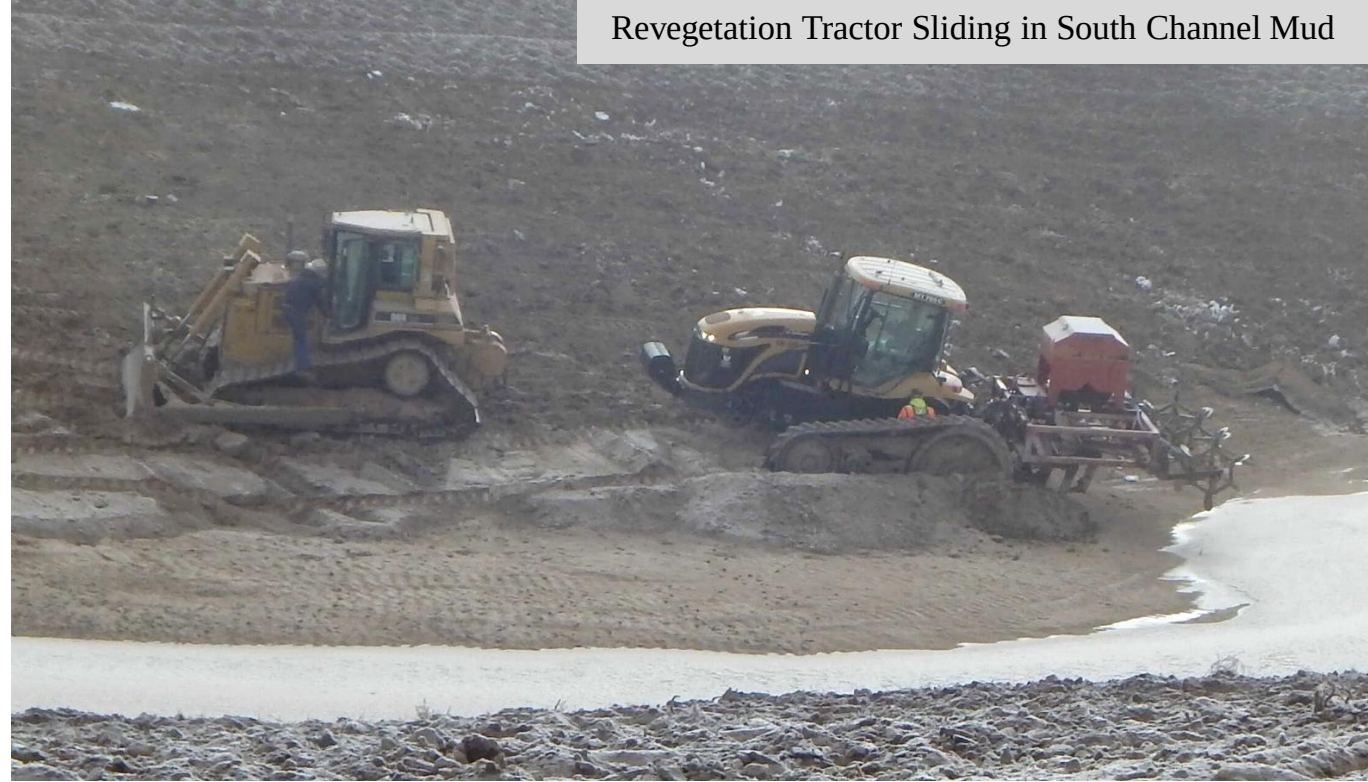
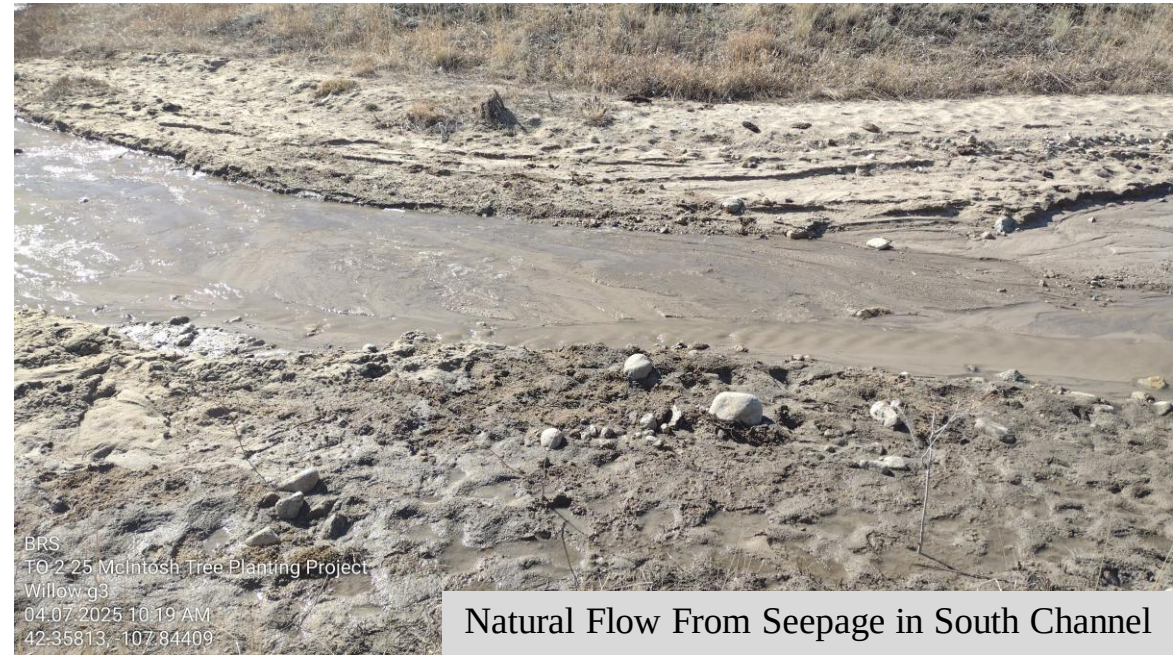
- Seepage continues in the South Spoils due to impoundment structure not reaching bedrock in all places
- South Spoils was wet but manageable for construction
- Seepage provides continuous low flow in Quaking Asp Draw

Natural Flow From Seepage in South Channel

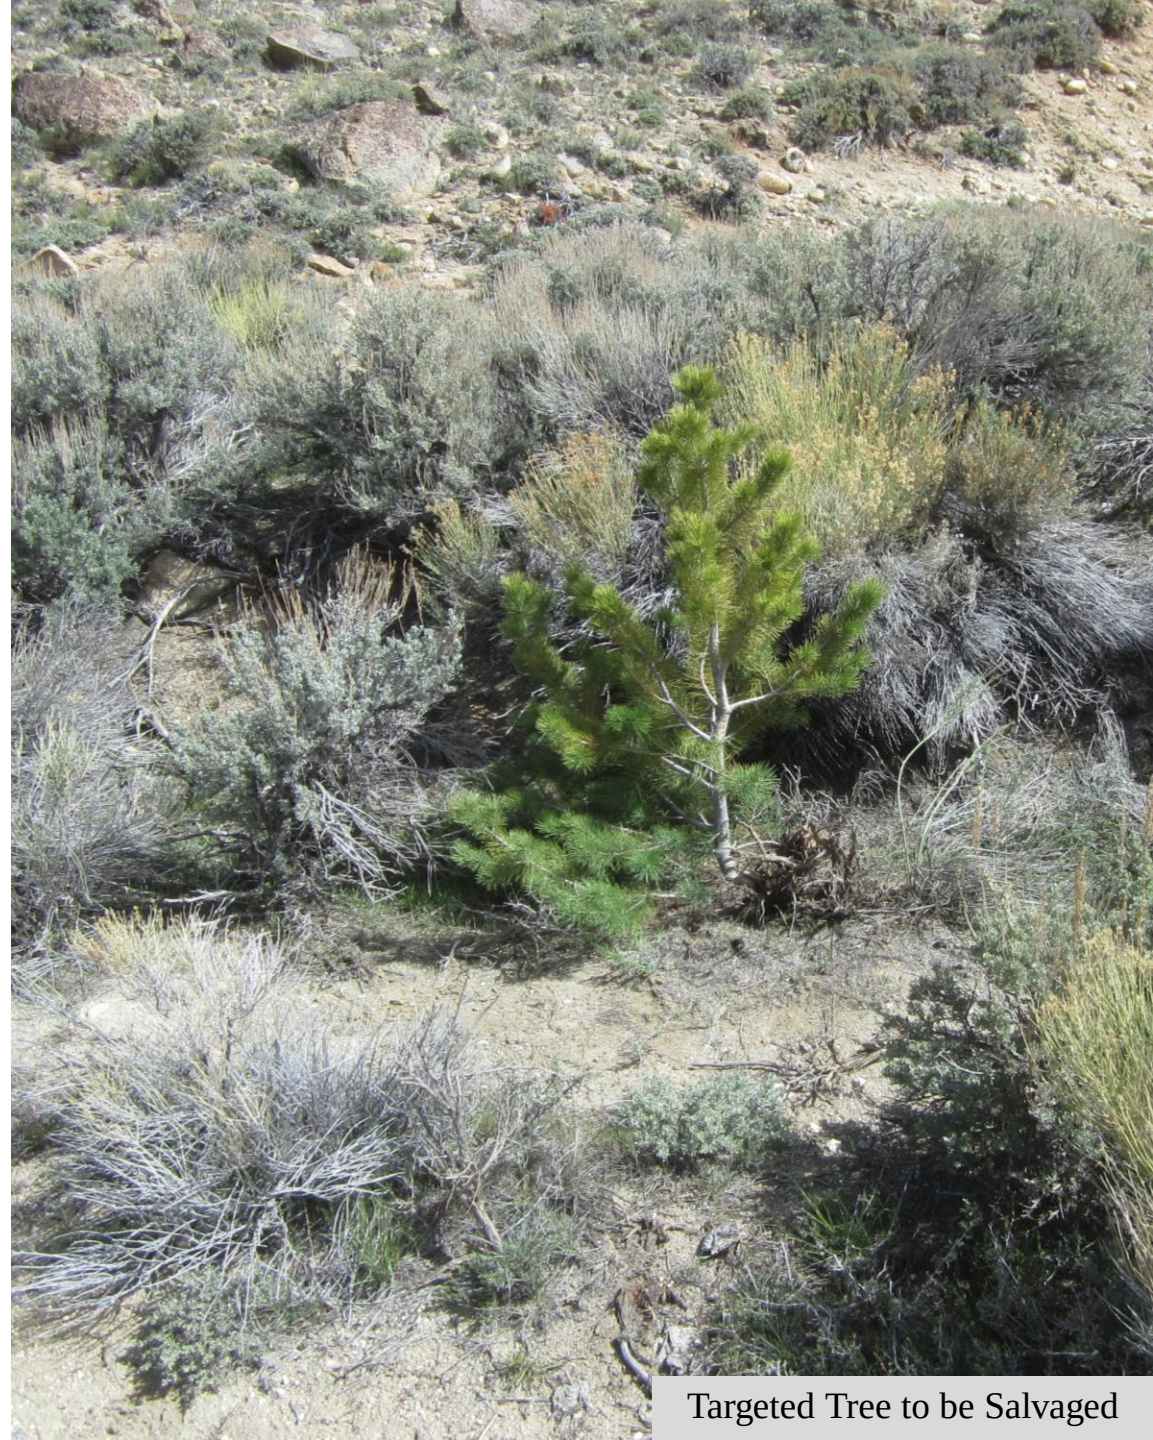
Targeted Tree to be Salvaged

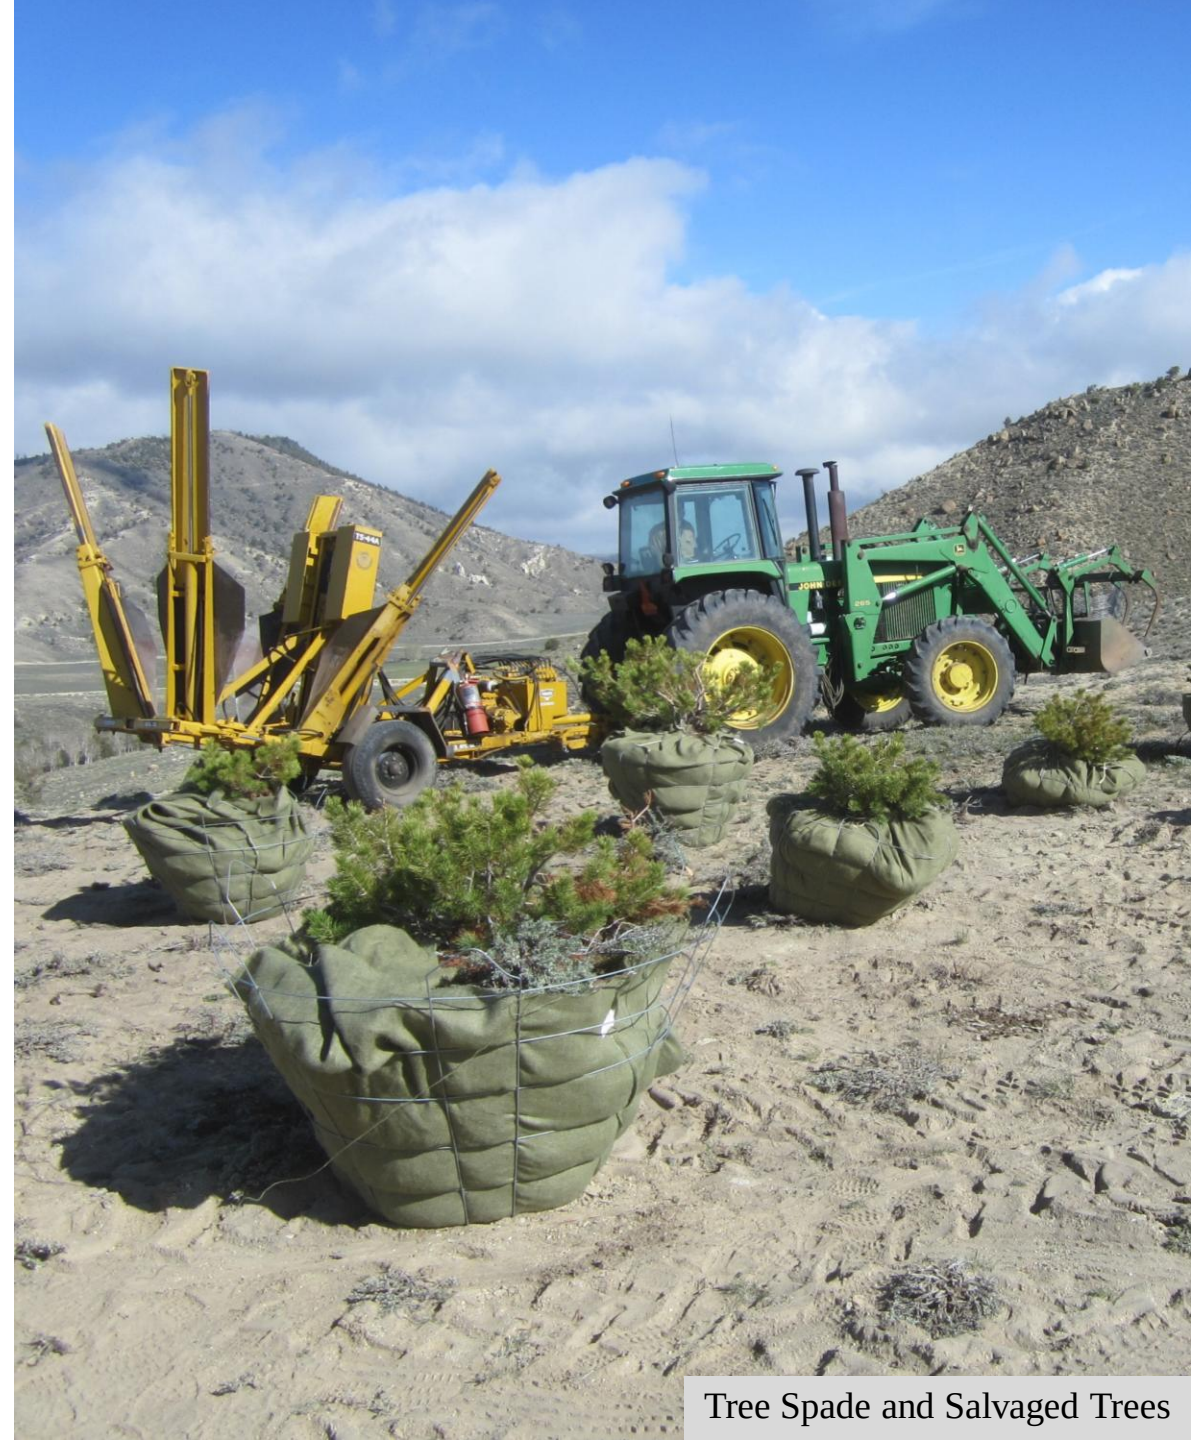
Tree Spade and Salvaged Trees

- P&F Services in May 2014 salvaged 106 limber pine trees
  - 71 small 1-2" diameter
  - 35 large 2-4" diameter
- Tree spade - flatter ground
- Mini excavator - on steep slopes
- Trees were dug, wrapped in burlap, and placed in wire baskets

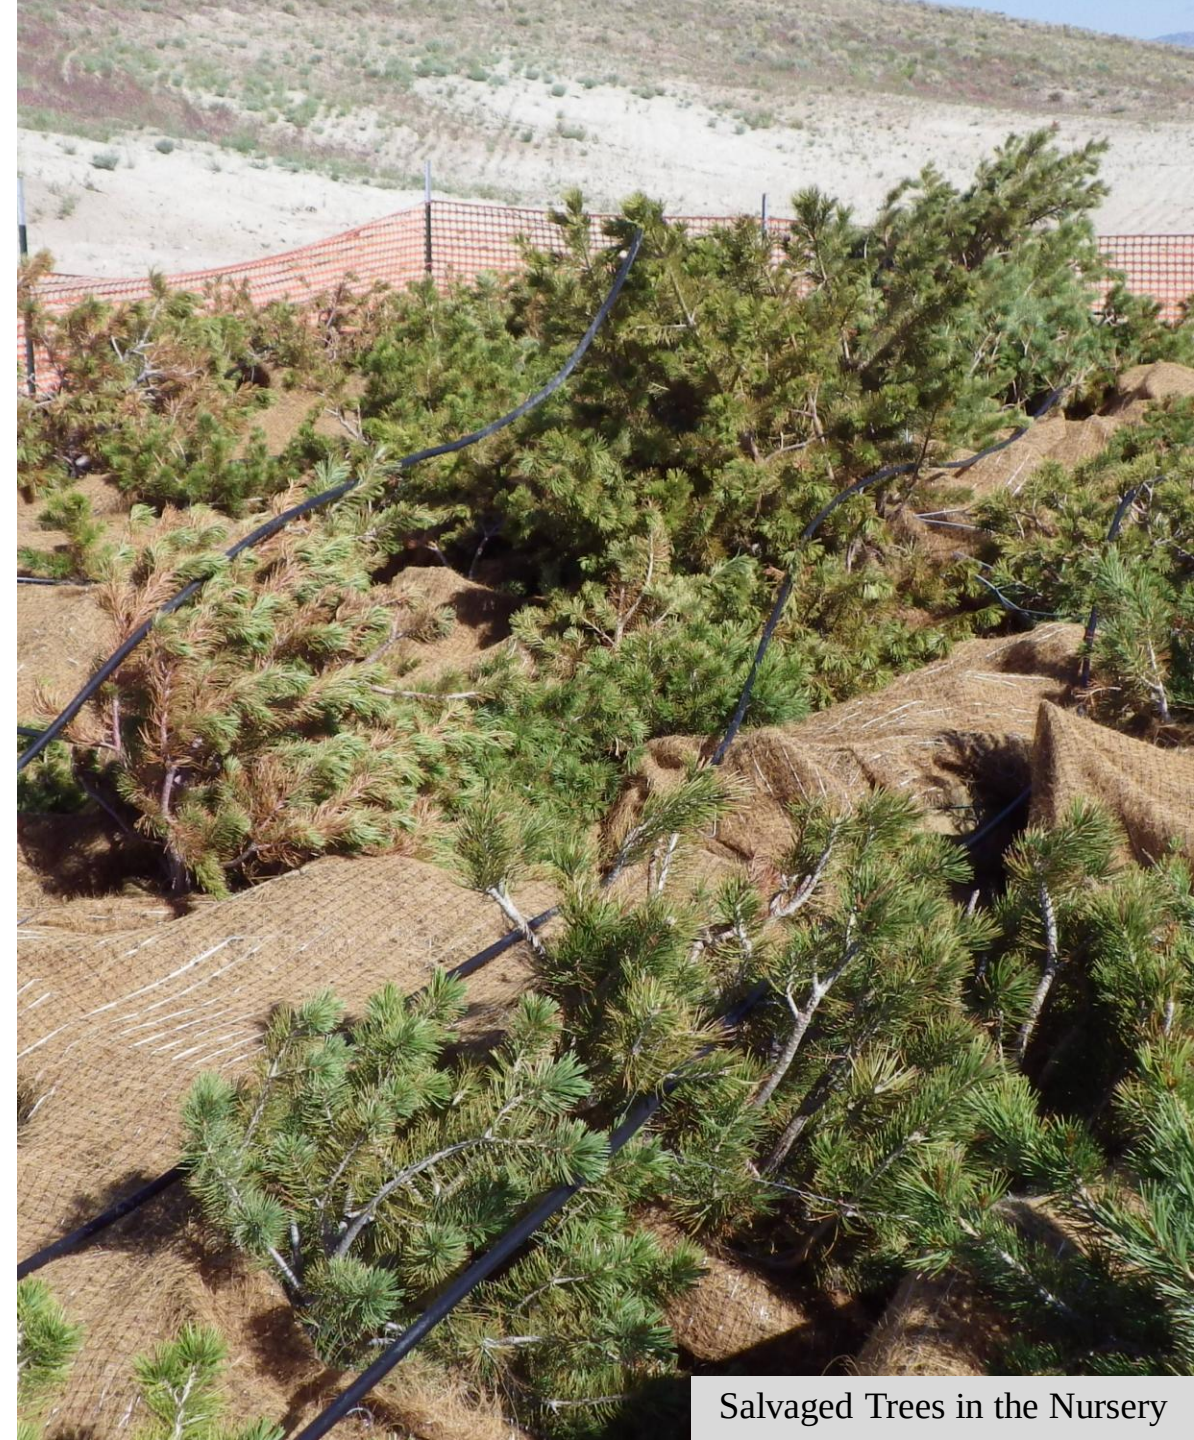
- Sheltered location selected between coversoil pile and reclaimed spoils pile
- Root balls placed tightly together and covered with coconut erosion control blanket
- Drip irrigation lines used to water trees
- 40 of 106 of the salvaged trees survived to planting
  - High mortality attributed to trees salvaged with the mini excavator breaking up root balls

Salvaged Trees in the Nursery
