# ASRS 2026

## McIntosh Habitat Enhancements

**AML PROJECT 160**  
**June, 2026**

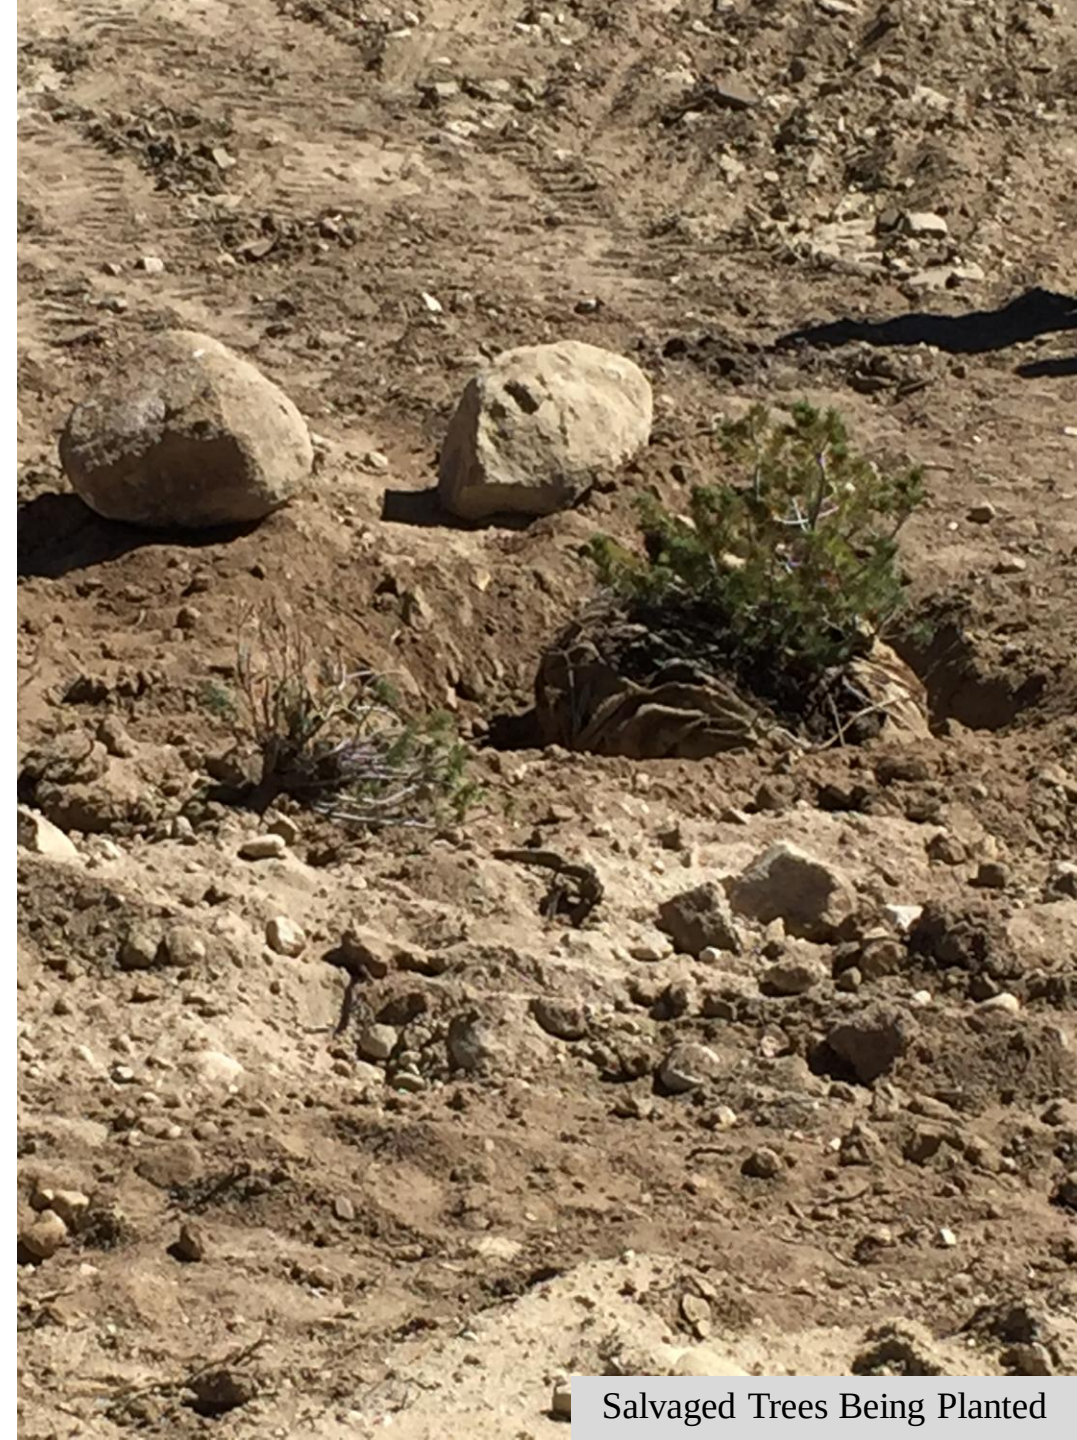
- Surviving trees planted on East and West Highwall slopes
- Trees planted by digging a hole with a mini excavator, placing wrapped root ball in hole, and filling with water two times during backfill

Salvaged Trees Being Planted

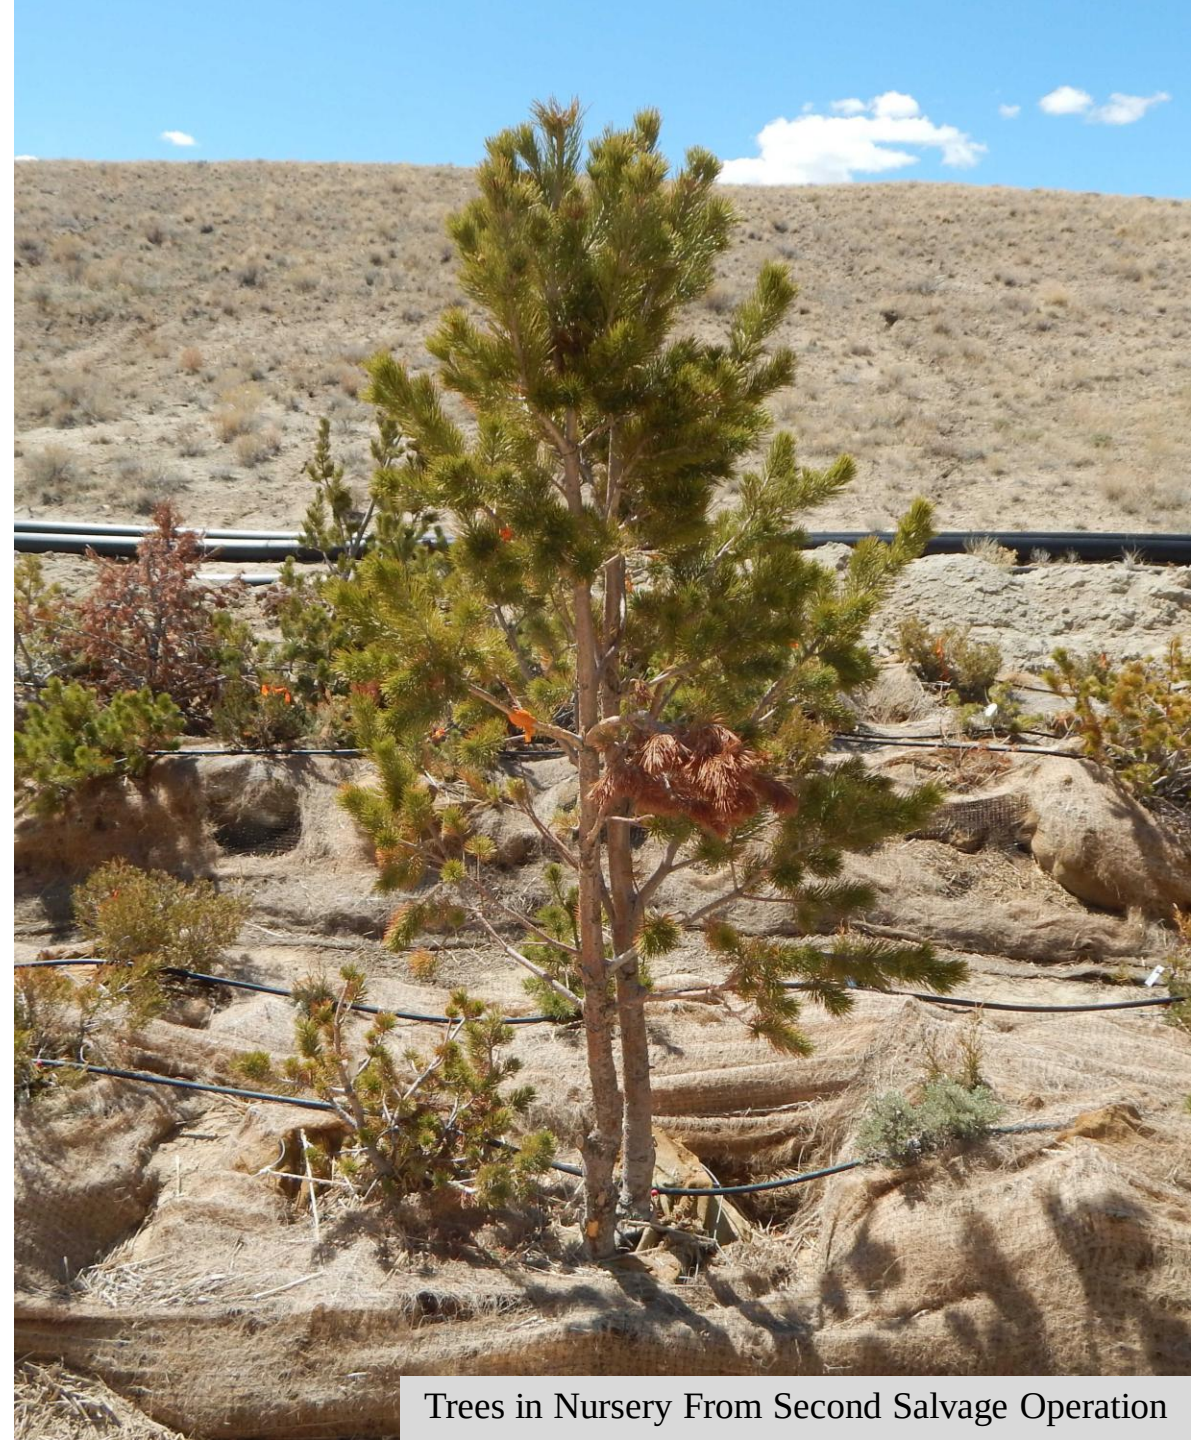
- Reused nursery site
- Perimeter berms installed for wind protection
- Straw packed between root balls
- Coconut erosion control blanket and drip irrigation system remained as before

Trees in Nursery From Second Salvage Operation

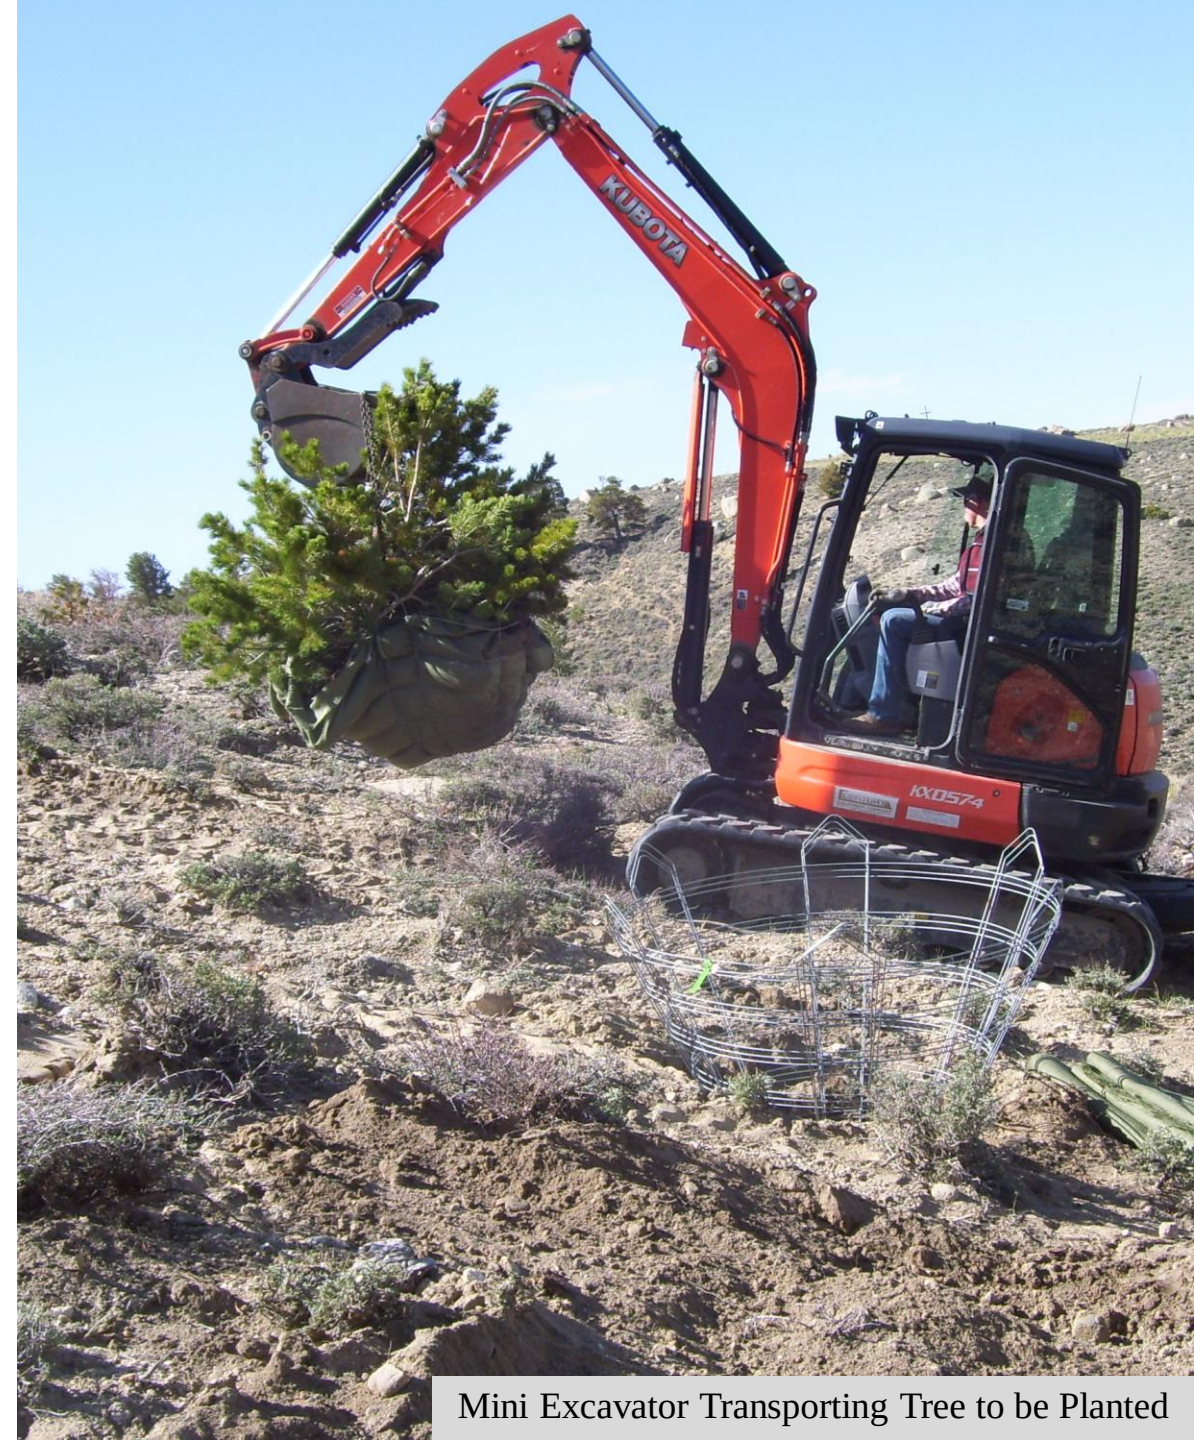
Mini Excavator Transporting Tree to be Planted

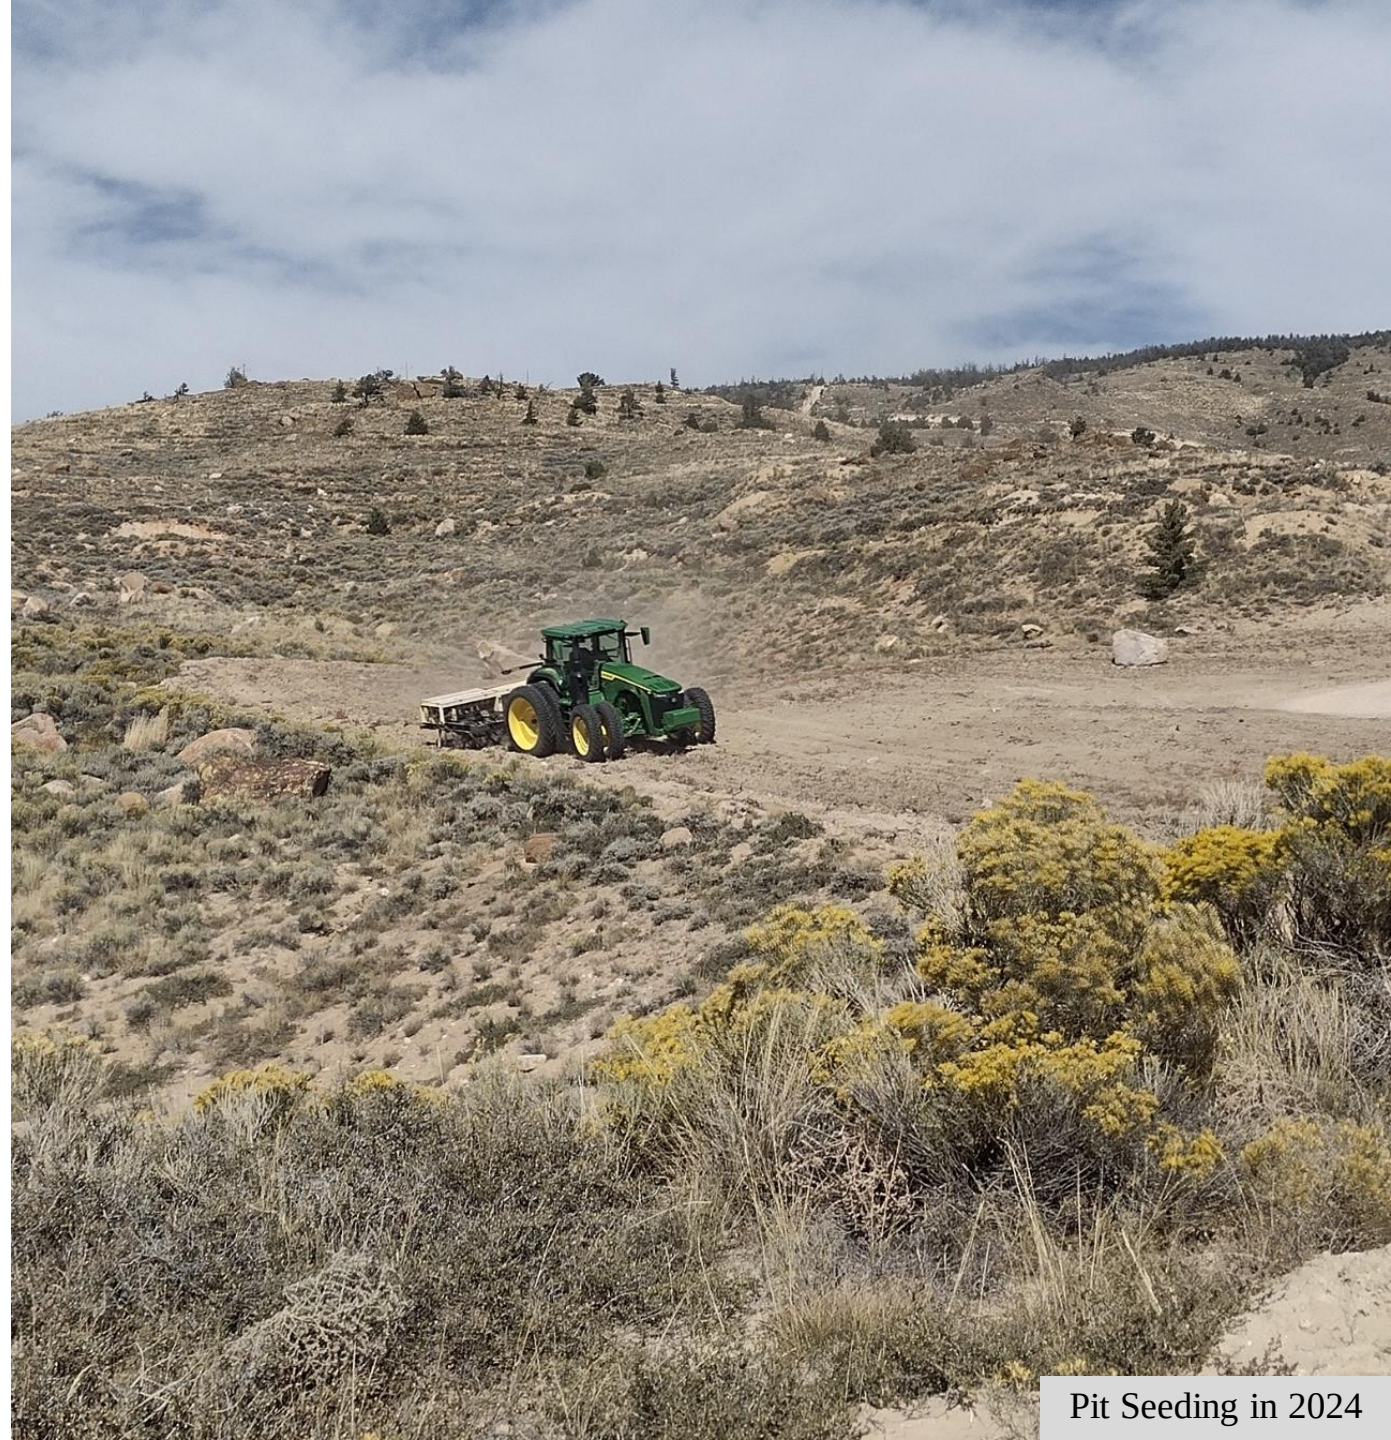
Pit Seeding in 2024

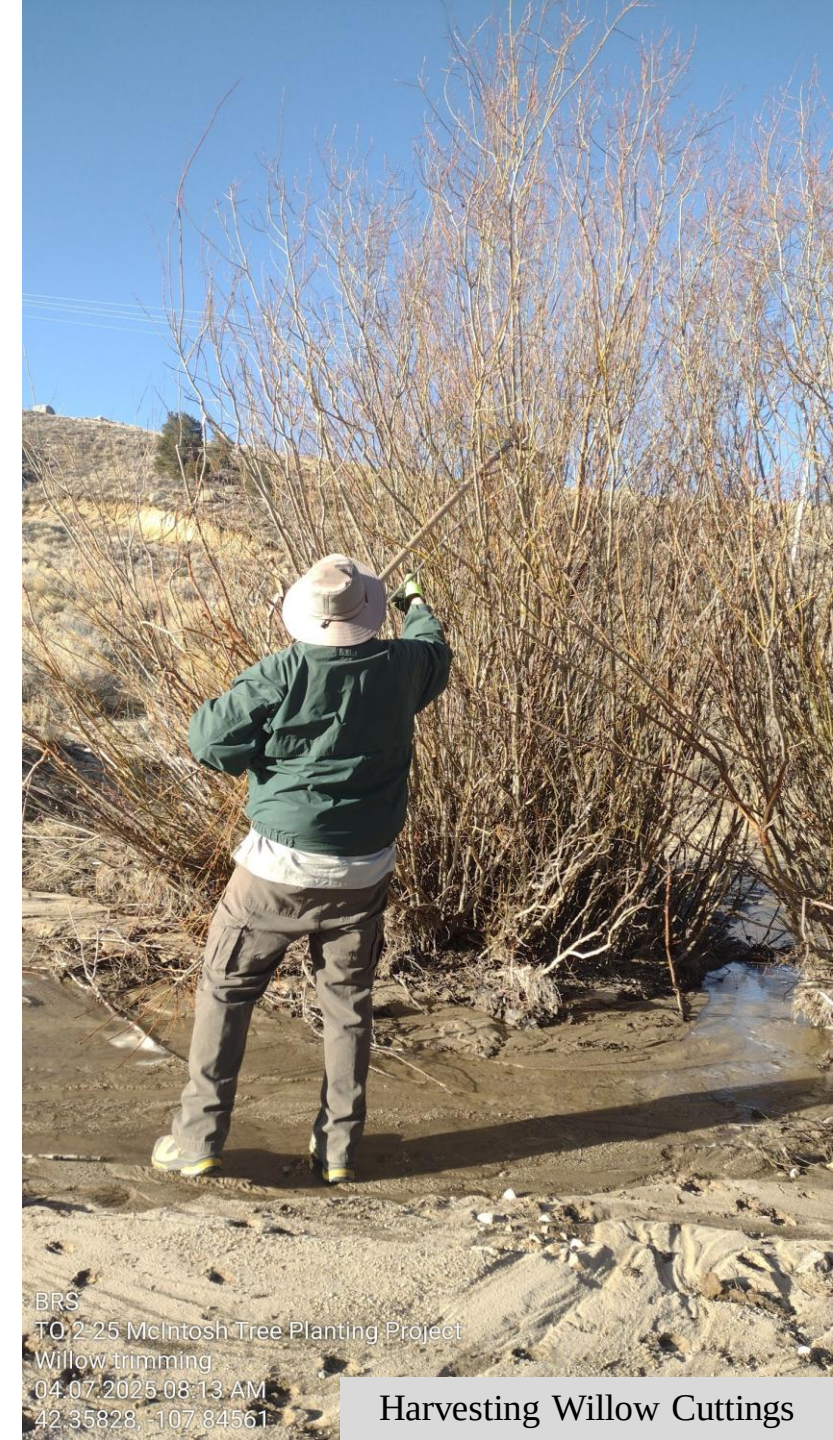
- Established willows in Quaking Asp Draw trimmed to create cuttings for planting
- Multiple starts trimmed from each larger branch cut from the plant
- Branches dead or damaged by moose avoided

Harvesting Willow Cuttings

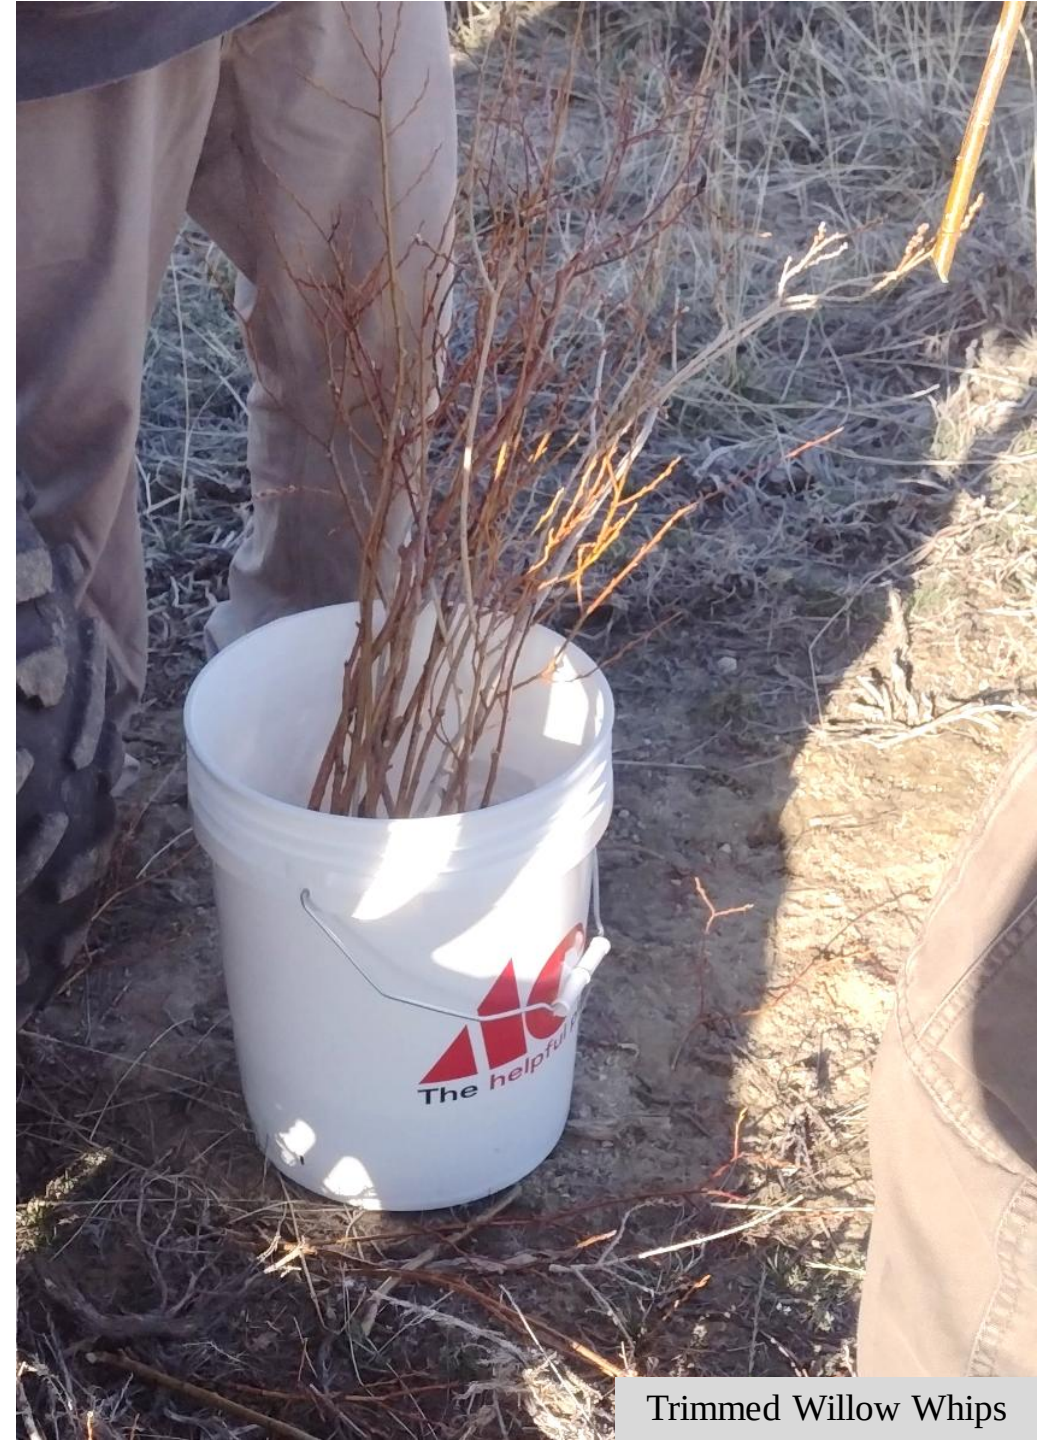
- Majority of foliage trimmed from cuttings, at least 15" of the bottom left free of growth to create whip
- Whips placed in bucket with water from flowing meander channel and root starter
- Stakes cut from main part of branches without foliage and placed in bucket
- Approximately 300 whips and 50 stakes harvested

Trimmed Willow Whips

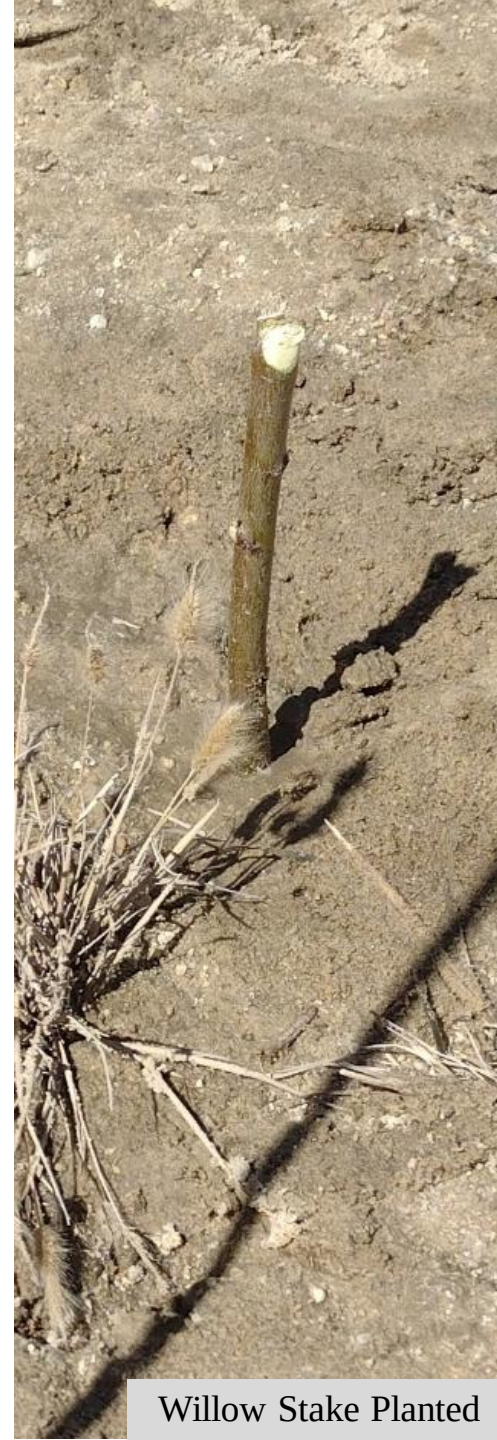
Willow Stake Planted

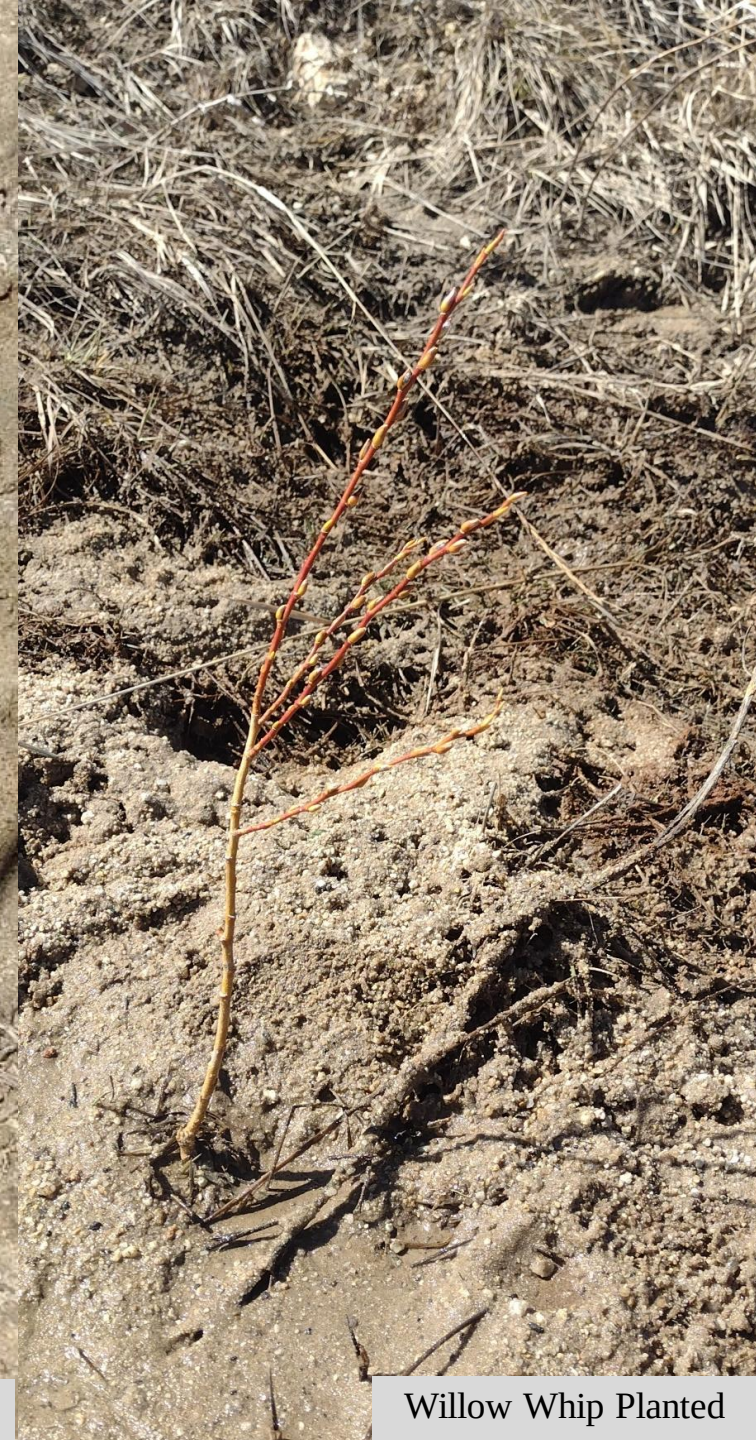
Willow Whip Planted

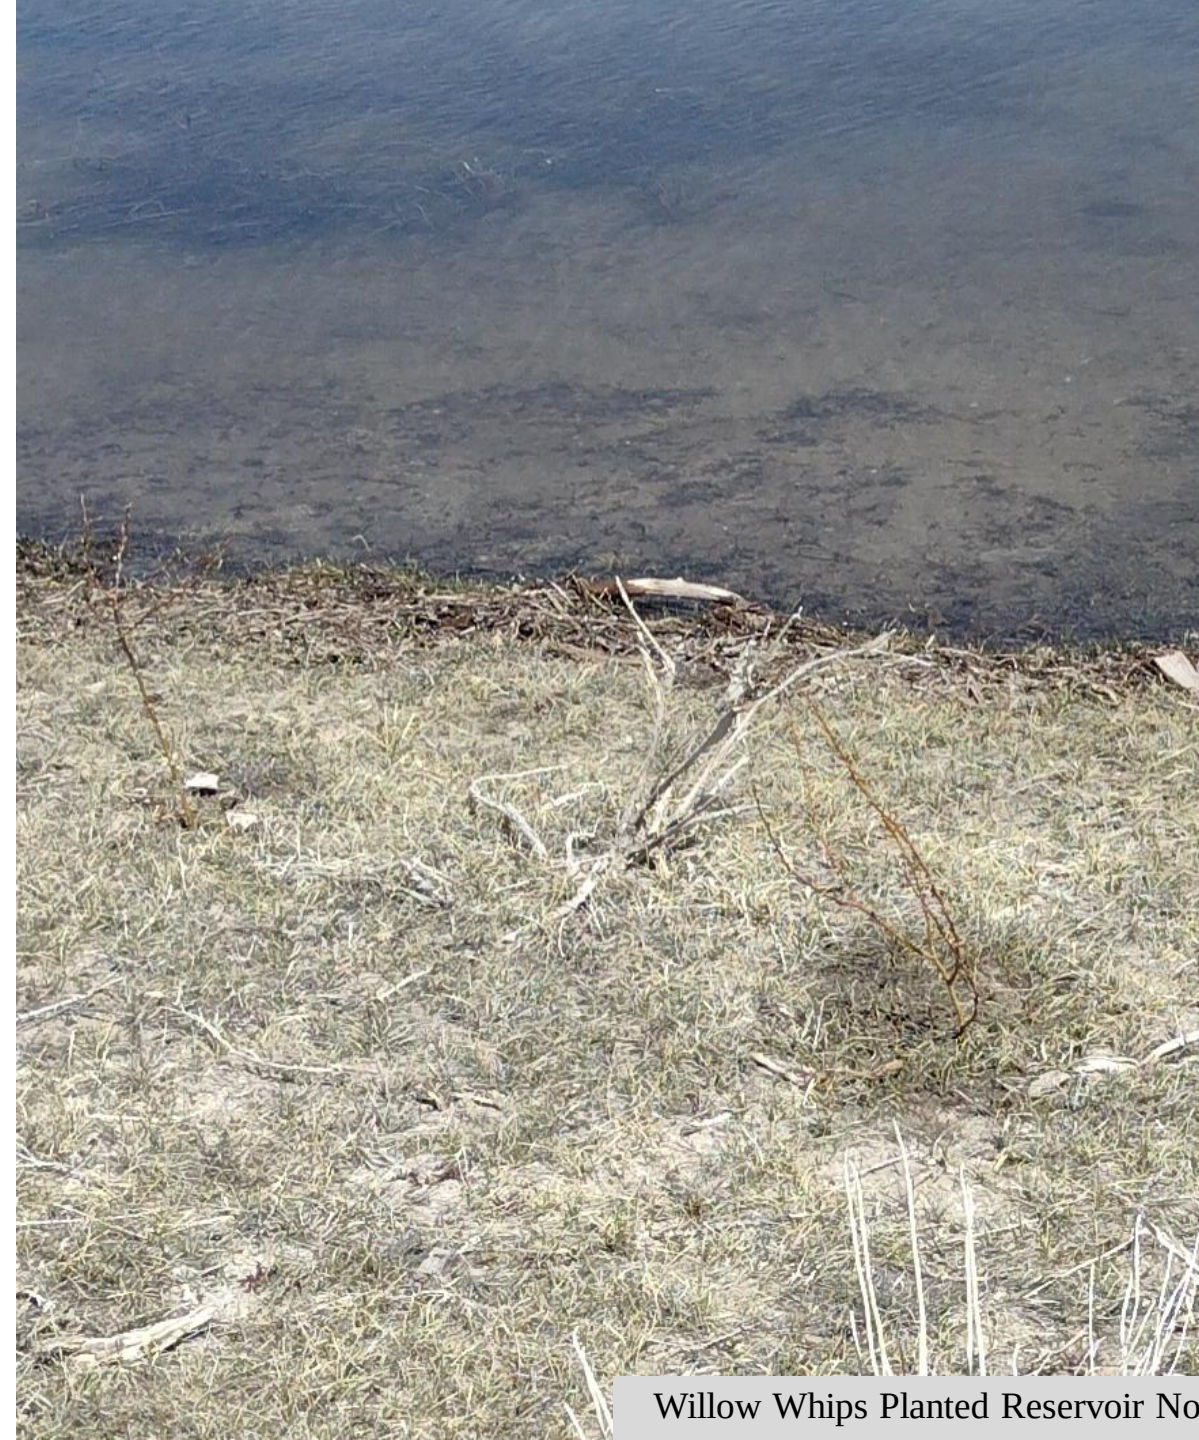
- Willow whips planted at Reservoirs No.1 and No. 2
- Flat area around reservoir No.1 planted
- Western side of reservoir No. 2 planted as willows were already present on eastern and northern sides

Willow Whips Planted Reservoir No

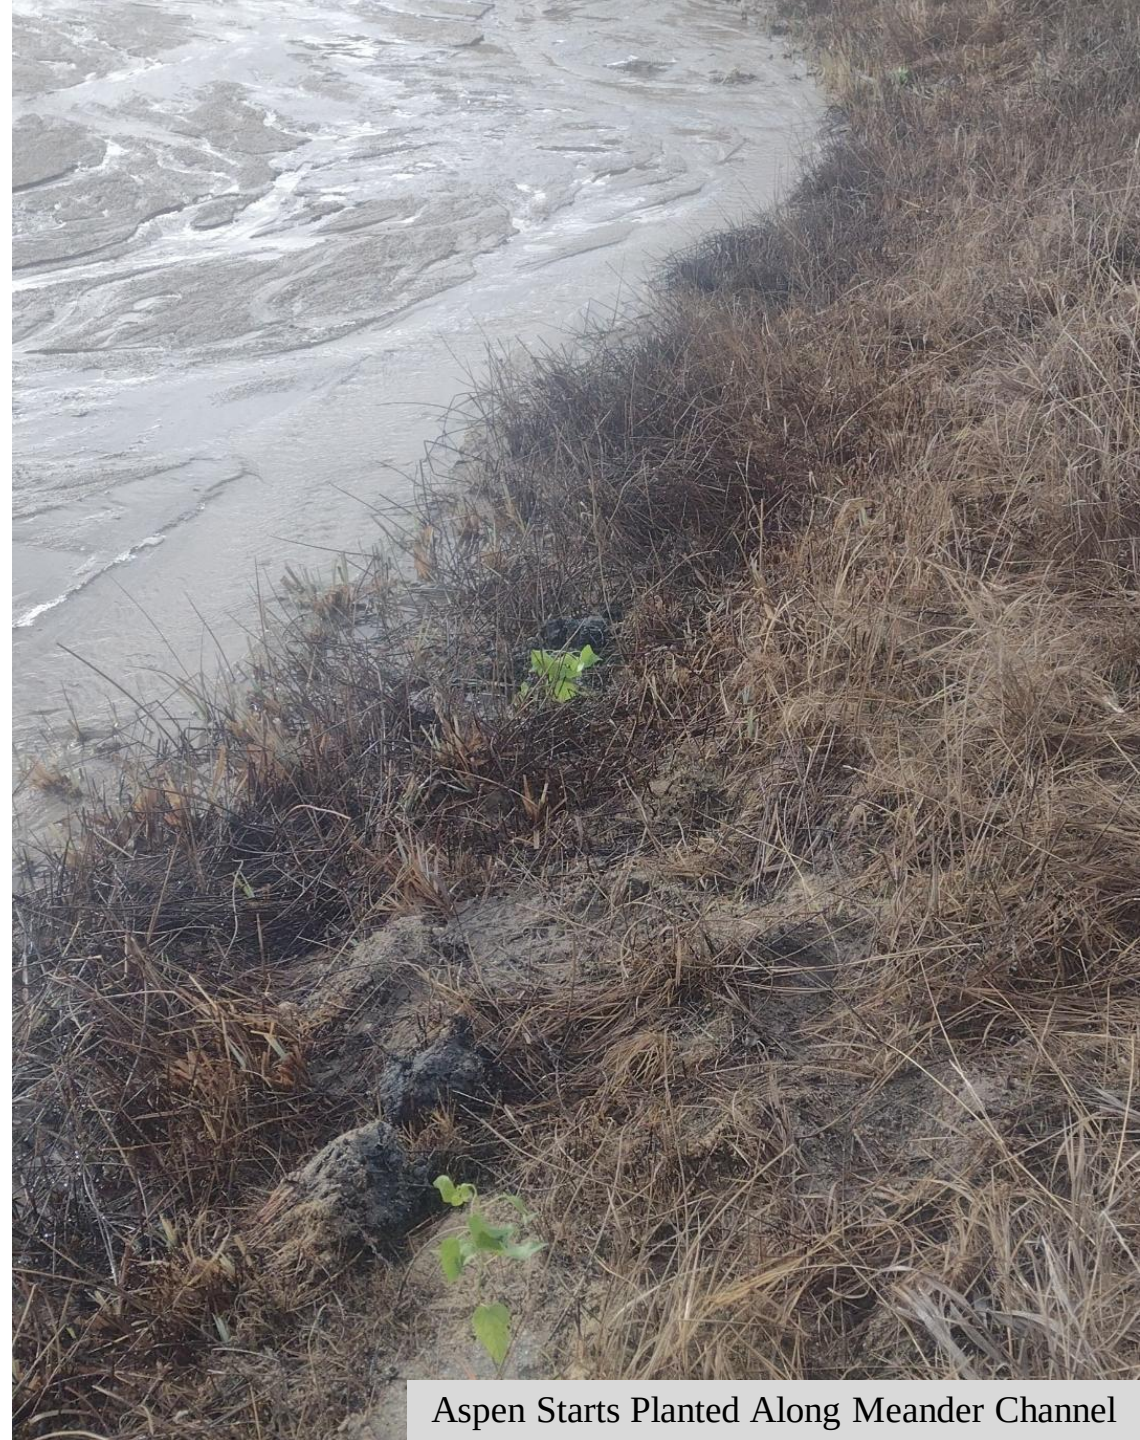
- Aspens from Popo Agie conservation district purchased
- Planted in groups along the meander channel and around Reservoir No. 2
- Long term survivability to be determined

Aspen Starts Planted Along Meander Channel
