# Triumph Mine Site

Design & Construction

Erin Hurley, Alta Science & Engineering, WSB

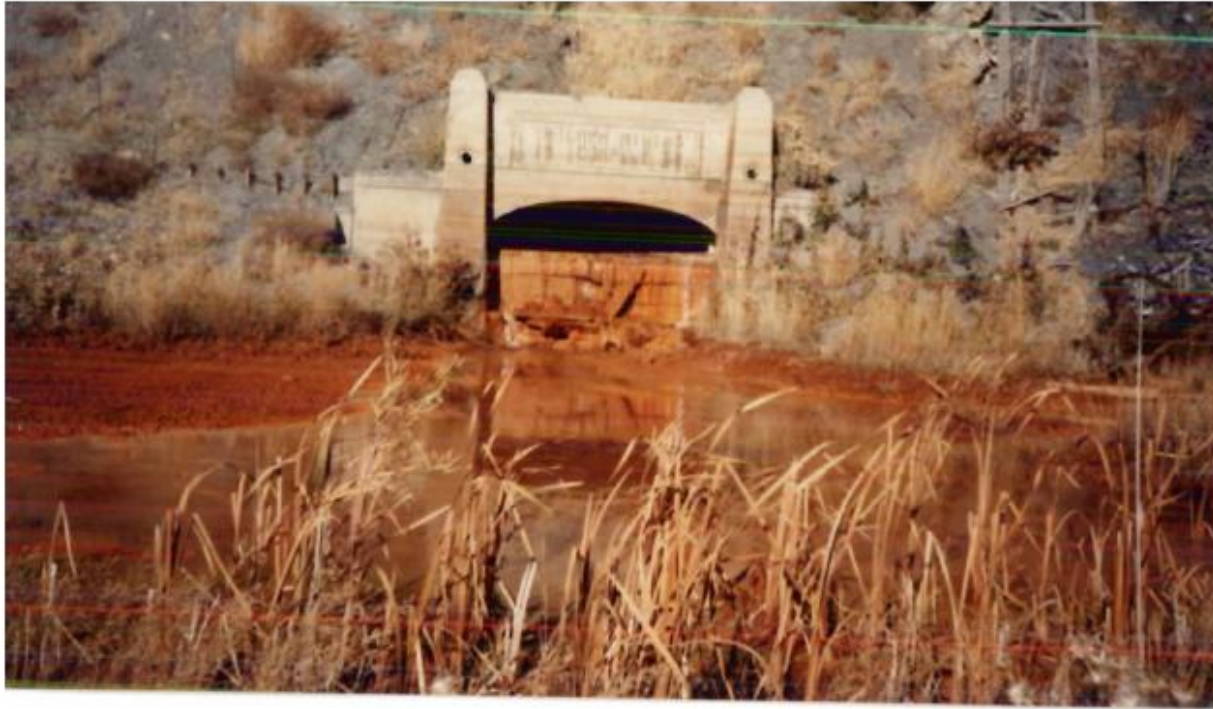
*Before the environmental cleanup.*

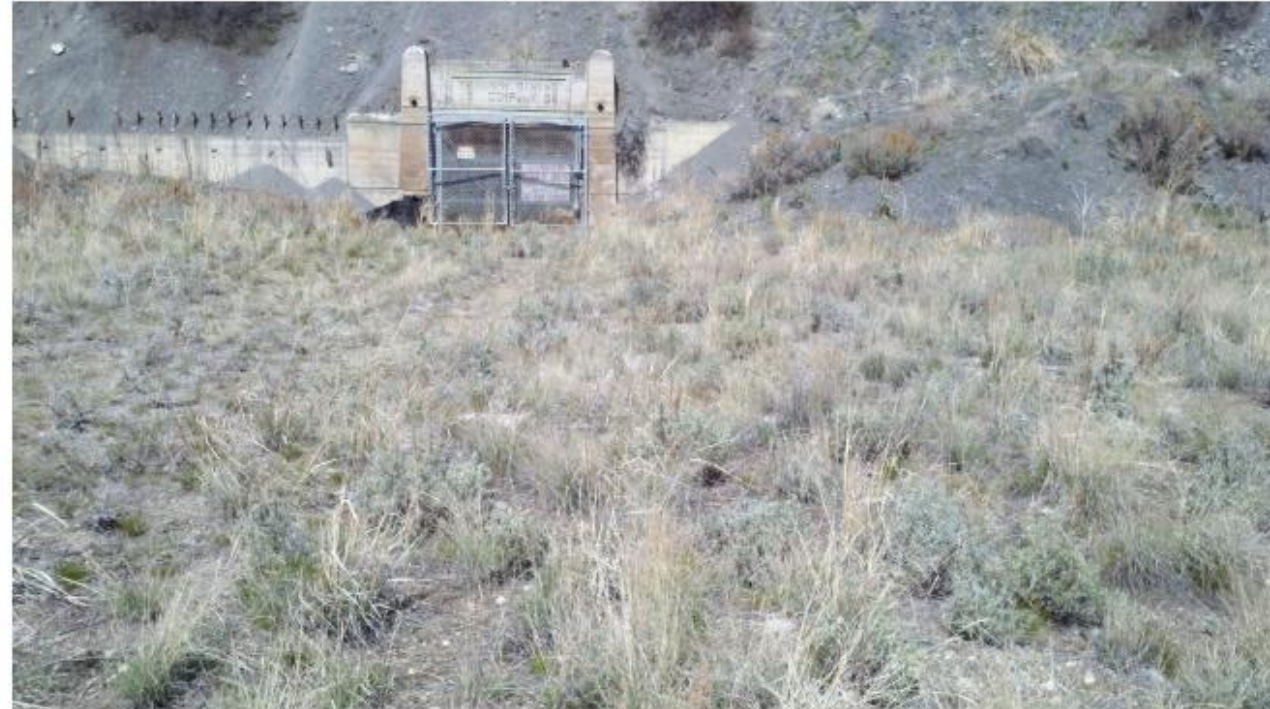
*After environmental cleanup.*

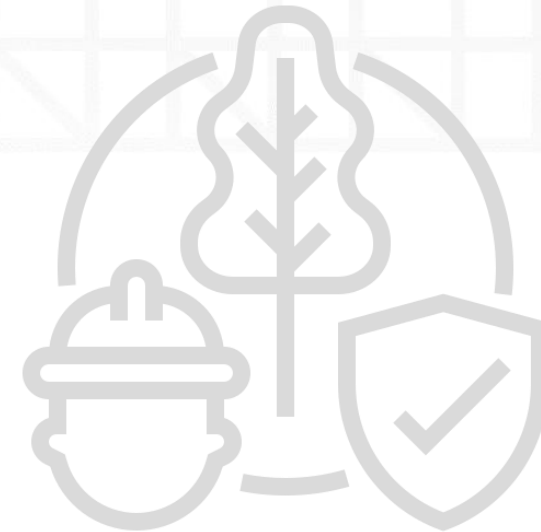
- Removed roadside material from 6" to 12" and replaced with clean
- Place removed material on existing tailings pile
- Cover with clean topsoil and revegetate

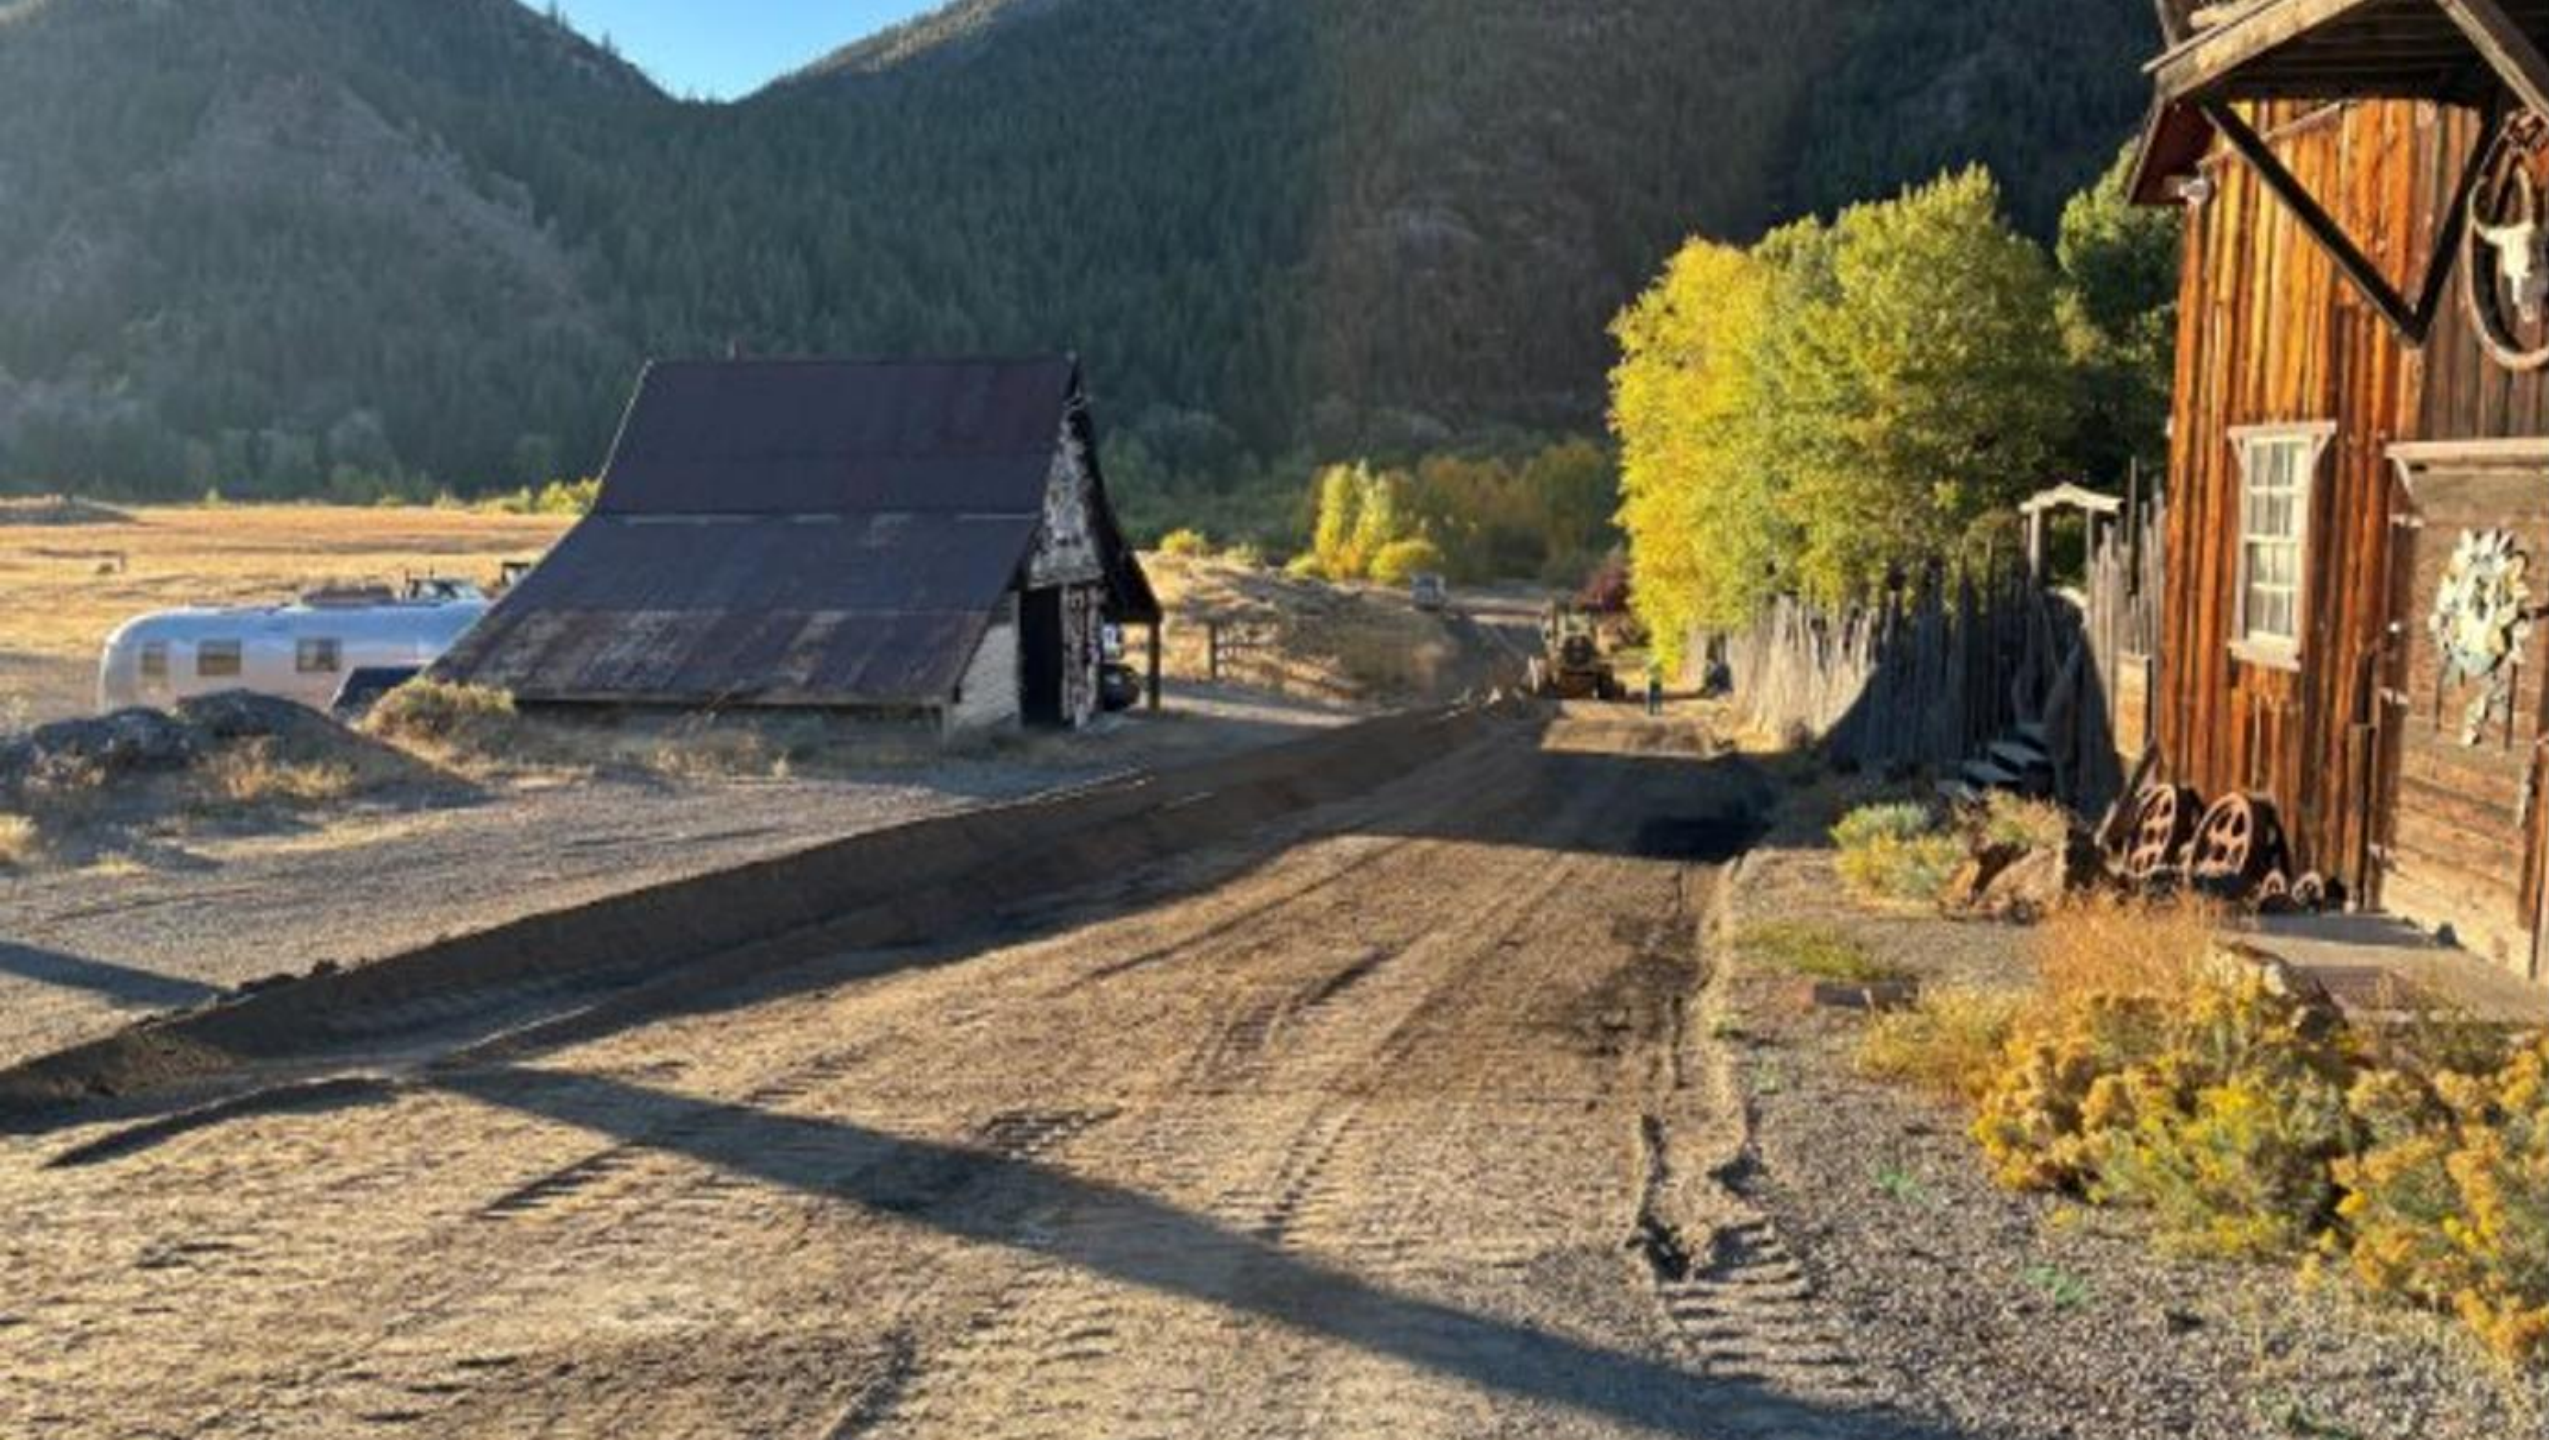
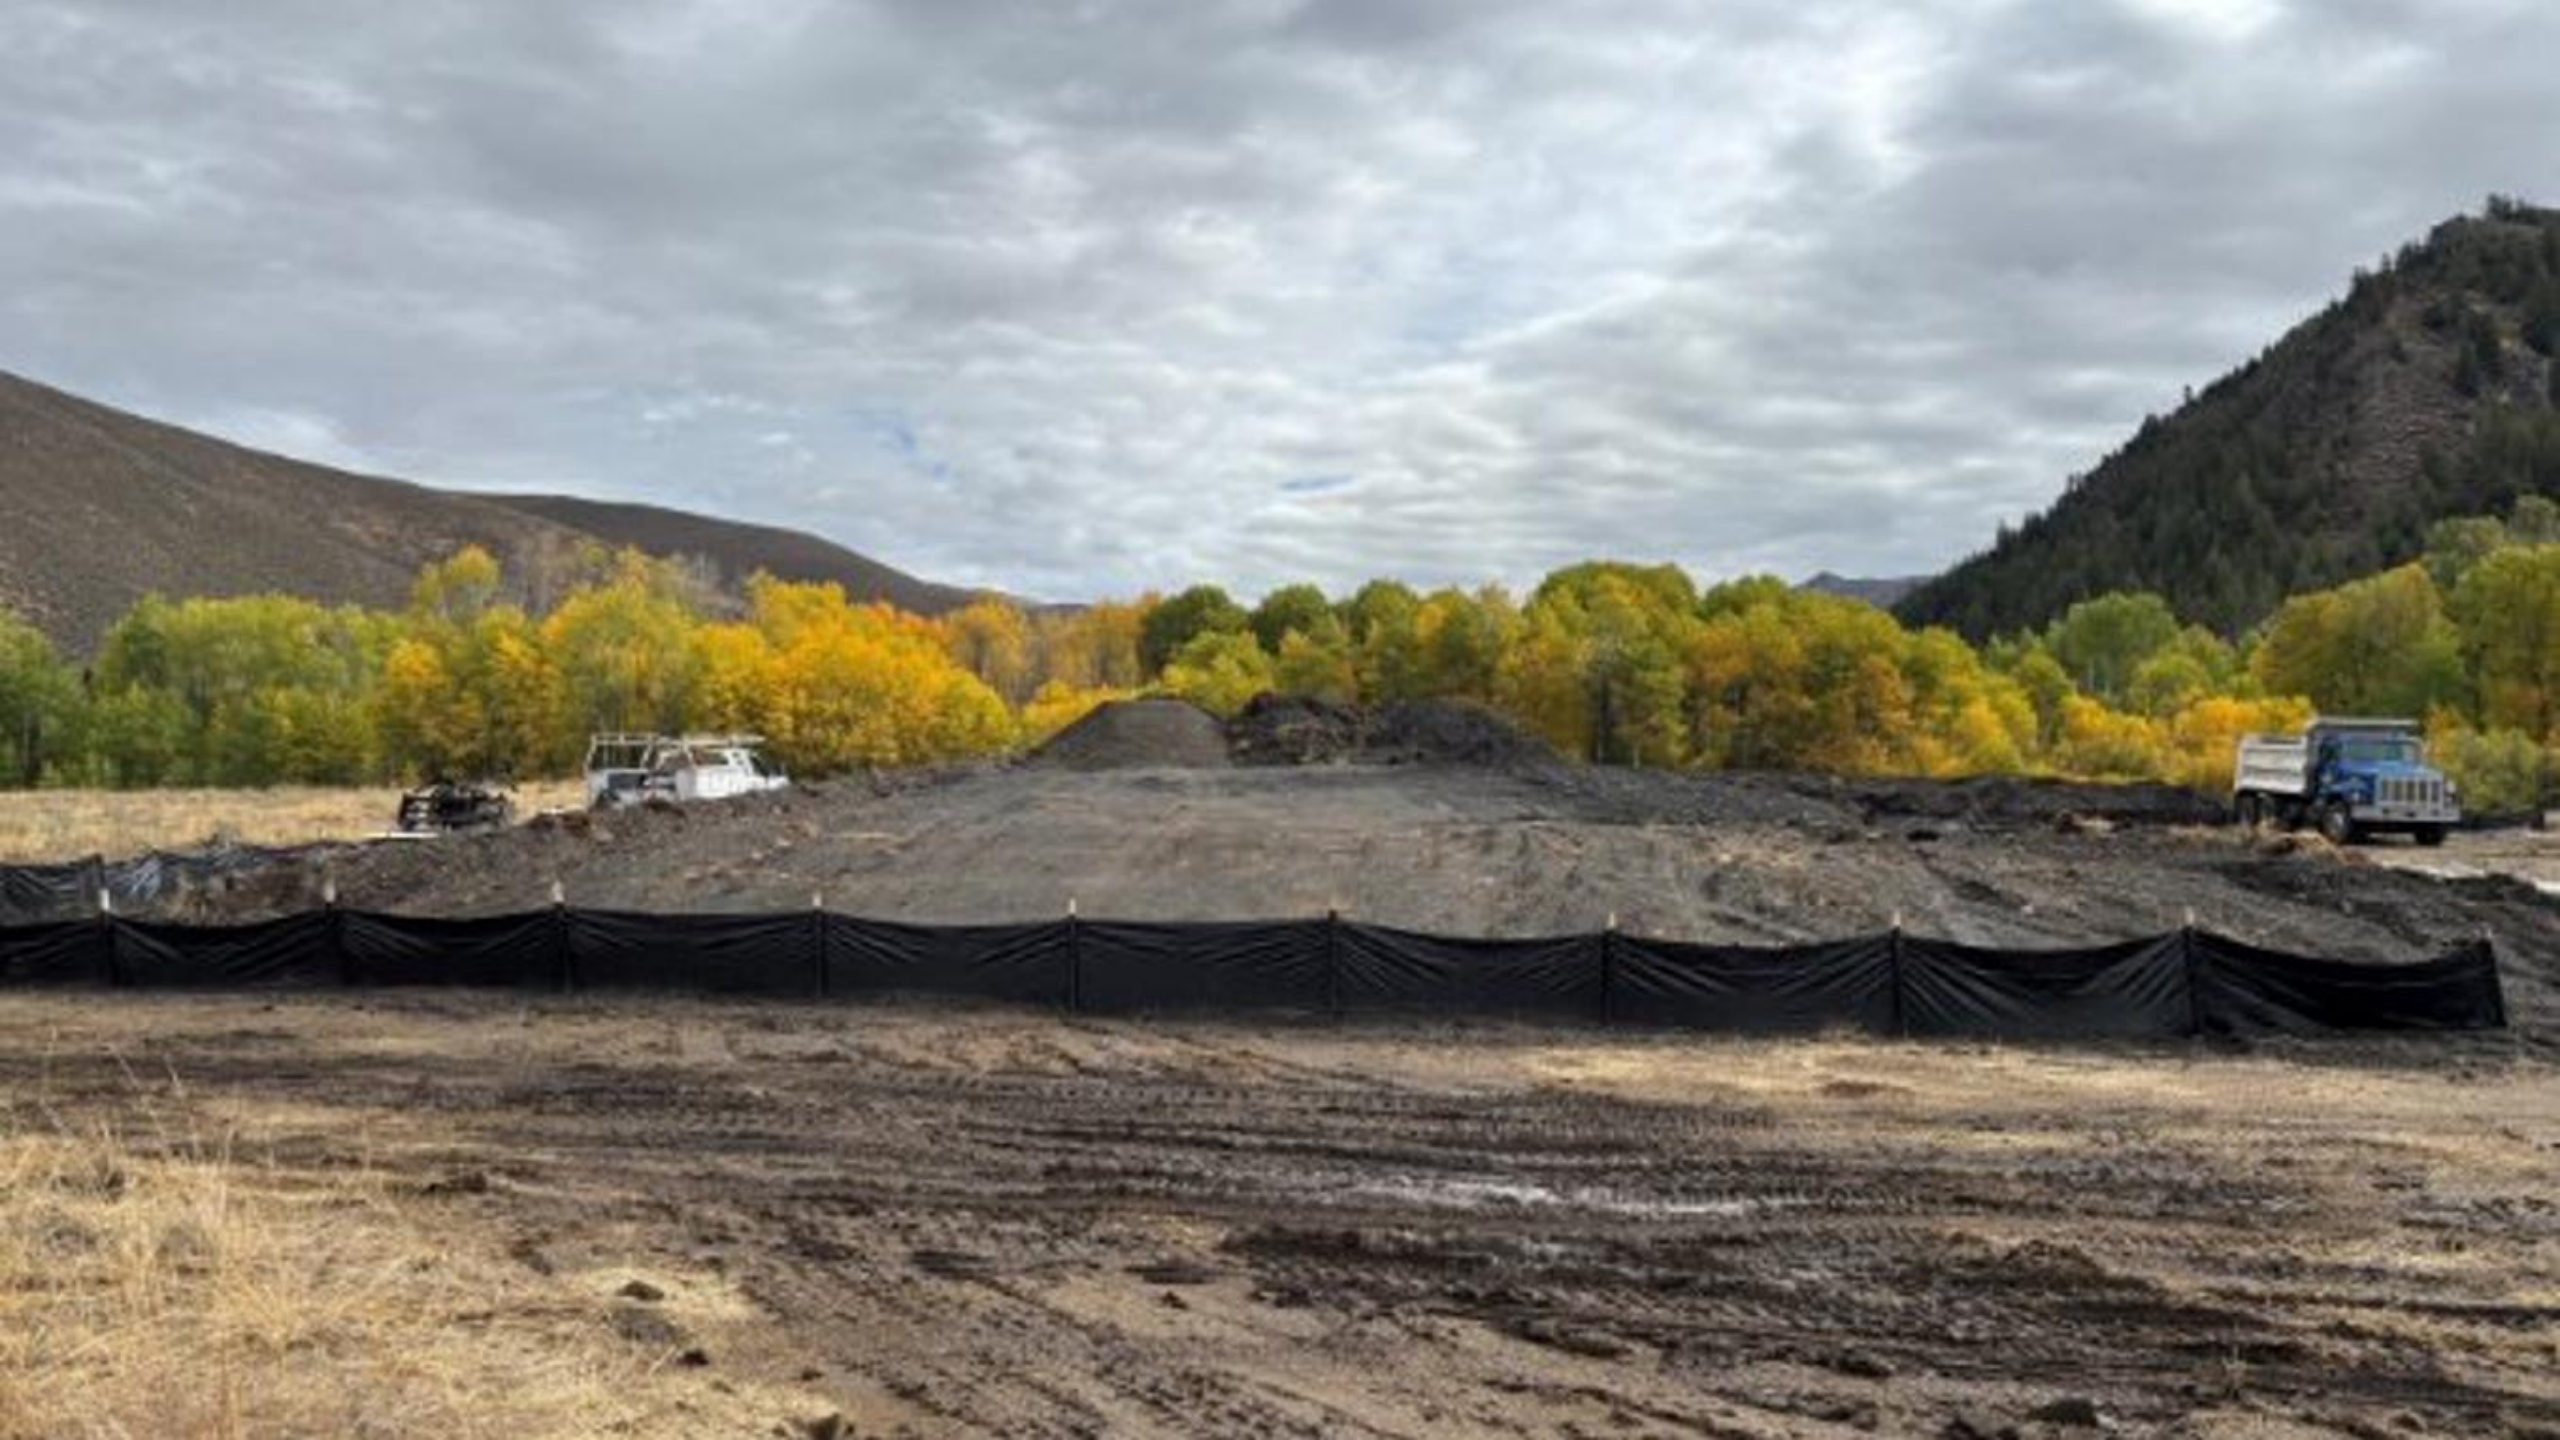
PLACE  
DEGRADED  
RING  
(NOTE 6)

WASTE  
PLACEMENT  
AREA

PRESERVE AND  
PROTECT EXISTING  
LTP ACCESS ROAD

RECLAIM  
COMMUNITY  
STOCKPILE  
(NOTE 5)

REPLACE  
DEGRADED  
ARMORING

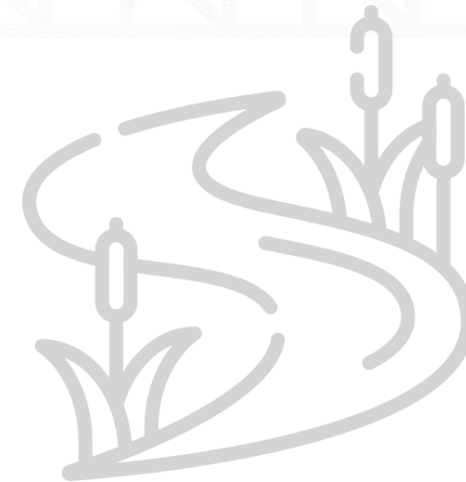
- Rerouted surge pond and permanent pond flow into newly constructed infiltration basins
- Installed new mine drainage collection system

- Emergency spillway in infiltration basin was raised 0.5 feet to allow for more storage before overtopping
- East Fork Lane was changed to a shallower crowned design for constructability
- One larger precast cleanout drain was installed in the portal instead of three smaller ones for cost saving and constructability
- The final location of the ecoblock retaining walls was field fit to limit interference with existing gates

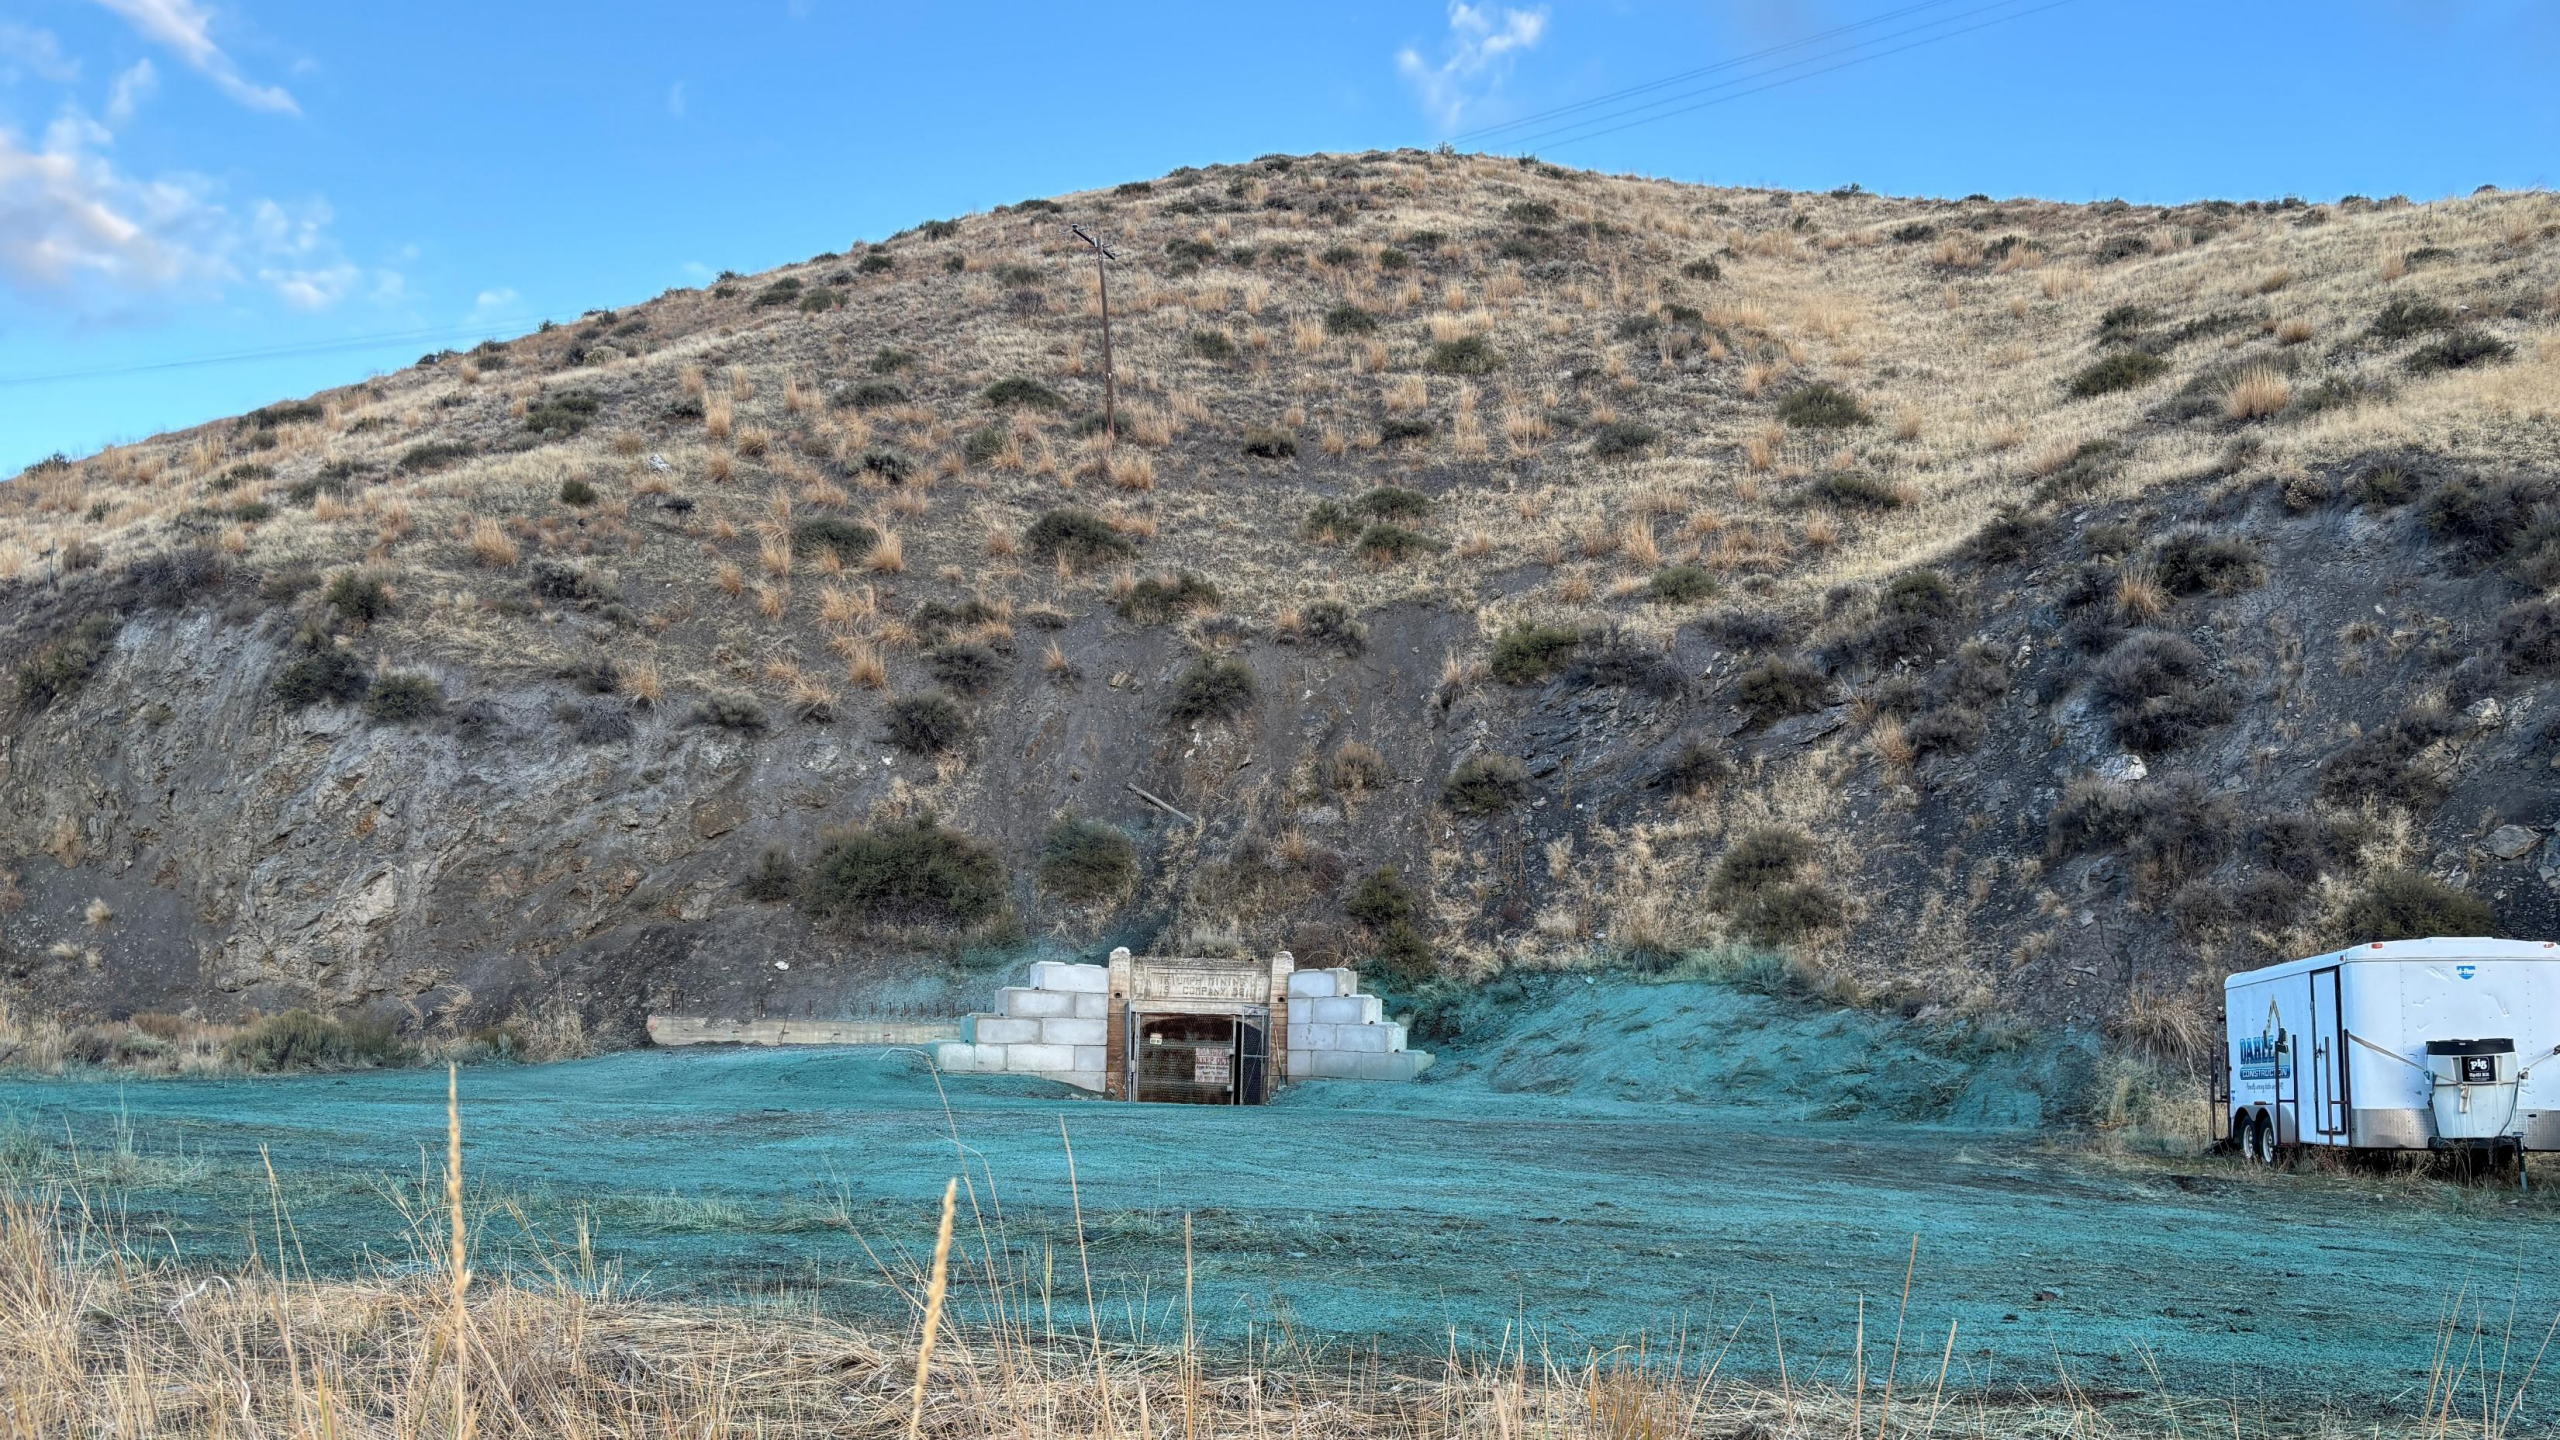
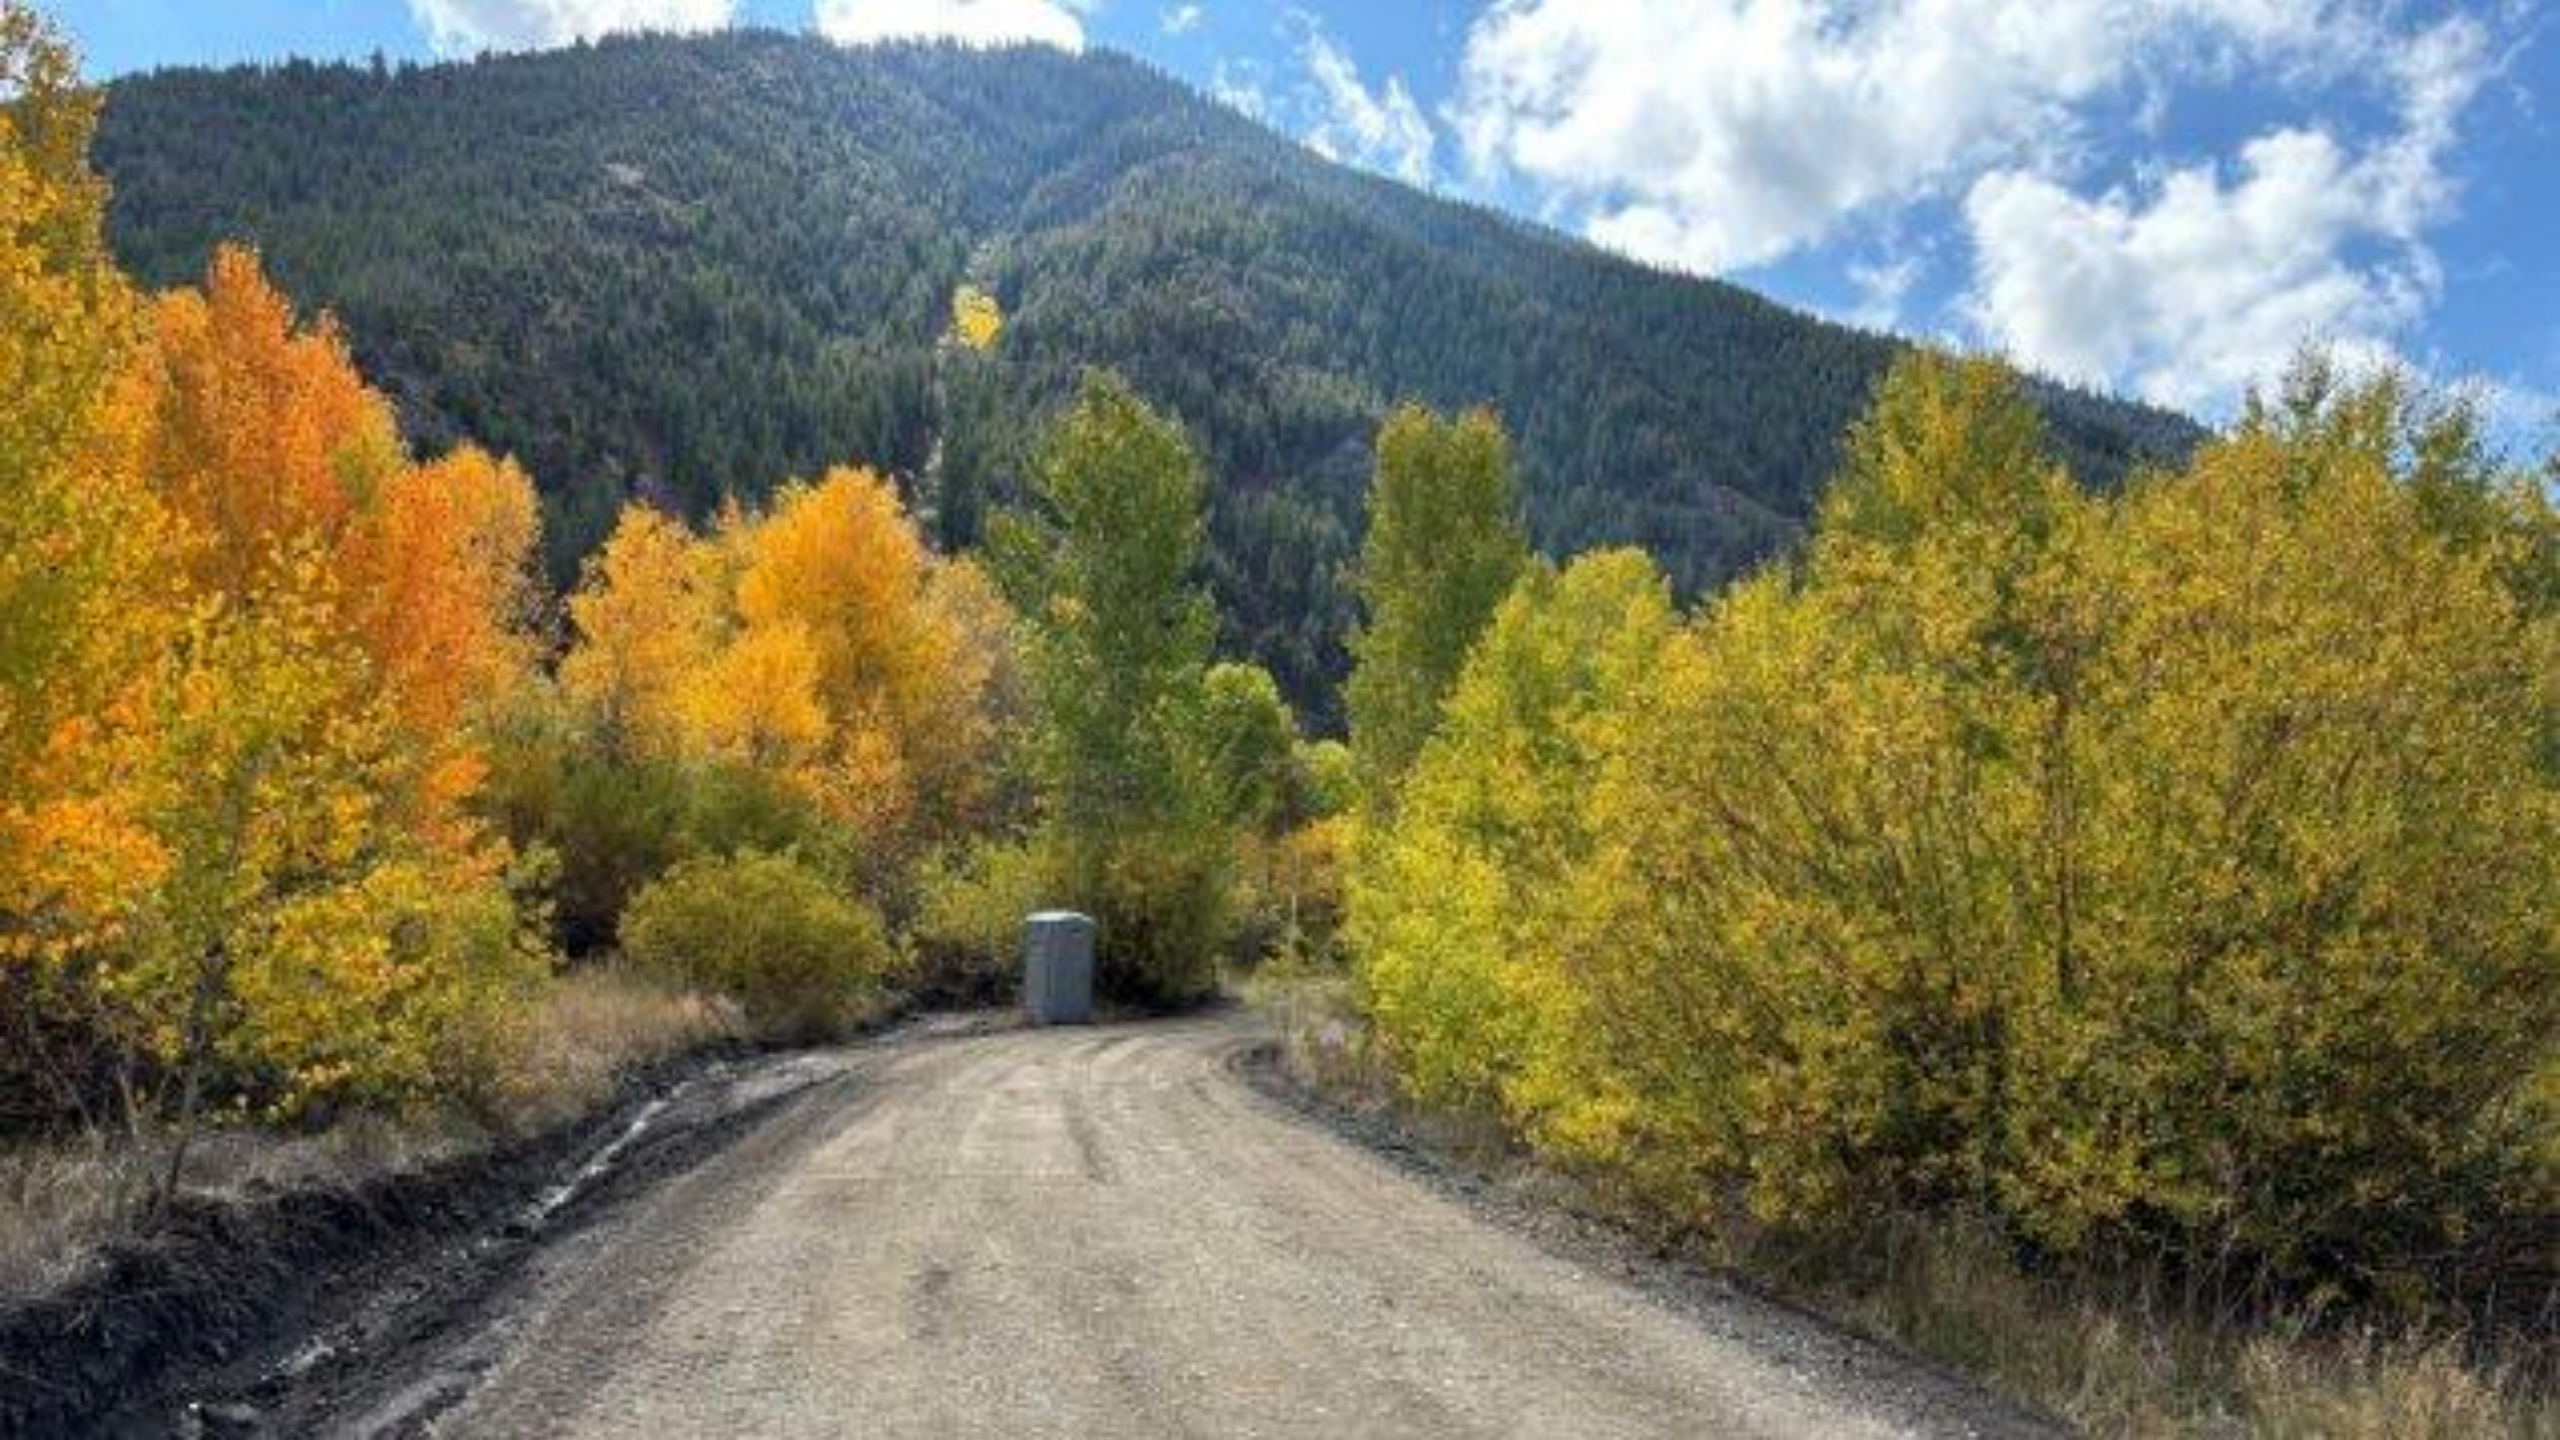
- Improved access to portal tunnel
- Repaired access road to tailings pile and community repository
- General repairs & clean up
- Install access road for surge pond and portal
  - Reduce crossing on private ground
