INVESTIGATION OF SUBSIDENCE EVENT OVER MULTIPLE SEAM MINING AREA

KEWAL K KOHLI, Ph.D

OFFICE OF SURFACE MINING RECLAMATION AND ENFORCEMENT

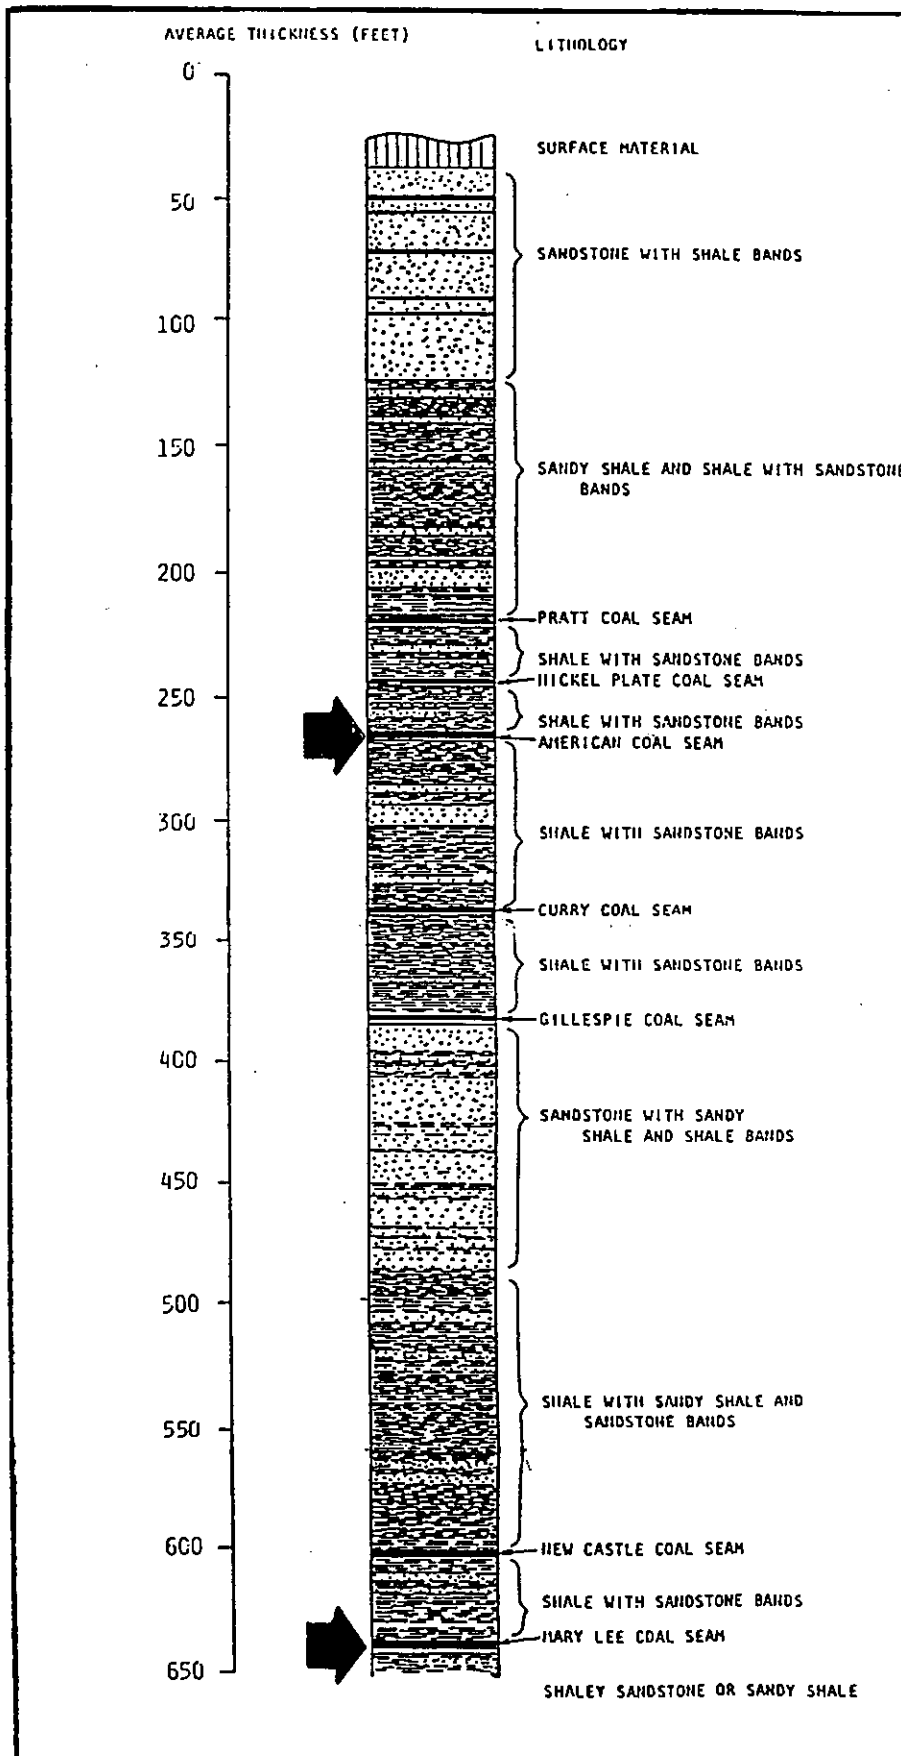
Figure 3 Geology of the Area

The investigation site is situated within the Warrior Coal Basin of Central Alabama. The Warrior Basin lies in the Pottsville Formation of Pennsylvanian age. The American and Mary Lee seams (Figure 3) are part of the Pottsville Formation and had been deep mined at this site.
