DECOMMISSIONING OF TAILINGS AND WASTE ROCK AREAS AT STEKENJOKK, SWEDEN $^{\rm 1}$

Per G Broman and Torbjörn Göransson²

Abstract: The zinc-/copper deposits at Stekenjokk were discovered in 1918. Operations started in 1976 and continued until October 1988. The operation left a 110 ha tailings and clarification pond, a minor open pit, waste rock dumps and surface installations mainly comprising a head frame with ore bins and a combined concentrator, workshop and office building.

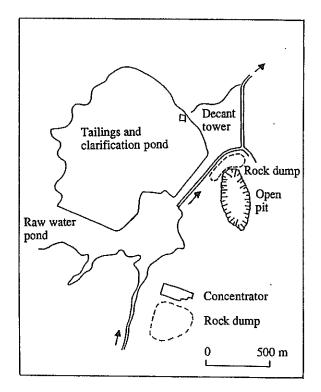
Figure 2. Mining facilities at Stekenjokk.

Remaining in Stekenjokk after operations ceased were a small open pit, a 110-hectare tailings and clarification pond, a dike enclosing Stekenjokk's raw water pond, rock dumps formed from ramp drifting and overburden stripping, and various, aboveground facilities (see figure 2). Table 1. Tonnage and ore contents.

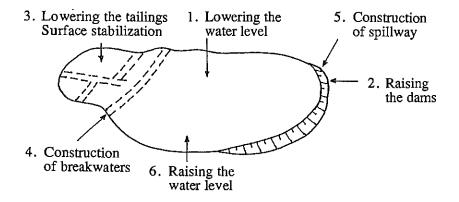
Figure 5. The working out of the flooding solution in detail.

The solution that eventually was formulated required that all stabilizing possibilities be used. As figure 5 demonstrates, this comprehensive action plan includes a large number of interim steps. First, the water level was lowered, and the dykes were raised three meters, the extent permitted by the availability of construction material, mainly moraine. Attaining the required water depth required more than raising the height of the dikes, it also proved necessary to lower the surface of the upstream part of the tailings area. To obtain a decrease in wave force, it was required that a breakwater system be constructed. It was also deemed necessary to superimpose coarse material in the shallow parts for added resistance to shear forces. Other important features of the plan included the design and construction of erosion-stable dikes having a long-term safety factor and able to withstand an earthquake with an intensity of 6 on the Richter Scale, with an epicenter directly under the dikes. Of equal importance was the design of erosion-stable spillway arrangements. Prior to plan approval, we were also required to demonstrate the effect of the lake's water freezing into a complete ice cover.
