Investigation Of Surface Effects From Mine Subsidence In Mountainous Terrain.

By Clyde DeRossett

Proceedings America Society of Mining and Reclamation, 2000 pp 137-143
DOI: 10.21000/JASMR00010137

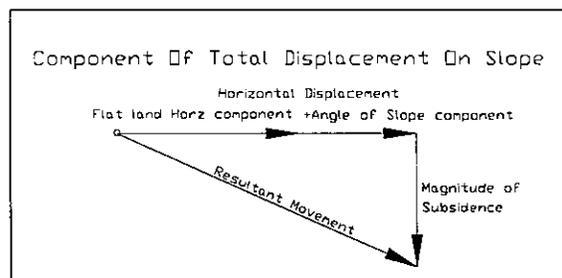
Figure No. 2. (After Lou et al 1996)

Lou et al (1996) studied the increased horizontal displacement on sloping terrain. Comparison of predicted flat land horizontal displacement values to measured values in sloping terrain was done. As he explained, total horizontal displacement can be related to the sum of subsidence, horizontal displacement as calculated for flat terrain and an incremental increase due to the surface slope (see Figure 2). Regression analysis of the data compared movement to the angle of the slope and a combination of the angle of the slope and magnitude of the subsidence. Horizontal displacement was best predicted when both slope angle

and amount of subsidence were used to predict the value. The surface fracture database seems to correlate with this data especially given the fact that so much of the mining in eastern Kentucky coalfields is done in thin seam mines. The dataset indicates that fractures tend to occur in coal mines with a greater mine void height which provide the greater surface subsidence (Figure No. 3). Higher than predicted horizontal displacement and large fractures located on the uphill side of pillared areas also indicate another phenomenon that needs to be considered. Downslope movement of the mountain will result in a compressional stress at the base. This compressive stress can impact structures located on the surface. This phenomena has been documented by others (Lin et al 1987, Khair and Molesky 1988) and has been observed in several cases investigated by the author. The trend of the fractures occurring on the uphill side, with fewer fractures found on the downhill side of the mountain indicates that compressional stresses are likely. It also is good practice when investigating subsidence damage claims to check the location of the uphill side of retreat mining area for evidence of surface subsidence. Absence of any surface fractures however, cannot be taken as proof of no mine

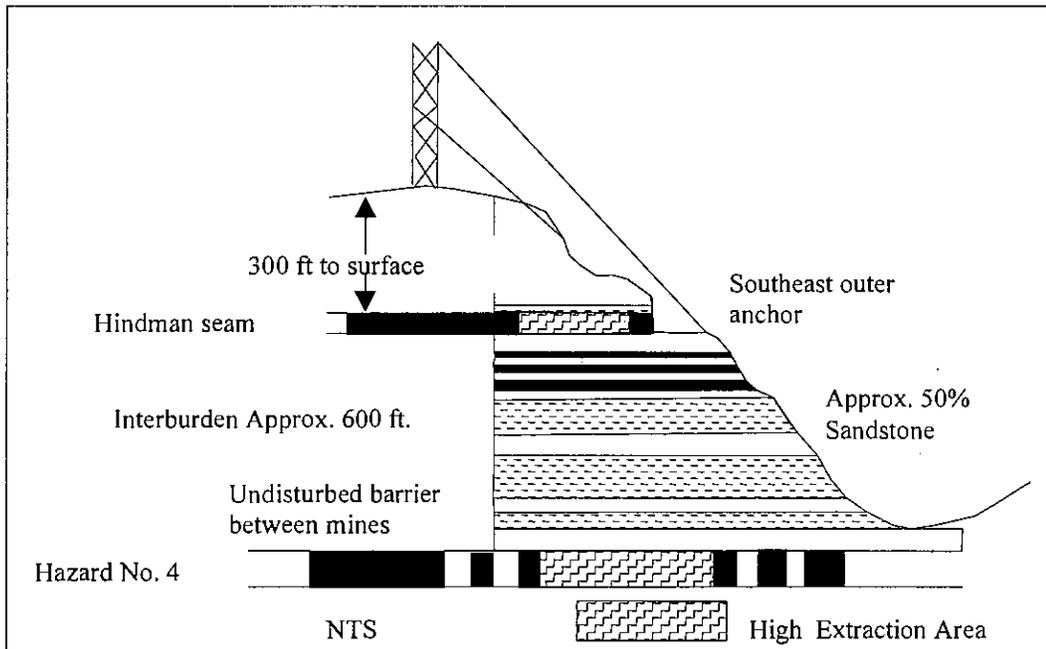
Figure No. 5. Generalized cross section.

be valid for all situations in mountainous terrain. The use of the above mentioned angles seems appropriate in looking at the radius of influence on the uphill side of the high extraction panel. That side of the panel should be experiencing tensile stresses. The presence of any joints in the strata would only tend to reduce the actual extent of strata movement to less than predicted by the above angles. Result of the investigation showed all the surface fractures except the natural joint at the northeast inner anchor, were outside of the expected radius of influence of the mineworks. This information, supported by the information concerning the tower displacement (explained later), allowed a conclusion that this mine had no impact on the tower.

The third mine was located approximately 600 feet above the active Hazard no. 4 mine (about 300 feet below the tower) and had mine works over the area of the tower and the surface fractures (see Figure No. 4b). These mine works were shown to have the mine pillars intact and the pillars were substantial enough to have supported the overburden. Review of the mine map showed pillaring operations only in small areas. The radius of influence for this area would not extend to the fracture closest to the tower. The fourth fracture found in the woods away from the tower plotted at the edge of the pillared area. This would be at a location that we typically locate these fractures. This would give some validation to the mine map accuracy.
