# RELEVELING AND BEHAVIOR OF STRAP RETROFITTED DAMAGED TEST FOUNDATIONS EXPOSED TO MINE SUBSIDENCE<sup>1</sup>

by Gennaro G. Marino, Ph.D., P.E.<sup>2</sup>

**Abstract.** Test foundation walls were constructed in an area of planned subsidence. These crawl space-sized block bearing walls were located in the tension zone of a longwall panel. The test walls were 12.2 m (40 ft) long and were vertically loaded on top with soil bins to simulate the house weight. As the longwall proceeded past these test foundations subsidence movements damaged the test structures. Using a steel strap retrofit and applying a cementitious surface coating, the foundations were structurally and aesthetically repaired. The repaired test foundations underwent significant subsequent subsidence as an adjacent longwall was mined beneath. The response of the repaired foundation is summarized. The second part of the paper describes releveling another set of the damaged test foundations after the first subsidence event by using an innovative procedure. First the straps were applied to the block bearing walls and then with wall jacks the top of the walls were successfully made level. This releveling procedure is ou

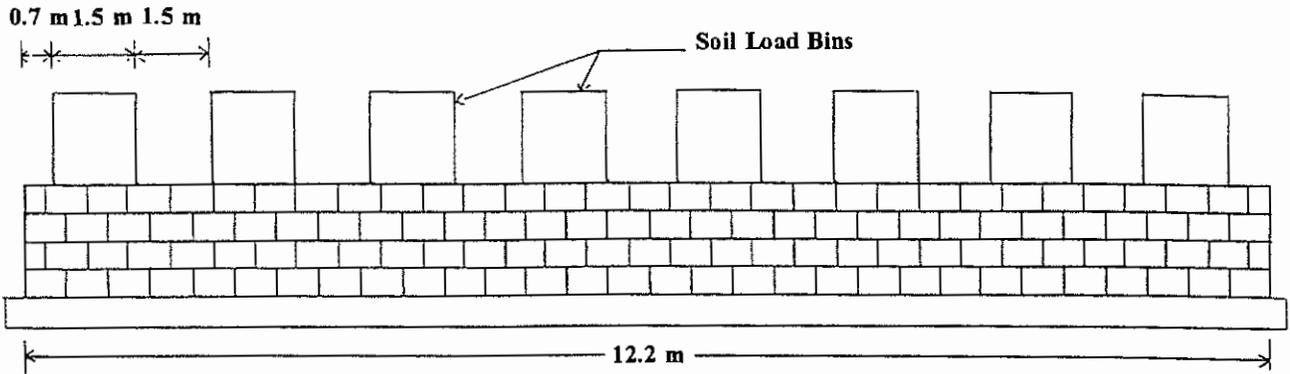
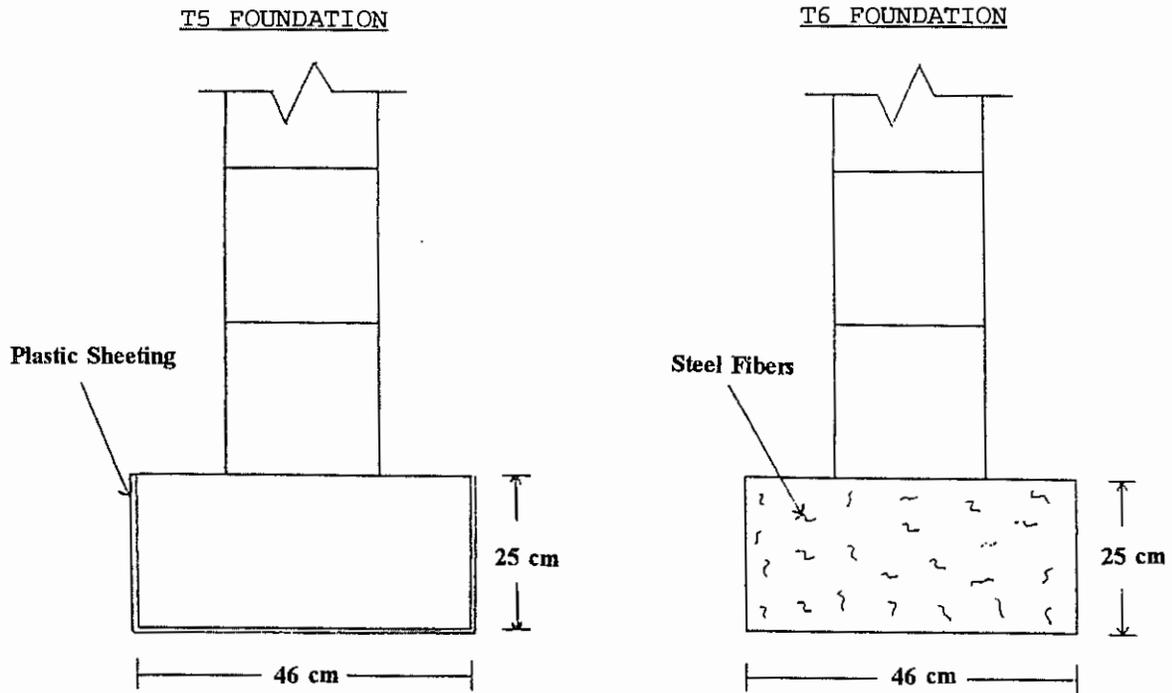
FIGURE 1 CONFIGURATION OF TEST WALLS

One pair of test walls was used for the retrofit test. They were designated as walls T5 and T6. Although the walls were of the same construction, different footing designs were used. The eastern-most foundation wall, T5, was founded on a footing constructed of normal concrete with a 0.004" plastic sheeting around it in an attempt to reduce friction between it and the subgrade. Foundation wall T6 was on a footing constructed of concrete with steel fibers in it. Figure 1 shows cross-section diagrams of the two footings.

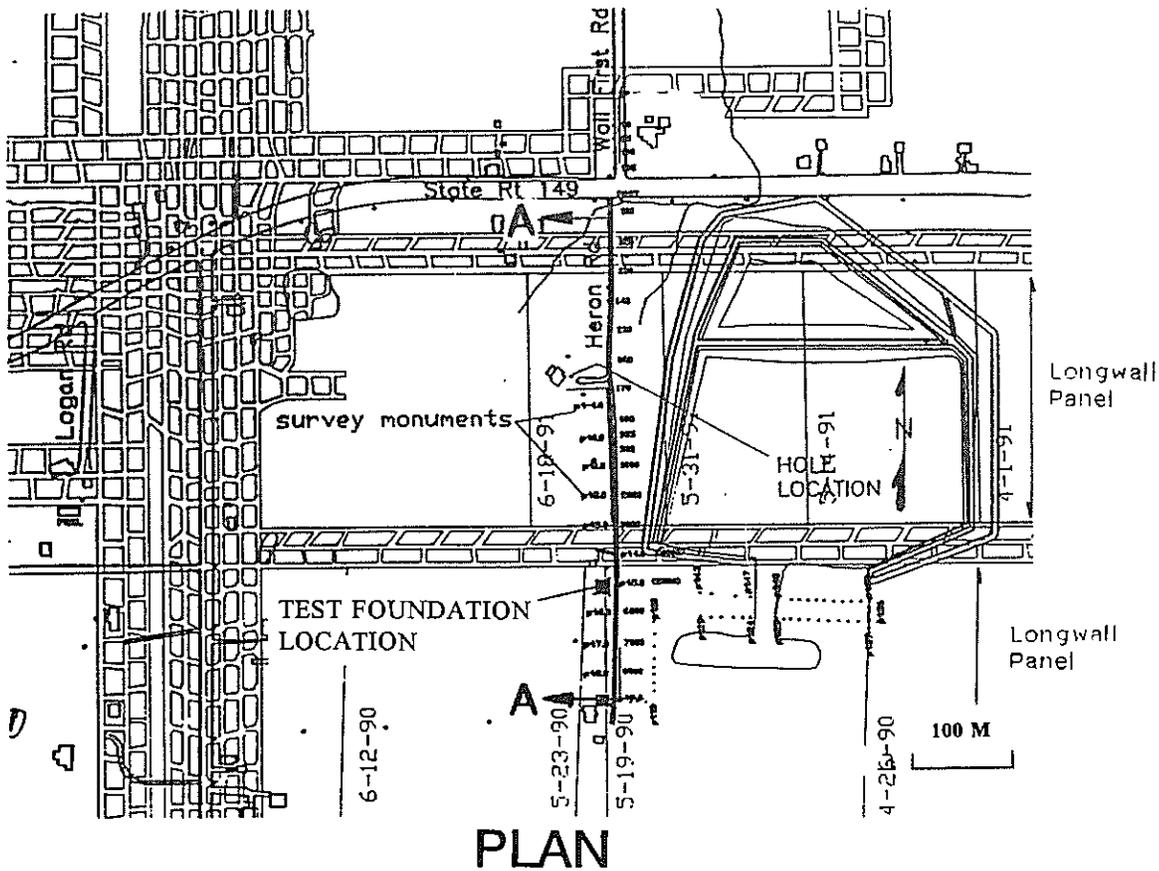
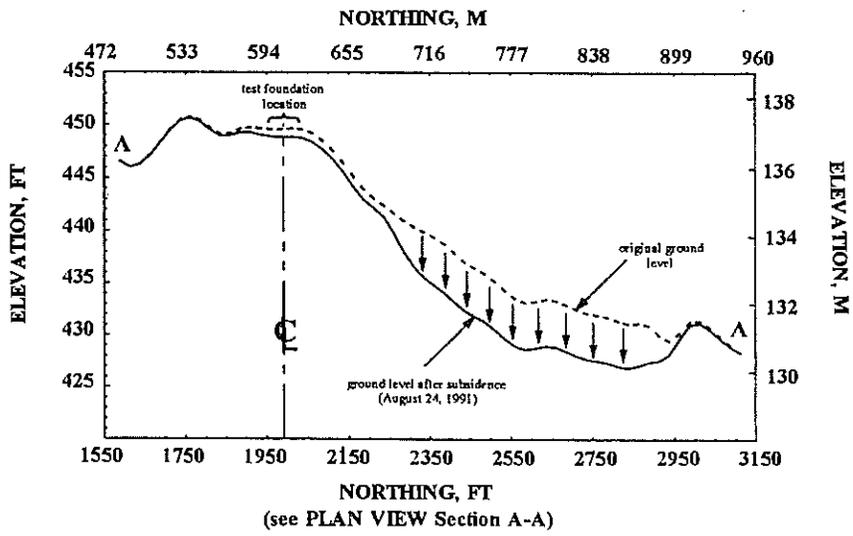
FIGURE 2 POSITION OF THE TEST FOUNDATIONS RELATIVE TO MINING ACTIVITY AND SUBSIDENCE PROFILE

The walls were erected near two future longwall mine panels. Figure 2 shows the location of the north-south test walls in relation to the relevant longwall panels. The walls were built during the spring of 1990 before any subsidence took place. During mid-May of 1990 the face of the first longwall panel was beneath the test site. Significant damage in the walls was induced by the subsidence movement over that panel. Figure 3 shows the main cracking in both T5 and T6 as of May, 1991. The walls were repaired using the new strap technique between 5/13/91 and 5/17/91. The face of the second panel was adjacent to the test foundations in early to mid-June 1991.

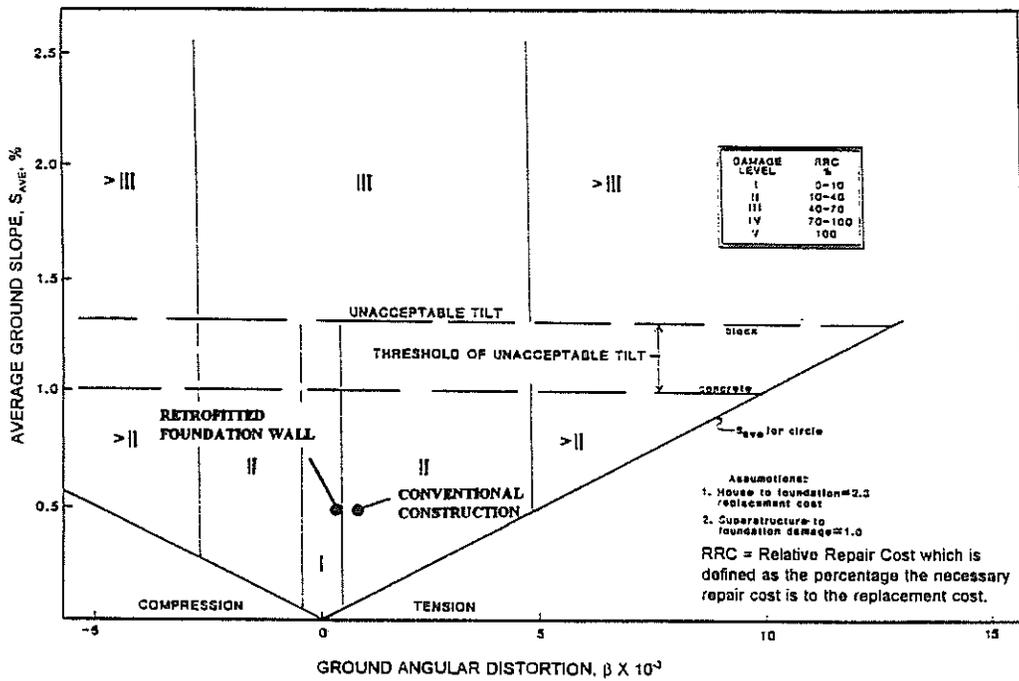
FIGURE 8 DAMAGE LEVELS RELATED TO THE ASSOCIATED ANGULAR DISTORTION AND AVERAGE SLOPE OF THE SAG PROFILES FOR HOUSES ON CRAWL-SPACE FOUNDATION (Marino and Mahar, 1985)

The November 1992 readings indicate the amount of ground distortion and tilt experienced by Foundations T5 and T6 since the repair was sufficient to cause damage to conventional residential construction. The most recent ground movements (shown in Tables 1 and 2) have been plotted on Figure 8. In Figure 8 are damage criteria for sag subsidence for houses resting on conventional block crawl-space foundations. This damage relationship assumes that ground distortion is empirically related to ground horizontal strain, i.e., as a house is exposed to some angular distortion level it is also exposed to a certain amount of ground strain. Therefore, ground strain can be considered to be inherently included in the damage plot shown in Figure 8.

As can be seen in Figure 8 a house exposed to the level of ground movement by the test foundations will likely sustain 10 to 40 percent Relative Repair Costs (RRC). RRC is defined as the percentage the necessary repair cost relative to the house replacement cost. This range of RRC values will usually include minor damage to the foundation and superstructure (see Table 3). At the most, possible replacement of accessory foundation element(s) or partial replacement of the brick veneer would be necessary. As noted above, the bending of the walls was about half that of the ground. This level of distortion reduces the estimated damage to Level I (see Figure 8). In other words, no damage to only RRC of 10 percent would
