MONITORING OF A HOUSE DURING MINING SUBSIDENCE

G. Lin¹, E.C. Drumm², R.M. Bennett², L. Powell³

Proceedings American Society of Mining and Reclamation, 1996 pp 184-203

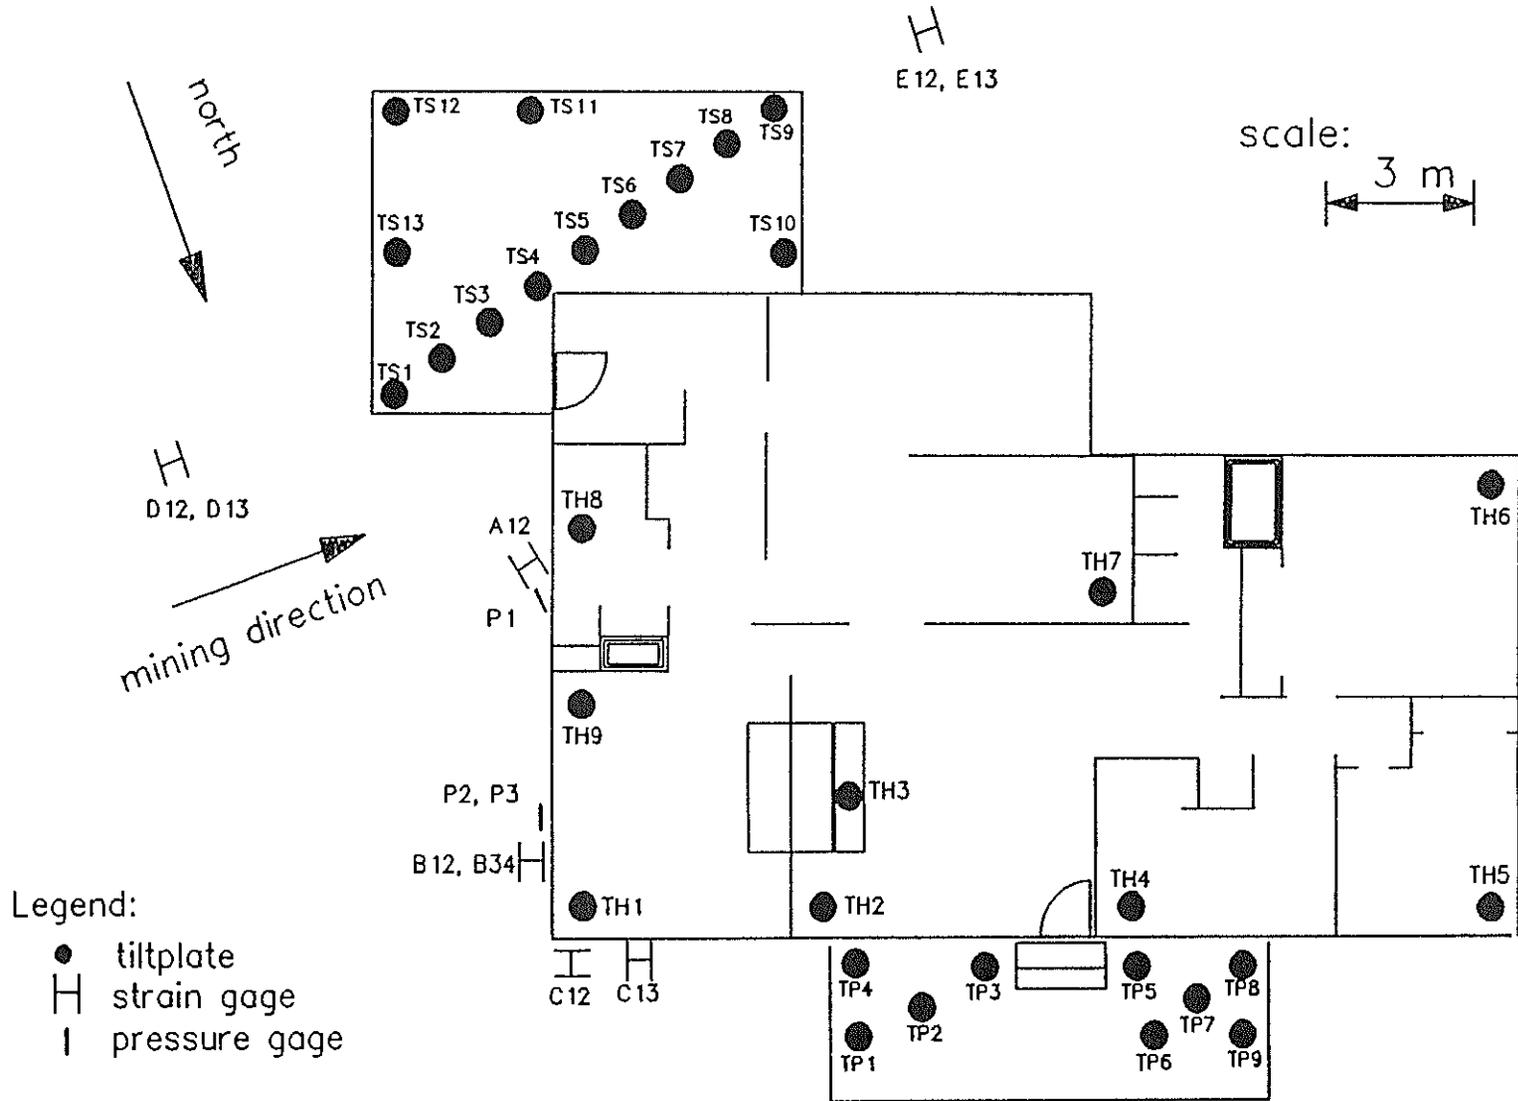
Figure 7 Instrument Locations on the House

The horizontal and vertical movements of the house were measured with a total station survey instrument by monitoring the position of seventy reflector monuments mounted on the structure (Lin 1993). In addition, a series of structural tilt measurements were obtained with tiltplates, and soil strain and lateral soil pressures were measured. The locations of the tilt plates, soil strain gages, and soil pressure gages are shown on a plan view of the house in Figure 7.

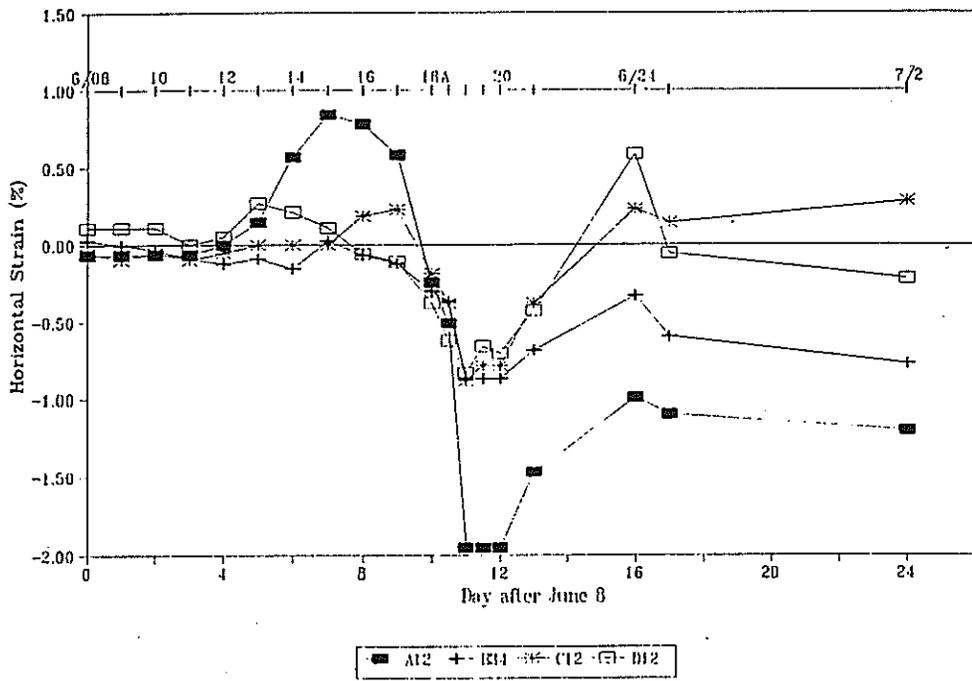
Figure 11 Measured Soil Strain over Time

Bison soil strain gages (Selig 1975; Bison Instruments 1989) were installed at several locations to record the soil strain. The soil strain in the horizontal direction is shown in Figure 11 for four locations. Gages A12, located next to the structure, and gage D12 located away from the structure, were oriented in the direction of mining. Gages B34 and C12 were located adjacent to the structure but oriented relative to the structure as shown in Figure 8. Gage A12 was installed at a depth of 0.6 m, while B34, C12, and D12 were installed at a depth of 0.4 m. The overall soil strain response is similar to the average soil strain over the length of the structure shown in Figure 7, with clear periods of tension (positive strain), followed by compression (negative strain). However, the strain magnitudes are different, and the soil strain gages located adjacent to the foundation were left with residual compressive strain after the subsidence wave passed. The residual compressive strain may reflect the plastic deformation that takes place near the footing during the compression phase. This plastic deformation of the soil is thought to cause the residual tension in the footing after the subsidence is complete. The gage length of the soil strain gage measurements was typically about 100 mm, which is much smaller than the gage length of nearly 20 m used to calculate the soil strain in Figure 7. Therefore, differences in the measured strains are not unexpected.

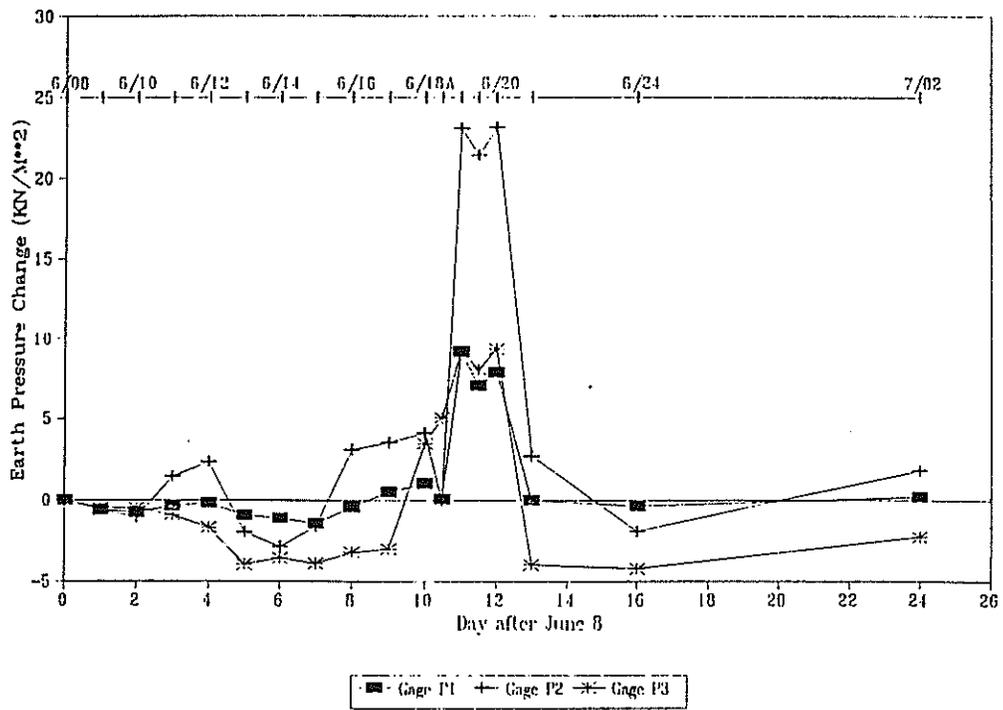
Figure 12. Change in Lateral Soil Pressure over Time

Soil pressure gages were installed to record the lateral earth pressures during the subsidence event. Lateral earth pressures can cause significant damage, especially to structures with basement walls. The soil pressure gages were located between the foundation wall and the surrounding soil. As shown in Figure 8, the pressure gages were oriented with the Bison soil strain gages. The recorded change in soil pressure during the subsidence event is shown in Figure 12. Although the magnitude of the compressive pressure differs from gage to gage, the trend of the pressure variation is similar. A

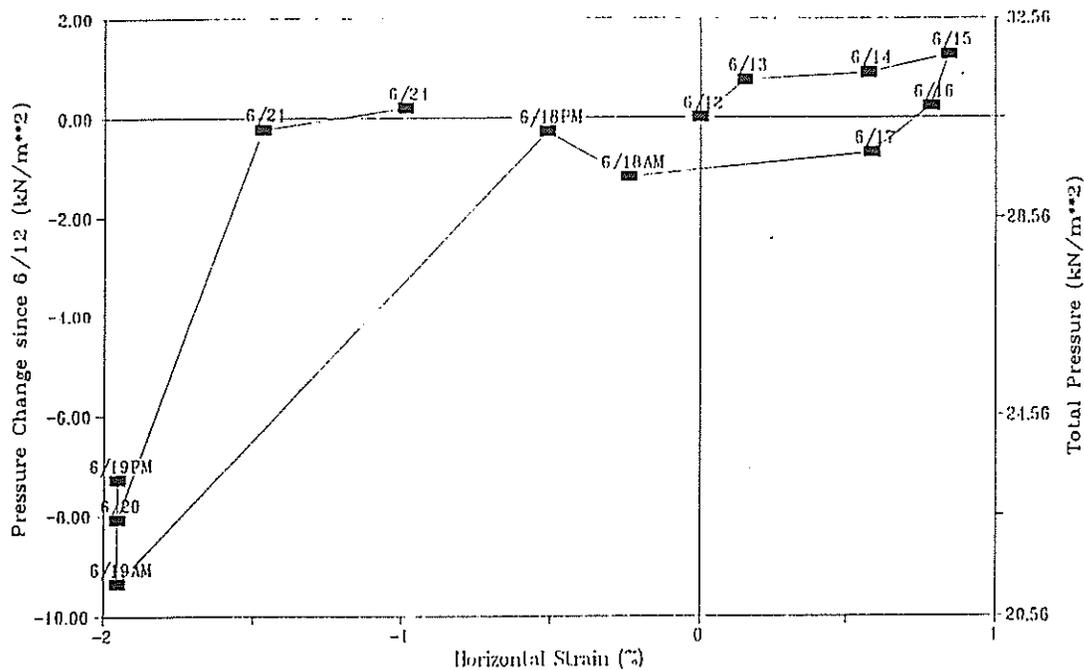
Figure 13 Soil Stress-Strain response during Subsidence

Since soil pressure gage P1 and soil strain gage A12 were installed at nearly the same location, the results can be combined to produce a lateral stress-strain response curve for the soil as shown in Figure 13. In this curve, the initial tensile strain and pressure are shown as positive, with the subsequent compression loading shown as negative. These instruments recorded much larger strain and stress during the compression phase than during the tension phase.
