# CONTINUOUS LIFT PIERS: DAMAGE REPAIR AND RESPONSE DURING SUBSIDENCE<sup>1</sup>

**Abstract:** A series of test foundations damaged during a longwall mining operation were left with permanent tilt, curvature, and substantial cracking. Two of the foundations were releveled using continuous lift piers. The continuous lift piers removed the tilt and curvature and significantly reduced the width of the foundation cracks. Following the releveled of the foundations, an adjacent longwall panel was mined, resulting in additional subsidence, although of smaller magnitude. The response of the releveled foundations was monitored and compared with the response of a footing that was not releveled. Although the continuous pier system does not strengthen the structure and distortion was observed during the second event, the system permitted the deformations to be removed in a few hours.

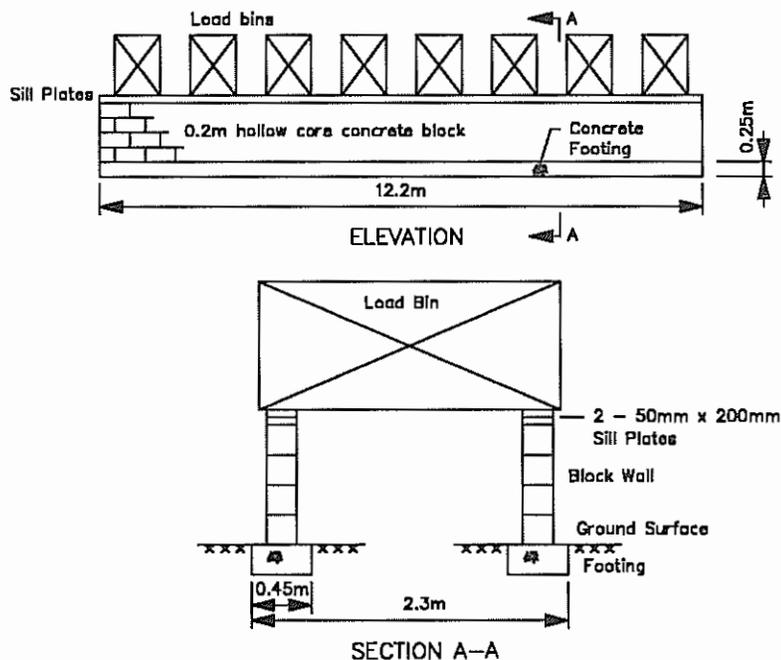
Figure 1. Schematic of test foundations and load bins.

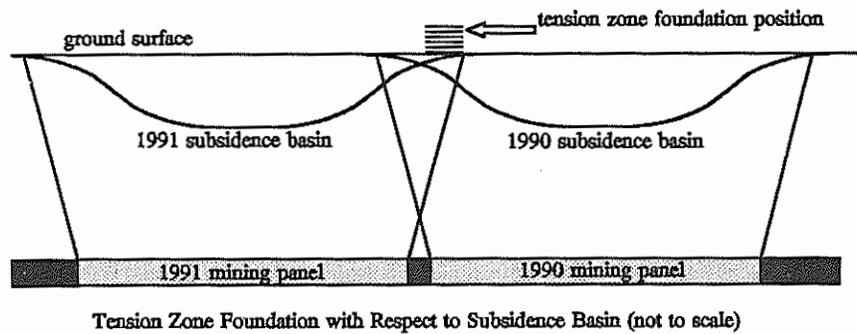
Figure 2. Relative location of tension zone foundations with respect to 1990 and 1991 mining panels.

The foundations were monitored during the second (1991) subsidence event with a precision level and tiltmeter. The deformation of the nearby ground was measured with a level and total station. Subsidence from the first (1990) panel was essentially complete by August 1990, and subsidence from the 1991 panel was not significant until late June 1991. The subsidence of the reinforced concrete footing is shown in figure 6. Maximum subsidence was about 0.26 m, with slightly more settlement at the north end than the south. Unlike the first subsidence event, the second event yielded nearly uniform ground deformations, resulting in minimal curvature in the foundations. During the 1991 subsidence, the foundations were located just outside the zone where maximum tension is expected, as shown in figure 2.
