# ACID MINE RECLAMATION IN SPOTSYLVANIA COUNTY, VIRGINIA, USA: USING WATER CHEMISTRY AND VEGETATION RE-ESTABLISHMENT AS A MEASURE OF SUCCESS<sup>1</sup>

Robert G. Sobeck, Jr.<sup>2</sup>, James E. Perry, Allen Bishop, and Edward Epp

Proceedings American Society of Mining and Reclamation, 2008 pp 1039-1069

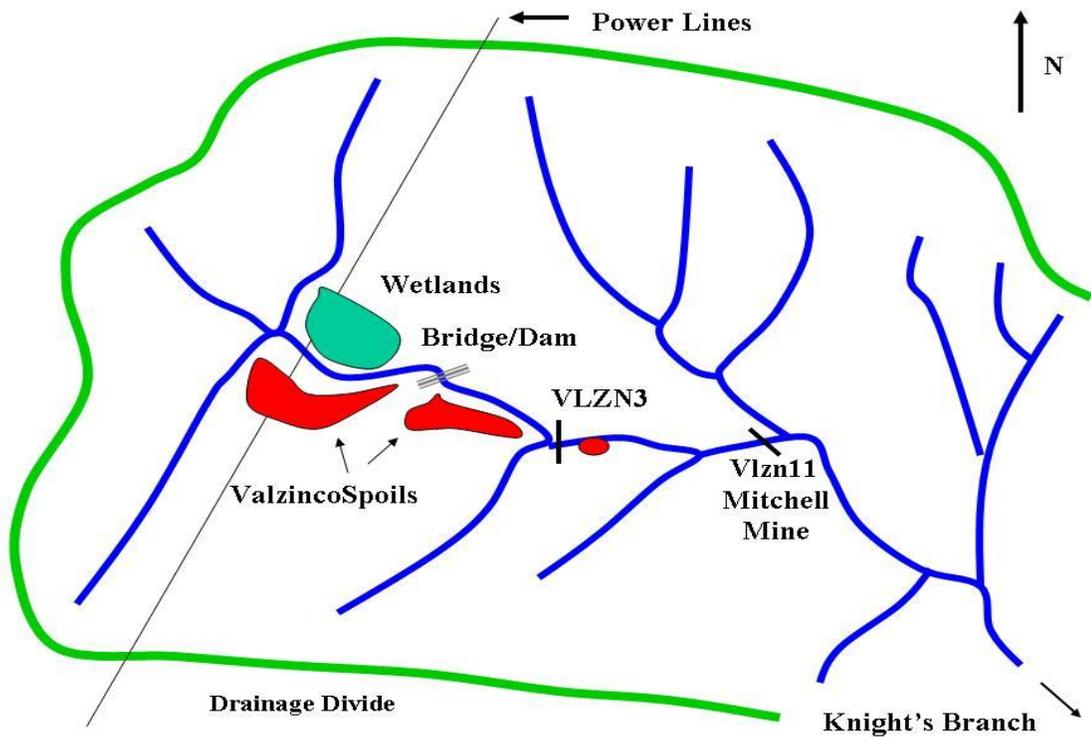
Figure 4. Arrangement of mine spoils in upper Knights Branch watershed (USGS, 1983).

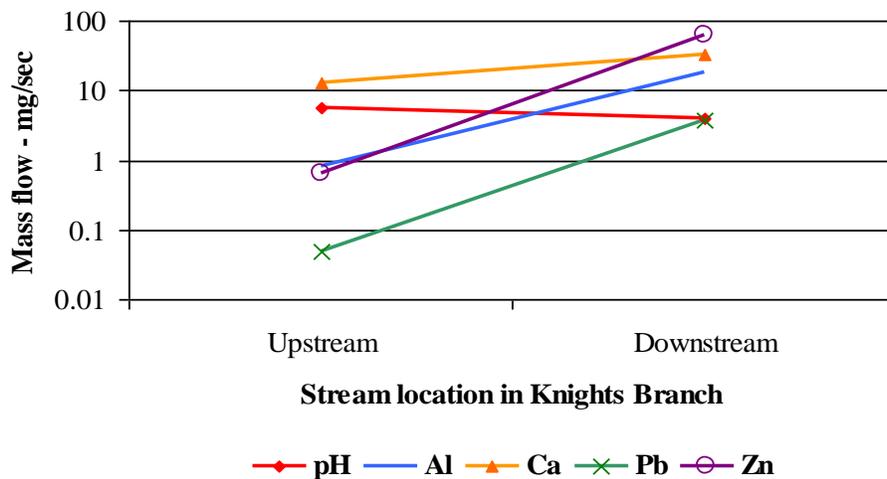
The data was used to calculate mass-flow conditions in Knights Branch for each constituent and relate the impairment to the pH as shown in Fig. 5.

Location	Flow L/s	pH	Alkalinity	Calcium	Lead	Zinc	Aluminum
Upstream	7.5	5.6	1.6 mg/l	1.7 mg/l	0.007 mg/l	0.085 mg/l	0.15 mg/l
Downstr.	21.2	3.9	None	1.5 mg/l	0.18 mg/l	2.9 mg/l	0.83 mg/l

Figure 5. Instantaneous mass-flow of selected metals in Knights Branch, upstream and downstream of Valzinco Mine, prior to reclamation.

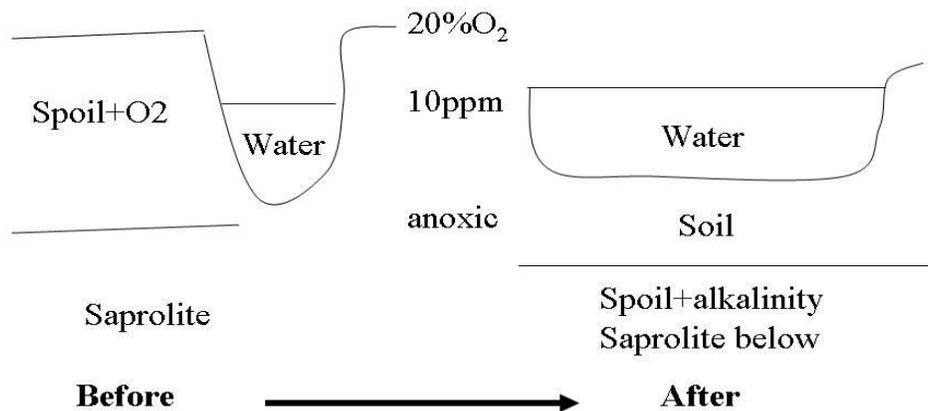
As depicted in Figs. 9 and 10, the spoils mass was greater than 3 meters deep on the upstream side of the dam at Valzinco and the downstream spoils were typically above the water level of Knights Branch when flows were below bankfull-stage. The environmental objectives of reclamation design at Valzinco were as follows and shown conceptually in Fig. 11:

Figure 11. Conceptual design for the conditions in Knights Branch watershed at Valzinco above and below the dam site.

- a. Separate the occurrence of the free oxygen interface from the mine spoils;
- b. Promote the expansion of wetlands over the saturated spoils and provide a temporary source of alkalinity until naturally occurring alkalinity develops in the anoxic zones of the sediments;
- c. Reduce the uptake of metals by vegetation in wetlands;
- d. Reduce fluvial transport of mine spoils downstream in the Knights Branch watershed;
- and
- e. Alter ground water chemistry occurring near the surface of the floodplain at Valzinco to promote anoxic conditions.

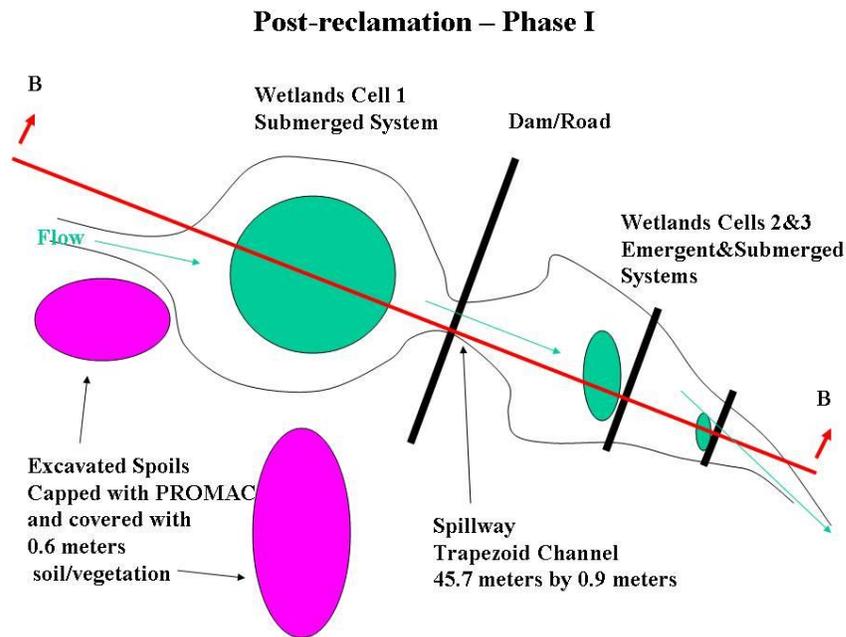
Figure 12. The surface design for reclamation of Valzinco Mine and restoration of Knights Branch.

Fluvial forces are the most efficient mechanism of sediment transport (i.e., mine spoils) through a watershed. The objective of reversing the biogeochemical processes developing AMD had to be achieved while accommodating the naturally occurring discharge of Knights Branch under flood conditions. The reclamation design completed by the authors at Valzinco accomplishes the following (see Figs. 12 and 13):

- e. Maintained the subsurface hydrologic regime and ground water levels as currently established while diffusing prior channel flow (depths of 1.83 to 3.05 meters) across the dam and back to the location of the former incised channel carrying the stream. This maintained saturated conditions in the soils supporting the wetlands while reducing fluvial transport under flood;

- h. Promoted low-profile aquatic vegetation in the wetlands cells to avoid uptake of dissolved metals as root growth remains within clean soil cover;
- i. Decreased slopes to reduce erosion potential;
- j. Confined spoils to small areas in landfills and decreases percolation of precipitation; and
- k. Established ground water monitoring wells throughout the valley, above and below the dam, to monitor ground water quality discharging to Knights Branch.

As stated previously, this design altered the overall site to preclude AMD from developing. This was accomplished in saturated riparian lands by shifting the oxidation-reduction potential above and within spoil masses to favor reducing conditions. Buried limestone was sacrificial alkalinity for promotion of vegetation. As reducing conditions develop in anoxic sediments of the wetlands, the biogeochemical cycles yield alkalinity and preclude oxidation of the various metal complexes within the spoils (Herlihy, 1984, Moval, 1986). The geomorphic elements of the design control flood waves and promote normal transport of watershed sediments (see Figs. 18 through 20). The two landfills confined spoils to a small “footprint” and have developed vegetation over the soil caps.

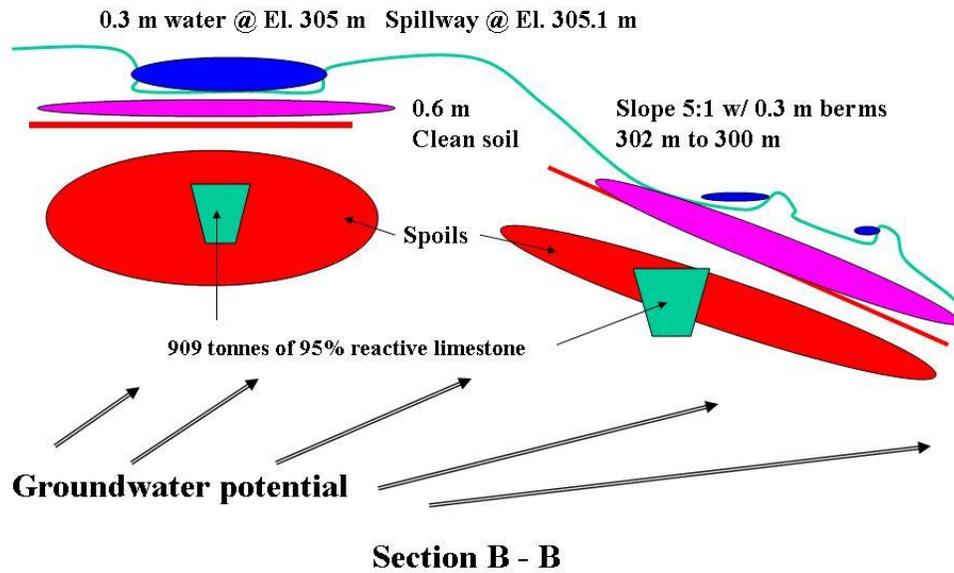
**For 25 year storm ~ 0.46 meters wave over spillway**

Figure 13. The subsurface aspects of the reclamation-restoration design in Knights Branch.

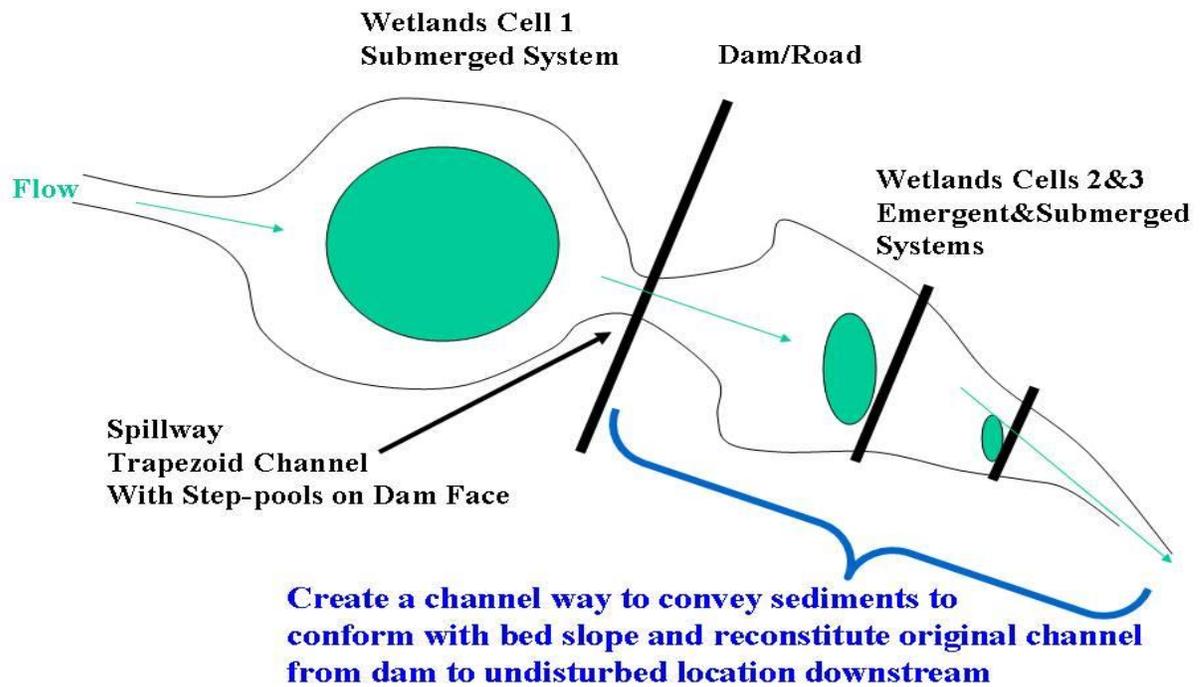
Figure 19. Added design features along Knights Branch to match hydrology to the geomorphic features of the valley.

The bankfull stage for the stream channel was established and an equivalent channel designed and constructed on the downstream face of the dam and at the discharges of the wetland cells (ends of arrows). Figure 19 represents the final design details for completing Phase II in Knights Branch. In this phase, the channel was reconstituted along the southern side of the valley in the location of the former incised channel prior to the construction of the dam. Periodic flood waves over the dam caused erosion on the downstream face, over the location of the pre-mine channel, as indicated in Fig. 20.
