# **Geomorphic Reclamation of Abandoned Coal Mines near Raton, NM**

#### The Swastika Mine and Dutchman Canyon Reclamation Project

Design and Construction Oversight

Presented By: Kate Malers, P.E.: Water & Earth Technologies (WET)

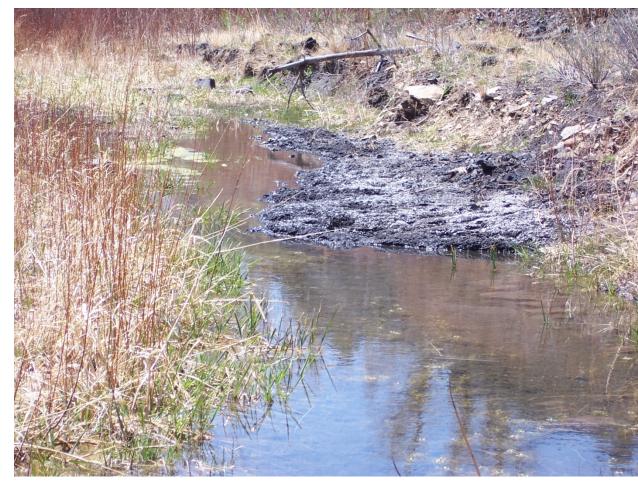
The "Dillon Canyon Stream" is an emphemeral tributary, with scattered perennial pools.

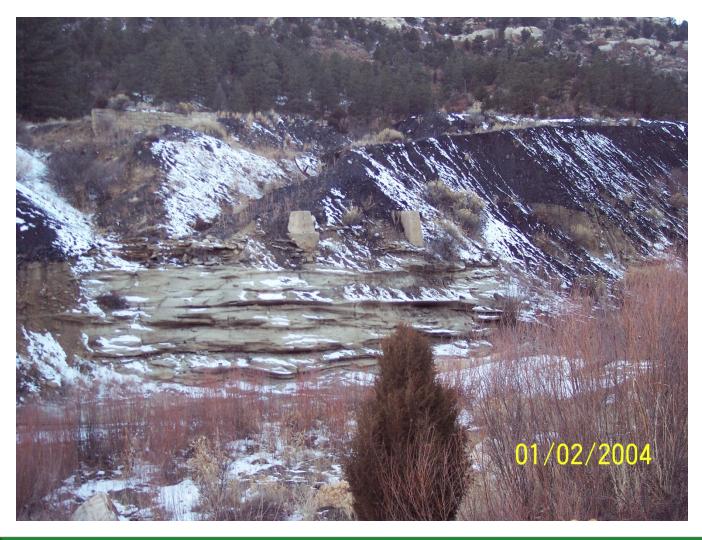
- Determining the design volume of coal waste to be reclaimed, given uncertainties about the underlying "native" landform obscured by the pile
- Determining appropriate slopes and slope lengths for reclaimed landforms that will have no underlying geologic structure

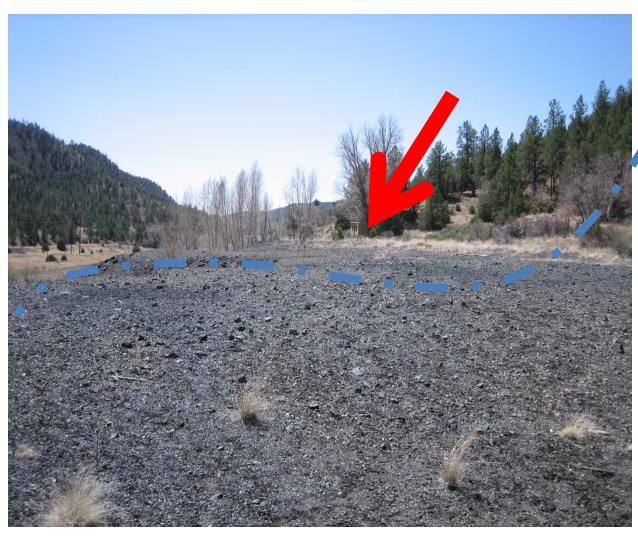
- Conveying runoff from the undisturbed hillside across the reclaimed landform and into the channel
- Preserving a row of archaeological features lying at the base of the hillside behind the bench of coal waste.

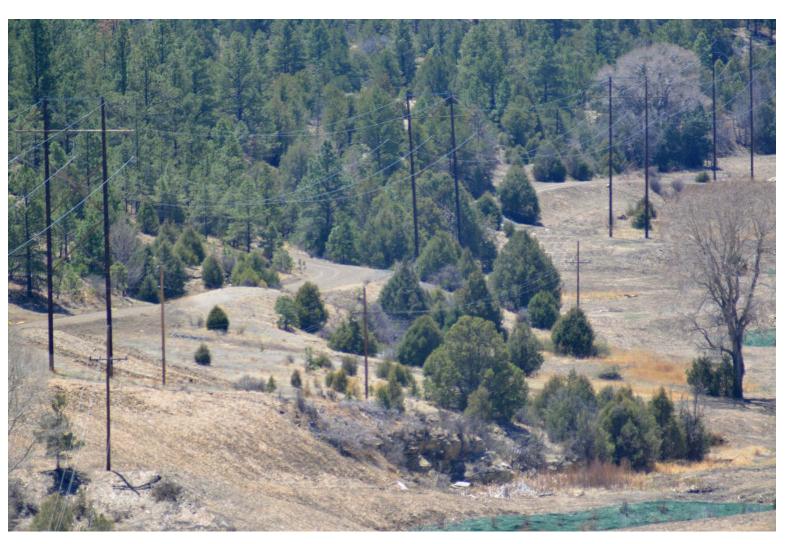
- Scattered archaeological features
- Power poles (during the design phase), and power lines (during construction)
- Scattered resources including mature trees and wetlands
