TREATMENT SYSTEM RESTORATION AND POWER GENERATION IN THE SLIPPERY ROCK CREEK WATERSHED

Presenters: Ryan M. Mahony & Daniel A. Guy

Slippery Rock Watershed Renaissance Initiative

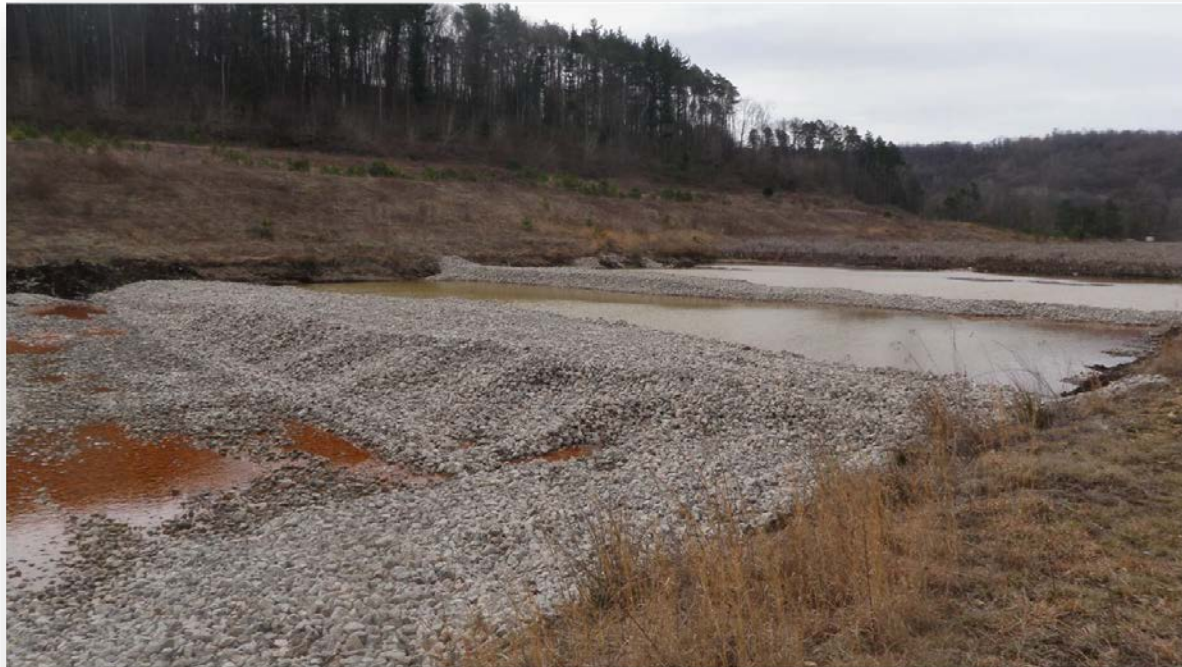
HFLB Draining

- In 2013, horizontal flow limestone bed (HFLB) became plugged
- Attempted backflushing, little improvement
- Stirring of HFLB recommended

- Rehabilitation July-August 2015
- Sediment pond construction for retaining sludge
- Washing/stirring HFLB stone
- Improved design of HFLB

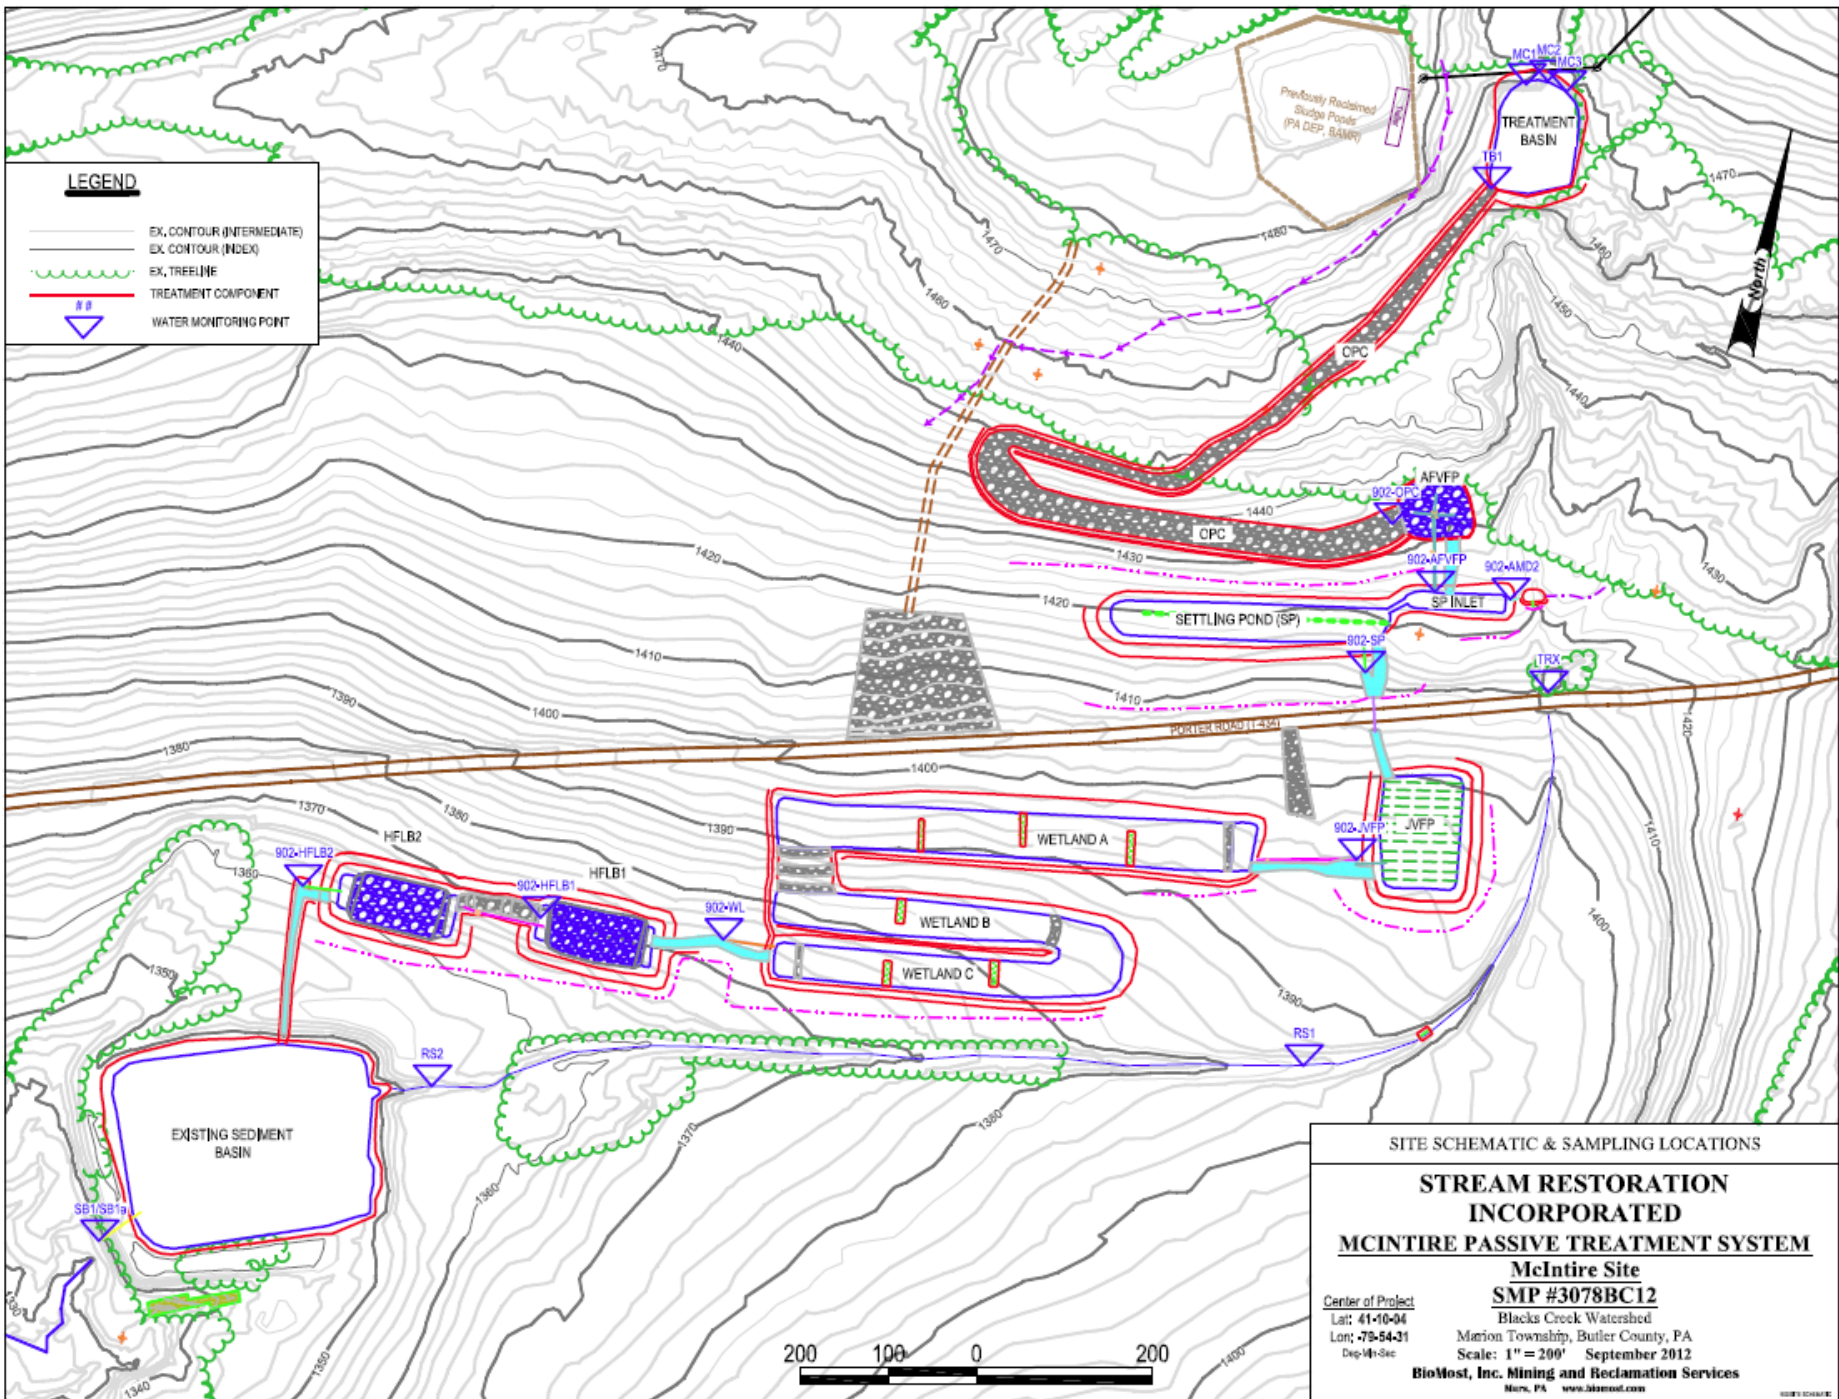
SITE SCHEMATIC & SAMPLING LOCATIONS

- After construction, issues with water retention in wetlands
- Constructed on previously mined land
- Best available on-site material compacted & used to construct components
