# Slippery Rock Creek Stream Bank Stabilization

Daniel Guy
Geologist
Stream Restoration Inc.

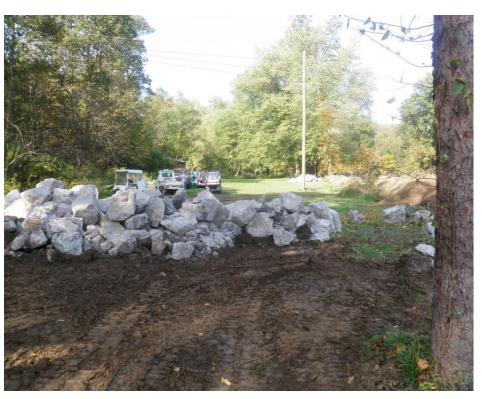
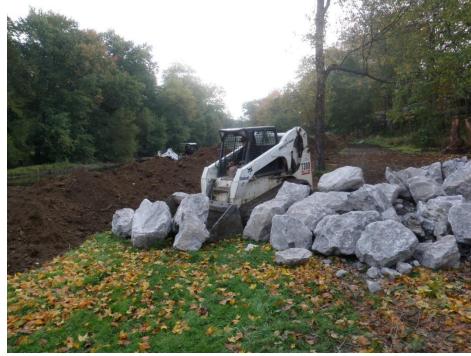
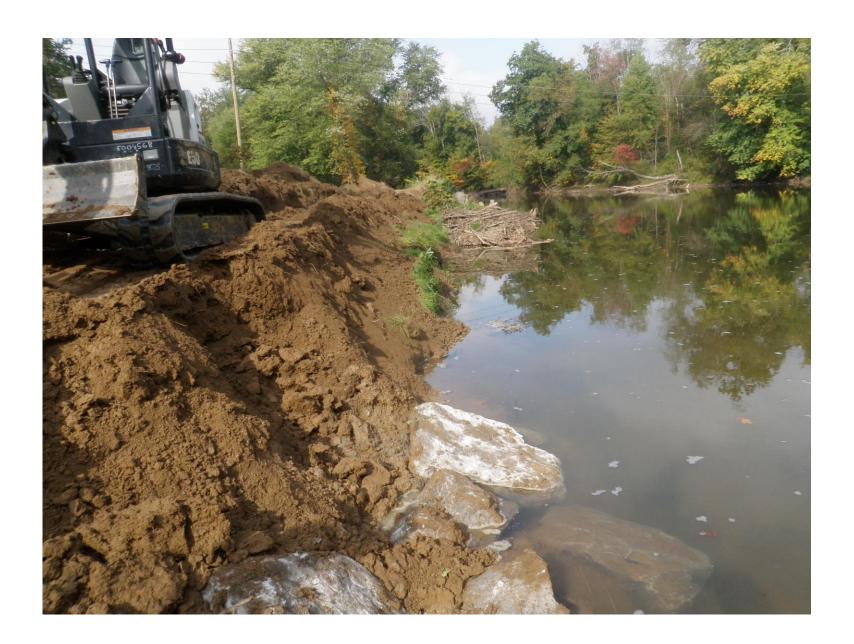
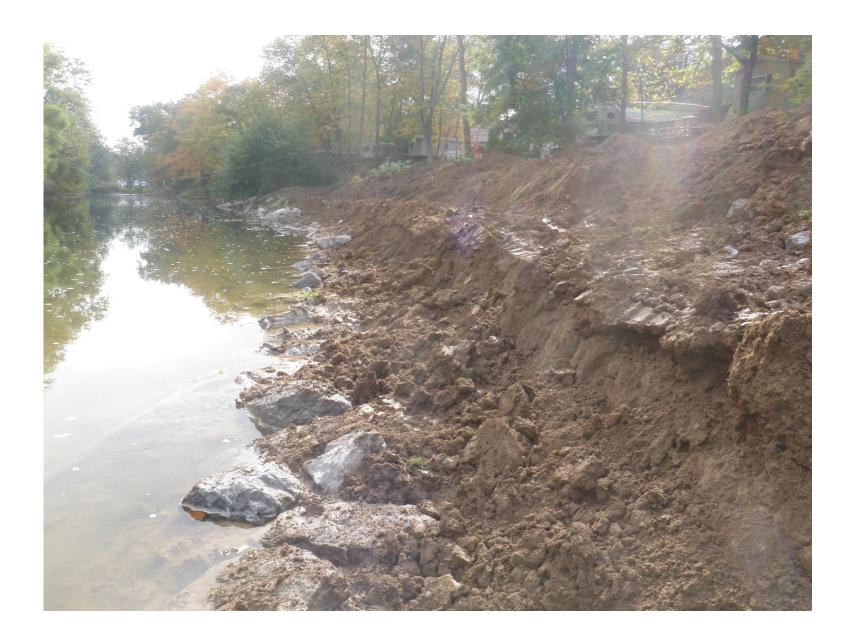
## **Construction Phase 2:** *Riprap*

- Limestone boulders that range from 12in-36in
- Used for slope stabilization and erosion control

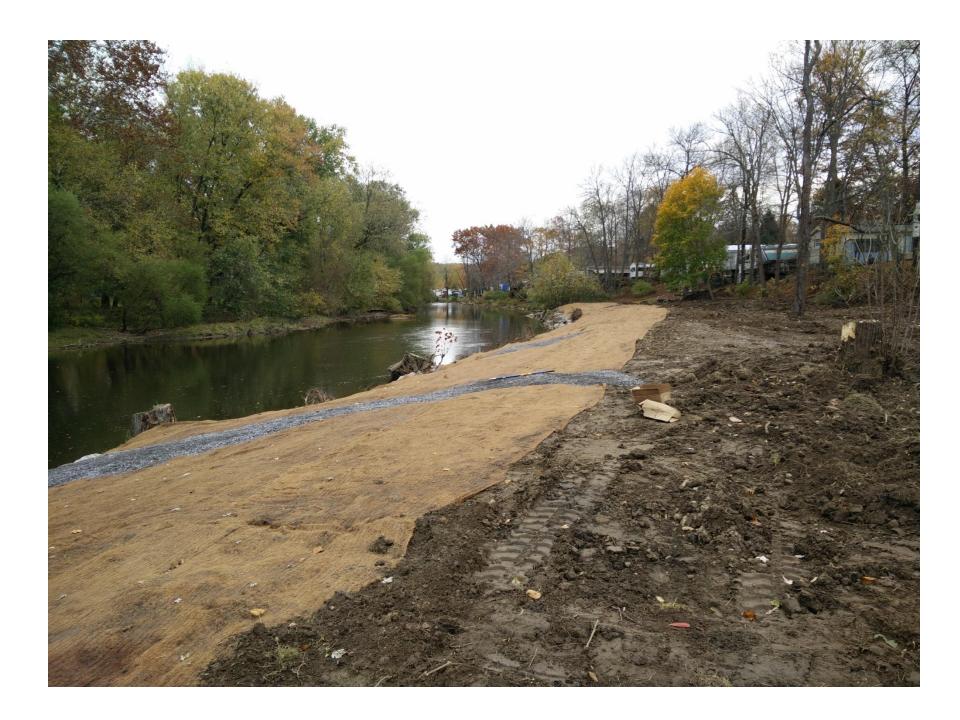
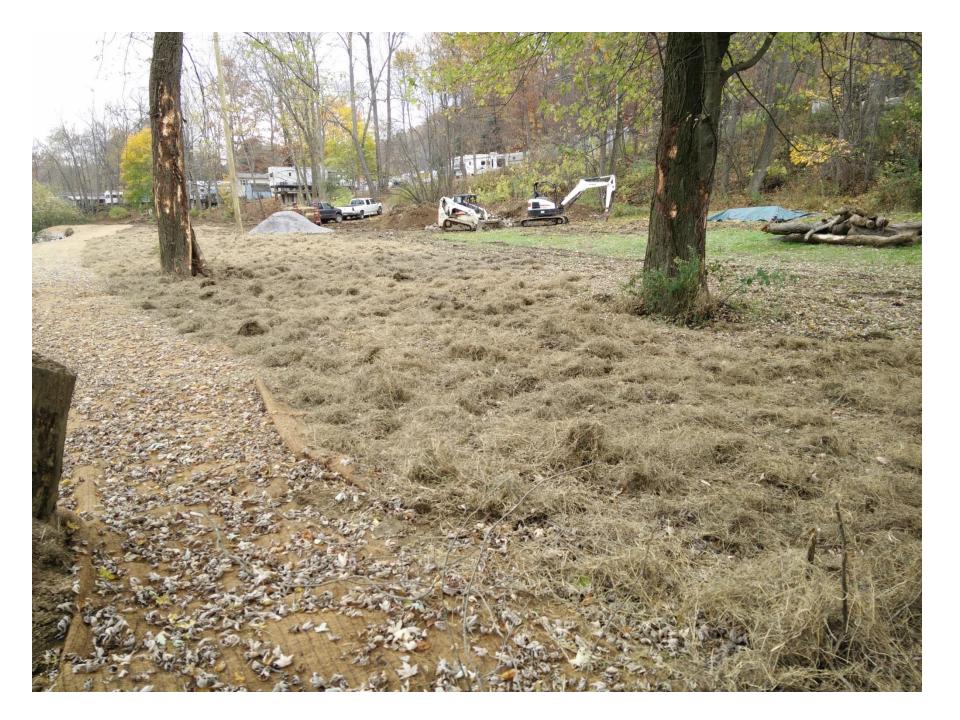
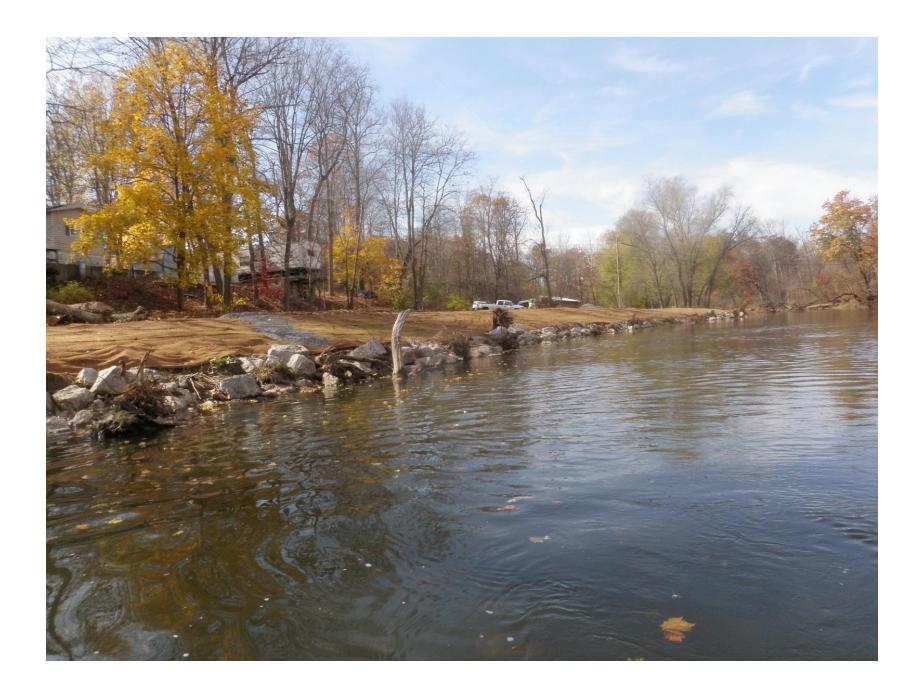
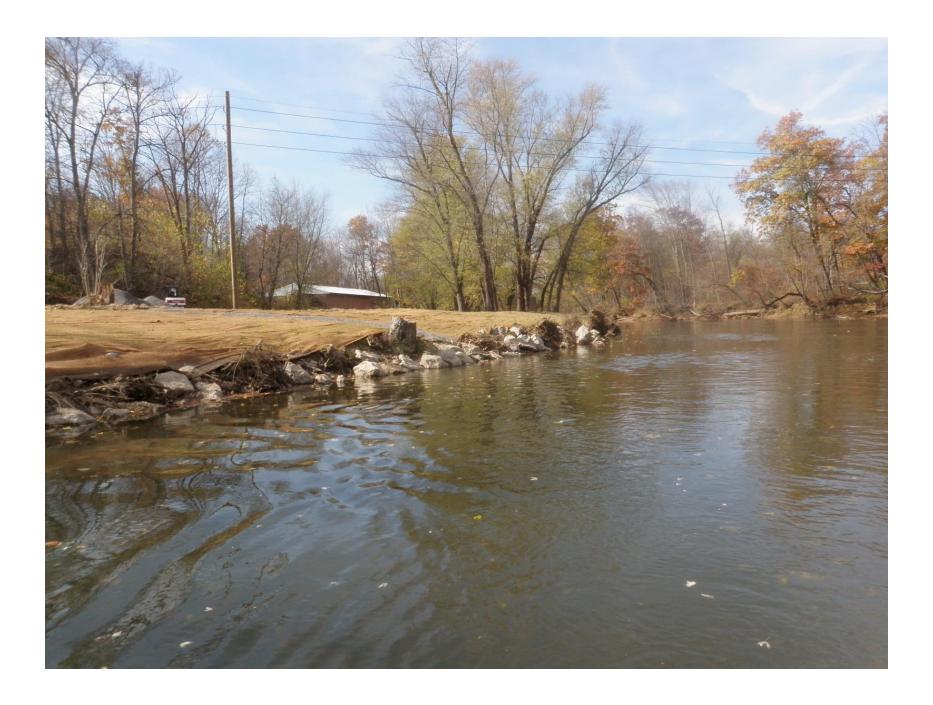
Coconut fiber erosion control blankets were laid along the bank and stapled in place to provide temporary erosion control until vegetation can take hold. Gravel was then placed on the designated paths to allow unrestricted access to the stream for fisherman and other recreational activities.
