Targeted Maintenance Efforts to Ensure a Decade of Successful Passive Treatment

Robert W. Nairn

School of Civil Engineering and Environmental Science

Mayer Ranch Passive Treatment System, Tar Creek Superfund Site, Commerce, OK

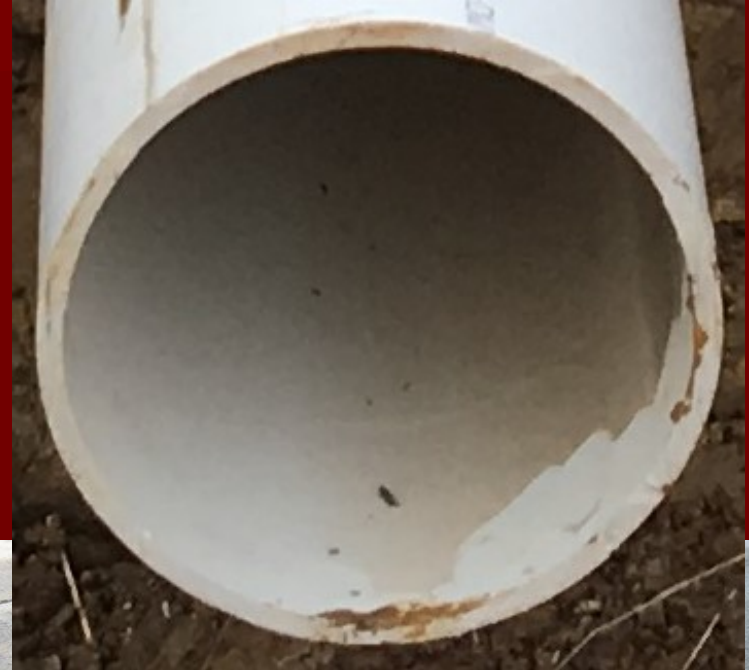
Pipe is clogged? Snake it!

- Rented sewer snake
- Tried every head attachment known to man
- Cloudy water, but no evidence of clog
- Reestablished flow for a few days/weeks

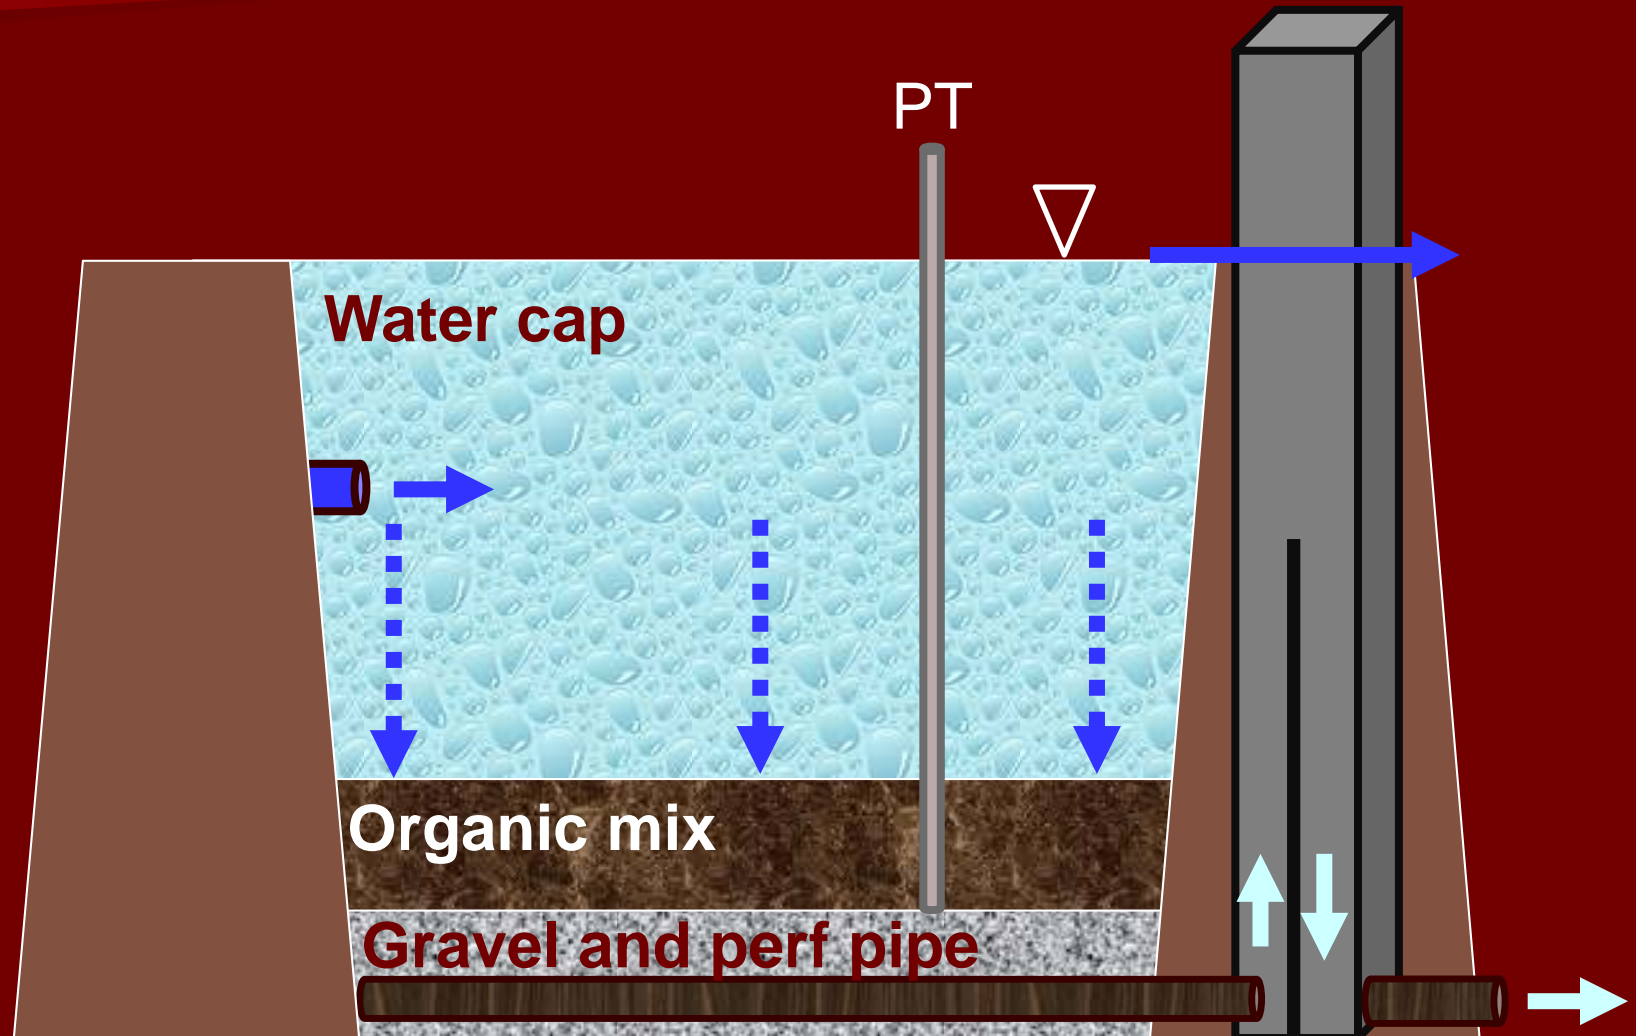
Field-Falling Head Tests

K (m/day)	
	C3N VFBR	C3S VFBR
2008 (pre-construction)		
Laboratory-Falling Head	4.77	4.77
2016 (8-years operation)		
Laboratory-Falling Head	0.51	---
Field-Falling Head	0.13	0.31
Modified Infiltrometer	0.19	0.17
Slug Test	1.25	0.43

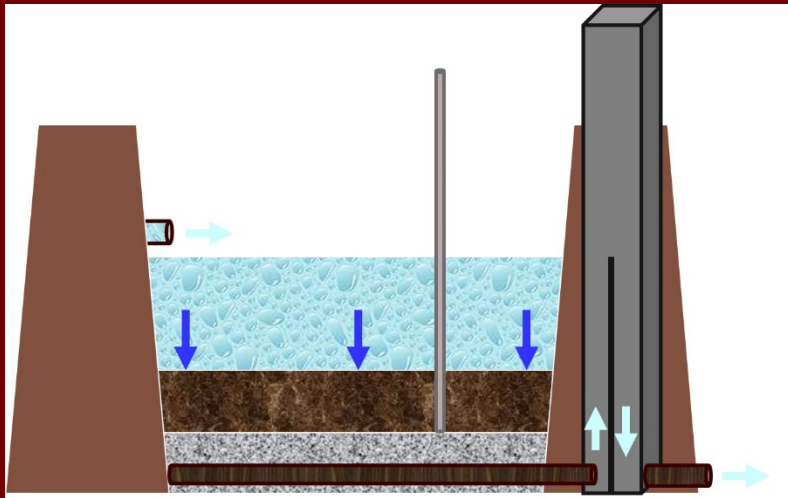
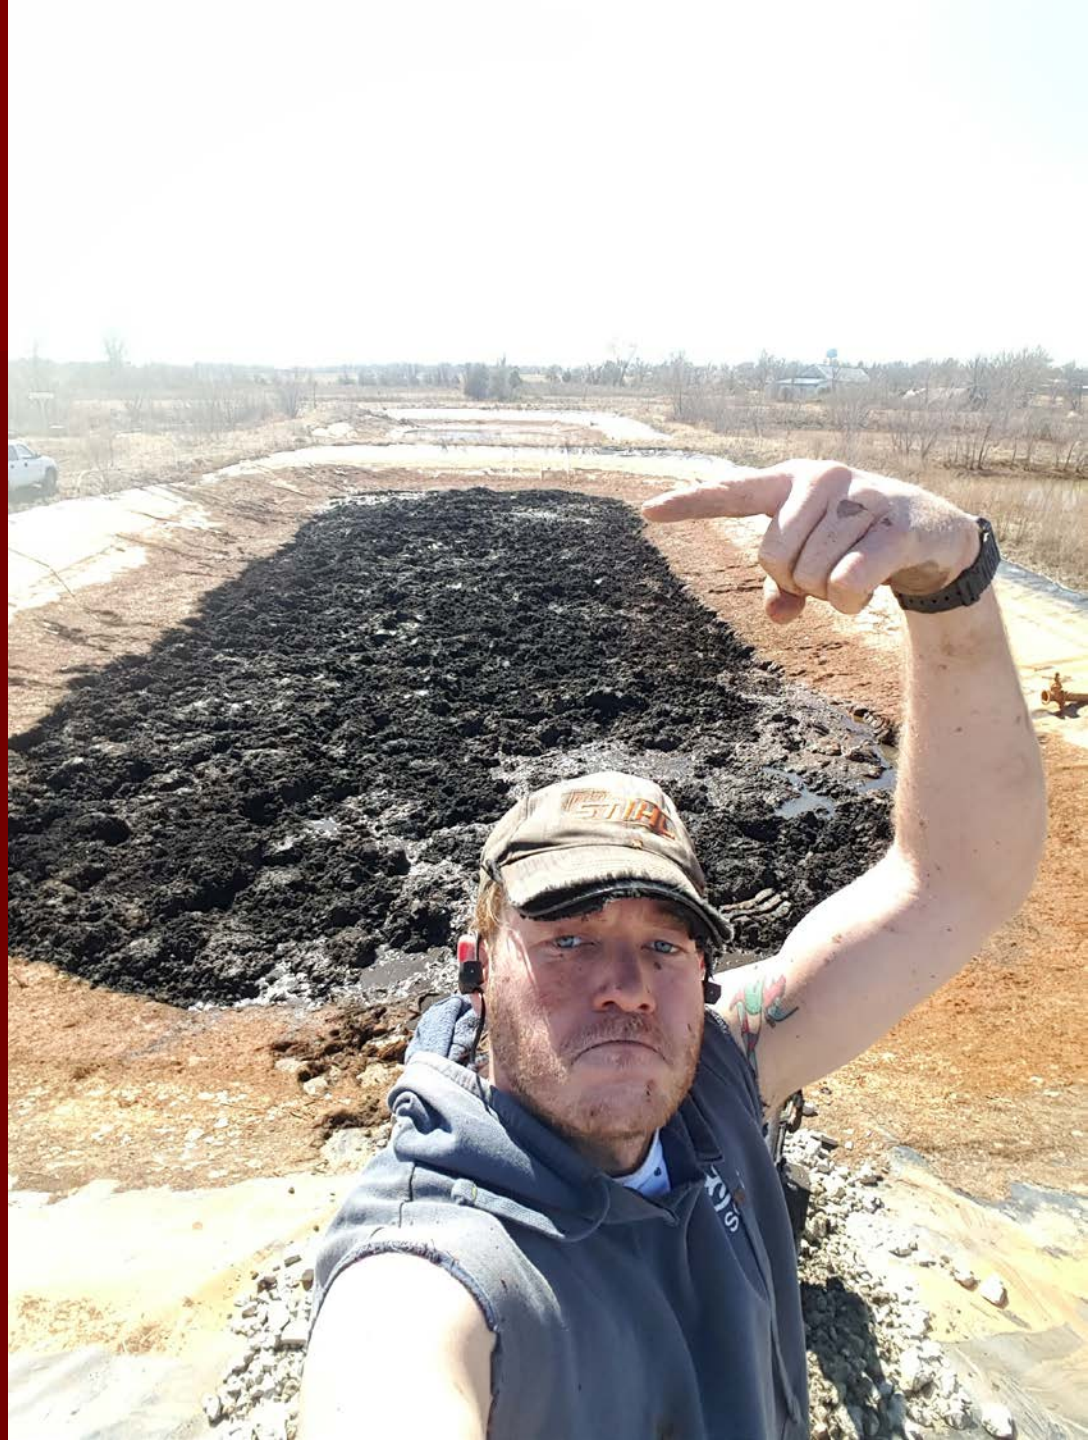
Proud Co- Author

- Field-Falling Head Test

K (m/day)	
	C3N VFBR	C3S VFBR
2008 (pre-construction)		
Laboratory-Falling Head	4.77	4.77
2016 (8-years operation)		
Laboratory-Falling Head	0.51	---
Field-Falling Head	0.13	0.31
Modified Infiltrometer	0.19	0.17
Slug Test	1.25	0.43
2017 (after flipping)		
Field-Falling Head	4.5	4.5
