# McDonald, PA Carbon Dioxide Gas Investigation and Remediation

September 2021 – May 2022

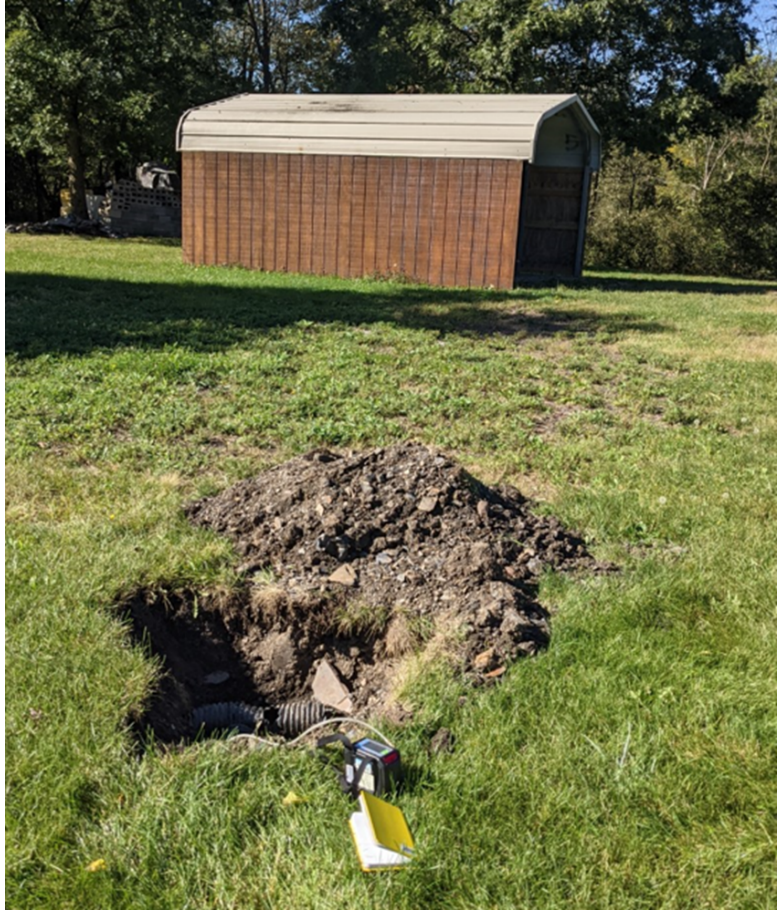
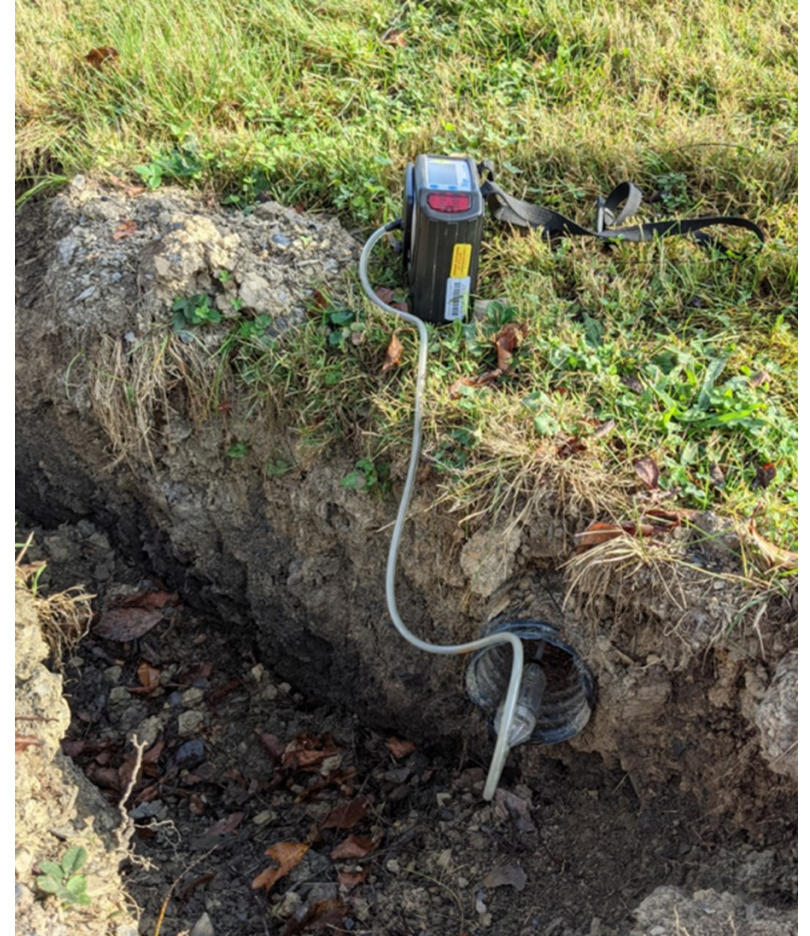
# Dug Trench Samples

| Site | Date | Time | CO2 % volume | O2 % volume |
|---|---|---|---|---|
| | 10/15/2021 | 10:27 AM | 4.9 | 17.4 |
| | 10/7/2021 | 10:20 AM | 4.4 | 18 |

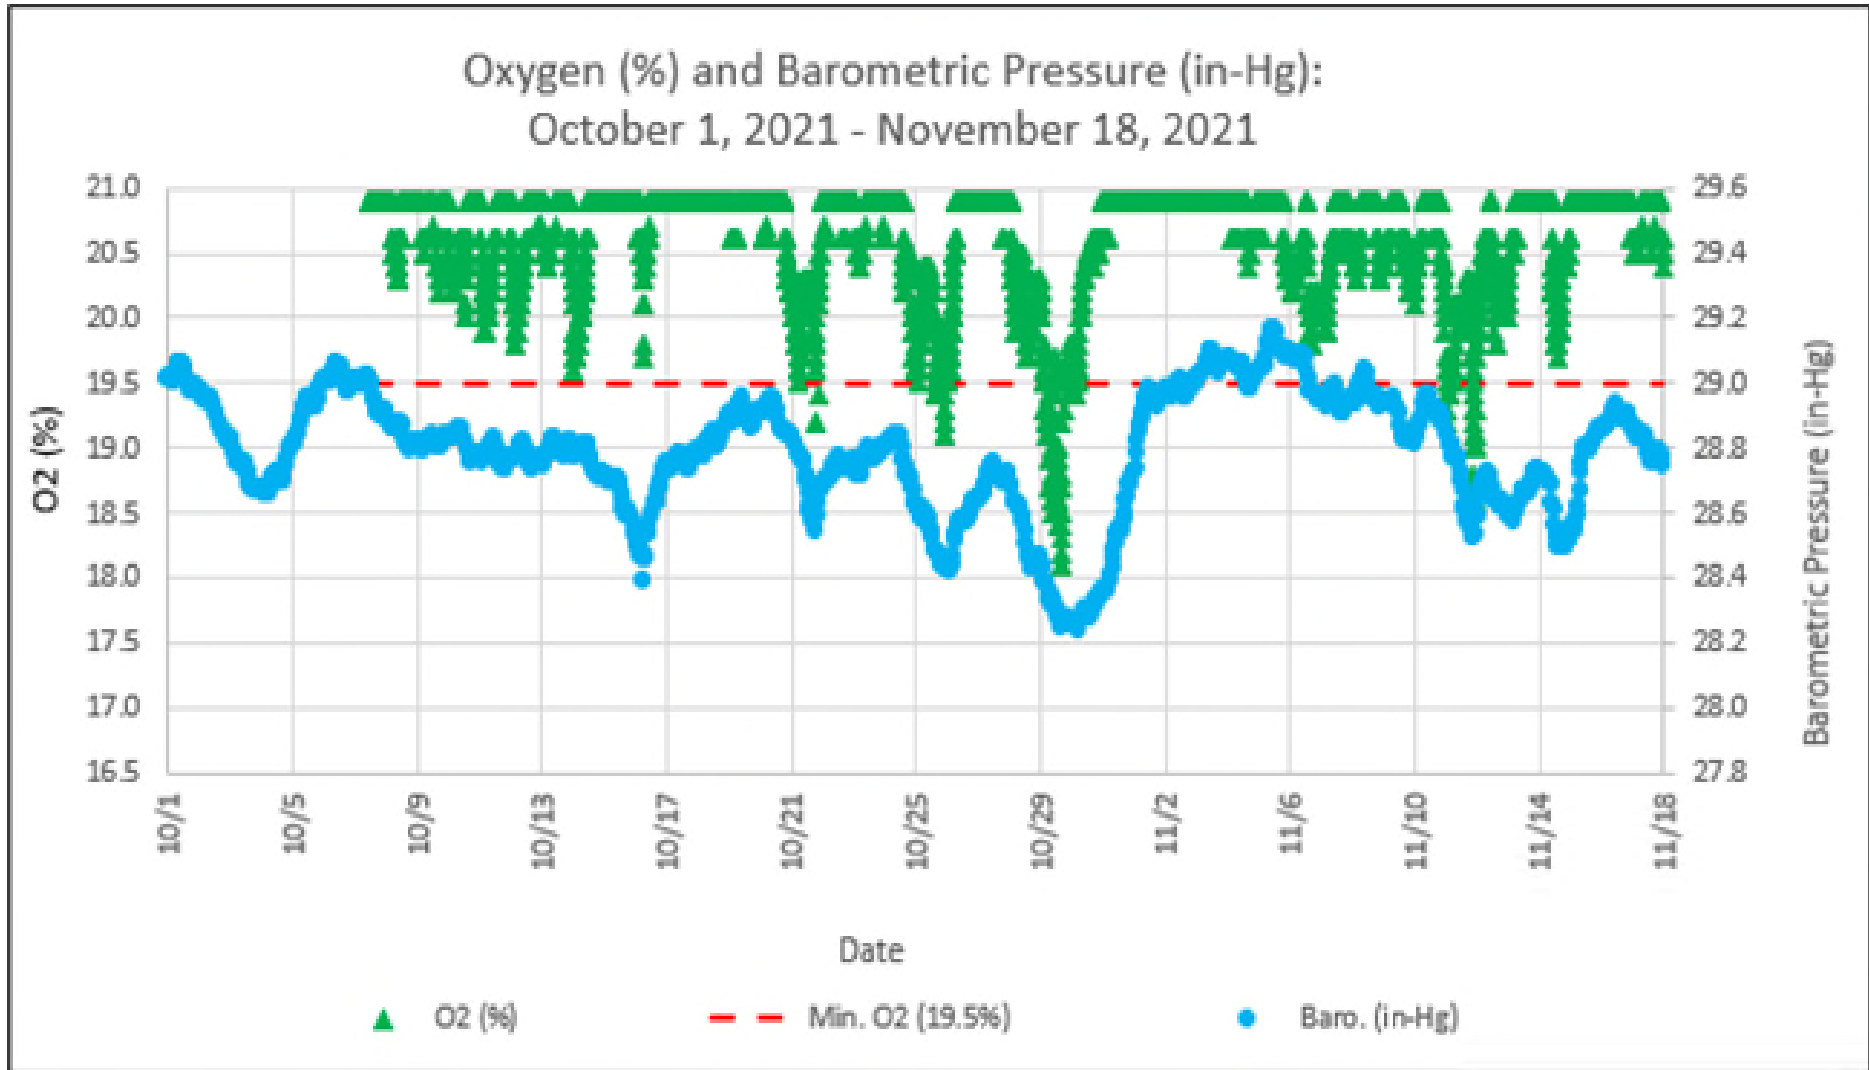
# Indoor Long-term Monitoring

- A gas meter was placed inside the residence to record gas values every 10 minutes during the investigation. Since  $\text{CO}_2$  is heavier than  $\text{O}_2$ , the gas meter was placed in the **basement**. Barometric pressure was tracked during the investigation.
- Spot gas samples were taken around the property and in the residence.

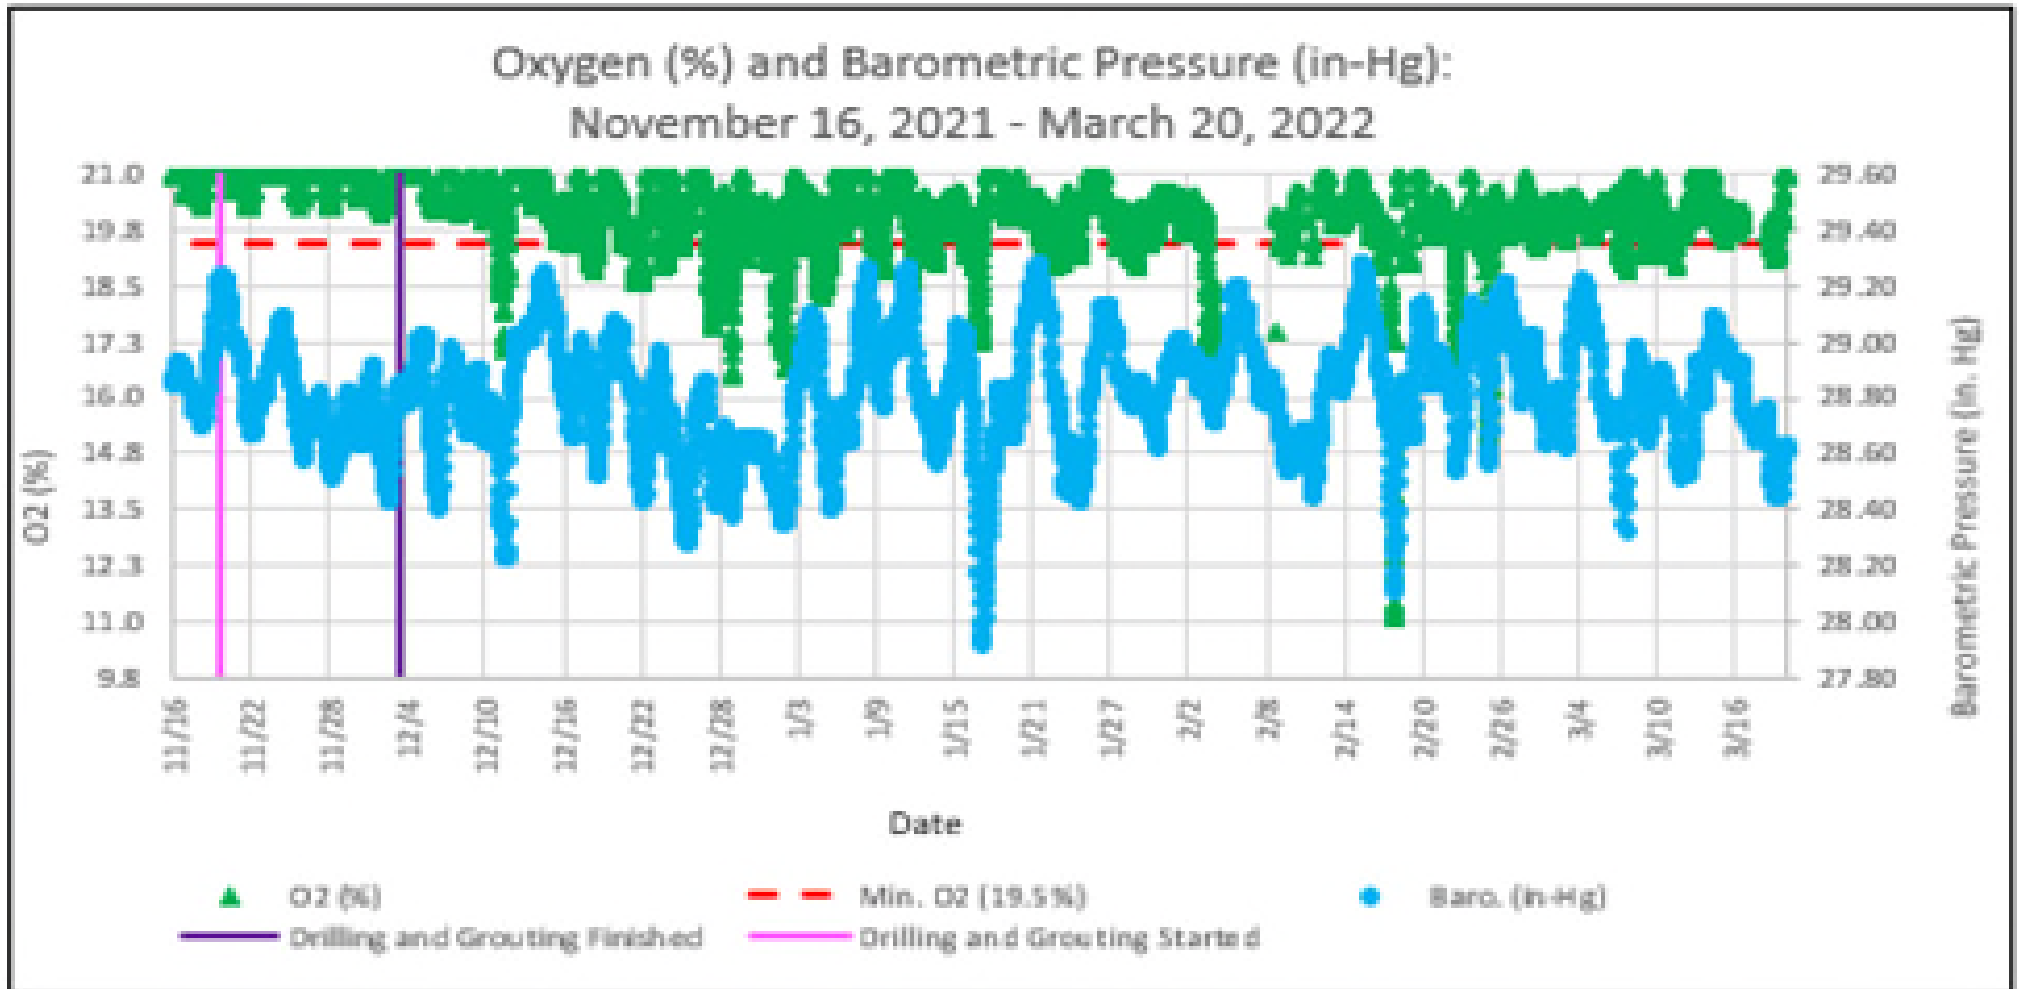
# Remediation Plan Effectiveness

- Long-term gas monitoring was discontinued on May 20, 2022.
- **The O<sub>2</sub> levels remained above 19.5% (20%) for approximately 30 days. (March 25 – April 14 and May 13 – 20, 2022).**
- The CO<sub>2</sub> levels were below the EPA's recommended level of 1.0% for approx. 30 days.
- **Special thanks are extended to PADEP-BAMR for allowing OSMRE to share their mine gas remediation project with the reclamation community and Ken Eltschlager (OSMRE-Mining Engineer).**
- The combination of filling the mine void space, providing a new pathway for the CO<sub>2</sub> gas, and **increasing the ventilation with fans was effective at remediating this relatively large site (~ 1 acre).**
- This successful remediation was unique since historically PADEP-BAMR has had successful remediation from only filling in the void space at smaller sites (~ 0.5 acres).

- 12 holes in total
- 3 locations will be bulk heads (G1-G3)
- “The plan is to build three bulkheads to reduce run away grout and allowing for the increased flowability of a fly ash grout to make sure to saturate the mine and roof fracturing.”
- 8 angle and vertical drill holes
- 2 degasification holes
- 1 degasification by driveway (unlabeled) [green filled circles]
- Used historical mine map for the location of void spaces.
