# STREAM RESTORATION DESIGN FOR NORTH FORK, INDIAN CREEK, ELKHORN MOUNTAINS, MONTANA <sup>1</sup>

**Abstract.** The North Fork of Indian Creek, a stream located in the Elkhorn Mountains, approximately 10 miles northwest of Townsend, Montana, has been selected for restoration. The stream, 4.5 miles long, is damaged by severe flood events and fluvially deposited streamside tailings from breached tailings impoundments. The stream is characterized by downcutting, incisement, vertical, unvegetated banks, and dysfunctional riparian areas. Prior to stream restoration, streamside tailings and remnants of the tailings impoundments will be removed to a repository. Subsequent restoration activities have been delineated into two types. The stream reaches through the two impoundments will be completely reconstructed. In total, roughly 550 ft. of new stream will be constructed. These reaches are located near the stream headwaters as well as in high gradient (8-10%) valley areas. Channel and floodplain reconstruction was based upon analysis of basin hydrology, (i.e.; determination of the bankfull discharge) and analysis of channel planform and profile. Meander planform and profile was selected t

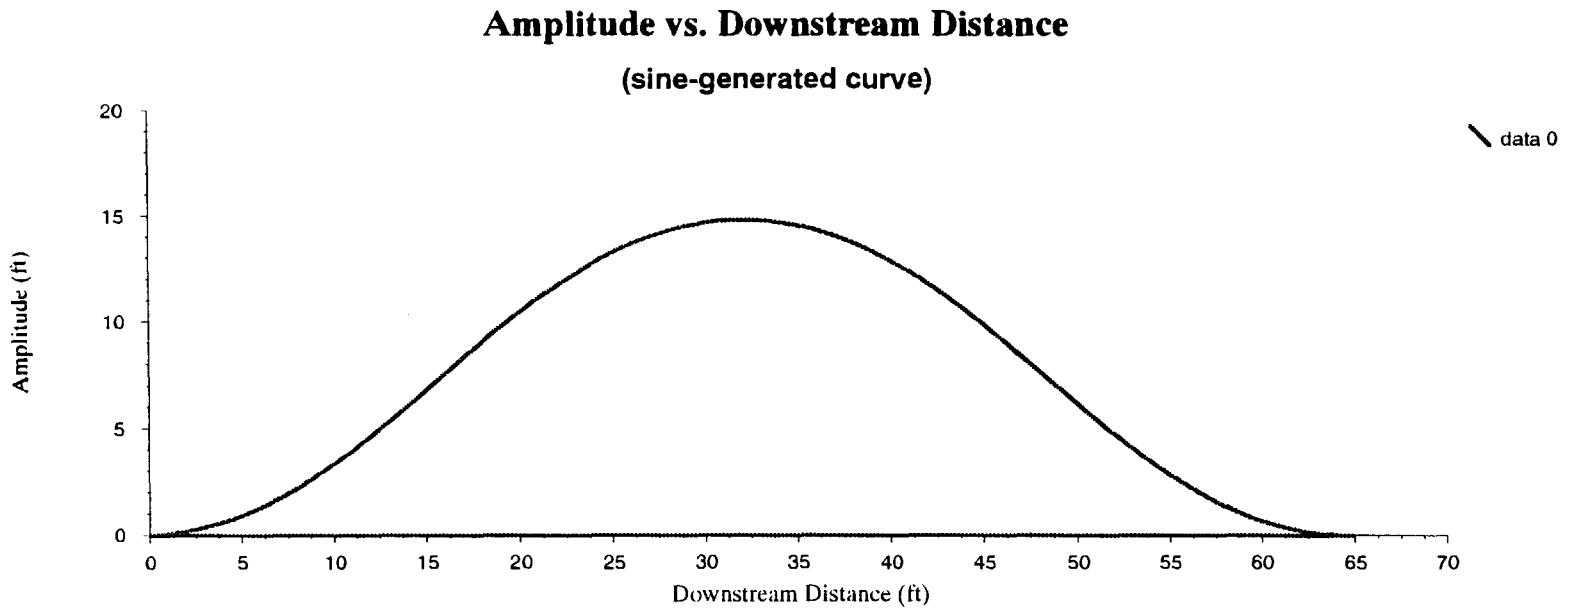
Figure 7. Stream Meander Curve

the meander amplitude as a function of downstream distance was plotted, Figure 7. This sine-generated curve represents the channel shape which minimizes the work of erosion on the banks, and the average path of random walks of a given length between two fixed points (Leopold 1994). Figure 7 shows a single meander. Three of these meanders will be joined to form each of the two new reaches. The planform and profile views of the new reach design is shown in Figure 8.
