# HIGH ALTITUDE MINE WASTE REMEDIATION - IMPLEMENTATION OF THE IDARADO REMEDIAL ACTION PLAN<sup>1</sup>

**Abstract:** The Idarado Mine in Colorado's San Juan Mountains includes 11 tailings areas, numerous waste rock dumps, and a large number of underground openings connected by over 100 miles of raises and drifts. The tailings and mine wastes were generated from different mining and milling operations between 1875 and 1978. The Idarado Remedial Action Plan (RAP) was an innovative 5-year program developed for remediating the impacts of historic mining activities in the San Miguel River and Red Mountain Creek drainages. The challenges during implementation included seasonal access limitations due to the high altitude construction areas, high volumes of runoff during snow melt, numerous abandoned underground openings and stoped-out veins, and high profile sites adjacent to busy jeep trails and a major ski resort town. Implementation of the RAP has included pioneering efforts in engineering design and construction of remedial measures. Innovative engineering designs included direct revegetation techniques for the stabilization of tailings piles, concrete cutoff walls and french drains

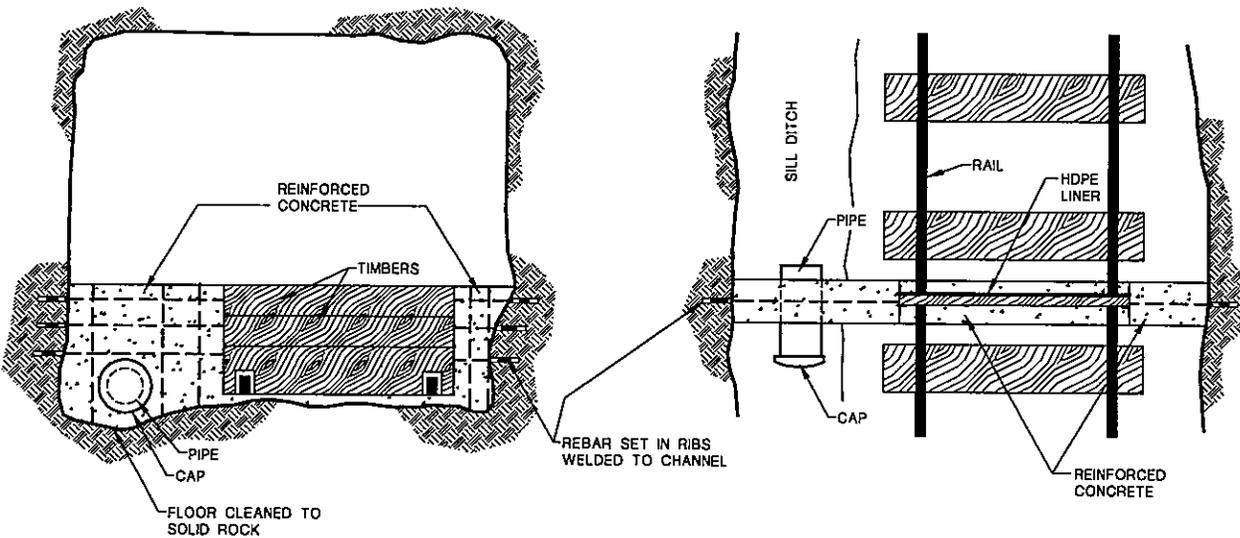
*Figure 5 – Underground Source Control – Sediment Trap*

Underground Mine. Twenty sediment traps have been constructed along drifts on the 1200 and 2900 levels where the highest flows have been historically observed. The sediment traps have been constructed in groups of 6 or 8 and intercept water coming out of the Black Bear Raise, 13 Argentine Raise, and 48 Argentine Ore Pass. The sediment traps are generally 250 feet (or one block) apart. A typical sediment trap design is included on Figure 5. In general, the sediment traps are approximately 3 feet high, 8 inches thick, and 8 to 12 feet wide (depending on the width of the drift) and constructed with reinforced concrete. The horizontal rebar is epoxy grouted into drillholes in the ribs, set between the forms, and welded to a steel channel into which 12-inch timbers are placed. The timber inserts are required over the tracks to provide access for the rail equipment for maintenance and cleaning of sediment traps located further up the drift. Sediment traps collect water flowing down the 2913 Argentine Raise, 2948 Argentine Ore Pass and the 1200 Level Tomboy Raise.

Mine diversions included collection dams, half-dams, and portal plugs behind which water would collect and be diverted away from mineralized areas using a system of pipes or sill ditches. The collection dams were designed to collect flow from a sill ditch and divert it into a pipe. Half-dams were constructed across the full width of the drift to also divert the flow into a pipe. Half-dams were typically 3-foot tall and allowed for a greater storage capacity during high flow times. Portal plugs were required at four mines (Union, Penn, Bullion, and Ophir). The plugs were designed to prevent discharges from the portal thereby causing water to back up and travel down known pathways in the mine for collection from a lower level. Finally, sediment traps were required to reduce suspended solids in the Mill and Meldrum portal discharges.

All underground structures were constructed with reinforced concrete and located where there was adequate structural confinement and the best local rock quality. The RAP required that the structures be constructed on competent ground. Preparation of the surrounding rock to be used at the concrete-rock interface included removal of loose material and excavation of a key in the ribs into which rebar was set to tie the concrete to the surrounding rock.
